INTERIM REPORT

ACOUSTIC EMISSION MONITORING OF STEEL BRIDGE MEMBERS

May 1995
VTRC 95-IR1

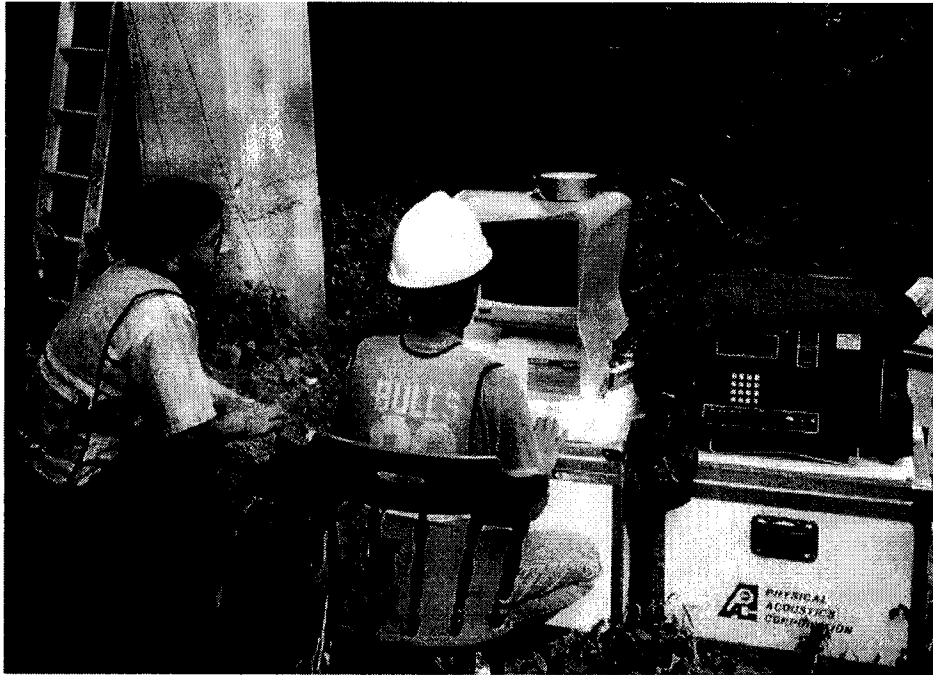
Figure 2. Spartan unit and 386 MHz personal computer.

An 8-channel Spartan AT AE data acquisition system manufactured by PAC was used to test the bridges. The entire system consisted of the Spartan unit and a 386 MHz personal computer (PC) (Figure 2). All system functions were controlled by the SA-LOC software program running in a DOS environment. Figure 3 is a block diagram of the system.

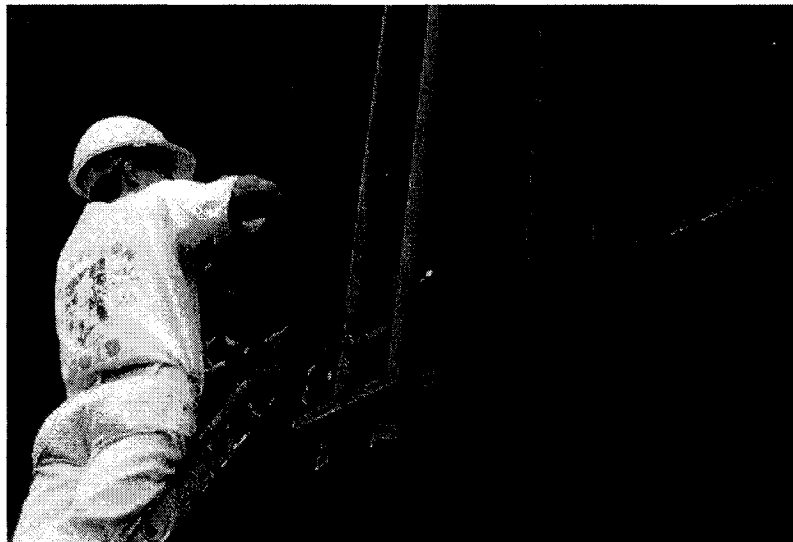
Figure 5. Pin and hanger connection, Rte. 460 bridge in Glenlyn, VA. Sensor and magnetic hold-down are attached to the end of the pin.

The pins were 0.31 m (1 ft) long and 102 mm (4 in) in diameter at the widest section. An R30I sensor was attached to each end of the two pins, as close as possible to the axial center of the pin. Figure 5 shows one end of a cracked pin where a sensor was placed. Magnetic hold-downs attached the sensors to the cracked pin, while duct tape was used to mount the sensors on the stainless steel pin. The Spartan system was configured to perform linear source location and an old pin that had been removed before the test was used to check the accuracy of the system settings. Since the pins being monitored were not exposed, the actual sensor set-up was simulated on the old pin and pencil lead break tests were performed along the length of this pin.

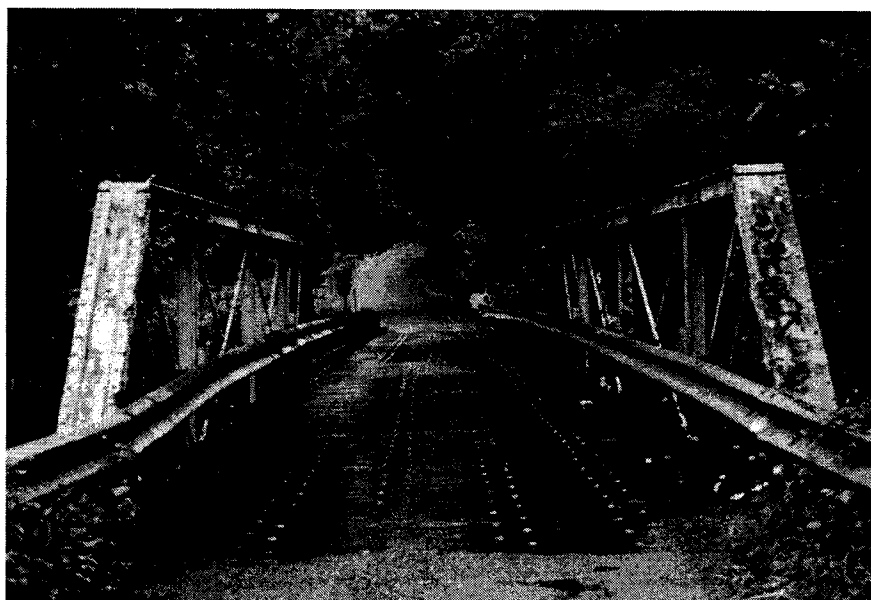
Figure 11. Rte. 671 bridge over the Moormans River in Albemarle Co., VA.

The Rt. 671 bridge over the Moormans River in Albemarle County (Figure 11) was monitored on July 27, 1994. A load limit of 3 tons had been posted for the bridge, due in part to a crack on one of the 19 mm (3/4 ") square diagonal counters (Figure 12). This was the only defect monitored for AE.

The part monitored had a simple geometry and the crack was well separated from possible noise sources. Noise could propagate only from the ends of the bar. Two R30I sensors were attached 152 mm (6 in) apart on opposite sides of the crack. These sensors were set up to do linear source location. A WD sensor for recording waveforms was mounted close to the crack on the opposite side of the bar.

The AE equipment was set up away from the bridge. Being on a secondary road, the bridge was loaded very intermittently. The crack was monitored for about 1.5 hours during a steady rain.

Although AE was detected every time a vehicle passed, only three events were recorded by the source location program, none of which came from the location of the crack. The triggering threshold of the TRA had been set at absolute minimum, yet no signals detected were strong enough to trigger it. No waveforms were recorded. The results show that the crack is benign and has become inactive. The unbroken appearance of the rust covering the crack tends to support this conclusion.

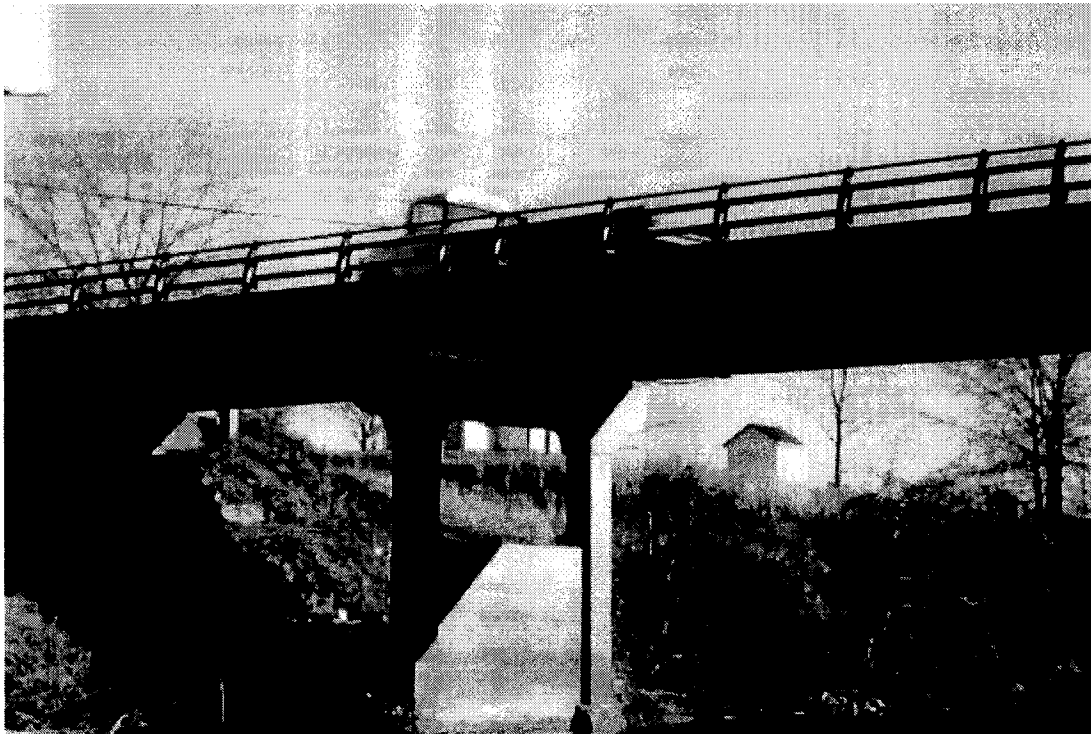
Figure 18. Rte. 29 north-bound bridge over the Robinson River in Madison County, VA.

The bridge, built in 1934, has 4 steel girders extending over 5 spans with an overall length of 59 m (193 ft). The suspended span #2 (Figure 18) is supported by 8 pin-and-hanger connectors on the north end and by a pin joint on the opposite end. The 609 mm (24 ") high by 165 mm (6.5 ") wide hangers, with a 229 mm (9 ") x 64 mm (2.5 ") slot cut out from the middle, were fabricated from 16 mm (5/8 ") thick steel plate.

During a regularly scheduled inspection in October 1992, cracks were found on two of the hangers. The east exterior hanger had one 9.4 mm (0.37 inch) long crack. Three similarly located cracks were found on the west interior hanger. The longest was 36 mm (1-7/16 ") and the shorter upper crack was 6 mm (0.25 in) long (Figure 19). The third crack, which is not a through part crack, does not appear in the figure and was visible only at the surface of the internal slot. All the cracks initiated at this internal cavity at practically the same location. Bolted catch plates were installed on both hangers to prevent collapse in the event of sudden failure of the hangers.

Both cracked hangers were monitored during the first AE test. An R30I sensor was attached as closely as possible to each crack. Sensor 2 was positioned close to the crack on the east hanger while sensors 1 and 3 were mounted on the ends of the pin (Figure 20). Sensors 4 and 5 monitored the two upper cracks and the lower crack on the west hanger (Figure 21). The WD wideband sensor 6 was installed on the top pin of the west hanger. Sensor placement was not originally intended to perform source location.

The results showed that a significant portion of all the detected AE events occurred close to sensor #4 at the upper crack, west hanger. Most signals were detected by only 1 or 2 sensors but the high amplitude events regularly hit three sensors (4, 5 and 7). The TRA data also showed that the highest amplitude signals originated there. Waveforms were collected from the WD sensor and sensors 1, 4, 5 and 6. The TRA was set at the lowest threshold possible, to maximize sensitivity. At this level, only the WD sensor and R30I sensor 4 detected signals that were recorded by the TRA. Apparently AE activity during the period of AE monitoring was greatest near the upper crack, although it could not be ascertained then if the AE signals were coming from the crack itself or from the nearby pin. These results were the basis for the decision to concentrate the monitoring effort on the upper crack of the west hanger in the next test.
