# FINAL REPORT

## EVALUATION OF UNDERDRAIN ON I-295

1. Report No. VTRC 96-R32	2. Government Accession No.	3. Recipient's Catalog No.	
4. Title and Subtitle  Evaluation of Underdrain On I-295		5. Report Date March 1996

The effectiveness of shoulder edge drains on I-295 south of Richmond was evaluated. Three adjacent outlets were monitored for outflow over a period of several months. Rainfall and outflow intensity and duration were continuously recorded using tipping bucket gages interfaced with a datalogger. The results indicated “excellent” to “good” quality of drainage, according to AASHTO criteria.

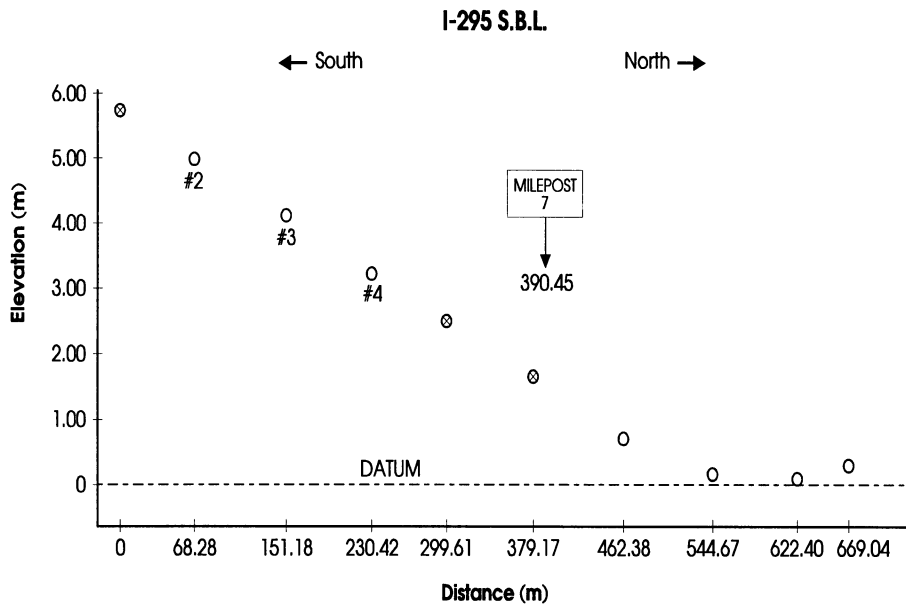
**Figure 2. Profile of outlets.**

NOTE: Outlets #2, #3, and #4 were monitored  
 ⊗ Denotes blocked outlet

The available instrumentation allowed a simultaneous monitoring of three outlets. It was decided to monitor three adjacent outlets with different invert elevations to assess the influence of the longitudinal roadway slope. Before selecting the test location, approximately 64 outlets were checked for obstructions with the Cues Mini Scout camera system. The objective was to find three unblocked outlets in a row, on a sloping portion of the roadway at an accessible location. Ultimately the monitoring was performed on I-295 south of Richmond, approximately 11 km from the merge with I-95. The pavement and underdrain cross section is shown in Figure 1. The longitudinal profile of the S.B.L. with outlet elevations is shown in Figure 2. Outlets labeled as #2, #3, and #4 were monitored.

Based on the AASHTO criteria for evaluating the quality of drainage, outlet #2 can be classified as "excellent," and the others as "good." A general trend of worsening quality of drainage (increasing drainage time) with the decrease in elevation is seen. Outlets located below #4, as shown in Figure 3, may be expected to drain significantly longer following the rain event.

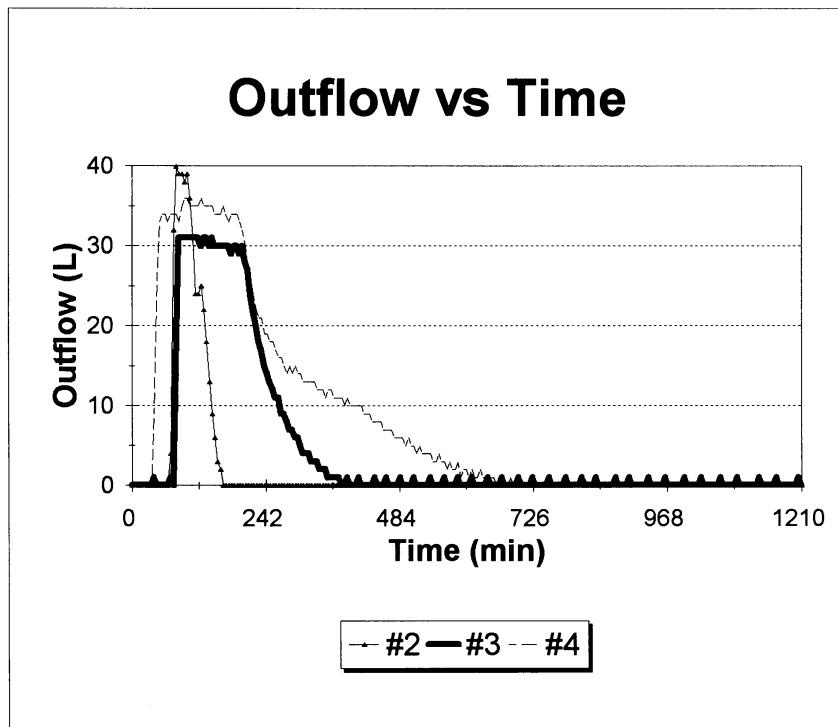
**May 8, 1994**

Field monitoring results are presented in Appendix A. Data represent cumulative flow values recorded in 5-minute segments. Various intensity rain events that occurred in the period of May 8 to October 23, 1994 are shown.

Data represent the performance of outlets spaced at 89 and 79 meters apart on a longitudinal roadway slope of approximately 1%. It can be seen that tipping buckets measuring the edge drain outflow frequently exceeded their measuring range, as evidenced by the flattening of the outflow graph (Appendix 1). Drainage times were found to increase with decreasing outlet elevation. It is evident that the outflow starts first and finishes last at the lowermost outlet. The following lag times after the end of the rain event were calculated:

<b>Date of Rain Event</b>	<b>Maximum Rainfall (mm/min)</b>	<b>LAG AFTER THE END OF THE RAIN EVENT (hr)</b>		
		<b>#2</b>	<b>#3</b>	<b>#4</b>
May 8,'94	0.36	0.6	4.4	8.8
July 4	0.30	0.5	2.5	5.2
July 17-18	1.80	0.6	3.4	6.6
Sept. 17-18	0.87	0.7	2.3	5.0
Sept. 25-26	1.62	0.6	3.2	7.5
Oct. 23	0.42	0.5	3.2	7.6
