INTERIM REPORT

**PILOT APPLICATIONS  
OF ELECTROCHEMICAL  
CHLORIDE EXTRACTION  
ON CONCRETE PIERS  
IN VIRGINIA**

**May 1996  
VTRC 96-IR4**

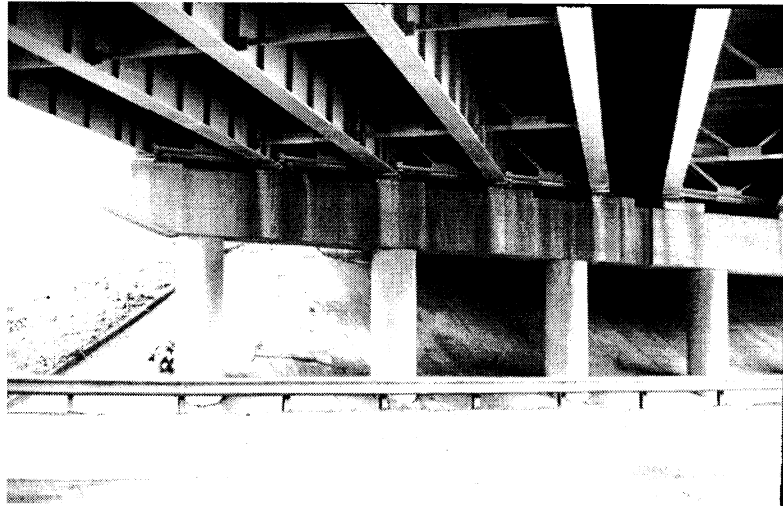
The concrete piers of a 27-year-old bridge on 5th Street (Rt. 631) over Interstate Route 64 in Charlottesville, Virginia were used in this study (Figure 1). The bridge has three pairs of concrete piers, each pair divided by a joint into an east and a west section. The lengths of the caps on the selected piers, which have a rectangular cross section of 1.3 m by 1.5 m (4.3 ft. by

*Figure 1. The concrete piers of the 5th Street Bridge over Interstate Route 64, Albemarle County, Virginia.*

4.8 ft), vary from 13.9 to 16.1 m (45.5 to 53.0 ft). The circular columns have a diameter of 1.1 m (3.5 ft), and vary in height (above ground) from 5.6 to 6.5 m (18.5 to 21.3 ft).

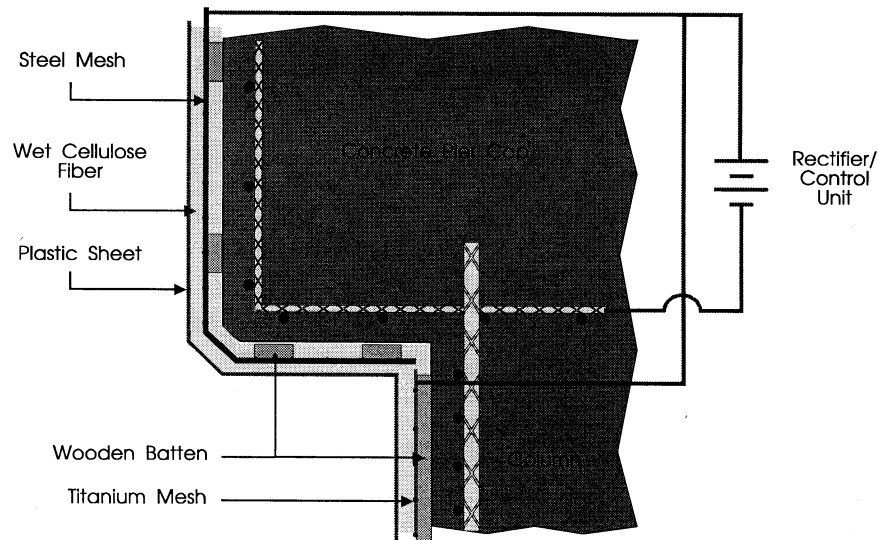
The Norcure™ anode system is a mesh anode surrounded by wet cellulose fibers. As Figures 2 and 3 show, steel mesh was used as anode on the pier caps. Inert catalyzed titanium mesh, which is not as stiff as steel mesh, was used on the curved end of each cap and the columns. The installation of this anode system on each of the piers proceeded as follows:

*Figure 2. Cross section plan of the setup for the ECE treatment of the concrete piers.*

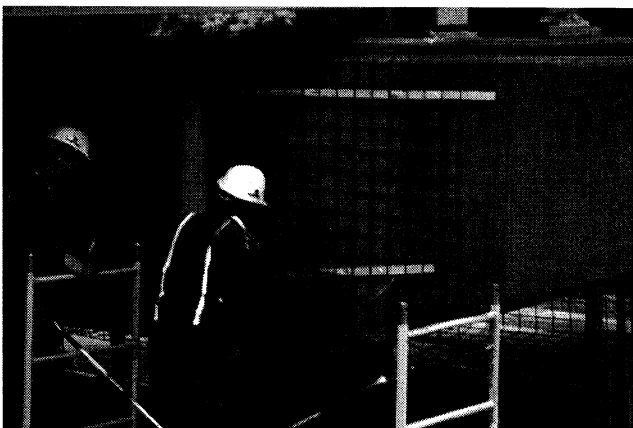
3. Placement of enough sections of 6 mm (0.25 in) thick steel mesh around each cap to cover everything except the curved end. (The mesh was pre-formed to fit over the wood spacers and around the caps.) All the mesh was secured around each cap with plastic ties, by running each tie underneath a wood spacer and over the mesh (Figure 4).

Figure 4. Construction workers securing a section of formed steel anode mesh around a pier cap.

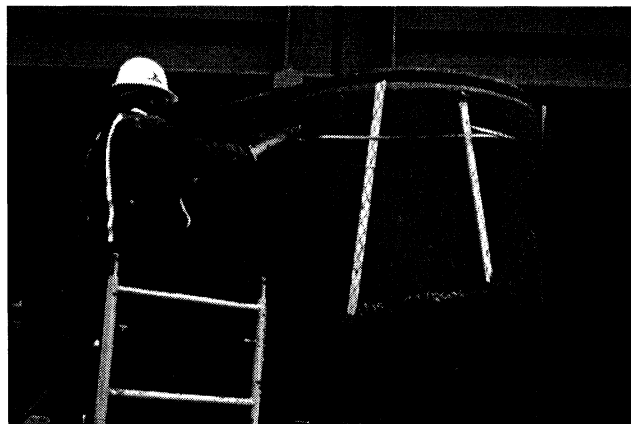
4. Connecting an insulated copper lead wire, of adequate gage, to each of the ground connections. Each connection was then waterproofed with epoxy.
5. Covering the entire cap, except the bearing pads, with wet cellulose fibers, by spraying the wet fibers over the cap until the layer is at least 50 mm (2 in) thick (Figure 6).

*Figure 6. Spraying wet cellulose fibers over the concrete pier cap.*

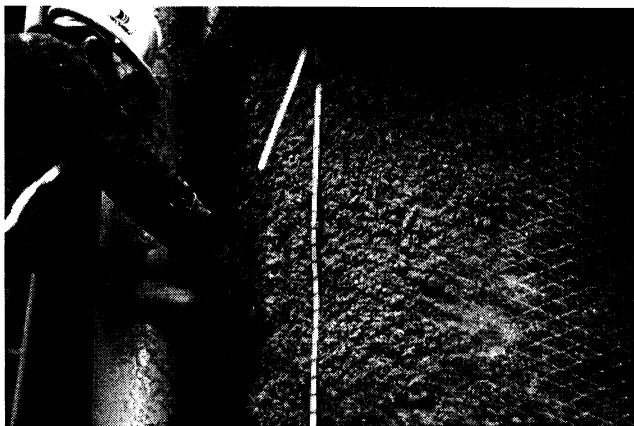
*Figure 8. Worker securing titanium mesh around a pier column coated with a layer of wet cellulose fibers. Note the titanium ribbon welded to the mesh.*

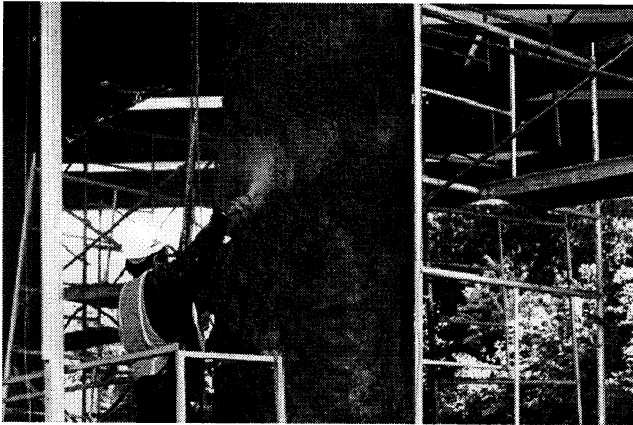
9. Application of a second layer of wet cellulose fibers over each column, to completely cover the titanium mesh (Figure 9). Including this layer, the fibers applied on each pier column totaled approximately 50 mm (2 in) thick.
10. Wrapping each column tightly, from top to bottom and allowing for considerable overlapping between turns, with a continuous piece of plastic film, such as Shrink Wrap (Figure 10). Figure 11 shows an entire pier completely wrapped.

*Figure 9. A final layer of wet cellulose fibers sprayed on a column, completely covering the titanium anode mesh.*

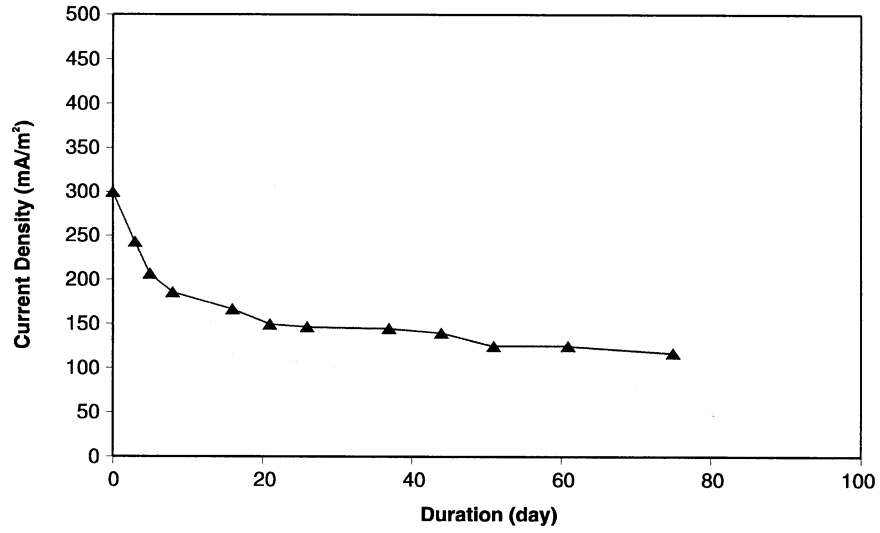
Figures 12 to 14 show the change in the density of direct current passing through each pier during treatment, which lasted from 72 to 77 days. The current passing through each pier, in general, decreased exponentially as treatment time increased. For example, in pier 1 the current started at  $300 \text{ mA/m}^2$  ( $27.9 \text{ mA/ft}^2$ ) and ended at  $117 \text{ mA/m}^2$  ( $10.9 \text{ mA/ft}^2$ ). This trend is commonly observed in the first several months of operation of cathodic protection systems, and is the result of a net increase in the electrical resistance of the concrete, which arises from the redistribution of different ions in the concrete. Table 2 summarizes various electrical parameters recorded for all piers during their treatment.

Figure 12. The treatment current passing through pier 1 under a constant voltage that averaged 38.5 volts.

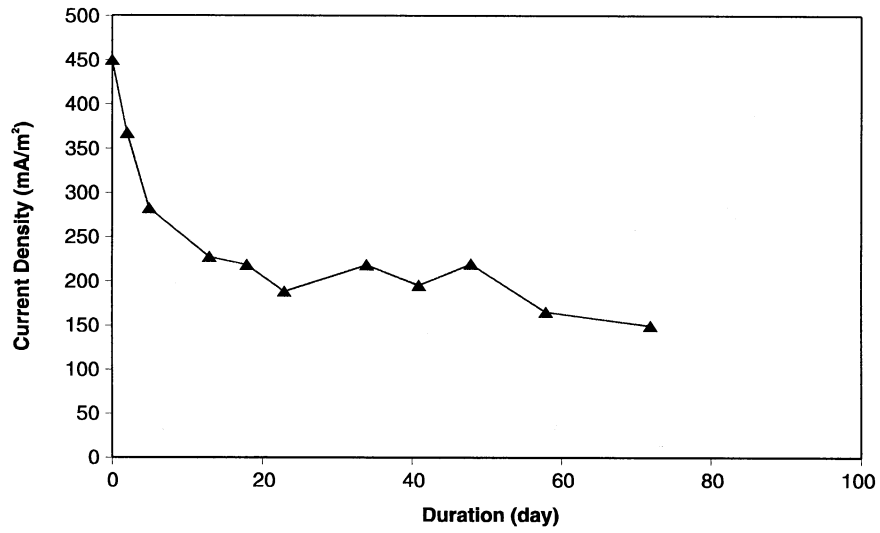
Figure 13. Current passing through pier 2 during treatment, under a constant voltage that averaged 40.1 volts.

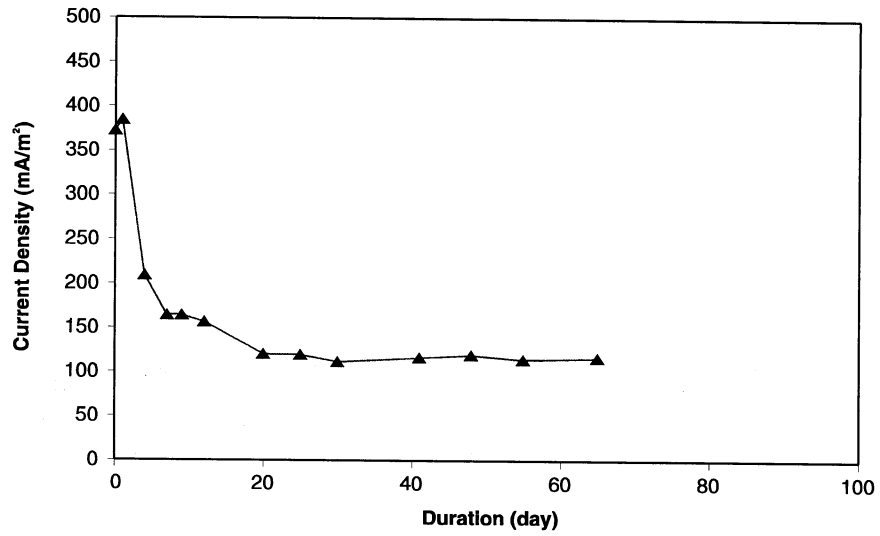
Figure 14. Current passing through pier 3 during treatment, under a constant voltage that averaged 41.2 volts.

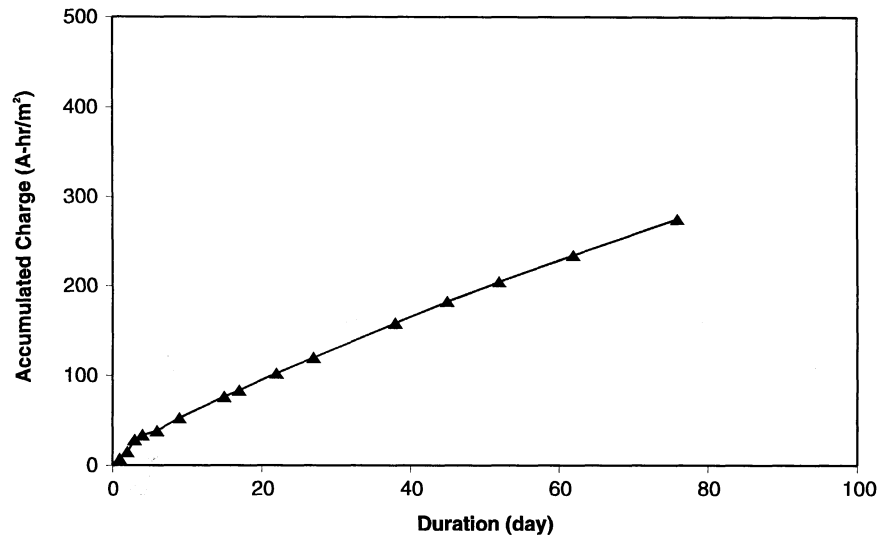
Figures 15 to 17 show the estimated total electrical charge applied on each pier at different stages of the treatment. At the end of the treatment, the accumulated charge ranged from a low of 249 A-hr/m<sup>2</sup> (23.1 A-hr/ft<sup>2</sup>) for pier 3, to a high of 382 A-hr/m<sup>2</sup> (35.5 A-hr/ft<sup>2</sup>) for pier 2 (Table 2). This range is less than the 600 to 1500 A-hr/m<sup>2</sup> (60 to 150 A-hr/ft<sup>2</sup>) suggested as typical in the SHRP Implementation Guideline.<sup>11</sup> This is perhaps due to the relatively thicker concrete cover over the rebars in these piers and the relatively high electrical resistances of the concrete, due to the quality of the concrete in these piers.

Figure 15. Total charge passing through pier 1.

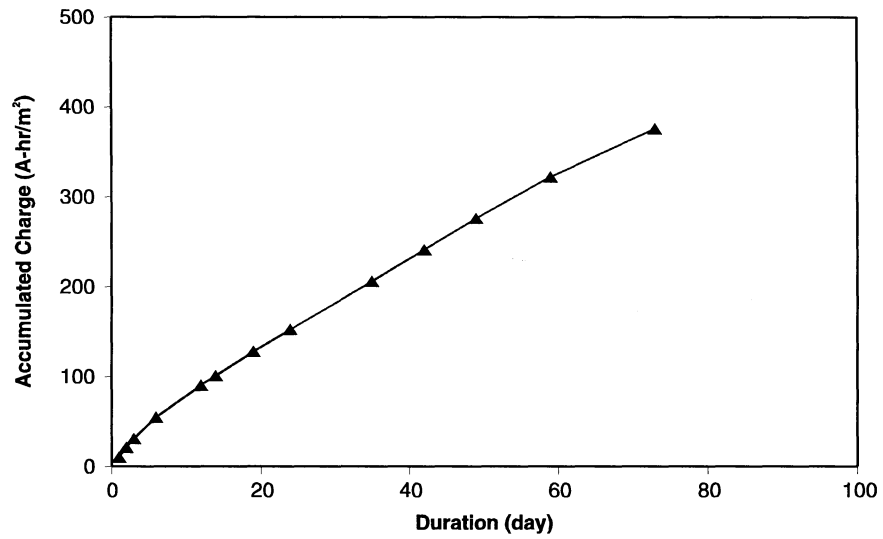
Figure 16. Total charge passing through pier 2.

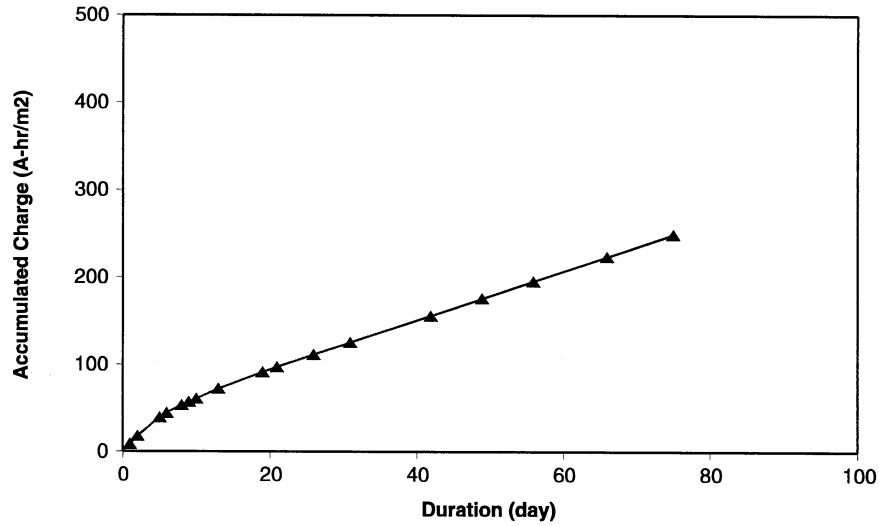
Figure 17. Total charge passing through pier 3.

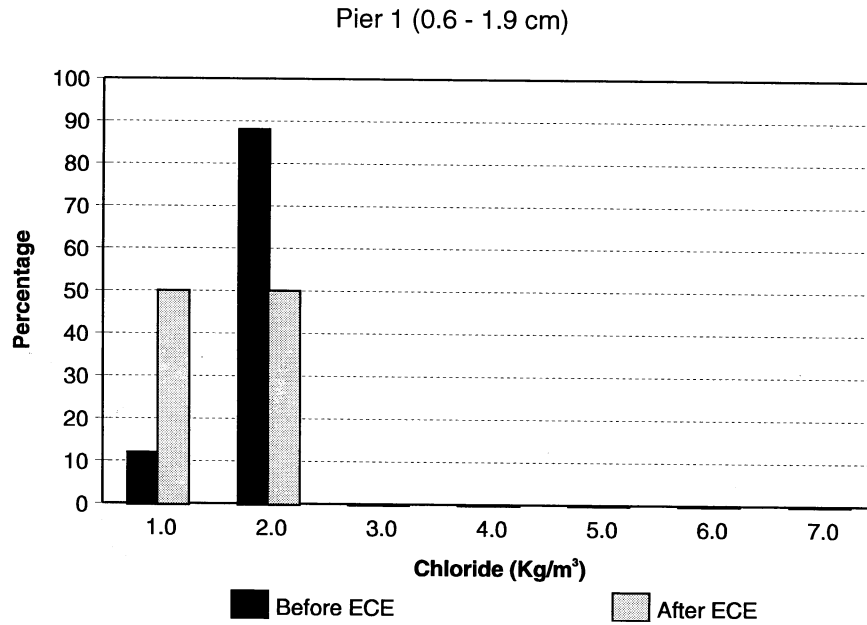
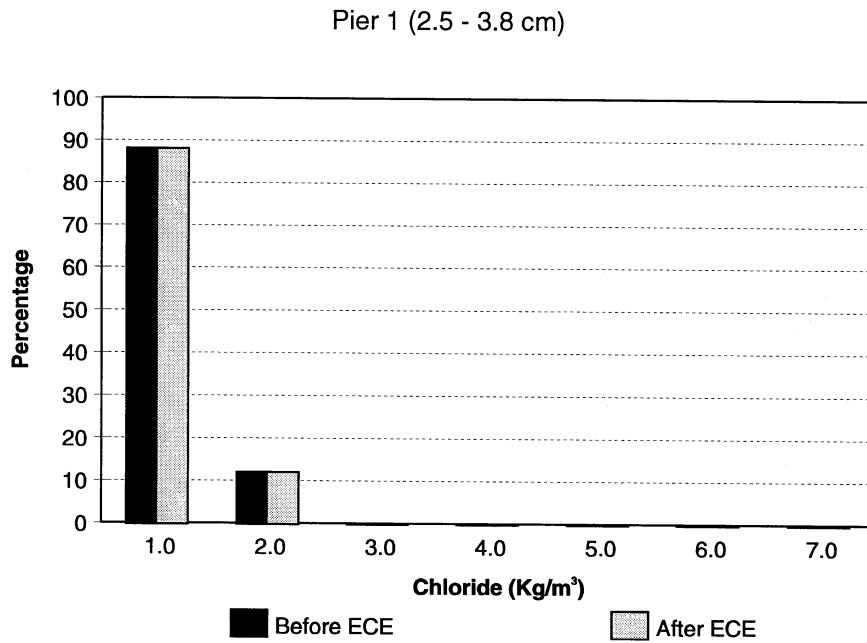
Comparison of the chloride contents in the concrete before and after the ECE treatment showed that the treatment led to a decrease in the concentration of chloride in all piers. Figures 18 to 20 show a shift in the distribution in chloride concentrations toward lower values among the concrete samples taken from each pier (at both sampling depths) after the treatment.

Figure 18. Change in the sample population distribution for chloride concentrations in pier 1, at two different depths, after ECE treatment.

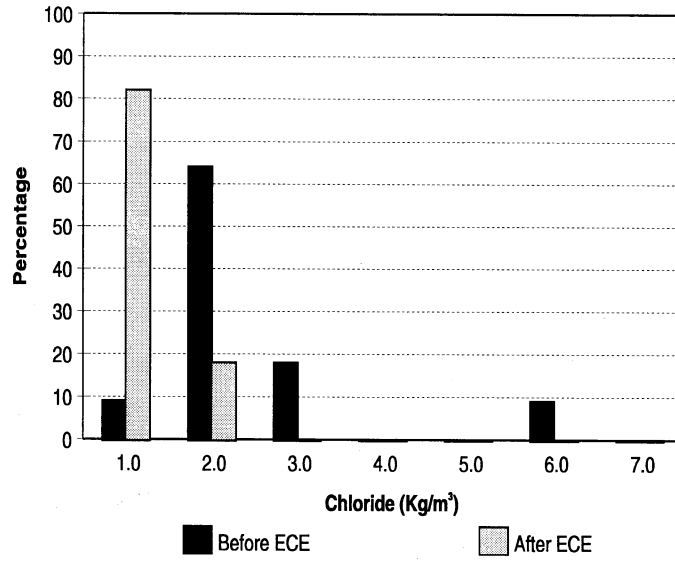
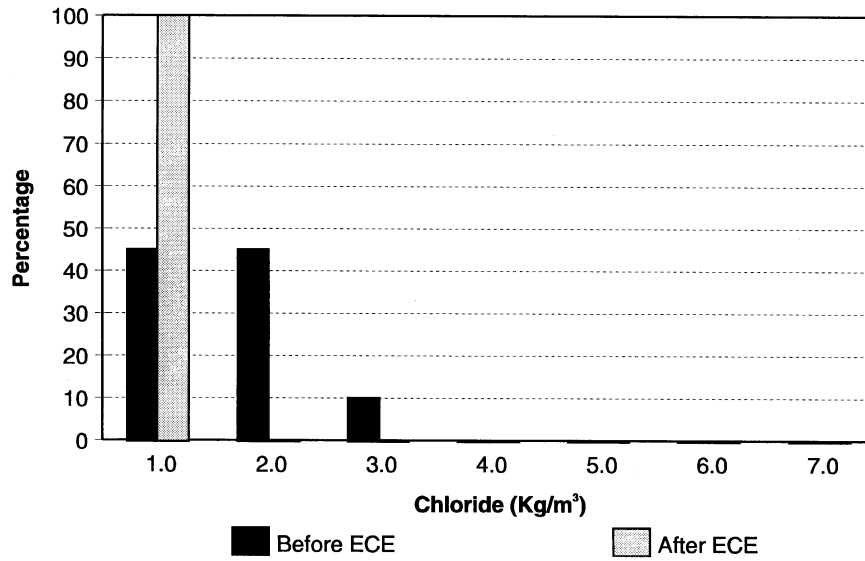
Figure 19. Change in the sample population distribution for chloride concentrations in pier 2, at two different depths, after ECE treatment.

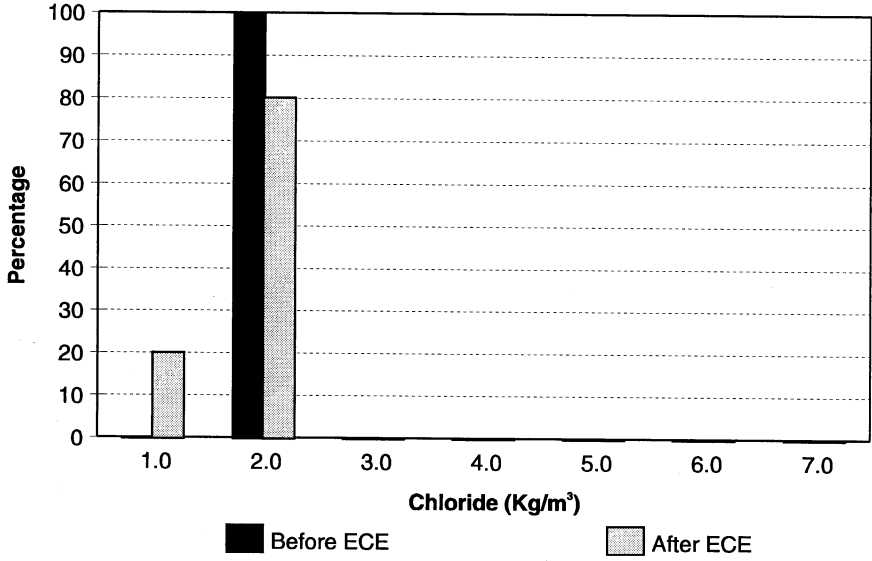
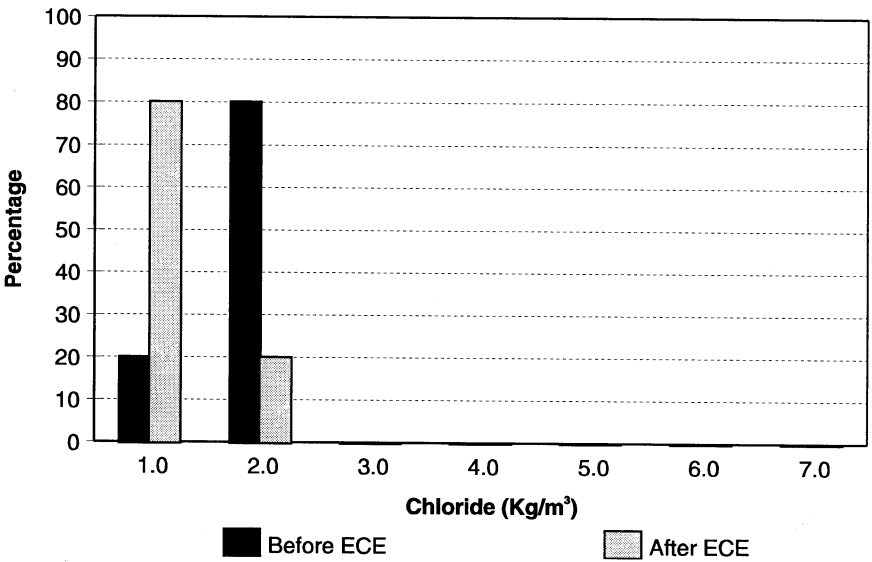
Figure 20. Change in the sample population distribution for chloride concentrations in pier 3, at two different depths, after ECE treatment.
