**FIELD STUDY
OF AN
INTEGRAL BACKWALL BRIDGE**

**Virginia Transportation Research Council
(A Cooperative Organization Sponsored Jointly by the
Virginia Department of Transportation and
the University of Virginia)**

**October 1996
VTRC 97-R7**

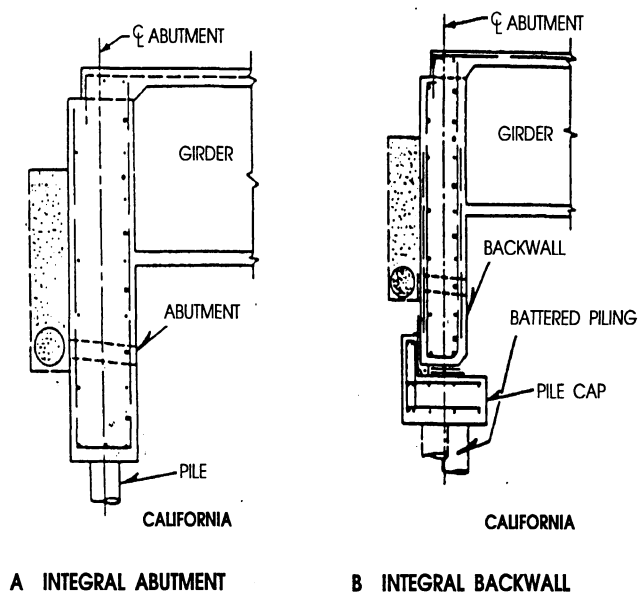
Figure 1. Examples of integral abutment and integral backwall design.

The most attractive aspect of integral bridge design is the elimination of deck expansion joints and their associated maintenance problems. Defective expansion joints often allow water and deicing chemicals to corrode key bridge components. In fully integral construction the superstructure is rigidly connected to abutments which expand against the soil backfill. In the semi-integral or integral backwall type of construction the superstructure is cast together with the backwall but separate from the underlying abutment and a horizontal joint is provided at the interface. Figure 1 shows typical design examples of each case (Soltani and Kukreti, 1992).

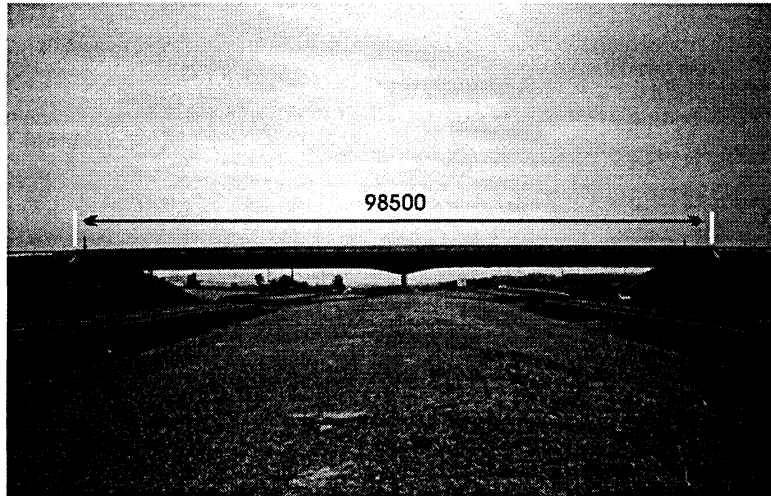
Figure 3. Bridge on Rte 257 over I-81.

An integral backwall bridge was constructed on Route 257 over Interstate 81 in Rockingham County, Virginia (Figure 2). This integral backwall bridge is a two span, steel girder composite structure, 98 m long, 25 m wide, and aligned on a 5 degree skew. Figure 3 shows the elevation view of the structure. Girders were fabricated from a high strength steel of 345 MPa yield stress. A set of bridge plans is included in Appendix A. The structure exceeds current VDOT maximum design length guidelines of 90 m. A significant design exception of this bridge is the lack of concrete approach slabs. The flexible pavement directly abuts the superstructure. Bridge designers were concerned that any remedial action necessary to rectify potential approach slab settlement would be significantly more expensive and inconvenient to the traveling public than re-grading a settling approach pavement.

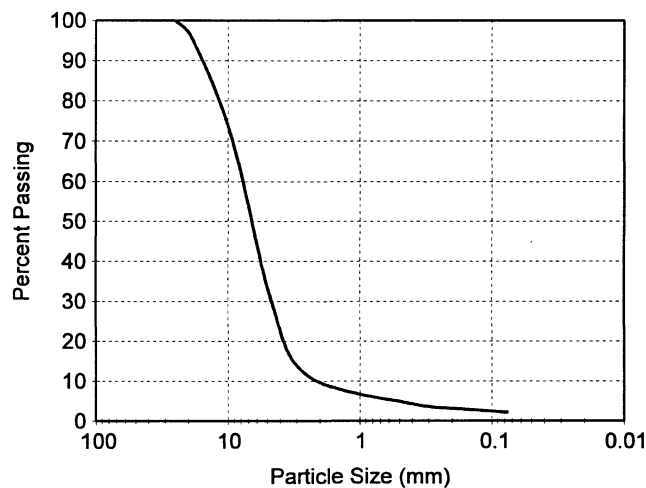
Figure 4. Backfill grain size distribution.

Before backfill placement the trench behind each abutment was approximately 2.5 m wide at the bottom and sloping back at a 1.5:1 grade. Free draining crushed stone backfill material (VDOT Type No. 78) was used. Figure 4 shows grain size distribution. Uniformly graded material is not typically used for abutment backfill in Virginia. It was selected for this particular project on an experimental basis, primarily due to its excellent drainage properties and low compressibility.

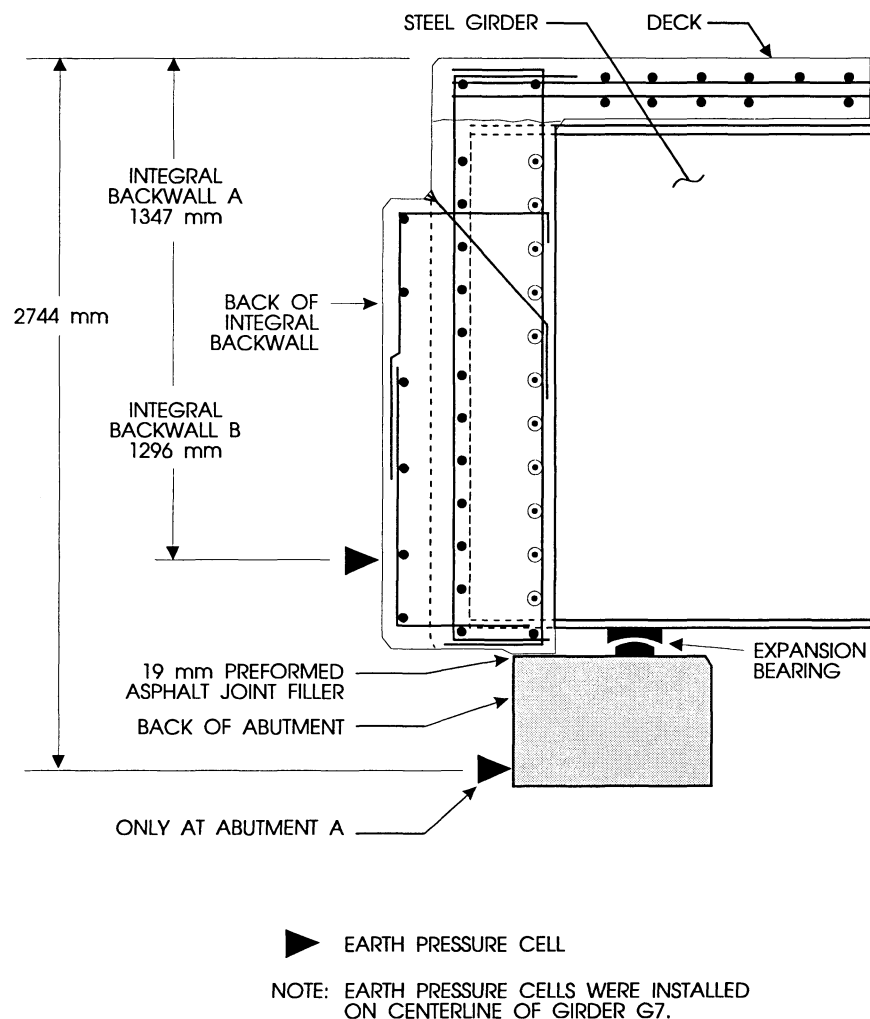
Figure 6. Location of earth pressure cells.

Instrumentation installed at Abutment A consisted of two soil pressure sensors and two strain gages interfaced with a datalogger. One soil pressure gage was installed at the back of the integral backwall and the other at the back of the abutment, on the centerline of girder G7. Geokon vibrating wire earth pressure cells, model 4800E with a range of 345 kPa, were attached to the concrete surface using a high strength epoxy compound. The location of soil pressure

sensors is shown in Figure 6. Each sensor was approximately 228 mm in diameter. Resistance strain gages produced by Measurements Incorporated were attached on top of the lower flange of girders G7 and G10, between the bearing centerline and the face of the integral backwall, as shown in Figure 7. All strain gages were of 350 ohms resistance and interconnected with Measurement Incorporated bridge completion modules. The excitation signal was provided by the datalogger.

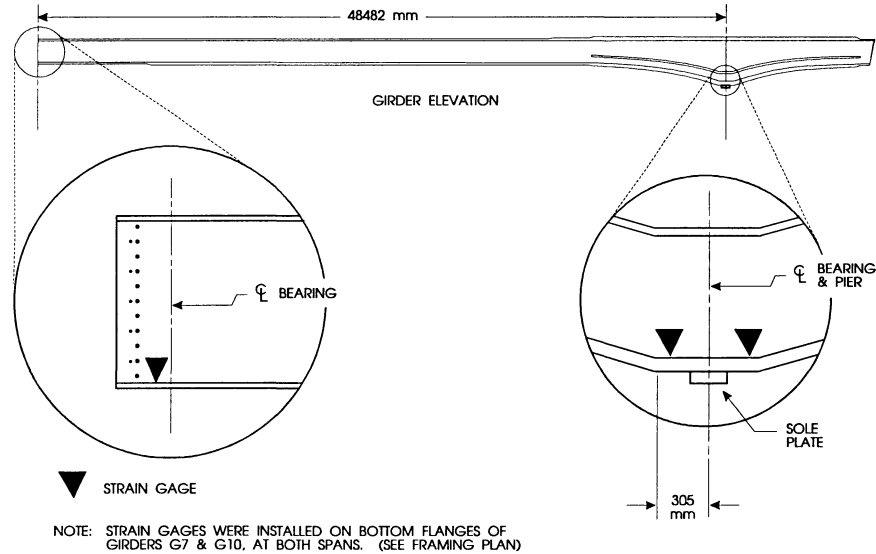
Figure 7. Location of strain gages.

Pier instrumentation included four strain gages (two at each span) installed on girders G7 and G10, adjacent to the fixed bearing assembly, and two temperature probes. One probe measured ambient air temperature in the vicinity of girder G7 over the pier. The other was coupled with a silicone grease to girder G7 to record the superstructure steel temperature.

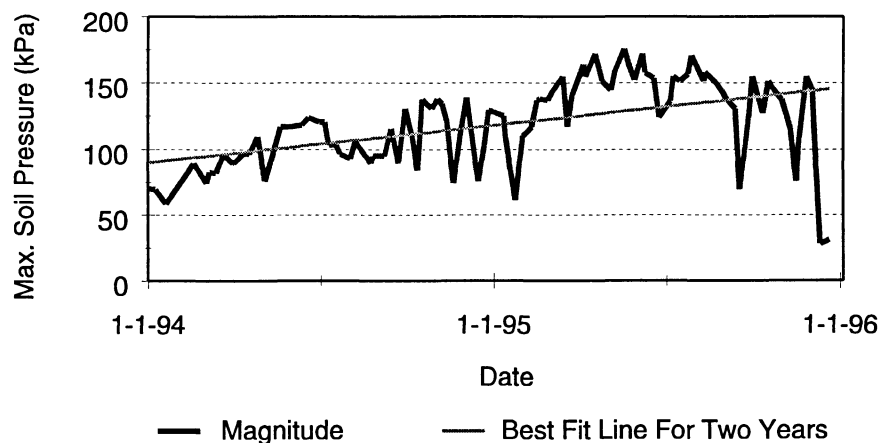
Figure 8. Maximum weekly soil pressures at integral backwall A.

Soil pressure behind integral backwall A varied considerably on a daily basis, in response to changes in the ambient air temperature. Maximum pressure was typically observed in the late afternoon and minimum in the early morning hours. Figure 8 shows a trend of maximum weekly soil pressures at integral backwall A from January 1994 to January 1996. The average magnitude increased for the first year of monitoring and leveled off in the second year. Maximum soil pressure behind the integral backwall reached approximately 175 kPa, correlating with a passive stress condition at a depth of 1.35 m.

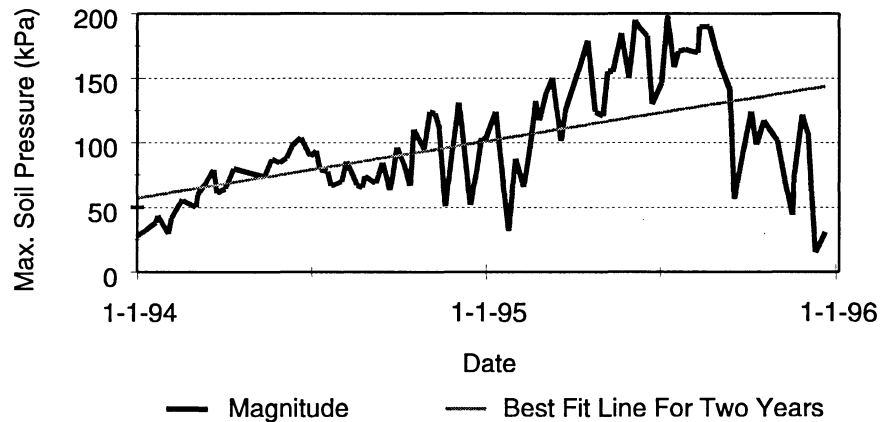
Figure 9. Maximum weekly soil pressures at integral backwall B.

Soil pressures behind integral backwall B were found to be perfectly in phase with the corresponding pressures at integral backwall A; however, the magnitudes were slightly greater. Possibly the difference was caused by a varied degree of backfill compaction at each abutment. Figure 9 shows a combined plot of maximum weekly soil pressures acting behind integral backwall B. The pattern is virtually identical to that observed at integral backwall A, with the maximum value reaching approximately 200 kPa at a depth of 1.30 m.

Stresses measured at the bottom flanges of steel girders generally corresponded to the pattern of soil pressures acting behind the integral backwalls. Typically, stress magnitudes at the ends of girders near abutment B were seen to change in response to the soil pressure exerted on the integral backwall. The shape of the steel stress plot at girder G7 was virtually the same as the shape of the soil pressure graph at integral backwall B.

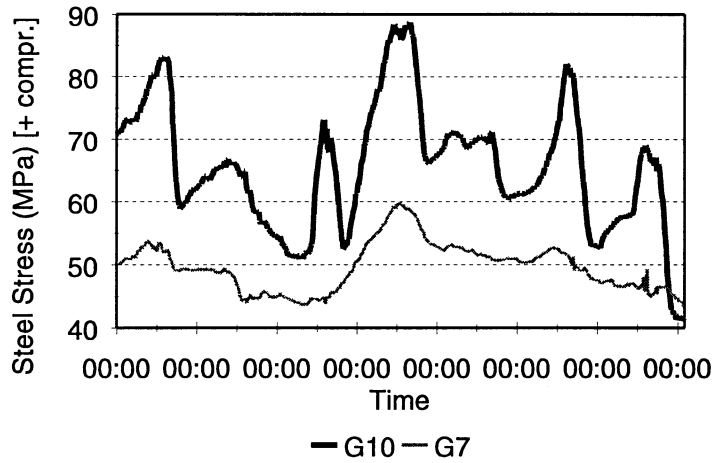
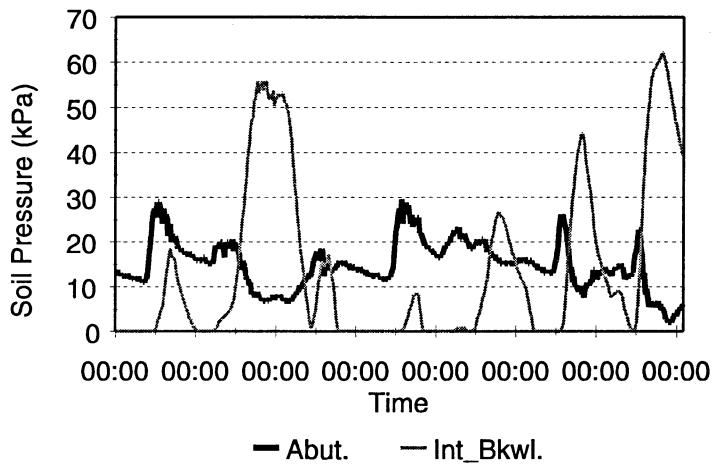
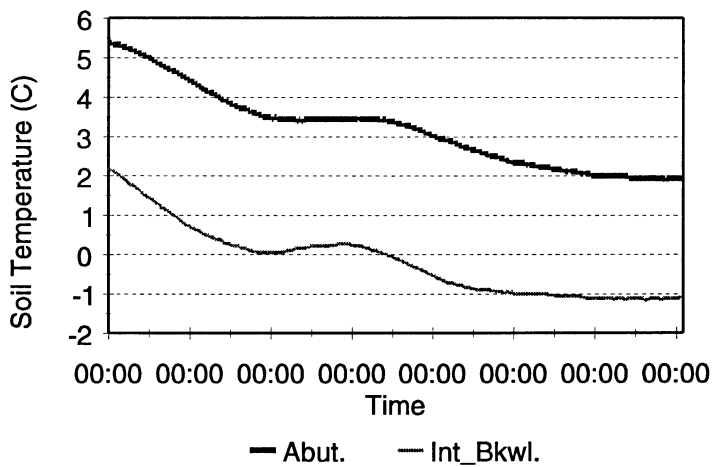
Figure 10. Abutment A data from January 16-22, 1994.

Elevated compressive stresses in the girder flanges at points in both spans were also observed during low ambient temperatures. Figures 10 through 12 (see following pages) present data from January 16-22, 1994, during a period of exceptionally cold weather. It can be seen that between January 18 and 19 compressive stresses increased by about 40 MPa, reaching peak values as air temperature plunged to -22°C (Fig. 11). At the same time soil pressures acting on both integral backwalls were practically negligible (Figs. 10 and 12). Maximum steel compressive stresses of approximately 90 MPa were recorded, significantly in excess of stresses associated with passive soil pressures. A possible explanation for this phenomenon may be the development of a thermal gradient between top of the deck and bottom of the girder. Russell and Gerken (1994) reported that stresses due to a thermal gradient through the vertical section of a structure can attain very high levels.

Bridge girders were designed for a maximum allowable compressive stress of 186 MPa. The live load and impact contributions due to the MS18 design load were estimated at approximately 8.5 MPa, based on a scaled field loading test. Thus, stresses due to thermal effects and a dead load of the deck, as presented in the graphs, appear to be well below the maximum allowable.

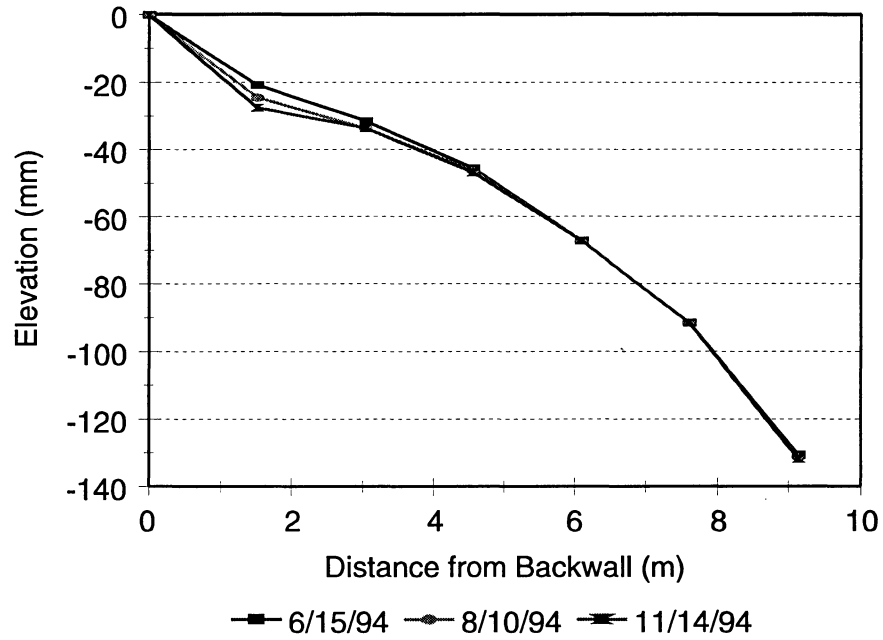
Figure 13. Abutment A approach elevations (1994).

Figures 13 and 14 show approach elevations between June and November 1994 at abutments A and B, respectively. Elevations were measured at 1.5 m intervals with reference to the bridge centerline at the back of the backwall. The settlement was concentrated within 5 m of the bridge near abutment A. At abutment B the approach settlement extended uniformly beyond 10 m from the bridge.

Damage to the approach pavement due to excessive settlement of the fill was the biggest maintenance problem observed with this bridge. The approach pavement was completed in October 1993, approximately 2 months after bridge construction. Although traffic was allowed to run on the base material before paving, a significant amount of approach settlement followed. The first major resurfacing was performed in May 1994. In the two years following construction the cost of repeated approach pavement patching due to continuous settlement amounted to approximately \$10,000.

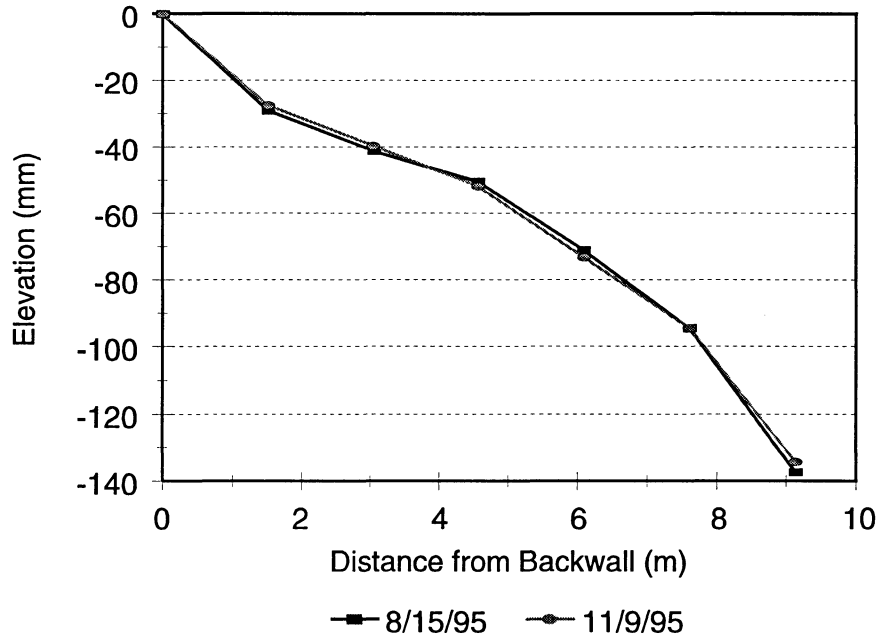
Figure 15. Abutment A approach elevations (1995).

Figures 15 and 16 show approach elevations between August and November 1995 at abutments A and B, respectively. The rate of settlement slowed down substantially in the second year of operation. The pavement approaching abutment B continued to settle more extensively than the abutment A approach. Poor channeling of surface water away from the bridge, causing erosion behind abutment B, may have been a contributing factor.

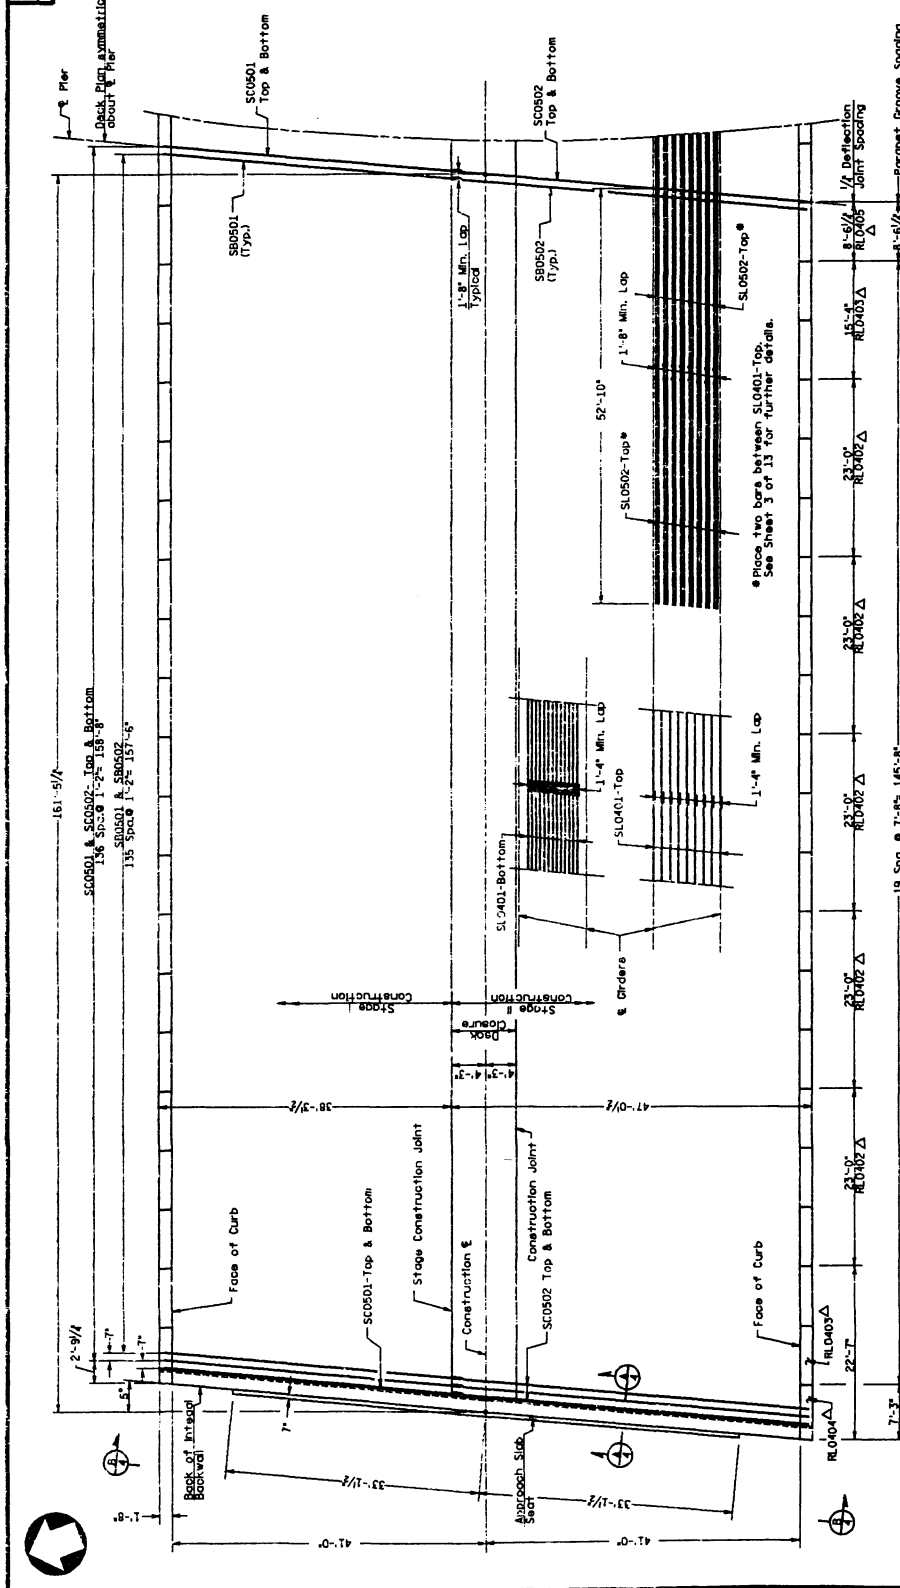
DECK PLAN
Scale: 1/8" = 1'-0"

- SEQUENCE OF INTEGRAL BACKWALL & DECK SLAB CONSTRUCTION:
- Place concrete in integral backwalls in ① and ② up to the limits shown on Sheet 5 of 13.
 - After concrete in integral backwalls has reached design strength, place remainder of deck slab concrete in ③ & ④.
 - Place concrete in ⑤.
 - Place concrete in integral backwalls in ⑥ and ⑦ up to the limits shown on Sheet 5 of 13.
 - After concrete in integral backwalls has reached design strength, place remainder of concrete in ⑧ & ⑨.
 - Place concrete in ⑩.
 - Place concrete in Deck Closure and Integral Backwall Closure in ⑪ & ⑫.
 - Place concrete in ⑬.

Note: The numbers shown indicate the suggested order of deck slab placement.
