FINAL REPORT

EVALUATION OF ASPHALT RUBBER STRESS-ABSORBING MEMBRANE

September 1997
VTRC 98-R11

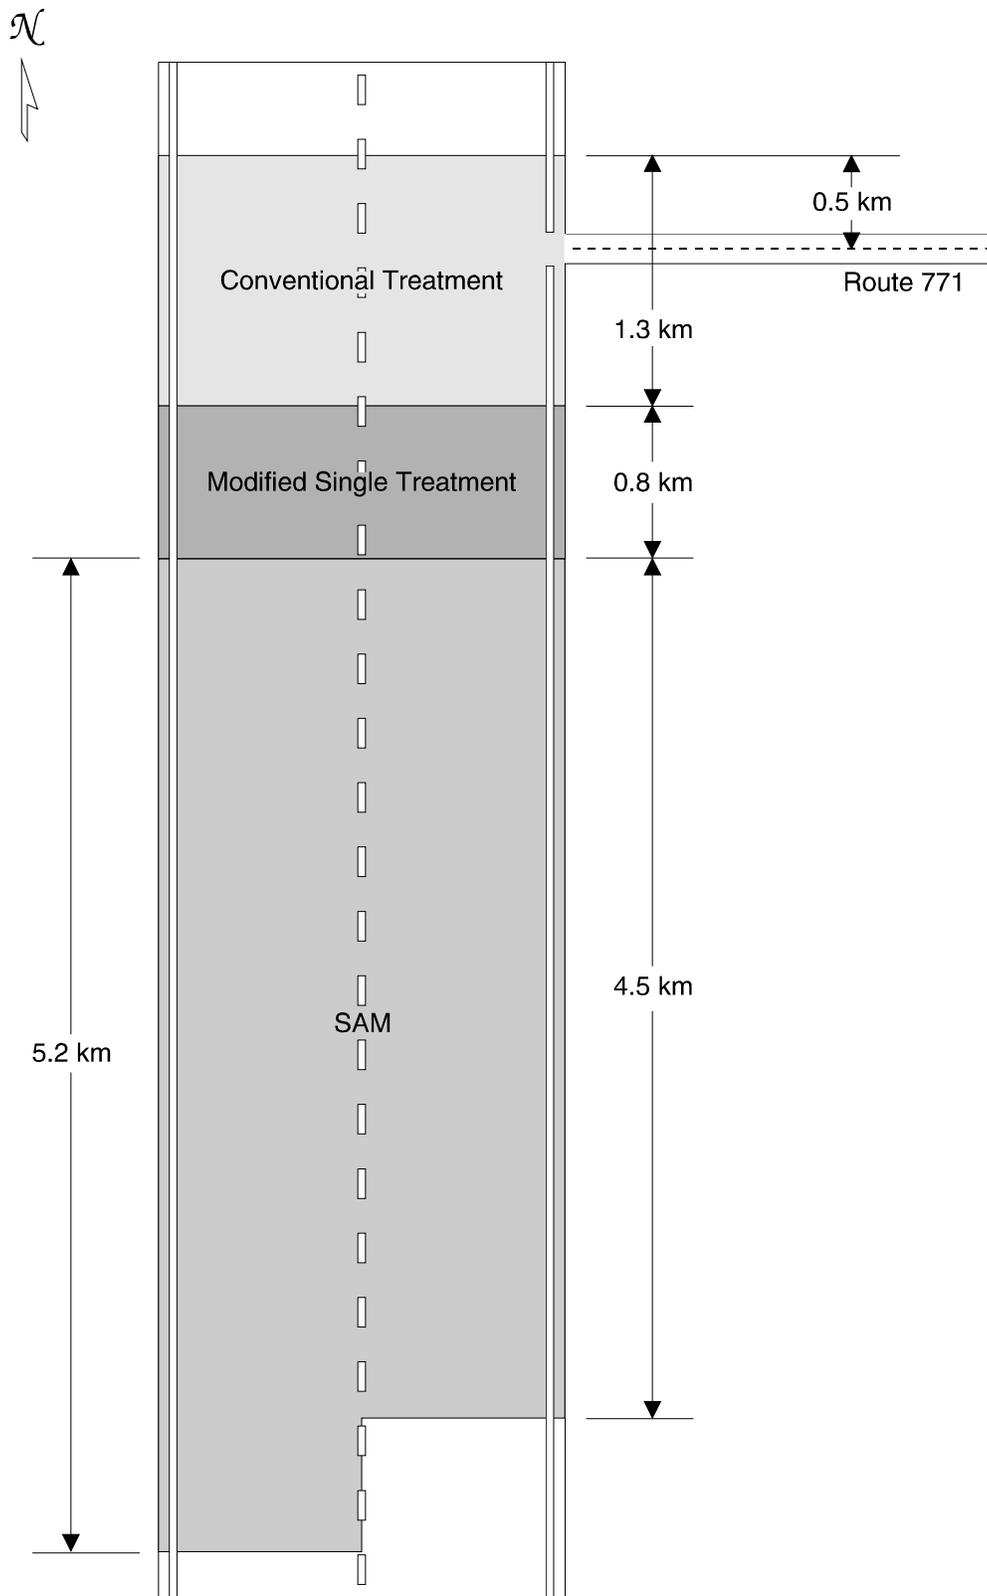
Figure 1. Test Sections

The test and control sections were placed on Route 11 in Wythe County from 31.23 km (19.40 milepost) to 38.41 km (23.16 milepost) (see Figure 1). Figure 2 shows the layers of the SAM and control sections. Both control treatments, conventional and modified single seal, are used extensively in Virginia. The conventional treatment consisted of a single layer of CRS-2L binder followed by a layer of coarse aggregate. The modified single seal consisted of a layer of

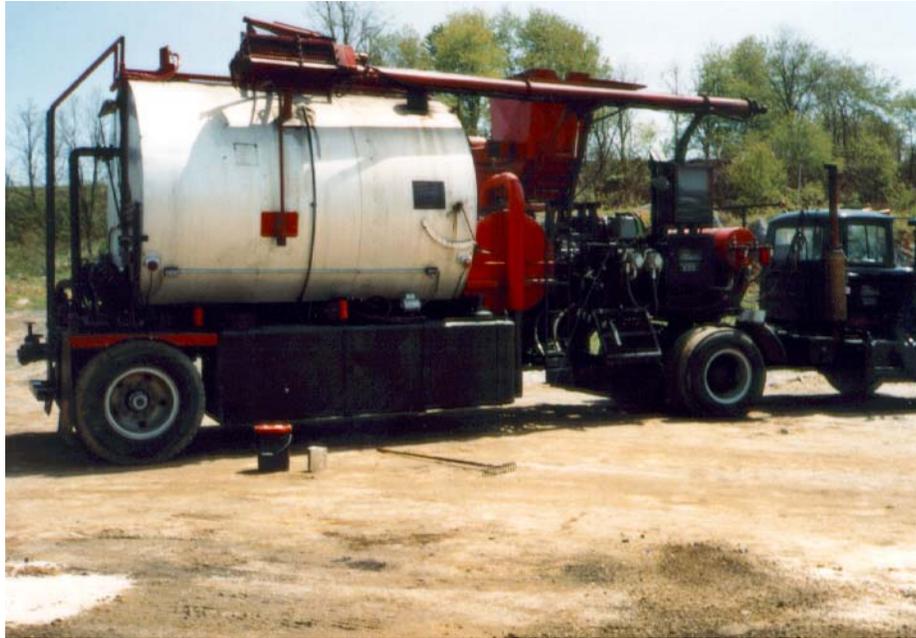
Figure 3. Asphalt Rubber Blending Unit

A special blending unit was used by Able Bituminous Contractors, Inc., to blend the AC-20 asphalt and the ground rubber. The heating and blending of the asphalt and rubber were done near the job site in the blending unit shown in Figure 3.

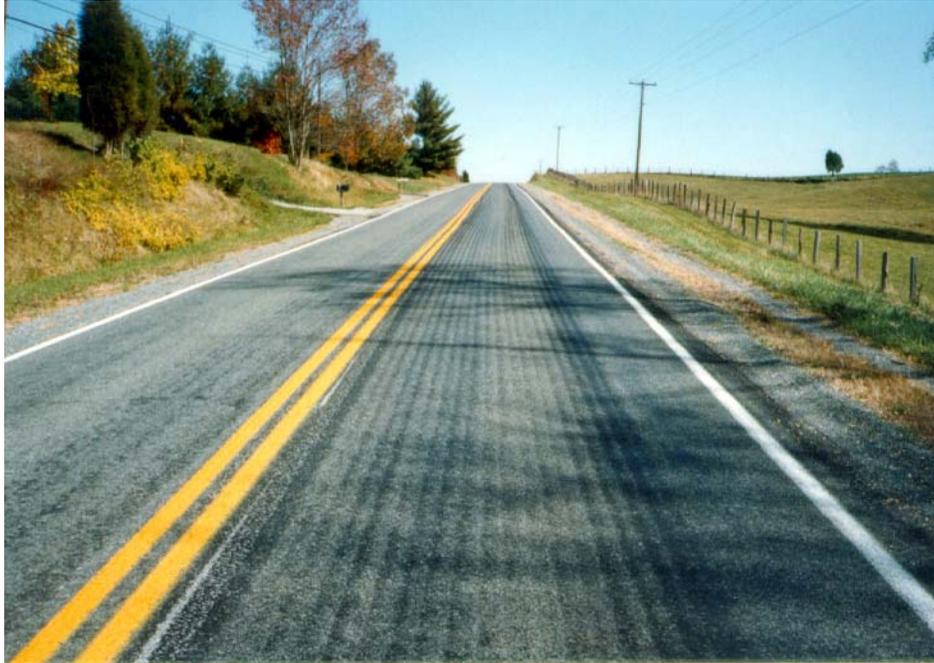
Figure 4. Streaking Caused by Use of Small-Diameter Nozzles

A representative of Able Bituminous Contractors, Inc., had developed a special nozzle to spray the rubberized asphalt mixture at the specified low rate. Although the nozzle was somewhat successful, clogging was a continual problem that often caused nonuniformity. As can be seen in Figure 4, severe streaking occurred when the asphalt rubber was sprayed through the small-diameter nozzles.
