1. Report No. FHWA/VTRC 05-CR24	2. Government Accession No.	3. Recipient's Catalog No.	
4. Title and Subtitle Performance of a Bridge Deck with Glass Fiber Reinforced Polymer Bars as the Top Mat of Reinforcement		5. Report Date June 2005

**PERFORMANCE OF A BRIDGE DECK WITH GLASS FIBER REINFORCED  
POLYMER BARS AS THE TOP MAT OF REINFORCEMENT**

**Via Department of Civil and Environmental Engineering  
Virginia Polytechnic Institute & State University**

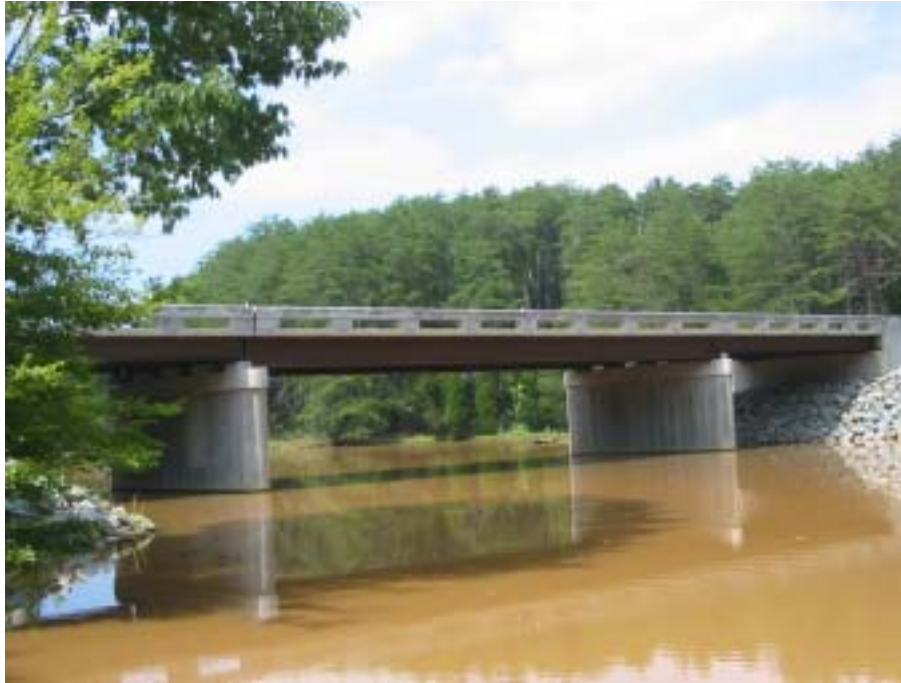
Administration's (FHWA) Innovative Bridge Research and Construction (IBRC) program worked with Virginia Tech to construct the Route 668 Bridge over Gills Creek in Franklin County, Virginia. The bridge was completed in July 2003 and is pictured in Figure 1. The deck of one span is reinforced with GFRP bars as the top mat and steel rebar as bottom mat. The other two spans are reinforced with steel bars as the top and bottom mat.

**Figure 1. Route 668 Bridge Over Gills Creek**

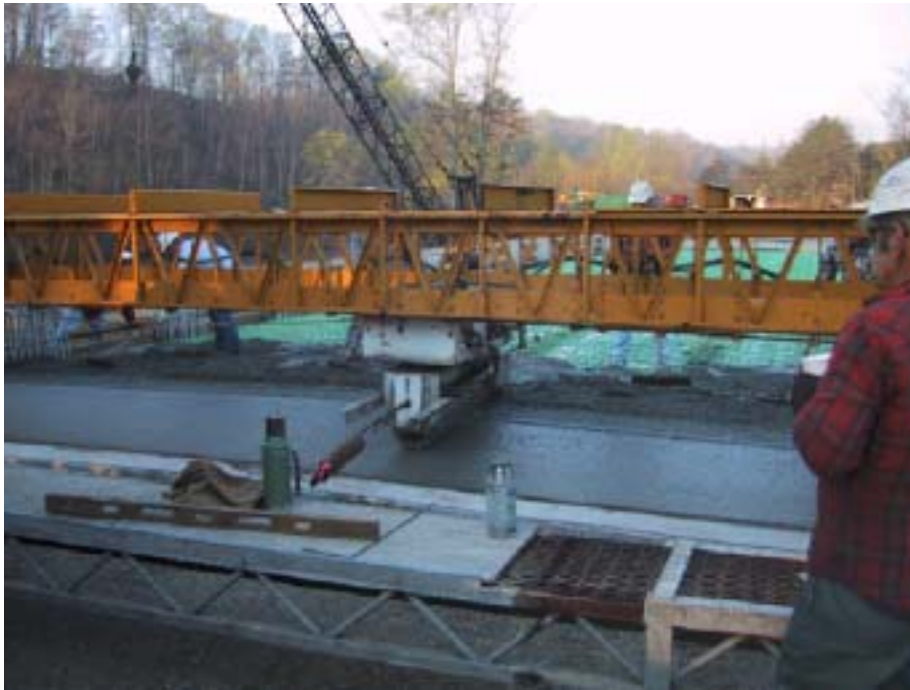
After the reinforcing bars were installed and the embedded gauges were secured in the deck, concrete was placed into the forms. The casting was accomplished in one day, with all three simple spans cast in one operation. The contractor started at the abutment side of Span C and continued across the bridge, finishing at the abutment side of Span A. Figure 6 shows the casting operation at the beginning of the day in Span C. Test cylinders of concrete placed in Spans A and C were made during the casting operation. The cylinders were then match-cured with the deck for approximately two weeks and then taken back to Virginia Tech for storage. When tested for 28-day compressive strength, the Span A cylinders averaged 7001 psi and the Span C cylinders averaged 6882 psi.

**Figure 6. Span C Concrete Casting**

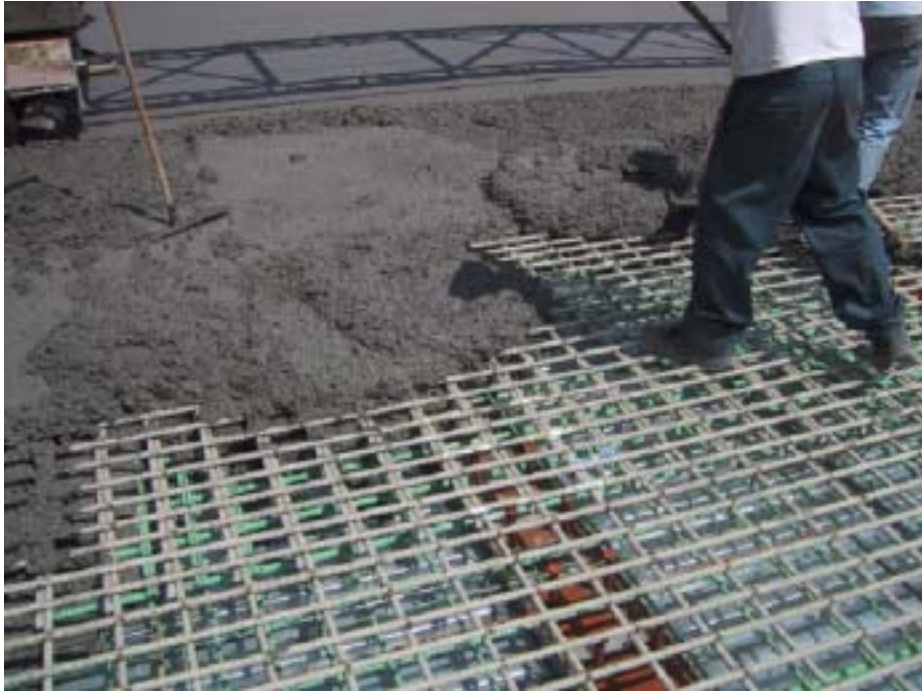
Great care was taken by the researcher as well as the construction workers to avoid contact with the installed gauges and wires during the casting operation. However, it should be noted that concrete was placed with a bucket about one to two feet above the bars, and in some cases this concrete was dropped directly on top of a section where gauges and thermocouples were present. Also, it should be noted that the workers tried to stay clear of the gauged sections while walking on the top mat of reinforcement. However, this was not always the case. Figure 7 shows the casting operation in the Span A end of the bridge.

**Figure 7. Span A Concrete Casting**

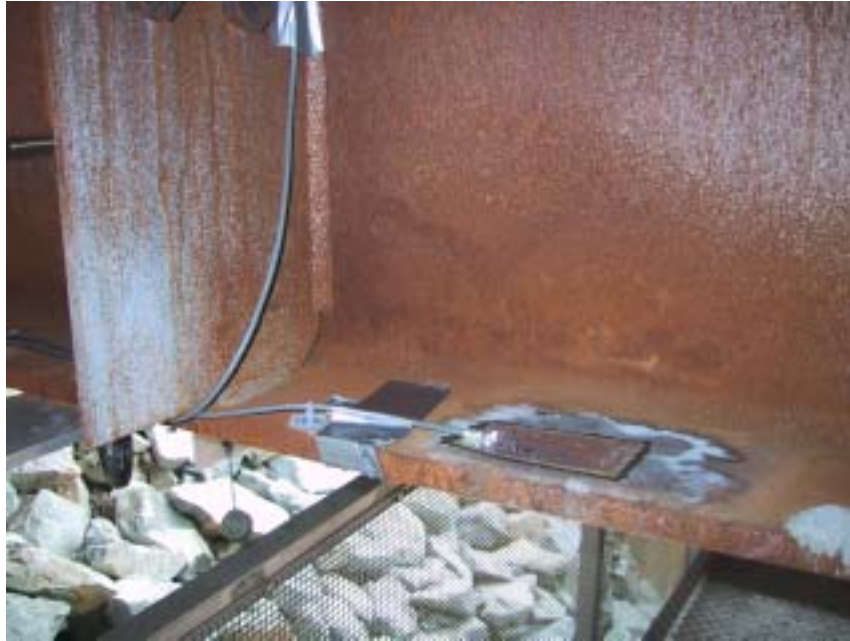
**Figure 8. ER Strain Gauge on Steel Girder**

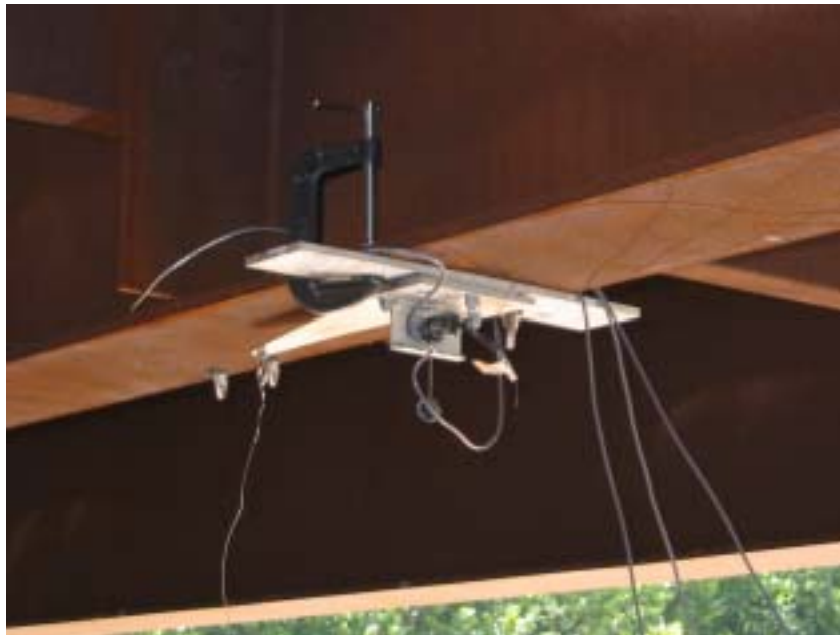
For the 2003 and 2004 tests, deflectometers were clamped to the bottom flange of each girder at the midspan of Spans A and C. A deflectometer is pictured in Figure 9. They are made of an aluminum plate between two thicker aluminum plates. The cantilevered plate in the middle is gauged with four strain gauges that are weatherproofed. At the end of the cantilevered plate is a metal loop. The metal loop was attached to a weight at ground level with wire, to pre-deflect the deflectometer approximately 1 in before the testing. The pre-deflection caused a strain in the top of the plate. When the truck ran over the bridge causing the girders to deflect, the decrease in strain was measured and converted to a corresponding deflection. During each test, the

**Figure 9. Deflectometer Clamped to Steel Girder**

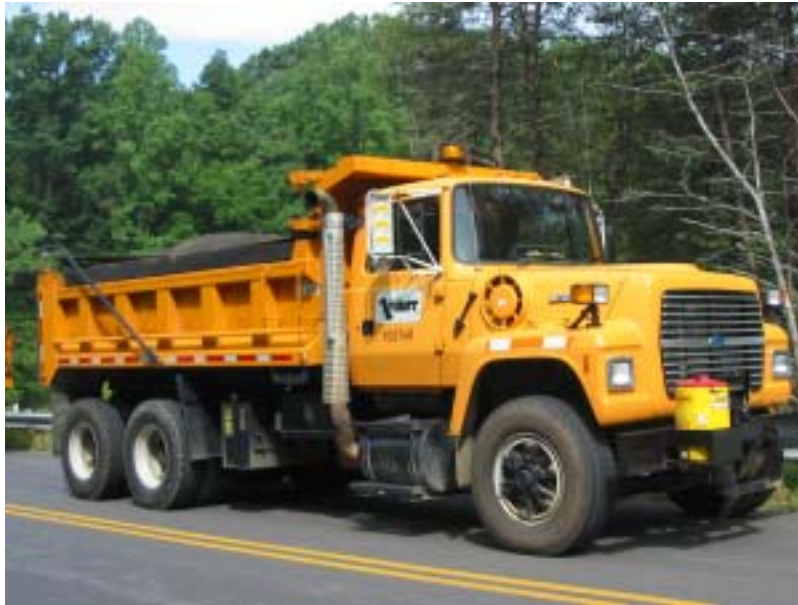
**Figure 10 VDOT Dump Truck Used for Live Load Testing**

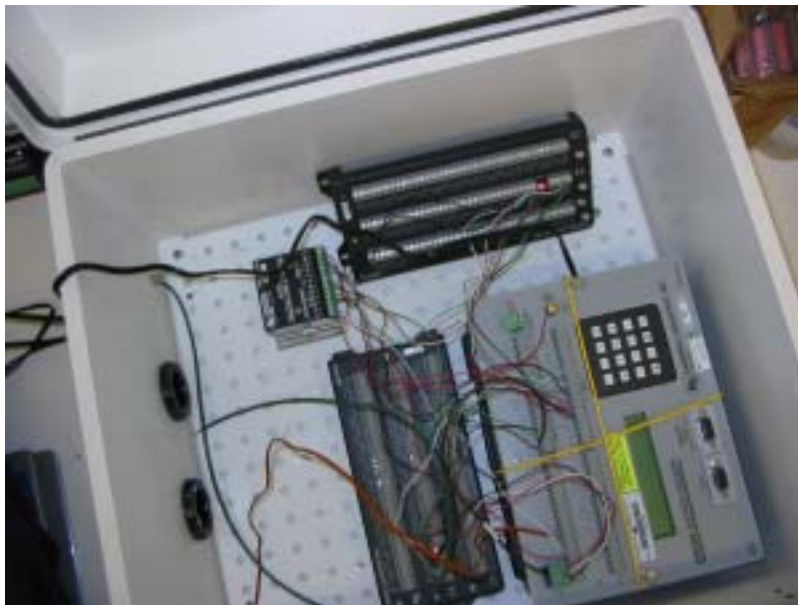
The Campbell was used to monitor the instrumentation of Span A of the Gills Creek Bridge. Since there were not enough ports to connect all of the instrumentation on the datalogger itself, additional boards had to be used. Two multiplexers were used, one for the ER strain gauges and one of the VW gauges. The thermocouples were connected directly to the Campbell. All of the components were screwed to a plate that was then secured in an environmentally resistant box. Figure 11 is a picture of the datalogger. After programming the datalogger in the lab, it was taken to the field location and the lead wires of the instrumentation were run through the access hole in the box and connected to the datalogger. Weatherproofing putty provided by the box manufacturer was placed in the access hole to fully seal the box, and desiccant packs were placed in the box to control the internal humidity. The box was locked and placed on the south abutment wall on the underside of the bridge. A solar panel was mounted on the parapet of the bridge to ensure that the datalogger had a constant power source.

**Figure 11. CR23X Micrologger and Instrumentation Components**

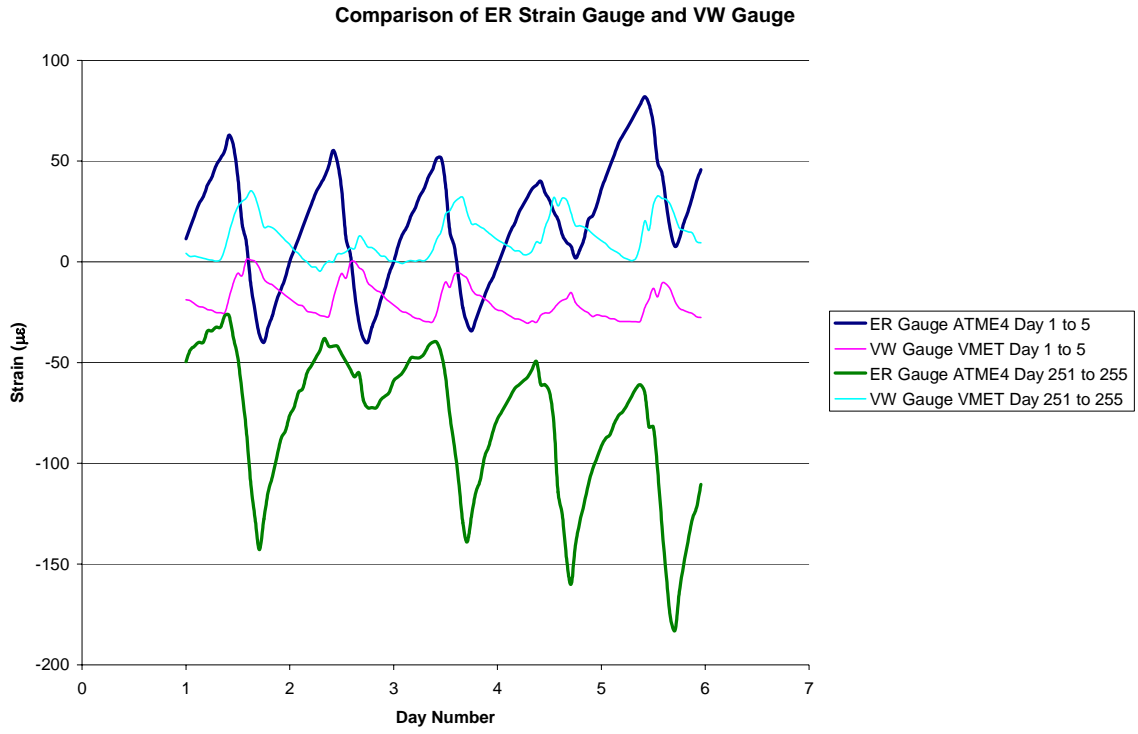
**Figure 45. Daily Comparison of ER Strain Gauge and VW Gauge at Midspan**

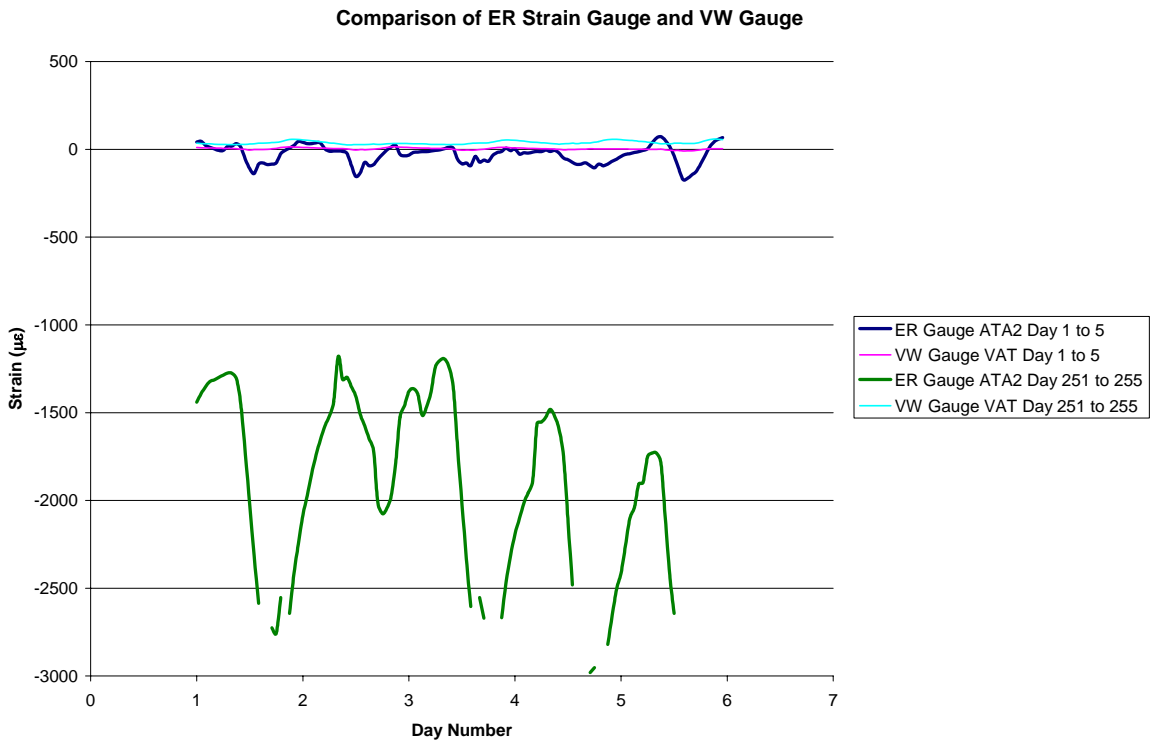
Figure 46 shows a worst case of how the ER strain gauges were not as reliable as VW gauges. This ER gauge went from fluctuating about 250  $\mu\epsilon$  in a day to 1500  $\mu\epsilon$ . It also shifted about 1500  $\mu\epsilon$ . The breaks in the later readings of the ATA2 gauge were when the gauge was not operating correctly and did not provide a reading. Again, the VW gauge was much more consistent, yet followed an opposite pattern of fluctuating strain.

**Figure 46. Daily Comparison of ER Strain Gauge and VW Gauge at Abutment**

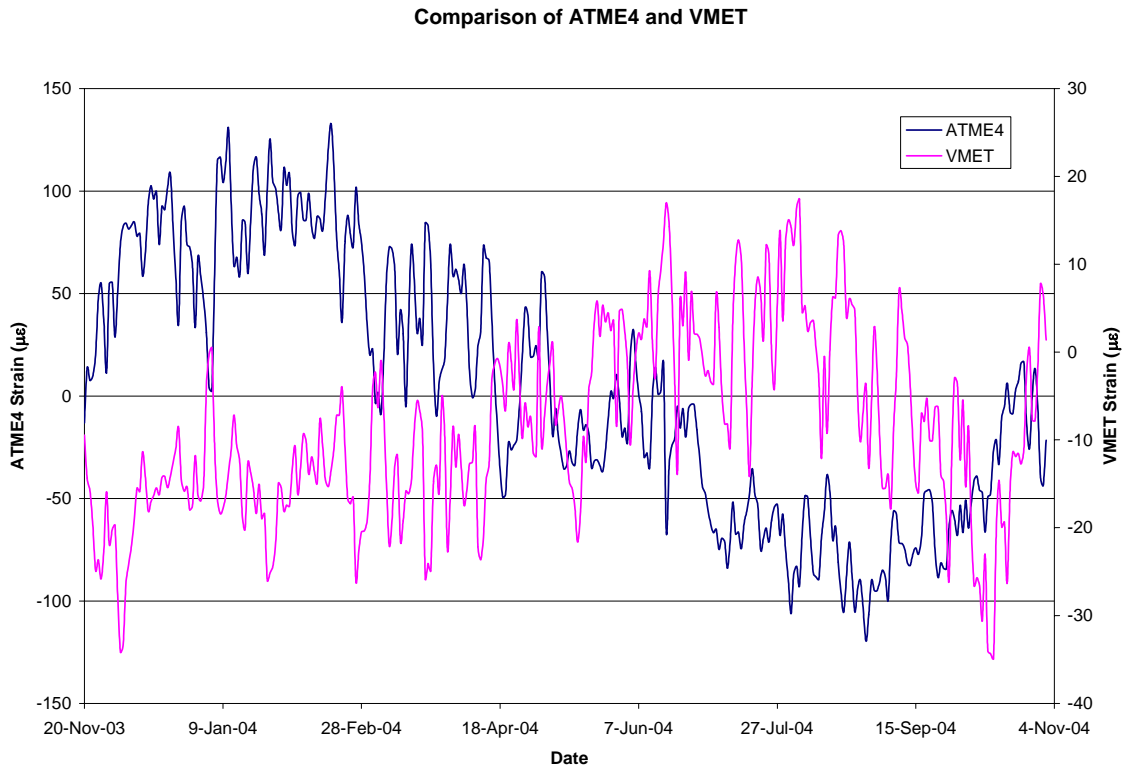
By comparing the results of the ER strain gauges and the VW gauges, it can be concluded that the ER strain gauges lose accuracy rapidly over time and should not be used for long-term monitoring of a bridge deck. However, the ER gauges may be useful in determining general trends in the strain changes but not necessarily the magnitude of those changes. To get a better idea of the pattern that the ER gauges and VW gauges followed for the year of monitoring, Figure 47 compares two gauges at the same location. Notice that the ER strain gauges and VW gauges are plotted on a different scale to better compare the general strain changes.

**Figure 47. Comparison of ATME4 and VMET**
