Report No. VTRC 06-R2	Report Date August 2005	No. Pages 37	Type Report: Final Period Covered: June 2004-May 2005	Project No.: 73197 Contract No.
Title: The Use of Highway Underpasses by Large Mammals in Virginia and Factors Influencing their Effectiveness				Key Words: wildlife crossings, highway underpasses, large mammals, white-tailed deer, black bear, deer-vehicle collisions
Author: Bridget M. Donaldson				
Performing Organization Name and Address:  Virginia Transportation Research Council 530 Edgemont Road Charlottesville, VA 22903				
Sponsoring Agencies' Name and Address  Virginia Department of Transportation 1401 E. Broad Street Richmond, VA 23219				
Supplementary Notes				
<p><b>Abstract</b></p> <p>The rapid increase in animal-vehicle collisions on U.S. roadways is a growing concern in terms of human safety, property damage and injury costs, and viability of wildlife populations. Wildlife crossing structures are gaining national recognition by transportation agencies as effective measures to reduce animal-vehicle collisions and connect wildlife habitats across transportation corridors. In Virginia, white-tailed deer and black bear pose the highest risk. This 1-year study w

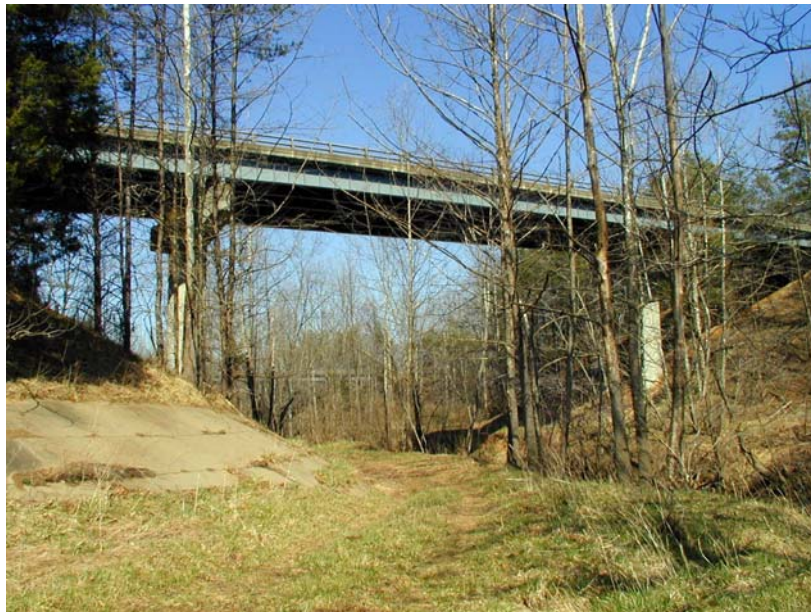
**Figure 4. Site 2: Eastbound Bridge on I-64 West of Charlottesville**

This underpass is a bridge along the eastbound lane of I-64 5 mi west of Site 1 (Figure 4). The bridge is 307 ft long and was constructed in 1969 to span the Mechum River. The river width is approximately 45 ft, with approximately 10-ft-wide grassy strips on each side to allow the passage of farm vehicles. The remaining area beneath the bridge is sloped with sandy substrate. The surrounding habitat comprises a mixture of trees and open farmland. Bridges such as these have been constructed in some states solely as wildlife underpasses, although they are among the most expensive crossings to install.

The bridge (Site 2) had the highest deer passage rate and lowest number of incidents of hesitancy behavior and turn-arounds. This was expected because of its large size and lack of walls, unlike the box culverts at Sites 1 and 3A. Based on the success of Sites 1 and 3A in facilitating deer passage, structures the size of Site 2 are likely not the most cost-effective if constructed solely to facilitate deer passage.

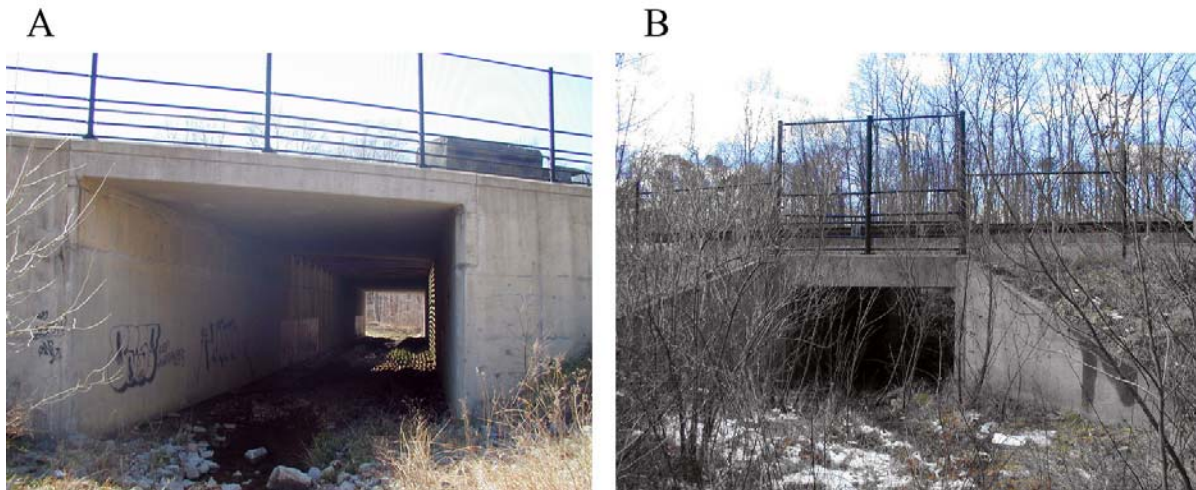
**Figure 5. Sites 3A and 3B: Single-barrel Box Culverts 0.25 Mi Apart Beneath Fairfax County Parkway**

Two single-barrel box culverts, approximately 0.25 mi apart, are situated beneath the Fairfax County Parkway (Figure 5). Because both culverts likely facilitate the movement of some of the same wildlife populations, they are useful for comparative purposes and are referred to as subsets of one site. These structures were designed as wildlife crossings, and installed during the construction of the parkway. Site 3A is 20 by 15 by 192 ft and has a small stream along one side of the open bottom. Site 3B is 10 by 6 by 105 ft and has a concrete bottom that allows for drainage during wet weather conditions. Approximately 40 ft of fencing was constructed along the road above both culverts. Both structures are in close proximity to wooded areas on each side. A large portion of the ceiling in the center of each structure consists of metal grating, installed to allow in light and thereby encourage deer use.

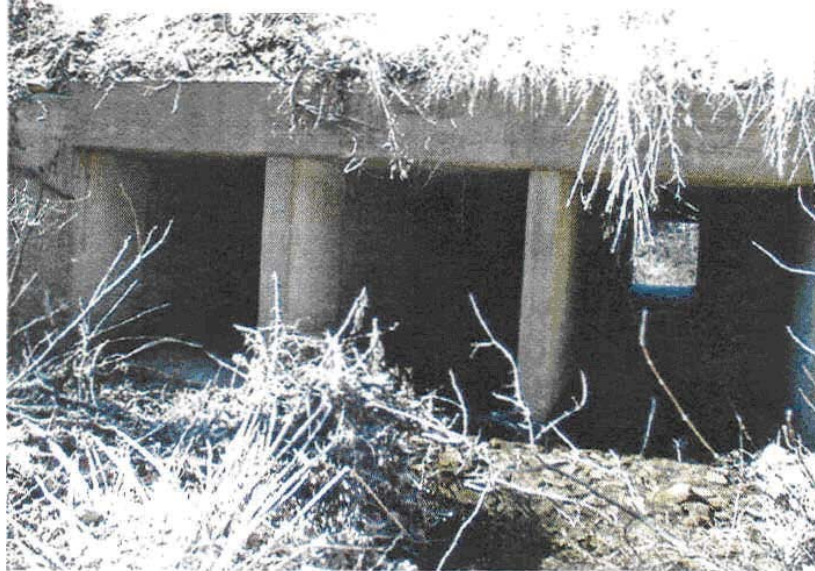
**Figure 6. Site 4: Triple-box Culvert Beneath Route 340 North of Grottoes**

Site 4 is a triple-box culvert 6 by 6 by 68 ft beneath Route 340 approximately 22 mi north of Waynesboro and just west of the Shenandoah National Park (Figure 6). Although the culvert was installed to allow stream passage, its location and size make it potentially suitable as a crossing for bear or other wildlife. The Virginia Department of Game and Inland Fisheries has studied bear populations in the area and in a 10-day period found more than 15 bears using a trail that crosses U.S. 340 to access cornfields. The box culvert is along the same section of Route 340 in which bear-vehicle collisions have occurred, including one in which the driver was killed. Installing fencing on each side of the culvert to direct bears to the culvert was considered but did not occur because the fencing would have encroached on private property.

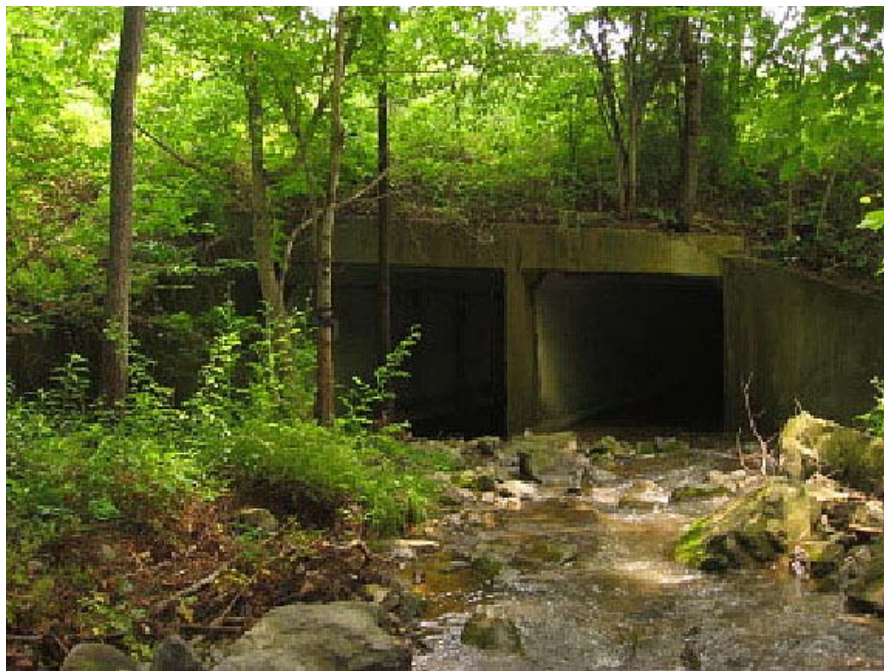
**Figure 7. Site 5: Double-box Culvert Beneath I-81 North of Buchanan**

Site 5 is located beneath I-81 just north of Buchanan in Botetourt County. This structure is a double-box culvert with a concrete floor (Figure 7). Each box measures 8 by 18 by 63 ft and facilitates passage of Cedar Bluff Creek. The water depth in each culvert is rarely greater than 0.5 in. This structure is in the Shenandoah Valley between the Allegheny Mountains and the Blue Ridge Mountains. Black bear inhabit these mountain ranges and cross I-81 to access the forested mountains on both sides of the highway.

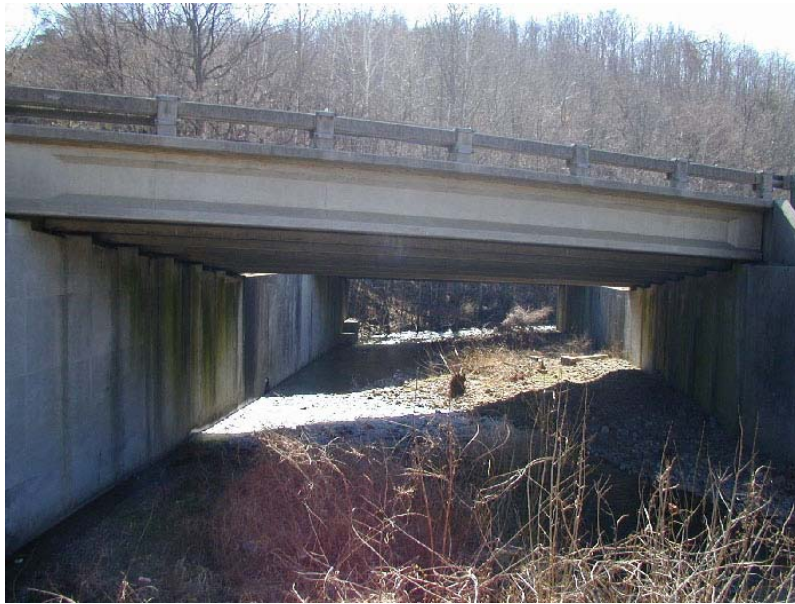
**Figure 8. Site 6: Bridge Along I-81 North of Buchanan**

Site 6 is a small bridge approximately 3 mi south of Site 5, also in Botetourt County (Figure 8). The bridge, which spans Purgatory Creek, is beneath I-81 and measures 59 by 44 ft. The creek is approximately one-third the width (20 ft) of the bridge; the remaining substrate consists of rocks and sand. Like Site 5, this structure is in the Shenandoah Valley between the Allegheny Mountains and the Blue Ridge Mountains and potentially provides a passage for black bears traveling across the highway.

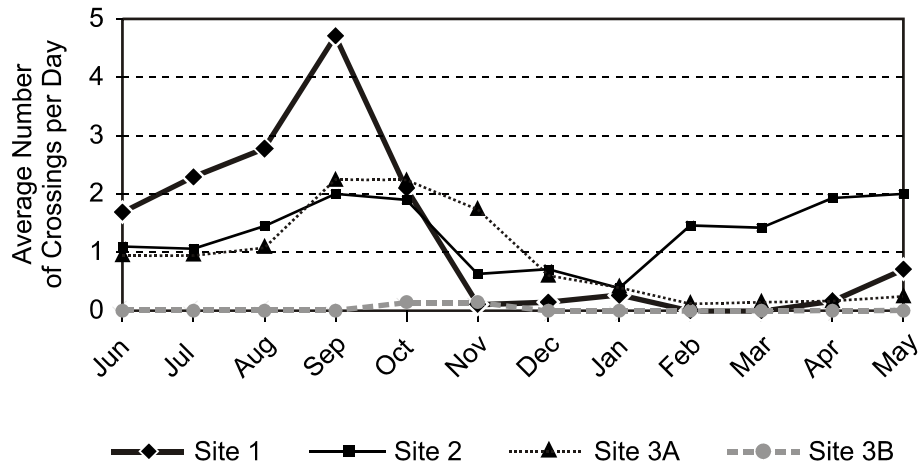
Figure 12. Average Number of White-Tailed Deer Crossings per Day Each Month from June 2004 through May 2005

The crossing frequency index was highest and most consistent at Site 2, with 1.34 crossings per day. Site 1 averaged 1.1 crossings per day; Site 3A averaged 0.91 crossing per day; and Site 3B received relatively little use, at 0.02 crossing per day. The monthly crossing frequency indices for each site peaked in the autumn months, dropped steeply in winter, and rose in late spring. During the period of heaviest activity in the fall, Site 1 received the heaviest use, with an average of 4.7 crossings per day in September (Figure 12). This corresponds to greater periods of movement associated with mating and feeding activities. Throughout the year, deer used underpasses at all times of the day, with peak activity occurring at dusk.

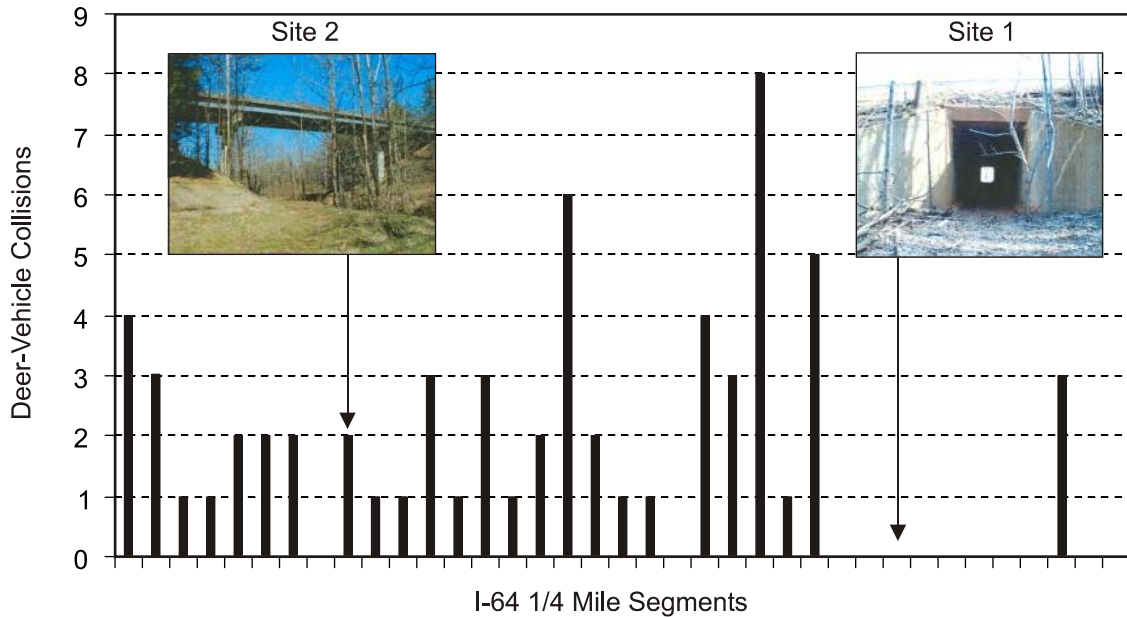
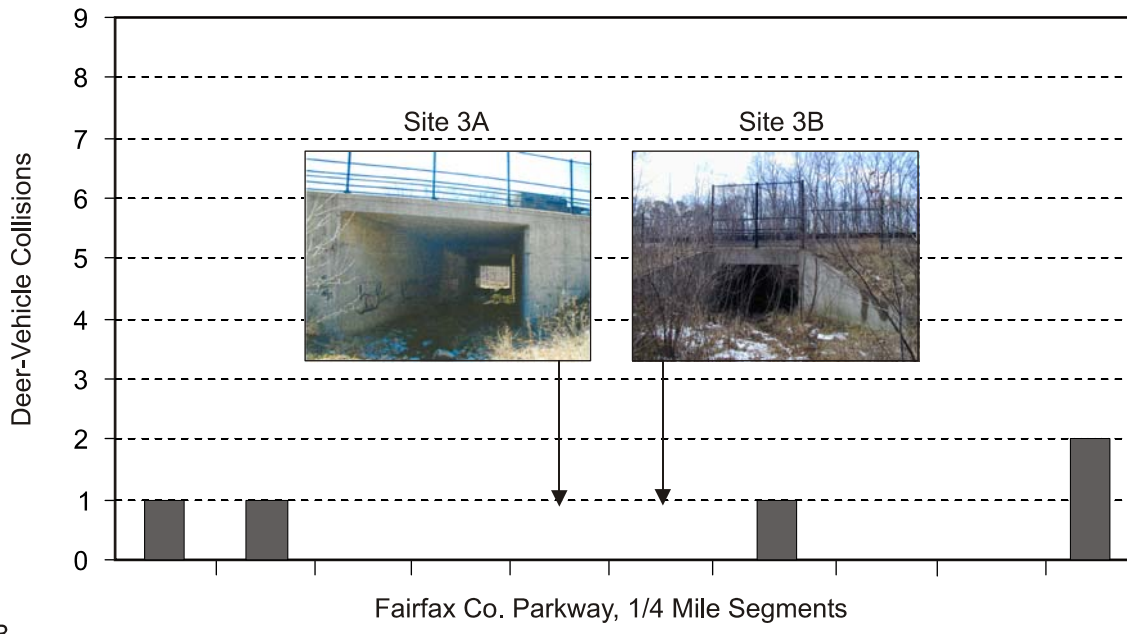
**Figure 20. Reported Deer-vehicle Collisions in Relation to Location of Underpasses Used by White-tailed Deer. DVC data for I-64 (A) include a 5-year period (1997-2001), and data for the Fairfax County Parkway include a 10-year period (1995-2004).**

Small sample sizes restricted the statistical analyses of the number of DVCs immediately surrounding the underpasses relative to segments with no underpasses. These data were therefore depicted graphically to illustrate the number of DVCs adjacent to underpass locations (Figure 20). For Site 1, there were no reported DVCs 0.75 mi to the west and 1.25 mi to the east of the underpass within a 5-year period (1997-2001) for which data were available. At the section east of the underpass, a high ridge prevents deer from entering the highway. Within the 2.5-mi road segment (flanked by two perpendicular roads) under which Sites 3A and 3B lie, there were five DVCs within a 10-year period (1995 through 2004).

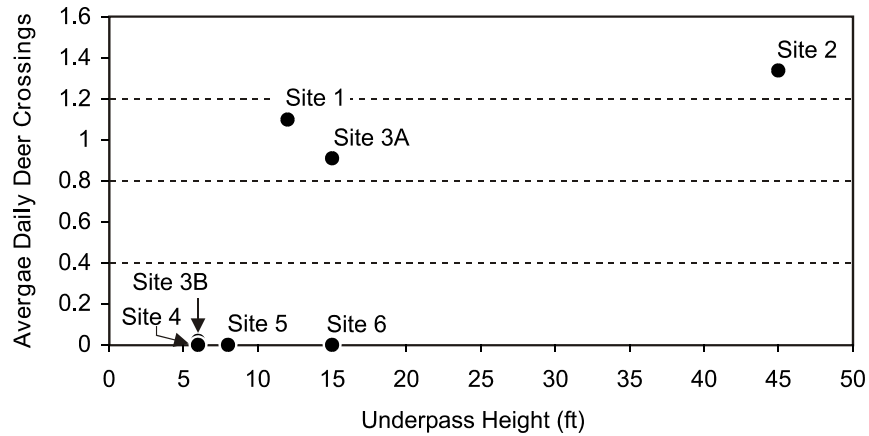
**Figure 21. Average Daily Deer Crossing Frequency from June 2004 through May 2005 in Relation to Underpass Height**

A large discrepancy in deer crossing frequency was apparent between structures with a height greater than or equal to 12 ft and those with a height less than 12 ft. To represent this distinction, height values were differentiated into these height groupings. Adjusting for deer habitat suitability at each site, a minimum underpass height of 12 ft was significantly correlated to crossing frequency (Beta = 0.78 ± 0.20, *P* = 0.047; Figure 21). Landscape and human activity variables were not significantly correlated to crossing frequency. Although not found to be statistically correlated to crossing frequency (possibly because of the sample size), attributes of successful structures included a minimum openness of 0.19, natural floors, forest cover within 15 ft of structure openings, and a level approach with clear visibility of the habitat on the other side.

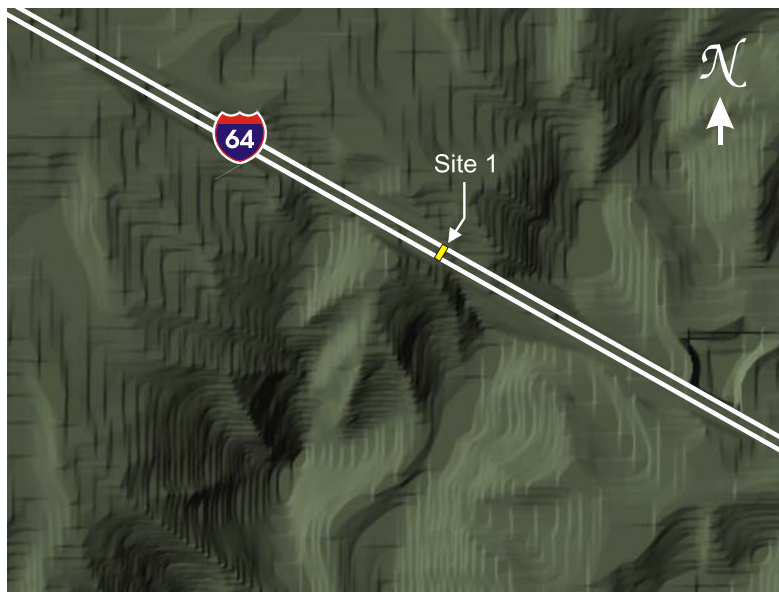
**Figure 22. Aerial View of Topographic Features Surrounding the Site 1 Bridge**

Although Site 1 received the second highest number of crossings, 21% of the approaches to Site 1 were associated with turn-arounds. The high number of crossings at this site was likely influenced by the presence of extensive fencing and the structure’s position in the landscape. Despite the fence’s shortcomings (low height and multiple breaks), it may have had a role in guiding deer toward the underpass. In addition to fencing, the southeastern borders along the underpass openings slope to a high ridge. This ridge functioned as a barrier to deer movement across the highway (as evidenced by no DVCs within 1.25 mi east of the underpass), and the surrounding hillsides served as a guideway for deer toward the underpass (Figure 22). Although

the optimal placement of Site 1 undoubtedly contributed to its high use by deer, the high number of hesitation and turn-arounds is likely explained by its relatively low openness index (0.19).

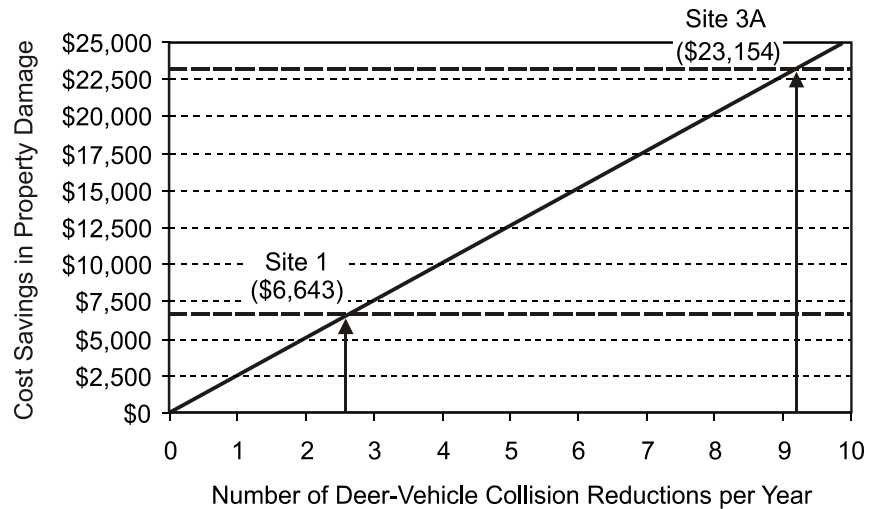
**Figure 23. Cost Savings in Property Damage from Reduction in Deer-Vehicle Collisions**

Using the method previously described, the annualized costs were calculated as \$6,643 for Site 1 and \$23,154 for Site 3A (based on total costs of \$257,864 and \$588,077, respectively). These underpasses are cost-effective in terms of property damage savings when they prevent a minimum of 2.6 DVCs per year and 9.2 DVCs per year, respectively (Figure 23).

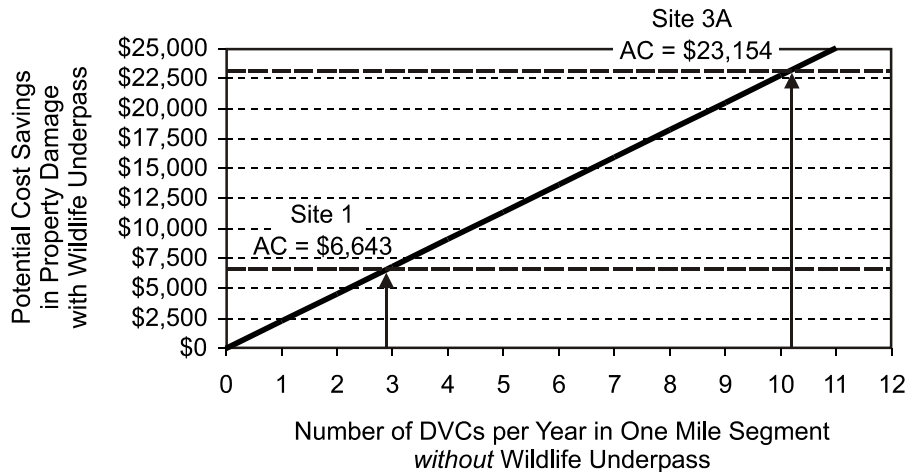
**Figure 24. Potential Cost Savings in Property Damage Assuming 90% Reduction in DVCs per Year with Wildlife Underpass Construction**

presence of a wildlife underpass with fencing. For example, there would be a savings of more than \$20,000 per year in property damage in an area with an underpass that would have averaged nine DVCs per year with no underpass. For underpasses with construction costs similar to those of Sites 1 and 3A, property damage cost savings would exceed underpass construction costs at areas that had 2.9 and 10.2 DVCs per year (pre-construction), respectively.

Using an estimate of 90% DVC reduction for underpasses with construction costs similar to those of Sites 1 and 3A, property damage cost savings would exceed underpass construction costs at areas that have 2.9 and 10.2 DVCs per year (pre-construction), respectively (Figure 24).
