Report No. VTRC 06-R14	Report Date February 2006	No. Pages 30	Type Report: Supplement to Final Period Covered: 11/04–12/05	Project No.: 70793 Contract No.
Title: Structural Load Testing and Flexure Analysis of the Route 701 Bridge in Louisa County, Virginia: Supplemental Report			Key Words: Structural Load Testing, Flexure, Cracking, Reinforced Concrete	
Authors: Jeremy Lucas, Thomas E. Cousins, and Michael C. Brown				
Performing Organization Name and Address: Virginia Transportation Research Council 530 Edgemont Road Charlottesville, VA 22903				
Sponsoring Agencies' Name and Address Virginia Department of Transportation 1401 E. Broad Street Richmond, VA 23219				
Supplementary Notes				
<p>Abstract</p> <p>A continuous slab bridge in Louisa County, Virginia, on Route 701 developed a planar horizontal crack along the length of all three spans. This project was designed to determine if the current 12-ton posted load restriction of the bridge (instituted in January 2002) could be raised and to determine if the horizontal crack causes degradation in the structural integrity, specifically stiffness, over time.</p> <p>These objectives were accomplished through field tests performed in

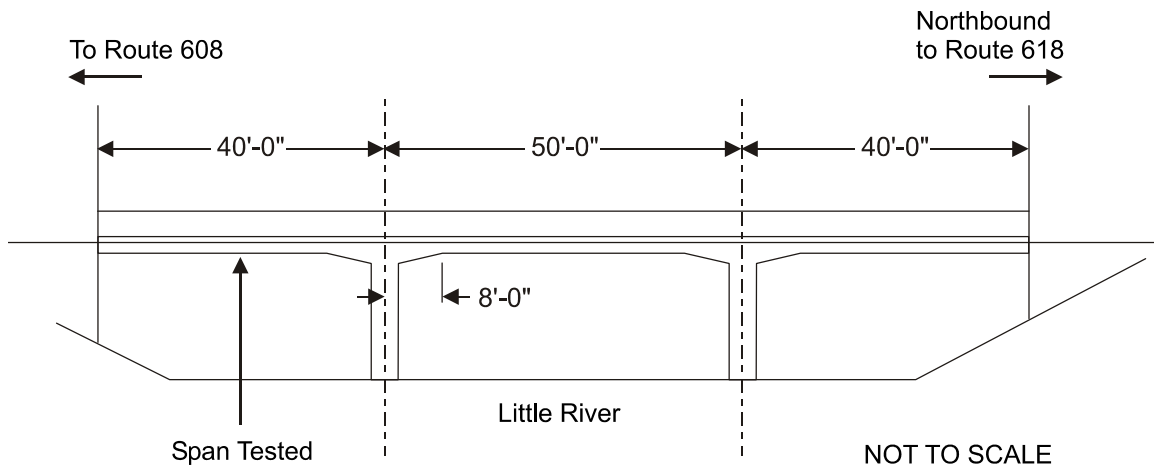
In the early 1980s, the Virginia Department of Highways & Transportation (1984) (now the Virginia Department of Transportation [VDOT]) constructed a continuous slab bridge on Route 701 across the Little River, approximately 1.4 miles south of Route 618 in Louisa County, Virginia. The bridge is a three-span continuous reinforced concrete slab bridge with a 15° skew. The end spans are both 40 ft and the center span is 50 ft in length. The spans are haunched toward the piers, with an average thickness of 22.5 in at the center span and 33.5 in at the piers. The overall width of the bridge is 29 ft 10 in, with two traveling lanes of 13 ft 3 in (see Figures 1 and 2).

Figure 1. Route 701 Bridge Over the Little River

Seven deflection sensors, corresponding to test lanes, were placed at midspan on the underside of the span nearest Route 608 (Figure 1). Since through visual inspection the crack was consistent along the entire length of the bridge, this span was used to test the slab because there was easy access to the underside of the slab (i.e., there was no water flow under it). The

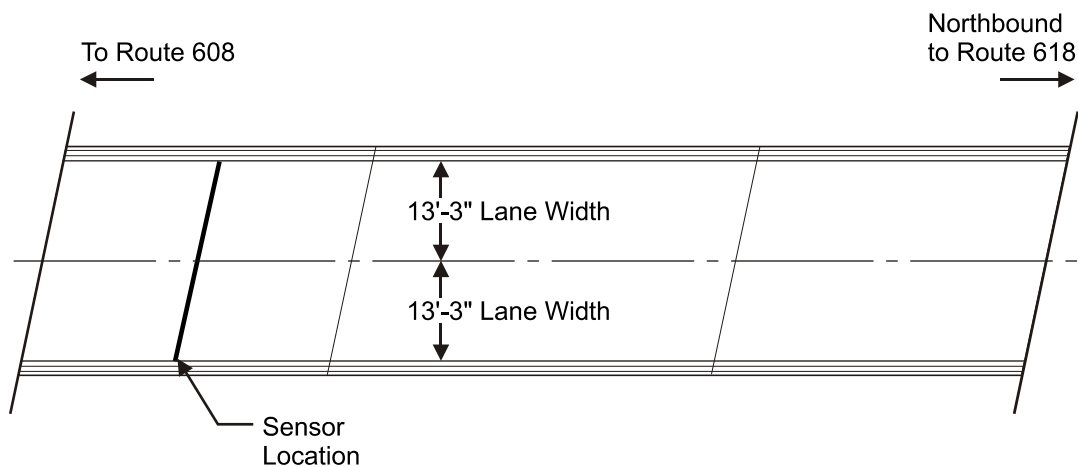
Figure 2. Plan View of Route 701 Bridge

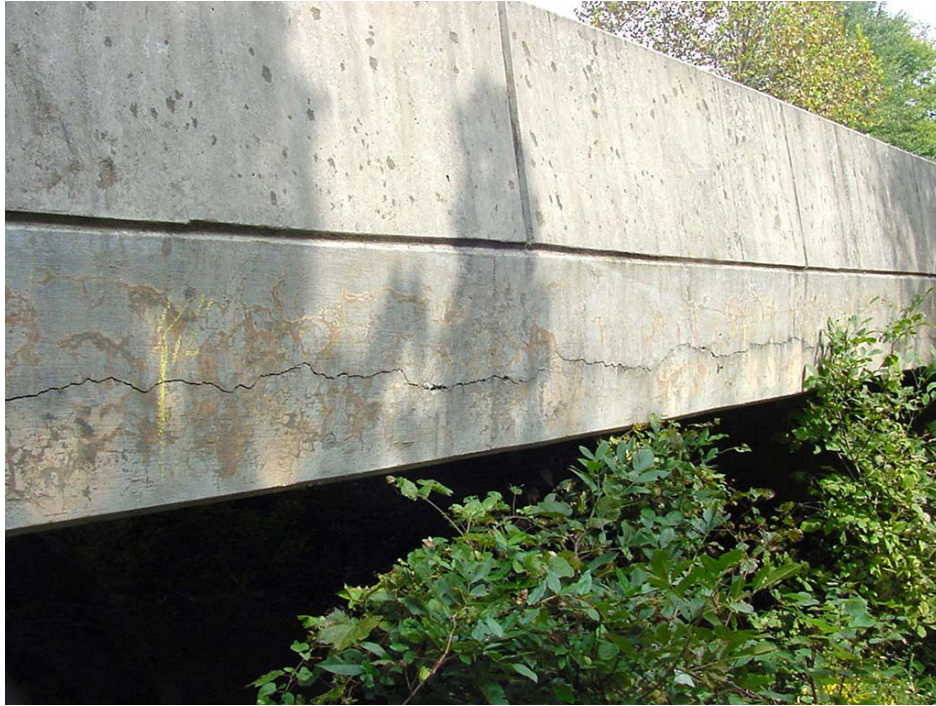
During a preliminary investigation by VTRC, the horizontal crack, which can be observed on both sides of the deck, was found to vary from a hairline to 0.25 in, as seen in Figures 3 and 4. Because of the nature of the cracking, the investigators presumed that the crack had propagated through the entire slab. The investigators determined that non-destructive testing was necessary to determine the extent of the cracking and load testing was necessary to assess the structural capacity of the bridge.

Figure 3. Cracks Along Length of Bridge

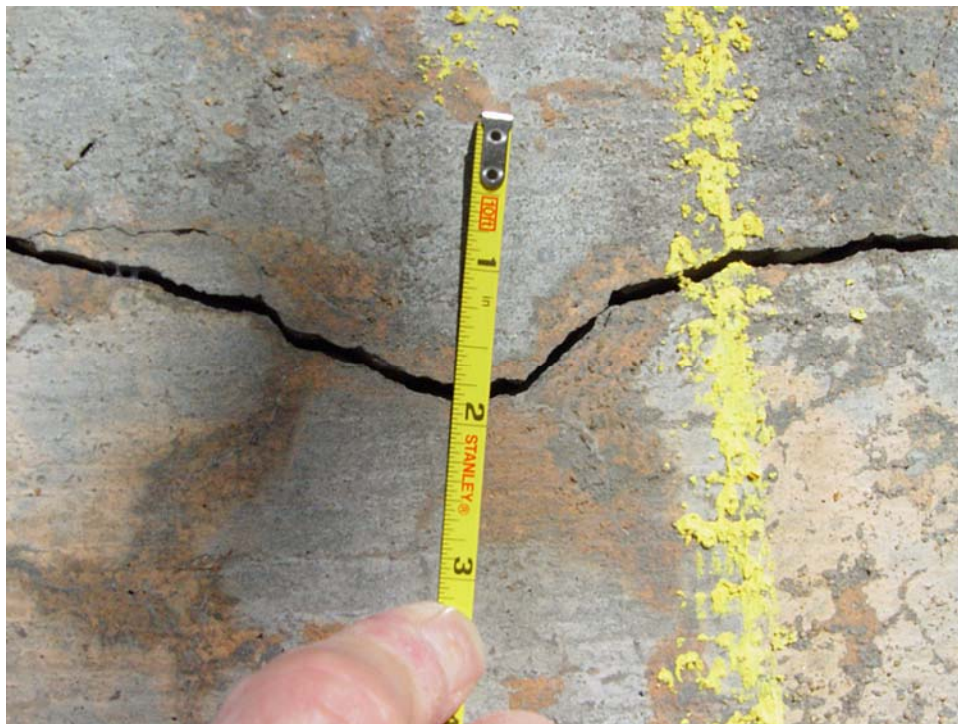
Figure 4. Cracks Can Be as Large as 0.25 In at Edge Surface of Slab

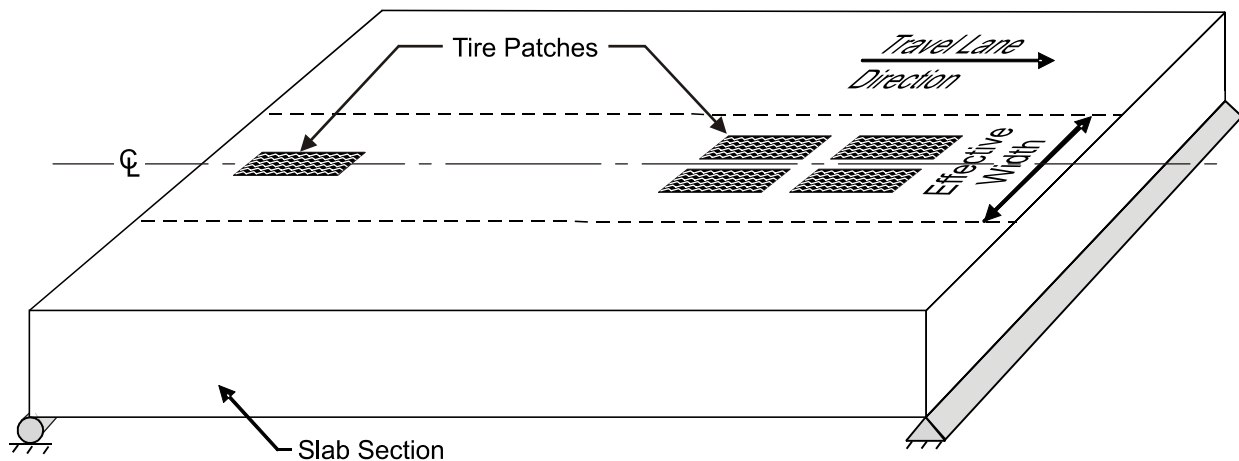
The bridge design code used was AASHTO's *Standard Specifications for Highway Bridges* (AASHTO 2002). The slab bridge is treated as a one-way slab with an effective width per wheel-line, as seen in Figure 5.

Figure 5. Effective Width of Wheel Line

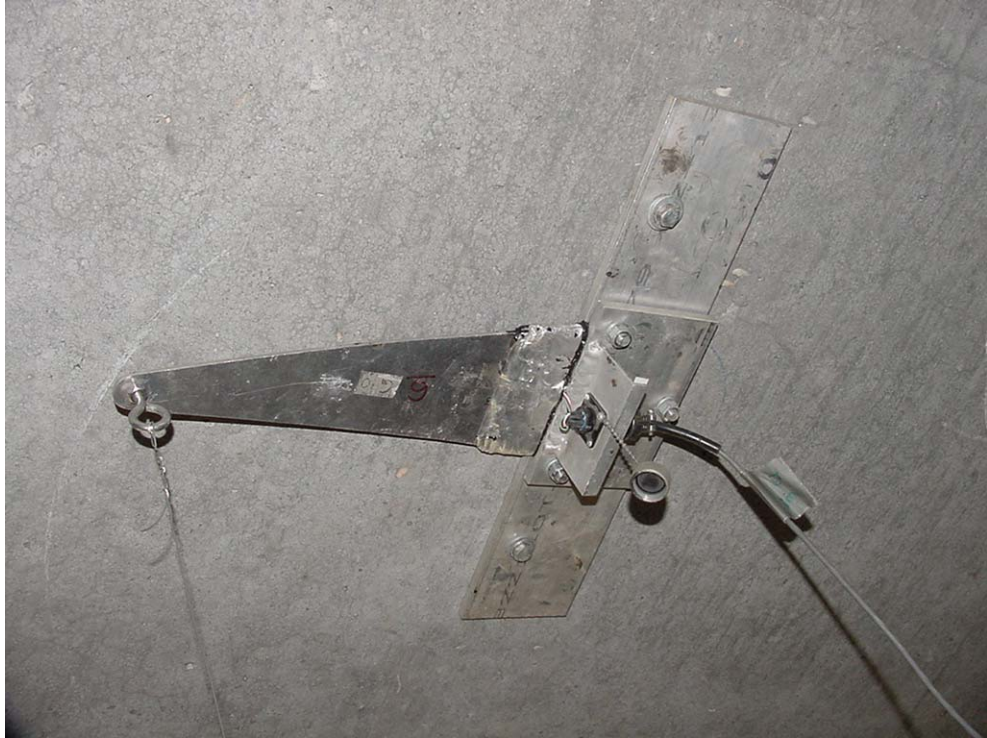
Deflection sensors fabricated by Virginia Polytechnic Institute & State University (Virginia Tech) in 1997 were used to measure deflection of the bridge (Figure 6). For the November 2003 test, the sensors were calibrated to the nearest 0.003 in in conjunction with the Optim Electronics MEGADAC data acquisition system and Test Control Software (TCS). The sensors were calibrated to the nearest 0.002 in in conjunction with Campbell Scientific, Inc.'s CR9000 Data Acquisition System and PC9000 Software Program for the October 2004 test.

Figure 6. Deflection Sensors

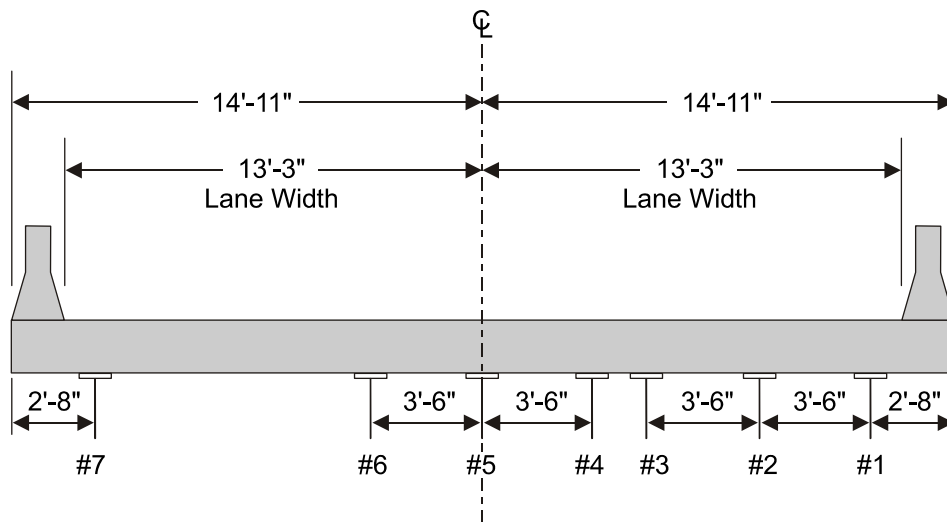
deflectometers were bolted to concrete anchors installed on the underside of the slab through the sensor's base plate at the locations shown in Figure 7. The sensors were pre-deflected approximately 0.75 in to allow the sensors to relax as the slab displaced downward. The sensors were connected through seven separate channels to the data acquisition system to record the change in deflection as the tests were run. The acquisition system was configured for a sample rate of 400 samples per second per channel. A sample of the refined data is provided in Figure 8.

Figure 7. Deflection Sensor Locations (at Midspan of Test Span)

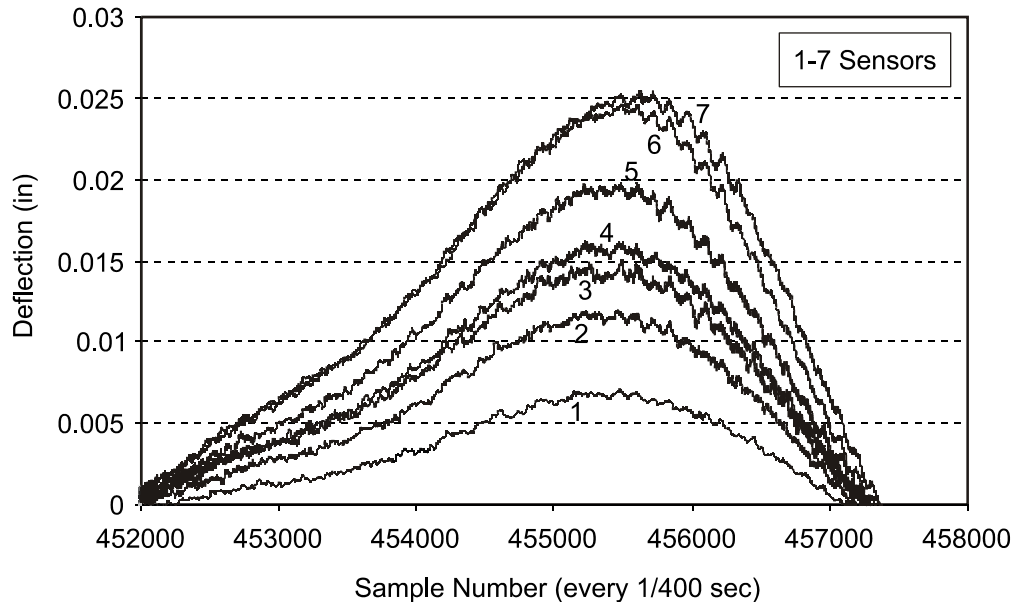
Figure 8. Refined Data Collected From Seven Deflectometers on Pass Along Upstream Shoulder (Lane 2)

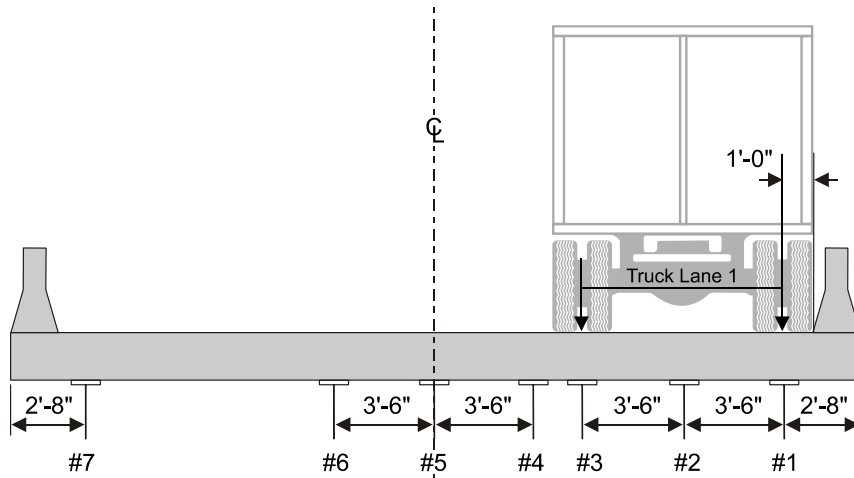
Three test lanes were used to orient the truck on the bridge. The placement of the test lanes and deflectometers were the same for the November 2003 and October 2004 tests so that the results could be compared. As seen in Figure 9, Test Lane 1 was on the downstream side of the bridge. The exterior wheel line of the truck was located 1 ft from the base of the parapet. This orientation coincides with the design lane for a slab beam (see AASHTO 2002). Three deflectometers, one under each wheel line and one corresponding to the center of the lane, were placed under this test lane. Test Lane 2, as seen in Figure 10, was located on the upstream side of the bridge with the truck's exterior wheel located 1 ft from the base of the parapet. Test Lane 3 was located along the centerline of the bridge; with the wheel lines located 3 ft 6 in off either side of the centerline. As seen in Figure 11, three deflectometers were located under Test Lane 3 similarly to those for Test Lane 1.

Figure 9. Truck Test Lane 1 (Facing Northbound)

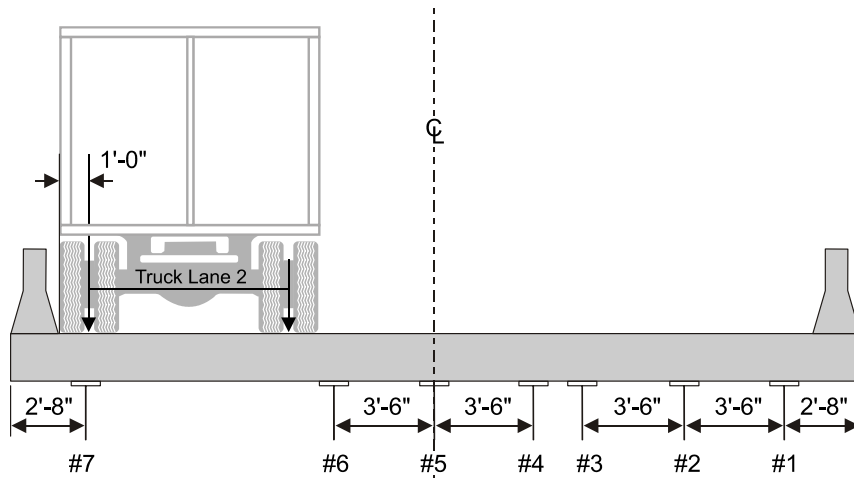
Figure 10. Truck Test Lane 2 (Facing Northbound)

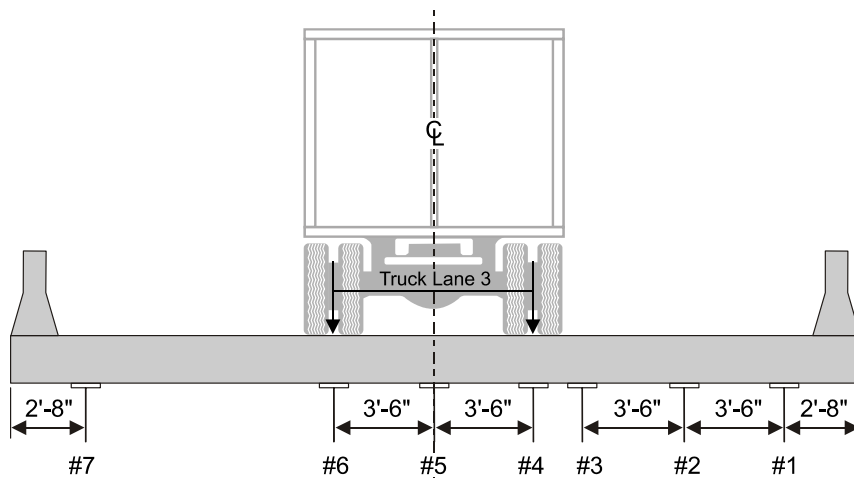
Figure 11. Truck Test Lane 3 (Facing Northbound With Center of Truck Aligned to Center of Bridge)

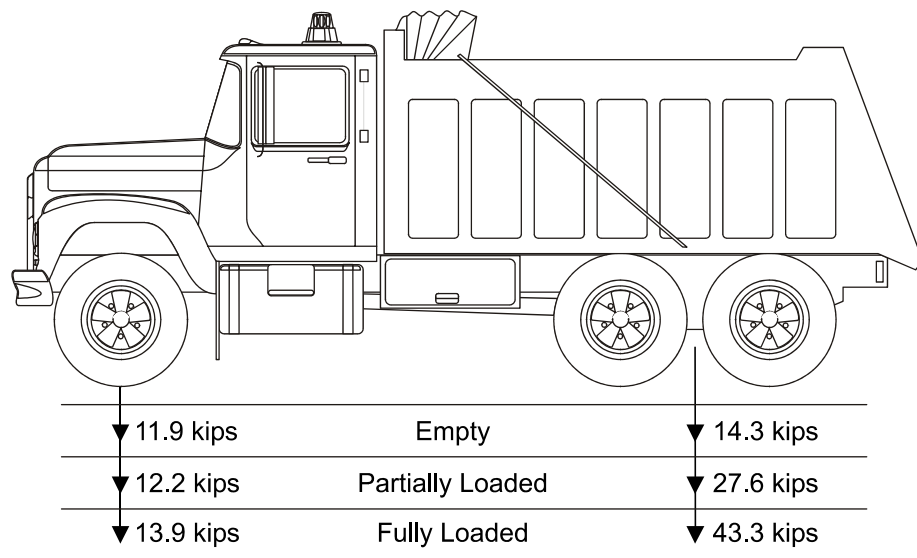
Figure 12. Weight Distribution Between Front and Rear Axles for November 2003

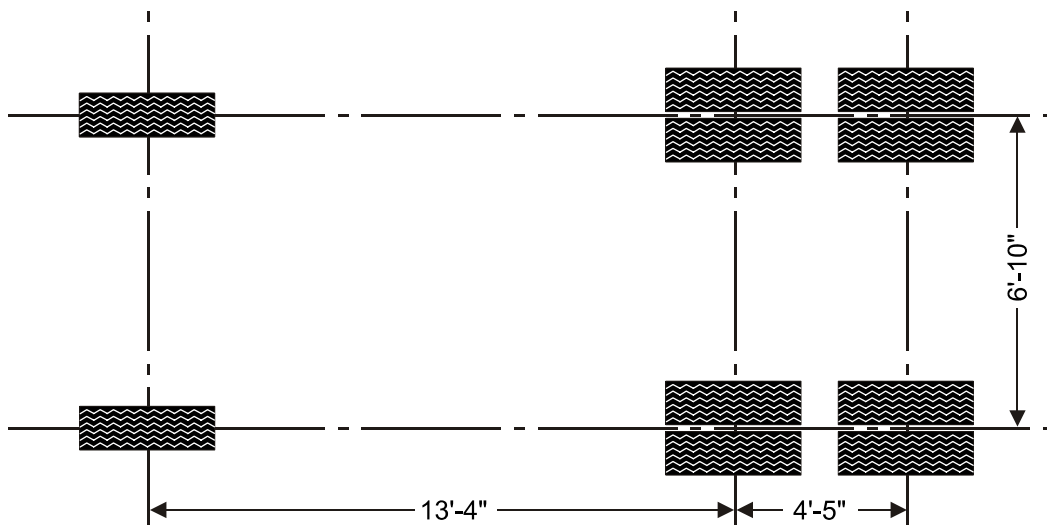
Figure 13. November 2003 Test Truck Footprint

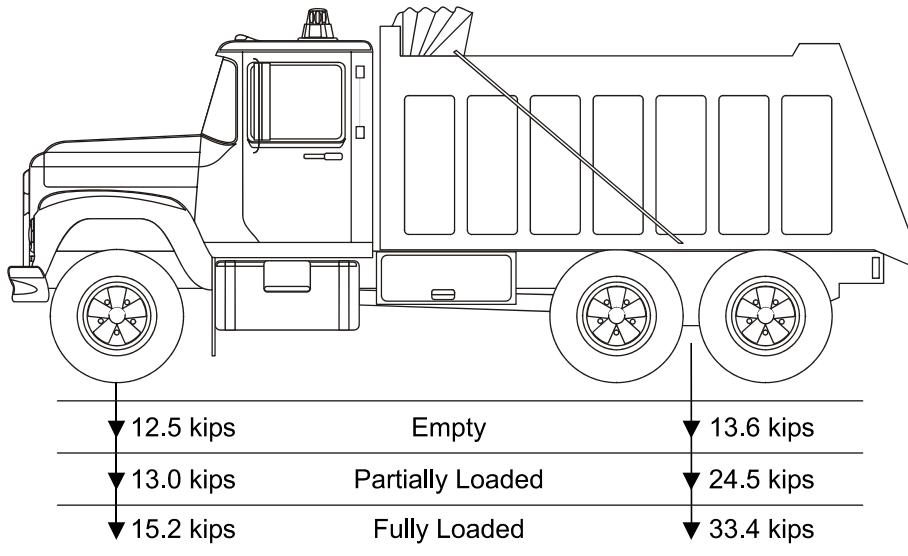
Figure 14. Weight Distribution Between Front and Rear Axles for October 2004

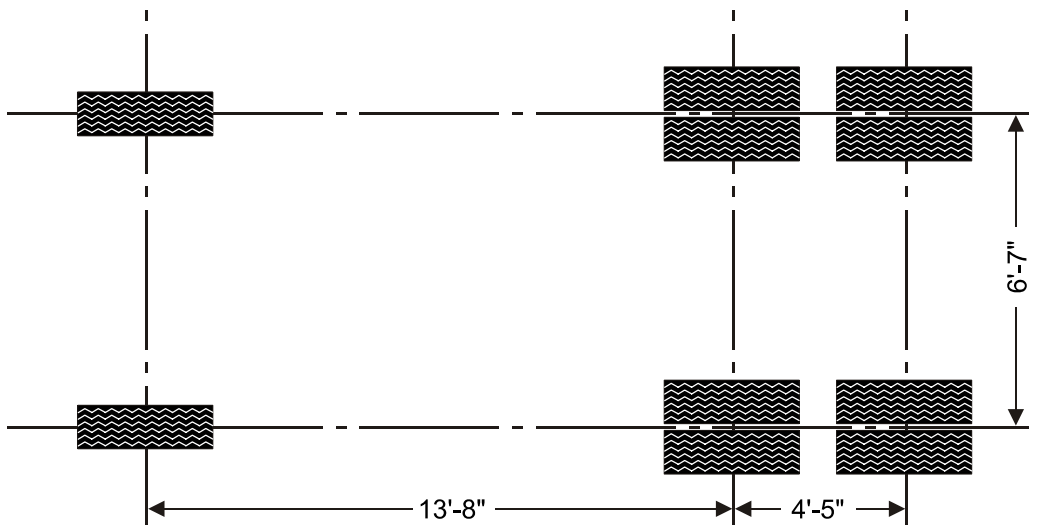
Figure 15. October 2004 Test Truck Footprint

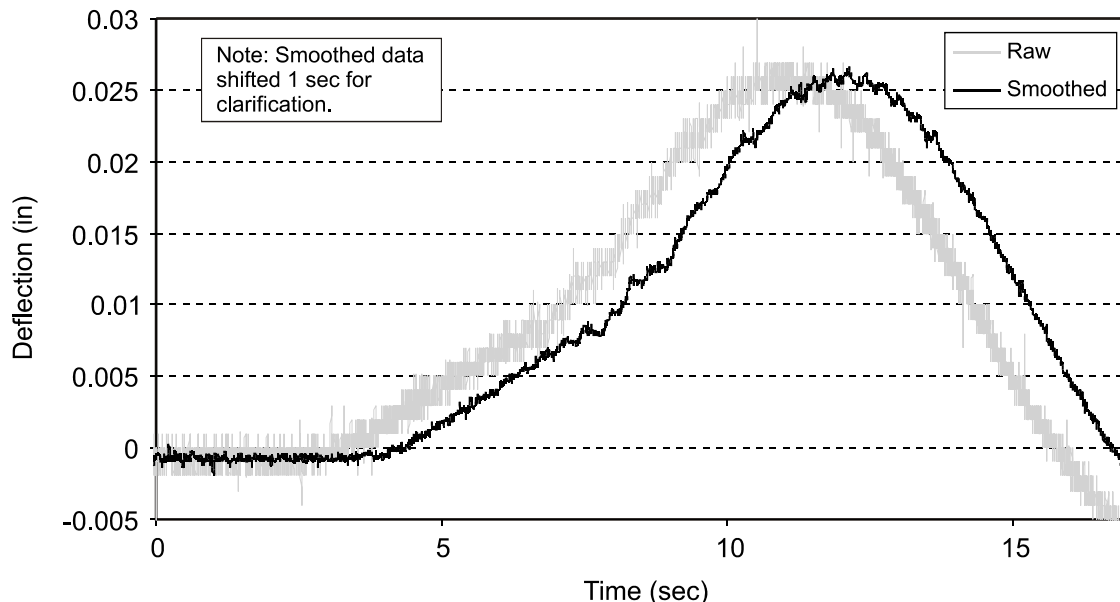
The procedure described herein was used on all static and dynamic tests for both testing years. Using Microsoft Excel, the data were visually inspected to determine if all sensors were reporting reasonable trends. A nine-point running average was then used to smooth the data and reduce electronic noise. Figure 16 shows a typical comparison of raw and smoothed data. Maximum deflections were determined for each sensor by finding the maximum point and averaging that with the surrounding points to account for electronic noise (Figure 17). During some runs, the sensors detected the “wobble” of the truck attributable to an uneven approach slab onto the span; in these cases, the average was found from the local maximum and minimum peak around that point (Figure 18). The maximums were graphed to find the deformed shape of the slab and to ensure that the deflections corresponded to the theoretical deformed shape a slab should approximately look like (Figure 19). Because of the end constraints imposed on a slab, a shallow “U” shape is expected when the slab is loaded in the center (Boresi and Schmidt, 2003).

Figure 16. Comparison of Raw and Smoothed Data (Positive Is Downward Deflection)

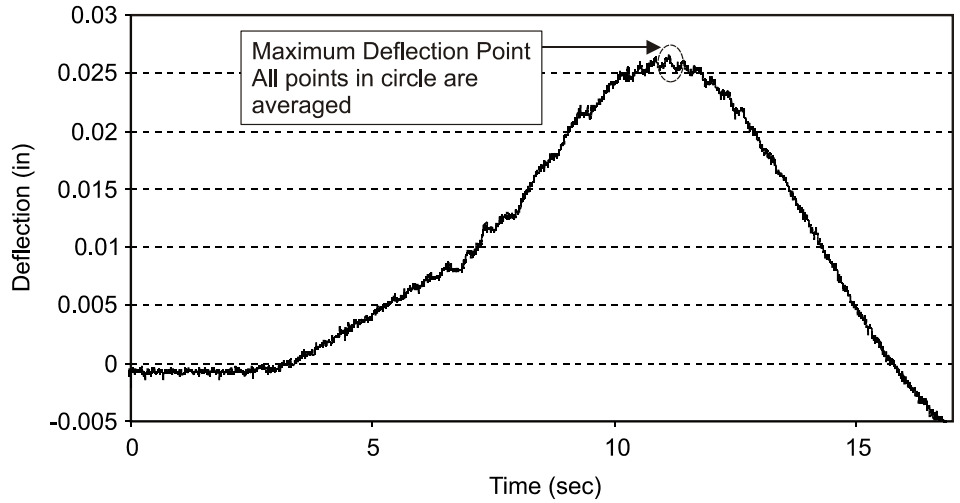
Figure 17. Determining Maximum Deflection (Downward Deflection Is Positive)

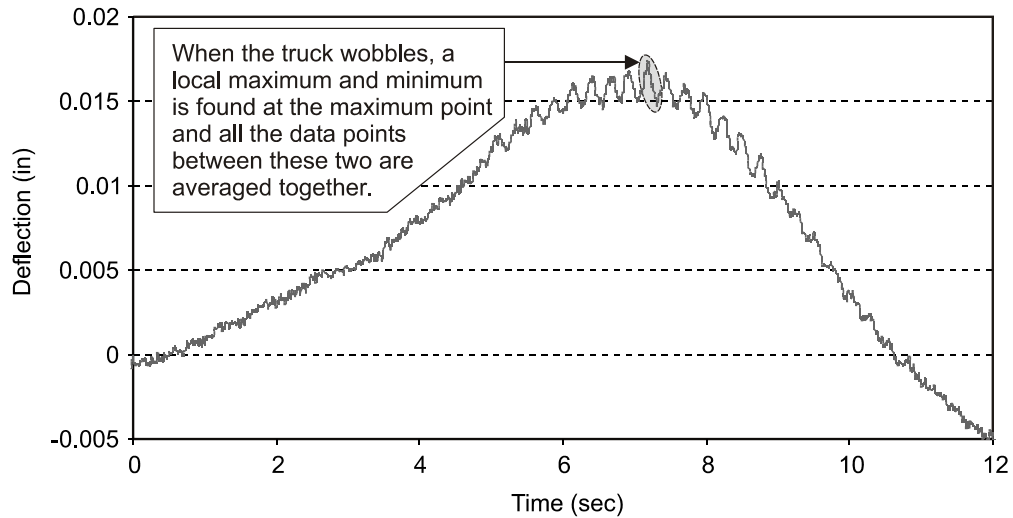
Figure 18. Determining Maximum Deflection When Truck “Wobbled” (Downward Deflection Is Positive)

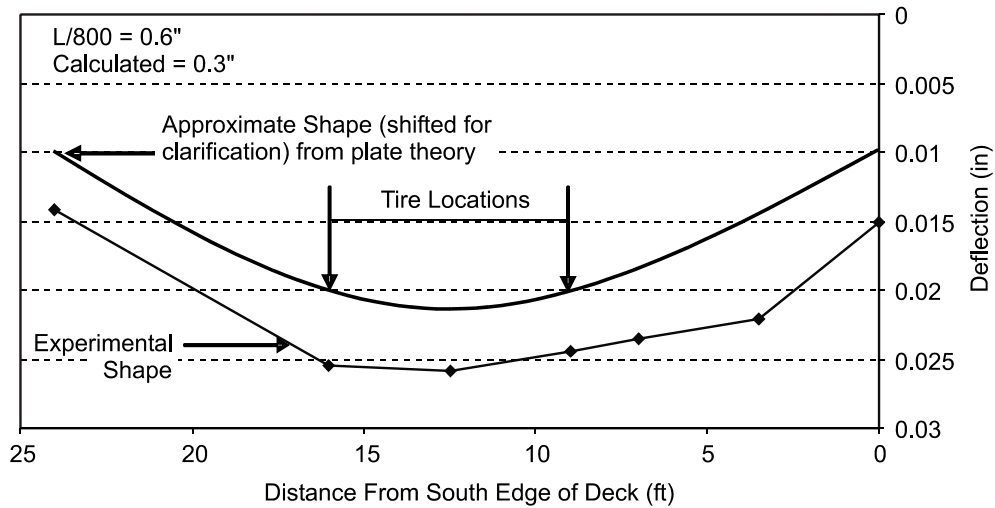
Figure 19. Sample of Deformed Shape

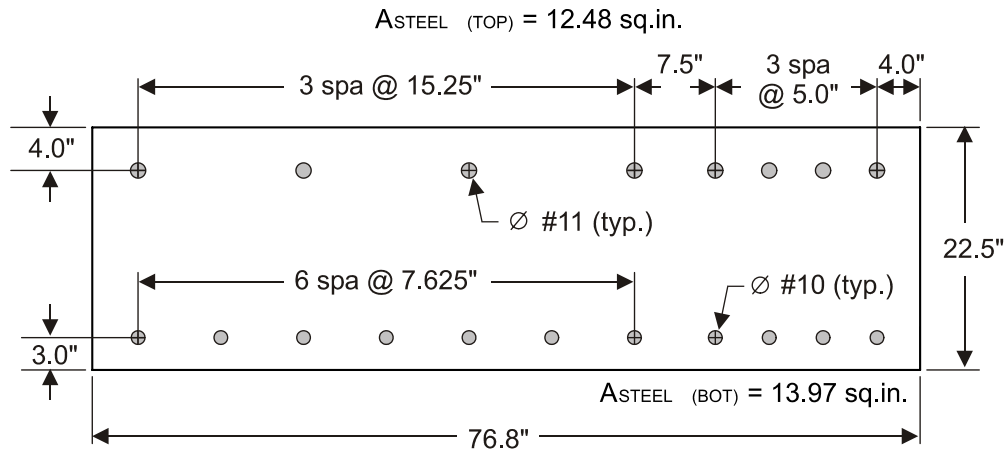
Some assumptions and simplifications were made to calculate the expected deflections. The slab was treated as a prismatic member with a constant, average depth of 22.5 in. There are different amounts of reinforcing steel at the edge of the slab and at the center. As seen in Figures 20 and 21, there is about the same area of steel in the top of the slab for both the edge (8 in²) and middle (7.8 in²) of the slab at midspan. There is a larger difference between the amounts of steel for the bottom reinforcement in the edge (15.2 in²) and middle (12.7 in²) of the slab. When the cracked moment of inertia was determined, it was assumed that the difference in the amount of reinforcing steel between the side and middle lanes was negligible in comparison to other assumptions when the deflection calculations were made; thus, the edge lane reinforcing steel layout was used for both loading conditions.

Figure 20. Reinforcement of an Effective Wheel Width at Edge of Slab

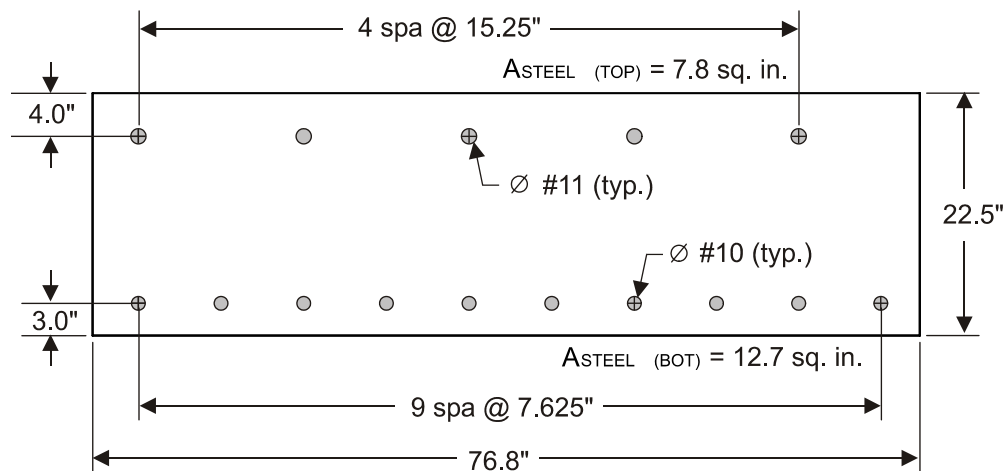
Figure 21. Reinforcement of an Effective Wheel Width at Center of Slab

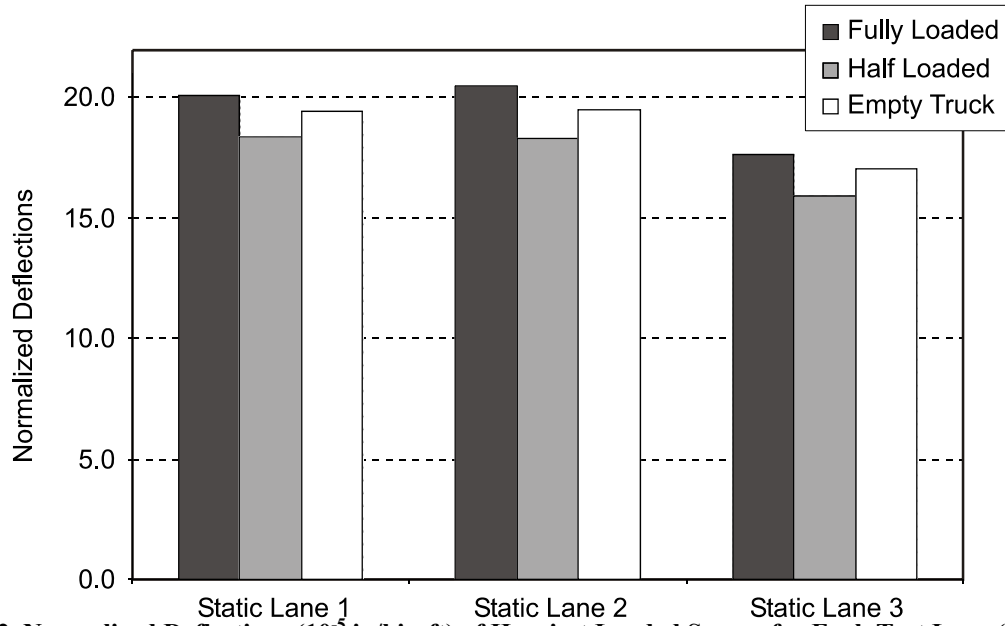
Normalized data (Tables 16 and 17) were used to determine if the bridge was exhibiting a linear-elastic behavior. Dividing the deflections by the maximum moment gives the slope of the curve of deflections versus applied moments. If this curve is linear (i.e., slope is constant), it can be assumed that the bridge is acting in a linear-elastic manner under the applied loading conditions. Equal normalized deflection values at a sensor among all load cases show that this slope is constant. Figures 22 and 23 graphically show the normalized deflections of the most heavily loaded deflection sensors for each lane. Representative samples of this linear behavior for Test Lanes 1 and 3 can be seen in Figures 24 and 25. Test Lane 2 is not shown because it is similar to Test Lane 1. The test data for the heaviest loaded sensors were linearly fit through the origin. The coefficient of determination, R^2 , determines how good of a fit the line is to the data points. The closer the coefficient is to 1, the more closely the estimated values of the trend line equation are to experimental data. The R^2 values of the linear trend lines found in Figures 24 and 25 range between 0.97 and 0.99, showing that over 95% of the experimental data is accurately modeled with a linear equation going through the origin. Based on the near linear behavior shown in Figures 24 and 25, it is concluded that the bridge was not loaded beyond its linear-elastic limit during the live load tests.

Figure 22. Normalized Deflections (10^{-5} in/kip-ft) of Heaviest Loaded Sensor for Each Test Lane (2003 Test)

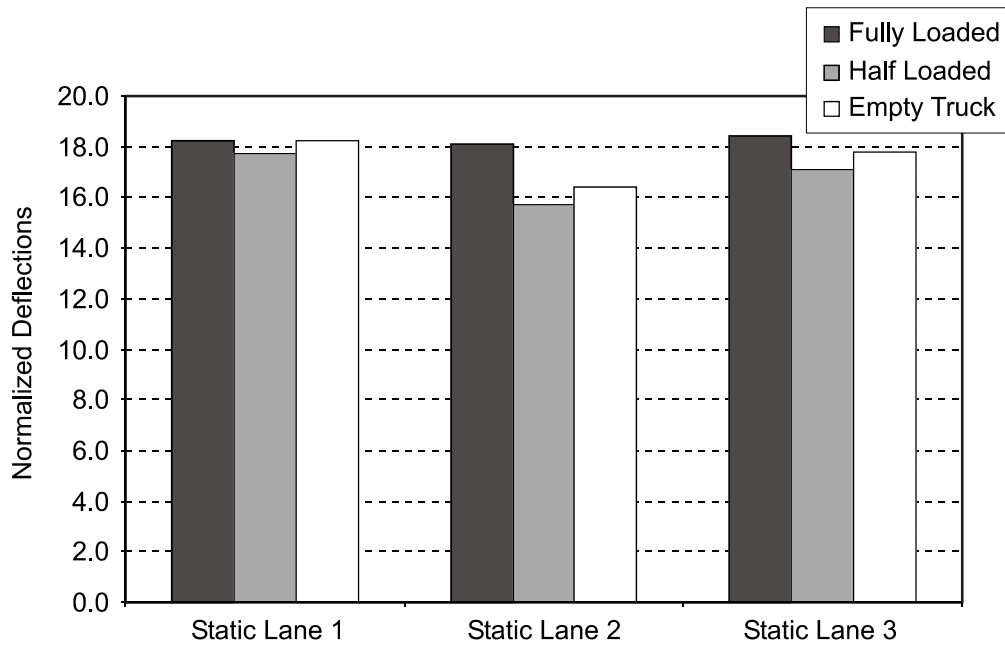
Figure 23. Normalized Deflections (10^{-5} in/kip-ft) of Heaviest Loaded Sensor for Each Test Lane (2004 Test)

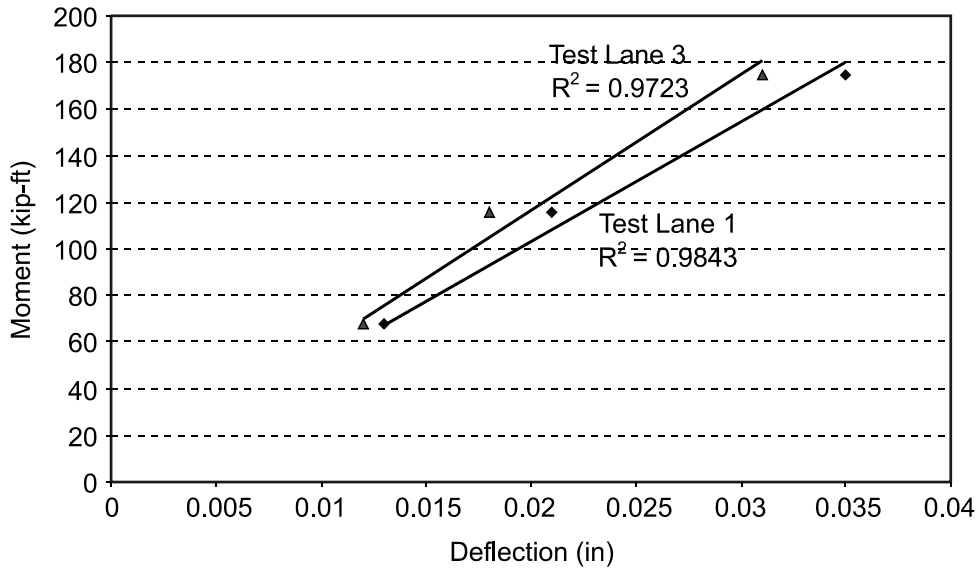
Figure 24. Load vs. Deflection for November 2003 Test Data

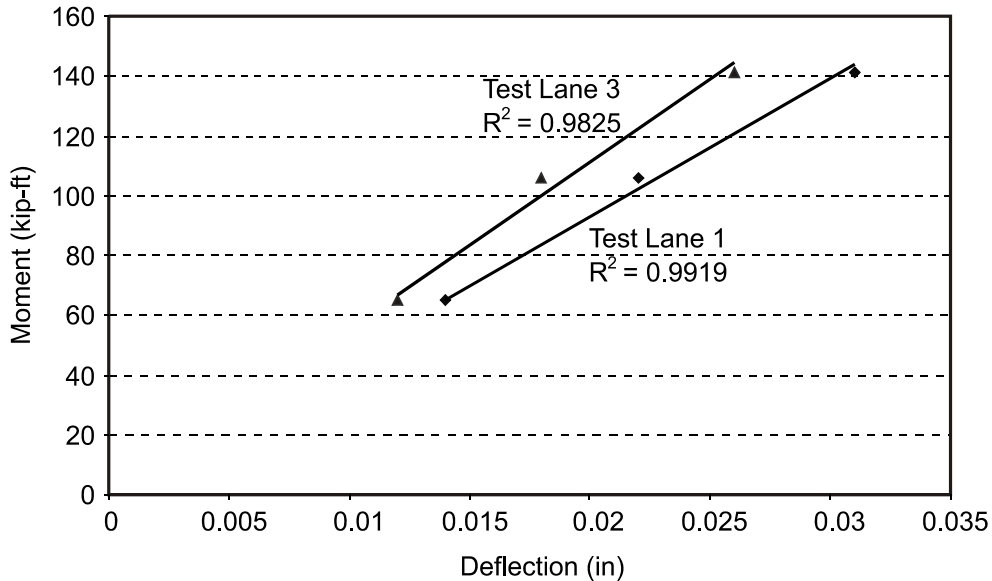
Figure 25. Load vs. Deflection for October 2004 Test Data

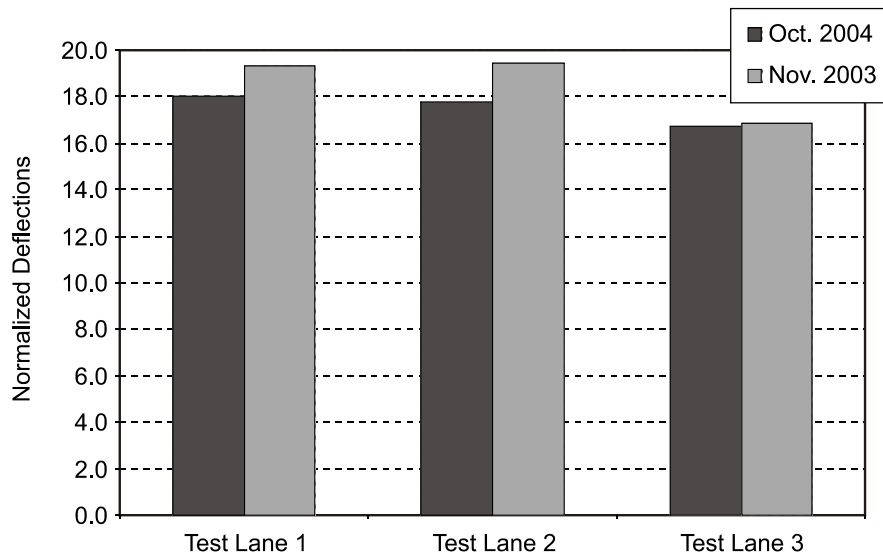
By comparing the 2003 test data to the normalized deflections of the 2004 test (Table 18), it can be suggested that there is no decrease in structural integrity in terms of stiffness. Figure 26 graphically shows this trend. This can be stated because there is minimal variation in the normalized deflections between the two tests. What variation there is can be attributed to electronic noise in the system and the fact that the values recorded are quite small. The larger variations in Deflectometers 2 and 7 are assumed to be sensor errors in the 2003 testing. Figure 27 shows how Sensors 2 and 7 reported lower values than what would theoretically be expected. Since the deflected shape is with the truck going down the center test lane, Sensor 7 should read about the same as Sensor 1. In addition, the large variation in Sensor 2 is attributed to slight calibration and sensor errors in the earlier tests because the deflected shape should be more of a smooth curve like that of November 2004. These sensor errors can be attributed to more electronic noise resulting from the different data acquisition system used in the earlier tests.

Figure 26. Comparison of Normalized Deflections (10^{-5} in/kip-ft) Between the Two Years

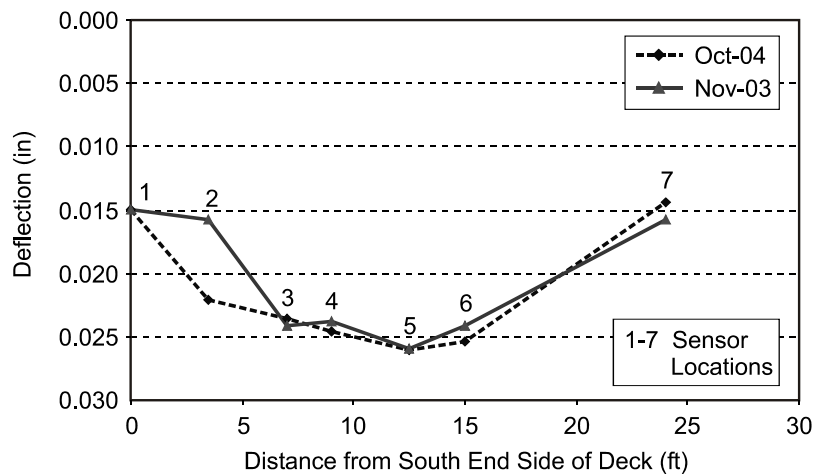
Figure 27. Comparison of Deflected Shapes (Deflection Down Is Positive)

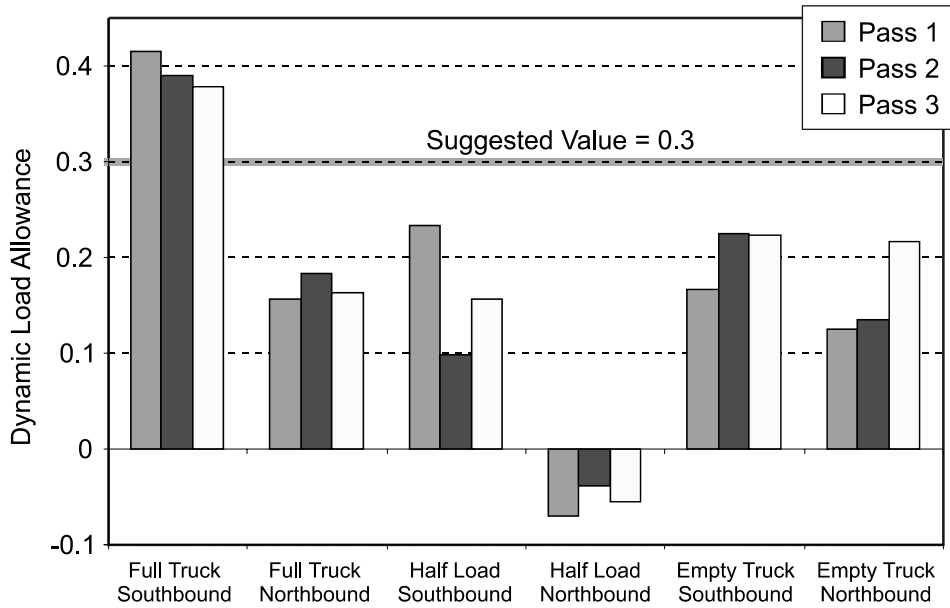
There is much debate and conflict between AASHTO specifications and research documents on what a design impact factor should be. However, the maximum impact factor is commonly considered to be approximately 0.3 (Taly, 1998). The average calculated dynamic load allowance of 0.25 and 0.20 with the 57 kip test truck of 2003 and the 49 kip test truck of 2004, respectively, corresponds well with the accepted values. Figures 28 and 29 show the dynamic load allowance for each run.

Figure 28. Dynamic Load Allowances for November 2003

The variation between the two tests can be attributed to the type of truck, weight of truck, and changes in the approach over the past year. The maximum measured values were about 0.4 for both tests, which is slightly above expected limits. This high maximum value may be attributed to the accuracy of the measurements in comparison to the magnitude of the deflections. Moving either the dynamic or the static value by a few thousandths of an inch (i.e., within the tolerance and precision of the data acquisition setup) will largely vary the impact factor. The large difference between the minimum and maximum dynamic load factors can be attributed to the different approaches the truck took to the slab. Tests that were run northbound had the truck going over an uneven approach, which may have caused lift on the truck while over the test span, whereas the tests running southbound were smoother because the truck approached the test span by traveling over the other two spans first, making the truck more likely in full contact with the deck by the time it reached the test slab.

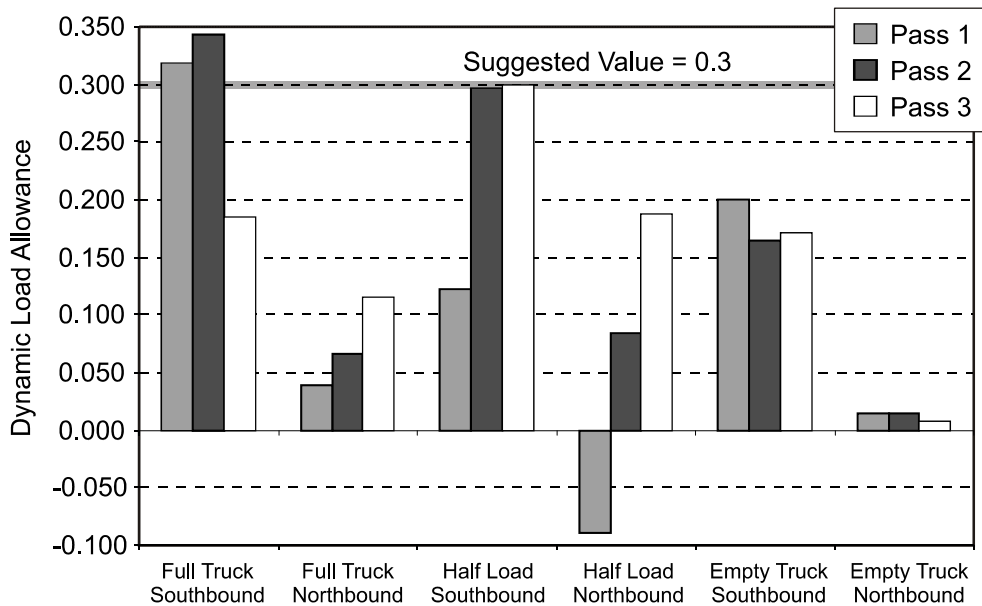
Figure 29. Dynamic Load Allowances for October 2004
