INSTALLATION OF PRESTRESSED PANEL SUBDECKS

July 1977
VHTRC 78-R1

This report is concerned with the field installation of prestressed panel subdecks on the Rte 220 bridges over relocated 23rd St. in the city of Roanoke. These were the first bridges to be constructed in Virginia utilizing the precast subdeck panel construction technique. The field study was conducted as a follow-up to the original study which resulted in the recommendation to install the panels on a bridge on an experimental basis and record any problems occurring during the installation; and further to offer suggestions for the possible improvement of the technique. Details regarding the general features of the prestressed panels used on the Rte 220 bridges are given in the report. Based on observations made during the installation of the panels, certain recommendations are offered.

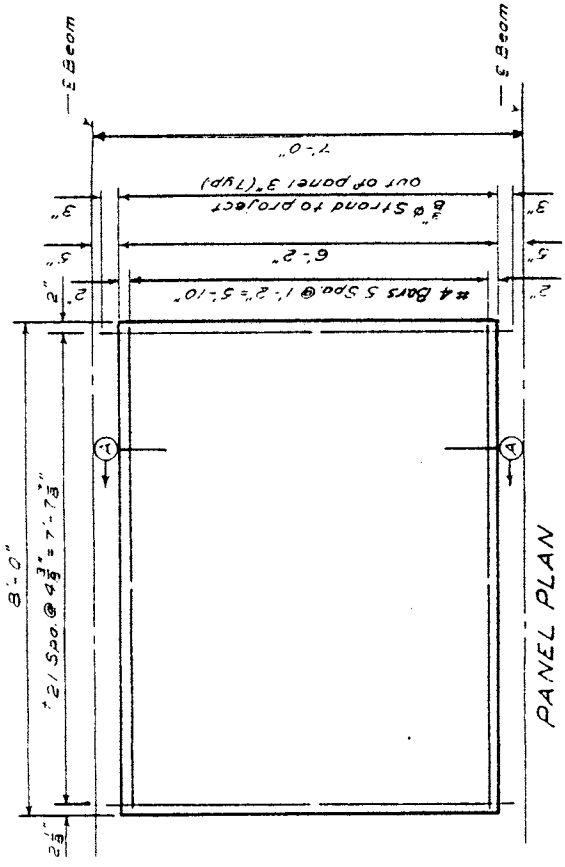
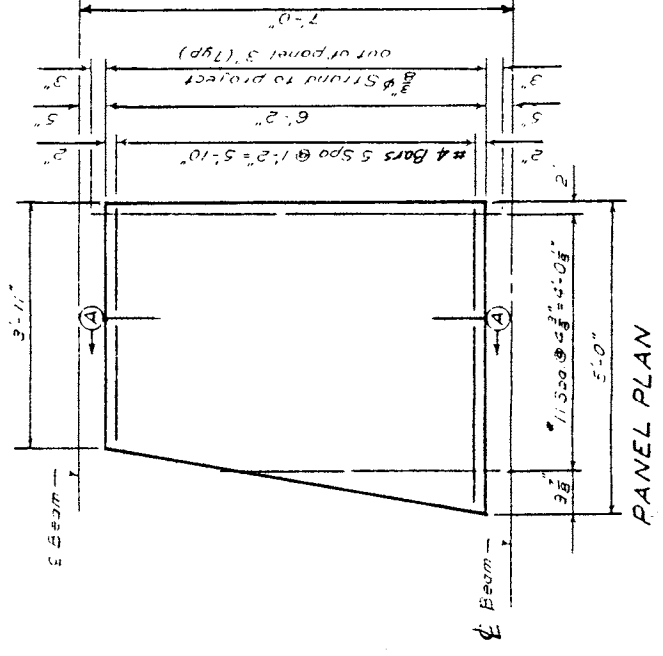
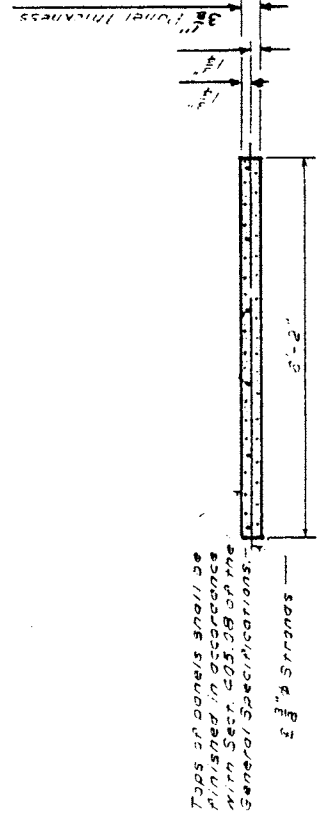
* 22 - 3/8" Strands. Total
Pressing force = 354, 200 lbs.

Tops of panels shall be
finished in accordance
with Sect. 005.08 of the
General Specifications.

Figure 1(b). Typical subdeck panel details for a 59-ft. span
(1 ft. = 0.3048 m).

The longer length panels, which were used on the 9.45 m (31-ft.) spans, contained thirty-one 9.5 mm (3/8-in.) diameter, 270 grade strands prestressed to 111 MPa (16.1 kips) per strand. The shorter length panels contained twenty-two 9.5 mm (3/8-in.) diameter strands — each prestressed to the same force as for the former panels. In each case, the panel thickness was 89 mm (3-1/2 in.), with the prestressing strands being located at the center of the depth. A welded, deformed steel wire fabric conforming to ASTM A497 and having a minimum yield strength of 483 MPa (70,000 psi) was also used in the panels. The design compressive strength of the panel concrete was 34.5 MPa (5,000 psi).

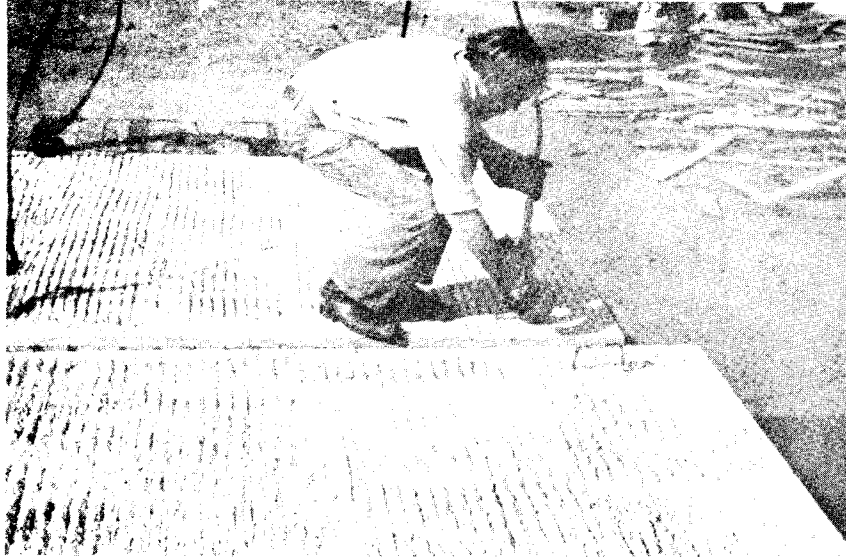
Figure 2. Prestressed panel is hooked for lifting onto the bridge superstructure.

In general, the placement sequence involves simply hooking the crane cables up to the panel lifting hooks (Figure 2) while the fresh mortar bed is being applied to the bearing surface on the top edge of the girders (Figure 3), lifting the panels out to the bridge (Figure 4), and gently setting them in position on the girders (Figure 5).

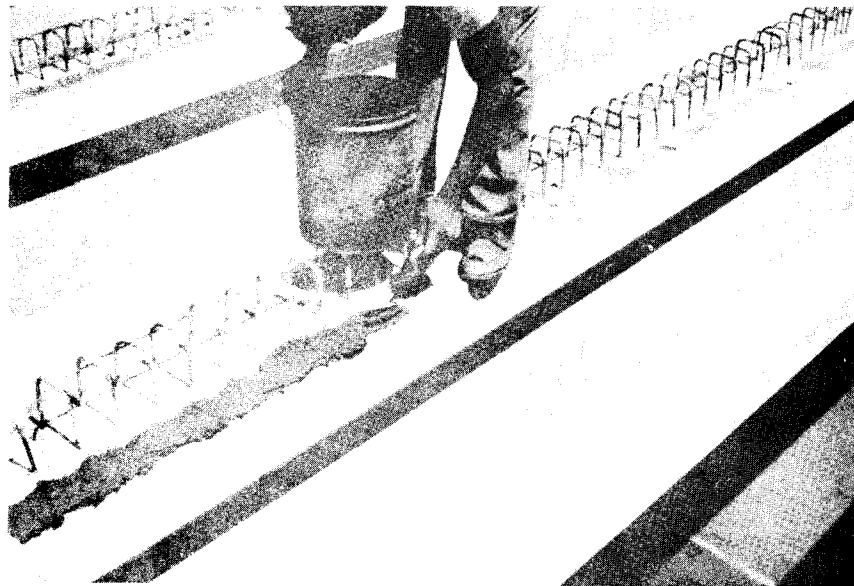
Figure 3. Fresh mortar being applied to the bearing area on the top flange of a girder.

The cement mortar used for the panel bearing seats was composed of 1 part cement to 2-1/2 parts sand. It was usually of stiff consistency, but occasionally too much water was added and the material was made more difficult to use for this particular purpose. For the first few panels that were placed, the mortar was applied to the top of the girders in a rather haphazard manner as can be observed in Figure 3. Since it was difficult to gauge the thickness of the mortar bed when it was placed in this manner, the contractor was requested to cut a 76 mm (3 in.) wide by 2.44 m (8 ft.) long strip of 16 mm (5/8 in.) thick plywood for use as an edge guide to help obtain the proper width and thickness of the mortar bed. This technique proved to work reasonably well since the 16 mm (5/8 in.) thick layer of mortar would normally settle to approximately the 13 mm (1/2 in.) thick layer desired.

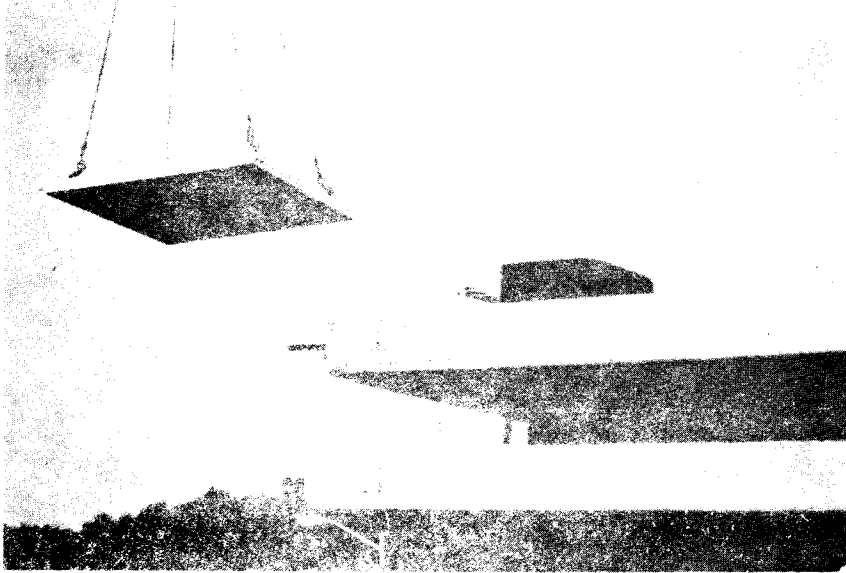
Figure 4. Panel being unloaded from the truck and swung out to the superstructure.

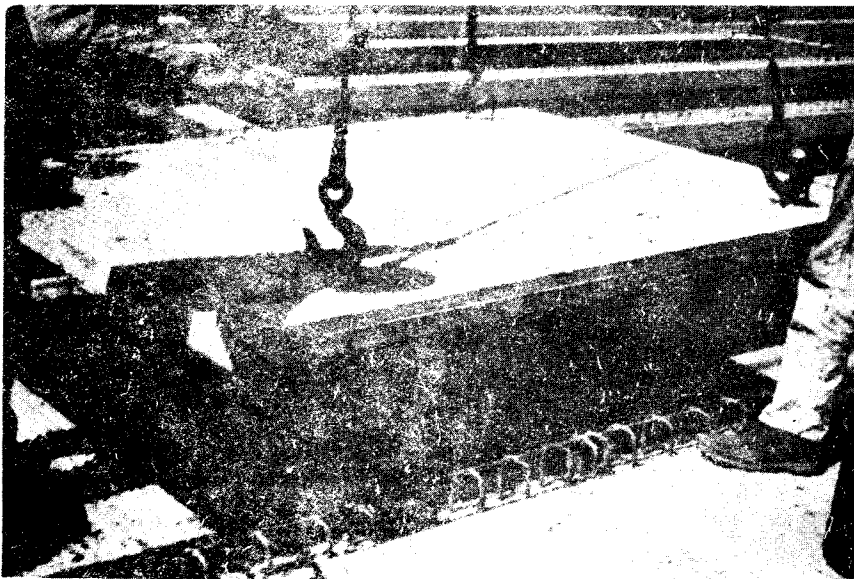
Figure 5. Panel being set in place on the bridge girders.

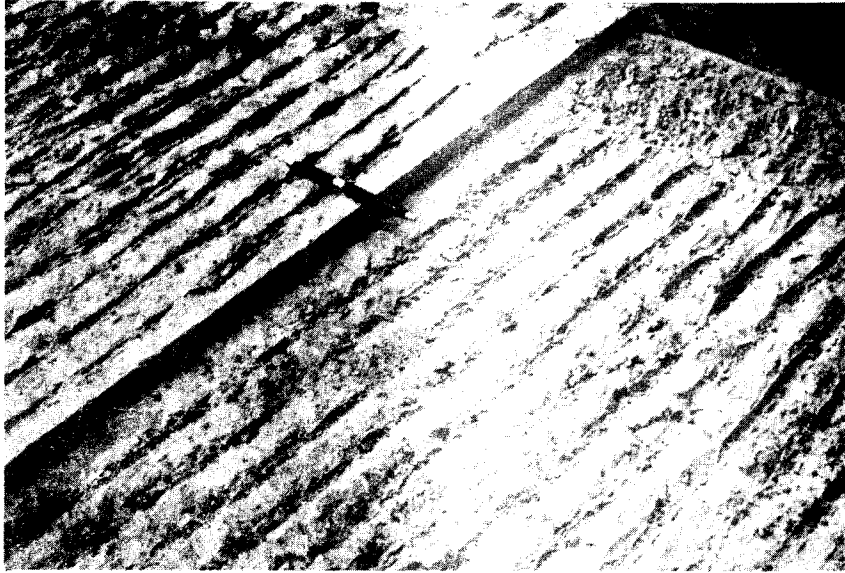
As might be expected, placement of the panels on a fresh mortar bed did result in a number of mismatched joint edges between adjacent panels. Figure 6 shows a joint between panel sections that illustrates one of the most extreme cases; the edges are mismatched by approximately 19 mm (3/4 in.). In addition to differences in mortar consistency, other factors that contribute to mismatched joint edges are slight differences in the elevations of the bearing surfaces on the girders, slight warpage in the prestressed panels, and the ease with which the panels are set on the mortar bed. The last mentioned factor probably plays the most important role, since it is often difficult to ease the panel into its proper resting position on the girders due to conflicts between the prestressing strands and the stirrups projecting out of the girders (Figure 7).

Figure 6. Example of a mismatched joint between adjacent panels.

Several elements contributed to the problem. First, the prestressing strands projecting out of the panels were often longer than the 76 mm (3 in.) anticipated on the plans. Secondly, if the first panel that is set at the beginning end of a span is only slightly out of skew, the error will be magnified proportional to the length further down the span as the succeeding panels are set. Therefore, if an attempt is made to keep the panel edges in line, there will be a gradual shifting of the panels that will result in an increased bearing area on one girder and a decreased area on the other. Thirdly, slight variations in the linear alignment of the beams or the stirrups can contribute to the problem. When conflicts between the panel prestressing steel and the girder stirrups arose during the panel placement, the stirrups were bent to the side as shown in Figure 8. The consequent jostling and maneuvering of the panels would often result in the panels being set down a little harder than desirable, or the shoving motions involved would disrupt the mortar bed — all of which are related to the mismatched joints shown earlier in Figure 6.

The surface texture (see Figures 6 and 7) produced by the disc rake appeared to be adequate, although it varied between panels. One group of panels were very slick on some areas of the surface. This was apparently due to a combination of rain and the protective covering making contact with the surface of the concrete during fabrication. The panels involved were sandblasted in-place on the bridge superstructure. A view of a slick surface area after it had been sandblasted is shown in Figure 10.

The previously described problems are of a very practical nature, and though occasional bending of the girder stirrups is not a desirable procedure no serious consequences of the operation were apparent. The best way to avoid the mismatched joints would probably be to use a preformed material on all or a portion of the bearing area, cut the prestressed strand projections to the plan length, and exercise considerable care in setting the first panels at the end of a span. While setting the first panel accurately is desirable, this too is not a crucial problem provided, of course, the error is not great. Small errors can be compensated for by setting succeeding panels to obtain the required bearing width on the beams and by not attempting to keep the bearing edges of adjacent panels in line. An example of this off-setting technique can be seen in the center portion of Figure 9.

3. The mortar bed used for setting the subdeck panels on the bearing area provides an adequate, even bearing surface, but it is difficult to maintain the desired thickness of the bed and to prevent mismatched edges at the joints between panels. Contractors should be encouraged to improvise a template to obtain an accurate width and thickness of the mortar. The template should be designed to prevent mortar from dropping off the edge of the girder onto the lower flange.

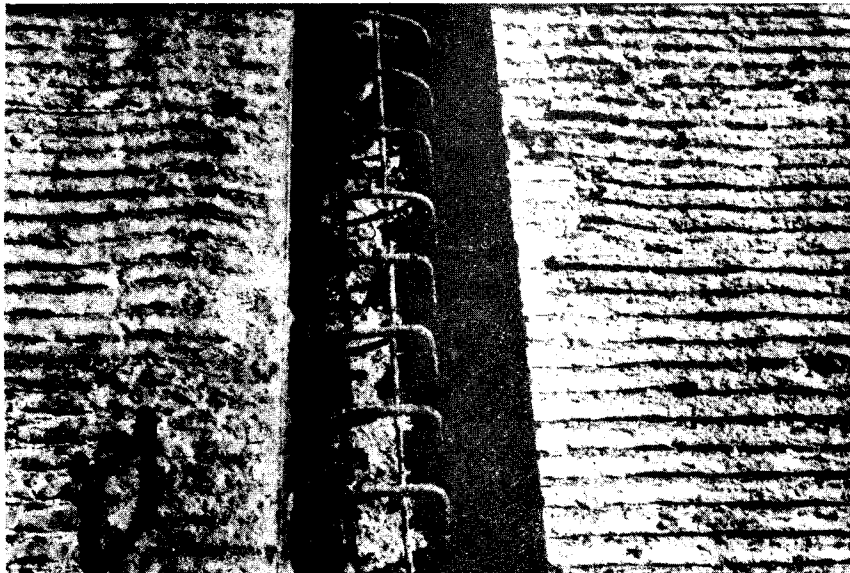
Figure 7. View of prestressing strands projecting into girder stirrups.

1. Consideration should be given to placing a note on future plans for prestressed panels that will discourage the use of small shims under the corners of the panels, a practice used to obtain the exact clearance in the bearing area between the bridge girder and panel.
2. The prestressed panel fabricators should be advised to make a more diligent effort to cut the stressing tendons to the projection lengths specified on the plans, and to keep the stirrups in the prestressed girders as linearly even as possible to avoid unnecessary conflicts with the prestressed tendons during placement of the panels.

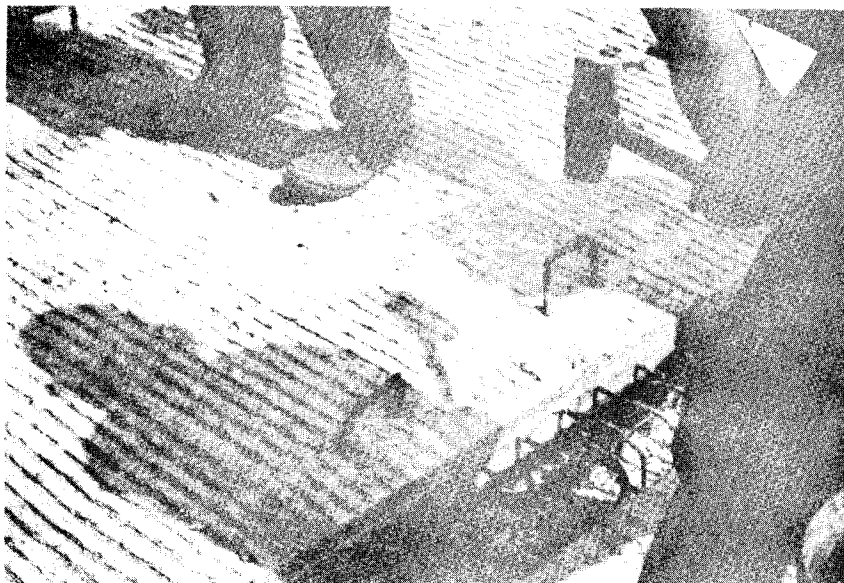
Figure 8. Sledge hammer being used to bend the girder stirrups so prestressed panel can be placed in proper position.

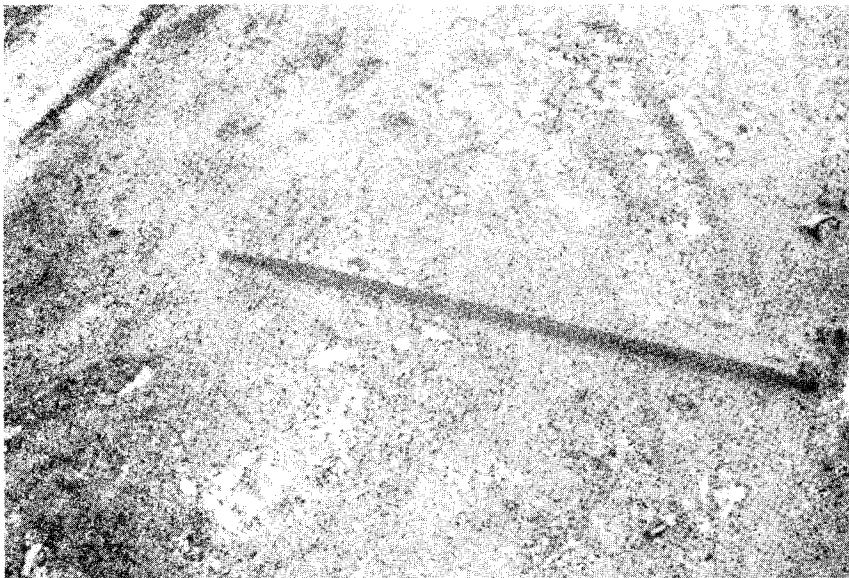
Figure 10. Surface texture of panel after sandblasting of slick area.

4. Contractors and inspection personnel should be advised of the importance of having a rough surface texture on the subdeck panels so that any having an unsatisfactory surface will be identified and corrected prior to placing the upper portion of the deck.

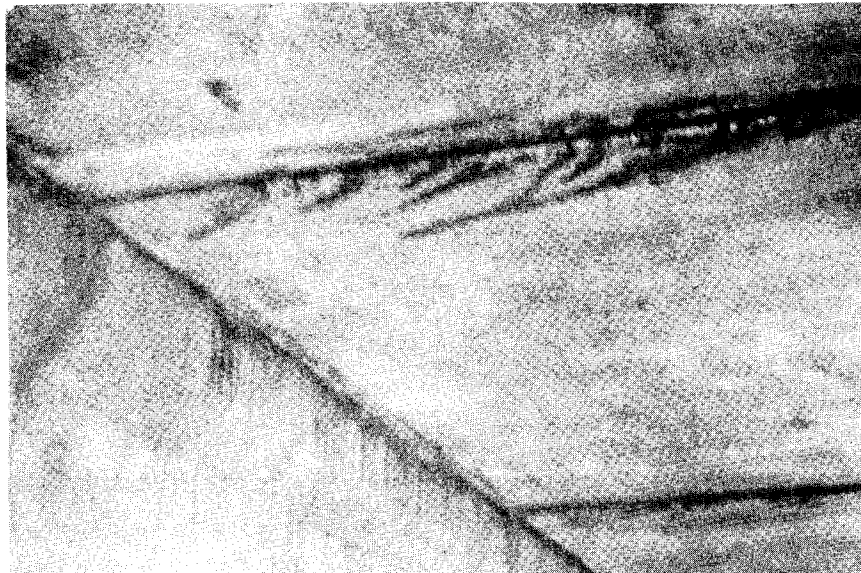
The joints between panels were of the simple butt type. No sealing or caulking compound was used on the joints prior to the placement of the cast-in-place portion of the deck. Since the subdeck panels were wet down prior to and during the deck placement operation, some water leaked through the joints. From observations of the underside of one of the spans during deck placement, however, there appeared to be only a minor amount of mortar seeping through. As might be expected, the joint leakage was random — some joints had no noticeable leakage whereas others obviously allowed the mortar to pass through as shown in Figure 11. In general, however, leakage through the panel joints appeared to be less than that which normally occurs when wood or permanent steel forms are used.

Figure 11. Leakage through joint between subdeck panels.

9. If adjacent panels are abutted as closely as possible, the joints do not appear to present a severe leakage problem. If esthetics of the underside of the bridge deck are considered to be important, caulking of the joints should be specified on the plans.

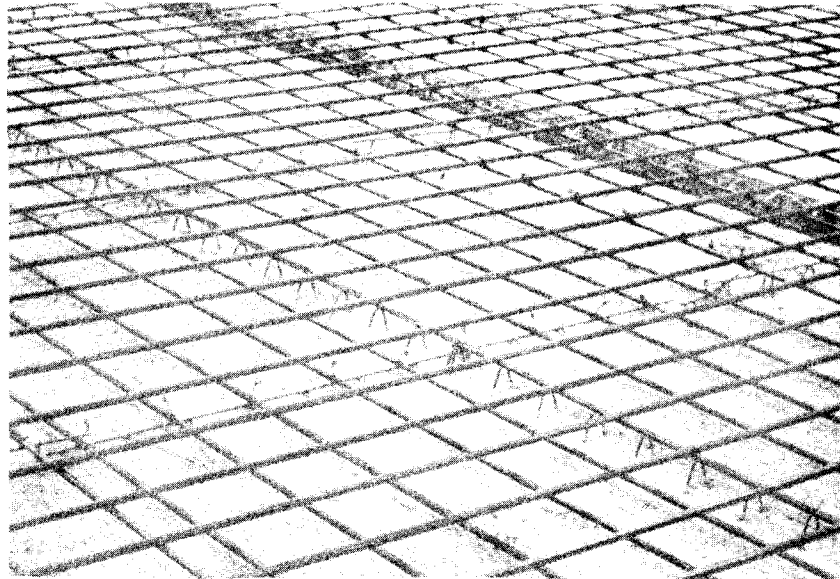
Figure 12. Epoxy coated reinforcing steel in place above subdeck panels.
