INTERIM REPORT

EVALUATION OF RECYCLED ASPHALTIC CONCRETE

Virginia Highway & Transportation Research Council  
(A Cooperative Organization Sponsored Jointly by the Virginia  
Department of Highways & Transportation and the University of Virginia)

VHTRC 77-R42

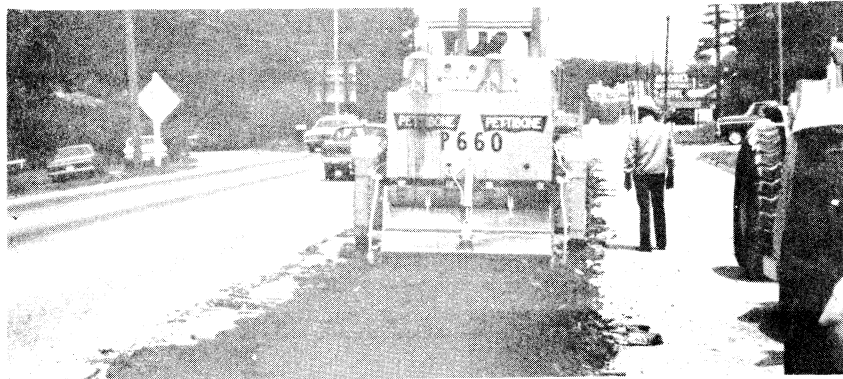
Figure 3. Pettibone pulverizer in use.

The project began May 24, 1976. Warren Brothers had decided to try both a Pettibone Pulverizer (Figure 3) and a Galion Planer (Figure 4) to remove the asphaltic concrete layers. This operation was experimental in that the Department was interested in seeing what type of product could be obtained by these machines. Warren Brothers also felt that the equipment might produce a gradation that would not have to be crushed and would therefore reduce hauling and crushing costs.

The equipment did, in fact, produce a material that did not require additional crushing. Table 3 shows the gradation produced by the Pettibone and Galion machines. The Pettibone removed the entire 5.5" of plant mix and the Galion removed the top 2".

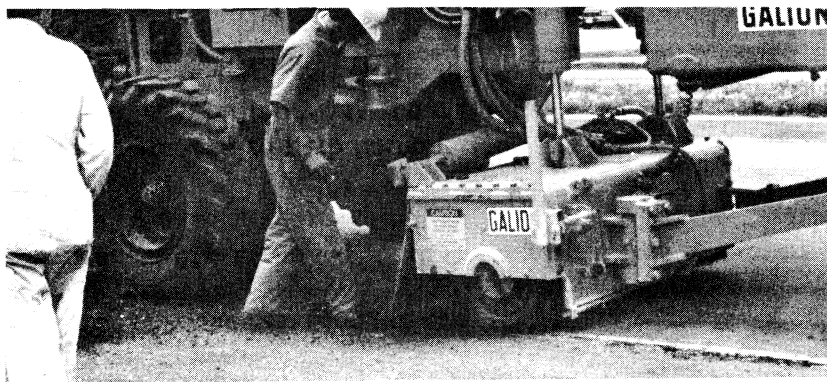
Figure 4. View of Galion scarifier.
