A CASE STUDY OF THREE METHODS USED IN
DETECTING BRIDGE DECK DETERIORATION
ASSOCIATED WITH SPALLING

Charles E. Smith
Highway Research Engineer

Virginia Highway Research Council
(A Cooperative Organization Sponsored Jointly by the Virginia
Department of Highways and the University of Virginia)

August 1973
VHRC 73-R4

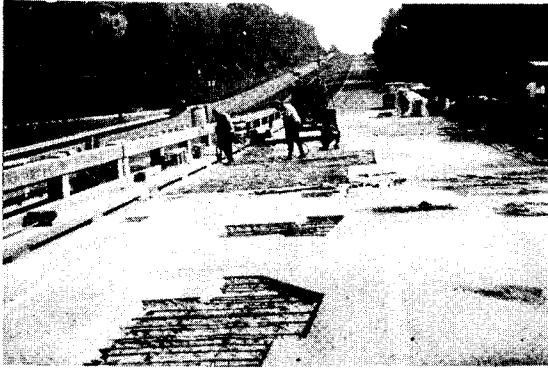
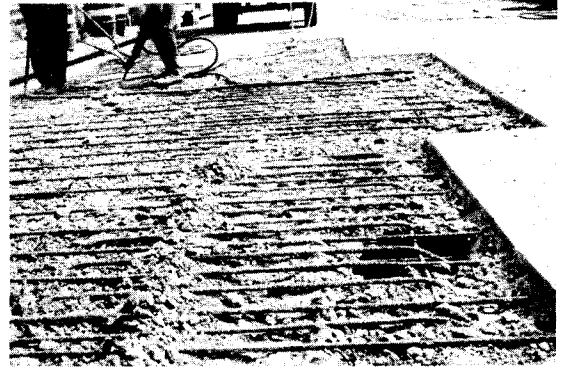
Figure 11. Exposed steel on second span (view looking north from first span).

As stated above, the only areas for which a visual survey of the reinforcement could be made to determine its degree of corrosion were the areas exposed as determined by the Hammer Method. However, these areas were sufficiently large to provide a meaningful evaluation of the ability of the three methods of detection to show areas of corrosion. Approximately 74 percent of the area of the deck was removed on span 2 and 48 percent on span 3. Figure 11(a) shows the removal of the concrete deck on the second span. This view was taken looking north on Route 360 and also shows the condition of the repaired traffic lane.

In the visual survey, areas of corrosion as opposed to a given point of corrosion were noted. Figure 11(b) shows the typical condition of the exposed steel on span 2. This figure also shows how the concrete was removed as well as the depth to which it was removed. Note the general condition of the reinforcing steel next to the opening in the deck. This condition was considered to represent corrosion. Figures 12(a) and 12(b) are close-up views of this area showing the extent of the corrosion of the steel.
