FINAL
CONTRACT REPORT
VTRC 09-CR4

**EXPERIMENTAL AND ANALYTICAL
INVESTIGATION OF FULL-DEPTH
PRECAST DECK PANELS
ON PRESTRESSED I-GIRDERS**

Via Department of Civil and Environmental Engineering
Virginia Polytechnic Institute & State University

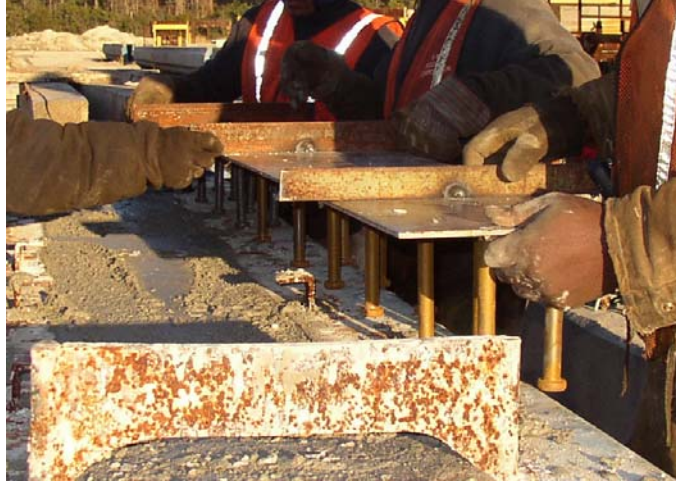
This research program investigated the performance of shear studs and hooked reinforcing bars with precast, prestressed girders. A portion of the hooked reinforcing bar, which was cast into the girder, protruded from the top flange into the shear pocket. The shear connector detail with shear studs was fabricated by casting a steel plate in the top flange of a prestressed girder. Shear studs were located on the bottom of the steel plate, as shown in Figure 2. Additional shear studs were then shot directly onto the top of the steel plate after the girder was erected and the panels were placed. No prior use or testing of this detail was found in the literature review.

Figure 2. New Detail For Horizontal Shear Reinforcement.

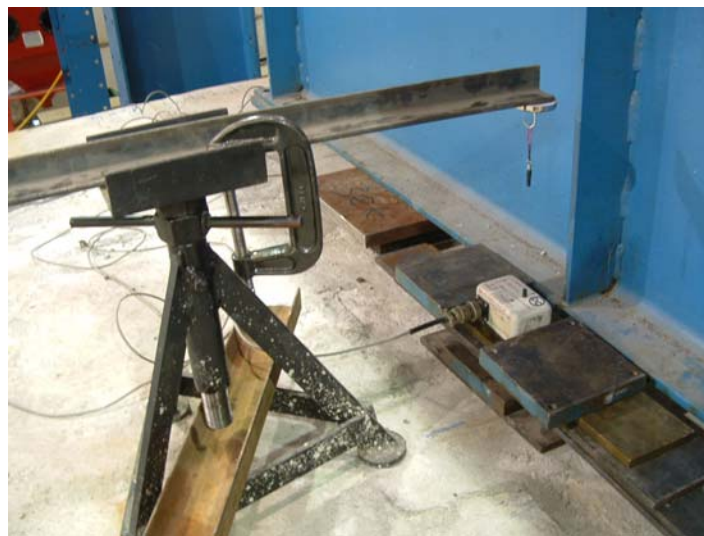
Figure 7. Setup to Measure the Relative Vertical Displacement at the Transverse Joints.

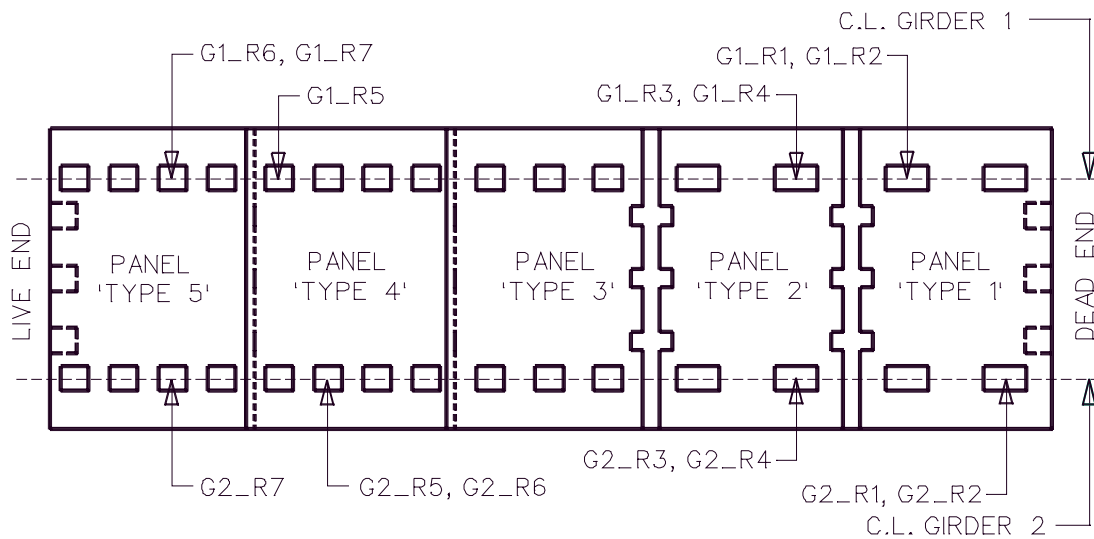
Figure 9. Locations of Instrumented Shear Connectors.

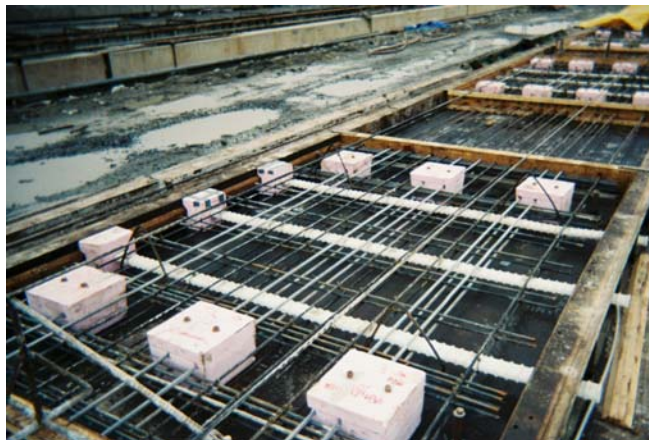
The blockouts for the shear pockets consisted of foam blocks and can be seen in Figures 20 and 21. The transverse joints were formed by attaching wood blocks conforming to the dimensions of the transverse joint to the side form of the stressing bed.

Figure 20. Layout of Stressing Bed for Precast Panels.

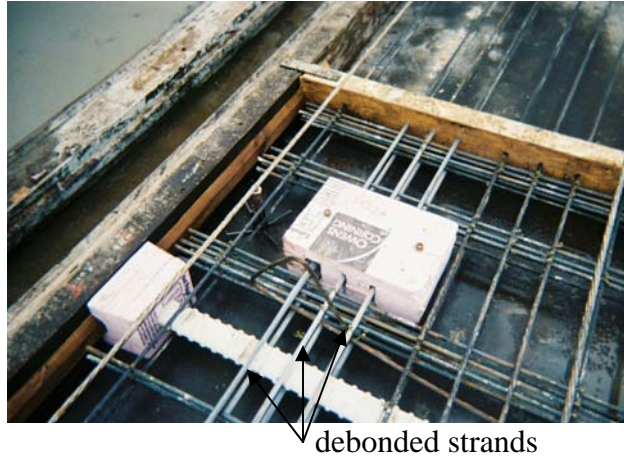
Figure 21. Formwork for Transverse Joint.

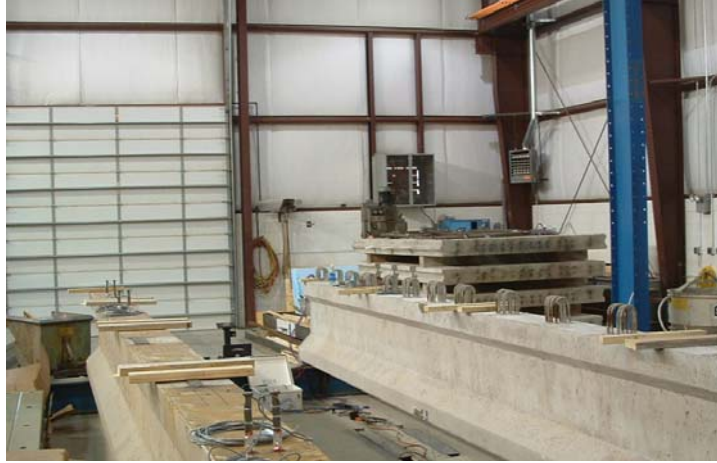
Figure 22. Girders with Wood Blocks in Place for Panel Erection.

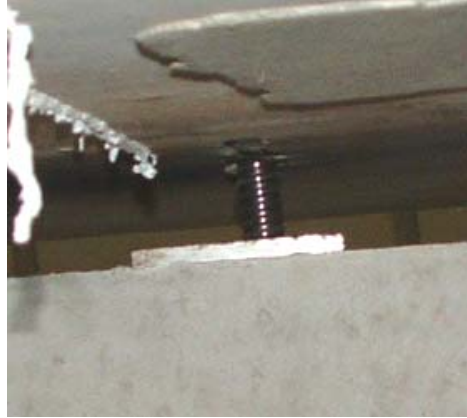
Figure 23. Leveling Bolt Bearing on Steel Plate.

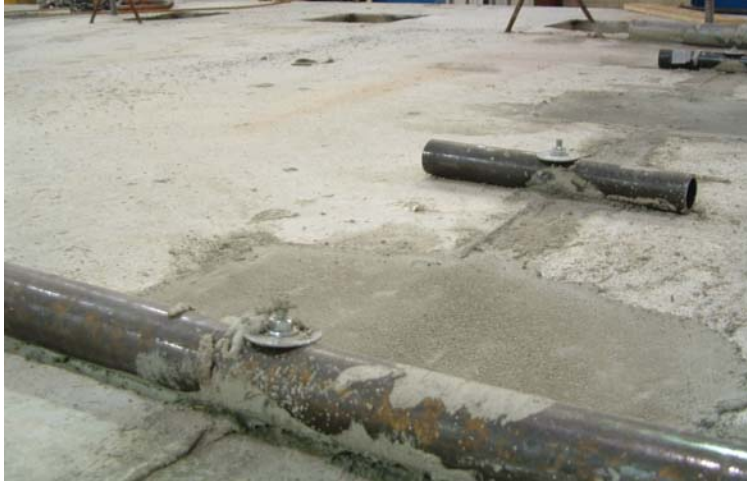
Figure 24. Grouted Female-Female Joints with Steel Pipe and Threaded Metal Rod Forming Alternative.

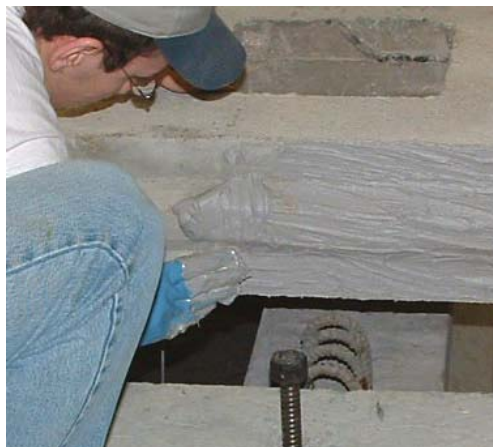
Epoxy was then placed on each side of panel 4 using chemical resistant gloves. This procedure is shown in Figure 25. Once the panels were in place, the rope was used to pull the strands back through the ducts in panel 4 and panel 5. Three members of the Virginia Tech research team performed the epoxying operation. One person operated the crane to lift panel 4

Figure 25. Epoxy Being Placed on Male-Female Joint.

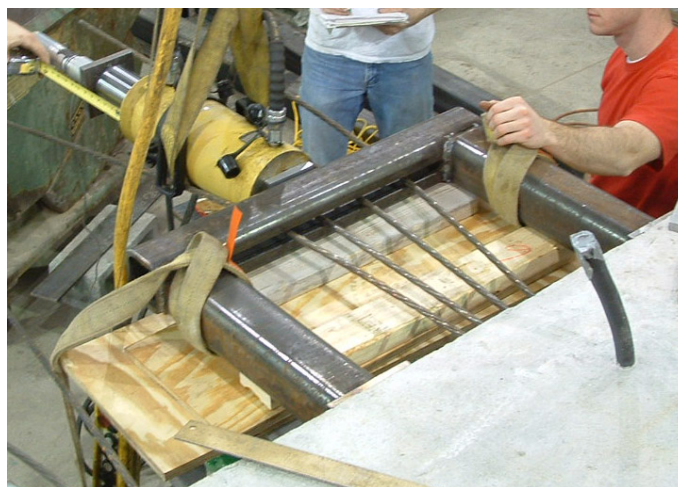
Figure 26. Stressing Chair Used for Lab Mockup.

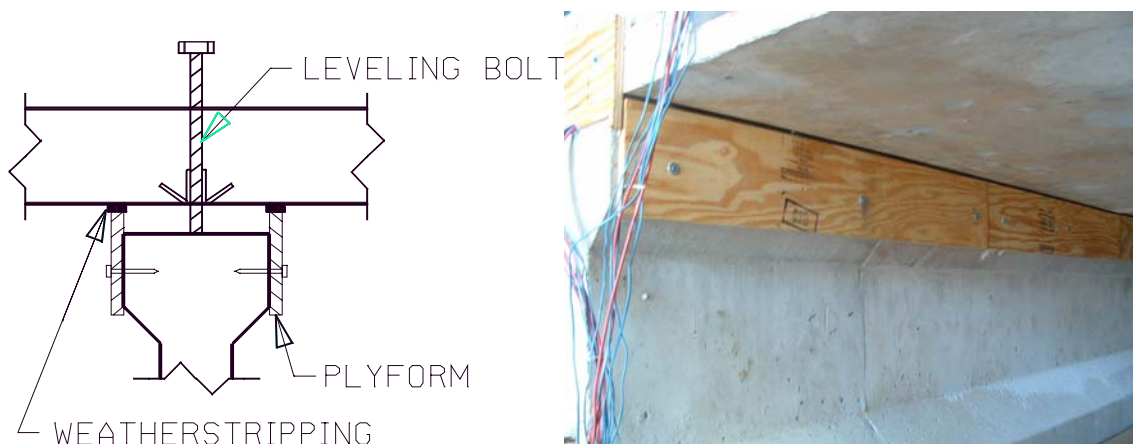
The formwork for the haunch was placed on 4/11/06 from 10:30 a.m. to 12:00 p.m. and from 5:30 p.m. to 8:10 p.m. Plyform sheets were used to form up the sides of the haunch. Weather stripping was placed between the bottom of the panel and top of the plyform to seal the gap at this interface. The plyform was secured to the girder with concrete stud anchors spaced at approximately 14 in. This is shown in Figure 27.

Figure 27. Formwork Detail for Haunch.

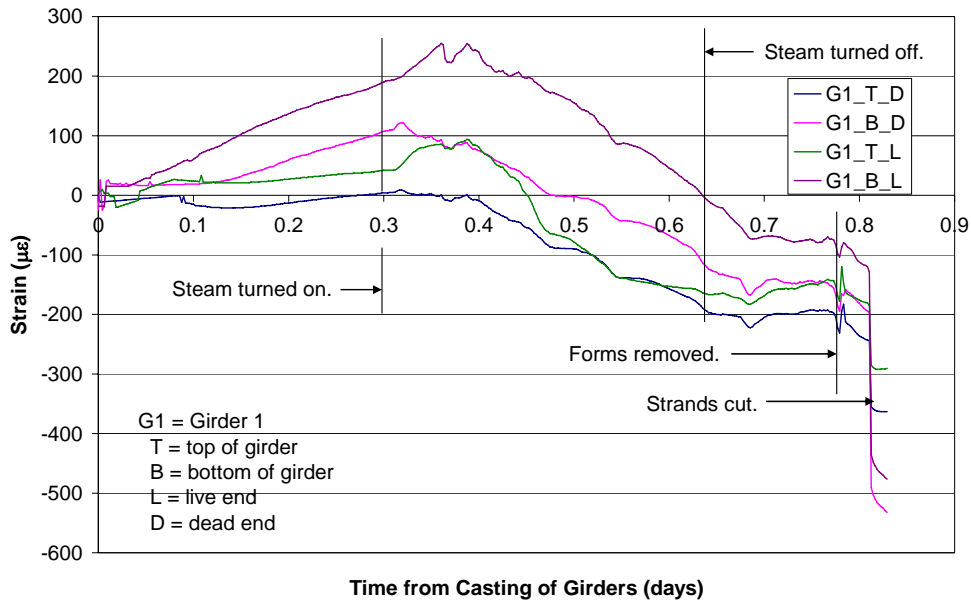
Figure 28. Variation of Strain with Time During Casting and Strand Release for Girder 1.

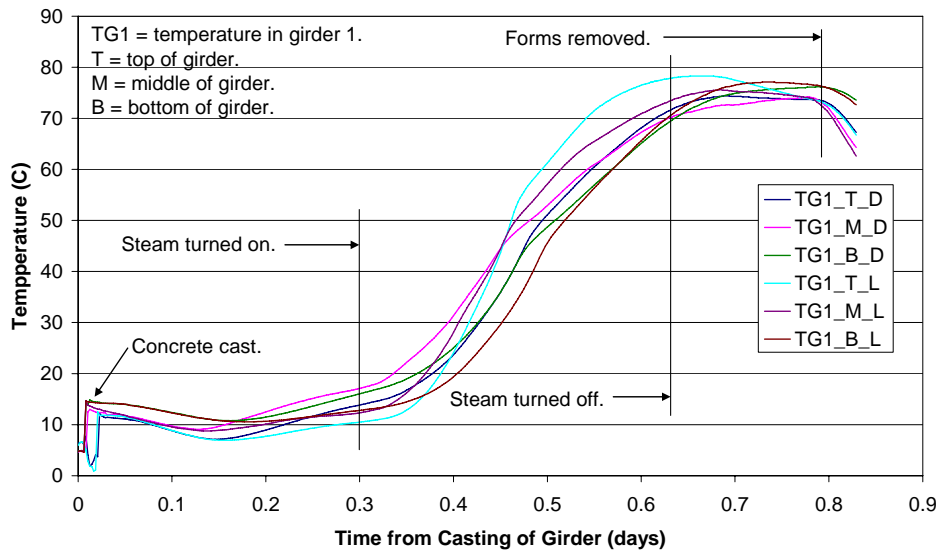
The temperature increased steadily initially and then began to drop around 0.79 day. This coincides with the time the formwork was removed. Temperature evolution, strength gain, elastic modulus gain, bond development, and other effects make it difficult to determine the stress in the concrete immediately prior to cutting the strands.

Figure 29. Variation of Temperature with Time During Casting and Strand Release for Girder 1.

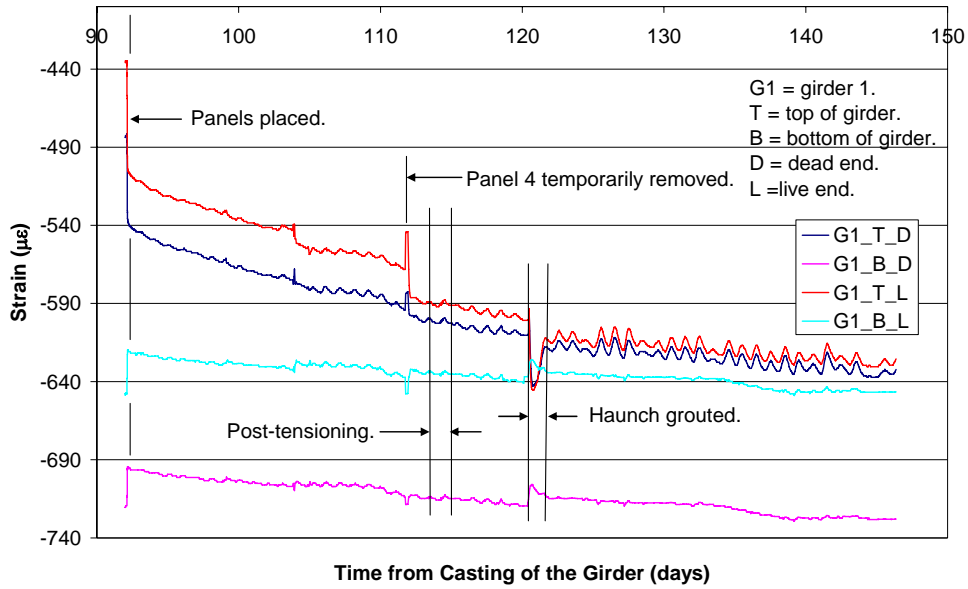
After the panels and girders were shipped to the Virginia Tech Structures Lab, the Campbell system was reattached to the lab specimen. Data from the VWGs were gathered from the time the panels were placed on the girders until the end of the time-dependent study. Figure 30 presents the strains in girder 1, Figure 31 presents the strains in girder 2, and Figure 32

Figure 30. Variation of Strain with Time for Girder 1 in Lab.

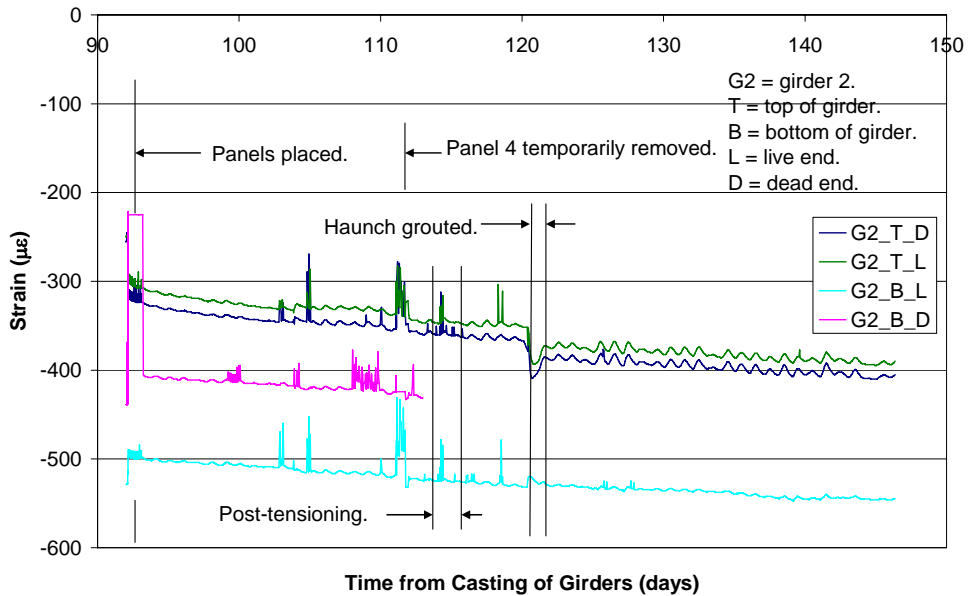
Figure 31. Variation of Strain with Time for Girder 2 in Lab.

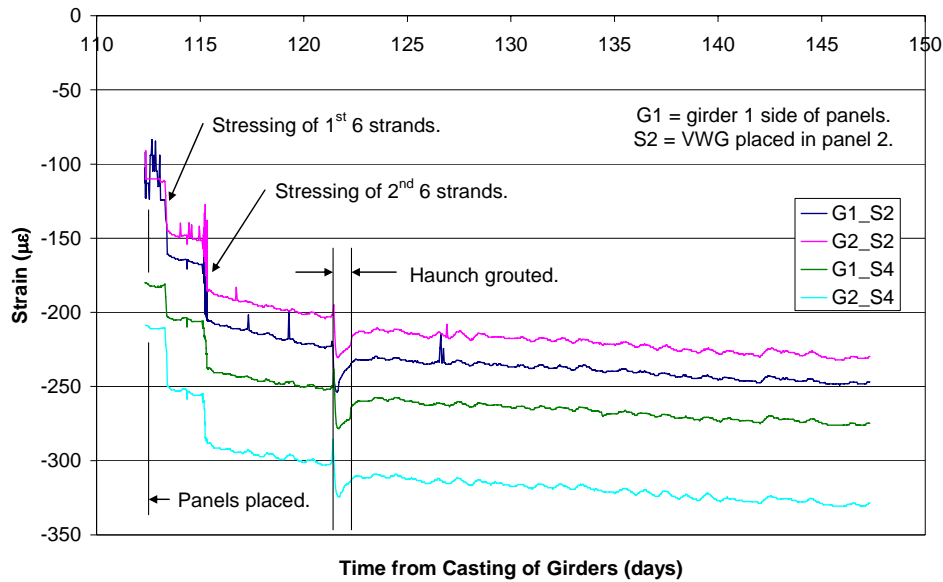
Figure 32. Variation of Strain with Time for Precast Panels in Lab.

presents the strains in the panels during the time intervals in the lab. Figure 33 displays the curvature in girder 1 during the time intervals in the lab. Notice that the start of the analysis in the lab is measured from the time the girders were cast. The general behavior of each member is discussed here along with the effects that key construction stages have on the system. The sign convention is positive (+) for tensile strains and tensile strain increments and negative (-) for compressive strains and compressive strain increments. The sign convention for curvature is positive (+) when the deck is in compression and the bottom of the girder is in tension and negative (-) when the deck is in tension and the bottom of the girder is in compression.

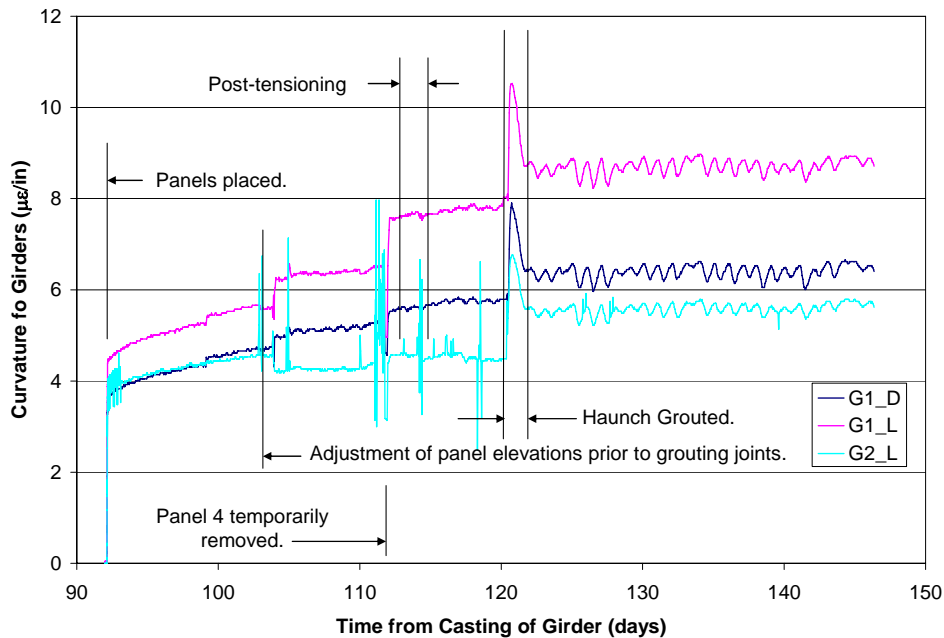
Figure 33. Variation of Curvature with Time for Girder 1 and Girder 2 in Lab.

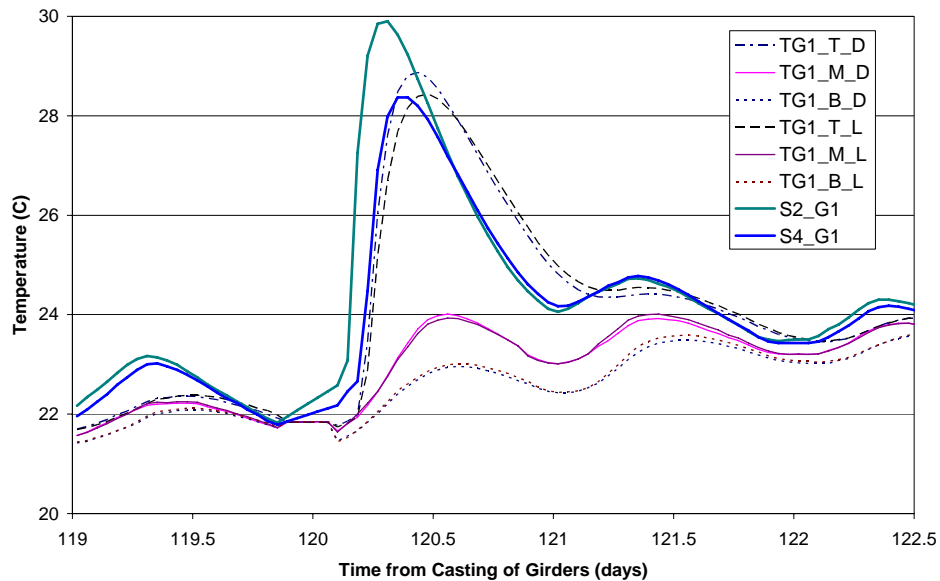
Figure 34. Variation of Temperature with Time in Girder 1 During Casting of Haunch.

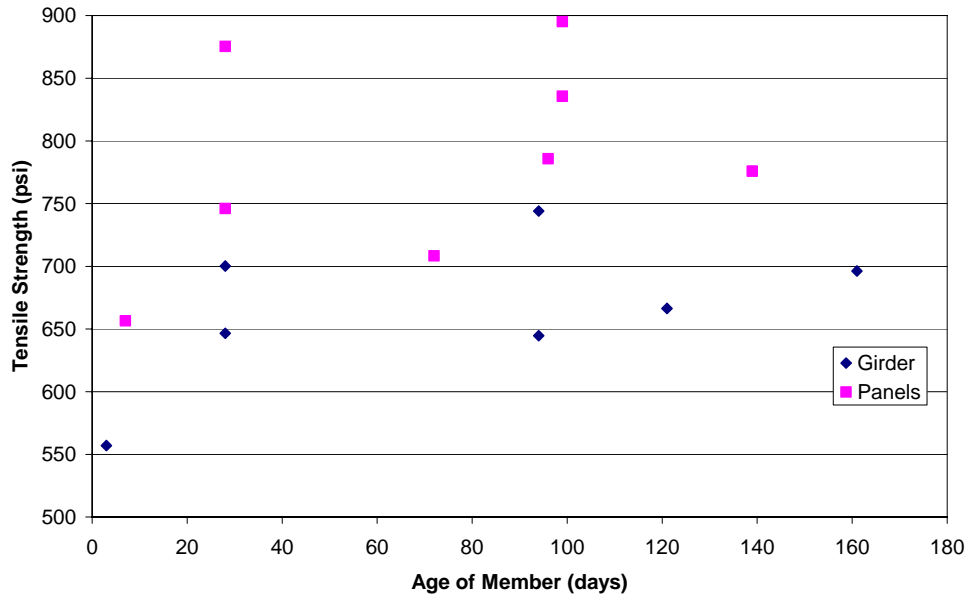
Figure 36. Tensile Strength of Materials Used for Lab Mockup.

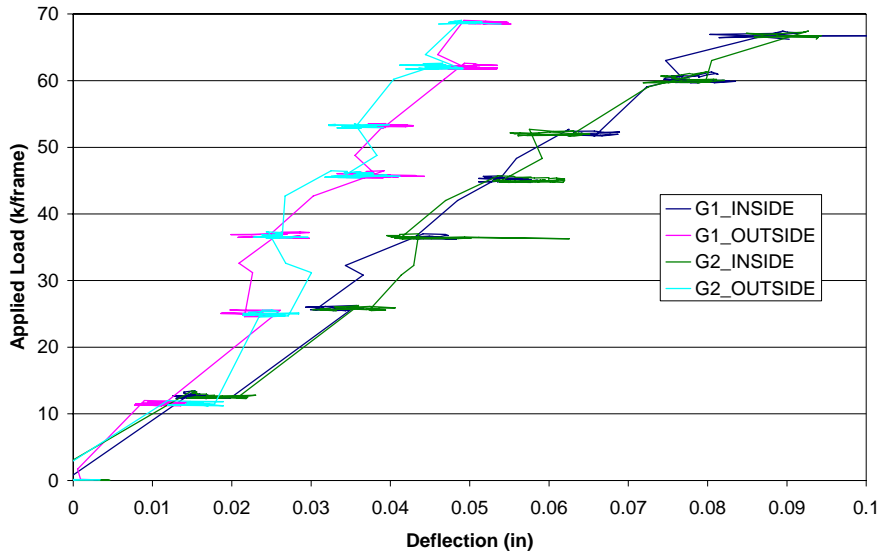
Figure 37. Deflection During Initial Static Test at Dead End.

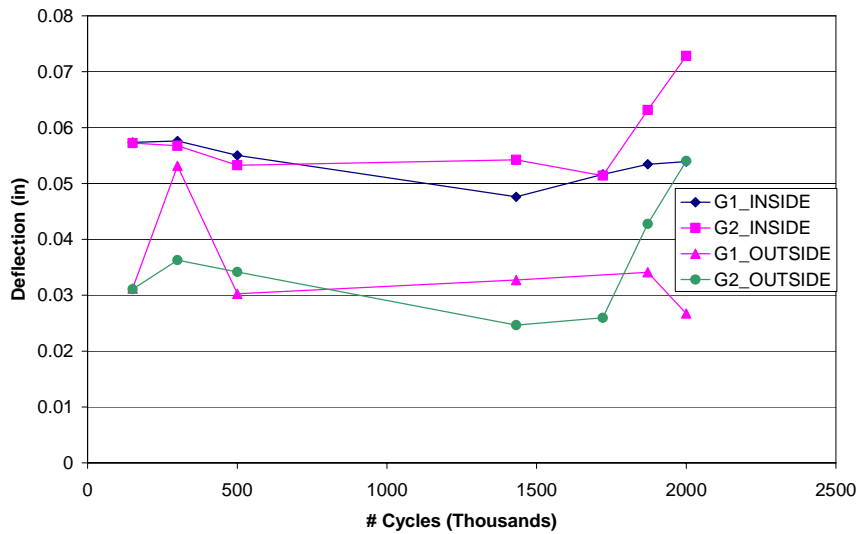
The lab mockup was subjected to 2 million cycles of load. Static tests were performed approximately every 100,000 cycles. Figure 38 shows the deflections at the dead end of the lab mockup at a load of 40 k/frame with respect to the number of cycles. There was an increase in the deflection of girder 2 after 1.7 million cycles. However, neither the LVDTs nor strain gages in the shear studs indicate girder 2 was experiencing a loss in composite action. Measurements of strain at the level of the prestressing strand indicate that the increase in tendon stress from 0 to 40 k/frame was less than 2 ksi, and that there was no significant change in that stress over the 2 million cycles. The strains in the shear connectors were also very small. The largest strain observed was 16 µε, which was less than 1 percent of the nominal yield strain. This indicates the shear connectors were not engaged in resisting the horizontal shear stresses developed during the cyclic testing. There was no cracking at the transverse joints and no relative vertical movement between adjacent panels was measured by the wirepots. No cracking was observed in the girder or deck. The cyclic testing had minimal effects, if any, on the degree of composite action in the lab mockup

Figure 38. Variation of Deflections at 40 kips with Number of Cycles at Dead End.

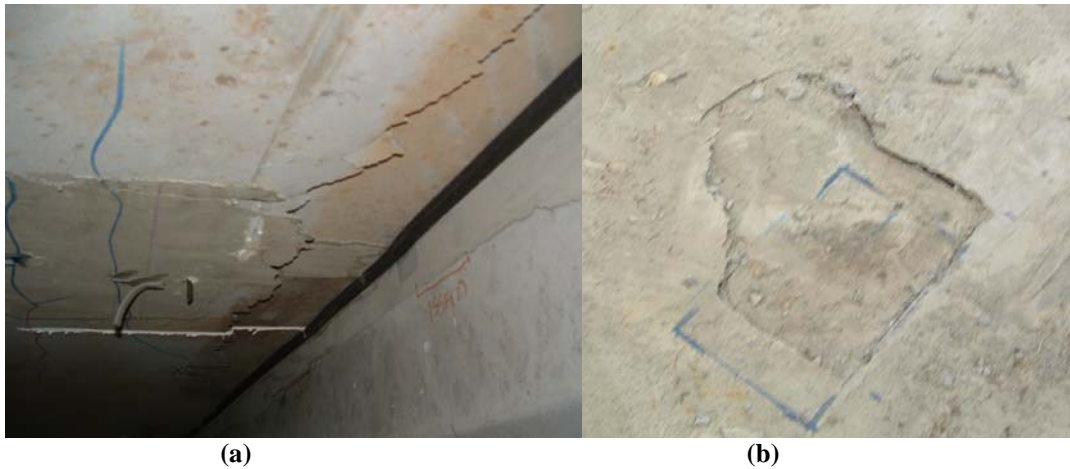
Figure 40. Punching Shear Failure at Dead End (a) Bottom Surface of Deck (b) Top Surface of Deck.

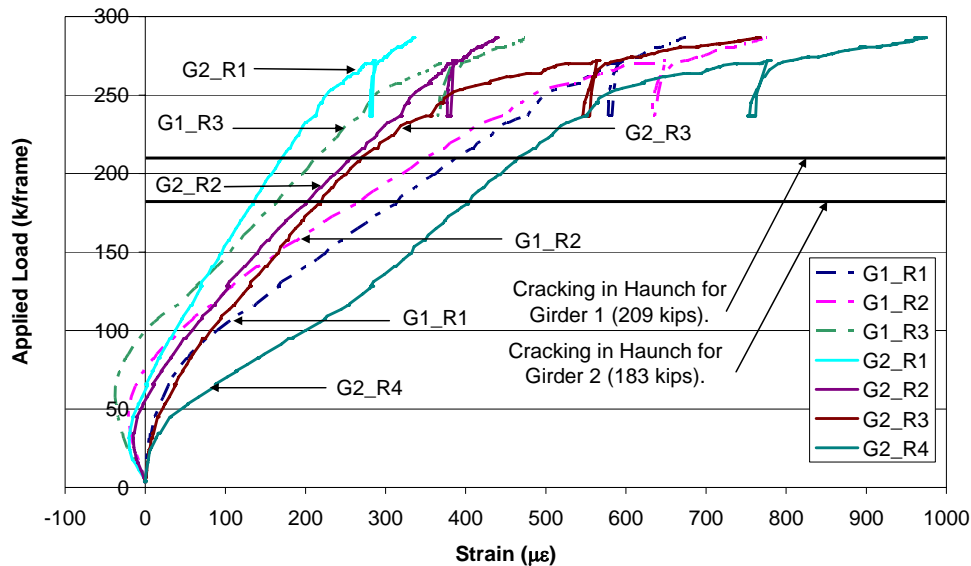
Figure 42. Connector Strains During Final Static Test at Dead End.

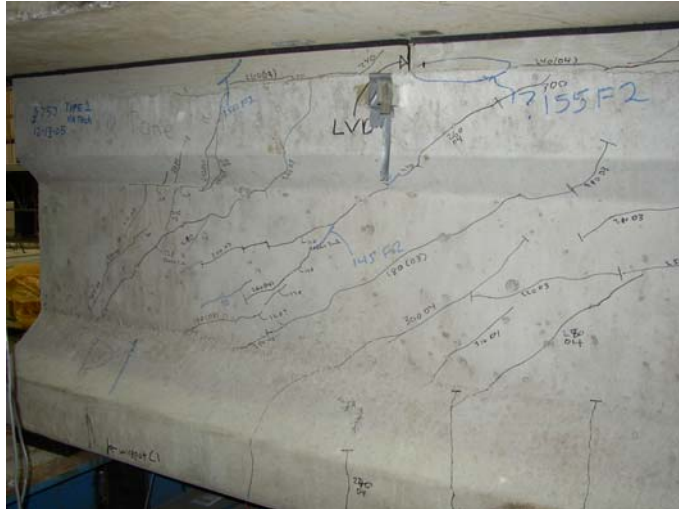
Figure 43. Cracking Pattern at Dead End for Girder 1 During Final Static Test.

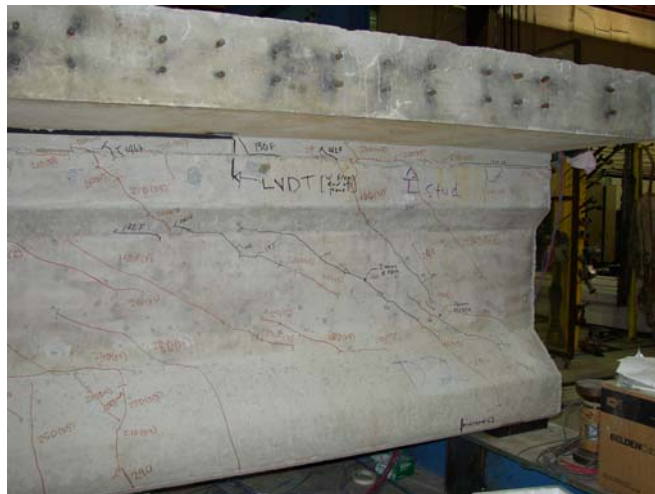
Figure 44. Cracking Pattern at Dead End for Girder 2 During Final Static Test.

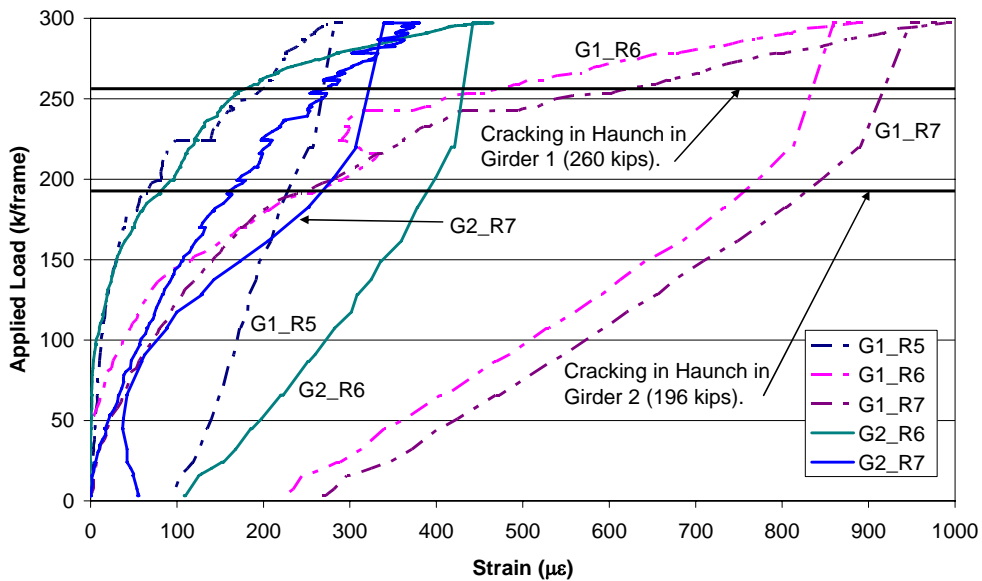
Figure 48. Connector Strains During Final Static Test at Live End.

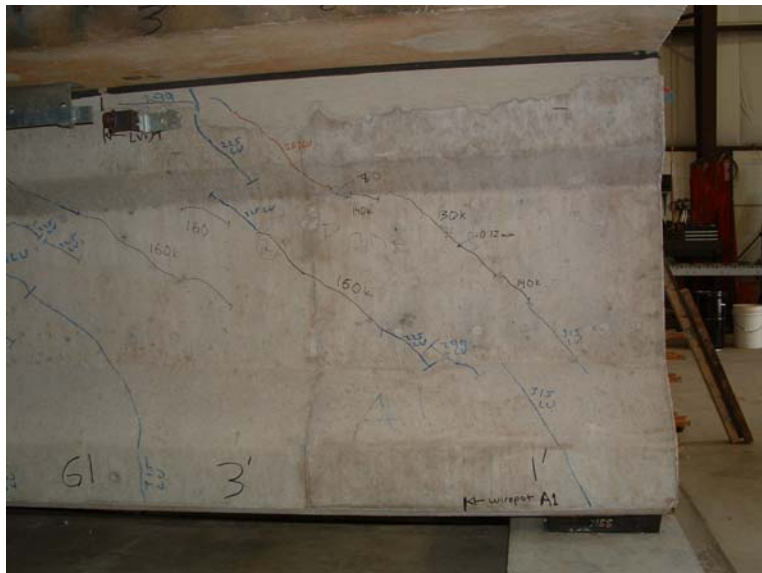
Figure 49. Cracking Pattern at Live End for Girder 1 During Final Static Test.

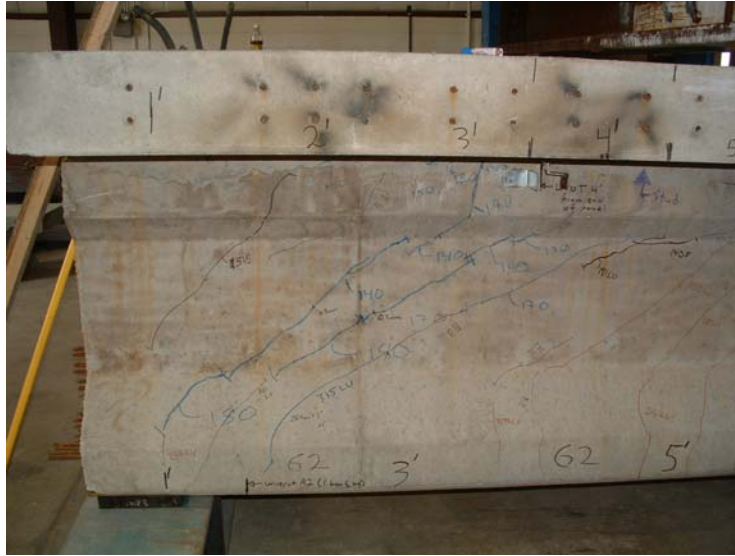
Figure 50. Cracking Pattern at Live End for Girder 2 During Final Static Test.

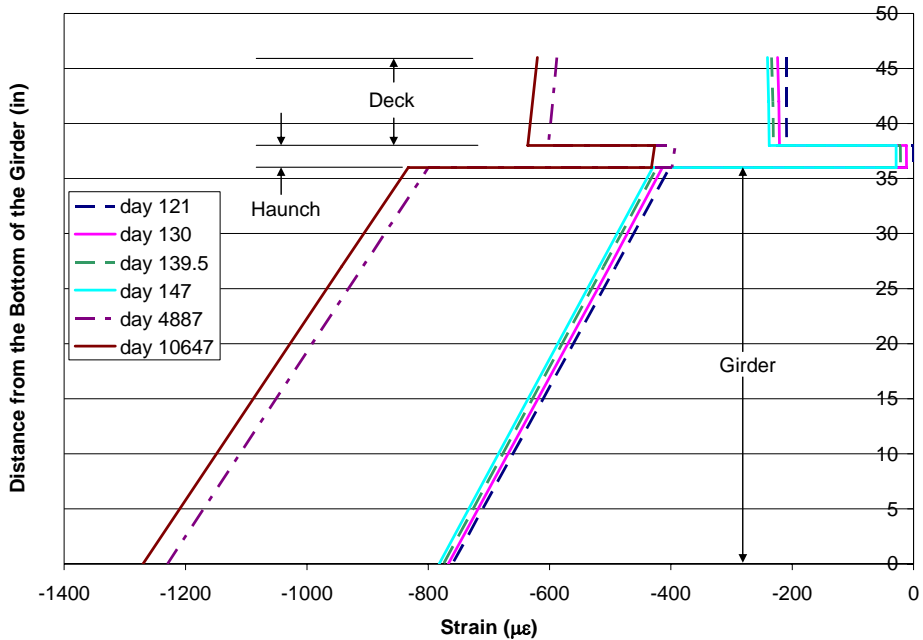
Figure 53. Strain Profiles in Composite Section for Different Times During Service Life.

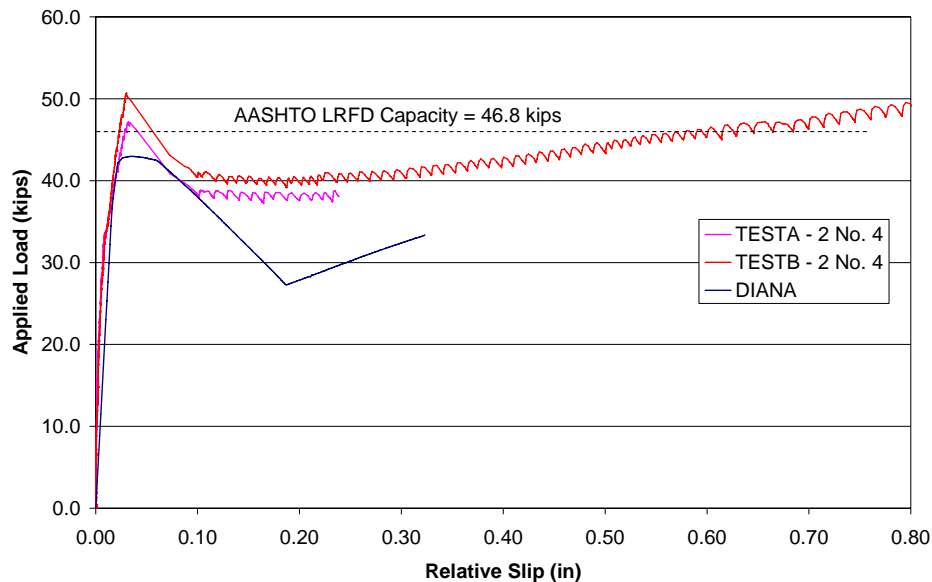
Figure 56. Comparison of Relative Slip of Push Off Specimen for 2 No. 4 bars with Softened Elastic Modulus Approach.

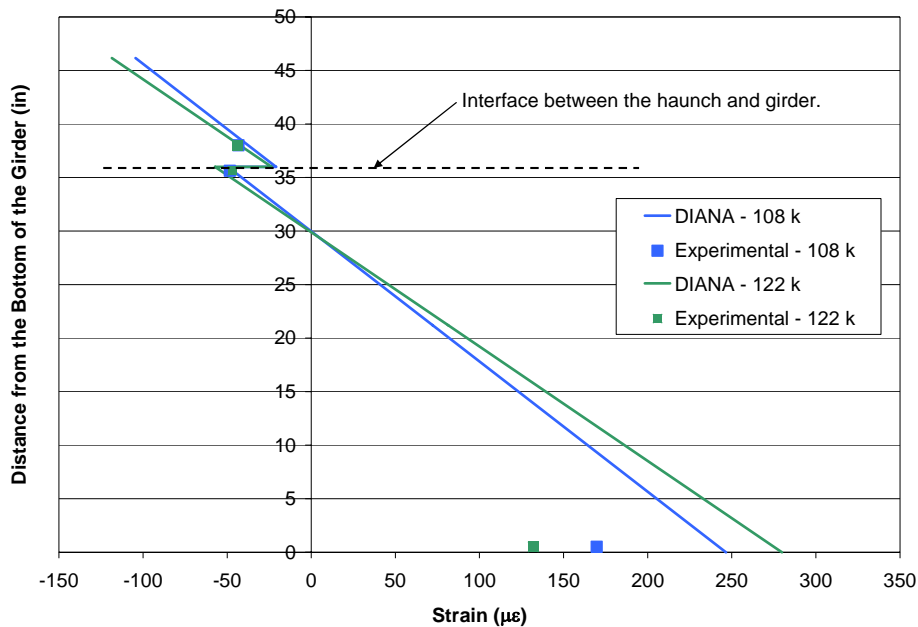
Figure 58. Strain Profile at Dead End for Hooked Reinforcing Bar Connectors.

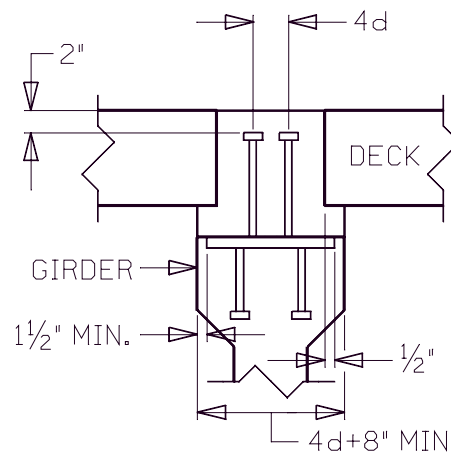
Figure 64. Requirements for New Shear Stud Detail.
