EVALUATION OF A PILOT INSTALLATION  
OF AN ENERGY-ABSORBING BRIDGE RAIL

W. T. McKeel, Jr.  
Research Engineer

June 1978

VHTRC 78-R56

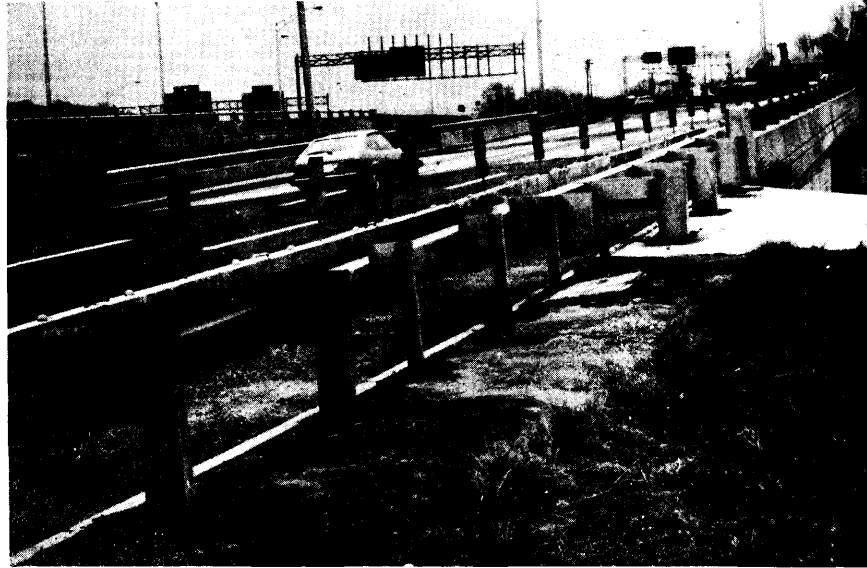
Figure 1. View of the transition between the W-beam approach guardrail (left) and bridge rail at the entry to the structure.

The final design is shown on the appended plan set 213-23A. Figure 1 shows a rear view of the transition at the bridge approach. As shown in Figure 2, a photo of the completed rail under traffic, the exit terminal was carried beyond the parapet on lightweight posts and ramped to the pavement.

Transition between the existing W-beam guardrail and the energy-absorbing rail at the entry end of the bridge, shown earlier in Figure 1, required the realignment or replacement of several posts. No special equipment was used, and the cutting of the concrete apron and hand excavation for the posts, Figure 16, required a considerable amount of time. Installation of the exit terminal, Figure 2, was relatively simple, as the smaller posts could be driven into the earth.

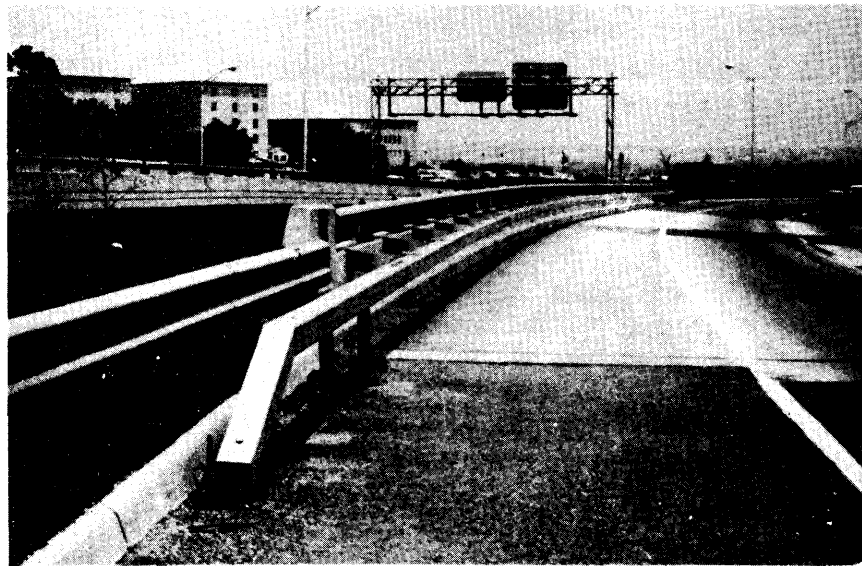
Figure 2. View of the exit terminal of the energy-absorbing rail.

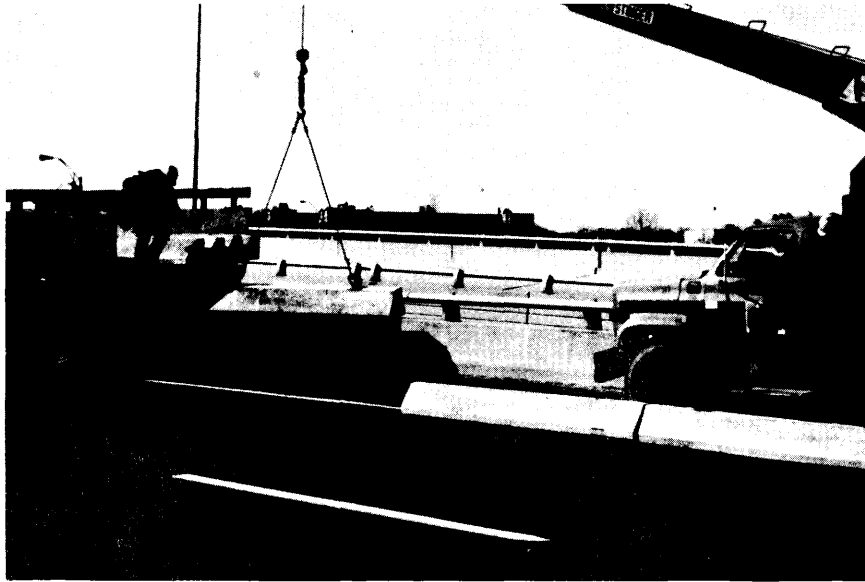
Figure 3. Placement of concrete barriers.

The sequence of operations on the bridge deck is described below. Barrier placement, Figure 3, was the first step in site preparation. It should be noted that the temporary curb-type barriers used on this installation, shown in the figure, are of a type no longer used or accepted by the Virginia Department of Highways and Transportation or the FHWA. As shown in Figure 3, the barriers were placed with the backs aligned with the edgeline to provide an 8 - 9 ft. (2.4 - 2.7 m) wide work area at the rail. This was believed to be the maximum encroachment on the roadway of an interstate highway for a relatively long period, two to three weeks, during which the barrier would be unattended. Unfortunately, the working space did not allow sufficient width for the contractor to use his crane truck after the rings were attached to the parapet.

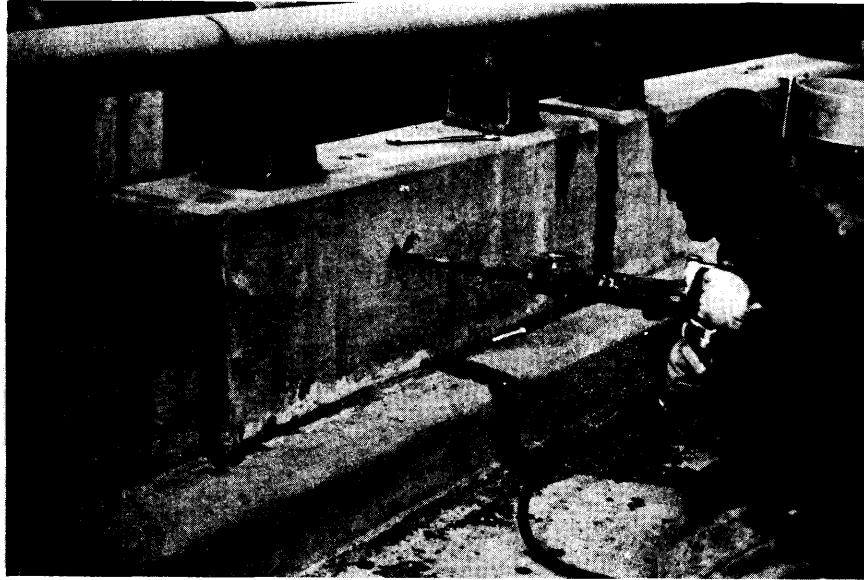
Figure 5. Drilling holes for support bolts, side face of parapet.

The contractor elected to proceed by first attaching all of the collapsible ring supports to the existing concrete parapets. The supports were used as templates to mark the bolt locations, Figure 4, and the holes were easily made using a pneumatic drill, Figures 5 and 6. Each support was attached by

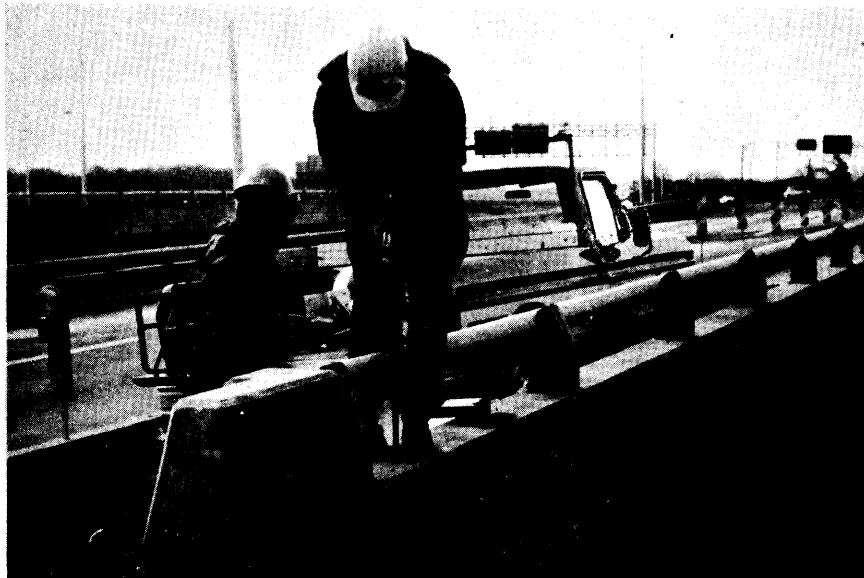
Figure 6. Drilling holes for support bolts, top face of parapet.

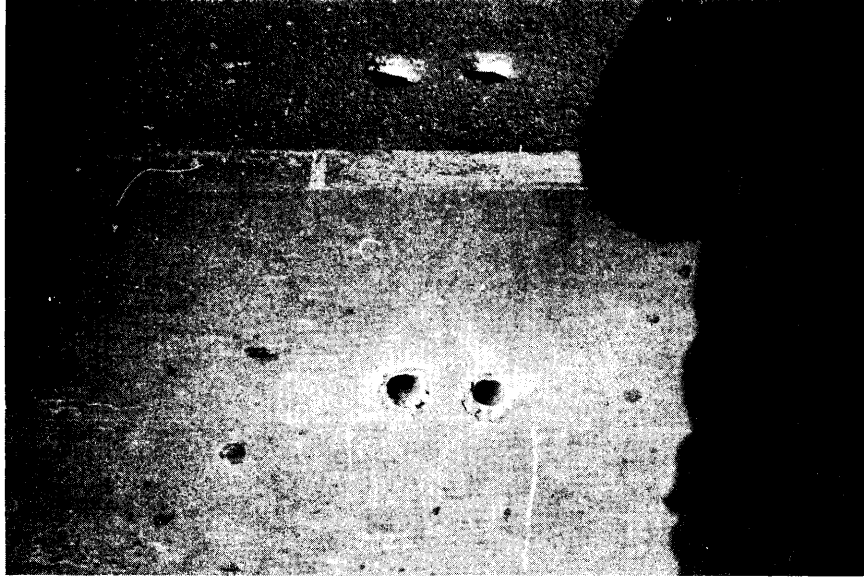
Figure 7. Four bolt holes required in parapet at each support location.

four bolts, two each in the front and top faces of the parapet. It was impossible to locate the holes, Figure 7, to miss the parapet reinforcing steel in every case, and cutting the steel, when encountered, required the use of an electric drill. Bolts, such as the one shown in Figure 8, were hammered into the holes, Figure 9, to expand the base of the serrated sleeve into the concrete. Care had to be taken to fully expand the sleeve before the bolt was removed to attach the support, as it proved impossible to tighten the bolt if the sleeve slipped against the wall of the holes. As indicated in Figure 10, all of the rings were attached to the parapet before any of the rail sections were installed.

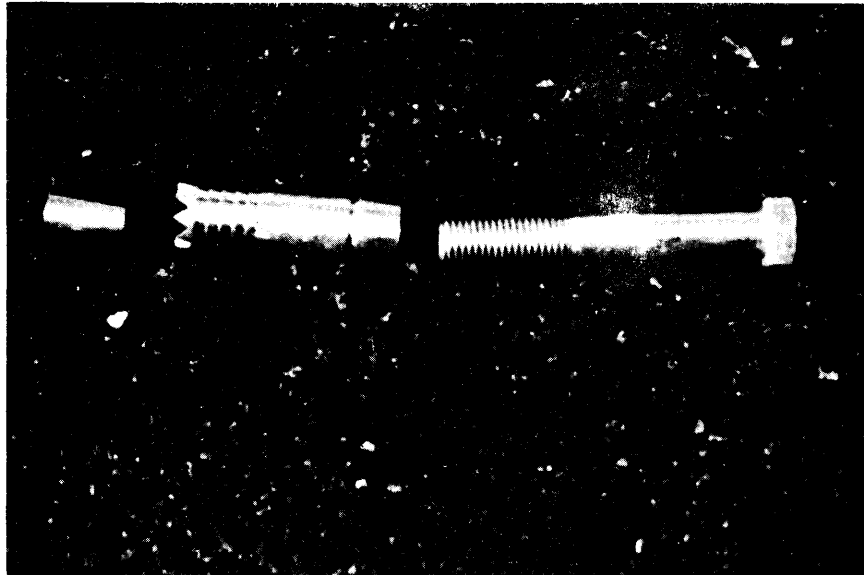
Figure 8. Anchor bolt for support.

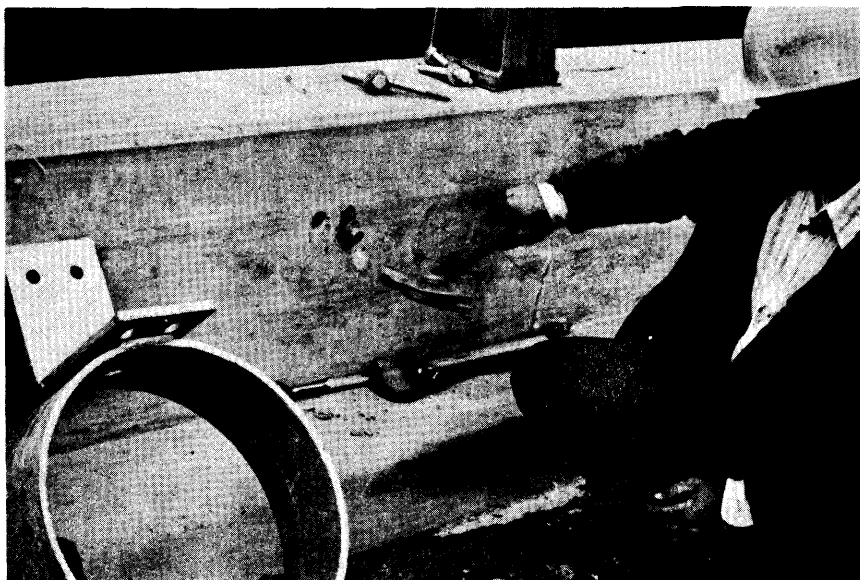
Figure 9. Hammering anchor bolt to set expanding sleeve against side of hole.

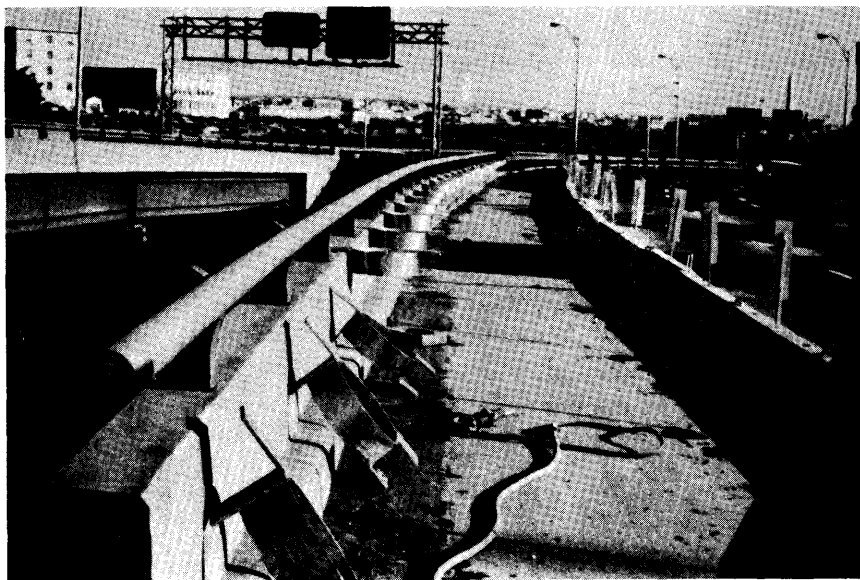
Figure 10. Collapsible ring supports installed before rail sections placed.

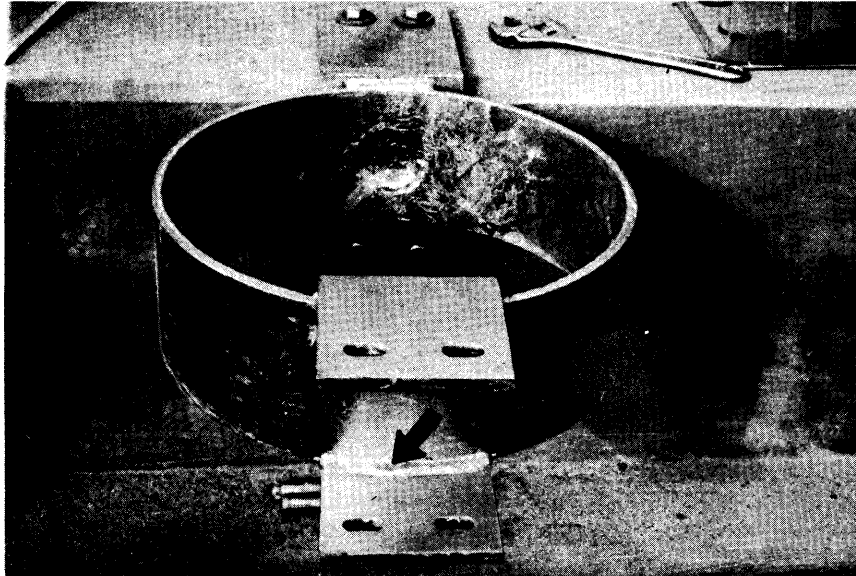
Attachment of the rail segments to the rings was more difficult than anticipated, primarily because of an error in fabricating the ring supports. Figure 11, a front view of a typical rail support, shows a weld indicated by the arrow between the bottom flange and the collapsible ring; a similar weld is located between the top flange and the ring. The adverse effect of these welds, which were not called for on the plans, was twofold; they intruded on the space to be occupied by the rail and they tended to draw the flanges toward each other, and thus decrease the width of the opening. Because of these factors, force was required to position the rail segments, Figure 12, and in some instances it was necessary to enlarge the holes in the rails slightly. Some difficulty was also experienced in aligning the rail longitudinally to provide passage for the bolts at the supports. In the future, contractors might consider erecting shorter sections of the complete barrier, both supports and rails, rather than installing all of the supports, particularly on curved bridges.

Figure 11. Front view of collapsible ring support showing weld (arrow) erroneously added by fabricator.

Installation of the ring supports is a time-consuming operation and is complicated by the occasional presence of reinforcing steel. The rather high number of hours shown for rail placement would not be expected on future jobs. The man-hours required for this operation were greatly increased by the fabrication error discussed previously, and the time required was also lengthened by the limited width of the working space that required hand-carrying all of the rail sections to their positions.

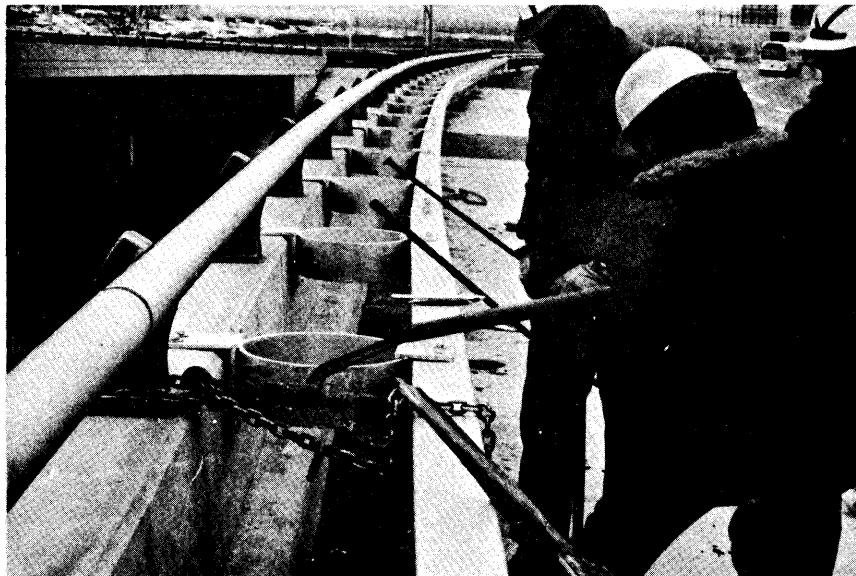
Figure 12. Attaching rail to collapsible ring support. Force was required due to presence of weld, Figure 11.

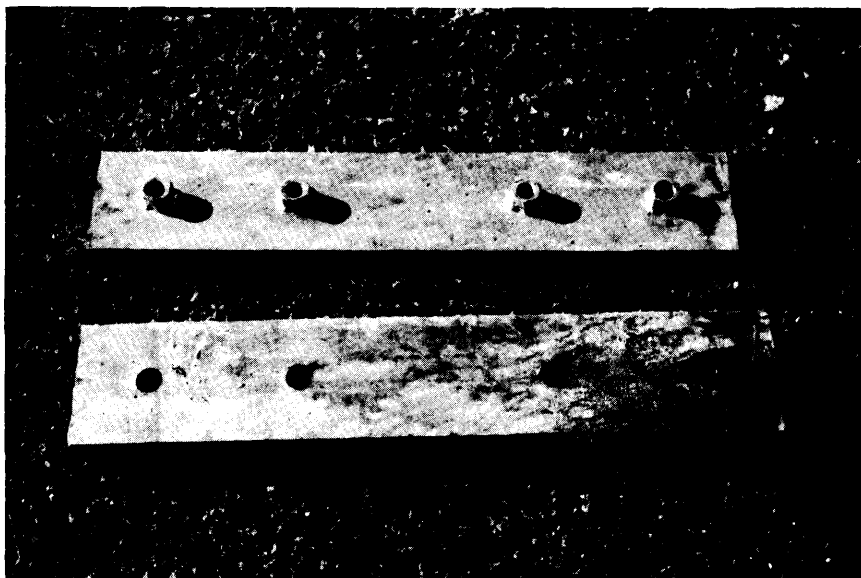
Figure 13. Splice plate for rail sections. Nuts are tack-welded to inner face.

Splice connections in the rail used plates, shown in Figure 13, with tack-welded nuts on the inner face to facilitate tightening of the bolts from the outside of the rail. Splicing operations are shown in Figures 14 and 15.

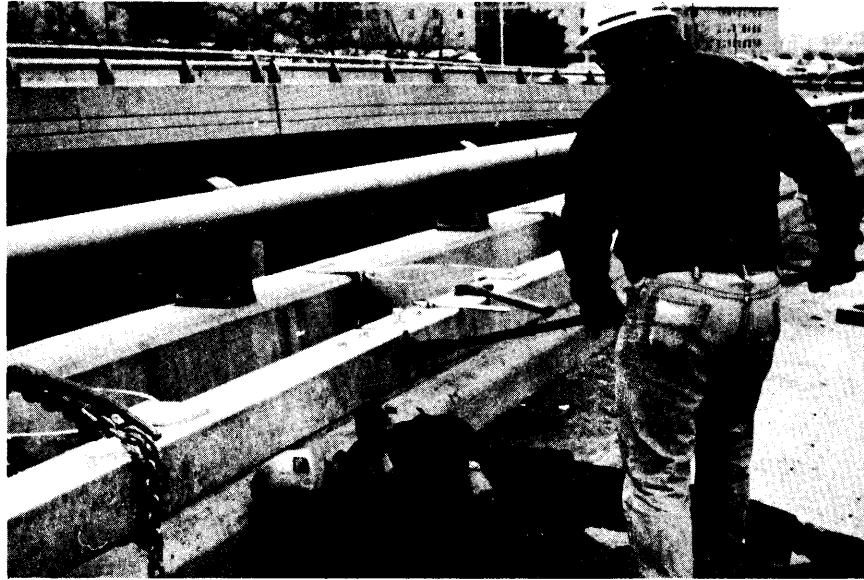
Figure 15. Completing rail splice.
