Virginia Transportation Research Council

Field Comparison
of the Installation and Cost
of Placement of Epoxy-Coated and
MMFX 2 Steel Deck Reinforcement:
Establishing a Baseline for Future
Deck Monitoring

STEPHEN R. SHARP, Ph.D., P.E.
Research Scientist

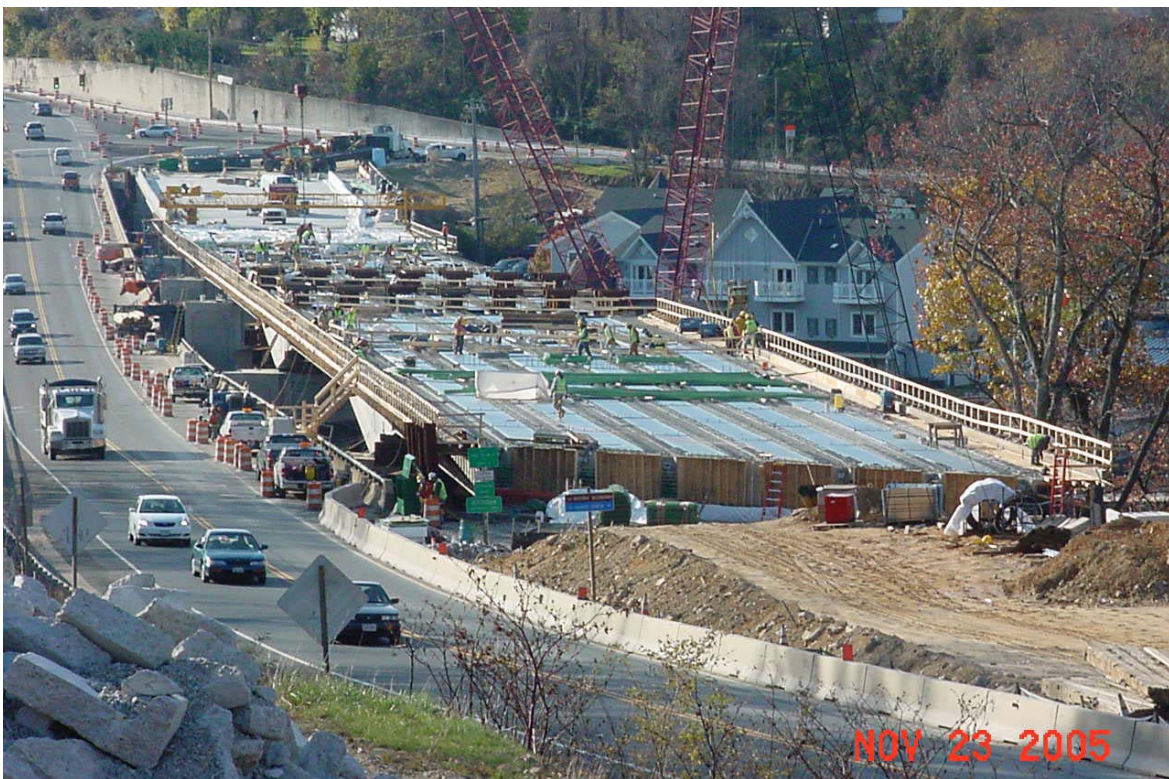
Figure 2. ECR Placement in Southbound Lane

The handling and storage of the ECR was evaluated in accordance with VDOT's 1997 *Road and Bridge Specifications* (VDOT, 1997), AASHTO M 284 (AASHTO, 2006), and ASTM A775/A775M (ASTM International, 2006a). According to ASTM, handling and storage of ECR require padded contact areas, padded bundling bands, and transport by lifting (rather than dragging) in a manner that prevents bar-to-bar abrasion. Further, storage of ECR outdoors for more than 2 months should entail protection from sunlight, salt spray, and general weather exposure and adequate ventilation to prevent condensation under protective sheeting (see Figure 2).

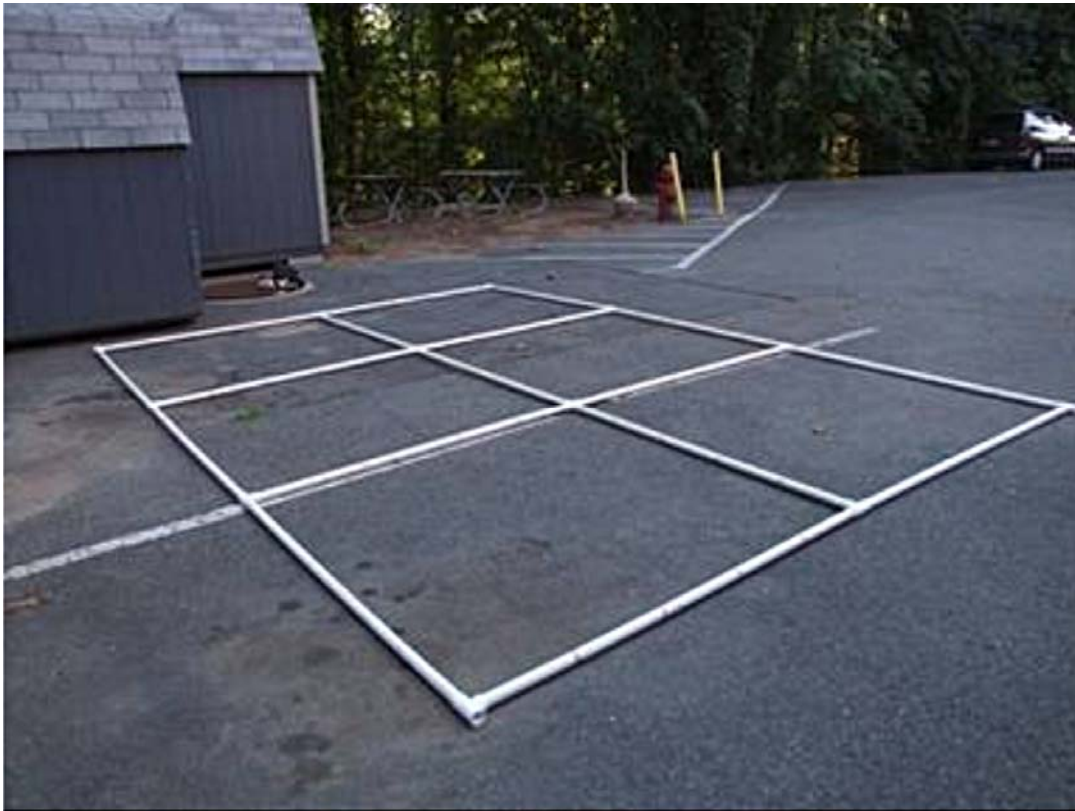
Figure 3. Crack Survey Grid

Crack mapping for this deck was performed on Spans D through G using a portable grid system. The grid was constructed using polyvinylchloride (PVC) pipe to create 5 ft by 5 ft boxes that had a marking every 1 ft. A photograph of the PVC grid is shown in Figure 3. An unmagnified crack comparator was used to aid in the estimation of the crack widths. Crack widths and locations were recorded on data sheets and later entered into a spreadsheet and plotted on grids for analysis.

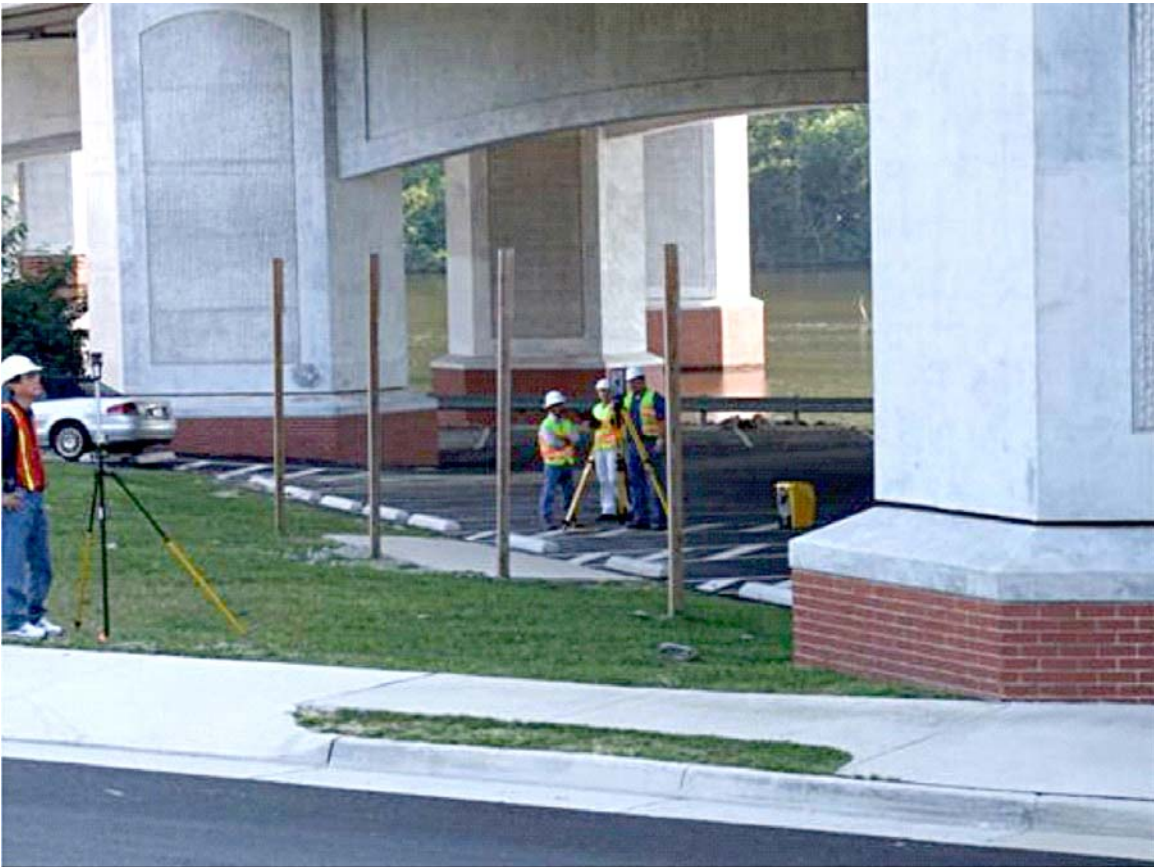
Figure 4. Gathering Coordinates to Locate Trimble VX System for Under-Bridge Crack Survey

Efflorescence pattern data on the underside of the two bridge decks were gathered for Spans A through C. This was done two ways: (1) using a Trimble VX Total Station to record visual details on Span B, and (2) using visual analysis (including binoculars) to catalog cracking on the underside of Spans A through C. The task of surveying cracks on the underside of the decks presented an opportunity to evaluate the Trimble VX Total Station.

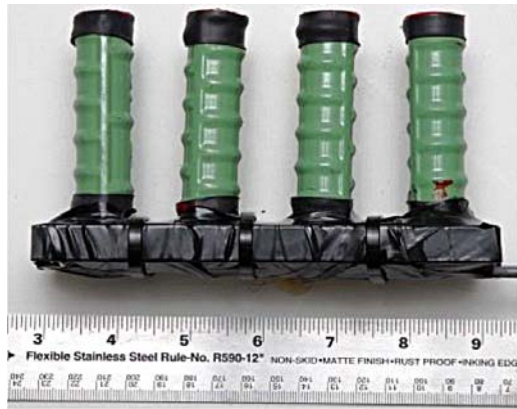
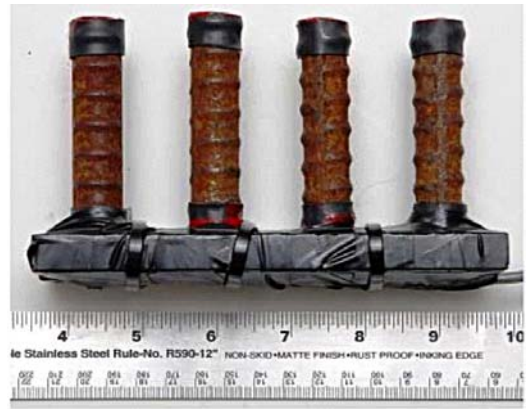
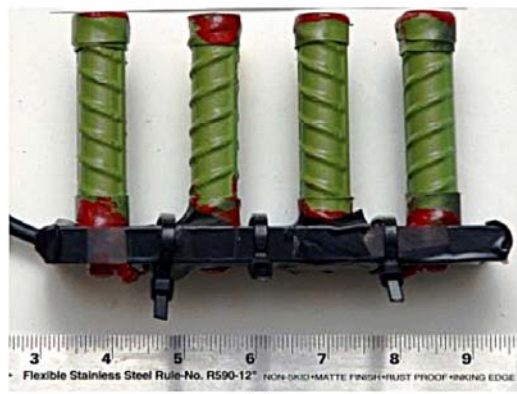
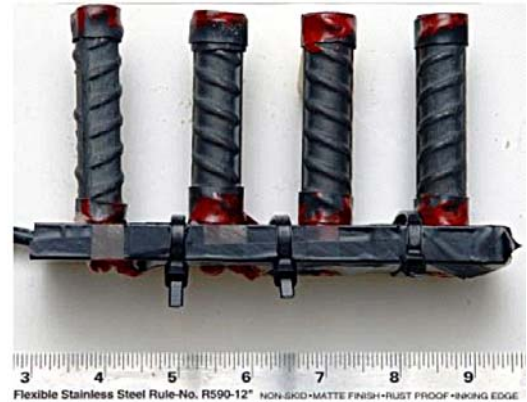
Figure 6. Photograph Showing Embedded Test Bars. (a) As-received ECR, (b) As-received MMFX 2, (c) Pristine ECR, (d) Pristine MMFX 2.

ECR and MMFX 2 bars were embedded in the northbound deck in both as-received and pristine conditions, which are shown in Figure 6. The ECR in Figure 6(c) was repaired with field-applied epoxy, which has a different color than the factory-applied coating shown in Figure 6(a). The MMFX 2 in Figure 6(b) illustrates the extreme surface rusting found on some of the bars. The degree of surface rust varied from none, as shown in Figure 6(d), to that shown in Figure 6(b).

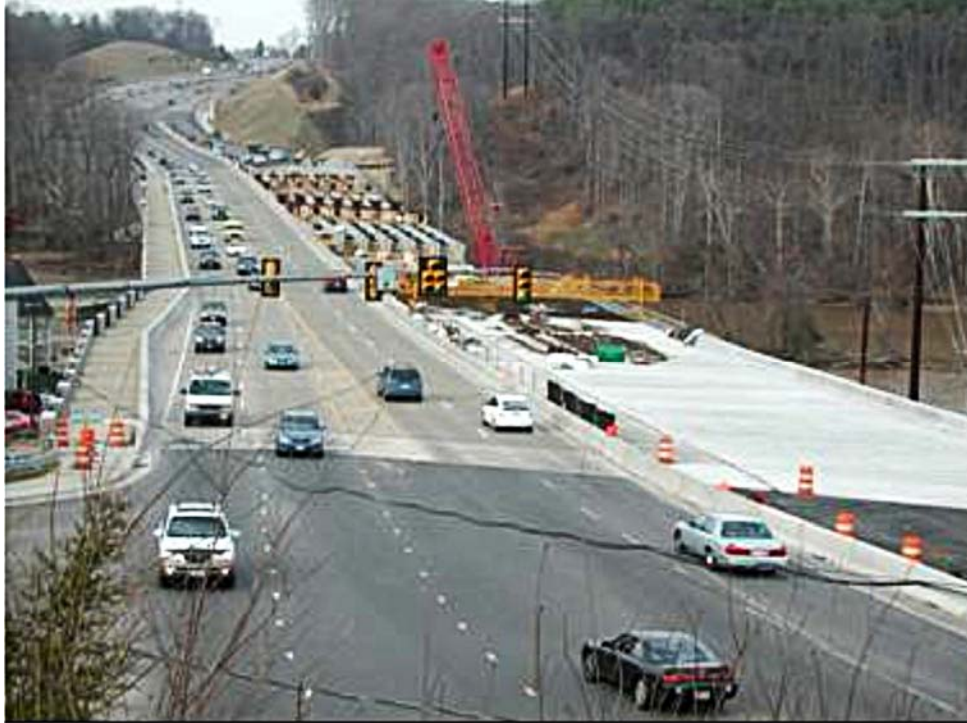
Figure 7. Traffic Configuration Before Southbound (ECR) Deck Sealing Operations

The deck sealing operation occurred during construction of the northbound lanes after the old bridge had undergone demolition. All traffic had been routed to the southbound deck by then, with two lanes each for northbound and southbound traffic including travel in the shoulder lane. Based on the recommendations in the *Highway Capacity Manual* for multilane highways (FHWA, 2000), it was assumed that the capacity was 1,400 vehicles per lane per hour, that free flow speed for the four undivided lanes was 45 mph, and that work zone speeds fell to 30 mph during periods of lane closures. Figure 7 shows the general traffic scenario during the deck sealing operation.

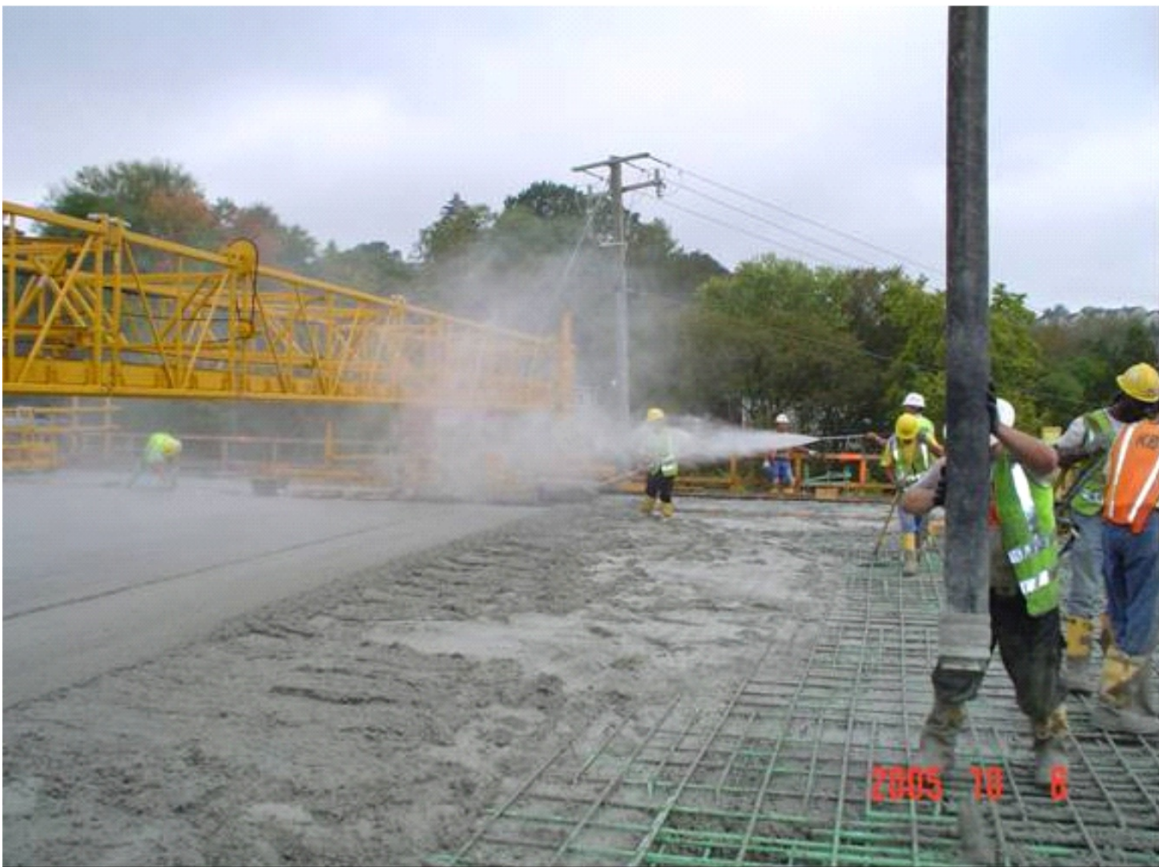
Figure 12. Sources of Coating Damage During Construction. (a) Cutting of bar ends, (b) Abrasion from bottom of shoes, (c) Impact of concrete as it leaves hose and strikes ECR.

Images collected during construction, shown in Figure 12, demonstrate various possible sources for the coating damage that existed during construction. In Figure 12(a), ECR had been cut and required repair of the end before the concrete could be placed. In Figure 12(b), grit from the bottom of shoes could have abraded the coating. In Figure 12(c), the impact from the concrete aggregate as it left the hose and contacted the ECR mat could have abraded the coating. However, the deck was inspected for proper tying of the steel and repair of coating. As shown in Figure 13, the ECR appeared to be in an acceptable condition and ready for the placement of concrete.

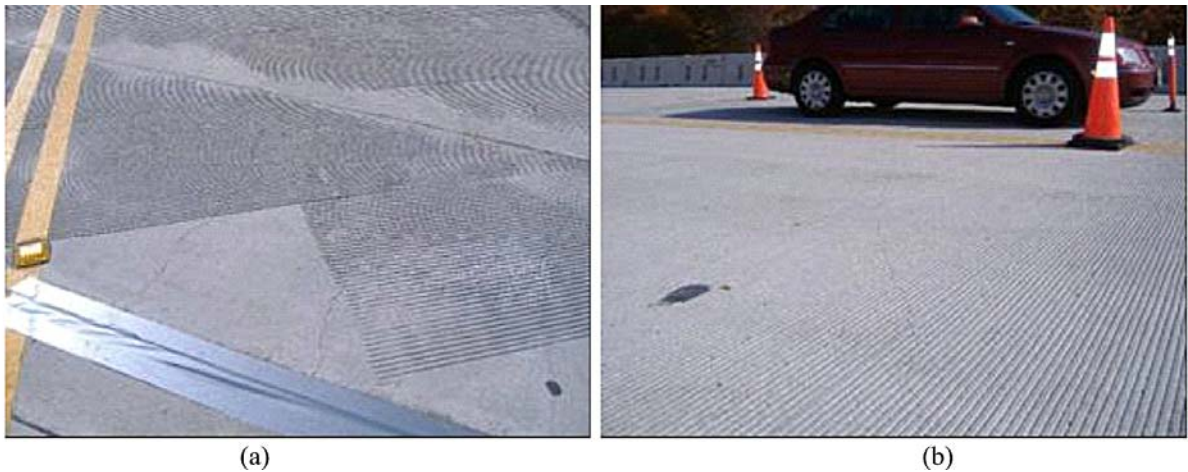
Figure 14. Cracks in Concrete on Stage I Southbound (ECR) Deck. (a) Cracks perpendicular to expansion joint, (b) Crack crosses diagonally across deck surface.

As discussed in the “Methods” section, the deck exhibited cracks that were deemed to be significant enough to warrant repair; examples of the cracks are shown in Figure 14. On November 3, 2006, the contractor began work to repair the cracks on the deck, which is shown in Figure 15. According to DWRs, this material, Sikadur 55 SLV epoxy, has a shelf life of 2 years in the original unopened container and a warranty of 5 years. The estimated set time for this sealant according to the DWRs is 11 hr at 40° F. To perform this operation, the following tasks were done:

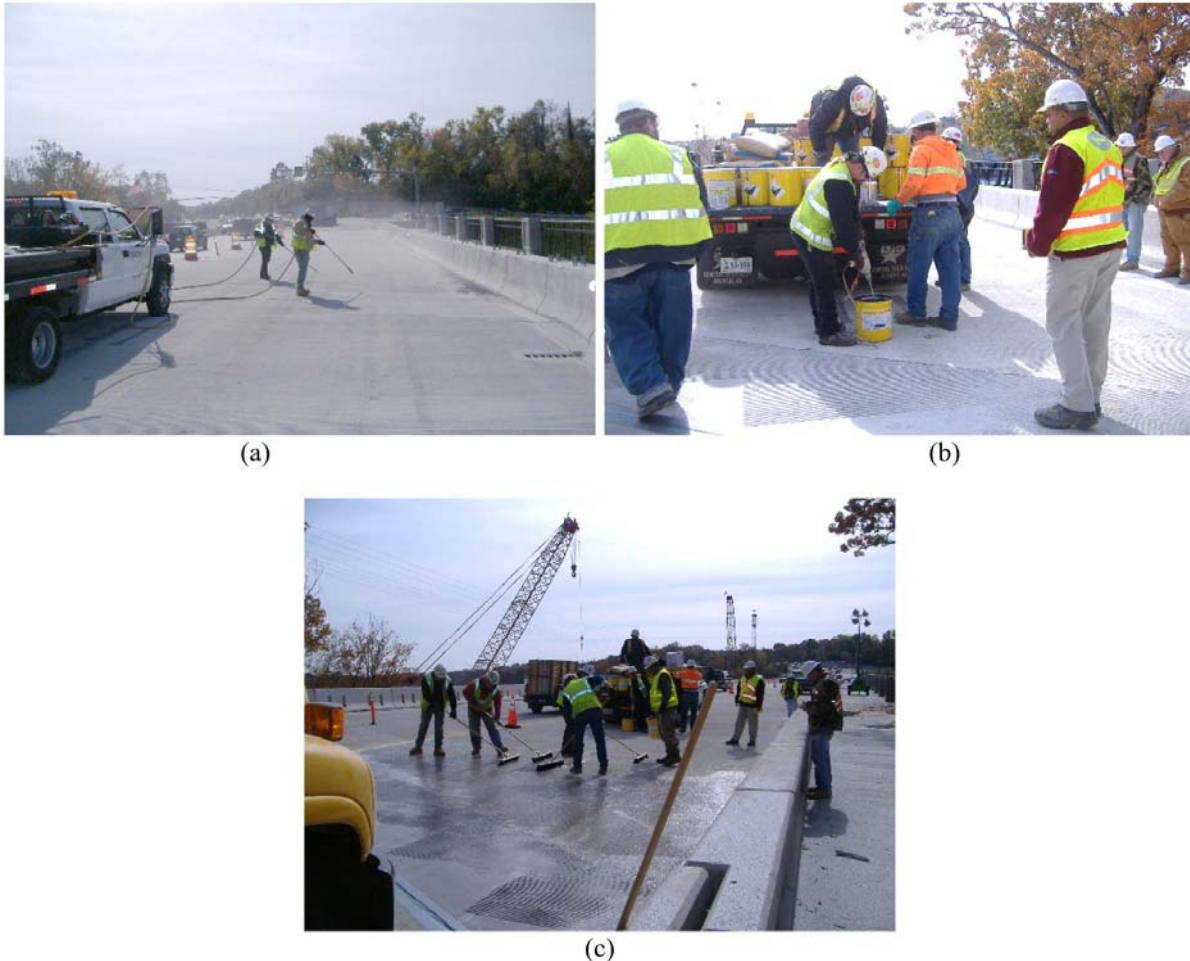
Figure 15. Crack Sealing of Southbound (ECR) Deck. (a) Cleaning of deck, (b) Mixing of epoxy, (c) Application of epoxy to deck surface.

1. Shotblast the deck surface.
2. Mix the Sikadur 55 SLV epoxy at a ratio of 1 gal Part A and 0.5 gal Part B epoxy.
3. Apply the epoxy to the deck.
4. Use brushes to spread the epoxy over the deck surface and into the cracks.
5. Allow the epoxy to cure.
6. Reapply traffic markings to the deck.

Initially the crack sealing, particularly the shoulder and travel lanes, was not performed in accordance with VDOT’s Special Provision for Gravity Filled Polymer Crack Sealing (VDOT, 2002) because the work was done during the day and evening and often at temperatures that were too low. The special provision states: “The concrete surface temperature shall not be less than 55°F

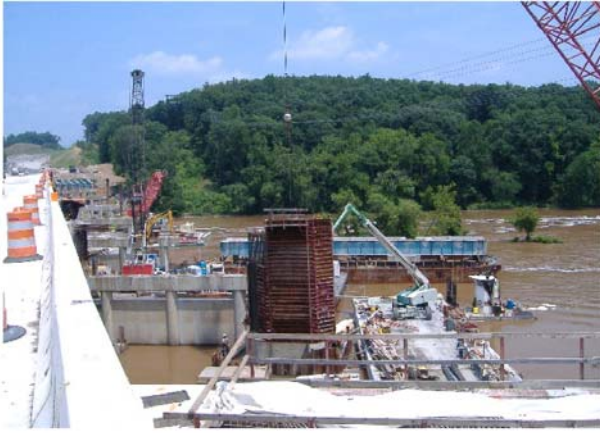
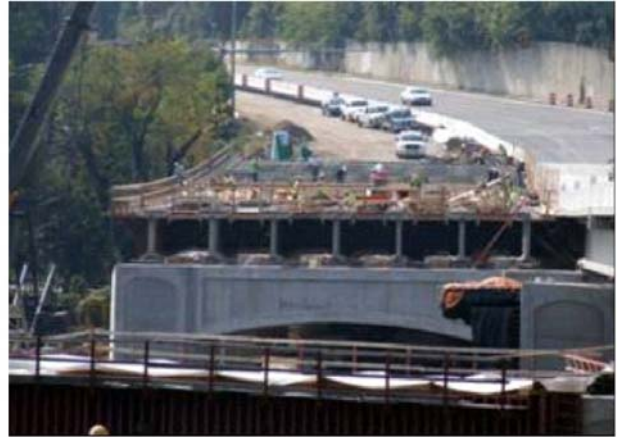
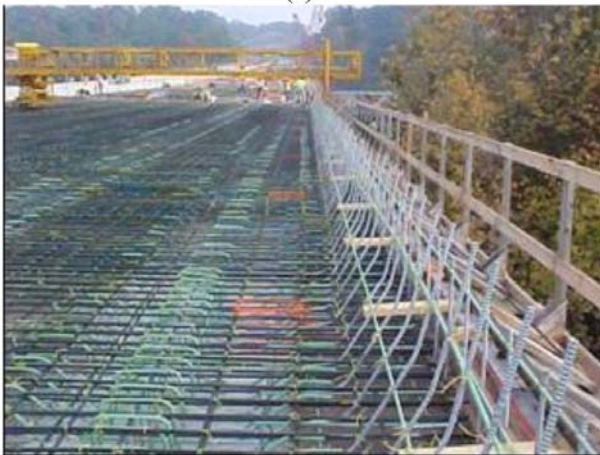
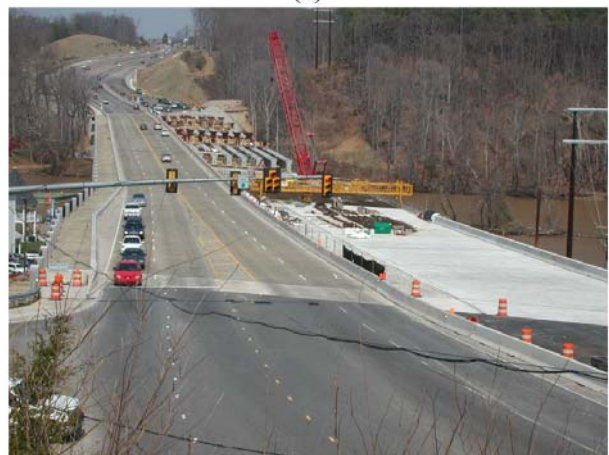
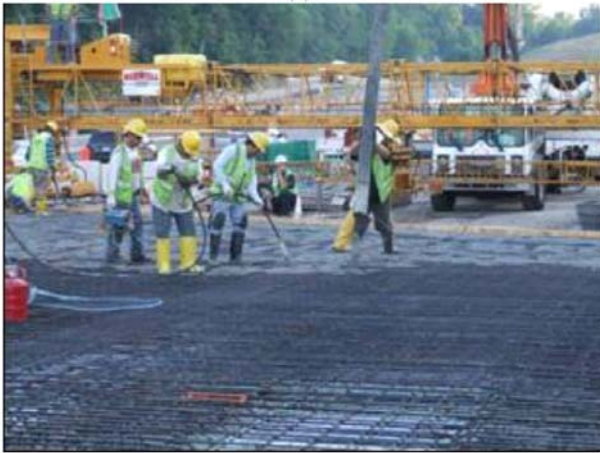
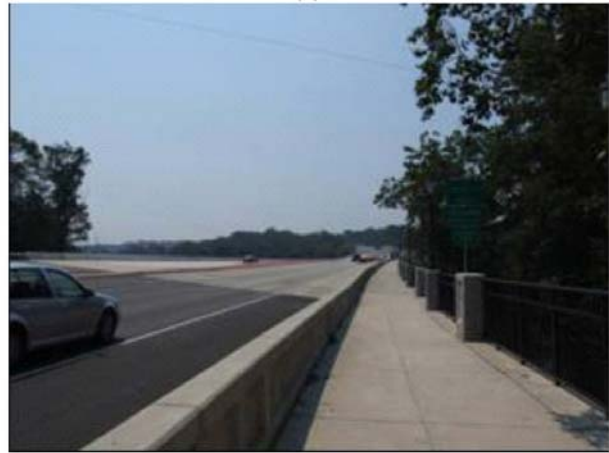
Figure 16. Construction of Northbound (MMFX 2) Deck. (a) Removal of old bridge and construction of new substructure, (b) Southern end of northbound lane, (c) ECR and MMFX 2 in deck with ECR and galvanized bars in parapet on Span A), (d) Construction continues to move from completed Span A deck toward Span G, (e) Placement of concrete on Span G, (f) Traffic moving freely across new structure.

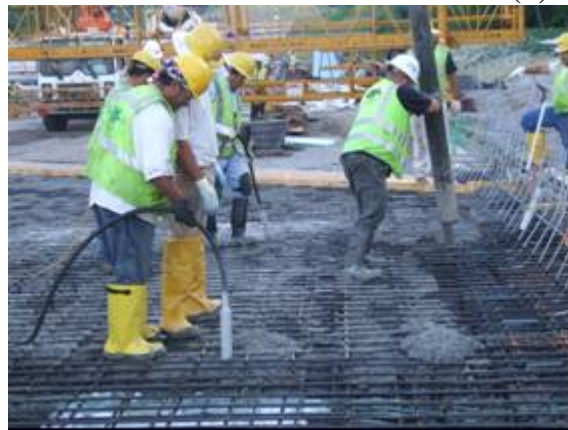
Figure 19. (a) Corrosion rate probes placed in future travel lane wheel path, (b) Close-up of probes, (c) Concrete placement and vibration over probes.

During the placement of concrete in Span G, eight sets of reinforcing steel probes were embedded in the concrete, as shown in Figure 19. Each probe was wired directly to a connection panel located inside a junction box embedded in the parapet. A sketch of the connection panel with labels and one of the plug-in connectors is shown in Figure 20. The connectors are used to maintain electrical continuity between the four bars in a given sensor. Currently, there are eight connectors, all of which are plugged in, so that all sensors shown have a continuous electrical path between each of the four embedded test bars. The embedded box also serves as a reference point to locate each probe, which is shown in Figure 21. Each probe was also located using the

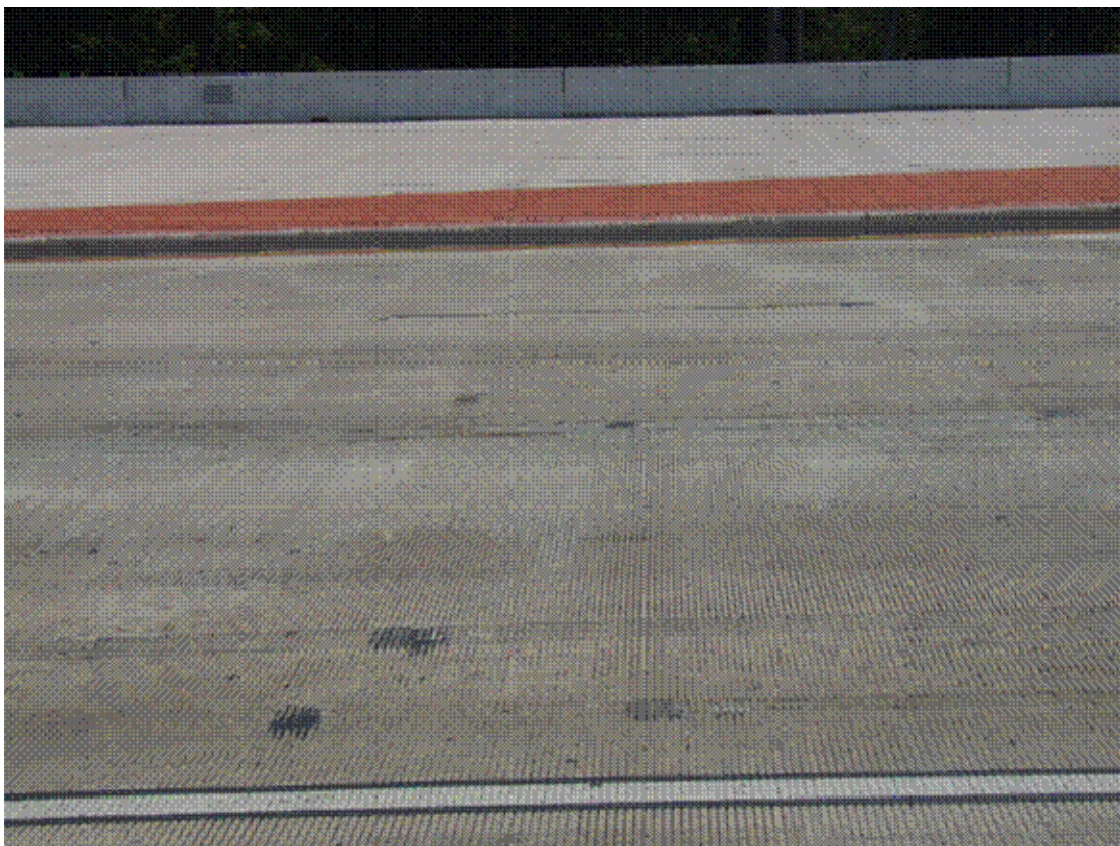
Figure 24. Southbound (ECR) Deck Image

At the time of this study, the southbound (ECR) deck appeared to be in good condition. The deck had a grooved surface finish, as shown in Figure 24. The epoxy sealant applied to the cracks appeared to be in fair shape. However, it is known that the epoxy did not completely penetrate into the deck based on the visual analysis of the underside of the deck by inspectors in 2008. Further, testing by VDOT on three 3.9-in-long concrete core samples (of 3.9 in in diameter) that were cracked verified that the epoxy penetrated only 1.4 in into the crack. However, after the epoxy sealant was applied, the moisture penetration through the deck that was detected before the sealant was applied had stopped.

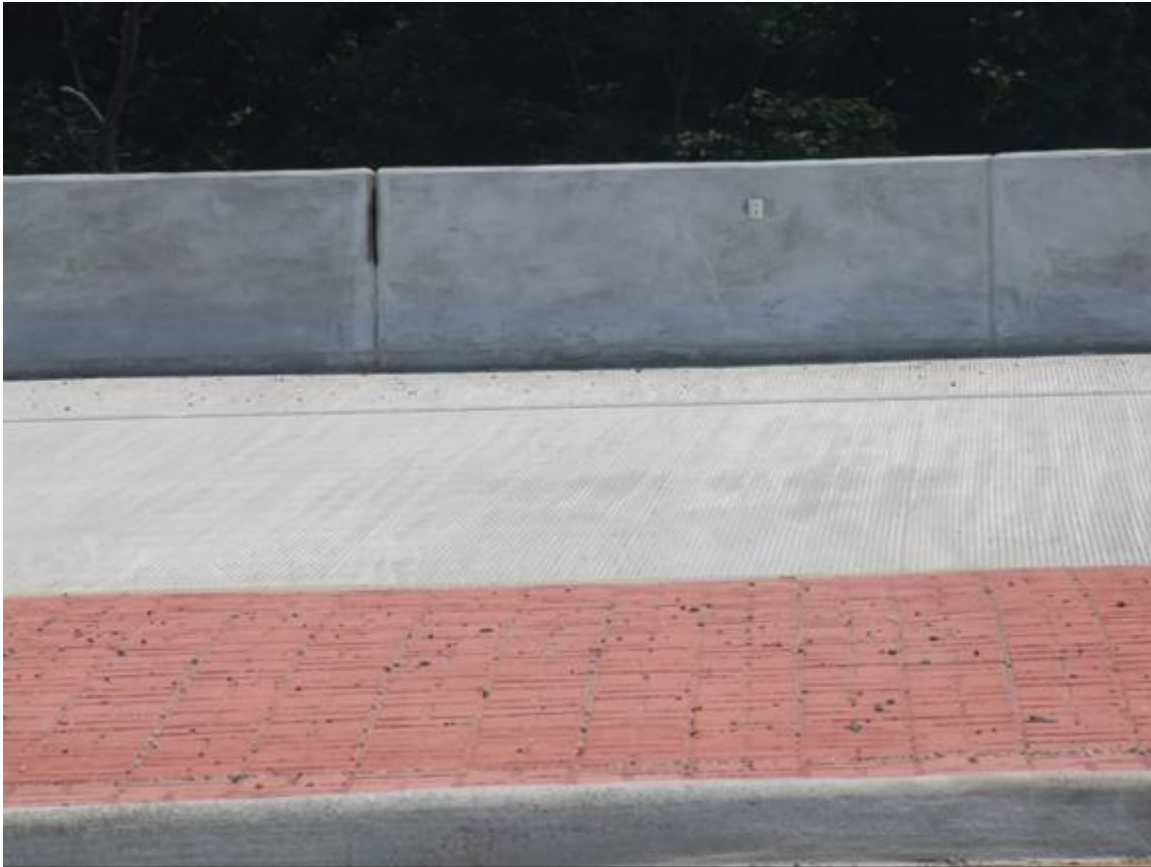
Figure 25. Northbound (MMFX 2) Raised Median and Deck Image

A visual survey of the northbound (MMFX 2) deck indicated the deck is in fairly good condition, as shown in Figure 25, and had a grooved surface finish. The deck did exhibit some cracking, which is discussed in greater detail later. It should be noted that the presence of SIP forms can justify the sealing of cracks in a deck. Even though this deck exhibited some cracking, it was decided in this case that an epoxy sealant would not be applied because the deck was constructed using CRR.

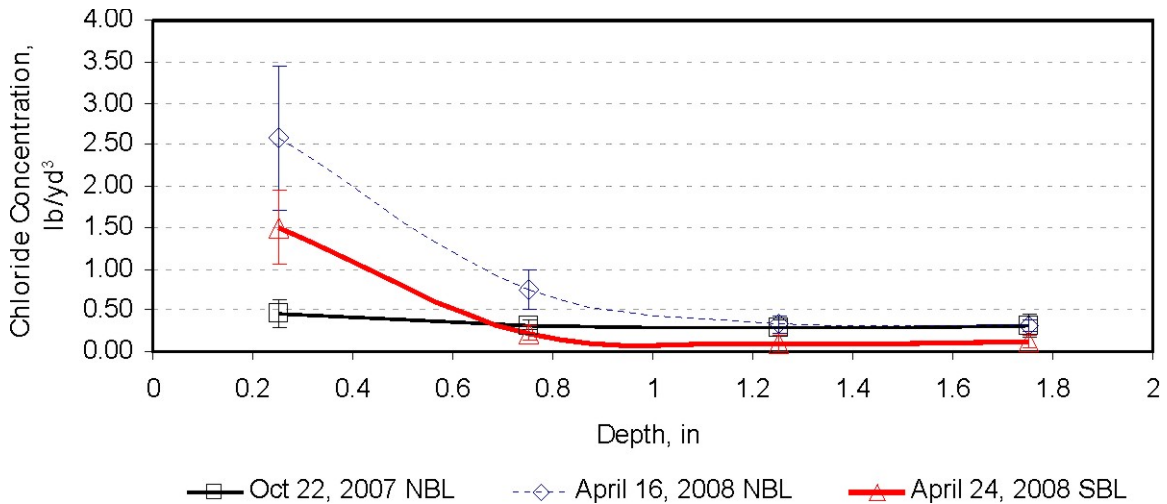
Figure 29. Comparison of Average Chloride Concentration for Northbound and Southbound Lanes. NBL = northbound lane, SBL = southbound lane.

According to the chloride concentrations, the northbound (MMFX 2) structure is exhibiting a higher chloride level concentration, which is shown in Figure 29. This was unexpected since the SBL is older than the NBL. One possibility is that the epoxy used to seal the cracks in the southbound deck is keeping the chlorides from penetrating into the concrete. However, comparison of the background level for the NBL, the October 22, 2007, line to the
