FINAL  
CONTRACT REPORT  
VTRC 09-CR15

**ANCHORAGE ZONE DESIGN  
FOR PRETENSIONED PRECAST BULB-T  
BRIDGE GIRDERS IN VIRGINIA**

Via Department of Civil and Environmental Engineering  
Virginia Polytechnic Institute & State University

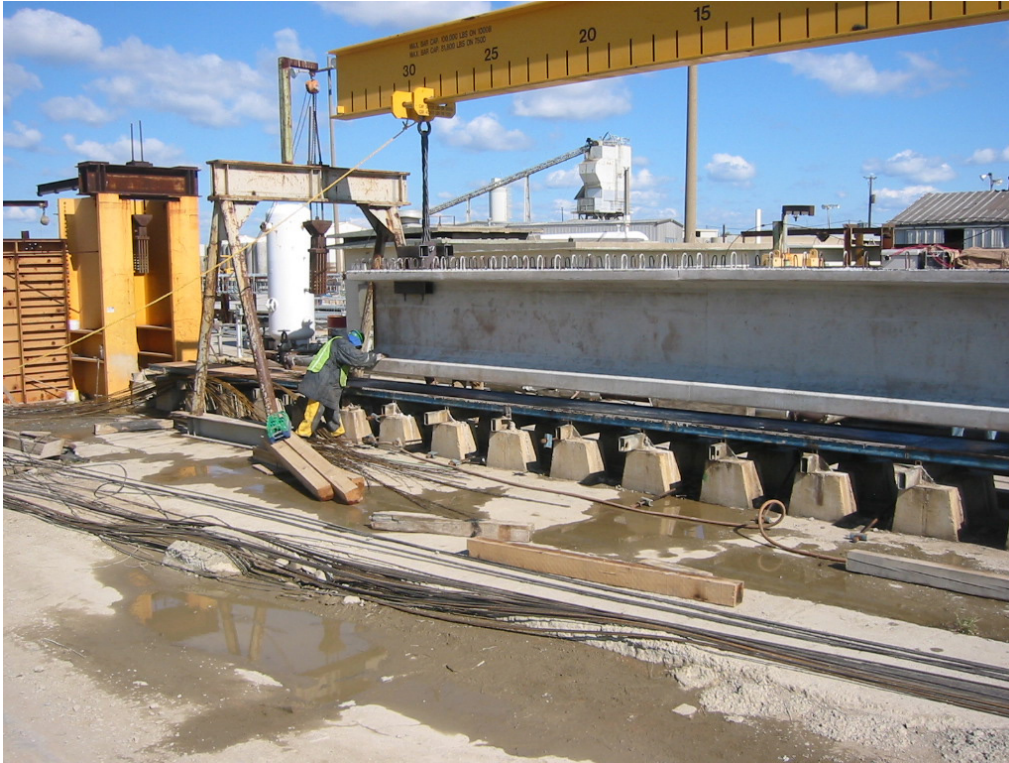
**Figure 15. Test Girder Lifted From Casting Bed on October 25, 2006**

An important component in this test was the initial lift from the casting bed. During this first movement, the girder is most vulnerable because the prestress force is the highest, since long term prestress losses have not started, and the concrete is relatively weak. Bayshore planned to leave the girder in the casting bed until it was transported to Virginia Tech, but since lifting the girder was necessary to verify the anchorage zone model, they agreed to lift the girder briefly. The readings from the strain gages were monitored throughout casting, transfer, and the first lift of the girder. After the girder was lifted, the data acquisition system was adjusted to take readings every 90 minutes and the strain gage readings were recorded throughout the life of the gages.

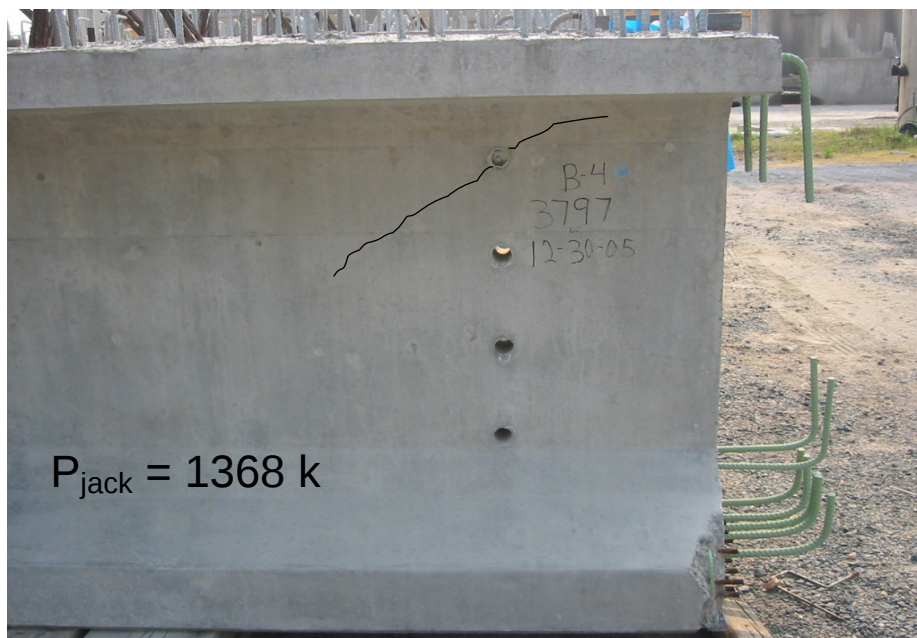
**Figure 16. PCBT-53 Anchorage Zone Case Study – Fair Condition**

The girder shown in Figure 16 is a 53-in bulb-T with 44  $\frac{1}{2}$ -in strands, 6 of which were harped. The total prestress force was 1,368 kips at the time the strands were tensioned. The crack pattern shown in Figure 16 was typical of eight other beams with the same magnitude of prestress force and stirrup arrangement. The area of vertical reinforcement within a distance of  $h/4$  from the end of the girder was 3.1 in<sup>2</sup> and this region was free of cracks. A diagonal crack formed near the top flange-web interface several inches in from the end of the beam and extended a length of almost 60 percent of the girder height. The widest portion of this crack measured approximately 0.010 in. This crack width would be acceptable for most bridge girders not exposed to salt water environments. This girder was classified as fair because of the length of the diagonal crack. It is desired for any diagonal cracks that develop near the top flange to terminate within  $h/2$ . Diagonal cracks that terminate within  $h/2$  are often tighter and are less of a concern to bridge inspectors. The diagonal crack in this girder was not repaired.

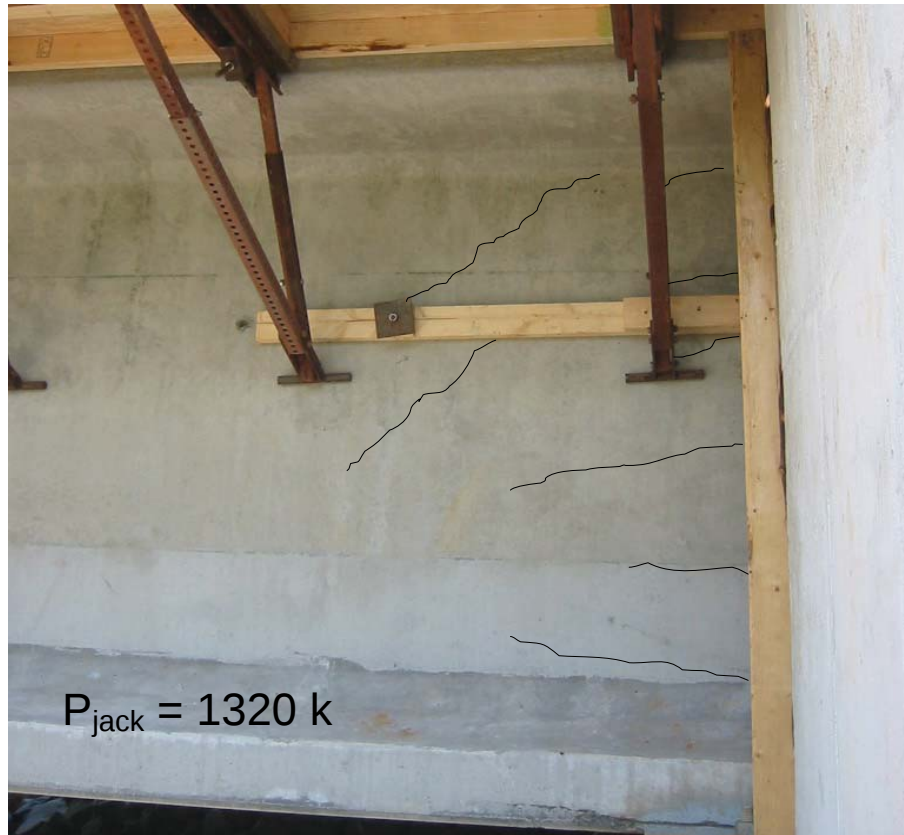
**Figure 19. PCBT-77 Anchorage Zone – Poor Condition**

Another example of a poor beam end is shown in Figure 19. This girder is also a PCBT-77. It was 106 ft long and contained a total of 30 0.6-in-diameter strands. Twenty-four of the strands were straight and six were harped. The magnitude of prestress force at the time the strands were tensioned was 1,320 kips. The area of vertical reinforcement provided within  $h/4$  from the beam end was 2.0 in<sup>2</sup>. This is slightly below the minimum reinforcement requirement outlined in AASHTO LRFD. The cracking at the end of the girder was severe and is shown in Figure 19. The cracks in this girder were surveyed after it was placed on the bearing pads of a bridge recently constructed in Virginia. This span of the bridge contained five girders and all of them exhibited a similar crack pattern. The composite deck was not poured at the time the cracks were surveyed. The longest diagonal crack extended longitudinally into the beam almost 70 percent of the girder height. The horizontal crack near the bottom flange extended over 50

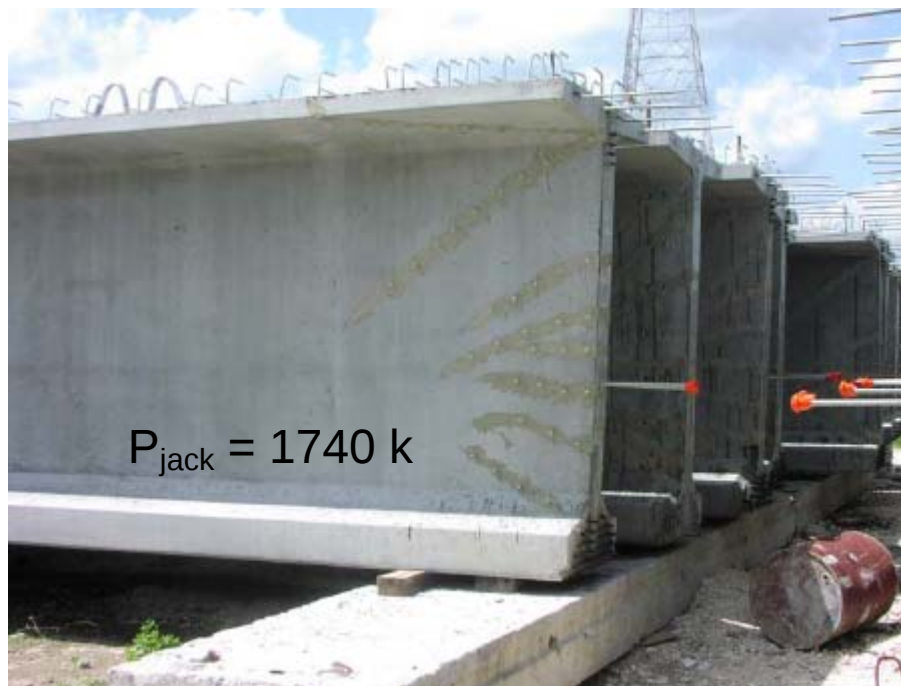
**Figure 20. 95.5 in PCBT Beam Ends with Repairs. Photograph from Davis et al. (2005)**

The next case study shows a girder that experienced severe anchorage zone cracking and was subsequently repaired by epoxy injection. The girder in Figure 20 is a 95.5 in PCEF Bulb-Tee girder constructed from lightweight concrete. The unit weight of the concrete was about 120 lb/ft<sup>3</sup> and the tensile strength of the concrete was approximately two-thirds that of normal weight concrete with the same design strength. It contained 56, ½-in-diameter strands with eight of the strands harped. The area of reinforcement within a distance of  $h/4$  from the beam end slightly exceeded the minimum requirement from AASHTO LRFD. The reinforcement pattern was not sufficient to control crack lengths and widths. The diagonal crack near the upper flange extended 69 in in length and had a width up to 0.025 in. As a result of the large crack widths, the girder was repaired by epoxy injection as seen in Figure 20.

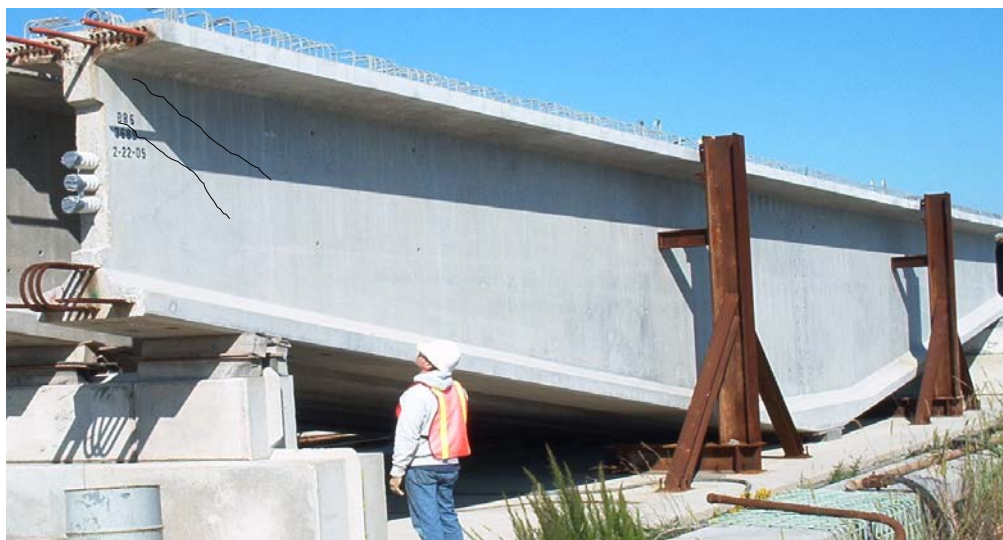
**Figure 22. Anchorage Zone Cracking Observed in Deep Haunched Girders**

Pier segments with anchorage zone cracking are also an area of concern. During site visits to Bayshore, diagonal and horizontal cracks were observed on deep haunched girders as shown in Figure 22. Cracking of this type could be detrimental to girder strength. When a girder with this type of cracking is in service, tension must cross the crack. As a result the crack could open and close as traffic crosses the bridge.
