MASH TEST 3-11 ON THE TEXAS T101 BRIDGE RAIL

Research/Test Report 9-1002-1

**TEXAS TRANSPORTATION INSTITUTE
THE TEXAS A&M UNIVERSITY SYSTEM
COLLEGE STATION, TEXAS**

TEXAS DEPARTMENT OF TRANSPORTATION

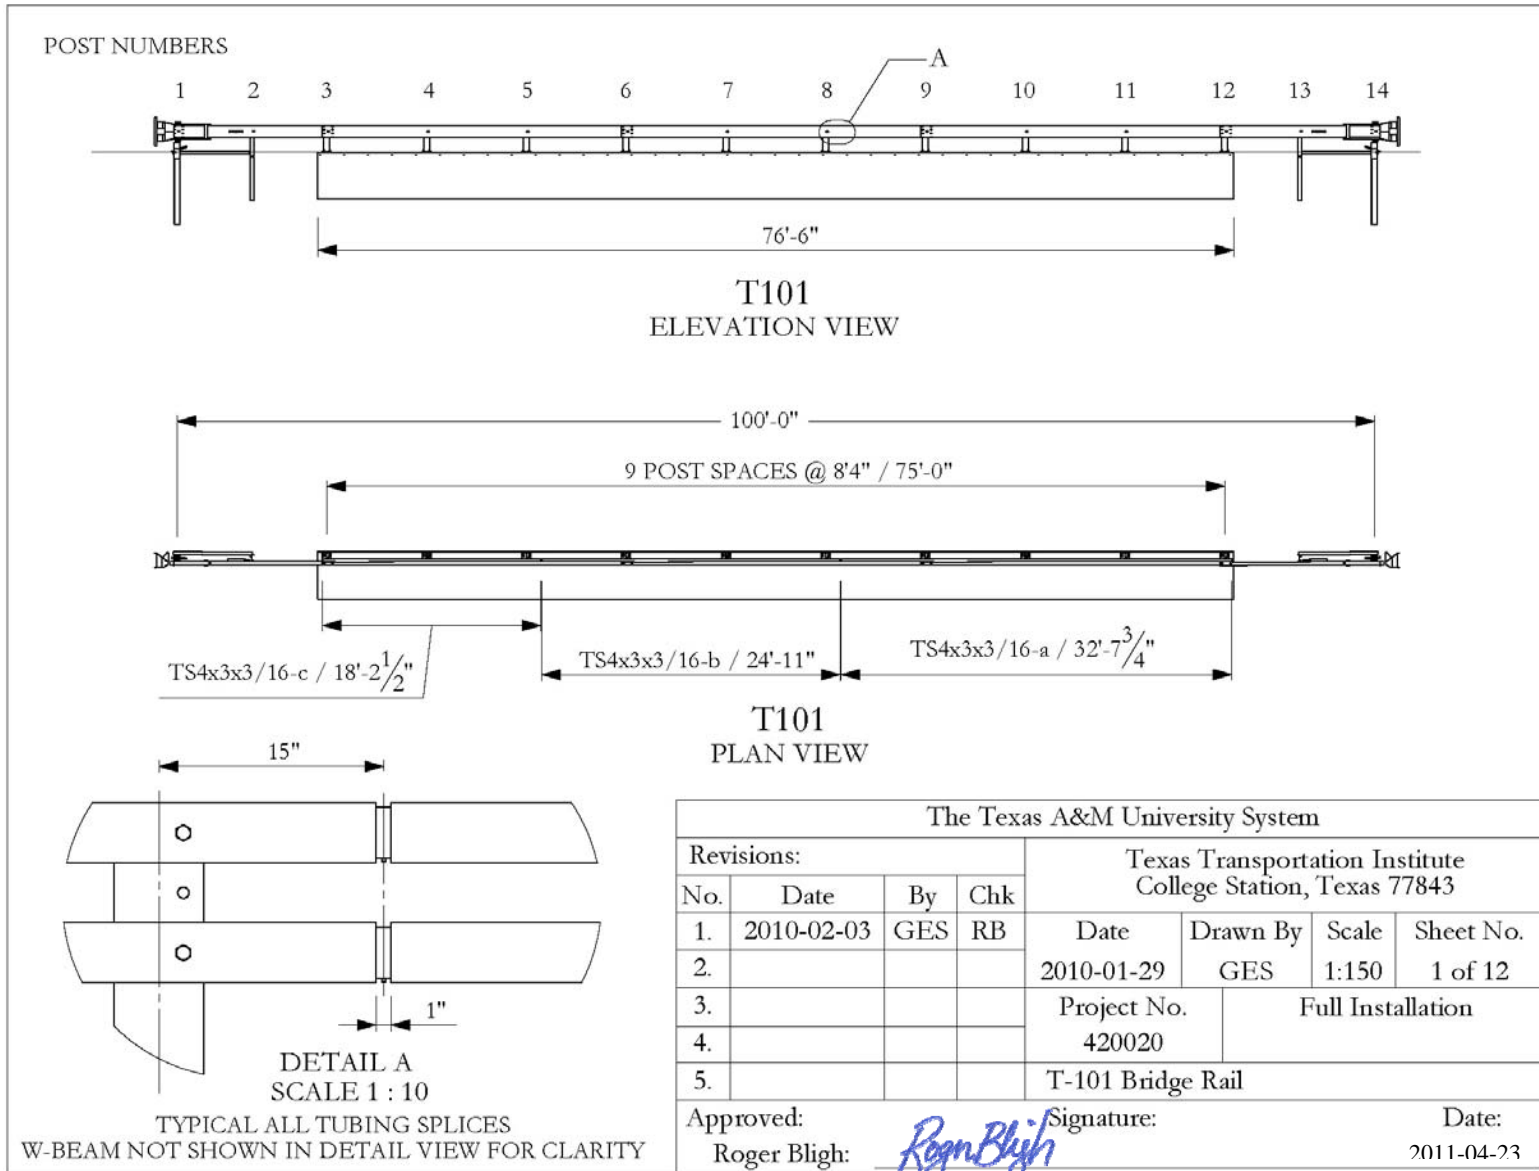
Figure 2.1. Details of the T101 Bridge Rail.

The rail element was 12 gauge AASHTO M180 grade corrugated W-beam backed by TS4 \times 3 \times 3/16 tubular steel elements of A500 Grade C steel. All reinforcement steel was Grade 60. The specified minimum compressive strength of the concrete for the T101 bridge deck was 3600 psi. On the day of the test, the compressive strength of the bridge deck measured 6344 psi. Appendix B contains mill certification sheets and other certification documents for the materials used in the T101 bridge rail installation, as well as concrete break tests.

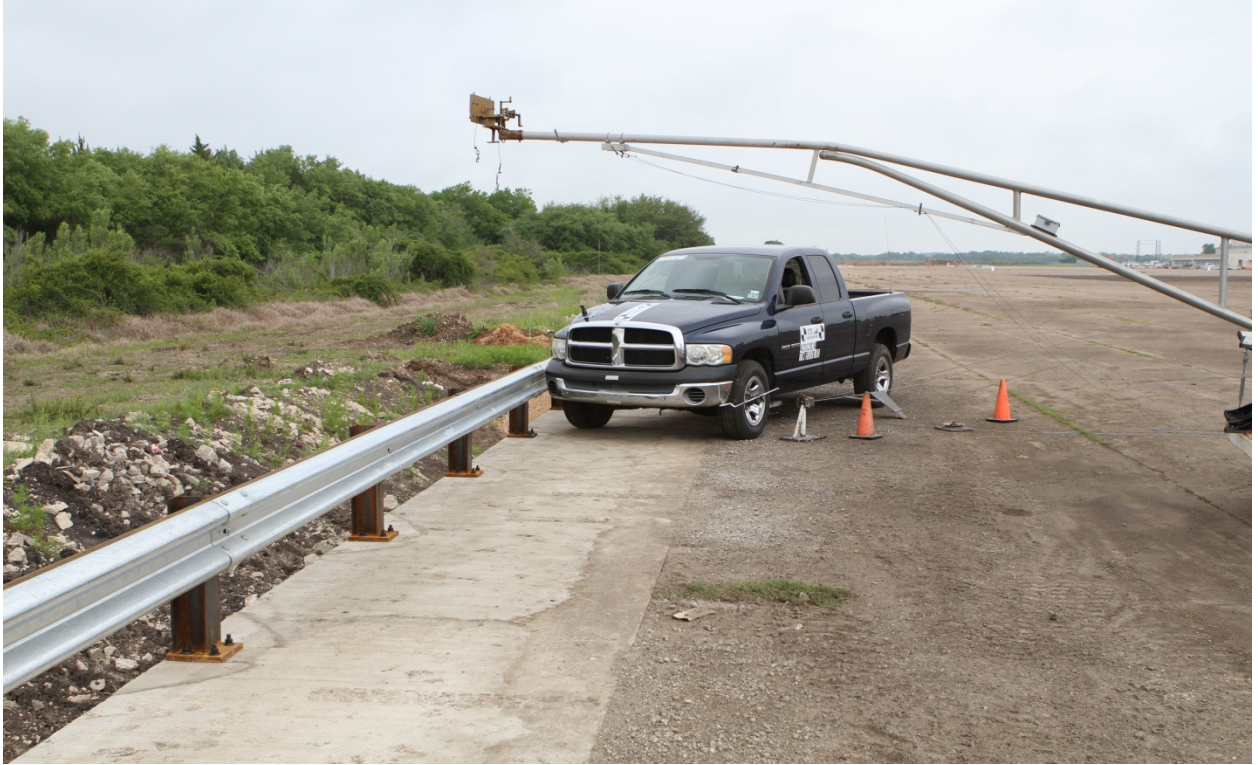
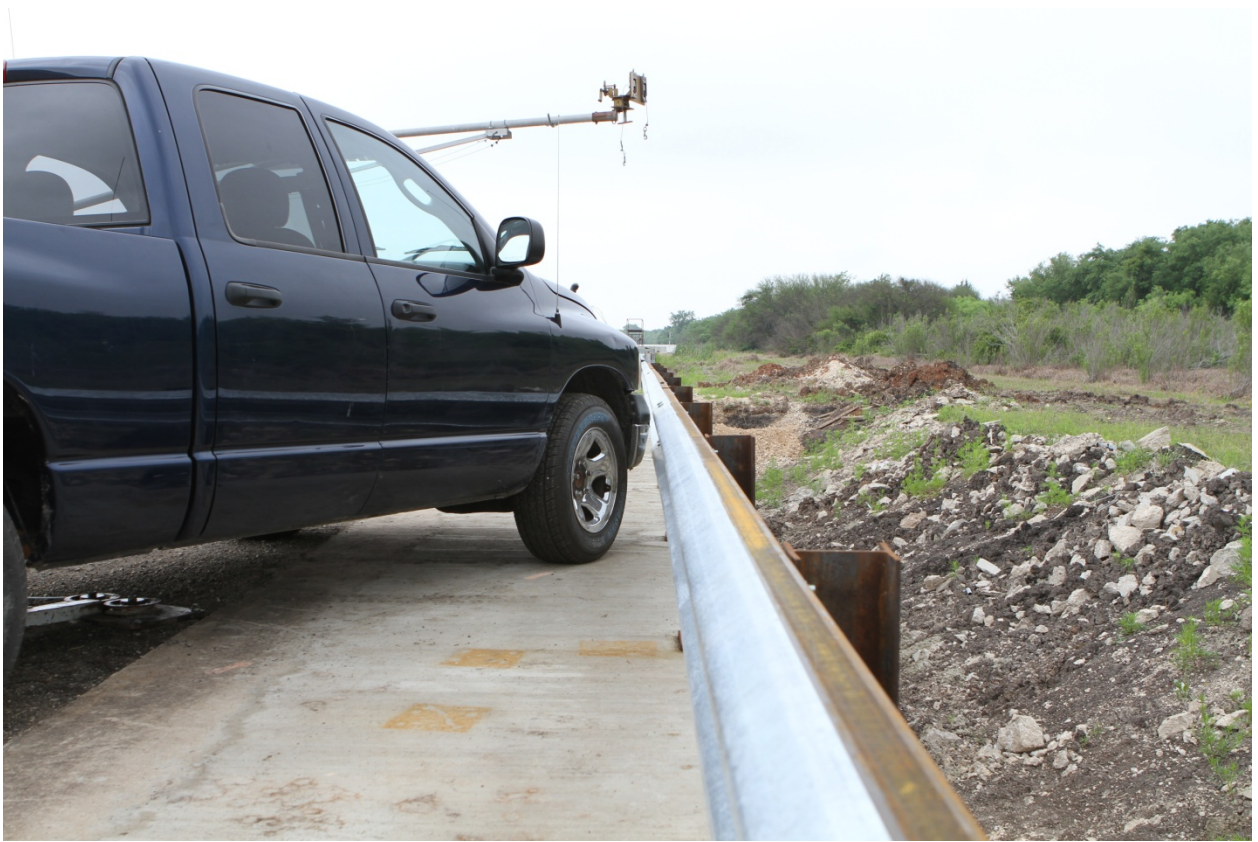
Figure 5.1. Vehicle/Installation Geometrics for Test No. 420020-1a.

The 2003 Dodge Ram 1500 Quad-Cab pickup impacted the T101 bridge rail at post 6 at an impact speed of 63.0 mi/h and an impact angle of 24.9 degrees. At 0.029 s after impact, the right front wheel assembly and tire detached from the vehicle, and at 0.042 s, the forward edge of the front passenger door began to peel back. The vehicle began to redirect at 0.071 s, and the rear of the vehicle contacted the bridge rail at 0.176 s. At 0.200 s, the vehicle was traveling parallel with the bridge rail at a speed of 53.7 mi/h. At 0.310 s, the vehicle lost contact with the bridge rail traveling at an impact speed and angle of 51.2 mi/h and 6.0 degrees, respectively. The vehicle subsequently rolled onto the impact (passenger) side and slid to a stop. Brakes on the vehicle were not applied, and the vehicle subsequently came to rest 180 ft downstream of impact and 21 ft toward traffic lanes from the traffic face of the bridge rail. Figures D1 and D2 in Appendix D show sequential photographs of the test period.

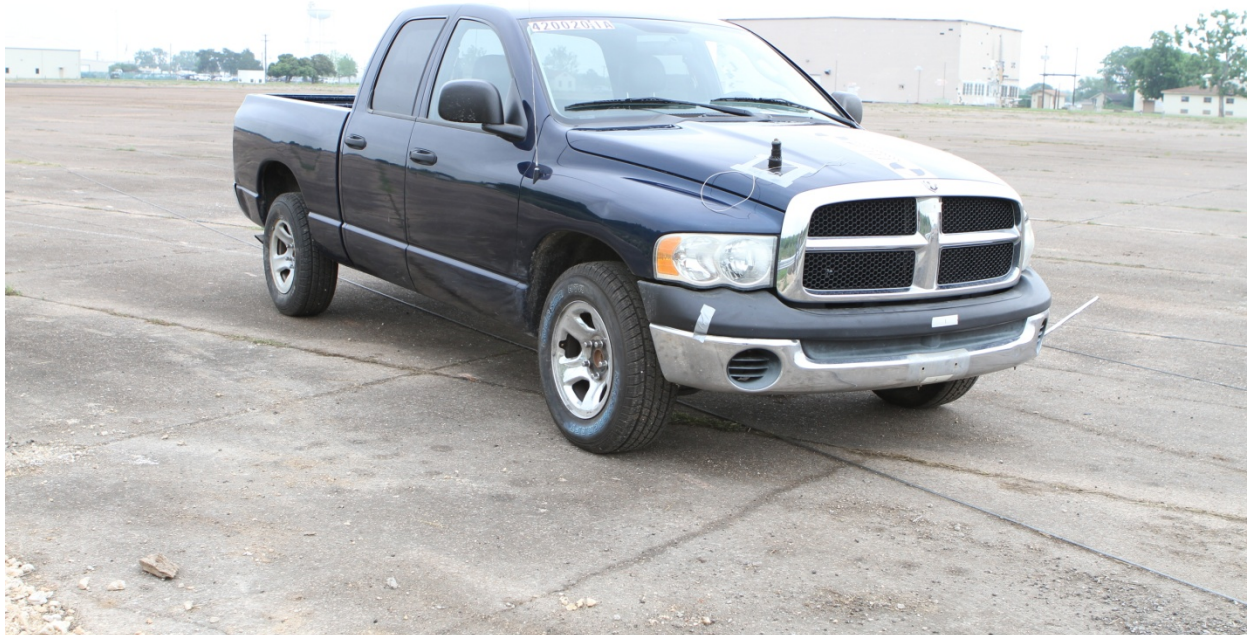
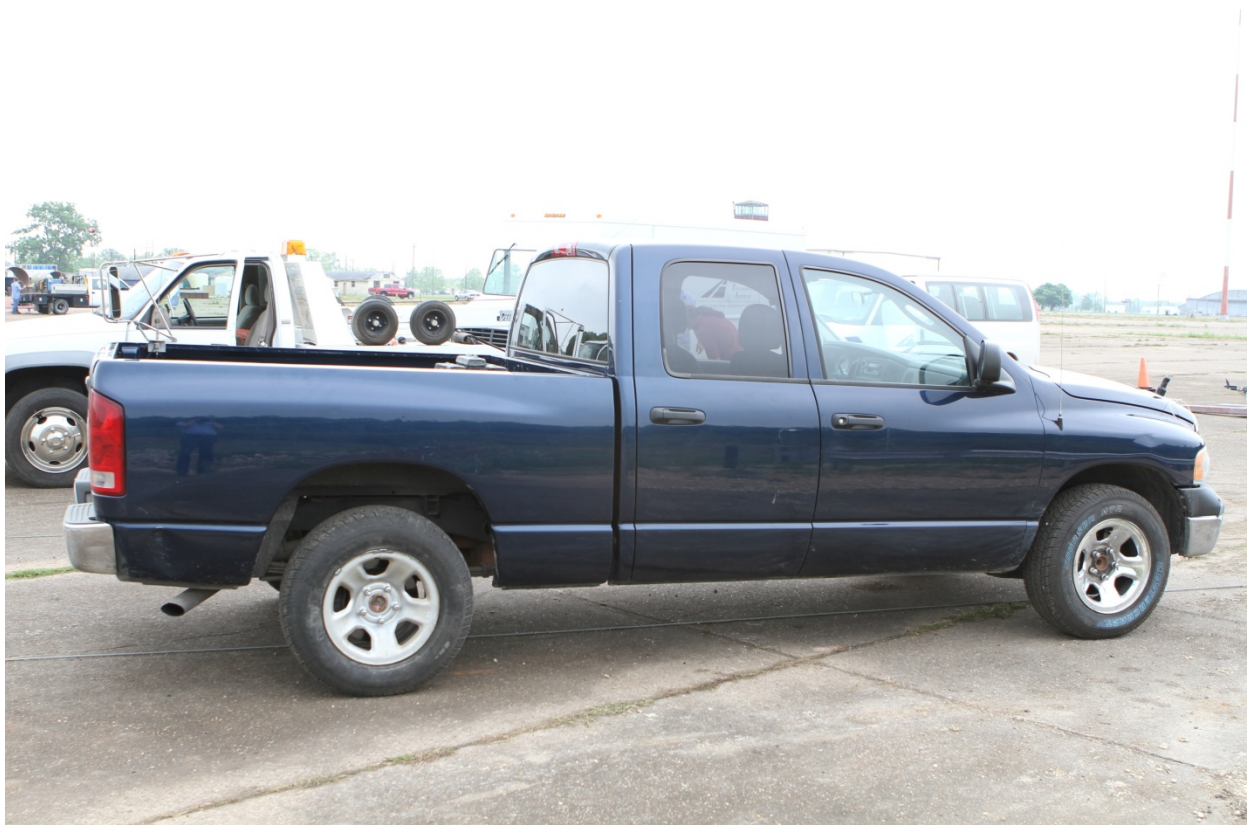
Figure 5.2. Vehicle before Test No. 420020-1a.

A 2003 Dodge Ram 1500 Quad-Cab pickup, shown in Figures 5.1 and 5.2, was used for the crash test. Test inertia weight of the vehicle was 5023 lb, and its gross static weight was 5023 lb. The height to the lower edge of the vehicle bumper was 13.5 inches, and it was 26.0 inches to the upper edge of the bumper. The vertical height to the vehicle center of gravity was 28.0 inches. Figure C1 and Table C1 in Appendix C give additional dimensions and information on the vehicle. The vehicle was directed into the installation using the cable reverse tow and guidance system, and was released to be free-wheeling and unrestrained just prior to impact.

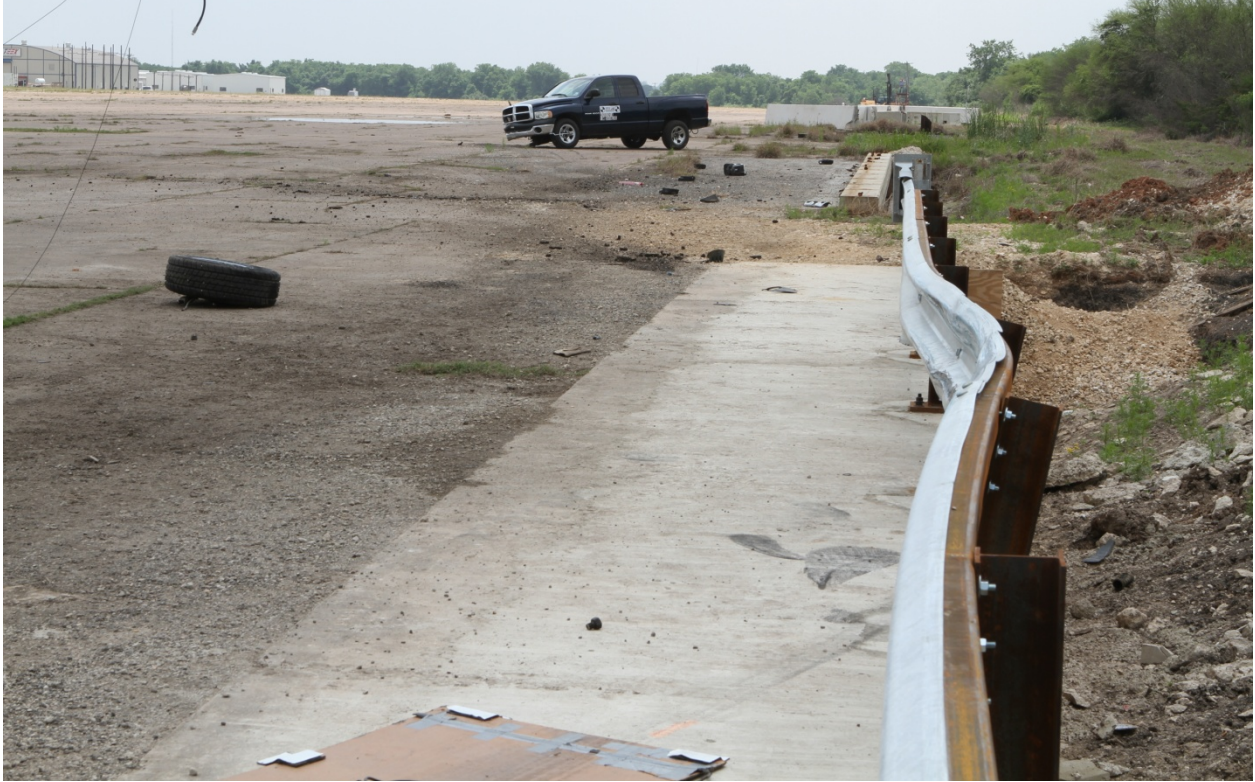
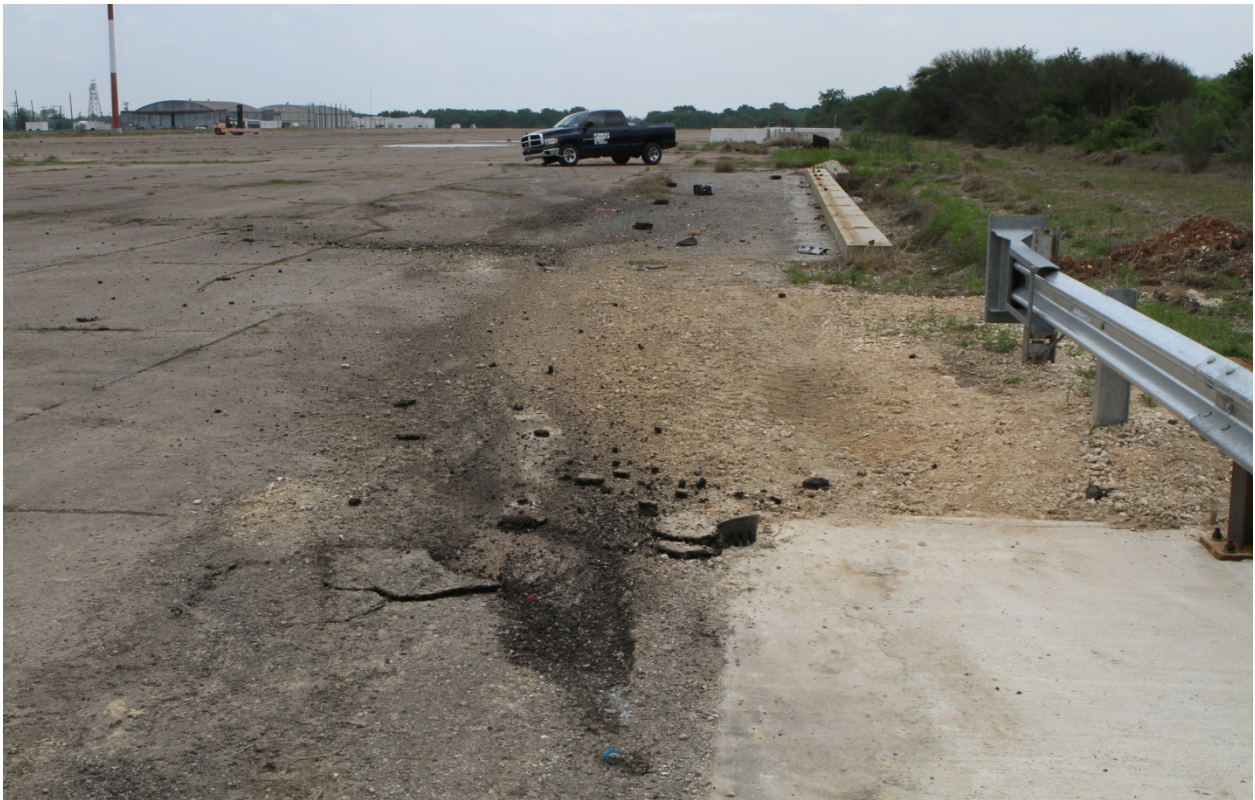
Figure 5.3. After Impact Vehicle Position after Test No. 420020-1a.

Figures 5.3 and 5.4 show the damage to the T101 bridge rail. The soil around post 1 was disturbed. Post 6 was leaning toward the field side 10 degrees, the concrete deck was cracked around the post, the front upstream anchor bolt broke, and the lower half of the rail was torn. Post 7 was leaning toward the field side 11 degrees and the concrete deck around the post was cracked. Post 8 was leaning toward the field side 1 degree. Length of contact of the vehicle with the bridge rail was 18 ft. Working width was 2.9 ft. Dynamic deflection of the bridge rail during the test was 2.2 ft, and permanent deformation was 2.0 ft.

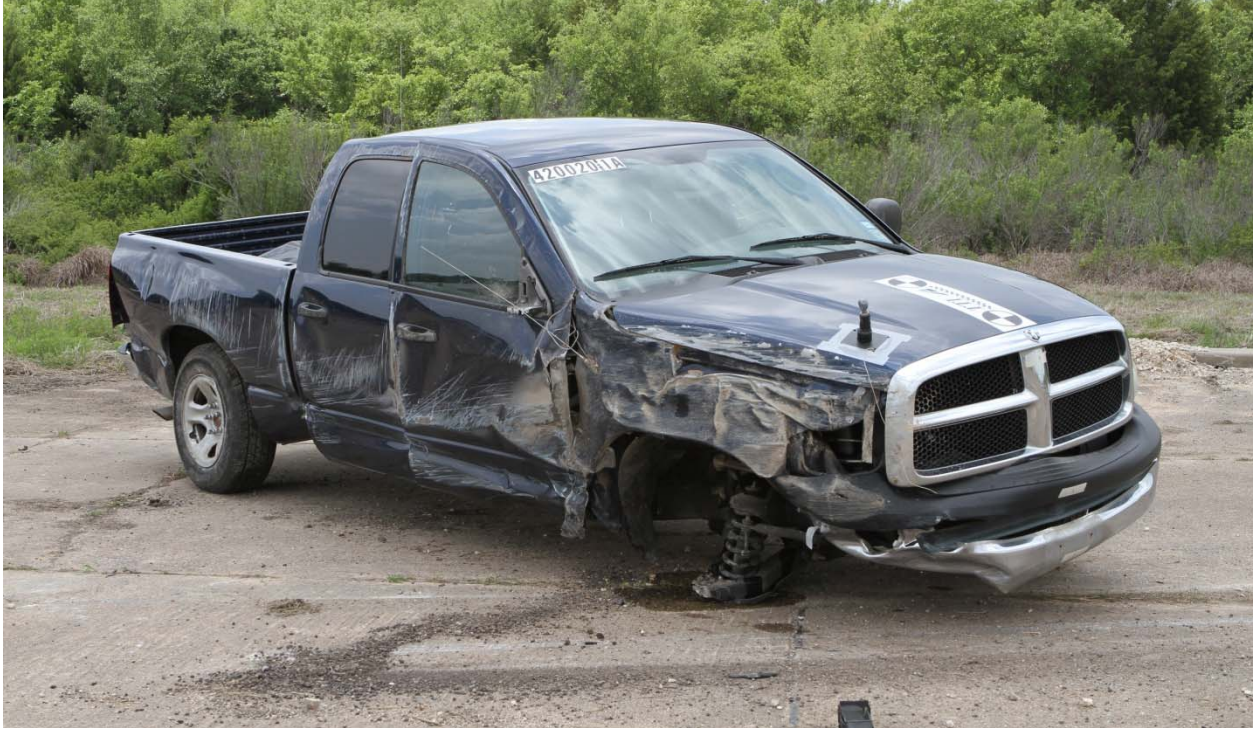
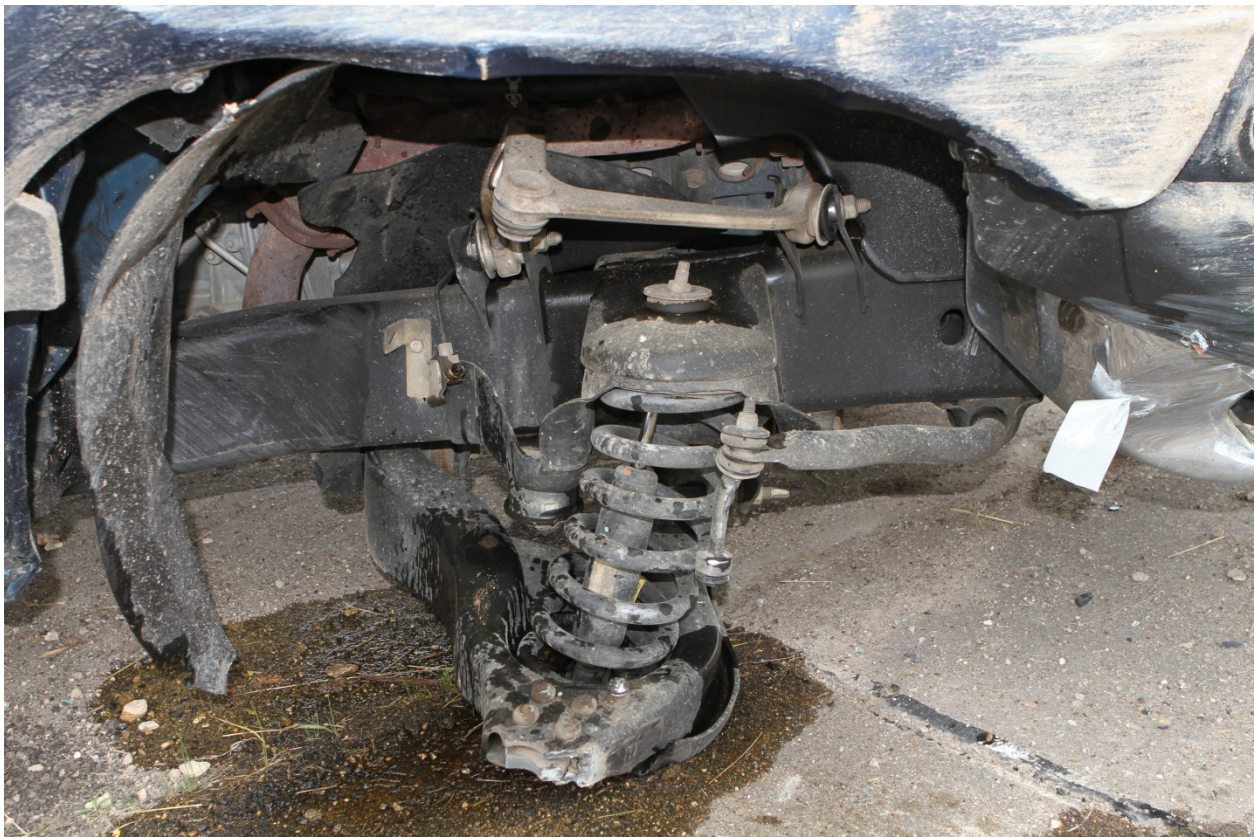
Figure 5.5. Vehicle after Test No. 420020-1a.

Figure 5.5 shows damage to the vehicle. The right front upper and lower ball joint, right front upper and lower A-arms, front sway bar and right frame rail were deformed. Also damaged were the front bumper, right front fender, right front wheel rim and tire, right front door, right rear door, right rear exterior bed, right rear wheel rim, and rear bumper. Maximum exterior crush to the vehicle was 12.0 inches in the side plane at the right front corner at bumper height. Maximum occupant compartment deformation was 1.5 inches in the firewall to front seat area near the toe pan on the right side. Figure 5.6 shows photographs of the interior of the vehicle. Exterior vehicle crush and occupant compartment measurements are shown in Appendix C, Tables C2 and C3.

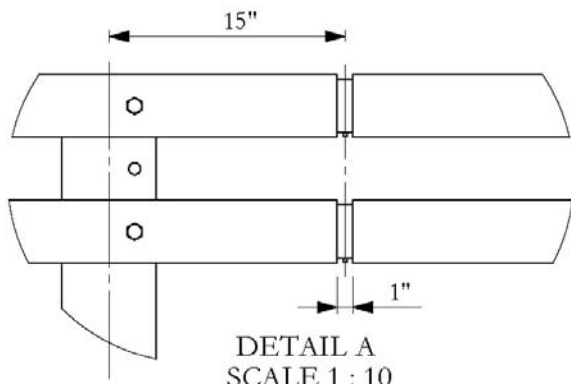
DETAIL A
SCALE 1 : 10

TYPICAL ALL TUBING SPLICES
W-BEAM NOT SHOWN IN DETAIL VIEW FOR CLARITY

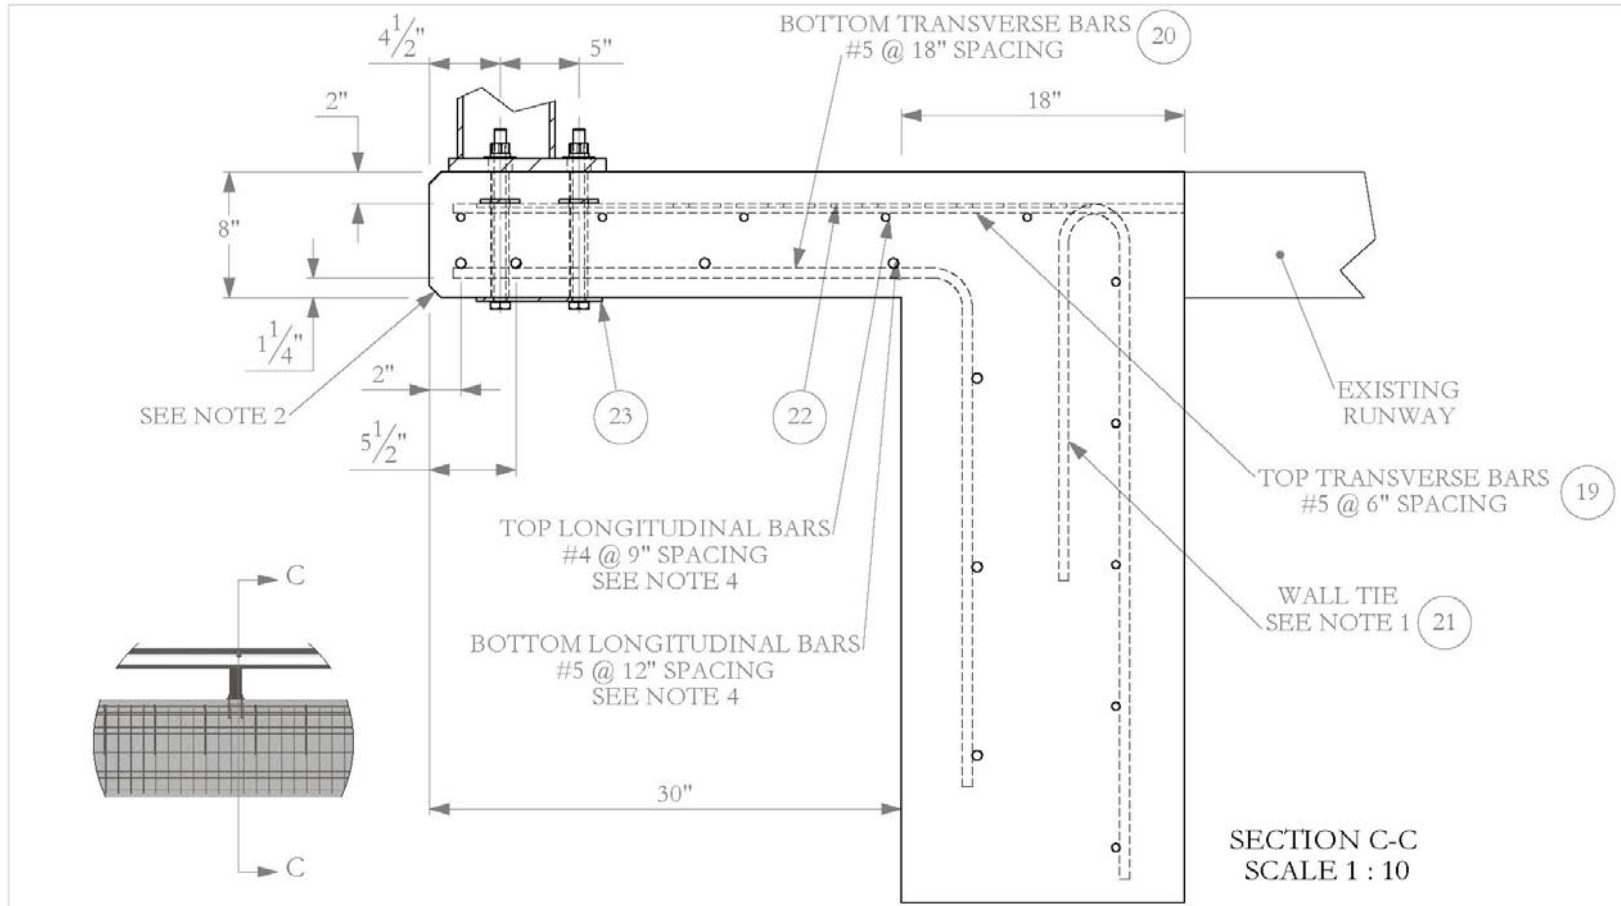
1. Wall tie rebar welded to existing rebar (not shown) at 24" spacing.
2. 3/4" chamfer top and bottom edges of deck.
3. Concrete - minimum 3600 p.s.i.
4. Rebar lap splices - #4 17"
#5 21"

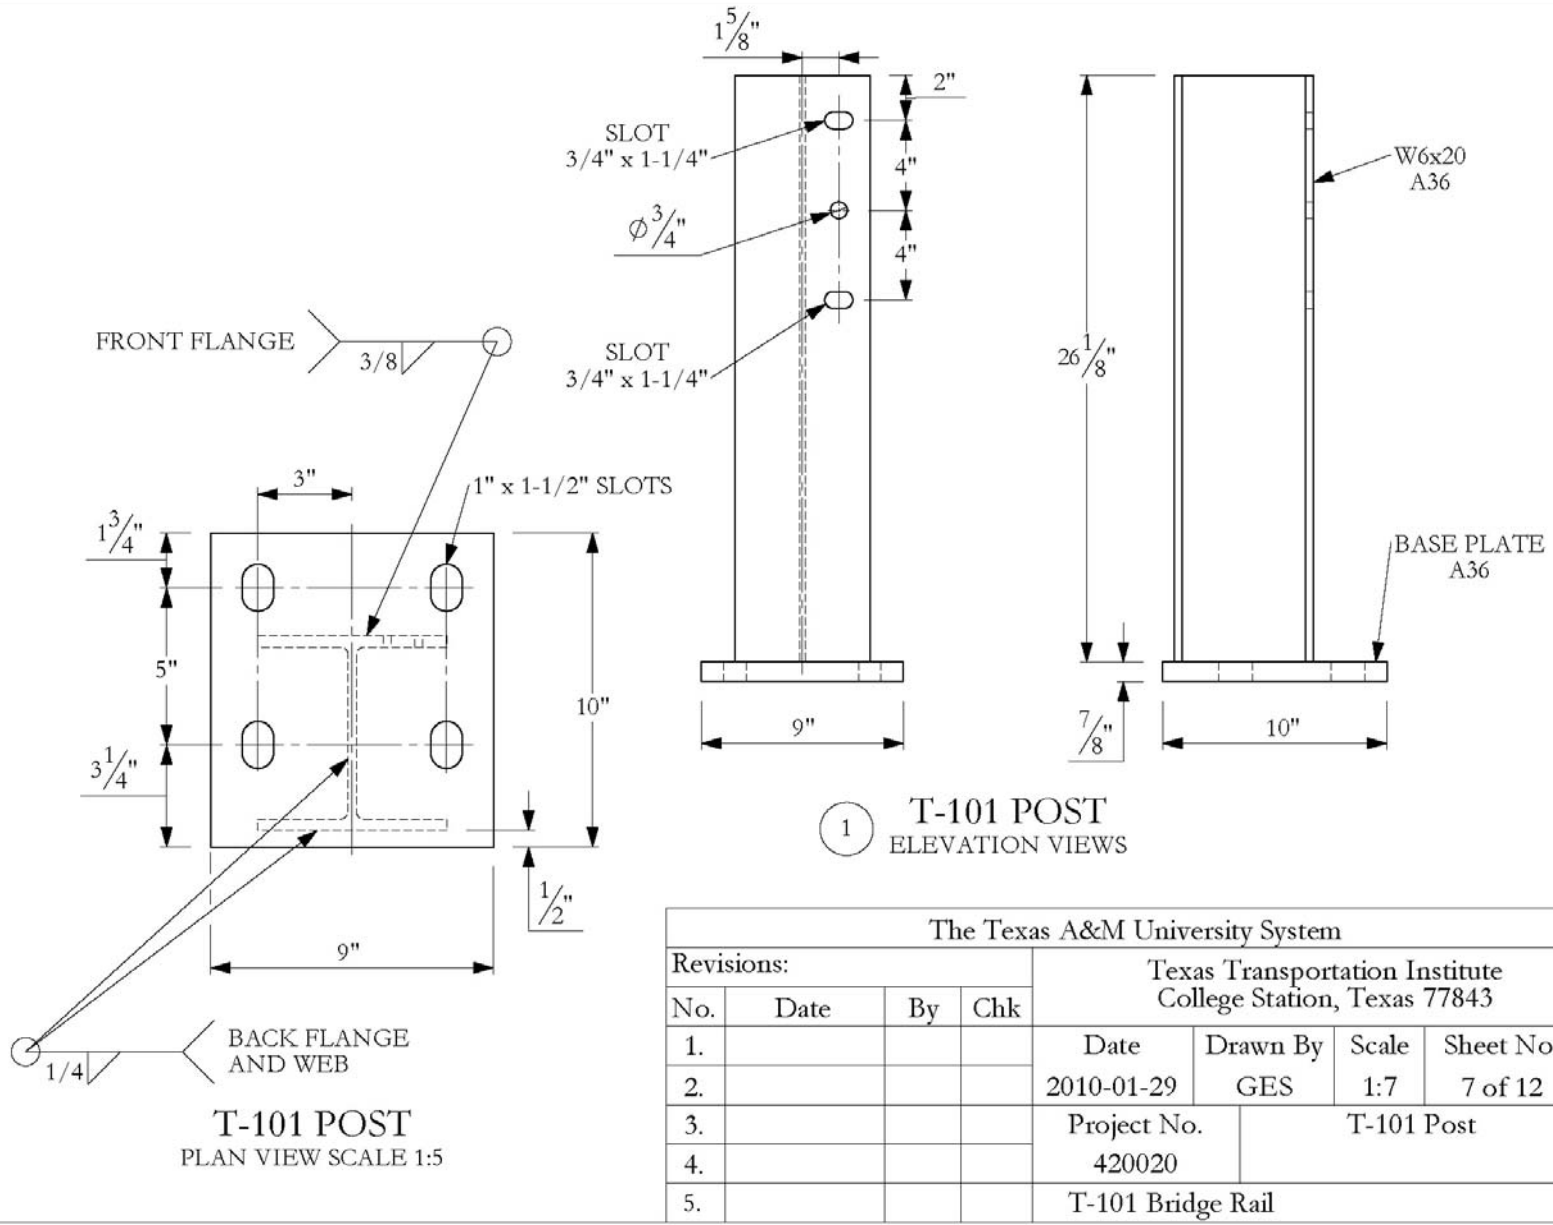
① T-101 POST
ELEVATION VIEWS

T-101 POST
PLAN VIEW SCALE 1:5

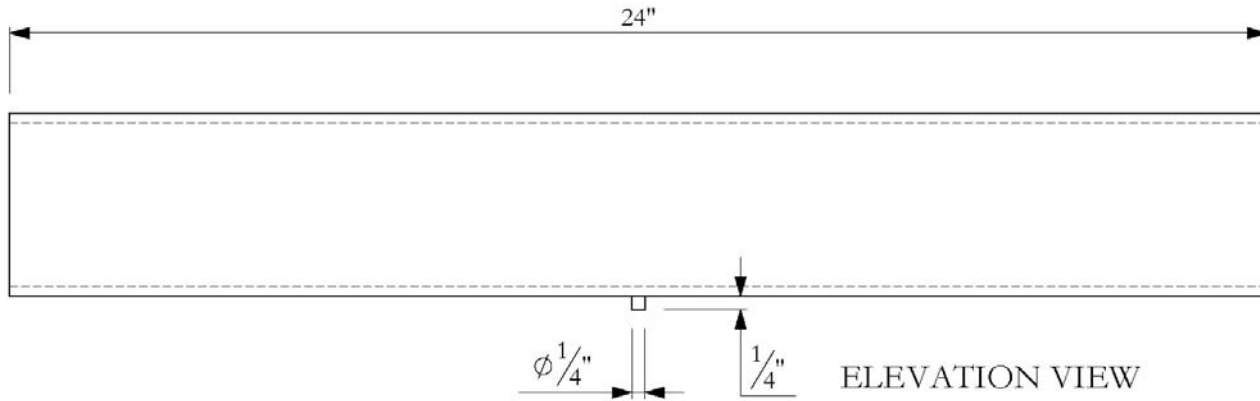
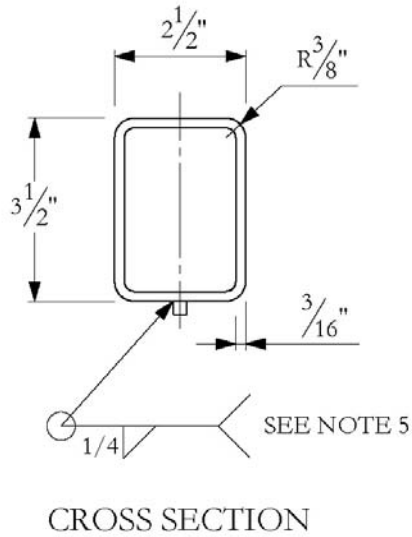
5 TUBING SPLICE

- 5. Welded stud shown. Driving fit pin is acceptable alternative.
- 6. Stud is A36 rod. Tubing is A500 Gr. C.

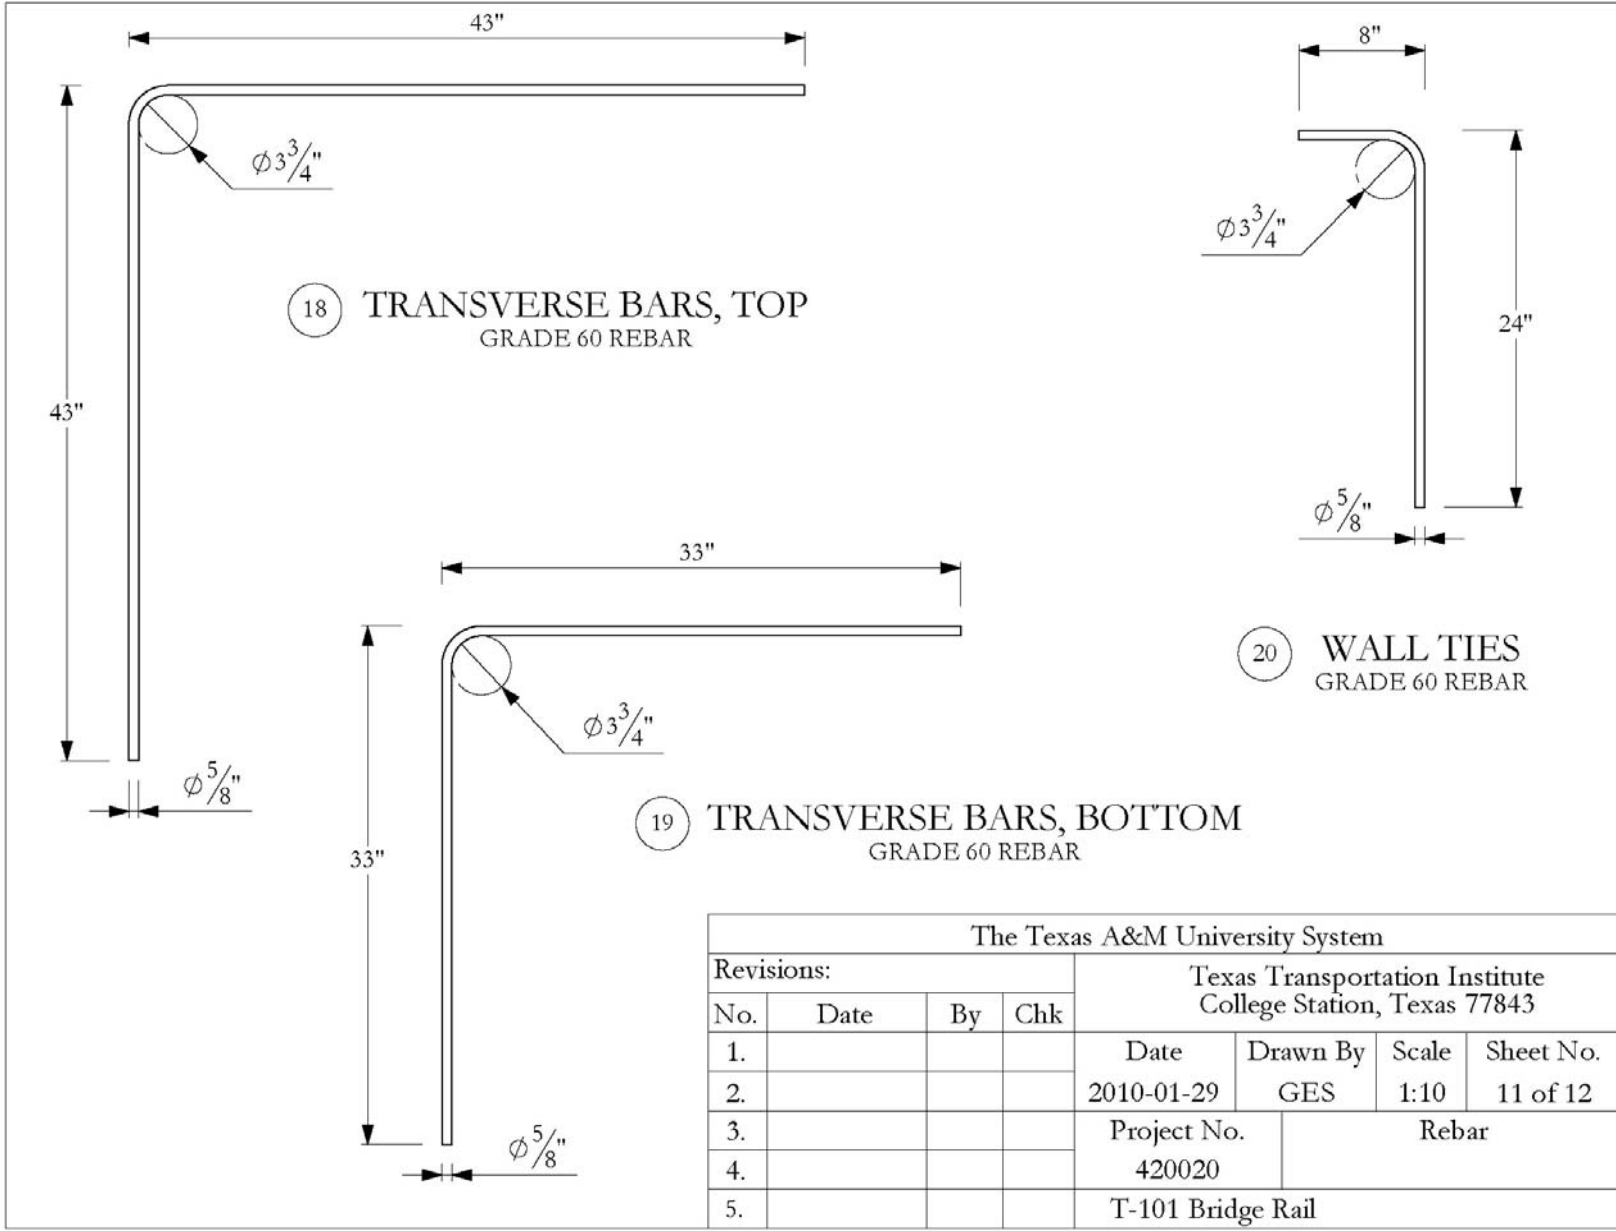
18 TRANSVERSE BARS, TOP
GRADE 60 REBAR

20 WALL TIES
GRADE 60 REBAR

19 TRANSVERSE BARS, BOTTOM
GRADE 60 REBAR
