# ***MASH TEST 3-11 OF THE TxDOT SINGLE SLOPE BRIDGE RAIL (TYPE SSTR) ON PAN-FORMED BRIDGE DECK***

## **Research/Test Report 9-1002-3**

Report 9-1002-3  
Project 9-1002  
Project Title: Roadside Safety Device Crash Testing Program

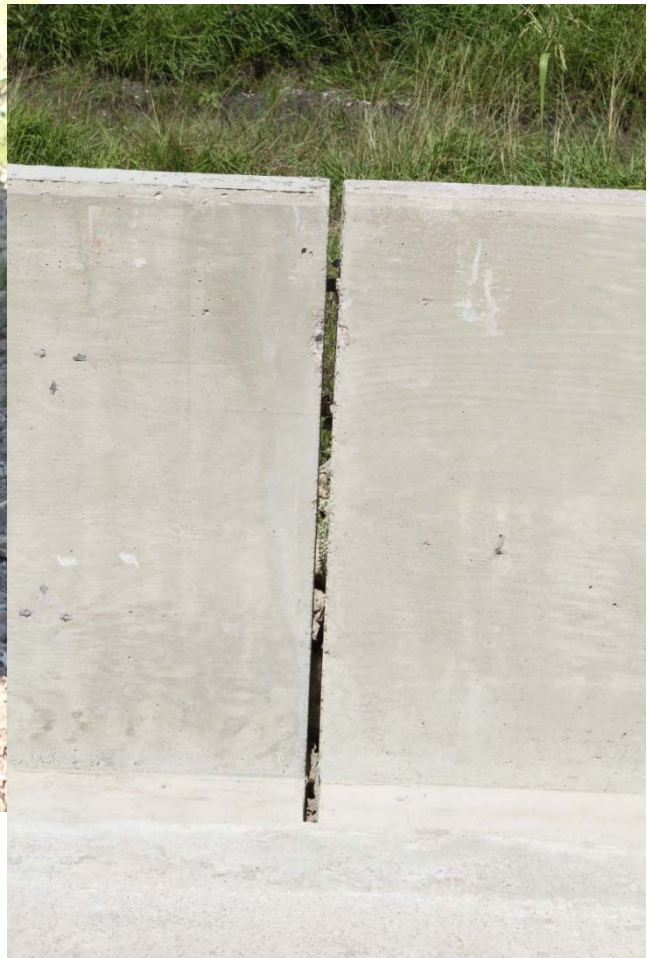
**Figure 2.2. TxDOT Pan-Formed Bridge Rail Installation before Test No. 420020-3.**

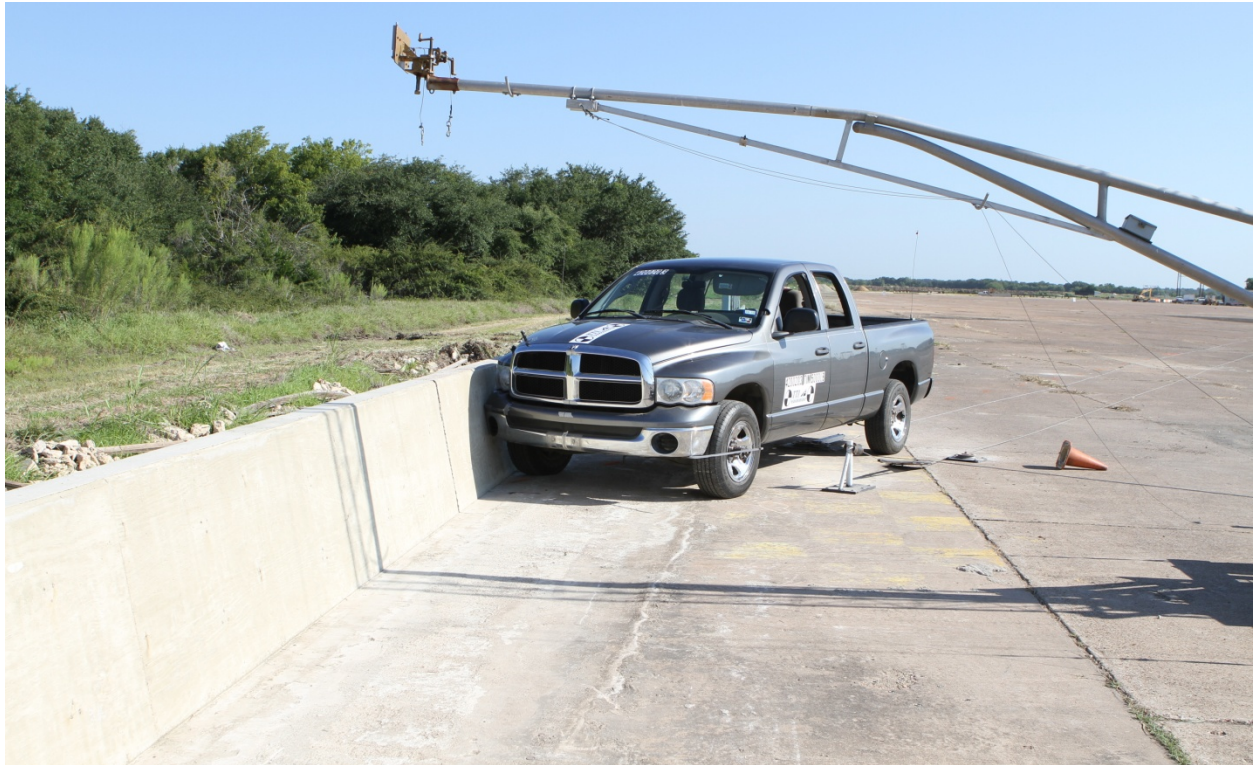
**Figure 5.1. Vehicle/Installation Geometrics for Test No. 420020-3.**

The 2270P vehicle, traveling at an impact speed of 63.8 mi/h, impacted the TxDOT pan-formed bridge rail with the right front corner of the bumper 5.2 ft upstream of the joint centerline in the TxDOT Type SSTR bridge rail at an impact angle of 24.8 degrees. Shortly after impact, the right front tire contacted the bridge rail, and the vehicle began redirection at 0.074 s after impact. The vehicle was traveling parallel with the bridge rail at 0.189 s, and was traveling at a speed of 50.6 mi/h. At 0.430 s, the 2270P vehicle lost contact with the bridge rail, traveling at an exit speed and angle of 49.5 mi/h and 7.2 degrees, respectively. Brakes on the vehicle were applied at 1.2 s after impact. The vehicle subsequently came to rest 170 ft downstream and 6 ft toward traffic lanes. Figures D1 and D2 in Appendix D show sequential photographs of the test period.

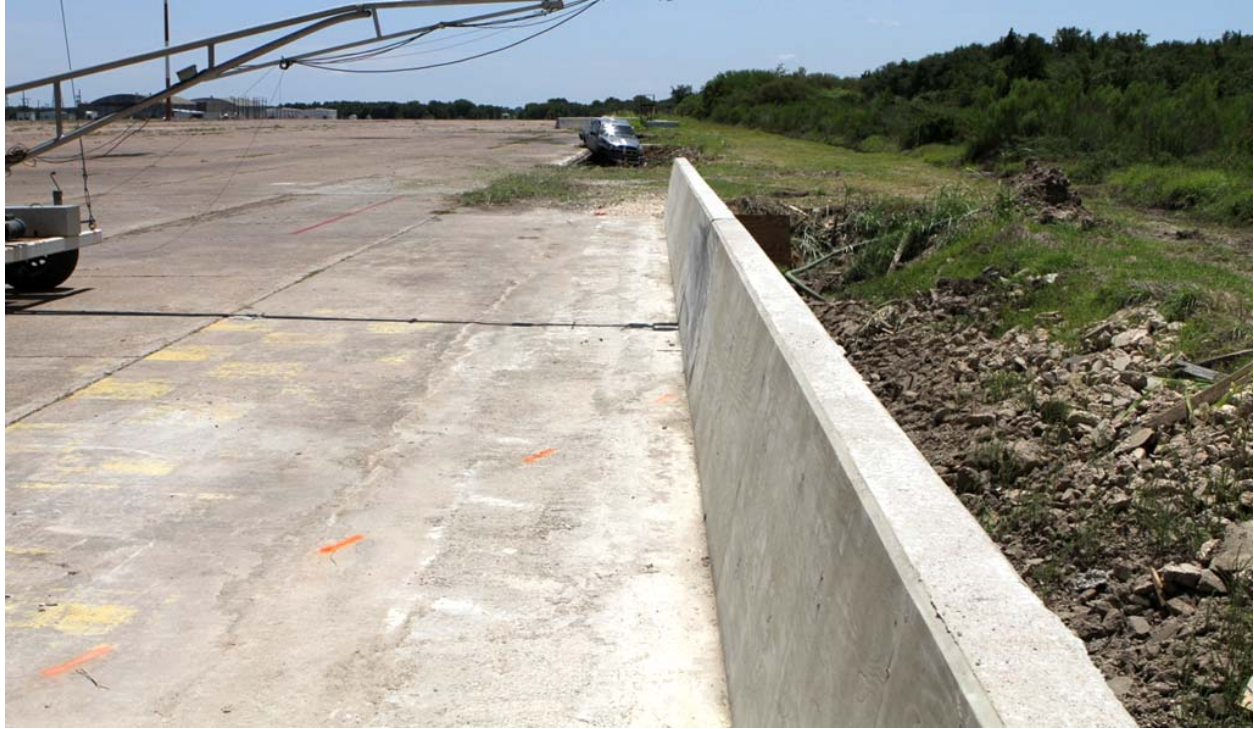
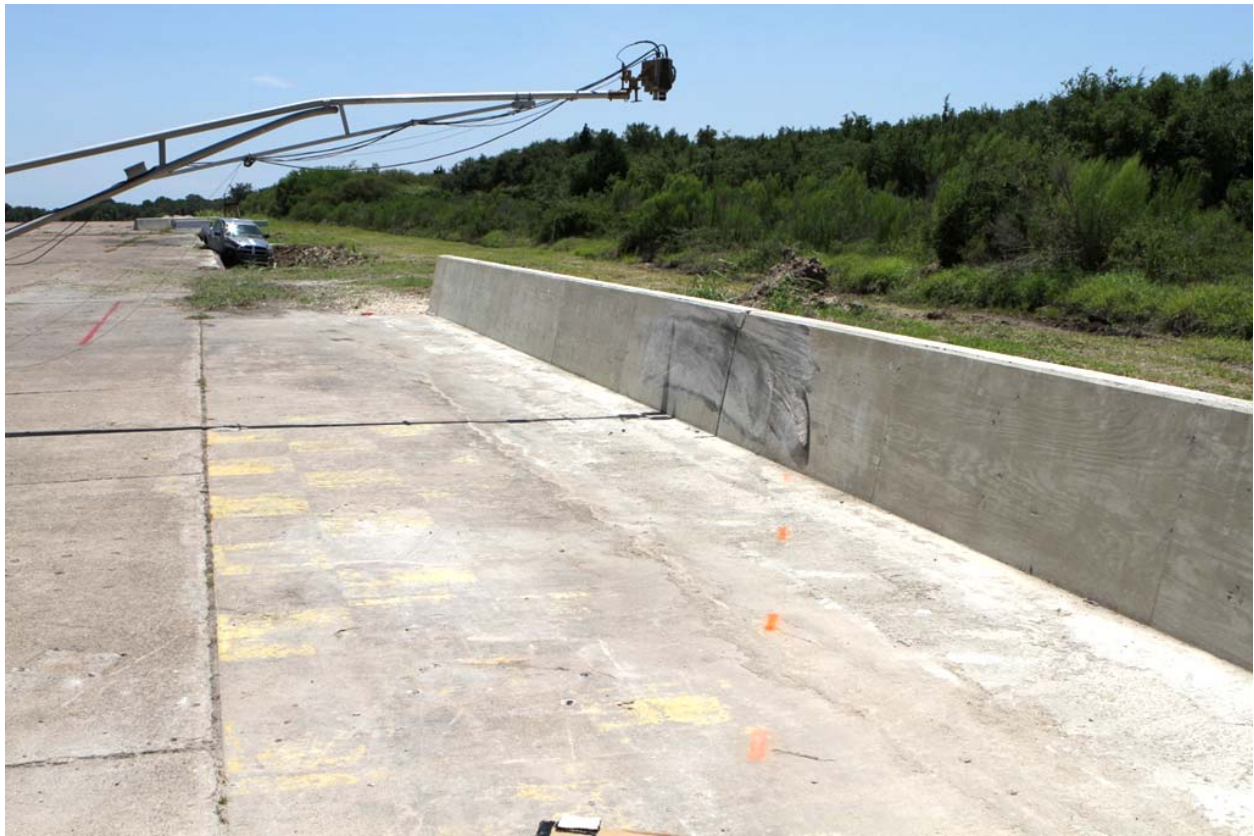
**Figure 5.3. After Impact Vehicle Position for Test No. 420020-3.**

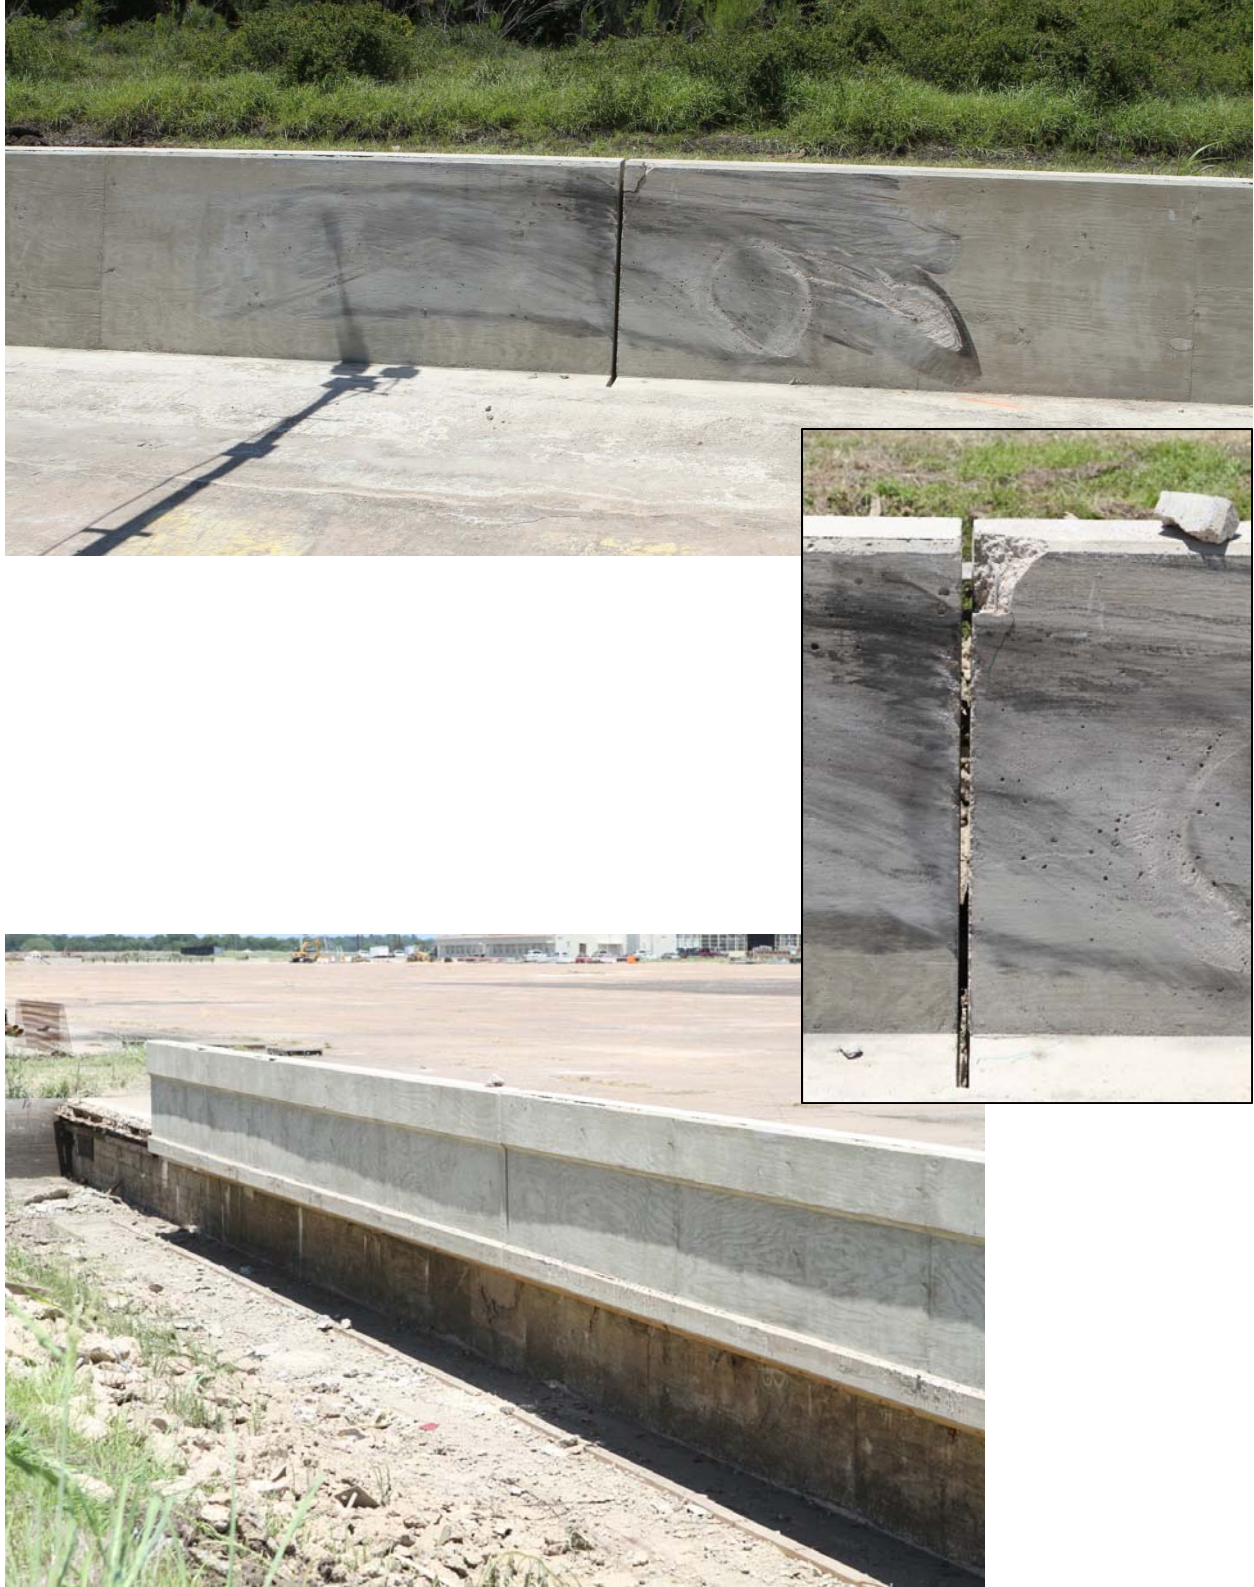
**Figure 5.4. Installation after Test No. 420020-3.**

Figures 5.3 and 5.4 show damage sustained by the TxDOT pan-formed bridge rail. Gouges and tire marks were evident in the length of contact for 12 ft beyond impact. The top traffic side corner of the downstream joint spalled off. Working width was 10 inches. No measurable dynamic deflection or permanent deformation occurred.

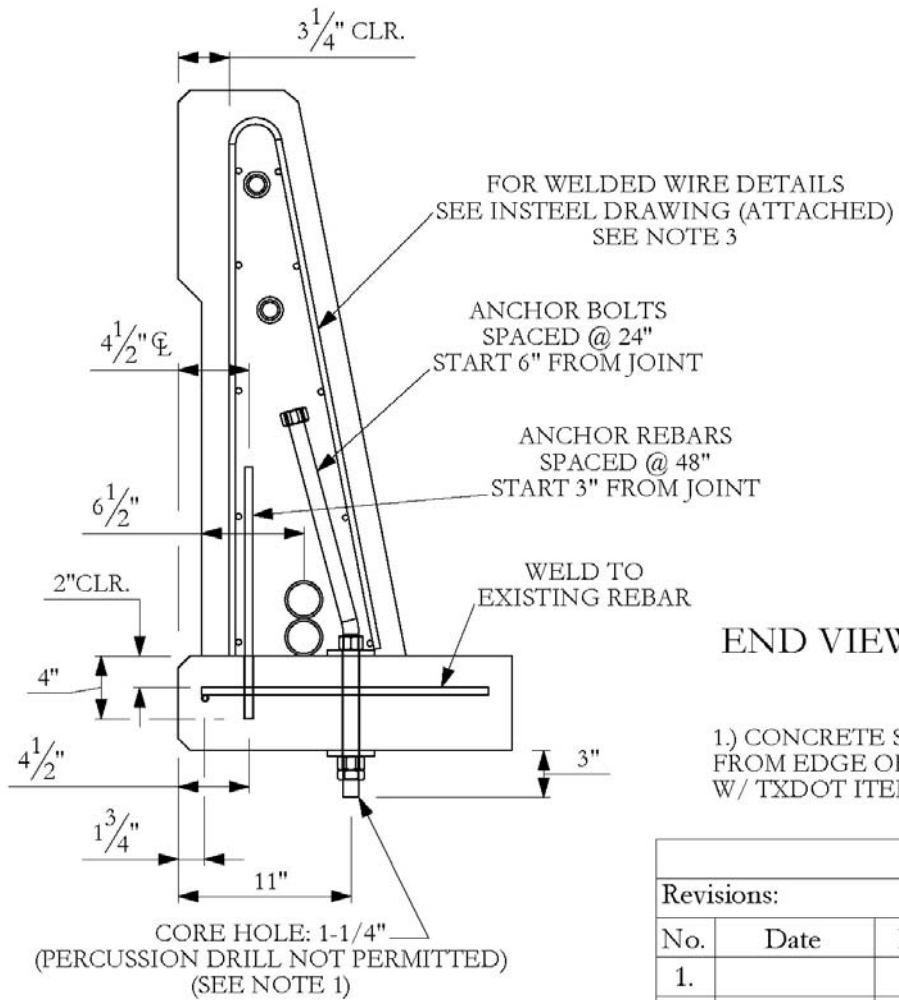
END VIEWS

1.) CONCRETE SPALLS IN BOTTOM OF DECK EXCEEDING 1/2" FROM EDGE OF HOLES SHALL BE PATCHED ACCORDING W/ TXDOT ITEM 429 CONCRETE STRUCTURE REPAIR

- 2.) ALL REBAR 1- 1/2" CLR. UNLESS OTHERWISE NOTED.
- 3.) WELDED WIRE SHALL MEET THE REQUIREMENTS OF ASTM A496 MATERIAL WITH A MINIMUM YIELD OF 70 KSI AND WELDED IN ACCORDANCE WITH ASTM A497 SPECIFICATIONS.

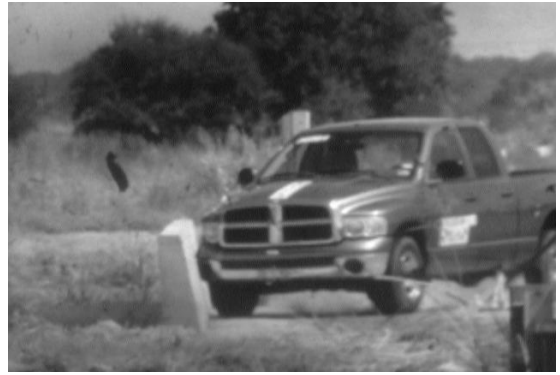
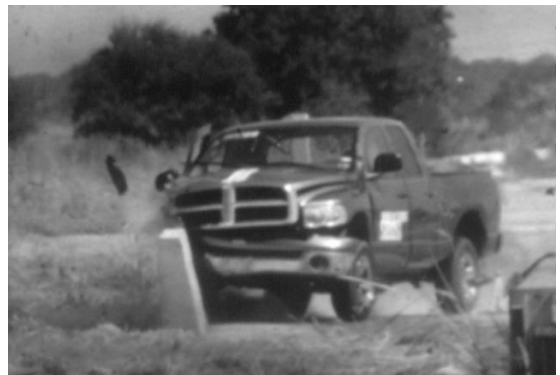
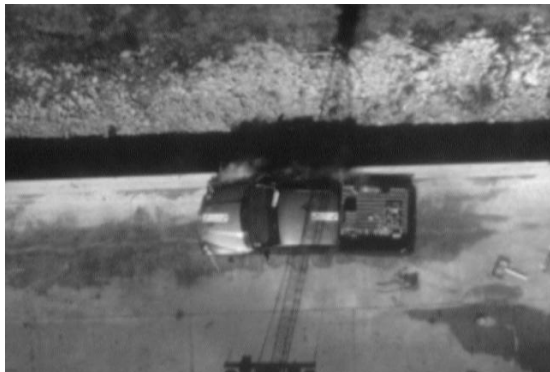
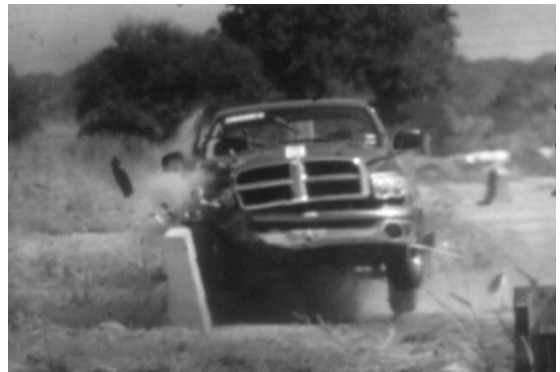
**Figure D1. Sequential Photographs for Test No. 420020-3  
(Overhead and Frontal Views).**

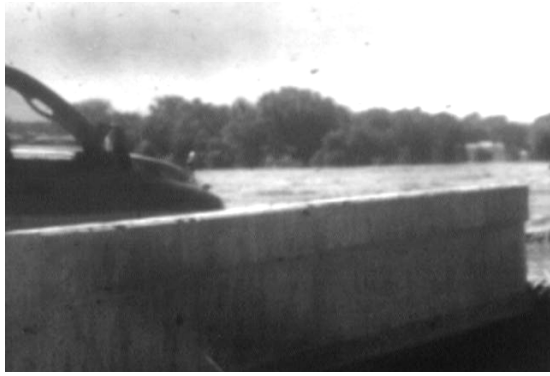
**Figure D2. Sequential Photographs for Test No. 420020-3 (Rear View).**

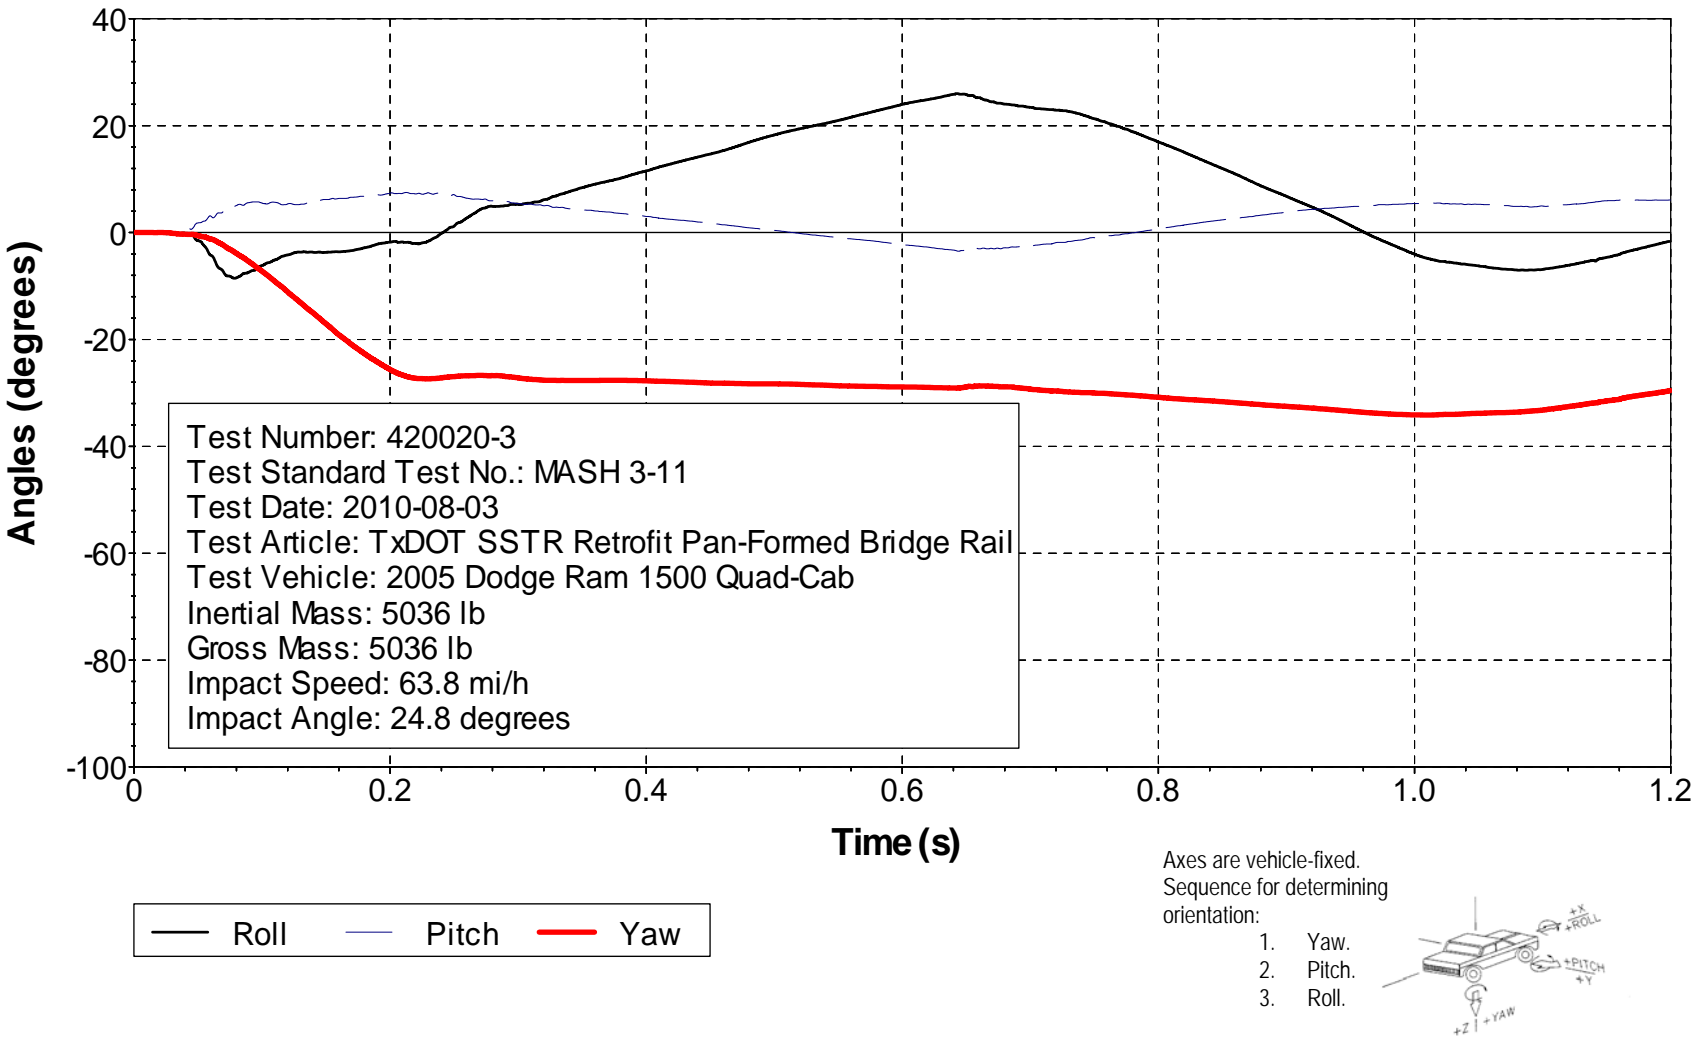
Figure E1. Vehicle Angular Displacements for Test No. 420020-3.

TRAP uses the data from the yaw, pitch, and roll rate transducers to compute angular displacement in degrees at 0.0001-s intervals and then plots yaw, pitch, and roll versus time. These displacements are in reference to the vehicle-fixed coordinate system with the initial position and orientation of the vehicle-fixed coordinate systems being initial impact.

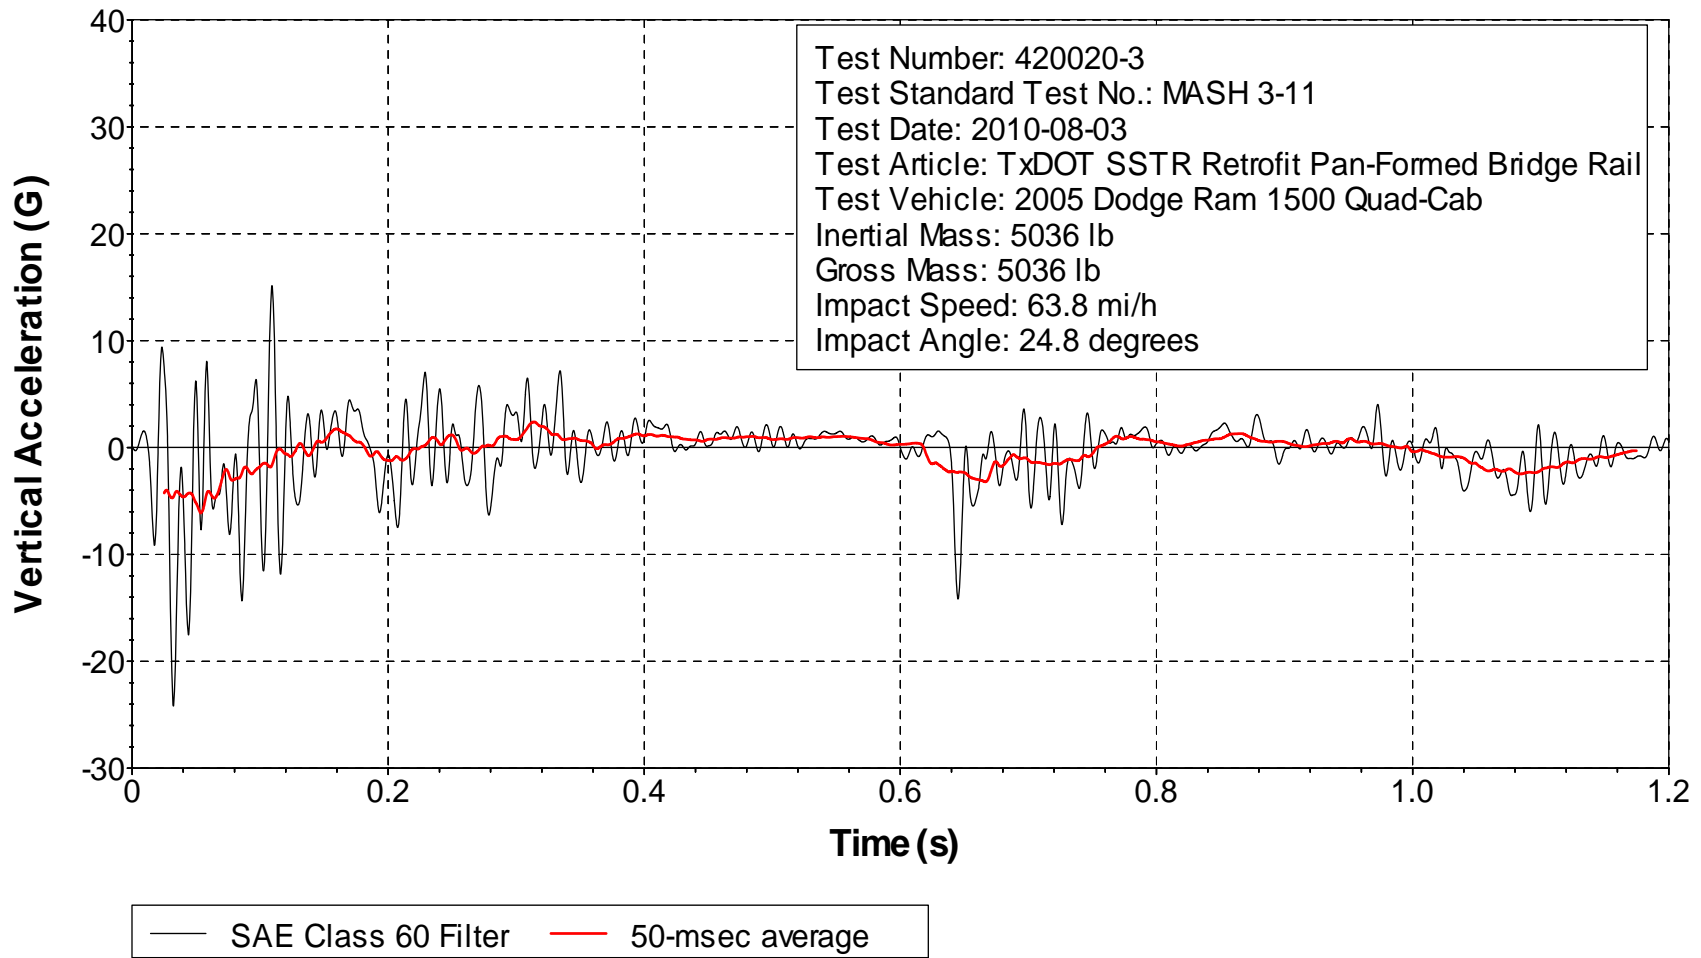
**Figure E4. Vehicle Vertical Accelerometer Trace for Test No. 420020-3  
(Accelerometer Located at Center of Gravity).**
