I-55 OGFC FIELD PERMEABILITY TESTING

REPORT NO.
FHWA/MS-RD-09-201
CMRC-09-4

Prepared by
Dr. Thomas D. White
and
Joe Ivy

Department of Civil and
Environmental Engineering
Mississippi State University
Construction Materials Research
Center

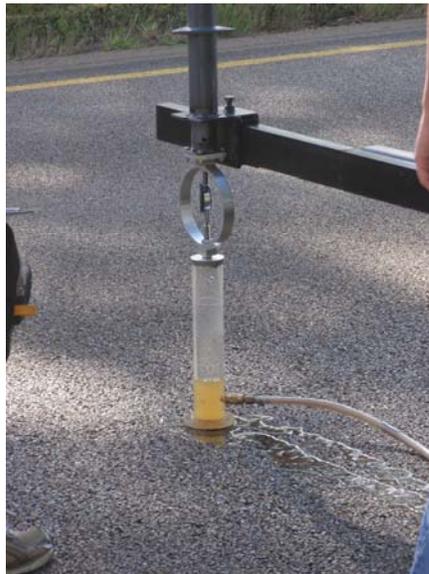
Figure 2 OGC Falling Head Permeability Test

The study recommended the falling head device developed by White (1975) for both laboratory and field permeability testing of OGFC/PFC pavement surfaces. This is the device fabricated to evaluate permeability of the I-55 OGFC test section. A view of the falling head device being used for current in situ permeability measurements is shown in Figure 2. The standpipe dimensions are shown in Figure 3. The rubber gasket used on

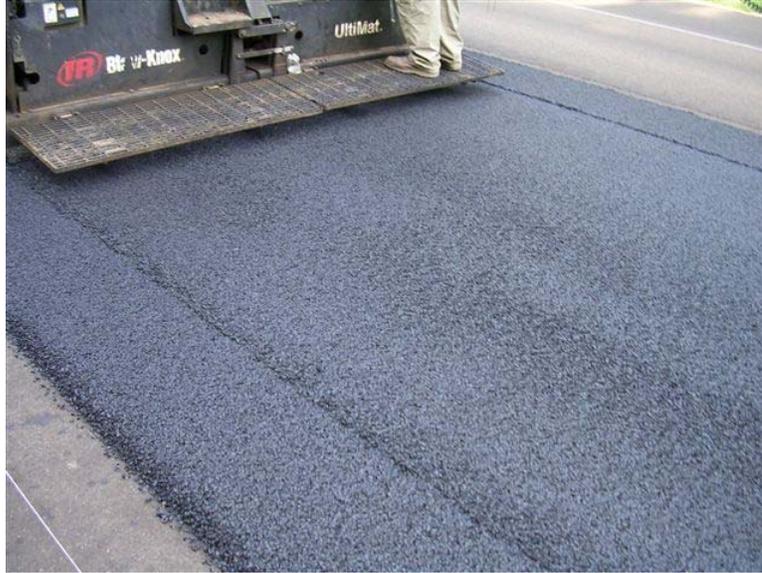
Figures 4, 5 and 6 show views during OGFC construction. In Figure 4, there appears to be a anomaly in the OGFC surface at the junctures of the laydown machine screed and the screed extensions. This anomaly exists on both sides of the lane. The anomalies are still visible after one pass of the roller in Figure 5 but are hard to discern in Figure 6 after rolling is complete. This type of anomaly in any type of HMA construction will manifest itself with time.

Figure 4 OGFC Laydown (After MDOT)

The current research project results are positive in that it has been shown OGFC can be successfully designed using local Mississippi aggregates and polymer modified asphalt. In service, the resulting OGFC can carry significant traffic while maintaining an adequate level of in situ permeability. The OGFC did not exhibit loss of aggregate through surface raveling or significant spalling along cracks generated at the juncture of the laydown machine screed and screed extensions during construction.

It is recommended that MDOT and industry address the issue of the laydown machine screed and screed extension junctures to alleviate the longitudinal cracking in OGFC. There may be a benefit to dense HMA as well.

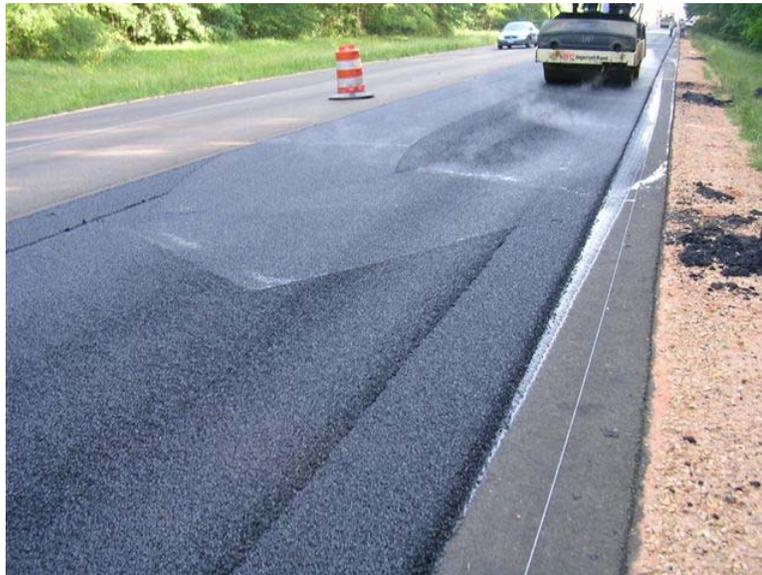
Figure 5 Rolling OGFC (After MDOT)

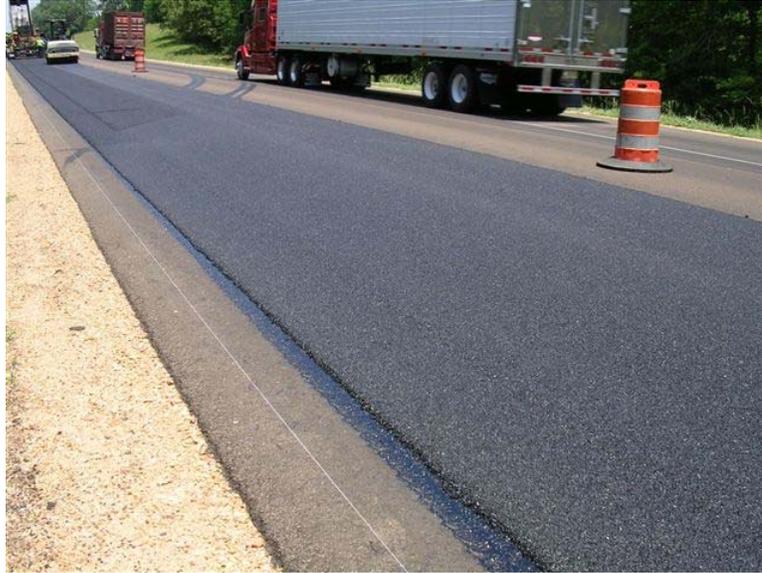
Figure 6 After Rolling (After MDOT)

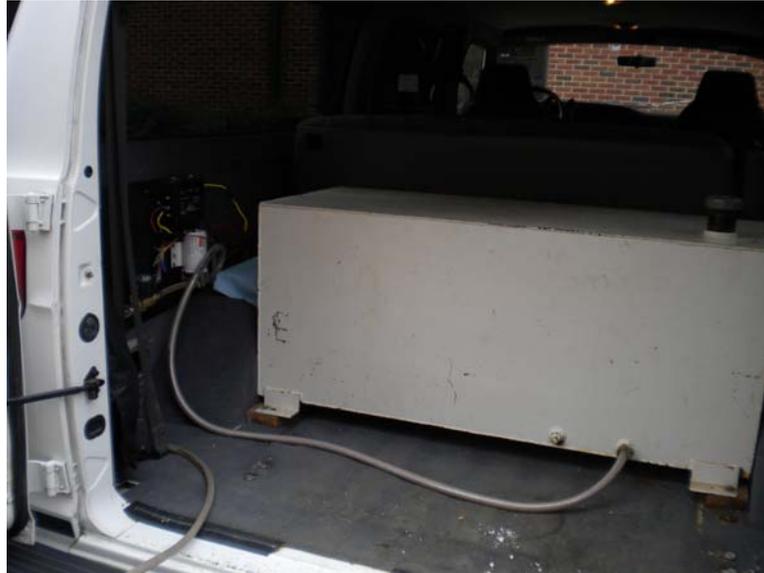
Figure 7 Water Tank

The water supply system includes an 80 gallon water tank, 5gpm pump, solenoid valve, and wireless receiver. Figure 7 shows the water tank and controls mounted in the rear of a van used for field testing. The 80 gallons of water was adequate for about three to four hours of testing. The tank was fabricated from steel and tended to rust internally which affected the appearance of water during the permeability test. Recommendations are that a plastic tank be used instead of the steel tank. Pump and controls are shown in Figure 8. Turning the pump on and off to fill up the standpipe was accomplished with a wireless switch. A digital stopwatch was used to determine time for the water level to fall between timing marks.

Both the falling head permeability device and the redesigned vehicle mounted reaction frame worked well. It is recommended a plastic tank be used in lieu of the steel tank because of the steel tank rusting. Extensions on the frame allow permeability tests to be conducted across a full lane width. Detail drawings of the frame are provided in an

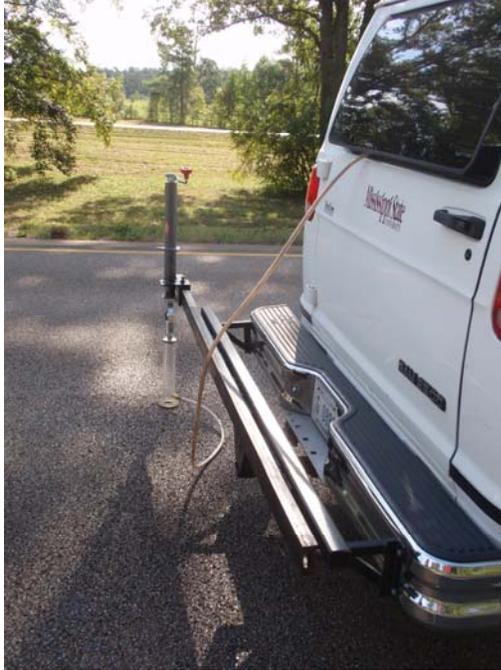
Figure 9 General View of Apparatus with Extension toward Pavement Centerline

The reaction frame mounted on the rear bumper is shown in Figure 9. Other components of the field apparatus in addition to the standpipe include a compression load ring and an integral bracket and jack. The frame is designed with extensions on each end and such that the bracket can slide from one end to the other. Details on the frame and fixtures are in drawings in Appendix A. Figures 10 and 11 show additional views of the apparatus and testing. Rust in the water is obvious.

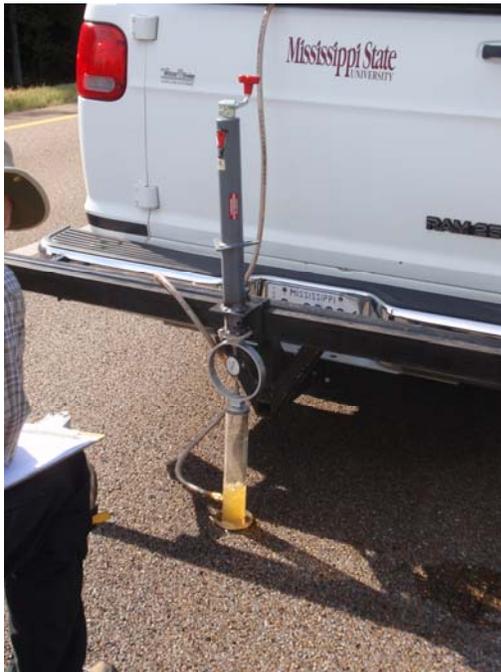
Figure 10 Testing on Outside Lane, Between Wheel Path

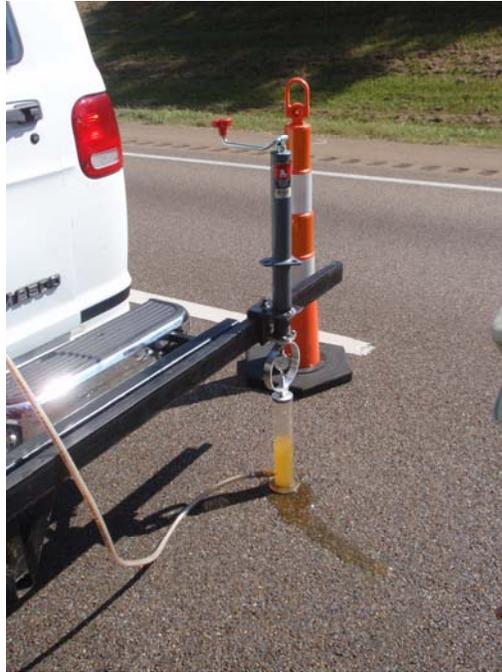
Figure 11 Test on Inside Lane, Inside Wheel Path

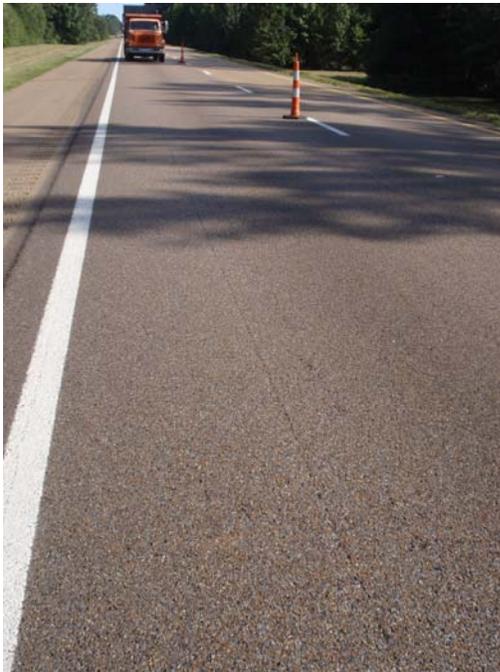
Figure 12 General Surface Condition and Longitudinal Crack Relative to Shoulder

After two and one-half years the OGFC on I-55 South is performing well. There is no general raveling of the surface or in wheel paths. Figures 12 and 13 show representative surface conditions. Occasional marks are noted from something scarring the surface such as a piece of equipment or vehicle. There is no evidence of excess asphalt from high asphalt content, segregation or drain down. The longitudinal anomalies (cracks) discussed relative to Figures 4, 5 and 6 are clearly visible in Figures 12 and 13. This crack exists on both sides of the lane. Crack severity varies and is shown in a more pronounced state in Figure 14. There is limited spalling and raveling along the crack. The polymer modified asphalt is beneficial in this regard. In Figure 12 there is a pattern parallel and about 8 inches from the longitudinal crack toward the pavement centerline that may be the effect of early traffic picking up some of the surface or a crack developing. The OGFC surface is performing well during inclement weather. Figure 15, obtained from MDOT, shows the transition from the OGFC surface to a dense HMA surface.

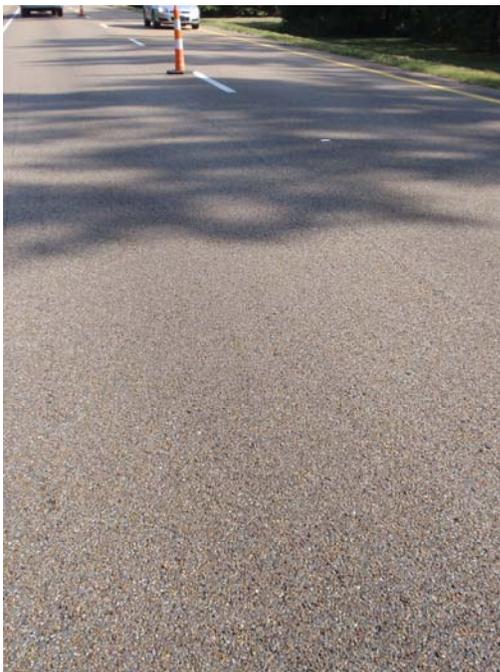
Figure 13 General Surface Condition and Longitudinal Crack Relative to Pavement Centerline

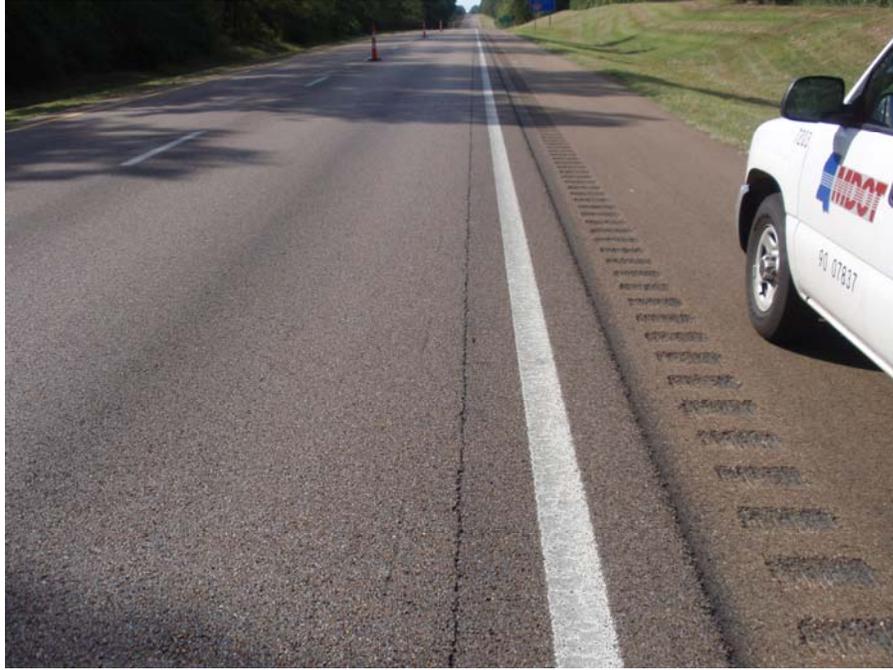
Figure 14 Severe Longitudinal Crack

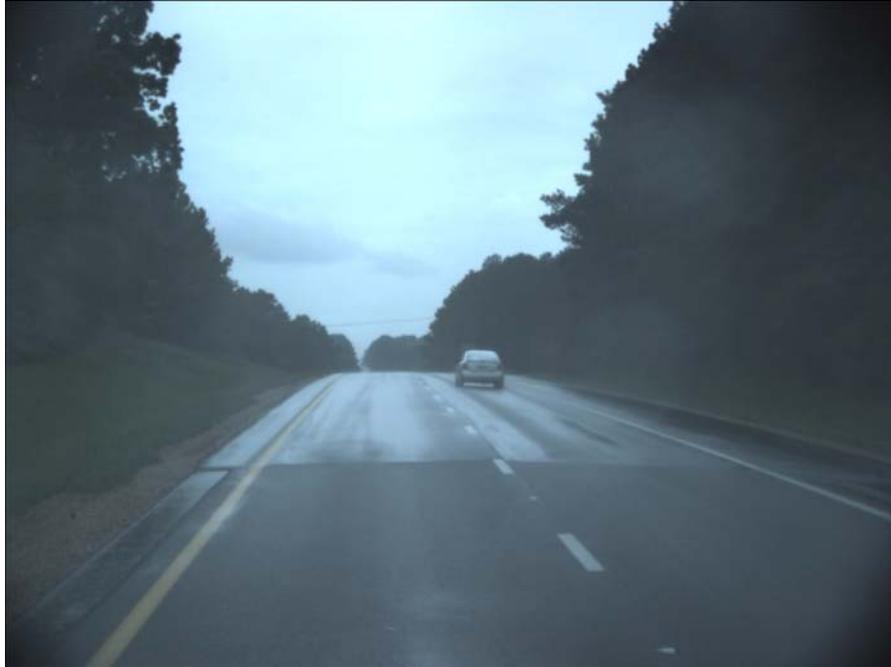
Figure 15 Transition From OGFC to Dense HMA During Rain Event (After MDOT)
