## Chip and Scrub Seal Field Test Results for Hwy 17 and Hwy 35

Final Report

FHWA/MS-DOT-RD-09-202-Vol II

Isaac L. Howard, PhD-Mississippi  
State University

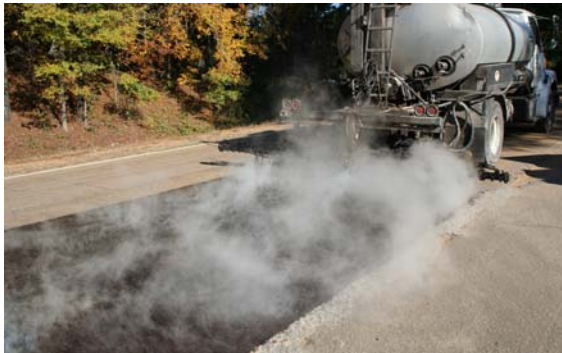
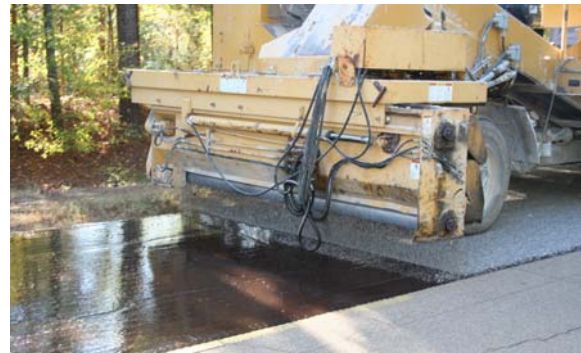
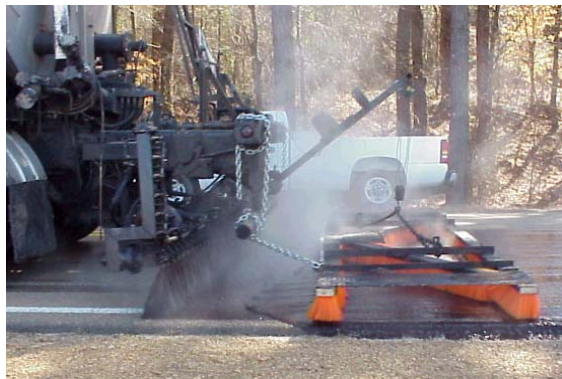
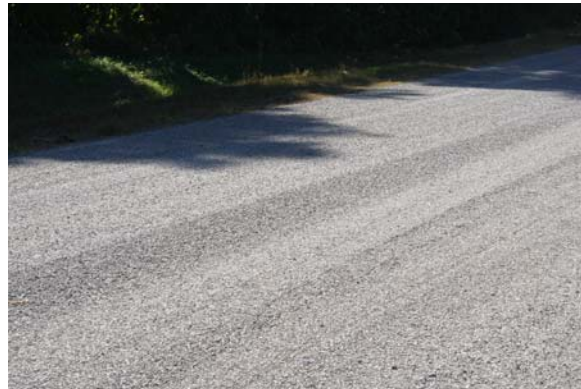
**Figure 1.1. Photos of Chip and Scrub Seal Treatments**

(a) Chip Seal Emulsion Application-Hwy 17

(b) Covering Emulsion w/ Aggregate-Hwy 17

(c) Scrub Seal Emulsion Application-Hwy 35

(d) Chip or Scrub Seal Completed-Hwy 17

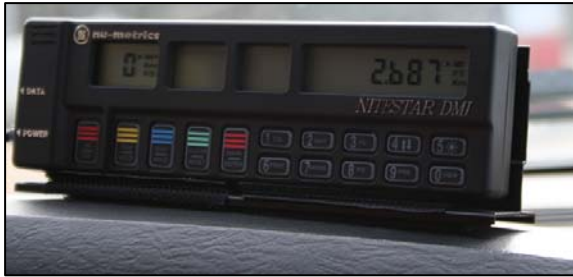
(a) Distance Measuring Instrument

The pavement was marked for coring, *FWD* testing, aggregate retention, and visual assessment. An example is shown in Figure 3.1(b). All these parameters were not measured at every location. Figure 3.1(b) is one of the few coordinates where all were measured at the same location. The reference location was determined using vehicle equipped with the *DMI*. The rear hitch of the vehicle was aligned with the county line of reference, so that when the desired distance had been traveled, the research team could use the rear hitch as alignment and mark the reference location with a small mark using pavement chalk. This reference point marked the center of the aggregate retention test, and the center of the area of visual assessment. *FWD* testing was performed 1.22 m (4 ft) behind the reference point to ensure the spike driven for aggregate retention did not affect the test. It was behind the reference since deflection was measured in the direction away from the spike. Coring was performed 3.05 m (10 ft) in front of the reference point to allow the equipment to back into position and not disturb the aggregate retention, visual assessment, or *FWD* test locations.

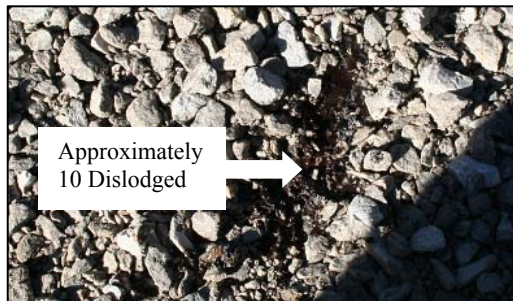
(a) Aggregate Dislodged by Hand

Traffic was allowed on the test section immediately (even prior to brooming), and it was apparent the emulsion was not set. Aggregate could easily be dislodged. The MSU research team could easily remove aggregate from the pavement as seen in Figure 3.3(a), and vehicles were noticeably stirring up aggregate as seen in Figure 3.3(b). Such early traffic opening could negatively affect the bond between the aggregate and emulsion.

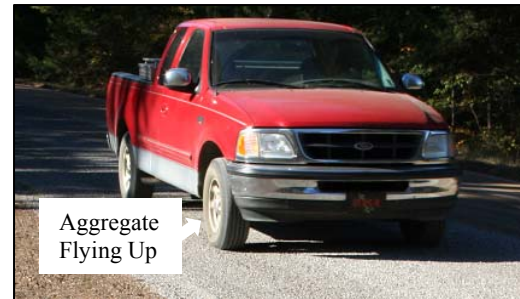
(b) Traffic Prior to Brooming

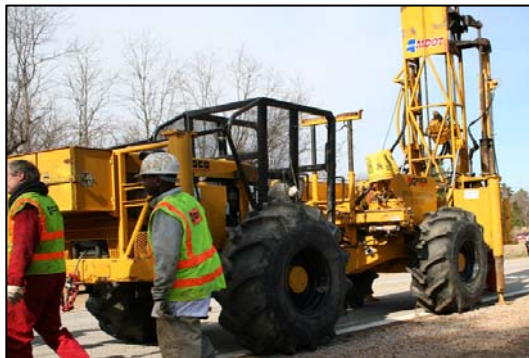
**Figure 3.4. Coring of Pavement for Determination of Thickness and Moisture Content**

The drill seen in Figure 3.4(a) was used to core the pavement prior to testing. Coring was performed in absence of water as seen in Figure 3.4(b) to simplify determination of subgrade moisture content. Subgrade moisture content can provide valuable data (both qualitative and quantitative) and pavement layer thicknesses were needed for *FWD* backcalculation. The interior of the cored hole was investigated to determine material type and asphalt thickness. The shavings of the asphalt layer were recovered for testing of overall binder properties (seal treatment had been fully applied at the time of coring).

(a) Drilling Equipment Used for Coring

(b) Coring Pavement Without Water

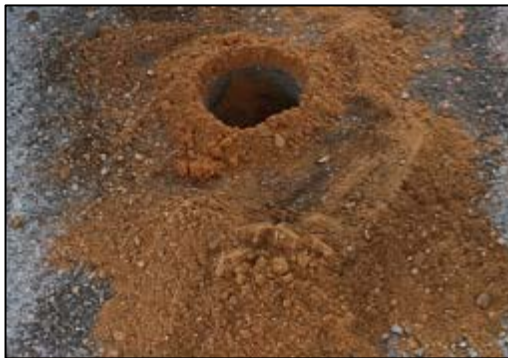
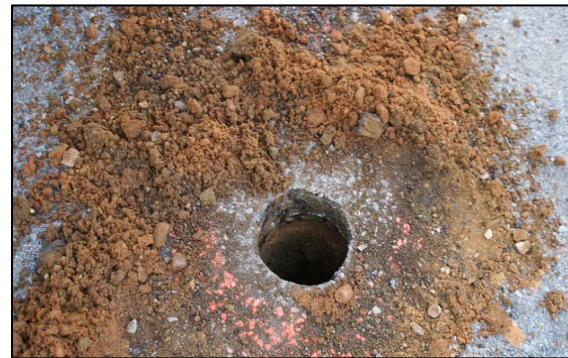
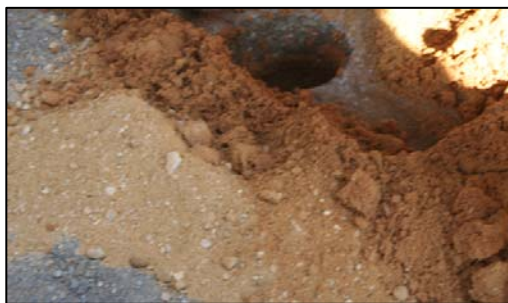
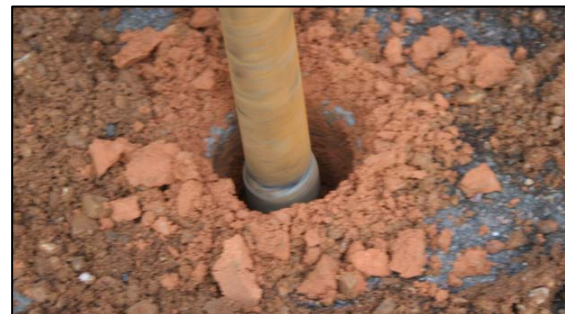
**Figure 3.5. Coring Photos Within Hwy 17 Highlighting Base/Subbase Materials**

(a) Core 1 at Coordinate 6.251N

(b) Core 2 at Coordinate 5.251N

(c) Core 3 at Coordinate 6.751S

(d) Core 4 at Coordinate 7.751S

Table 3.2 summarizes the pavement properties obtained from coring prior to testing. The asphalt thicknesses varied somewhat between locations. Figure 3.5 contains photos of each core to provide additional physical meaning to the descriptions of Table 3.2. Samples taken from each hole were combined and Atterberg Limit testing performed for the material

3: Core 4 was noticeably different than the other cores

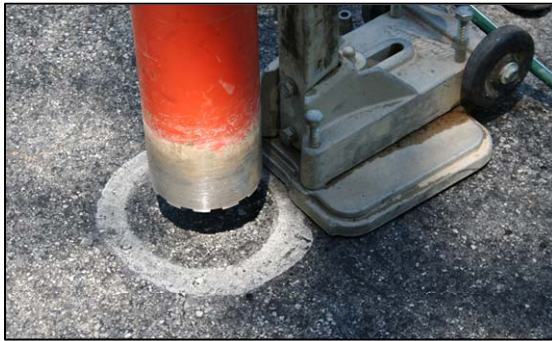
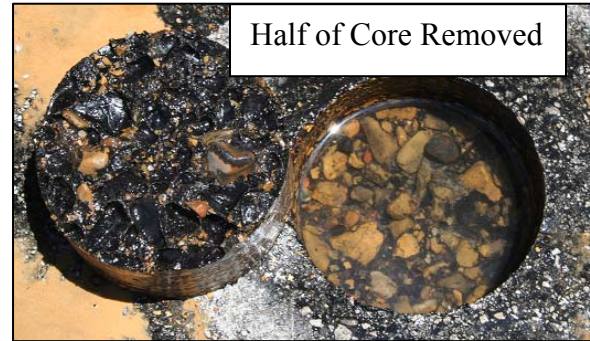
**Figure 3.7. Coring of Hwy 17 After Test Phases**

provide thickness repeatability measurements. The results of coring are provided in Table 3.4. Note that five of the twelve locations had stripped significantly (Figure 3.7b) and that the core at coordinate 7.251 had a crack through the core.

(a) Coring of FWD Test Location

(b) Example of Stripped Core

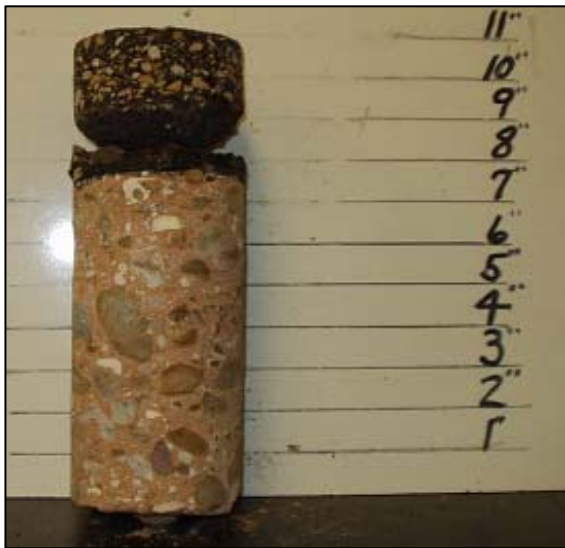
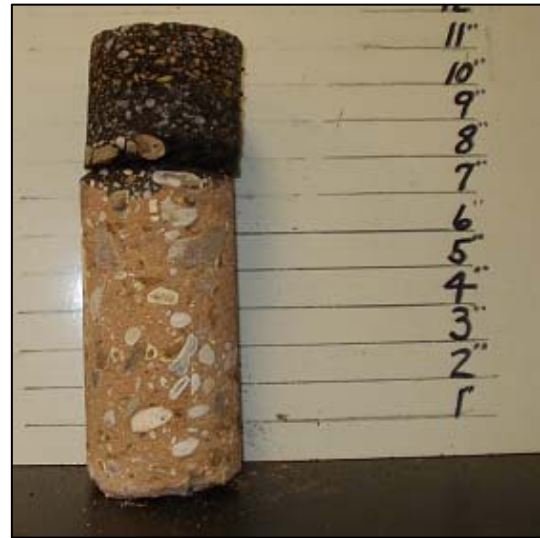
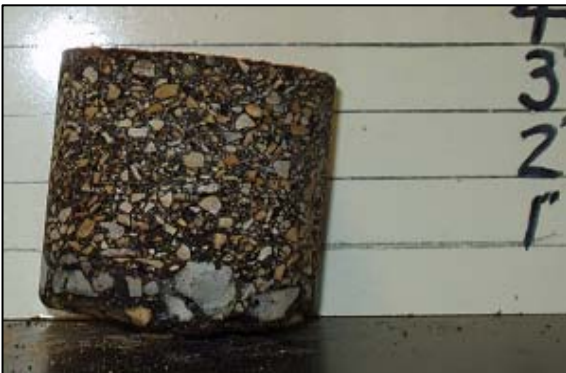
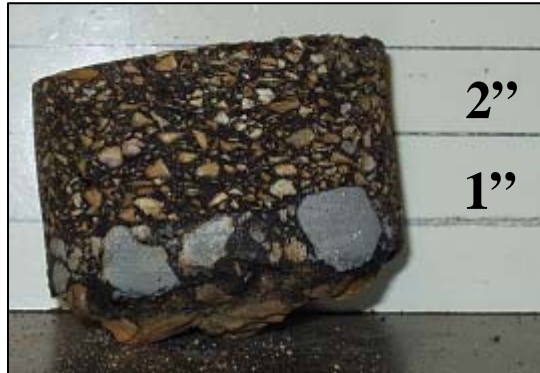
**Figure 3.9. Coring Photos of Hwy 35**

Coring was performed in sections 3 and 4 prior to the 2005 scrub seal construction. Table 3.5 summarizes the locations of the cores. Figure 3.9 provides photos of the cores and estimates of layer thickness.

(a) Hwy 35 Core 1

(b) Hwy 35 Core 2

(c) Hwy 35 Core 3

(d) Hwy 35 Core 4

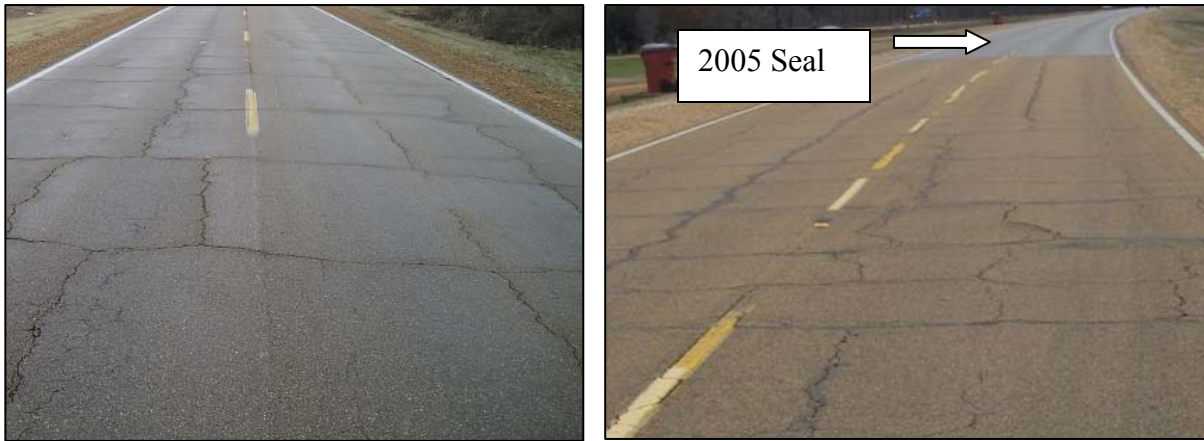
(a) Two Months Prior to 2005 Seal

(b) Ten Months Prior to 2007 Seal

consisted of 5.08 cm (2 in) of asphalt concrete. A condition survey performed on 11/16/05 resulted in: *PCR* of 77, *IRI* of 1.30 mm/m (82.37 in/mi), and Rut depth of 6.1 mm (0.24 in). Original construction of coordinates 19.273 to 23.465 was in January of 1965 and contained 35.6 cm (14 in) of base/subbase and 2.54 cm (1 in) of double bituminous surface treatment. An overlay was placed in December of 1983 that consisted of 5.08 cm (2 in) of asphalt concrete. A condition survey performed on 11/16/05 resulted in: *PCR* of 63, *IRI* of 1.76 mm/m (111.5 in/mi), and Rut depth of 3.3 mm (0.13 in). Figure 3.10 provides photos taken by MDOT at discrete intervals prior to sealing activities.

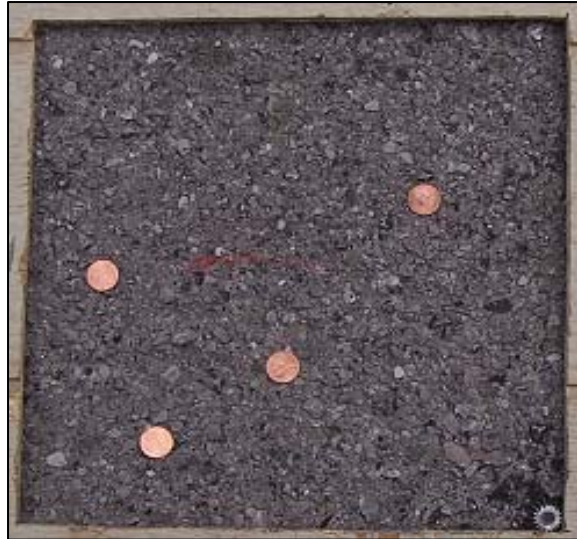
**Figure 3.11. Aggregate Retention Testing**

A piece of clear Plexiglas was placed over the hole and a transparency with a printed grid with horizontal and vertical spacing of 1.27 cm (0.5 in), or 256 squares, was subsequently placed onto the Plexiglas (the same transparency was used between phases). Some testing did not make use of the Plexiglas or the wooden board, but at least one of these items was present for all testing. The areas where aggregate was lost in a given phase were colored onto the transparency with a permanent marker; a different color was used for each test phase on the same transparency. The operator colored 1/4, 1/2, 3/4, or the entire square.

(a) Original Method (Phase 1)

(b) Final Method (Phases 2 and 3)

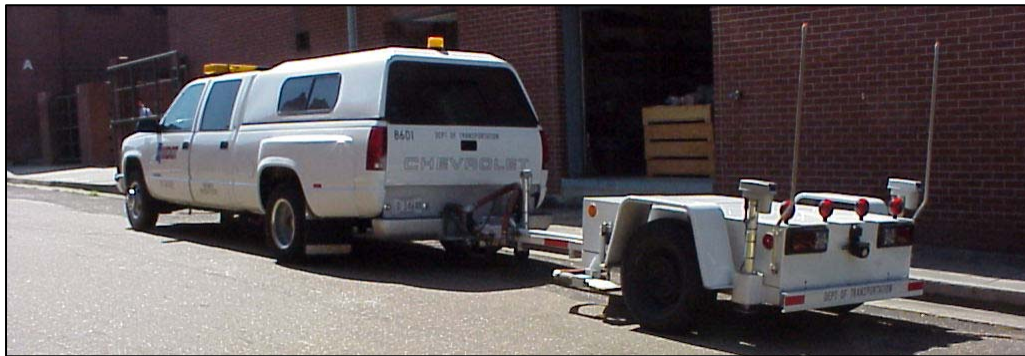
*Figure 3.12. Locked Wheel Skid Trailer*

Skid testing was performed on *Hwy 35* as per ASTM E 274-97. The test employs a locked wheel skid device pulled behind a truck. All testing was performed at 65 km/h (40 mph) and a ribbed tire was used making the test data SN(65)R. The test was conducted three times within each section. Skid testing was not performed at the same time as the test phases due to scheduling and other *MDOT* commitments for the equipment. *K.J. Law Engineers, Inc* manufactured the skid trailer model T1290, and Figure 3.12 is a photo of the device.

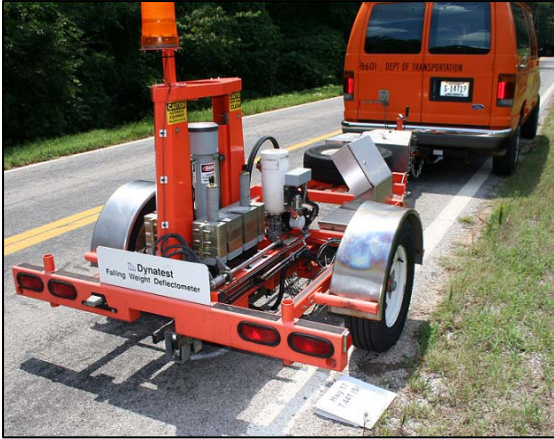
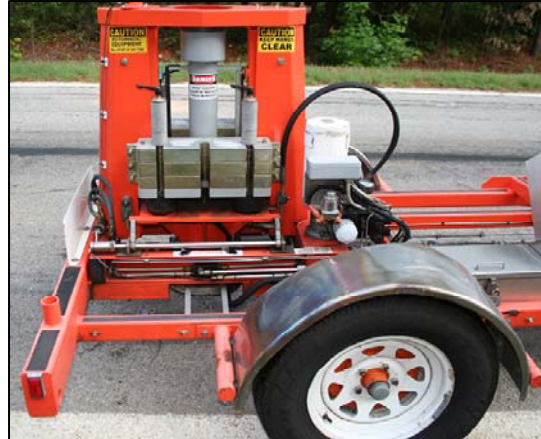
**Figure 3.13. Falling Weight Deflectometer Used for Testing**

The Falling Weight Deflectometer (*FWD*) used during testing was a *Dynatest® Model 8000*. Figure 3.13 contains photos of the device. The *FWD* works by dropping weights a known distance onto a cushioned load plate resting on the pavement to produce a desired impulse into the pavement. The force applied to the pavement is measured with a load cell and the stress is calculated using the known dimensions of the load plate.

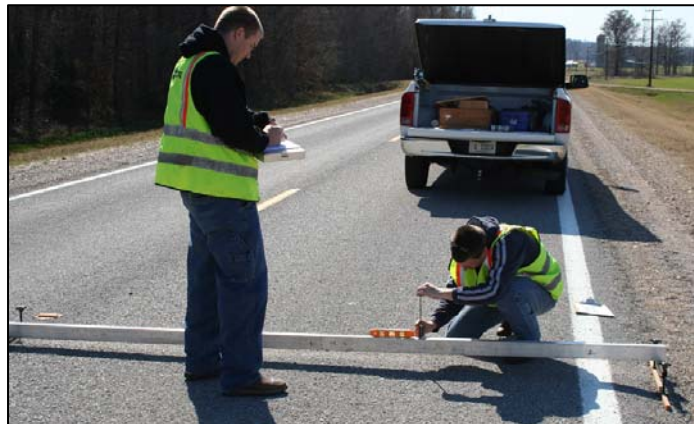
**Figure 3.14. Manual Rut Measurements**

Manual rut measurements were performed with a metal rut bar as shown in Figure 3.14. A rigid bar with lateral distance markers was leveled and a caliper was used to measure

to the pavement surface at twelve locations across the lane width. Some of the measurements were used for cross slope calculations and the remaining measurements were used to determine the rut depth profile of the lane. These measurements were performed only on *Hwy 35* to provide a baseline measurement for comparison to profiler data, as well as for general information regarding the test sections. Manual rut measurements were not performed on *Hwy 17* due to logistical and traffic control constraints.

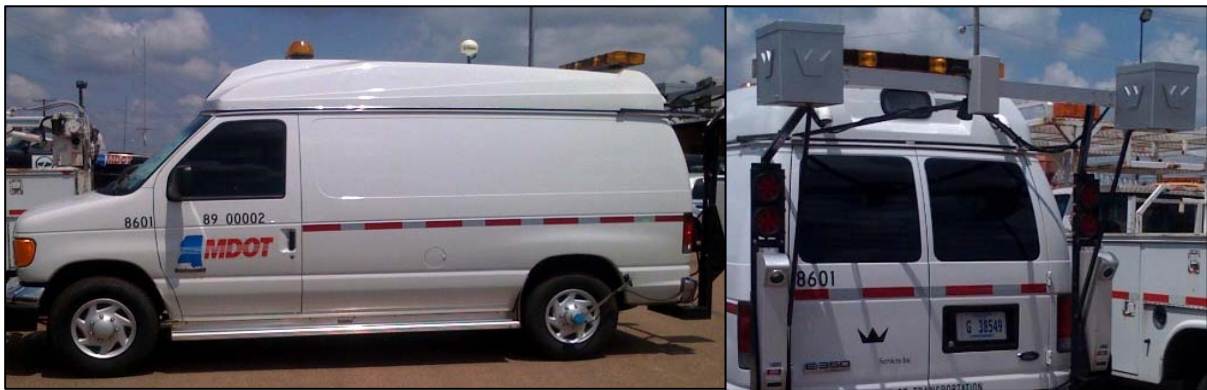
**Figure 3.16. Automated Data Collection Vehicle Used for Roadway Profiles**

A *Pathway Services Inc.* profiler was used to collect distress data under *Mississippi State Study 173* that was used in this project. A *PathRunner XP* model *LG-23* was used to collect the data. Data was collected in three phases. The data collection vehicle collects the necessary automated road survey data in one pass at normal highway speeds. The vehicle is equipped with cameras, lasers, accelerometers, distance measuring interfaces, global positioning system features, and electronic controls. Data collected for this project were: 1) rut depths (*Rut*), 2) International Roughness Index (*IRI*), 3) Fatigue cracking ( $C_F$ ) 4) longitudinal cracking ( $C_L$ ); 5) Transverse cracking ( $C_T$ ); and 6) Block cracking ( $C_B$ ). Photos of the *PathRunner XP* can be seen in Figure 3.16.

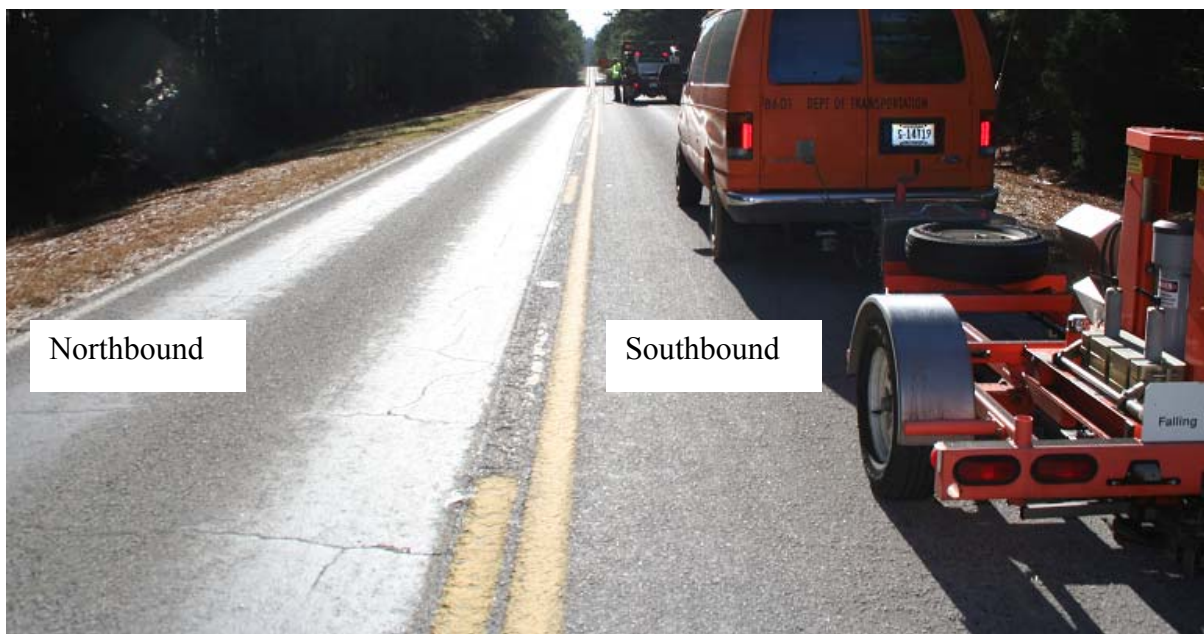
**Figure 4.1. Relative Differences in Hwy 17 Wheel Path Aggregate Coverage (Jan 2009)**

this behavior. Empty log trucks were frequently traveling southbound, were loaded, and traveled loaded on the northbound lane of the test section. No quantitative data was obtained

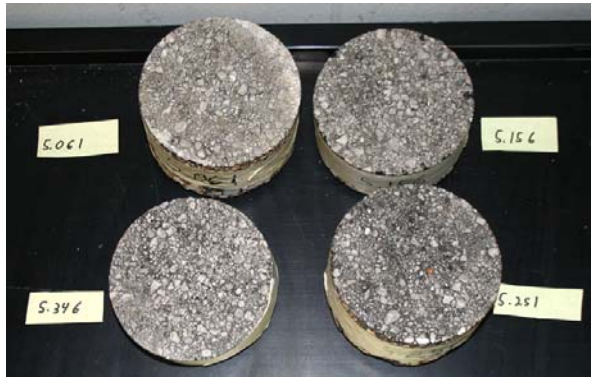
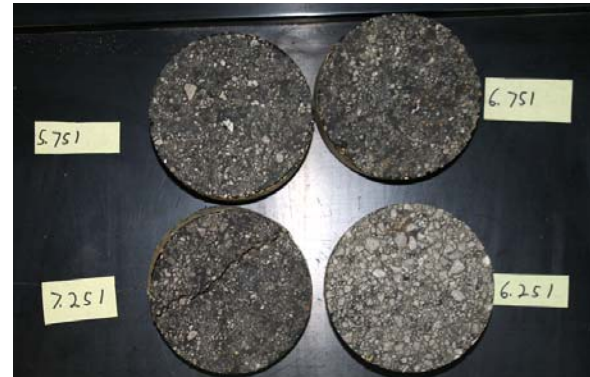
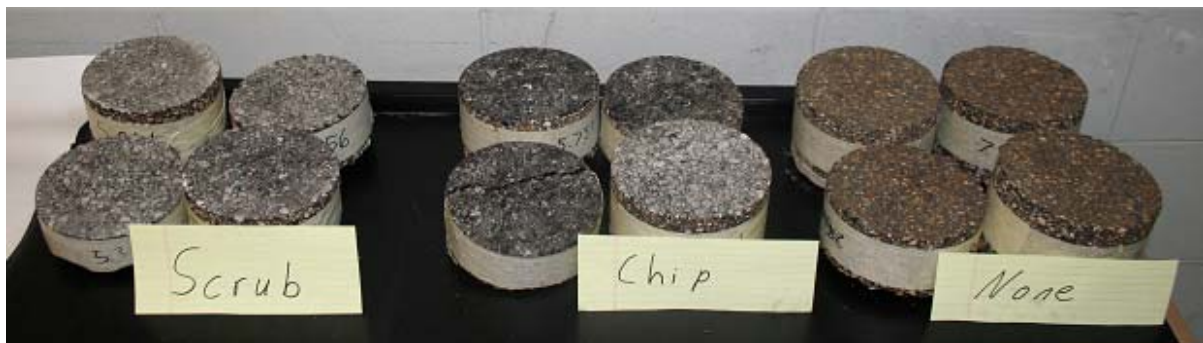
**Figure 4.4. Photos of Cores Taken From Northbound Hwy 17**

for effective evaluation. The average total aggregate loss of the two chip seal sections was 2.89%, while the average total aggregate loss of the four scrub seal sections was 3.45%. The slightly higher loss of aggregate from the scrub seal sections, though, should be considered in the context that all four scrub seal sections were able to be evaluated while only two of the six chip seal sections were able to be evaluated.

(a) Scrub Seal Cores

(b) Chip Seal Cores

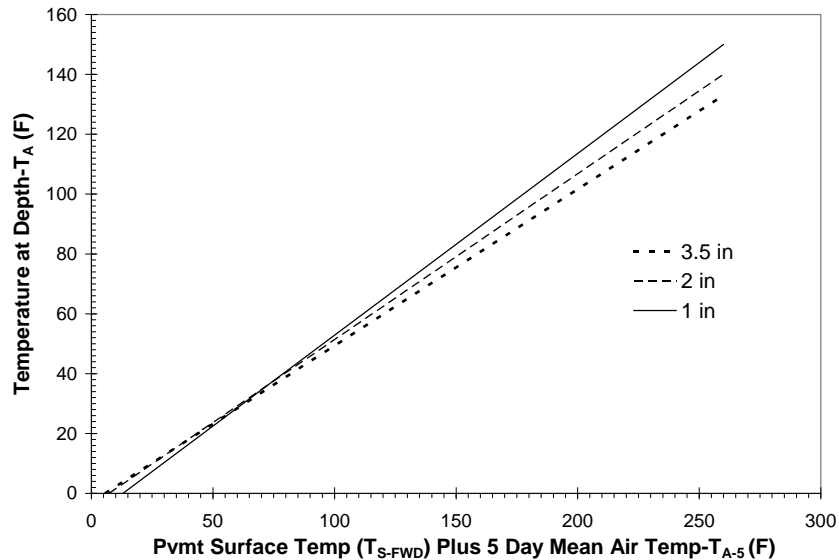
**Figure 4.9. *AASHTO* (1986) Temperature Predictions for Depths of Interest**

Two temperature correction methods were selected for the research: 1) Kim et al. (1995); and 2) *AASHTO* procedure. The approach of Kim et al. (1995) was selected since a similar binder grade and the same pavement thickness were included in both studies (See Section 2.6 for additional information). The *AASHTO* procedure was selected since it is familiar to many pavement engineers and at present is the nationally accepted method. Applicable data from the *AASHTO* (1986) procedure is re-produced in Figure 4.9 for depths near the top, near the middle, and at the bottom of *Hwy 17*.

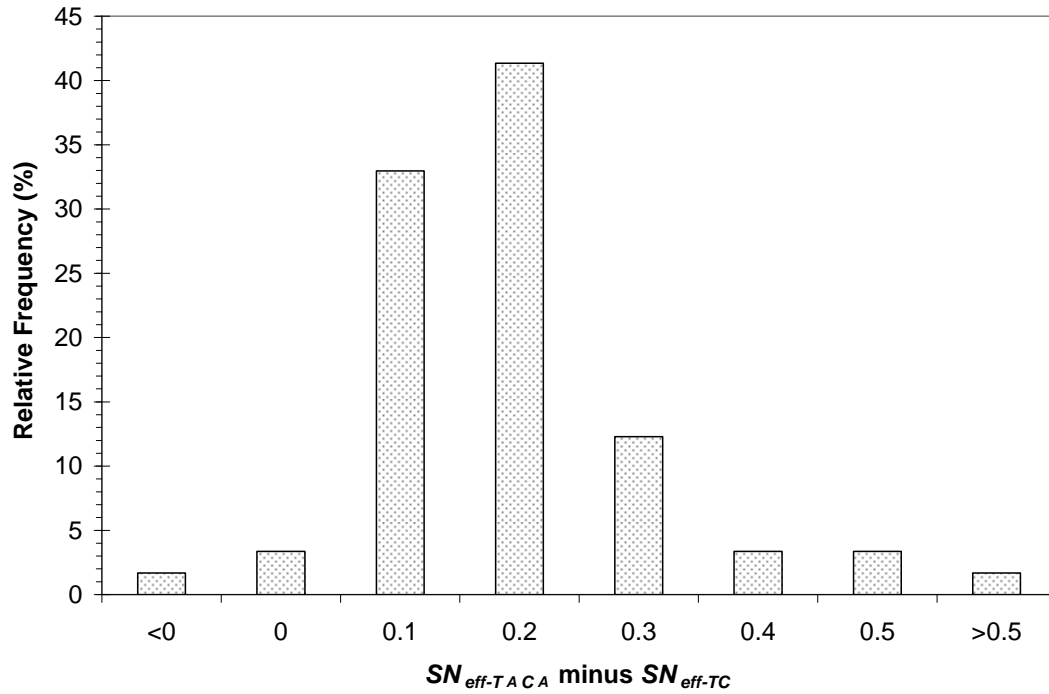
**Figure 4.14. Comparison of Effective Structural Capacity Calculation Methods**

Figure 4.14 compares the  $SN_{eff}$  values for the two different approaches (*TC* and *T<sub>A</sub>C<sub>A</sub>*). The *TC* approach generally calculated between 0.1 to 0.3 less units of structural capacity relative to the AASHTO approach (*T<sub>A</sub>C<sub>A</sub>*). Based on the estimated structural capacity of a pavement during design with the average layer thicknesses of the test section, lower  $SN_{eff}$  values appear to be more reasonable. The *TC* approach would be slightly favored by the author for the conditions encountered.

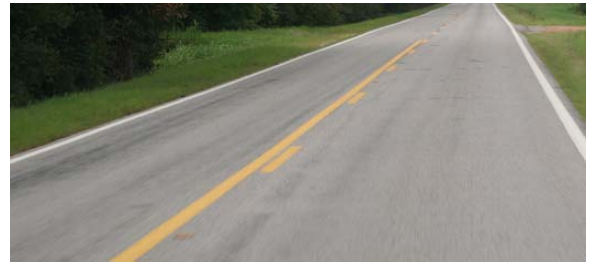
*(f) Photo 14 of 16*

**Figure A.10. Windshield Survey of Southern Half of Hwy 35 During Test Phase 2: Aug 08**

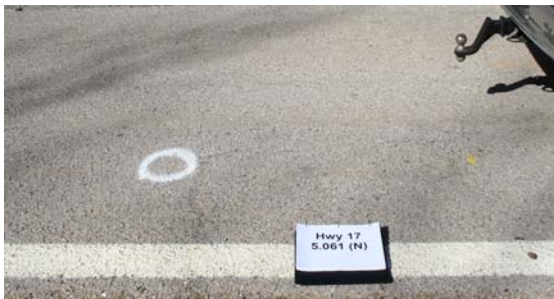
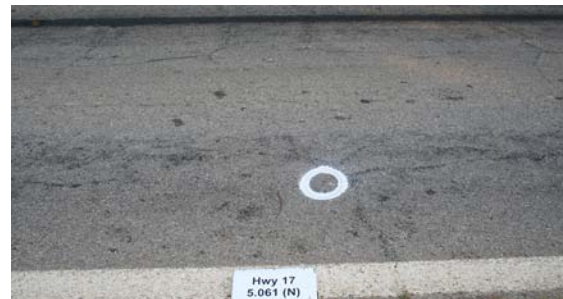
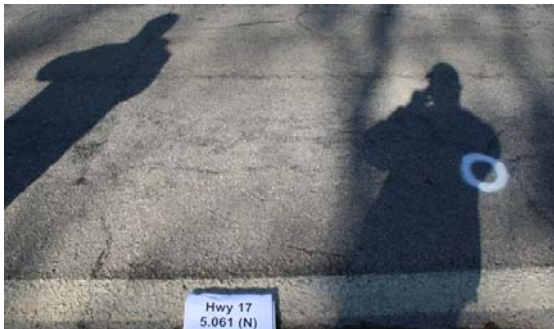
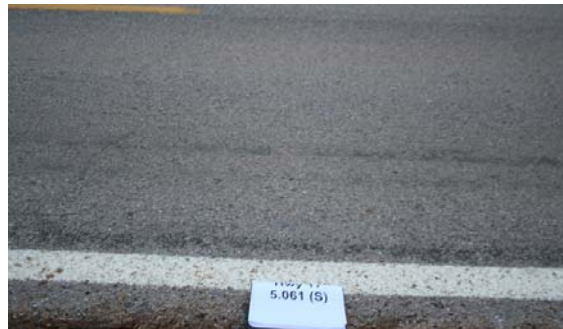
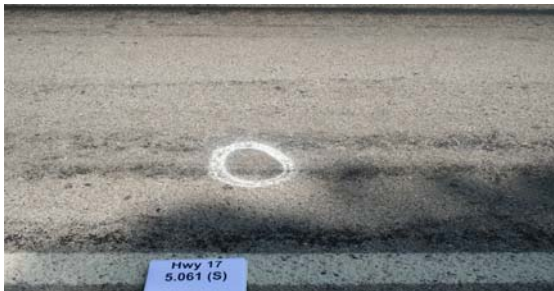
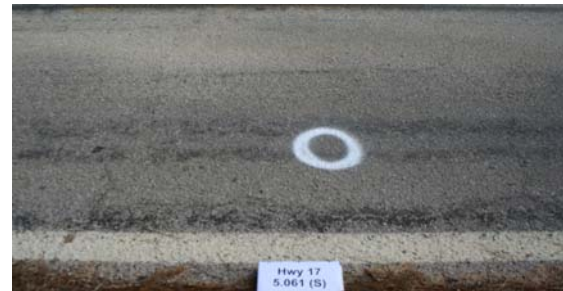
**Figure A.11. Visual Assessment Photos of Hwy 17 Coordinate 5.061**

A photo was taken at each test location during each test phase. These photos were taken to provide a visual representation of the pavement at test locations. The research team and MDOT personnel also performed distress surveys at these locations. The following figures show each test location over the duration of testing.

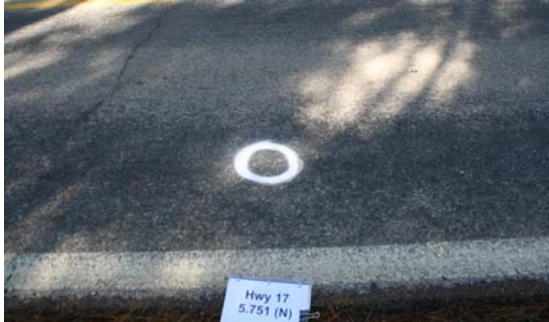
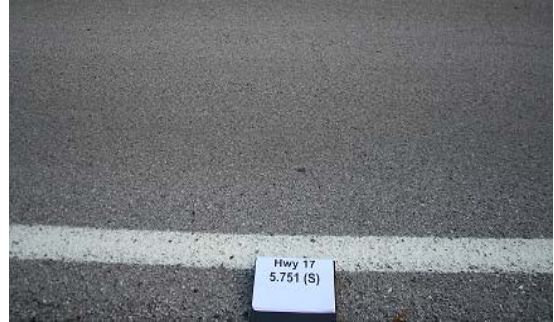
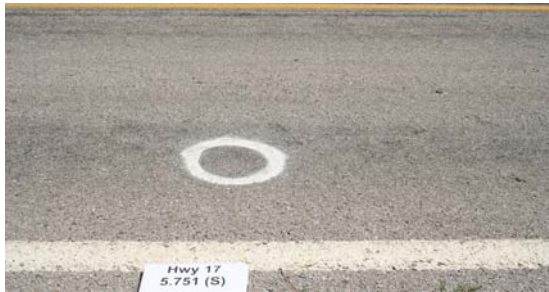
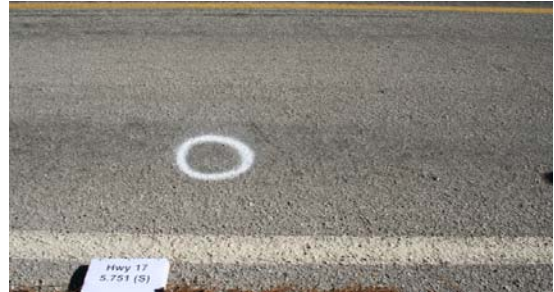
***Figure A.18. Visual Assessment Photos of Hwy 17 Coordinate 5.751***

*(c) Phase 3-Northbound-Jan 2009*

*(d) Phase 1-Southbound-Jan 2008*

*(e) Phase 2-Southbound-Aug 2008*

*(f) Phase 3-Southbound-Jan 2009*

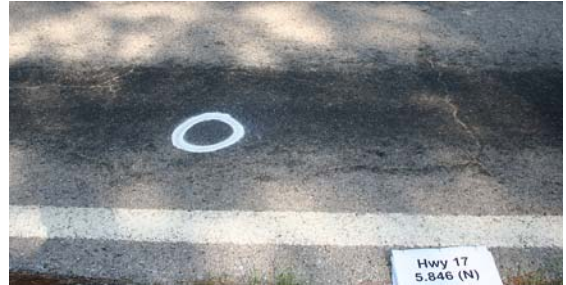
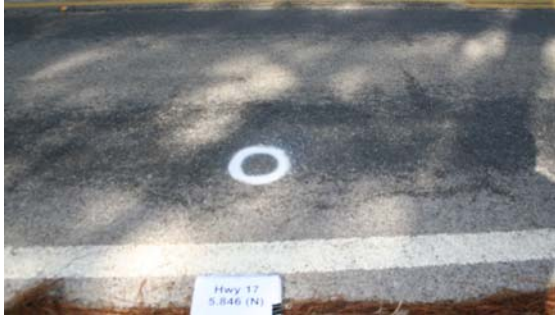
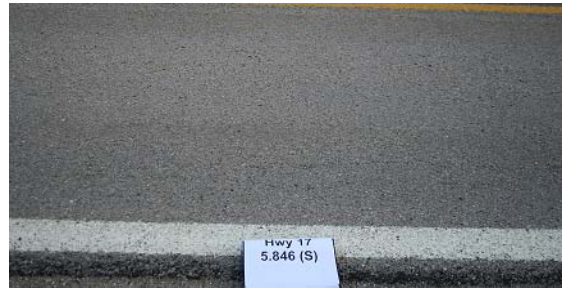
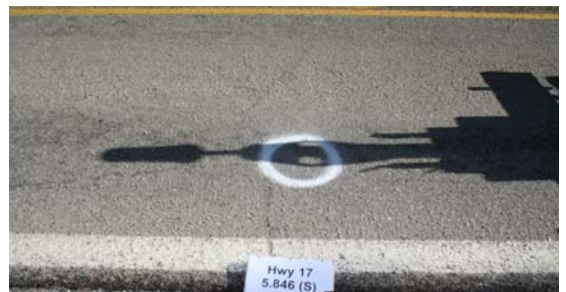
***Figure A.19 Visual Assessment Photos of Hwy 17 Coordinate 5.846***

*(b) Phase 2-Northbound-Aug 2008*

*(c) Phase 3-Northbound-Jan 2009*

*(d) Phase 1-Southbound-Jan 2008*

*(f) Phase 3-Southbound-Jan 2009*

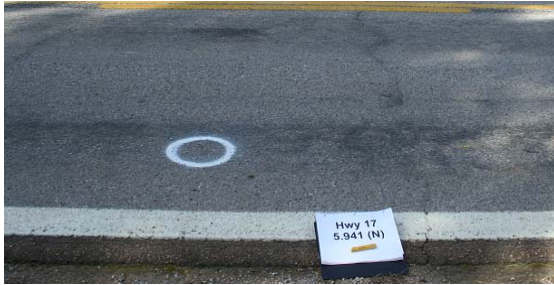
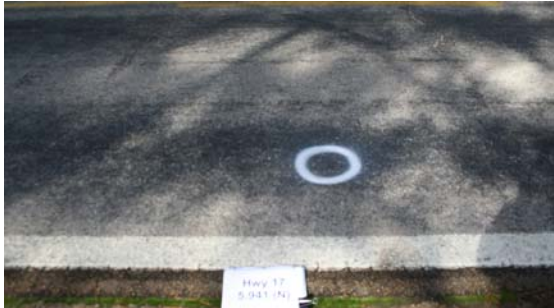
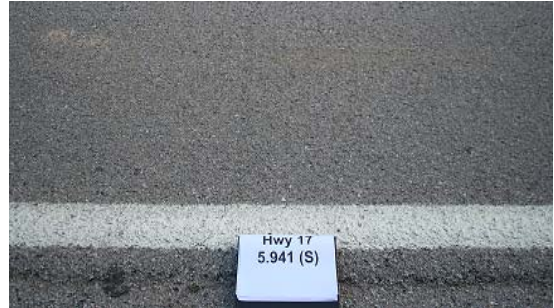
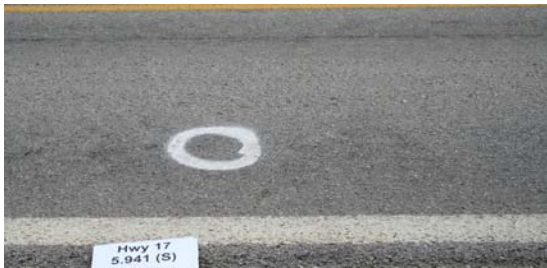
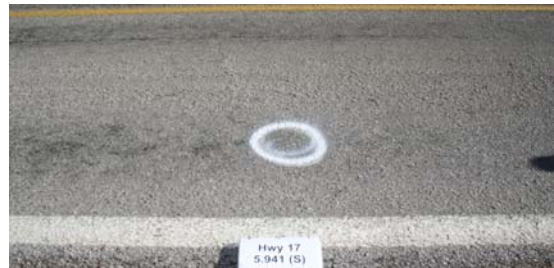
***Figure A.20. Visual Assessment Photos of Hwy 17 Coordinate 5.941***

*(a) Phase 1-Northbound-Jan 2008*

*(c) Phase 3-Northbound-Jan 2009*

*(d) Phase 1-Southbound-Jan 2008*

*(e) Phase 2-Southbound-Aug 2008*

*(f) Phase 3-Southbound-Jan 2009*

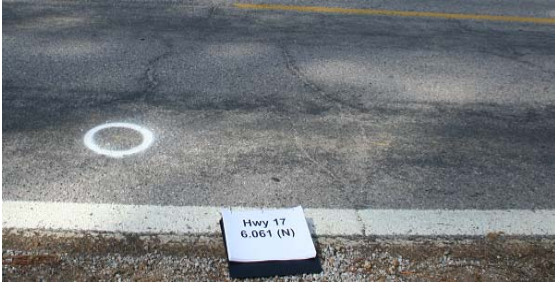
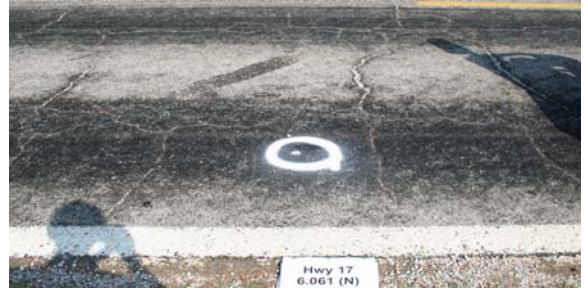
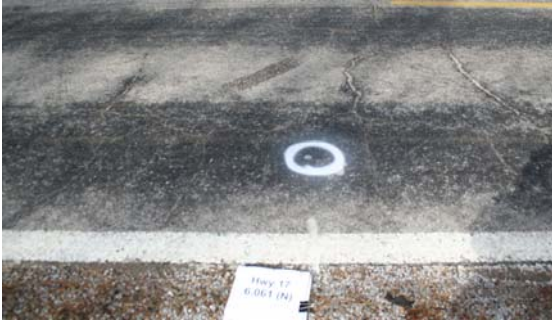
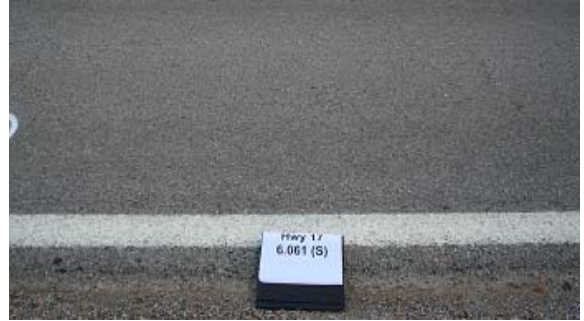
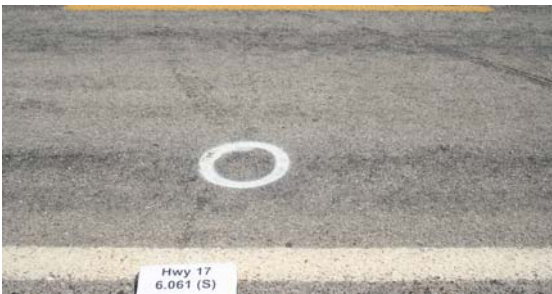
***Figure A.21. Visual Assessment Photos of Hwy 17 Coordinate 6.061***

*(a) Phase 1-Northbound-Jan 2008*

*(b) Phase 2-Northbound-Aug 2008*

*(c) Phase 3-Northbound-Jan 2009*

*(d) Phase 1-Southbound-Jan 2008*

*(e) Phase 2-Southbound-Aug 2008*

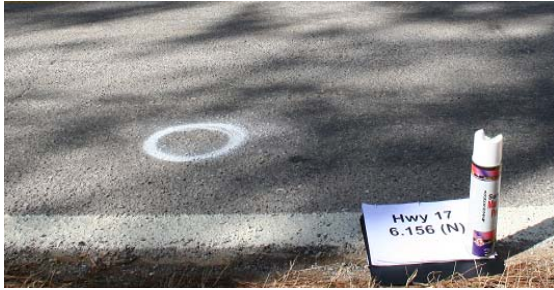
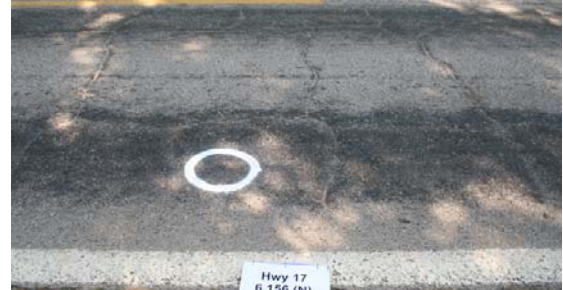
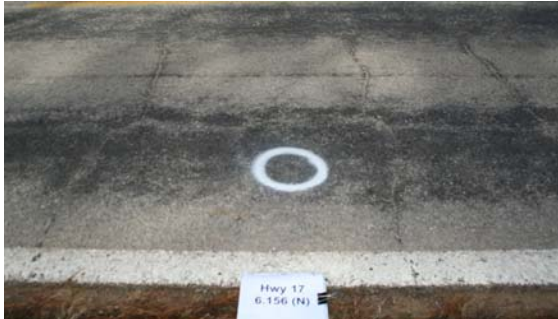
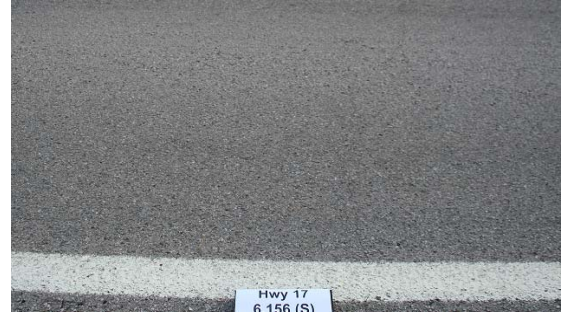
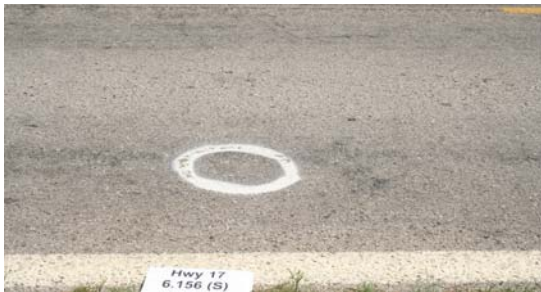
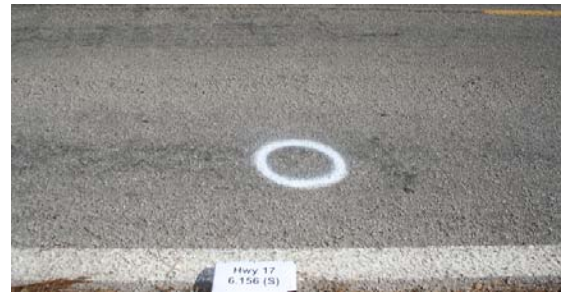
**Figure A.22. Visual Assessment Photos of Hwy 17 Coordinate 6.156**

*(a) Phase 1-Northbound-Jan 2008*

*(b) Phase 2-Northbound-Aug 2008*

*(c) Phase 3-Northbound-Jan 2009*

*(d) Phase 1-Southbound-Jan 2008*

*(e) Phase 2-Southbound-Aug 2008*

*(f) Phase 3-Southbound-Jan 2009*

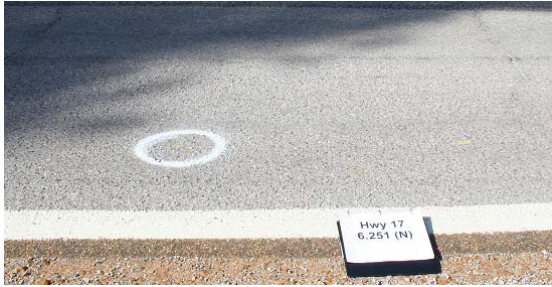
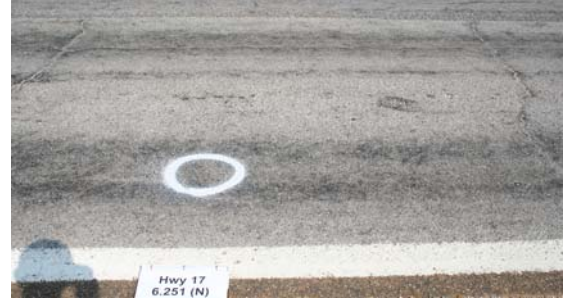
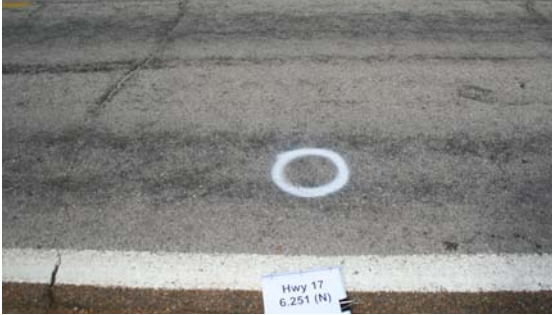
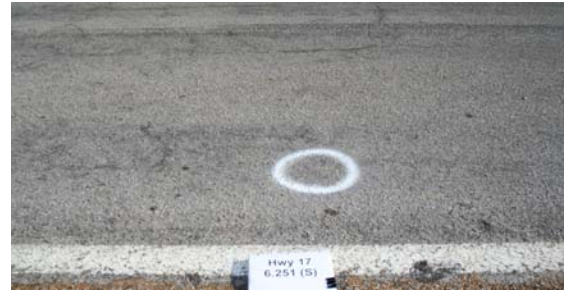
***Figure A.23 Visual Assessment Photos of Hwy 17 Coordinate 6.251***

*(a) Phase 1-Northbound-Jan 2008*

*(b) Phase 2-Northbound-Aug 2008*

*(c) Phase 3-Northbound-Jan 2009*

*(f) Phase 3-Southbound-Jan 2009*

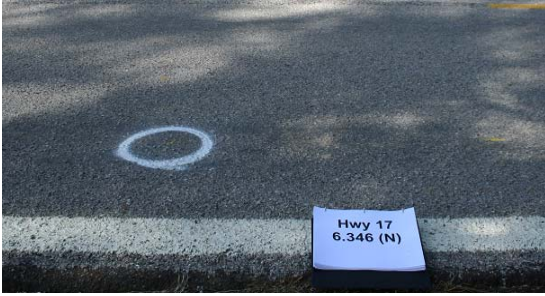
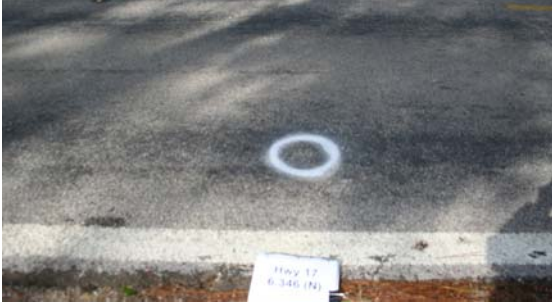
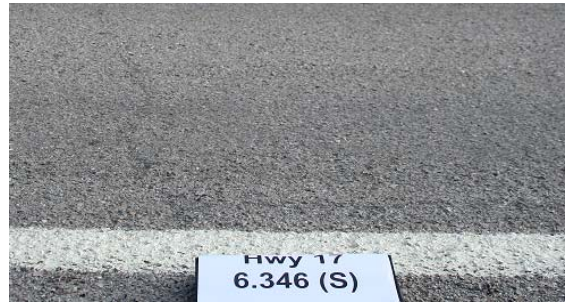
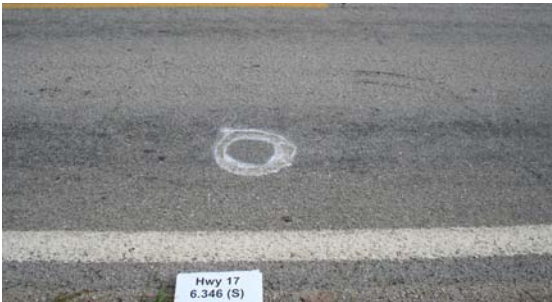
***Figure A.24. Visual Assessment Photos of Hwy 17 Coordinate 6.346***

*(a) Phase 1-Northbound-Jan 2008*

*(c) Phase 3-Northbound-Jan 2009*

*(d) Phase 1-Southbound-Jan 2008*

*(e) Phase 2-Southbound-Aug 2008*

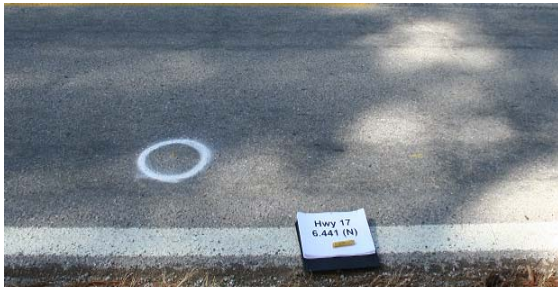
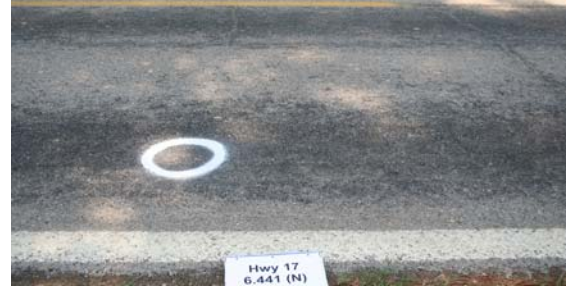
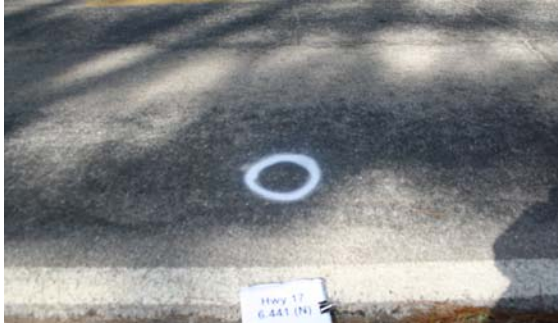
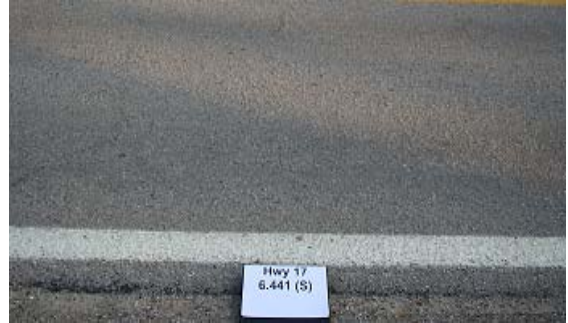
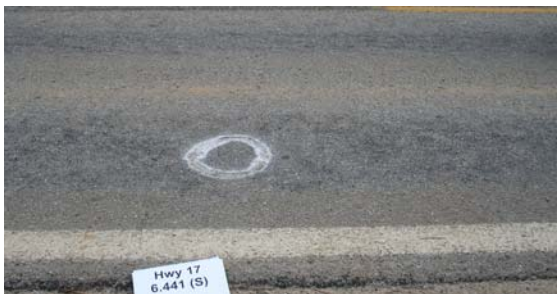
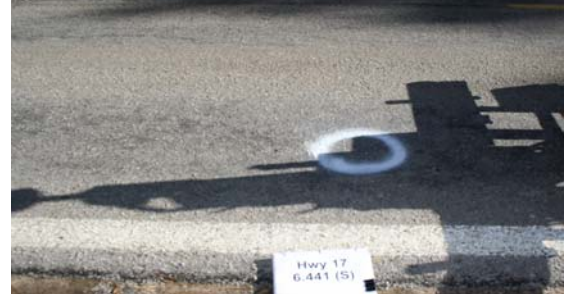
***Figure A.25. Visual Assessment Photos of Hwy 17 Coordinate 6.441***

*(a) Phase 1-Northbound-Jan 2008*

*(b) Phase 2-Northbound-Aug 2008*

*(c) Phase 3-Northbound-Jan 2009*

*(d) Phase 1-Southbound-Jan 2008*

*(e) Phase 2-Southbound-Aug 2008*

*(f) Phase 3-Southbound-Jan 2009*

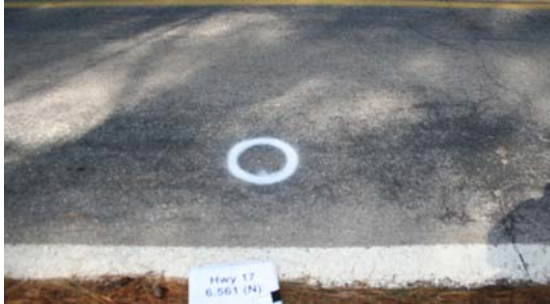
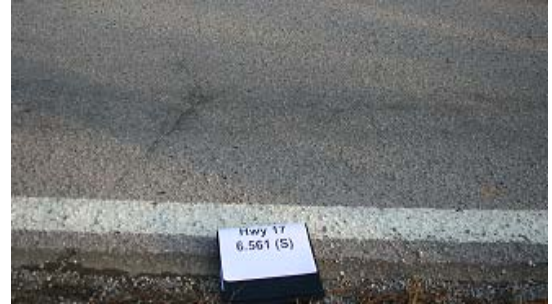
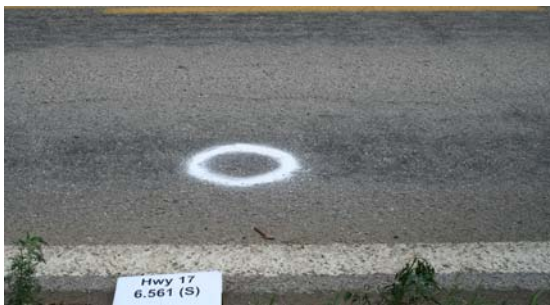
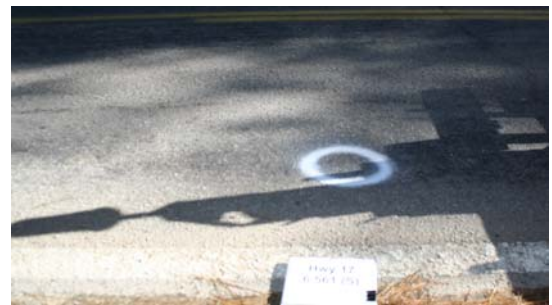
***Figure A.26. Visual Assessment Photos of Hwy 17 Coordinate 6.561***

*(b) Phase 2-Northbound-Aug 2008*

*(c) Phase 3-Northbound-Jan 2009*

*(d) Phase 1-Southbound-Jan 2008*

*(e) Phase 2-Southbound-Aug 2008*

*(f) Phase 3-Southbound-Jan 2009*

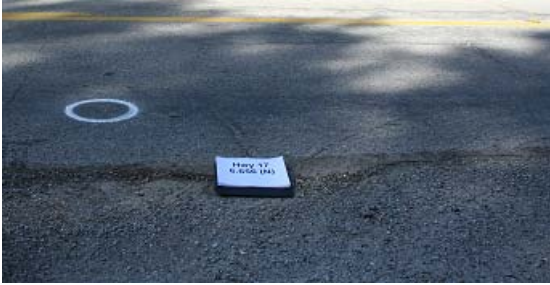
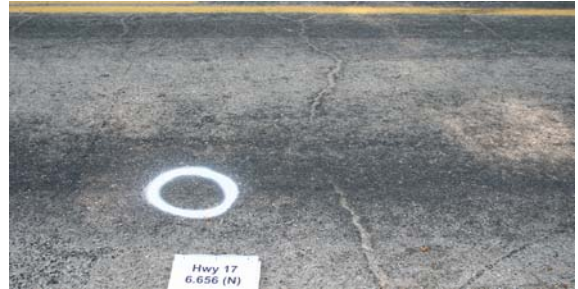
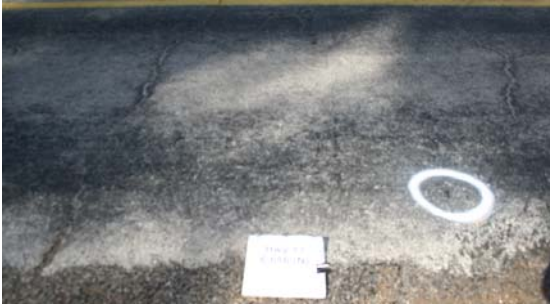
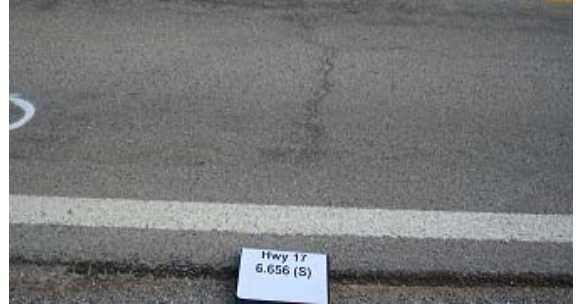
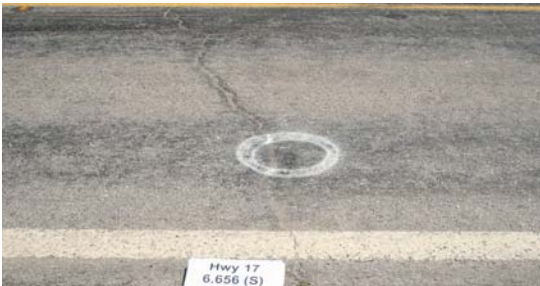
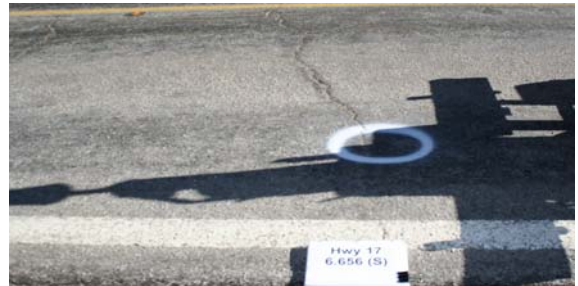
**Figure A.27. Visual Assessment Photos of Hwy 17 Coordinate 6.656**

*(a) Phase 1-Northbound-Jan 2008*

*(b) Phase 2-Northbound-Aug 2008*

*(c) Phase 3-Northbound-Jan 2009*

*(d) Phase 1-Southbound-Jan 2008*

*(e) Phase 2-Southbound-Aug 2008*

*(f) Phase 3-Southbound-Jan 2009*

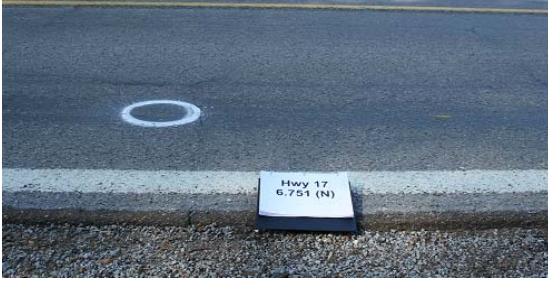
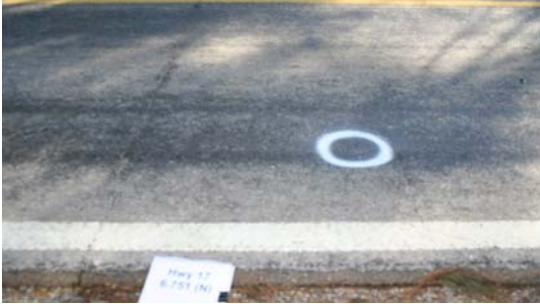
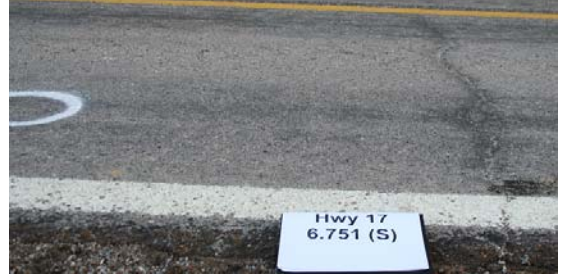
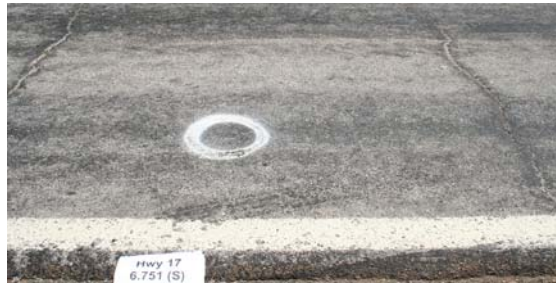
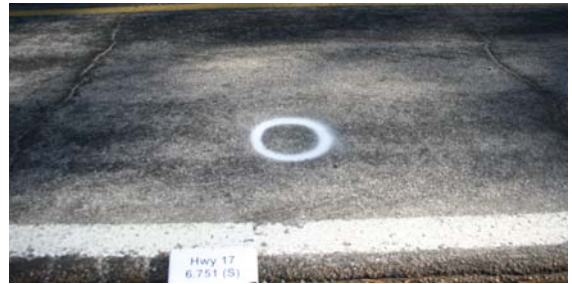
***Figure A.28. Visual Assessment Photos of Hwy 17 Coordinate 6.751***

*(a) Phase 1-Northbound-Jan 2008*

*(b) Phase 2-Northbound-Aug 2008*

*(c) Phase 3-Northbound-Jan 2009*

*(d) Phase 1-Southbound-Jan 2008*

*(e) Phase 2-Southbound-Aug 2008*

*(f) Phase 3-Southbound-Jan 2009*
