## Chip and Scrub Seal Field Test Results for Hwy 17 and Hwy 35

Final Report

FHWA/MS-DOT-RD-09-202-Vol II

Isaac L. Howard, PhD-Mississippi  
State University

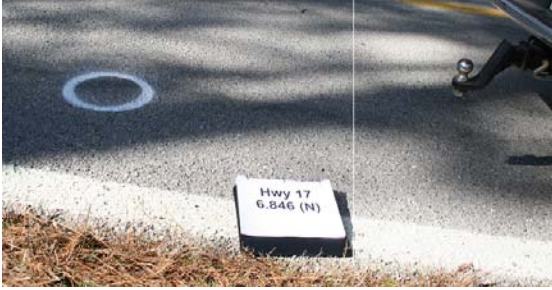
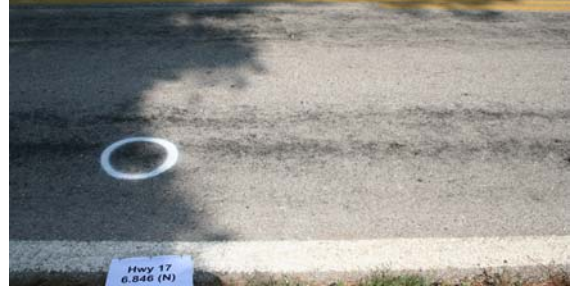
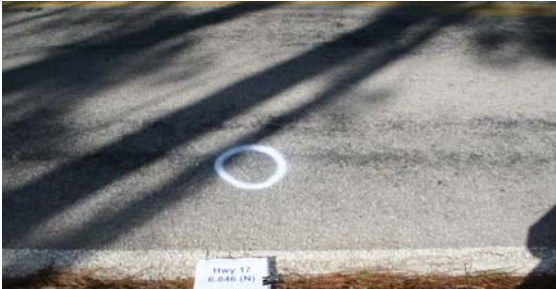
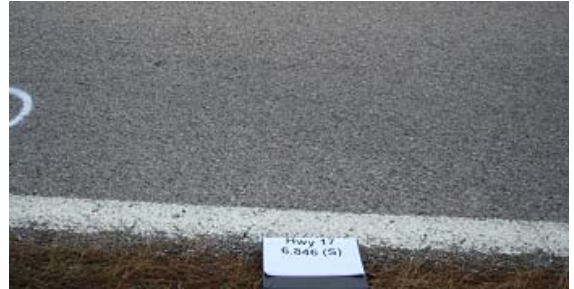
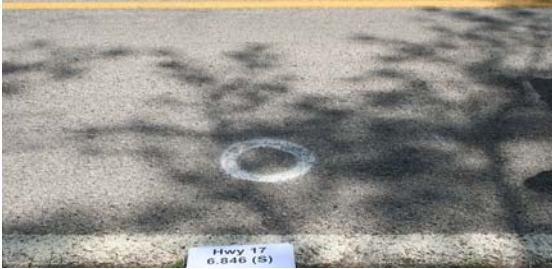
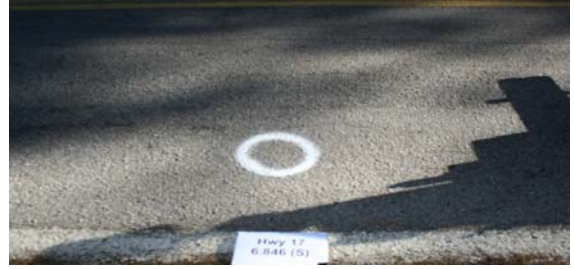
***Figure A.29. Visual Assessment Photos of Hwy 17 Coordinate 6.846***

*(a) Phase 1-Northbound-Jan 2008*

*(b) Phase 2-Northbound-Aug 2008*

*(c) Phase 3-Northbound-Jan 2009*

*(d) Phase 1-Southbound-Jan 2008*

*(e) Phase 2-Southbound-Aug 2008*

*(f) Phase 3-Southbound-Jan 2009*

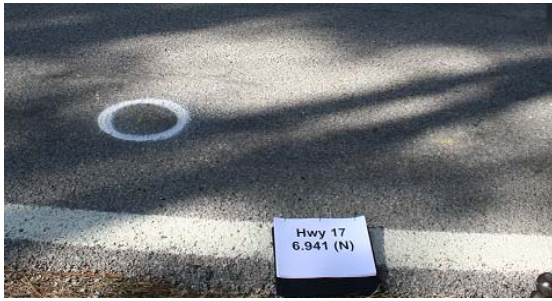
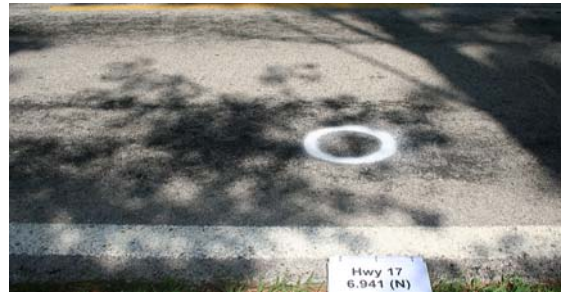
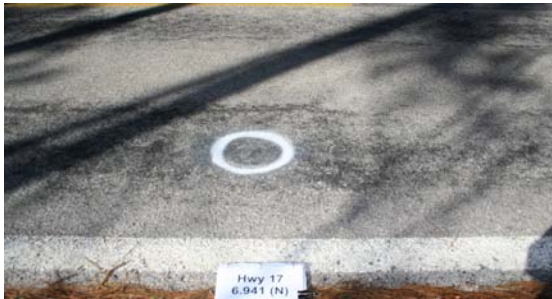
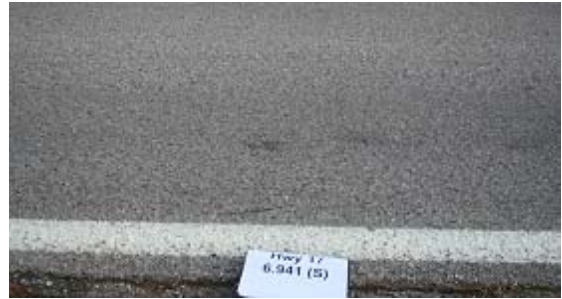
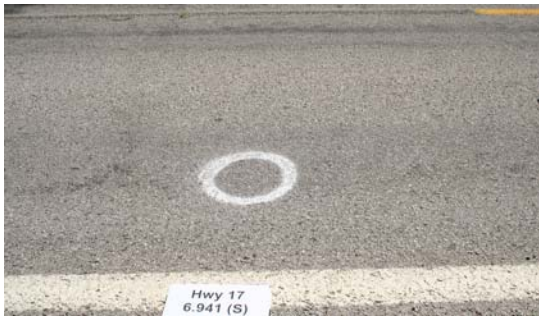
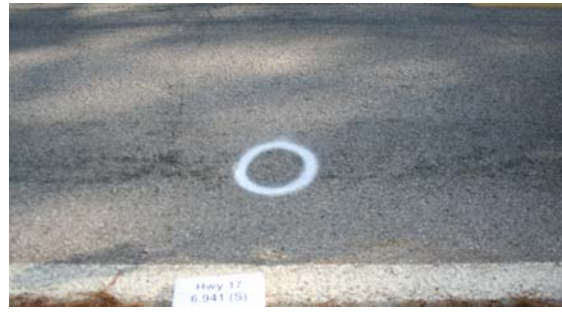
***Figure A.30. Visual Assessment Photos of Hwy 17 Coordinate 6.941***

*(a) Phase 1-Northbound-Jan 2008*

*(b) Phase 2-Northbound-Aug 2008*

*(c) Phase 3-Northbound-Jan 2009*

*(d) Phase 1-Southbound-Jan 2008*

*(e) Phase 2-Southbound-Aug 2008*

*(f) Phase 3-Southbound-Jan 2009*

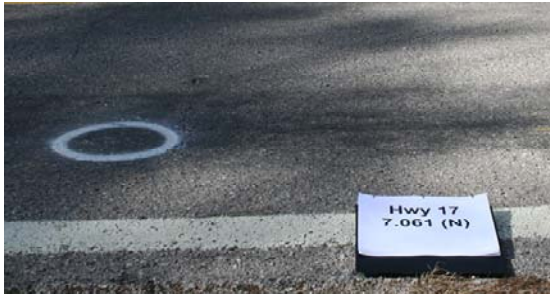
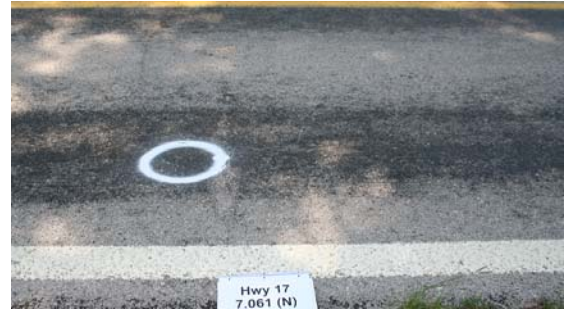
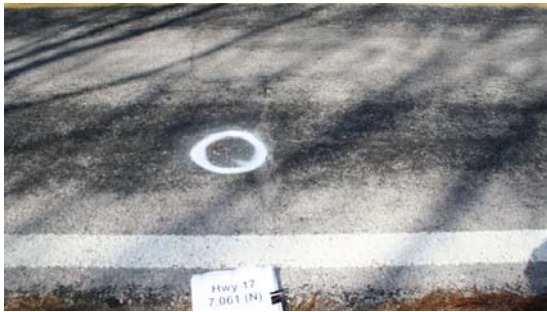
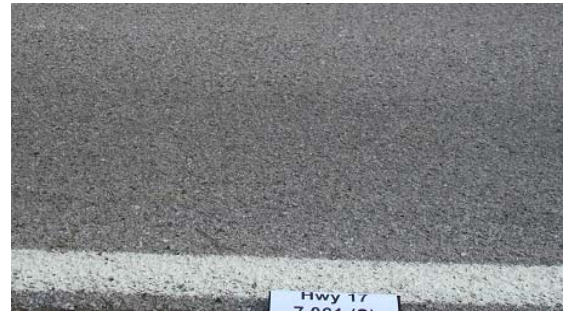
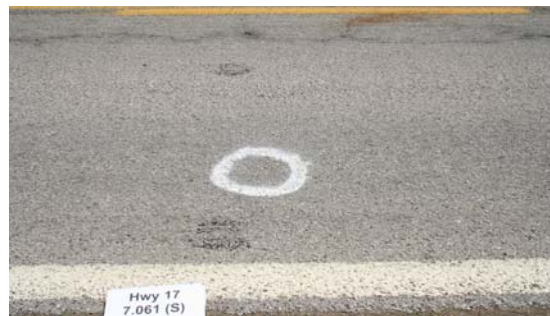
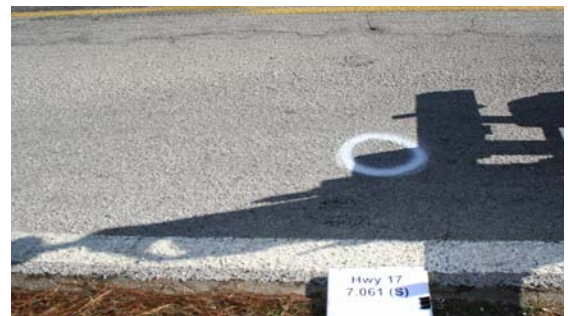
***Figure A.31. Visual Assessment Photos of Hwy 17 Coordinate 7.061***

*(a) Phase 1-Northbound-Jan 2008*

*(b) Phase 2-Northbound-Aug 2008*

*(c) Phase 3-Northbound-Jan 2009*

*(d) Phase 1-Southbound-Jan 2008*

*(e) Phase 2-Southbound-Aug 2008*

*(f) Phase 3-Southbound-Jan 2009*

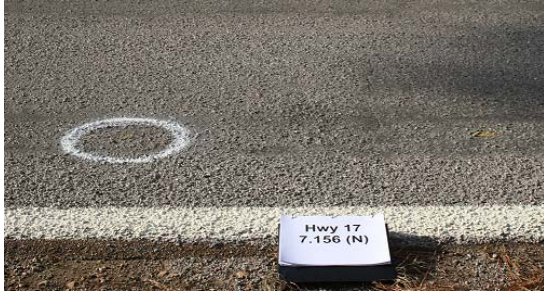
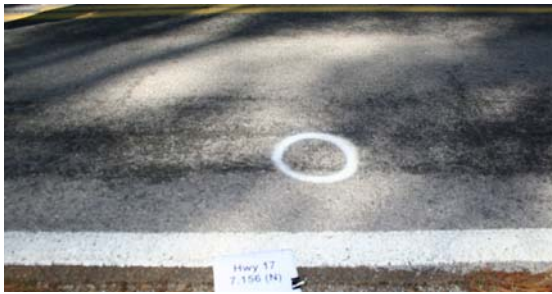
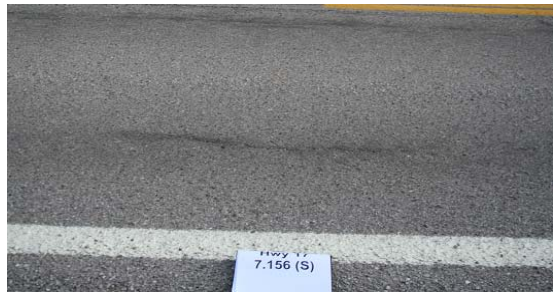
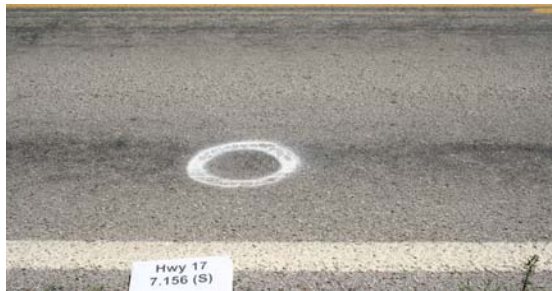
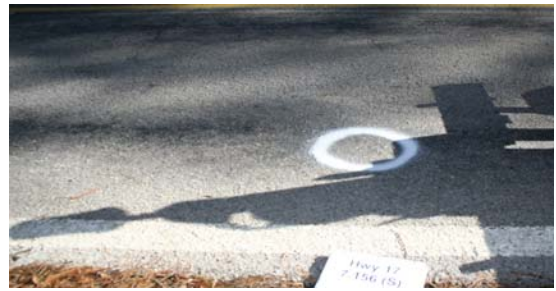
**Figure A.32. Visual Assessment Photos of Hwy 17 Coordinate 7.156**

(a) Phase 1-Northbound-Jan 2008

(b) Phase 2-Northbound-Aug 2008

(c) Phase 3-Northbound-Jan 2009

(d) Phase 1-Southbound-Jan 2008

(e) Phase 2-Southbound-Aug 2008

(f) Phase 3-Southbound-Jan 2009
