EVALUATION OF ORGANIC MATTER
ADDITION AND INCORPORATION ON
STEEP CUT SLOPES: *PHASE II TEST PLOT
CONSTRUCTION AND PERFORMANCE
MONITORING*

FHWA/MT-07-001/8176

Final Report

prepared for
THE STATE OF MONTANA
DEPARTMENT OF TRANSPORTATION

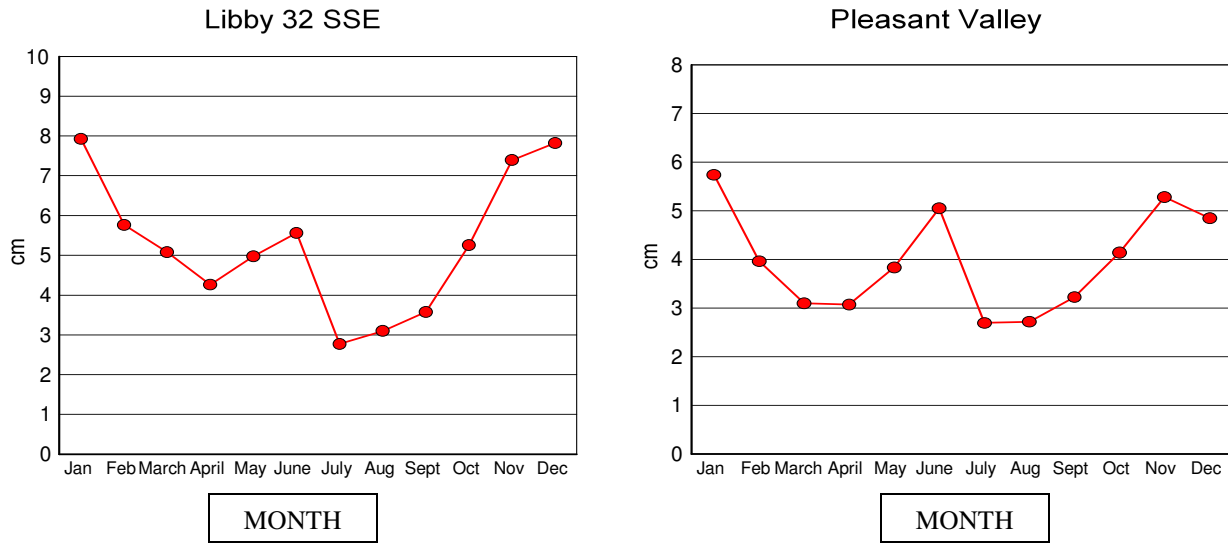
Figure 2. Monthly precipitation for NOAA stations 245020 (Libby 32 SSE) and 246576 (Pleasant Valley).

Approximately 60 percent of the precipitation occurs during the October through March period with January receiving the greatest monthly precipitation for the year. June receives the greatest precipitation during the growing season, while July, August, and September are the driest months of the year (Figure 2). Most precipitation in the November through April period occurs as snowfall with some accumulated snow depth occurring during these months. Mean annual precipitation for the Libby 32 SSE climate station is 63.4 cm (24.96 inches) while the Pleasant Valley station reports 47.7 cm (18.78 inches) of annual precipitation.

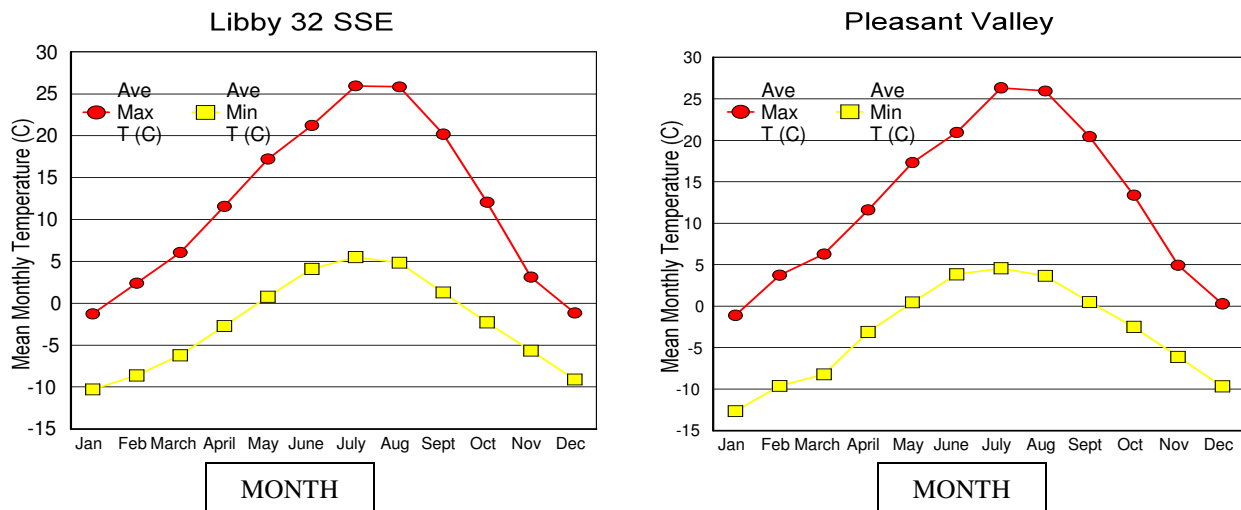
Figure 3. Mean monthly maximum and minimum temperatures at climate stations near the Happs Inn research sites.

The mean annual temperature at the two NOAA sites is 4.7 degrees C (40.5 degrees F). Average maximum temperatures range from -1.2 degrees C (29.9 degrees F) in January to 26.1 degrees C (79.1 degrees F) in July. Average minimum temperatures remain less than 0° C in the October through April period (Figure 3).

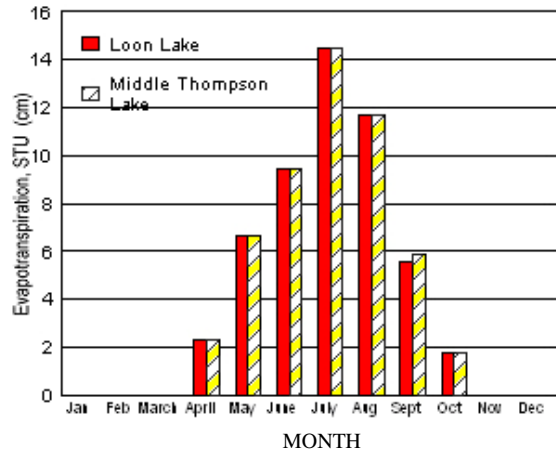
Figure 4. Mean monthly evapotranspiration for Happys Inn research sites. Values determined by Caprio (1971) solar-thermal unit method.

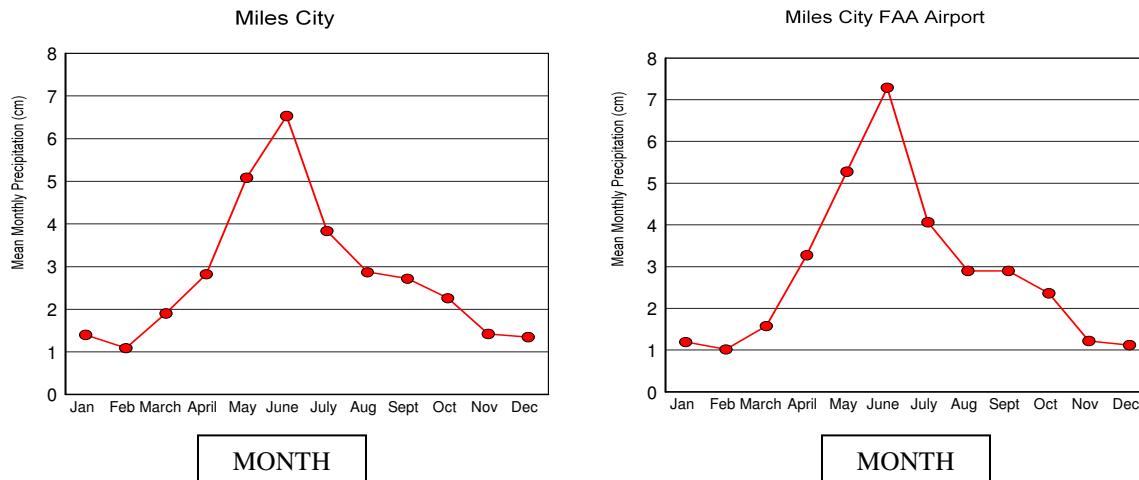
Figure 12. Monthly precipitation for NOAA stations 245685 (Miles City) and 245690 (Miles City FAA Airport).

Climatic data is available from two stations near the research sites: 1) Miles City (Station 245685), and 2) Miles City FAA Airport (Station 245690). These stations are approximately 5.4 (8.7 km) and 4 miles (6.3 km) southwest of the research sites, respectively (Figure 11). Elevations at these stations (719.3 [0.45 miles] and 799.8 m [0.5 miles], respectively) bracket the elevation of the research plots. The period of record for Station 245685 is January 1, 1893 through July 31, 1982. The record for Station 245690 extends from January 16, 1937 through the present. The overall amount and distribution of average monthly precipitation at the two stations is very similar, with the airport receiving slightly more total annual precipitation (34.2 versus 33.3 cm; 13.5 versus 13.1 inch) likely due to the 80.5 m (264 feet) elevation difference between the stations (Figure 12). The annual distribution of precipitation is typical of Eastern Montana. Approximately 75 percent of the precipitation occurs during the growing season from April through September with the month of June receiving the greatest amount.

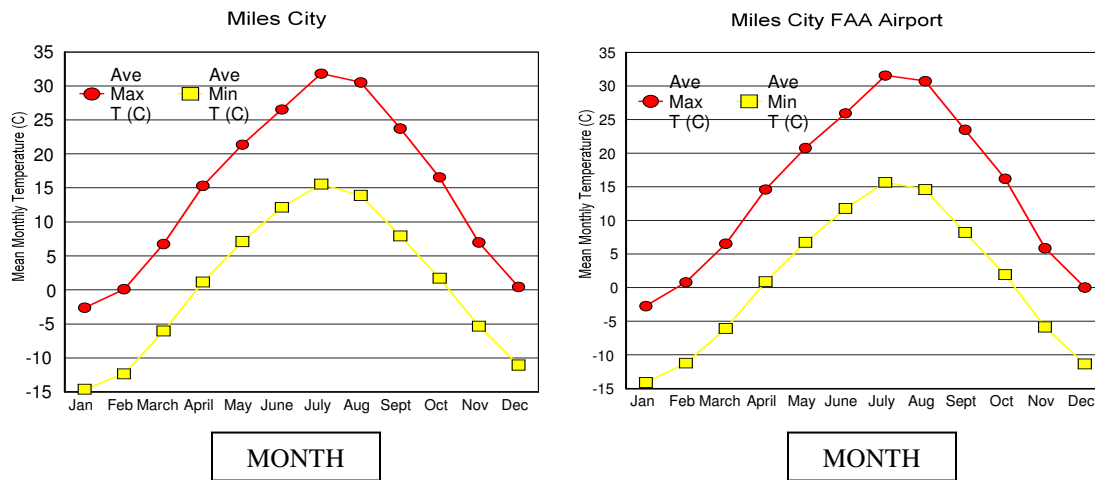
Figure 13. Mean monthly maximum and minimum temperatures for Miles City and Miles City FAA Airport climate stations.

The mean annual temperature at the two NOAA sites is 7.7 degrees C (45.9 degrees F). Average maximum temperatures range from -2.7 degrees C (27.1 degrees F) in January to 31.8 degrees C (89.3 degrees F) in July. Average minimum temperatures remain less than 0° C in the November through March period (Figure 13).

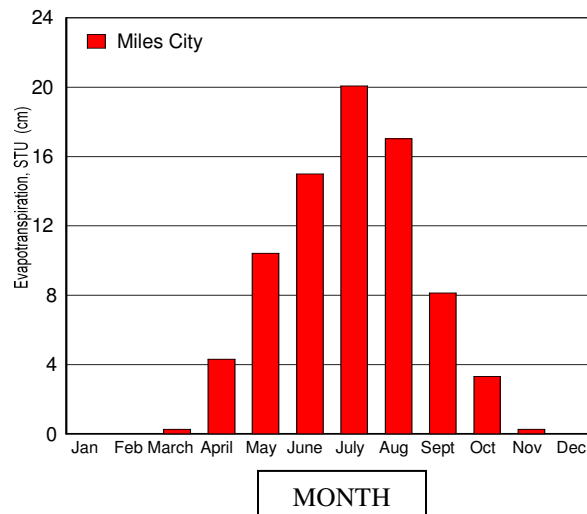
Figure 14. Mean monthly potential evapotranspiration for the Miles City research area. Values determined through MAPS program by Caprio (1971) solar-thermal unit method.

The MAPS program (Caprio et al., 2001) calculated annual potential evapotranspiration (PET) is 79 cm (31 inches). The April through September potential evapotranspiration (PET) of 74.9 cm (29.5 inch) (solar unit method) exceeds precipitation during this period (24.8 cm; 9.7 onch) by nearly 300 percent. The month of July exhibits the greatest PET (20 cm; 7.8 inch) indicating a potential deficit of nearly 16 cm (6.3 inch) between available precipitation and PET (Figure 14). While the bulk of the annual precipitation occurs during the early growing season, available soil moisture is clearly the primary controlling factor for vegetation production at this site.

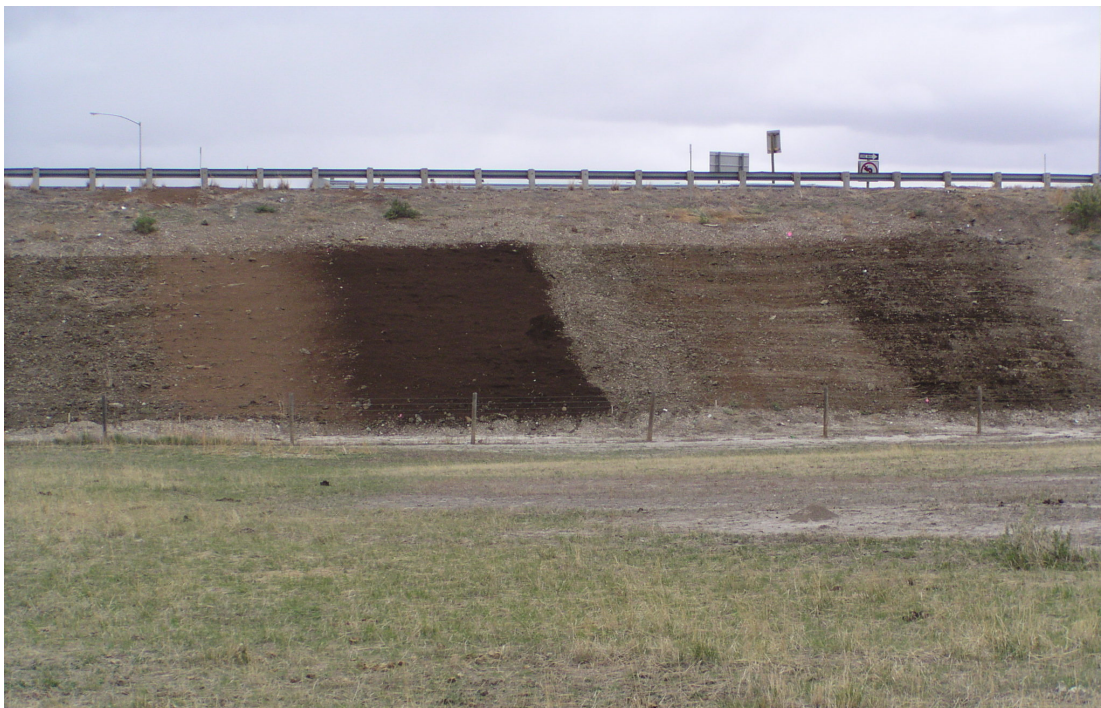
Figure 16. Plots 19 (compost blanket) and 20 (incorporated compost), I-94 off-ramp area, showing Rocky Mountain compost on the left (light-colored) and Earth Systems compost on the right (dark-colored).

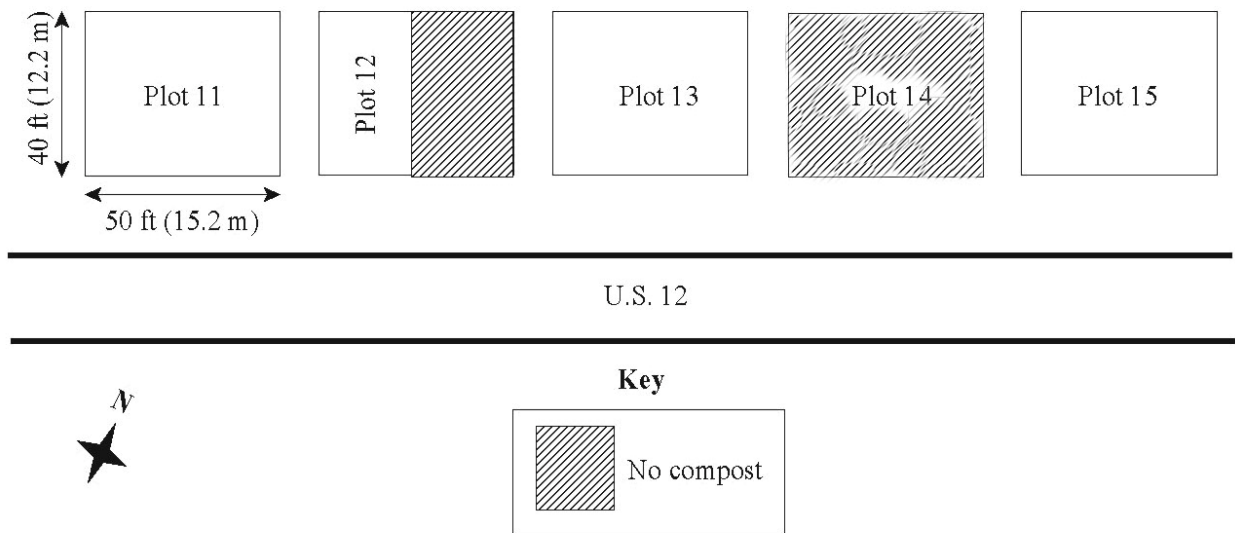
Figure 17. Research plot layouts at the U.S. Highway 12 cut slope site.

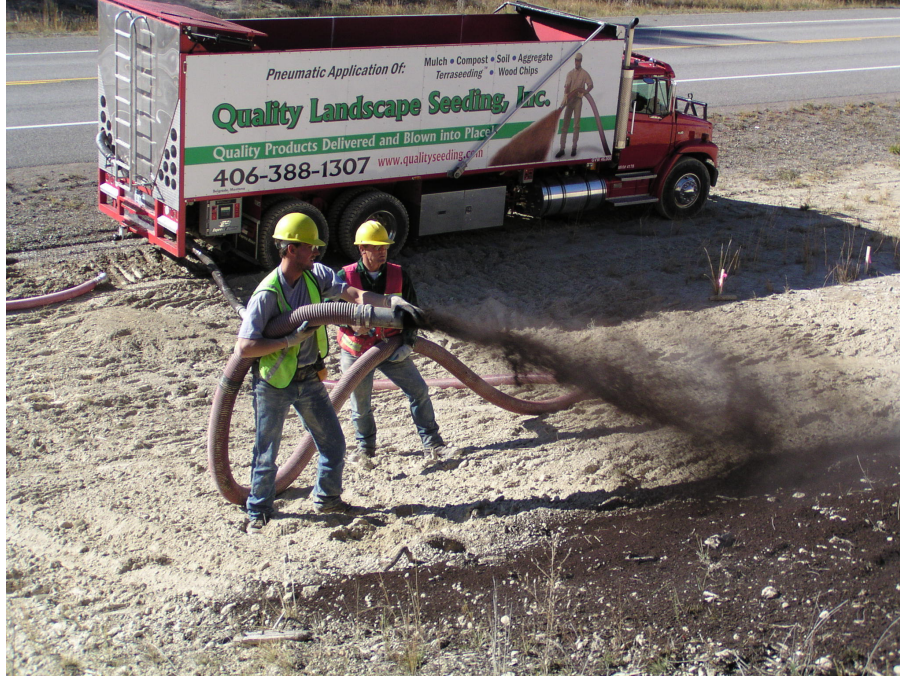
Figure 19. Express Blower Model EB-30 applying compost at the MP 77 site.

The blower truck experienced no difficulties applying compost to the research plots (Figure 19). The maximum length of the research plots was only 10 to 20 percent of the capability of the truck (standard hose length is 111.6 m or 366 feet) and no clogging of feeders or blower hose occurred. Minor hand shoveling inside the truck box was required to feed compost to the walking floor when the unit was near empty. This was apparently caused by the tilt of the unit produced by stationing it partially in the borrow pit to maintain a clear traffic lane. Compost application was timed for several plots. Approximately 10 minutes was required to apply a controlled 1.3 cm (1 inch) compost layer on each plot and an additional 15 to 20 minutes to apply the remaining 3.8 cm (1.5 inch) of compost on the 5.1 cm (2 inch) treatments for an approximate rate of 0.05 ha/hr (0.02 acre/hr) (Table 13). These rates should not be construed as the expected rate on a full scale project. Due to the size of the research plots, more time was required to ensure the applied compost was within plot boundaries. The application of two specific compost layers increased application time by about 10 percent. Manufacturer literature suggests normal application rates of 0.76 to 1.53 m³ (1 to 2 cubic yards) per hour. At the higher rate, a 5.08 cm (2 inch) compost blanket would be applied at 0.18 ha/hr (0.07 acre/hr).

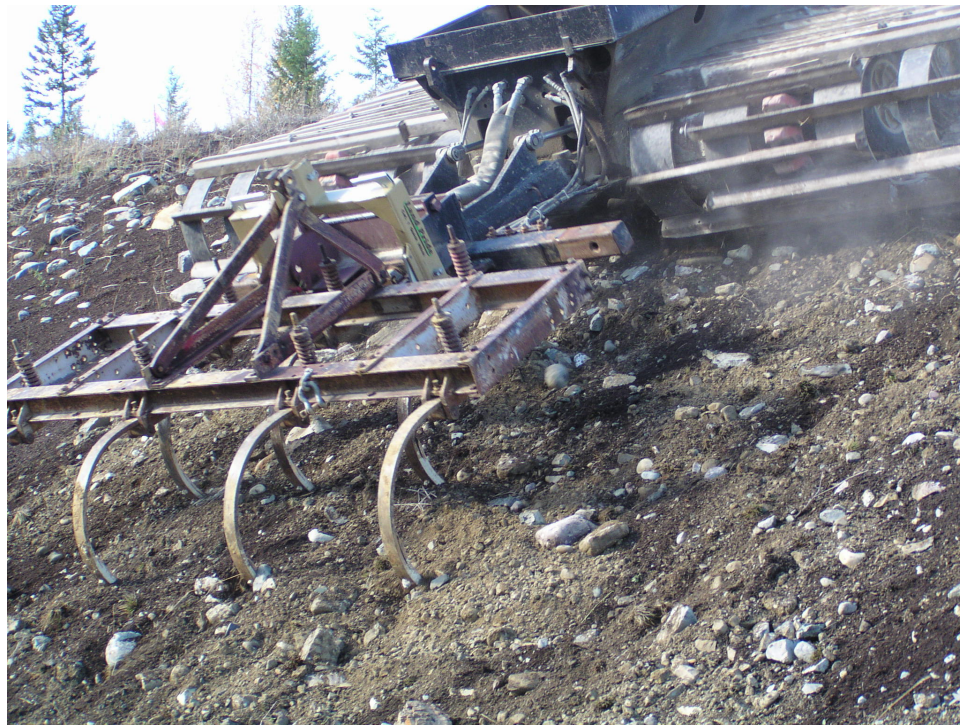
Figure 21. Graham Hoeme 2.4 m (8 ft) spring-shanked chisel plow at the Loon Lake site.

The Graham Hoeme chisel plow utilized for this study worked equally well in both coarse and fine textural classes of material (Figure 21). Shank spacing was set at 0.35 m (1.1 ft) for the 2.4 m (8 ft) wide implement. Potential tilling depth was well in excess of the specified 10.2 cm (4 in) compost incorporation depth for this project. No breakage or other problems were encountered with this unit. It is likely that a wider implement of similar design could have been utilized, especially at the MP 77 site.

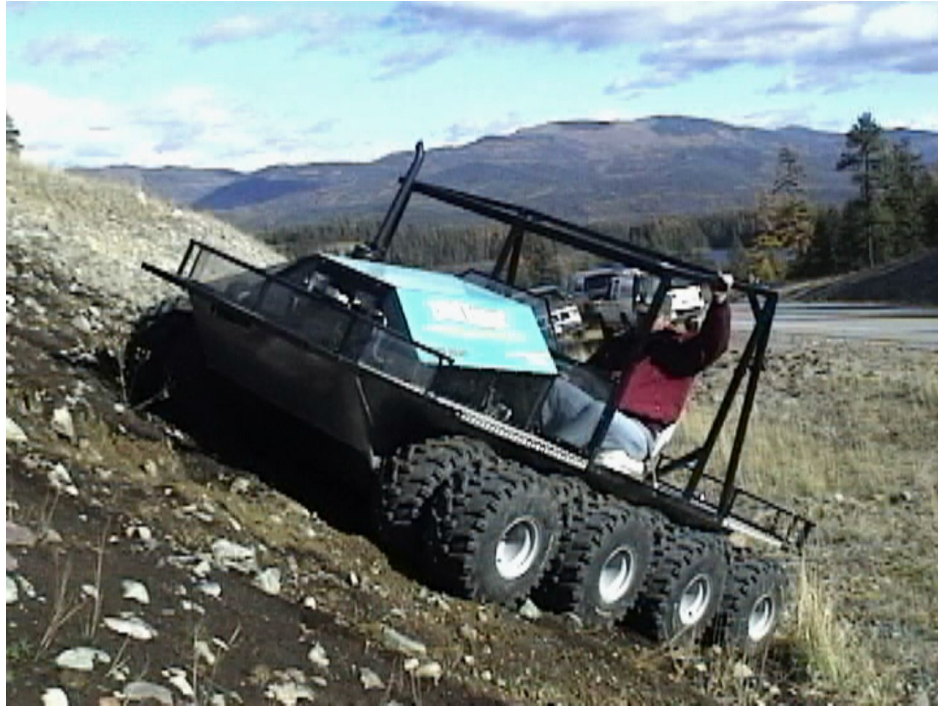
Figure 22. Land Tamer industrial model LT adjacent to Loon Lake research site.

PFM Manufacturing provided a standard industrial LT model for demonstration purposes at the MP 69 site (Figure 22). This unit is a diesel powered eight-wheeled vehicle utilizing a hydrostatic drive. While this machine had no trouble traversing the 50 percent slopes at MP 69, either on the contour or at an angle, it suffered from problems similar to the snowcat. Its rigid suspension limited wheel contact when riding over large cobble and boulders. The resulting loss of traction was sufficient to prevent direct traverse up slope at this site even without any tillage implements. The Land Tamer was not demonstrated at the MP 77 site. It is the authors' opinion that this unit would have performed acceptably well on the silt-dominated materials using a small tillage implement.

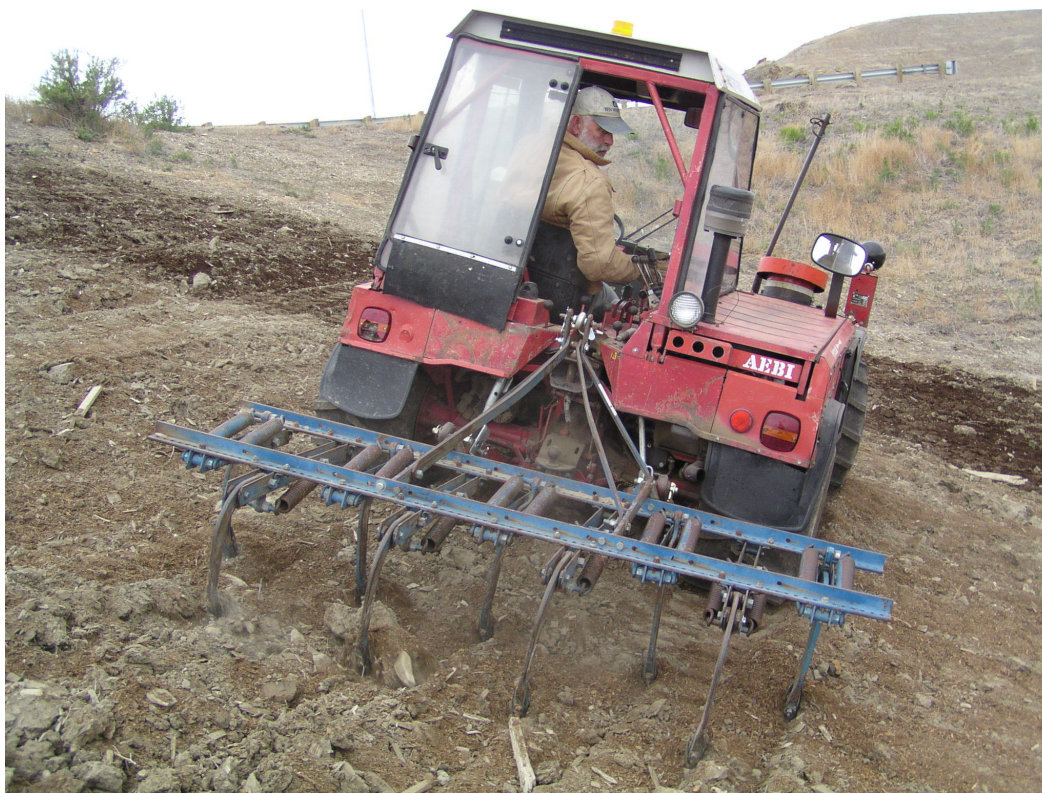
Figure 25. Ford spring-shanked tiller on Plot 20 (Rocky Mountain compost in foreground, Earth Systems material in background).

The Ford tiller used for this work had 9 shanks mounted at 0.30 m (1 foot) centers (Figure 25). All shanks were spring-loaded which allowed passage over several large boulders encountered when tilling plots 11 through 15. All shanks were equipped with chisel points. All initial plot tillage was across the slope. Compost mixing was initially up-down the slope followed by a second pass across the slope. The AEBI TT88 had little difficulty obtaining the desired 10.2 cm (4 inch) tillage depth and was capable sinking the shanks 0.3 m (1 foot), especially when tilling down slope.

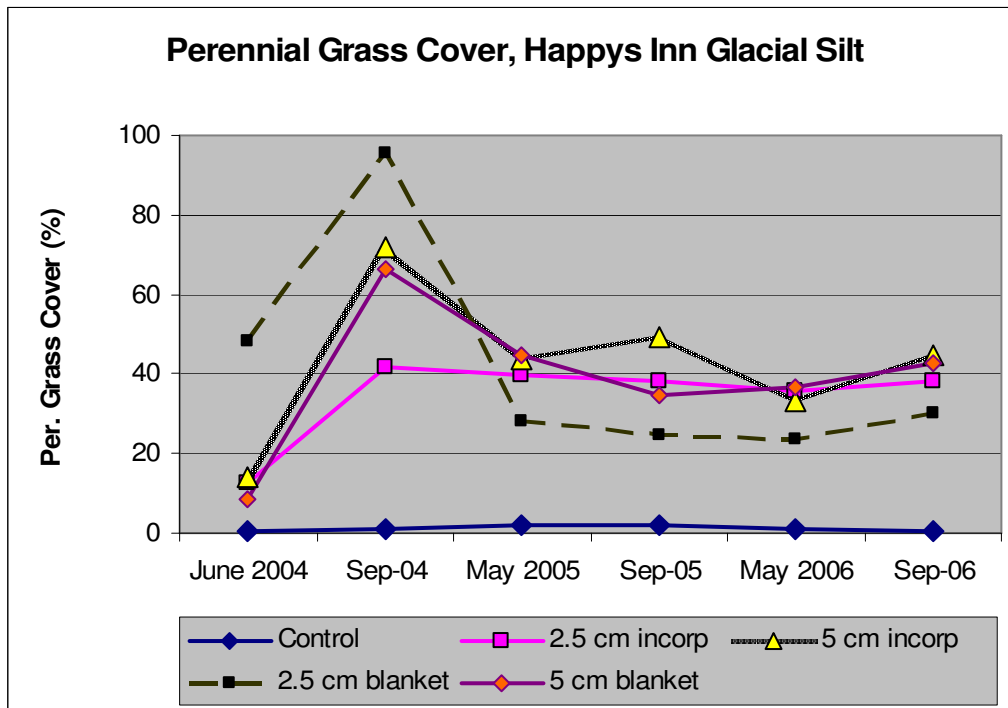
Figure 28. Response of perennial grasses to applied compost treatments compared to an untreated control at the Middle Thompson Lake research sites.

Analysis of perennial grass development and persistence is presented in Figure 28 at the Happys Inn glacial silt site. Since the seed mix was dominated by perennial grasses they were used as an overall performance metric for the compost treatments compared to the control. The research sites at Happys Inn were constructed in the fall of 2003 with the expectation that vegetation monitoring during the first growing season would be limited to measurement of emergent plant density. However, by June of the first growing season sufficient vegetation developed that measurement of cover was possible and by September of 2004 many of the seeded species had grown to maturity on the compost treated plots. The remarkable growth of the seeded species during the first growing season can be seen in the photo chronology presented in Appendix D. The progression of plant growth on plot 3, the 5 cm (2 inch) compost rate incorporated into the top 10 cm (4 inch) of soil is shown in Appendix Figure D1. Photographs are not presented for all of the plots; rather plot 3 was selected as a good representation of the compost treatments at the glacial silt research sites. Figure 28 also shows that perennial grass cover peaked in the first growing season and then held at relatively stable levels during the second and third growing season. The control plot exhibited very little perennial grass growth with most plants observed only a few centimeters tall and often withered and stressed in appearance. The response of perennial grasses to applied compost was unmistakable and readily observed from the highway as robust green rectangles.

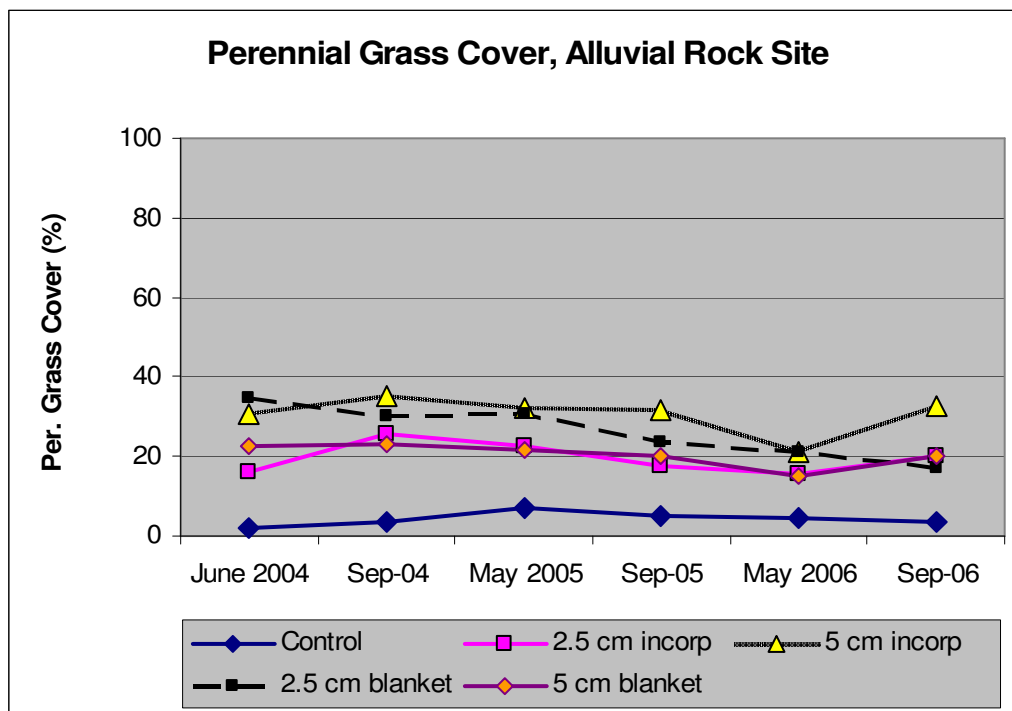
Figure 29. Response of perennial grasses to applied compost treatments compared to control at the Loon Lake research sites.

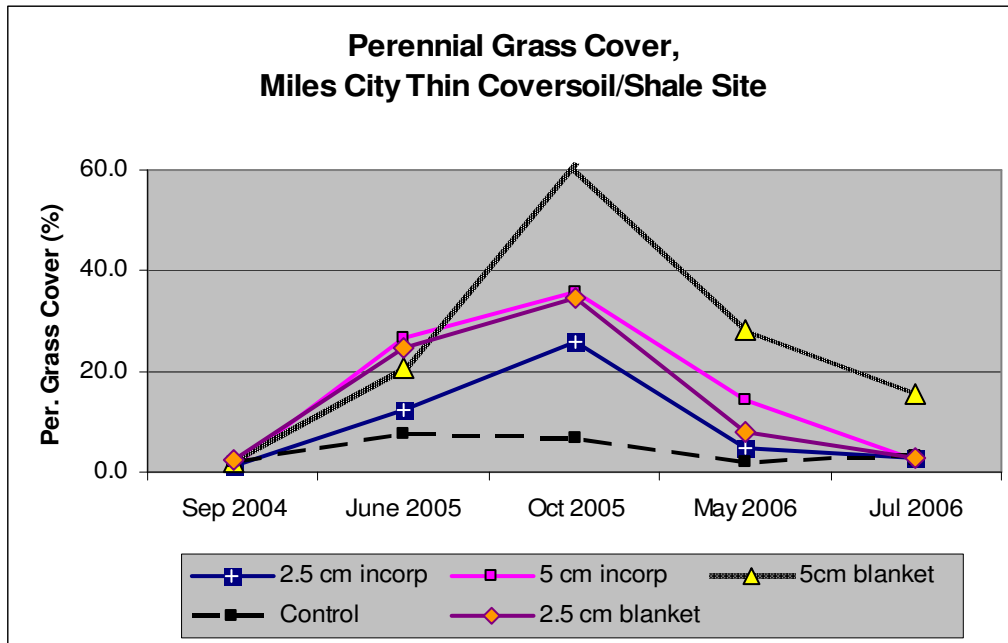
Figure 30. Response of perennial grasses to applied compost treatments compared to a control at the Miles City cut slope research sites on U.S. Highway 12.

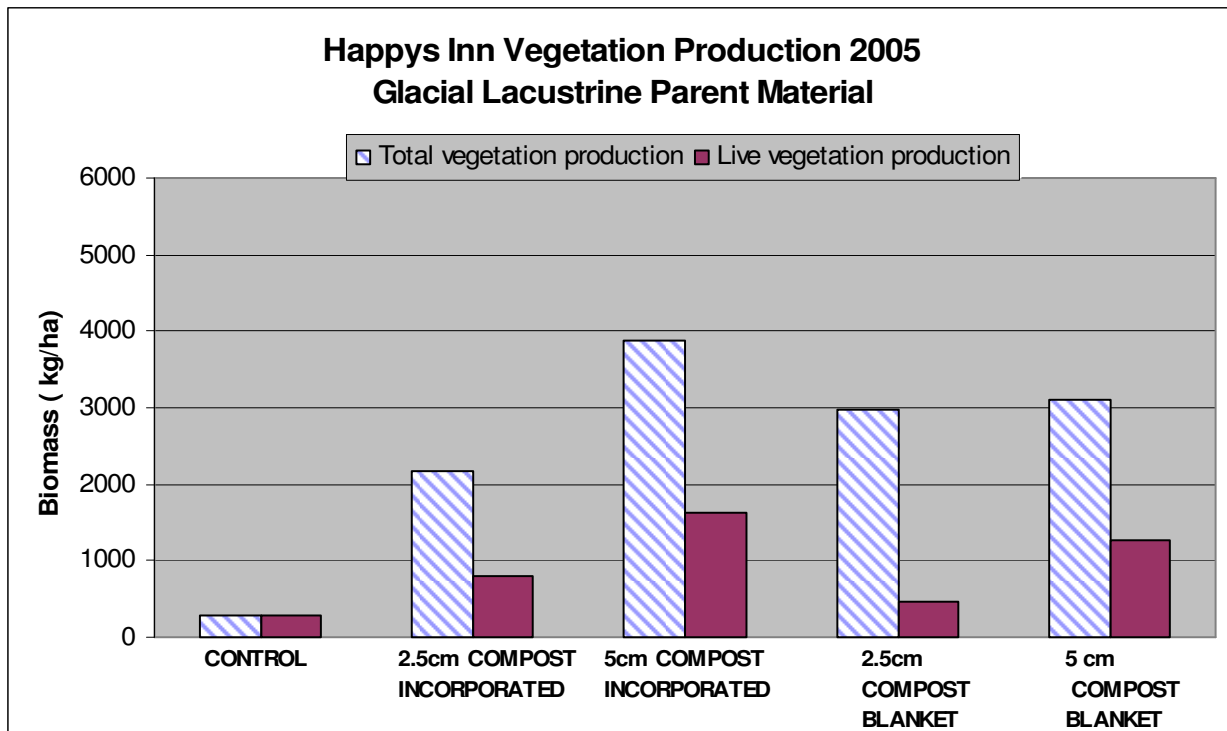
Figure 32. Total and live plant production measured at the Happys Inn glacial silt research sites along U.S. Highway 2 during 2005 at the end of the second growing season.

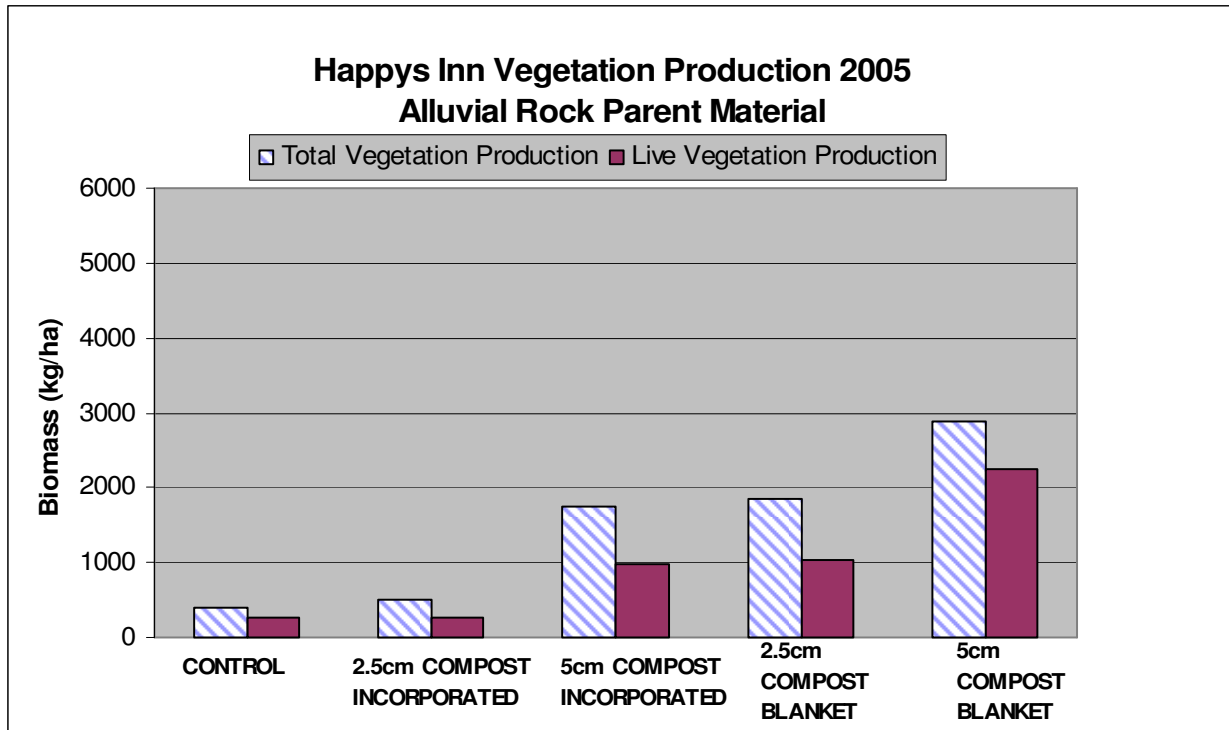
Figure 33. Total and live plant production measured at the Happys Inn alluvial rock research sites along U.S. Highway 2 during 2005 at the end of the second growing season.

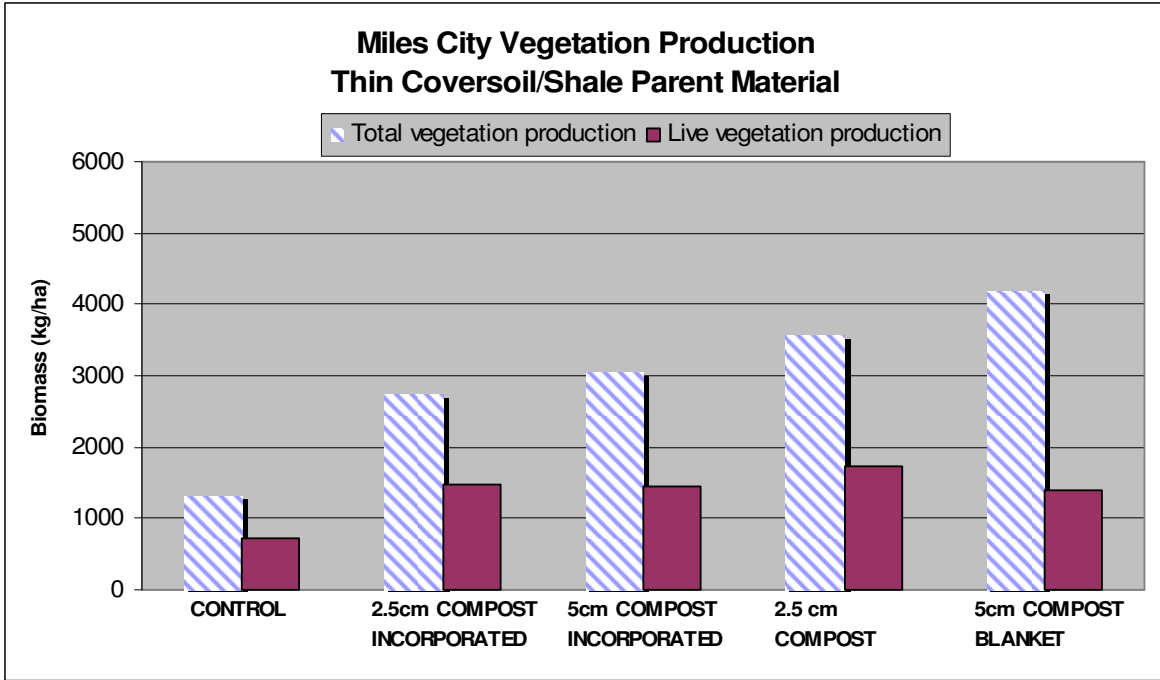
Figure 34. Total and live plant production measured at the Miles City thin coversoil/shale research sites along U.S. Highway 12 during 2006 at the end of the third growing season.

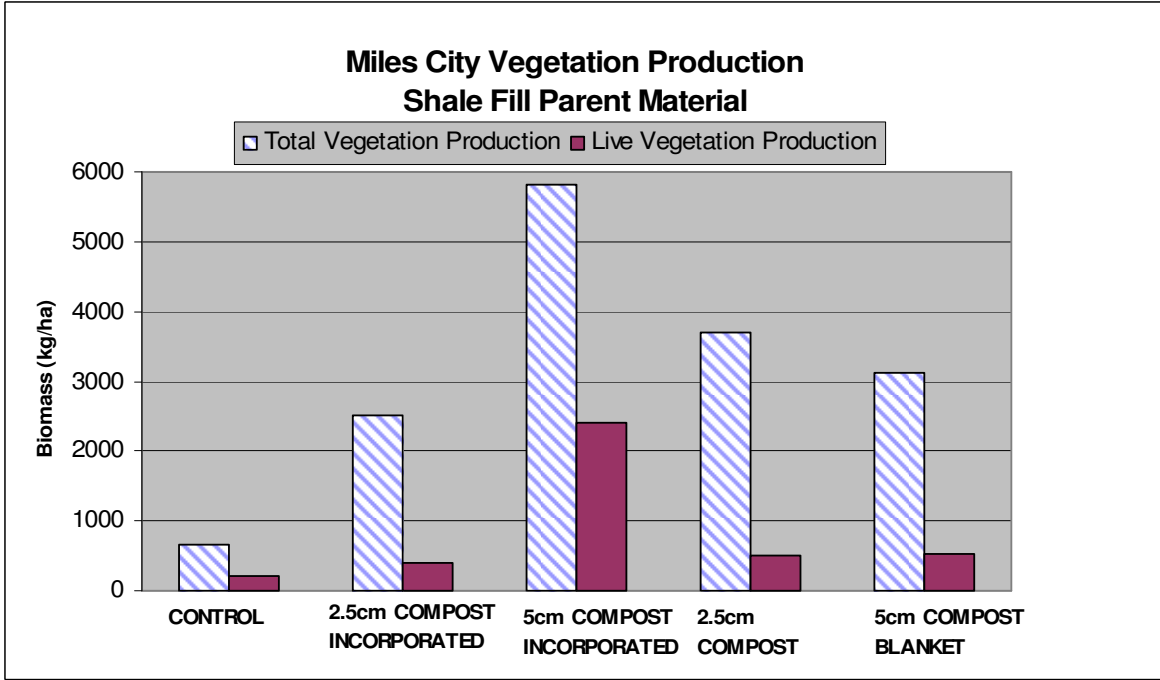
Figure 35. Total and live plant production measured at the Miles City shale fill research sites along Interstate 94 during 2006 at the end of the third growing season.

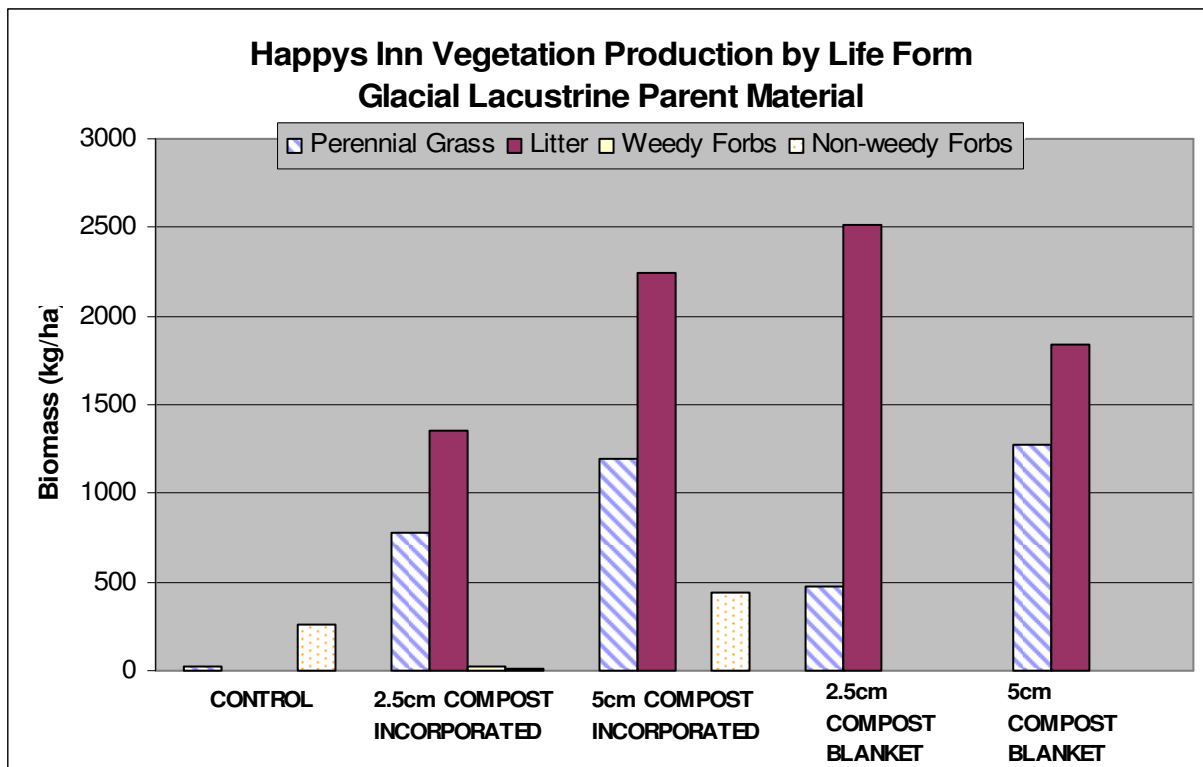
Figure 36. Plant production by life form at Happys Inn research plots 1-5 constructed on glacial silt parent material (2005 data).

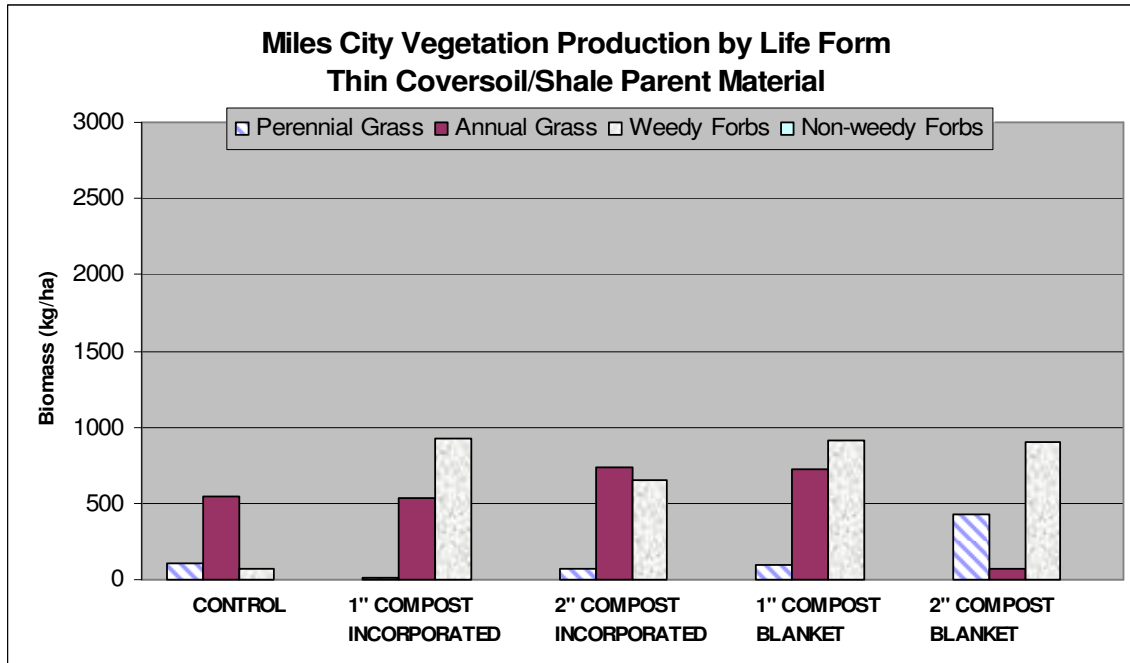
Figure 38. Plant production by life form at Miles City research plots 11-15 constructed on thin coversoil/shale parent material (2006 data).

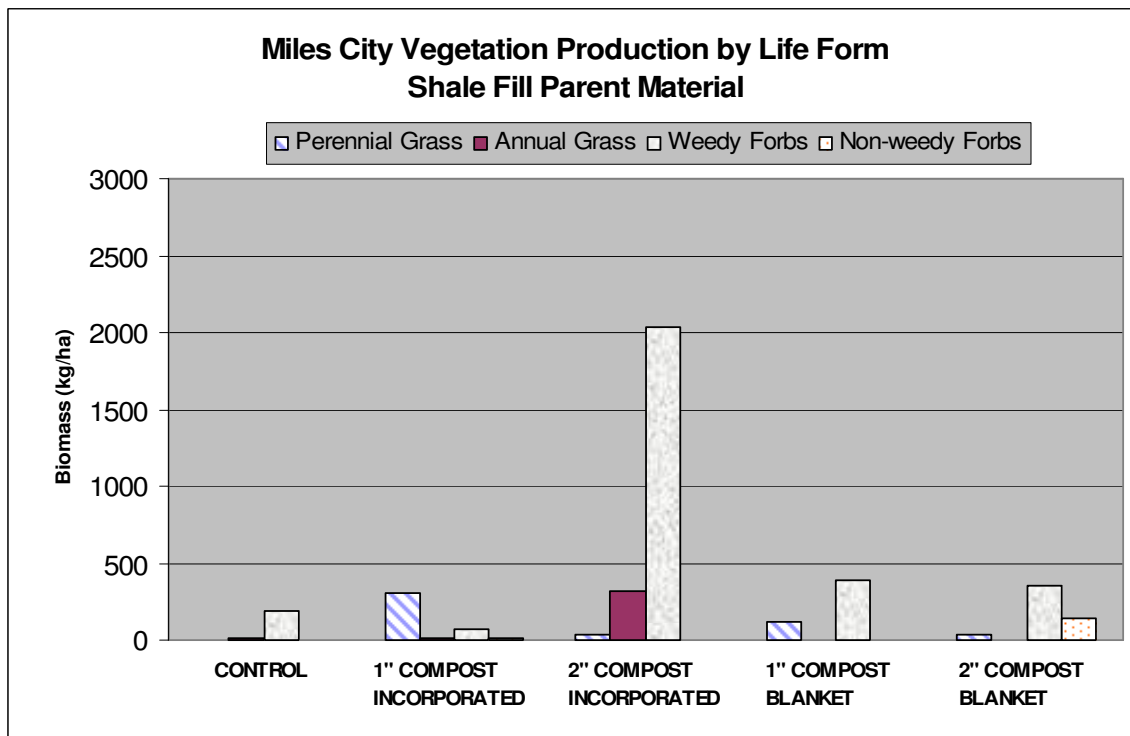
Figure 39. Plant production by life form at Miles City research plots 16-20 constructed on shale parent material (2006 data).

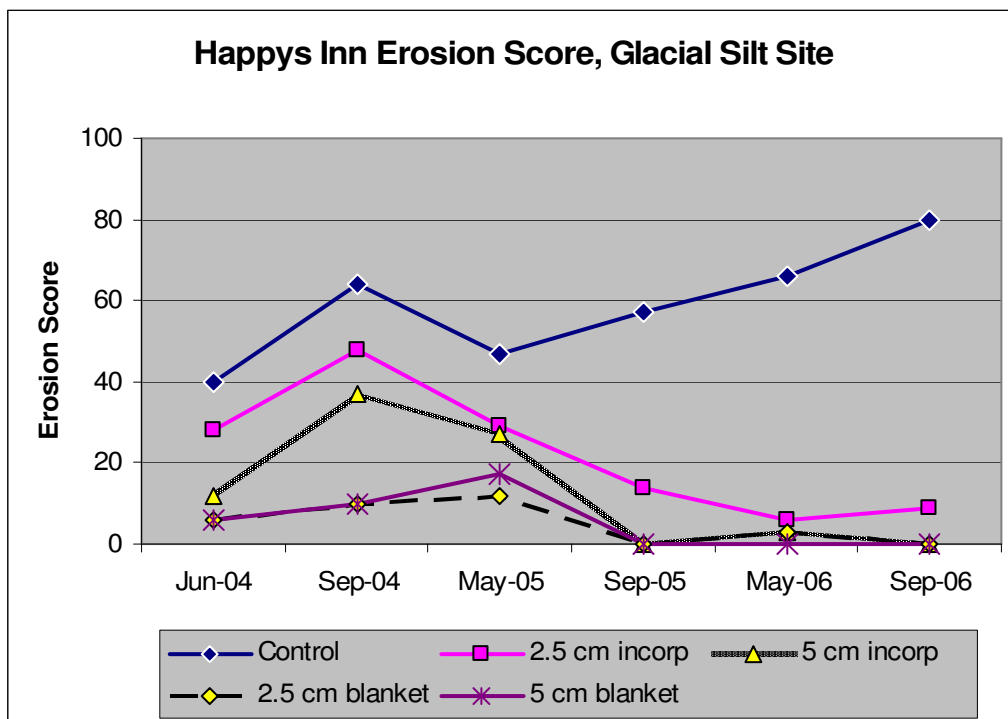
Erosion scores are classified into erosion condition classes (Clark, 1980) as follows:

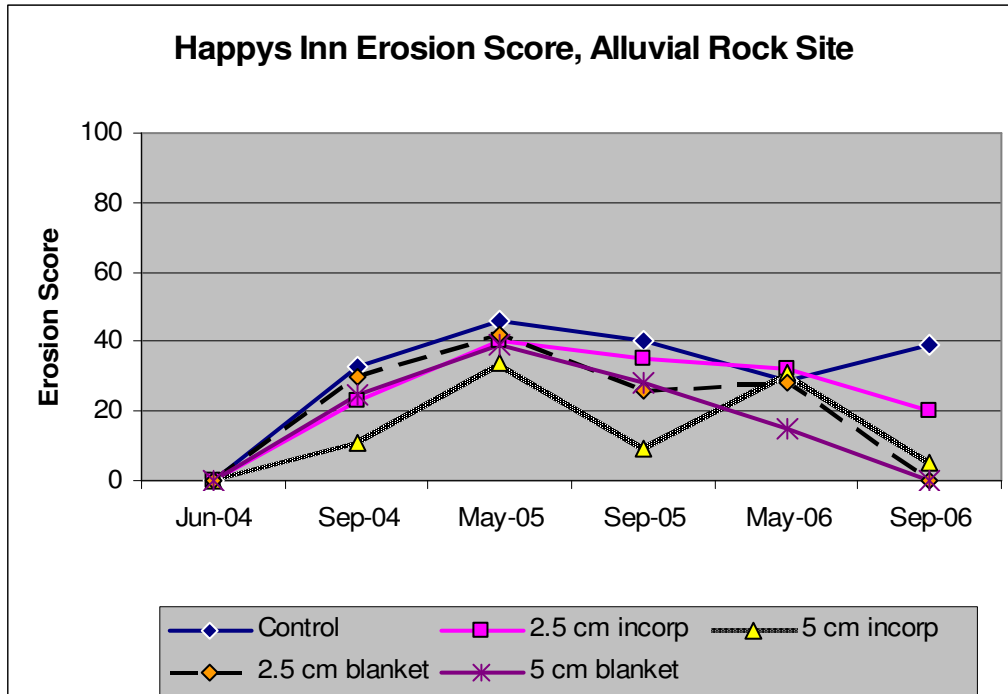
Figure 41. Erosion condition assessment at the alluvial rock research site, Plots 6-10 during 3 years of monitoring.

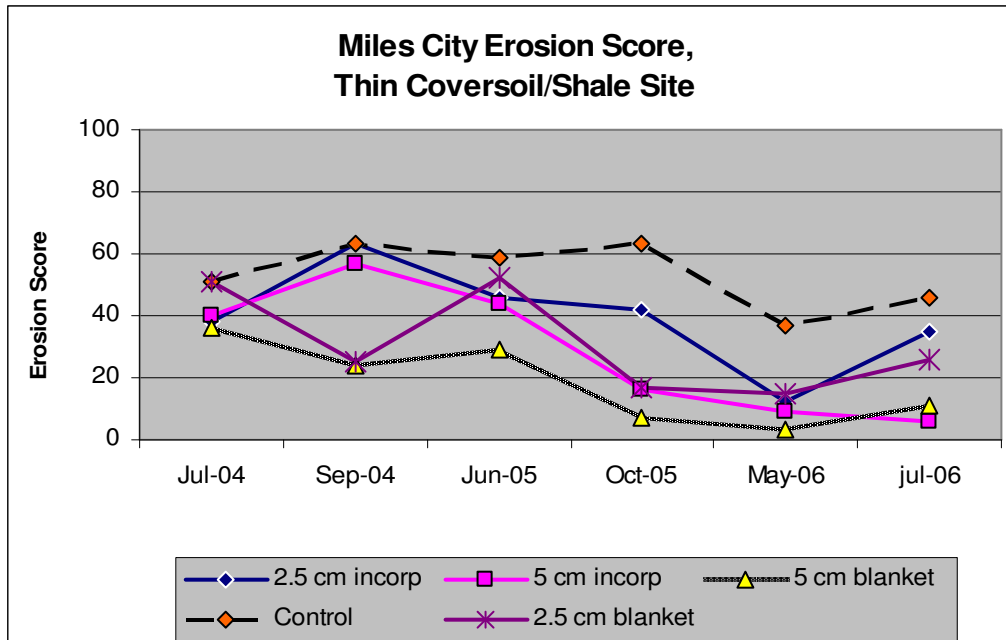
Figure 42. Erosion condition assessment at the thin coversoil/shale research site, Plots 11-15 during 3 years of monitoring.

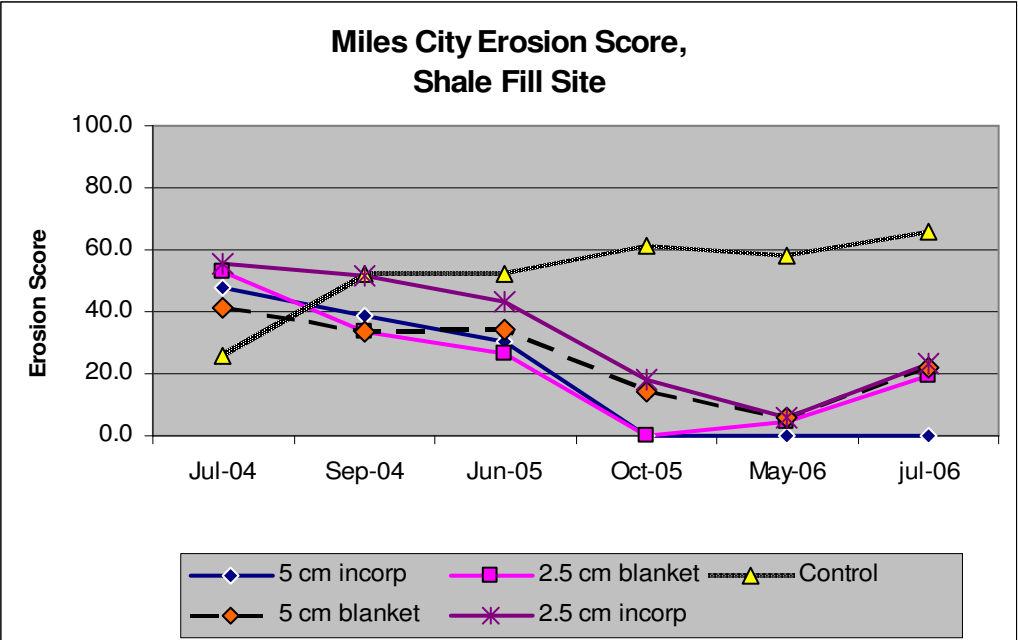
Figure 43. Erosion condition assessment at the shale fill research site, Plots 16-20 during 3 years of monitoring.
