EVALUATION OF ORGANIC MATTER
ADDITION AND INCORPORATION ON
STEEP CUT SLOPES: *PHASE II TEST PLOT
CONSTRUCTION AND PERFORMANCE
MONITORING*

FHWA/MT-07-001/8176

Final Report

prepared for
THE STATE OF MONTANA
DEPARTMENT OF TRANSPORTATION

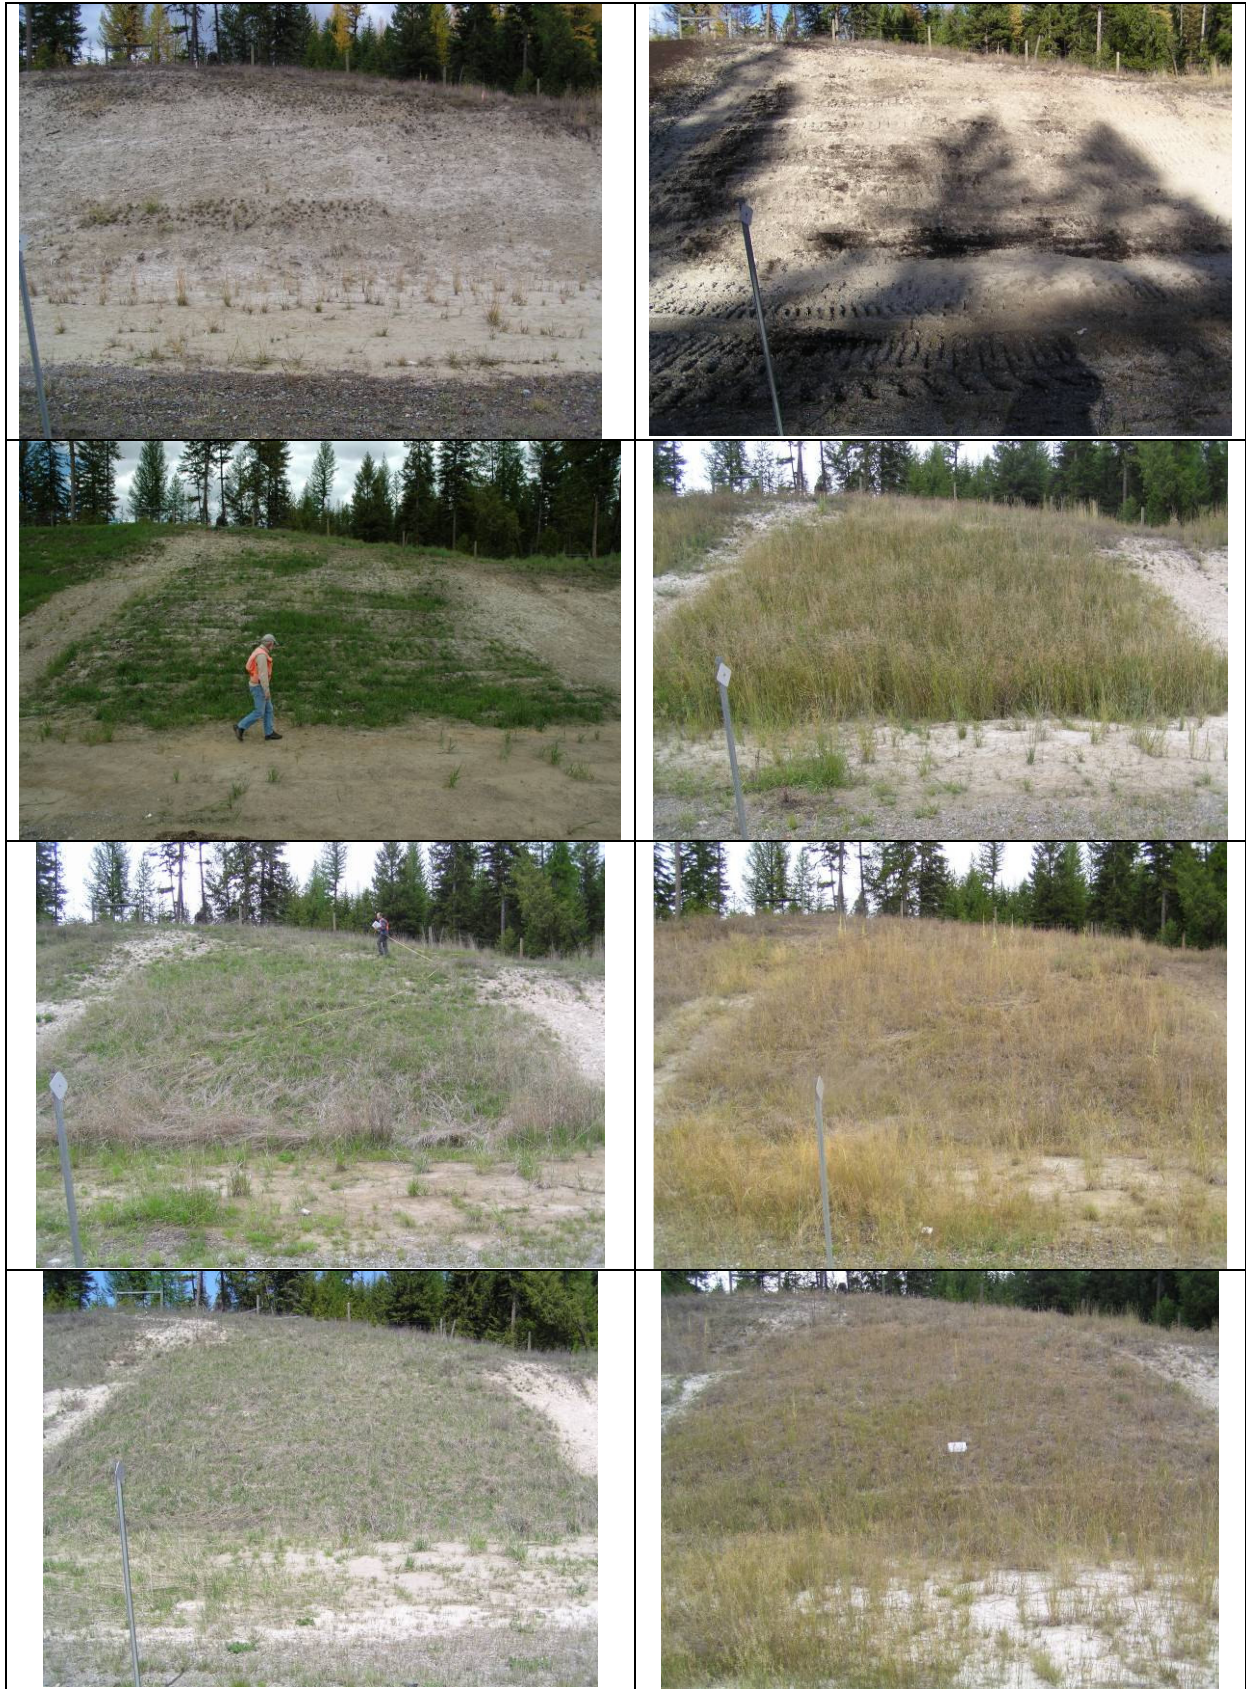
Figure D1. Photo chronology from Plot 3, glacial silt site near Happys Inn, 5 cm incorporated compost treatment from upper left to lower right: before and after construction (2003), spring and fall monitoring, 2004, 2005 and 2006.
