# Continued Monitoring of Instrumented Pavement in Ohio

Final Report  
December 2002

1. Report No. FHWA/OH-2002/035		2. Government Accession No.		3. Recipient's Catalog No.	
4. Title and Subtitle  Continued Monitoring of Pavement in Ohio			5. Report Date  December 2002

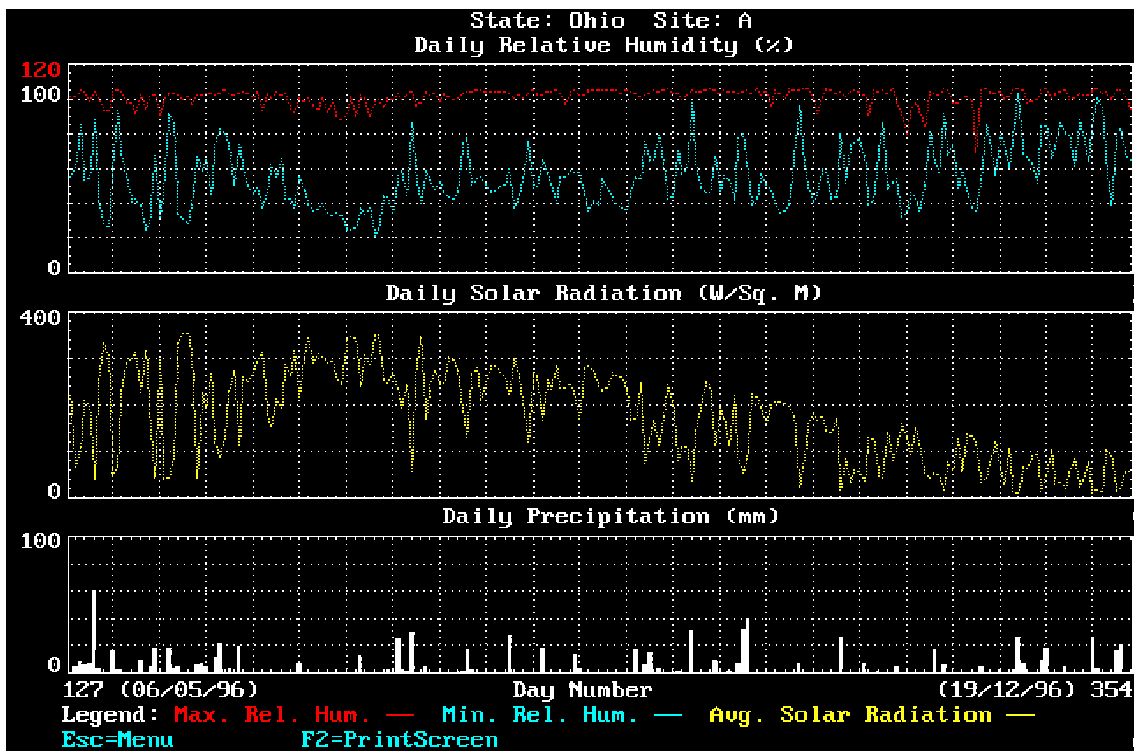
Figure 2.5 Typical AWSCheck Display of Daily Humidity, Radiation, and Precipitation Data

Figures 2.5 to 2.7 provide samples of Options 2, 3, and 6 respectively. As with the Onsite data, the weather station data must be checked for quality and consistency. Options 1 through 3 above only permit viewing of the data, while Options 4 through 7 permit the user to edit the data manually.

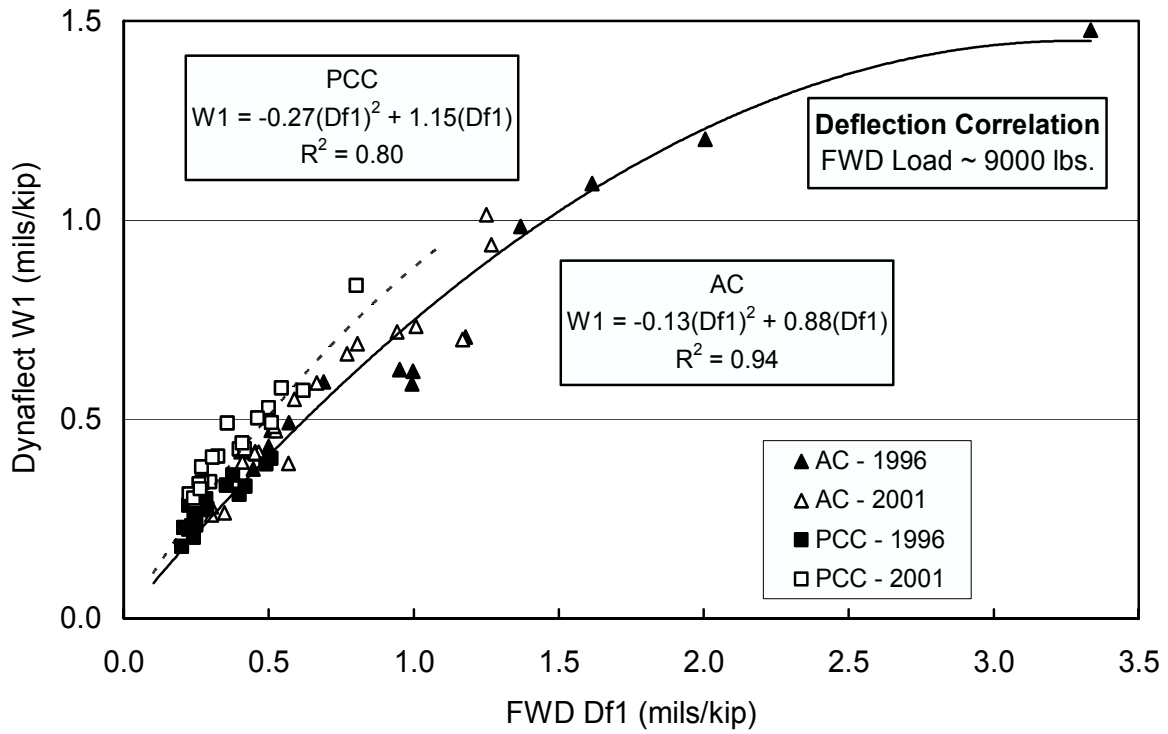
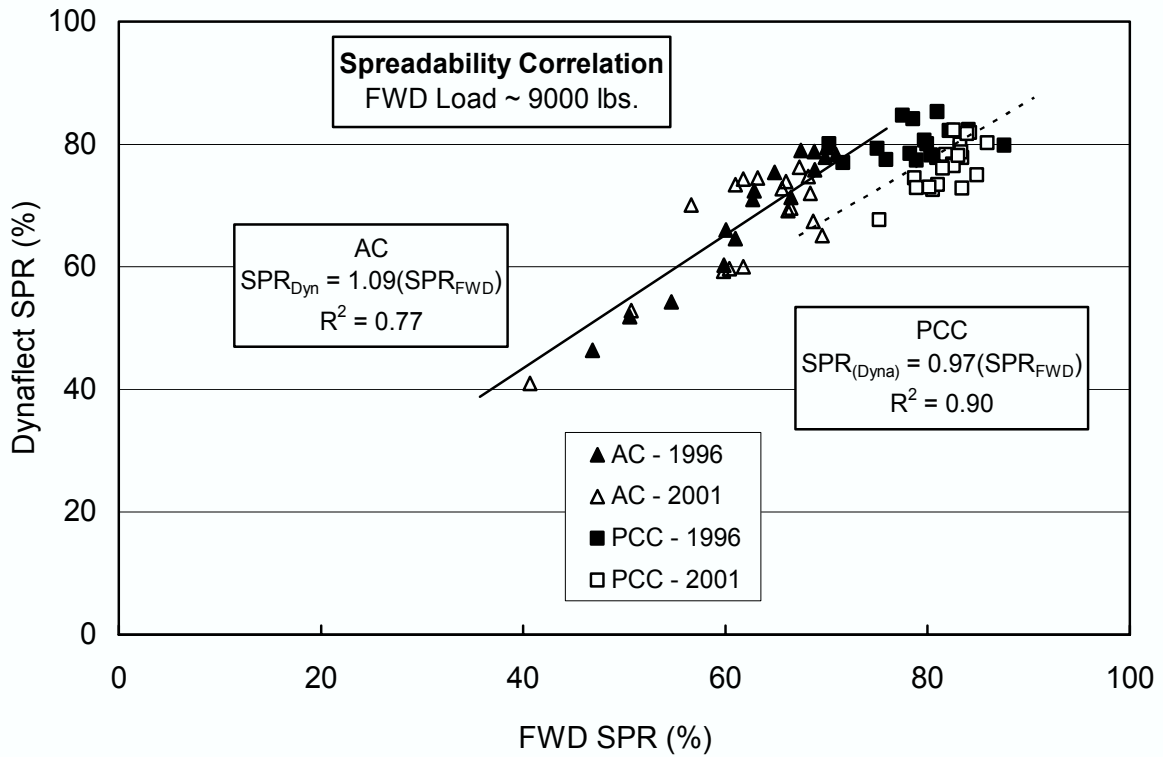
**Figure 2.8 Correlation of FWD and Dynaflect Responses on SHRP Test Sections**

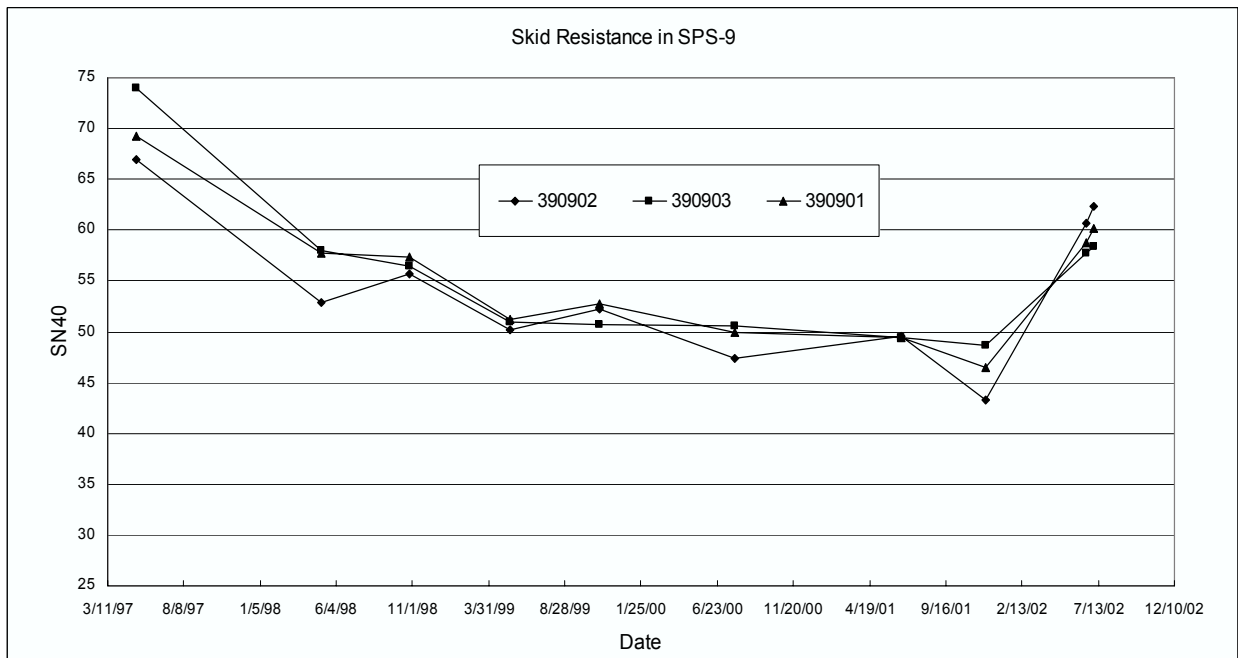
**Figure 2.13 Skid Resistance in SPS-9**

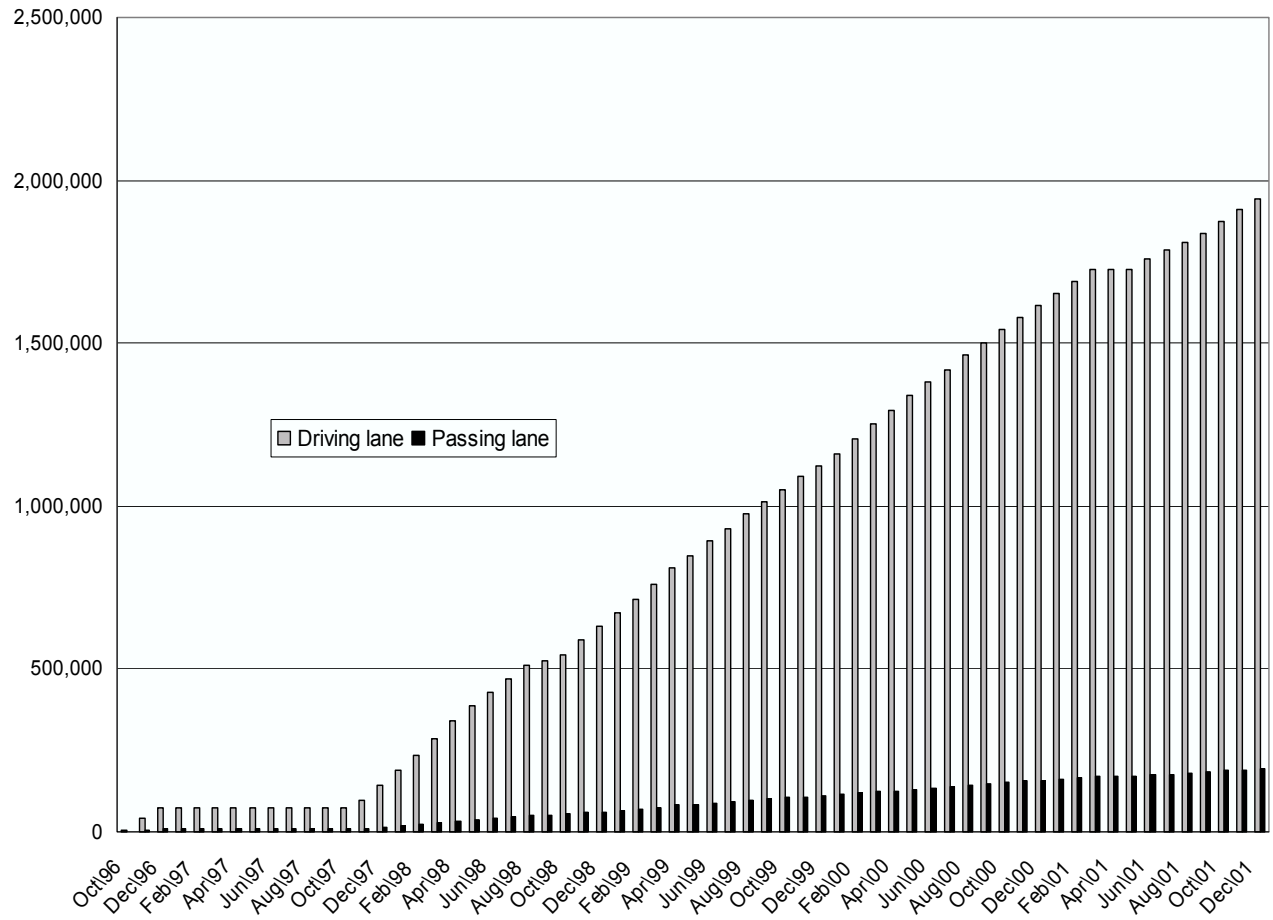
Figures 2.14 and 2.15 are plots of accumulated Equivalent Single Axle 18 Kip Loads (ESALs) measured by the weigh-in-motion scales mounted in the northbound and southbound pavement lanes, respectively. The number of ESALs in the southbound lanes containing the SPS-1 and SPS-9 experiments has been revised substantially upward from that shown earlier in the report entitled “Coordination of Load Response Instrumentation of SHRP Pavements – Ohio University,” published in May 1999. The northbound and southbound ESAL counts are amazingly close with both directions, averaging about 500,000 ESALs annually. Traffic data obtained on the ramp with a different WIM system was difficult to process and is not presented here, although informal on-site observations indicate traffic volumes were extremely low with only an occasional sighting of a commercial vehicle using the ramp.

**Figure 2.15 Accumulated ESALs Southbound (AC)**

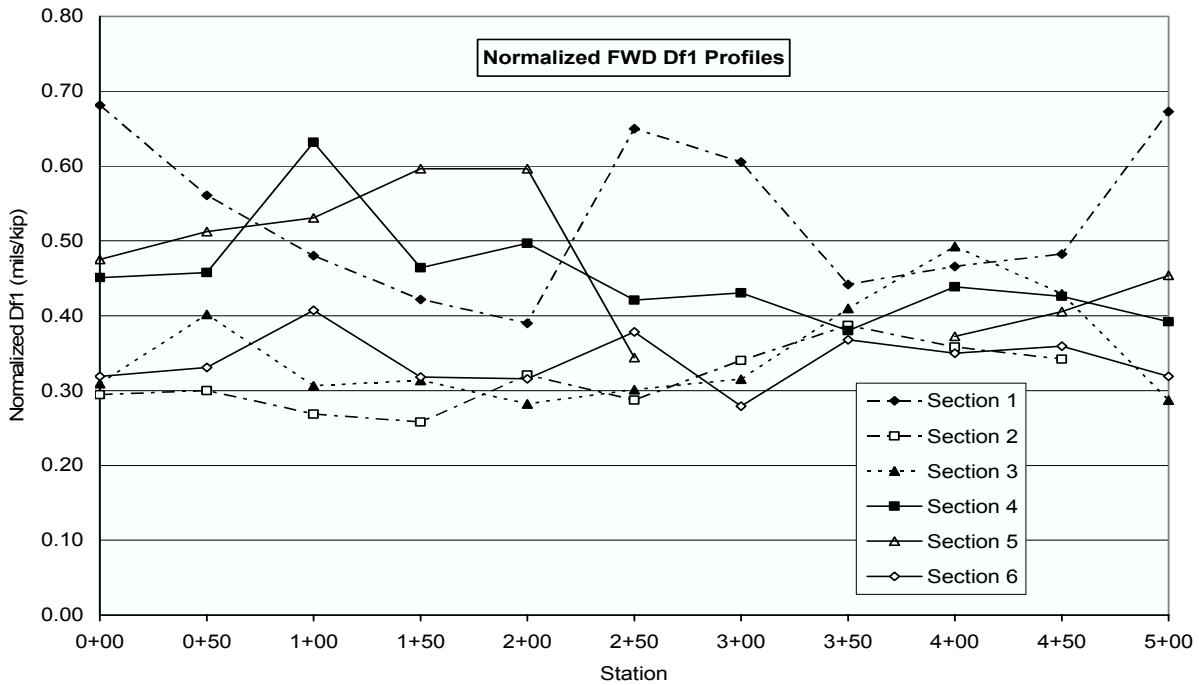
FWD measurements were conducted at 50-foot intervals along a 500-foot length of all six test sections to determine the relative stiffness of AC pavements with the various bases constructed on this pavement. Figure 3.1 shows the profiles of normalized DF1 measurements along the 500-foot lengths monitored and Table 3.4 summarizes the average section Df1 measurements obtained at loads approximating 9,000 lbs. In Section 5, a bridge deck between Stations 2+50 and 4+00 caused an interruption in the profile and the last point at Station 5+00 was not recorded in Section 2.

Figure 3.1 Normalized Df1 Profiles on LOG 33, June 1998

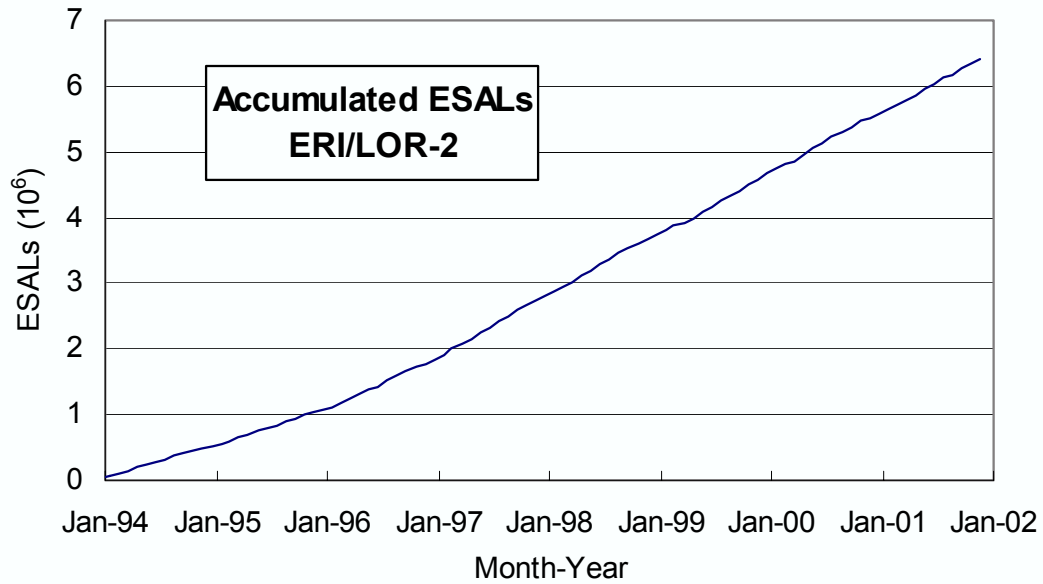
A significant increase in ESAL loading in March 1997 may have been about the time tolls were raised and construction was in progress on the Ohio Turnpike. In general, traffic loading was higher during the spring and summer months than during the fall and winter. Figure 4.1 shows the number of ESALs accumulated on this pavement since the test sections were constructed.

**Figure 4.1 Accumulated ESALs on ERI/LOR 2**

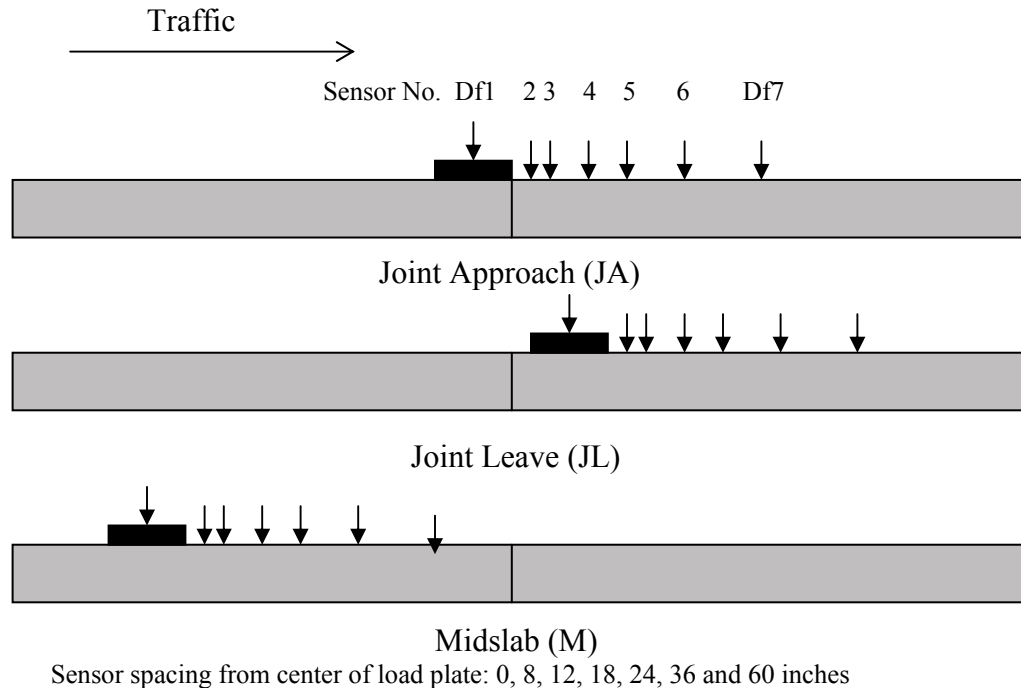
In this set of FWD measurements, a few slabs were selected for testing in each section containing a particular combination of joint spacing and base type. The load plate was placed on both sides of the joints and at one or more locations along the interior of the slab. In these configurations, the geophones measuring vertical surface deflection were located as shown in Figure 4.2. Readings were initiated at 8:40 am at which time the surface temperature of the pavement was 69° F and the pavement gradient would be expected to be minimal.

**Figure 4.2 FWD Load Plate and Sensor Positioning – June 1999**

Df1 deflections measured with the FWD load plate located in the middle portion of the slab reflect the composite vertical stiffness of the entire layered pavement structure, including the pavement, base and subgrade. When slabs are cracked, there is likely to be some reduction in stiffness. Every effort was made to have the FWD load plate and all geophones on an uncracked section of pavement; otherwise, there would likely be a discontinuity in the FWD deflection profile. Deflections measured with the FWD load plate located near a joint are indicative of the vertical stiffness of the slab ends at the time of the measurements. The presence of temperature and/or moisture gradients in PCC slabs causes the slab ends to curl and warp at the ends, thereby affecting the degree to which they are supported by the underlying layers. Therefore, the stiffness of slab ends can be low in the morning when they are curled upward and acting as a cantilever, and high in the afternoon as the pavement surface warms and brings the slab back into contact with the base layer. Once in contact with the base, slab end stiffness at joints is affected by moisture conditions in the base and subgrade around the joints.

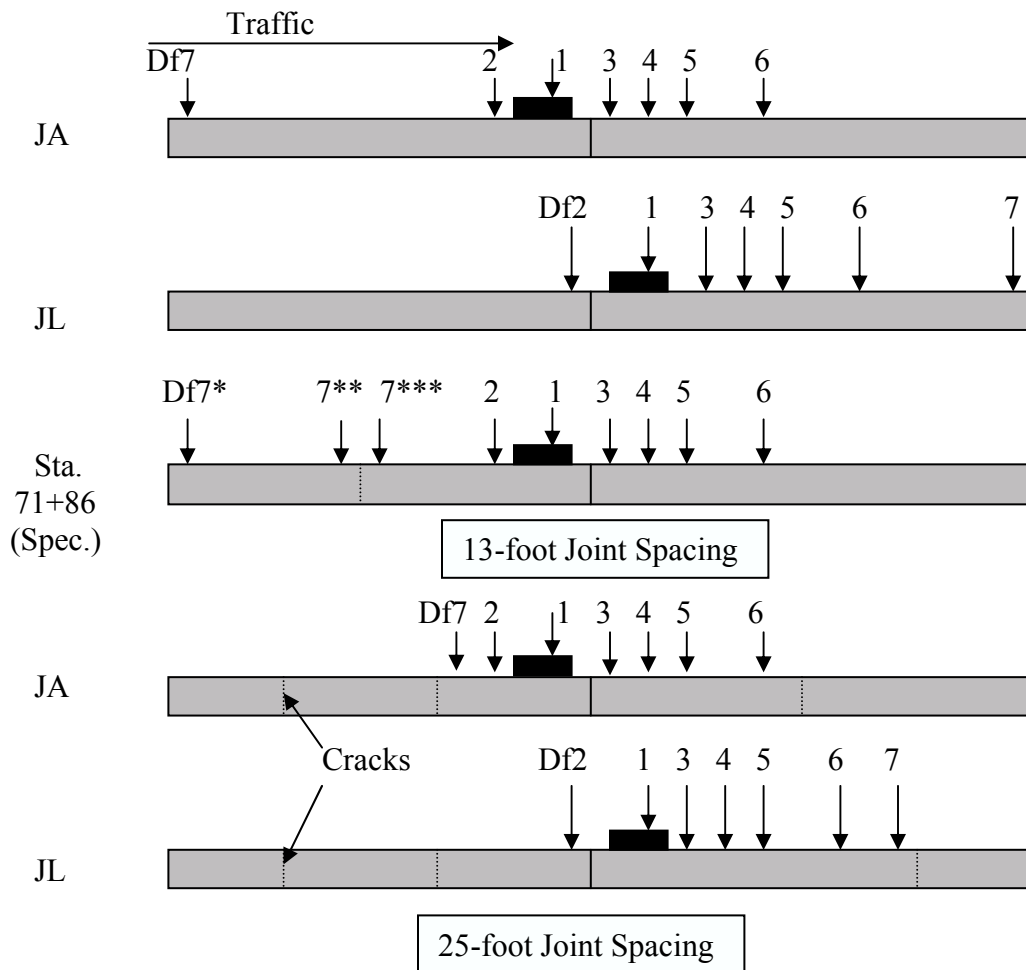
Sensor spacing from center of load plate: -12, 0, 12, 18, 24 and 36 inches, with Df7 being placed just inside the nearest crack or joint on the loaded slab

**Figure 4.3 FWD Load Plate and Sensor Positioning – August 1999**
