# **Instrumentation, Monitoring, and Testing at the CUY-90-15.24 Central Viaduct Project**

**Robert Y. Liang  
Department of Civil Engineering  
The University of Akron  
Akron, Ohio 44325-3905**

**June 2000**

16. Abstract A research project has been carried out to ensure construction safety and verification of design assumptions, and to gain insights on the foundation structure behavior of Bridge CUY-90-15.24, the Central Viaduct, also known as the Inner Belt Bridge, which is part of the Interstate Highway System in Cleveland, Ohio. The objectives include: (i) providing real-time measurements to allow project engineers to make sensible but critical decisions, (ii) long-term monitoring as part of bridge maintenance program to assess maintenance needs, (iii) re-assess design assumptions so that new knowledge can be gained and applied for future projects, (iv) Advance the knowledge on soil structure interactions and slope stabilization techniques, (v) form valuable database for current FHWA development of LRFD (Load Resistance Factor Design) for substructures, (vi) Perform FEM (Finite element Method) Simulation (Verified with Field Measurements) to provide further details of subst

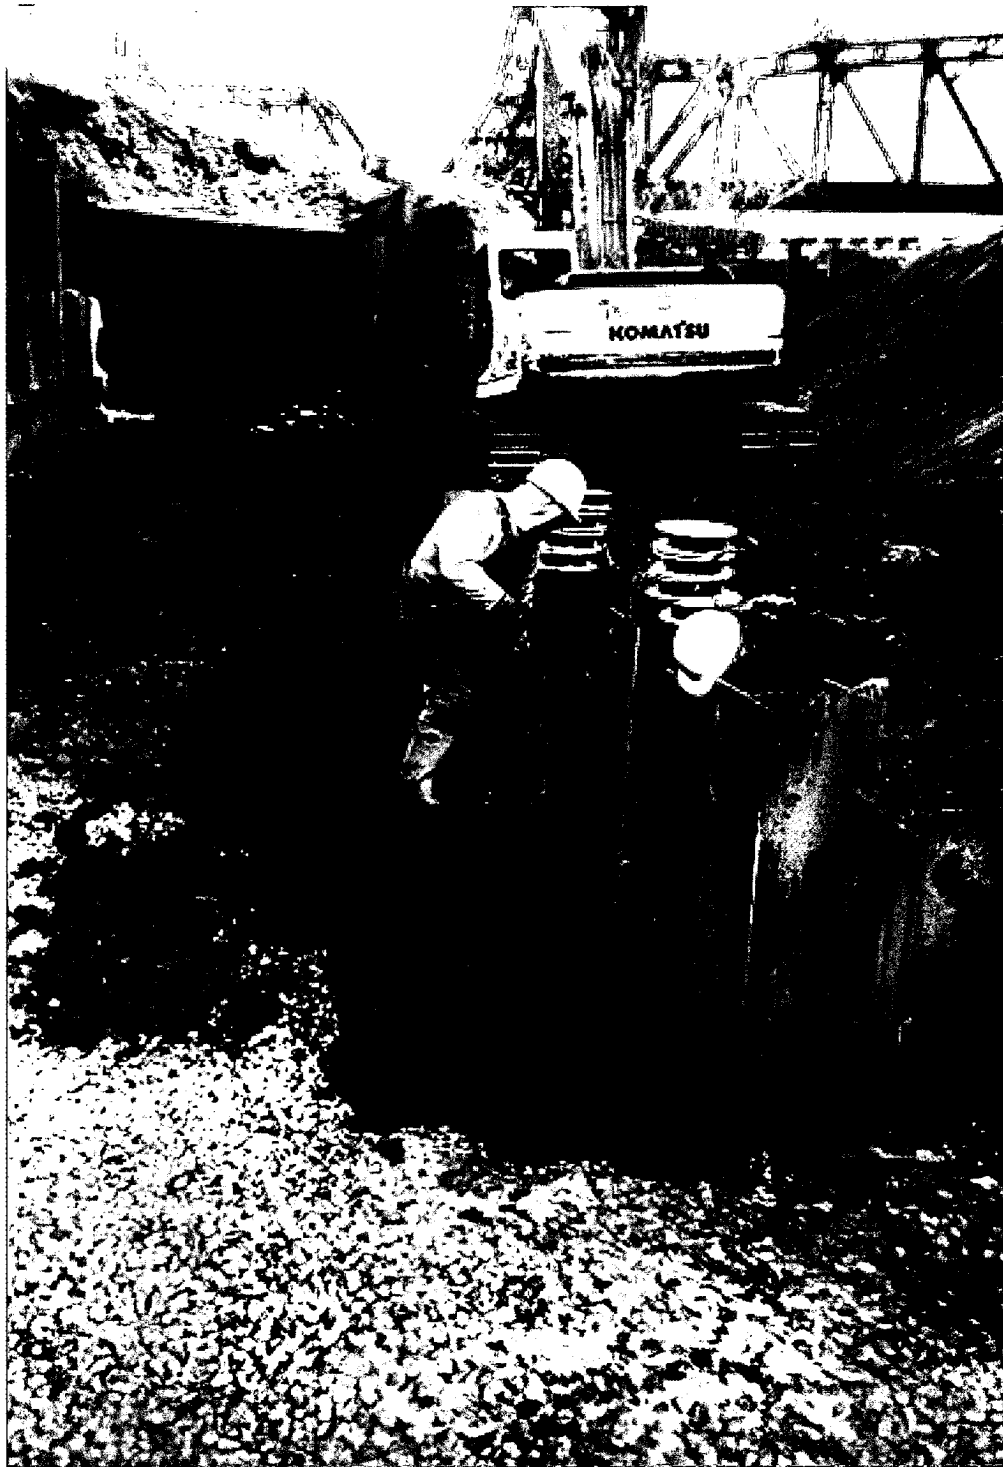
Fig. 3.7: Ground being filled to the final grade for the pile cap construction.

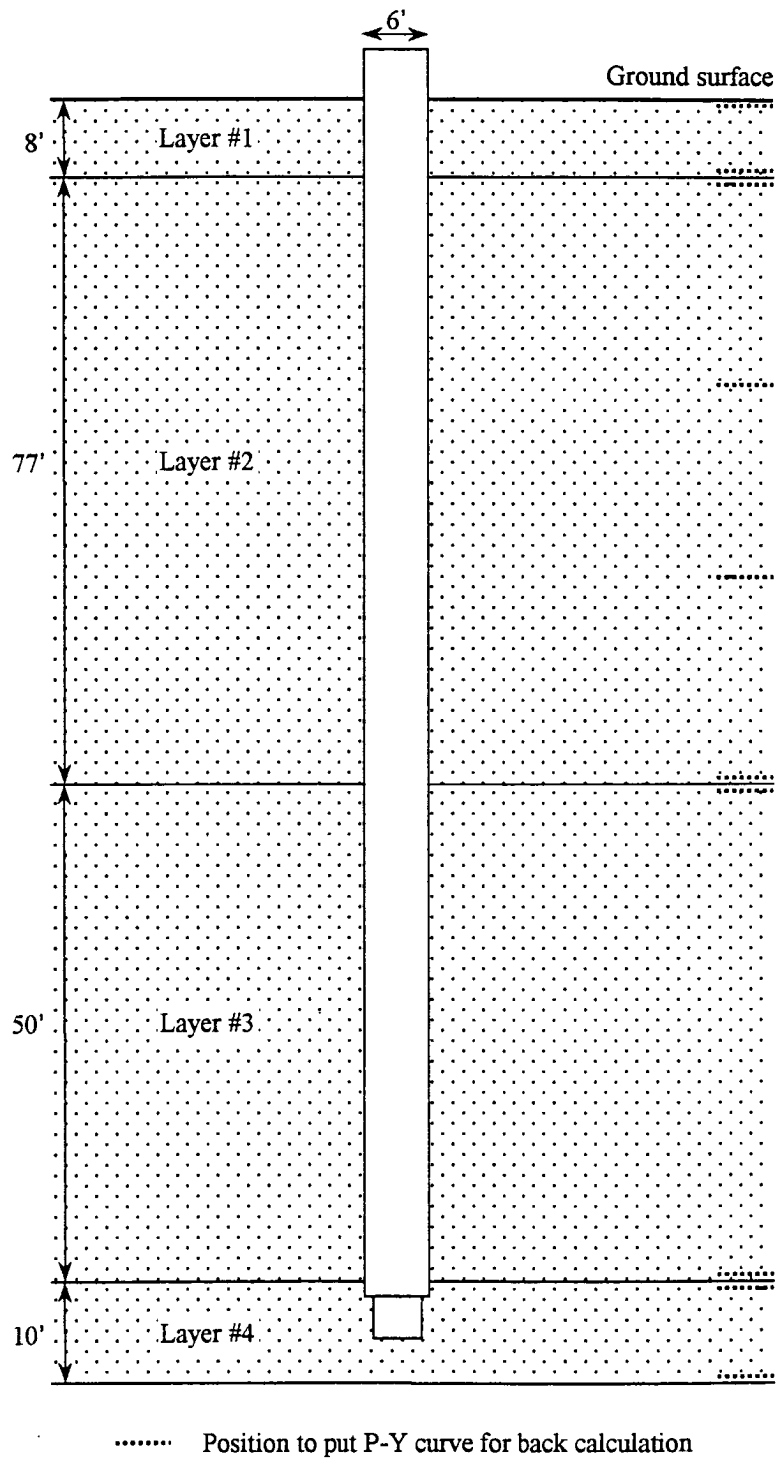
Fig. 6.1: The shaft geometry showing p-y curve positions  
(Shaft #1 at CUY-90-15.24 Project)

The back calculated p-y curves were then used in the COM624P program to predict the drilled shaft displacement under various lateral loads. The measured and the predicted deflections corresponding to 100 kips, 300 kips, 500 kips, 600 kips, 680 kips are shown in Fig. 6.6 ~ Fig. 6.10, respectively. Furthermore, presented in Fig. 6.11 is the measured and predicted load vs. displacement at the head of the drilled shaft. The predicted displacements by the back calculated p-y curves using the inclinometer data are much closer to the measured displacements when compared to the predictions based on the SPT correlations.
