# Forensic Investigation of AC and PCC Pavements with Extended Service Life

## Volume 1

Report FHWA/OH-2010/004A

for the  
Ohio Department of Transportation  
Office of Research and Development

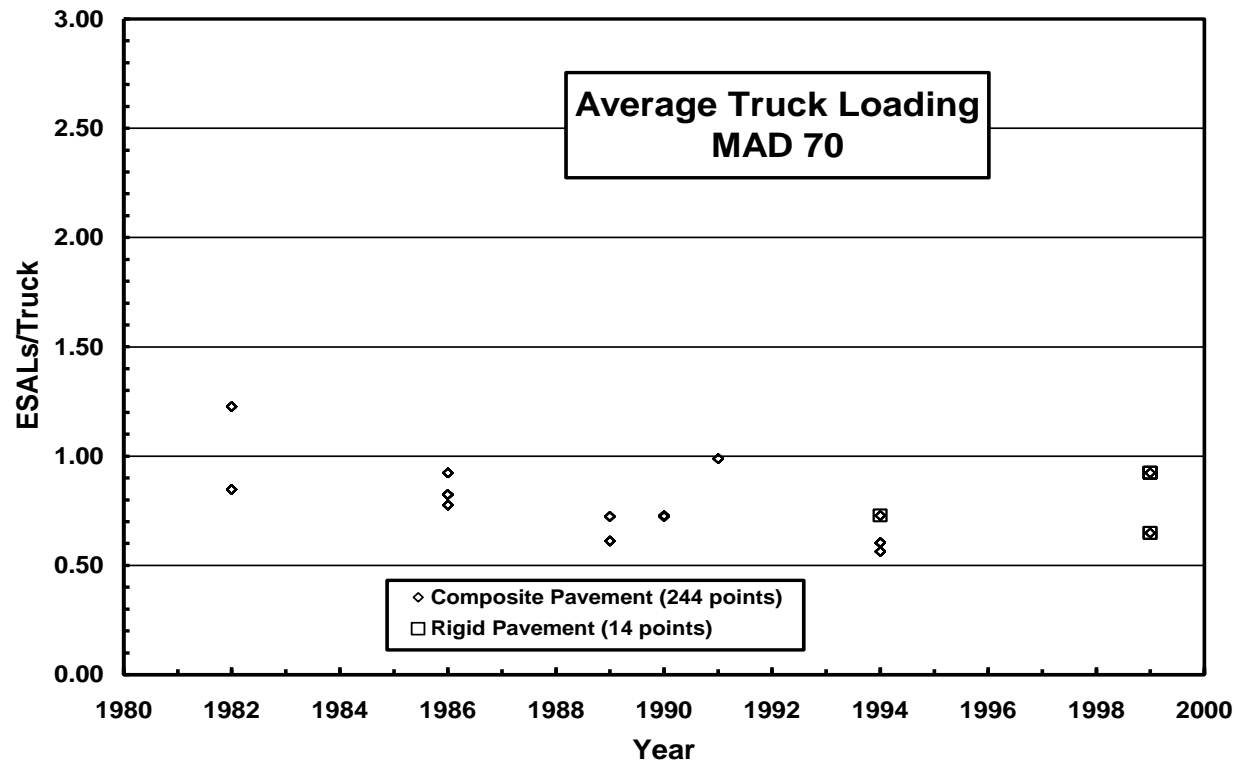
Figure 2.1 – ESALs/Truck Calculated on MAD 70

While it was possible to sort out pavement projects which appeared to be viable candidates using the DATA\_Project History tables, a problem occurred when a quick check was performed on traffic data in the DATA\_ODOT tables. Daily ESALs were divided by average daily truck volumes to determine an average number of ESALs per truck. These values were calculated annually on sections of arbitrarily selected routes through a few counties from 1982-2000. Some routes consistently maintained values between 0.50 to 1.00 ESALs/truck, which was reasonable, while other routes had values ranging from 0.20 to almost 3.00 ESALs/truck. Figure 2.1 shows good data on I-70 through Madison County, an interstate route carrying a high volume of trucks, and Figure 2.2 shows highly variable data on US 33 through Athens County, a primary route carrying light truck traffic. Based on the wide variations in ESALs/truck calculated over time and over various other routes, it was decided that traffic loading data were unreliable in the PMIS, and plans were altered to use pavement condition ratings versus age instead of pavement condition ratings versus accumulated traffic loading to evaluate pavement performance. This procedural change of using age rather than traffic loading to select pavement projects was not expected to have a significant impact on the outcome of the research since pavement designs are based on B&C truck volumes estimated for the design life of the pavement.

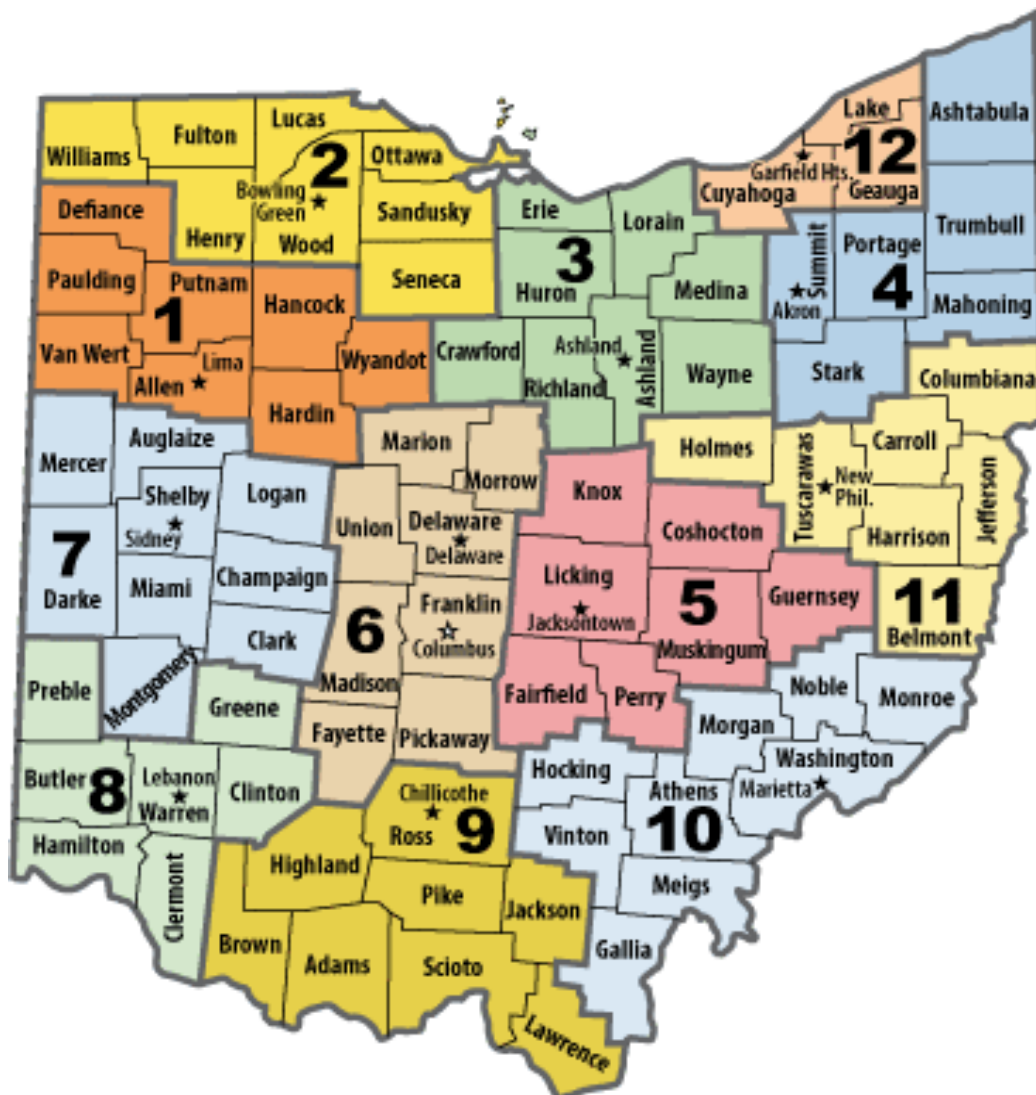
Figure 2.9 – ODOT Field Districts

Figure 2.9 shows the layout of field districts in ODOT, and Figures 2.10 and 2.11 show the performance of flexible and rigid pavements by district. While the trends in Figures 2.10 and 2.11 are interesting, they represent very limited data and cannot, therefore, be considered as reliable indicators of district performance. Figure 2.10 consists of about 1,700 ratings from 42 sections of flexible pavement in ten counties, and Figure 2.11 consists of about 1,700 ratings from 30 sections of rigid pavement in eleven counties.

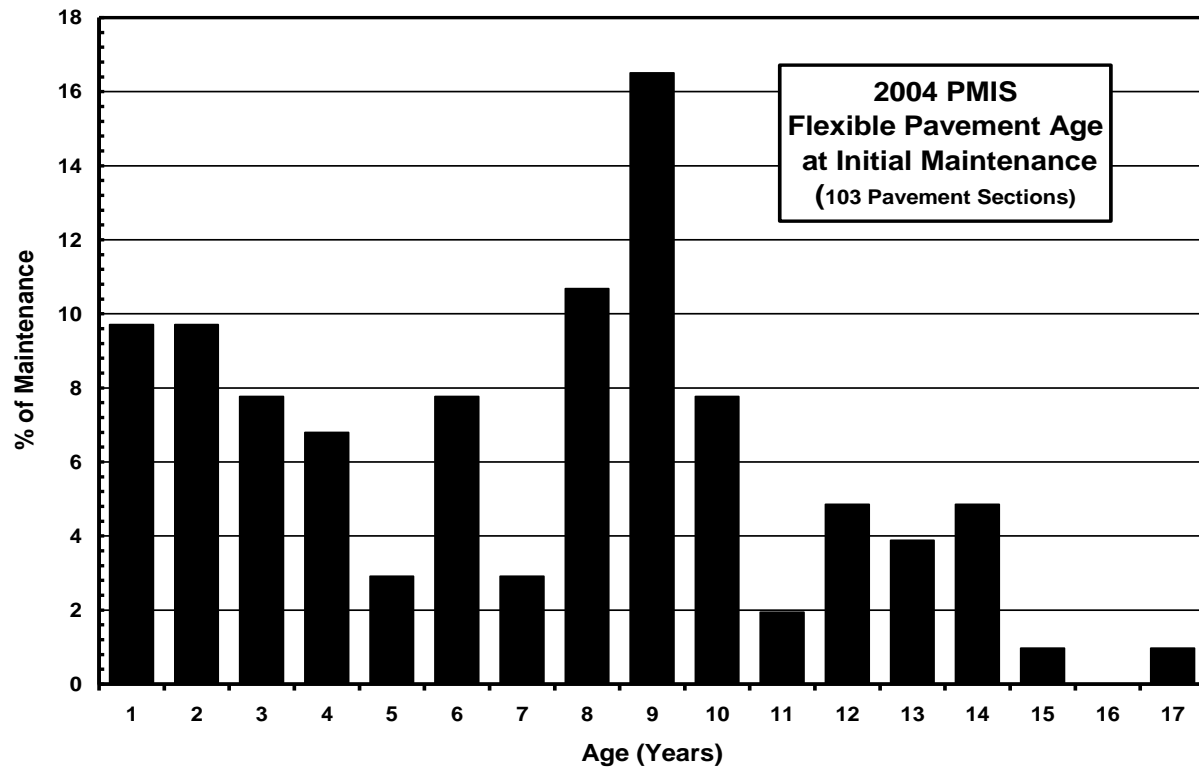
**Figure 2.12 - Frequency of Initial Maintenance on Flexible Pavements**

Figures 2.12 and 2.13 show maintenance being performed on flexible pavements over the first 10 years after construction and then tapering off. Figures 2.14 and 2.15 show that, while a few rigid pavements received maintenance soon after construction, most of the maintenance occurred 15 – 25 years after construction and then tapered off over the next 15 years. Figures 2.16 and 2.17 show the data in Figures 2.12 – 2.15 expressed as cumulative percentages of all initial maintenance and AC 50/60 initial maintenance. Figures 2.18 and 2.19 show the cumulative percentages separated out by district with data points being removed to clarify the polynomial trendlines. As discussed earlier, many factors other than performance can affect the timing of pavement maintenance in the ODOT districts. These factors, plus the limited number of projects available in individual districts, restrict the reliability of the district trendlines, especially for flexible pavements. The high percentage of AC 50 and AC 60 maintenance projects dominate the bar charts and cumulative distributions statewide.

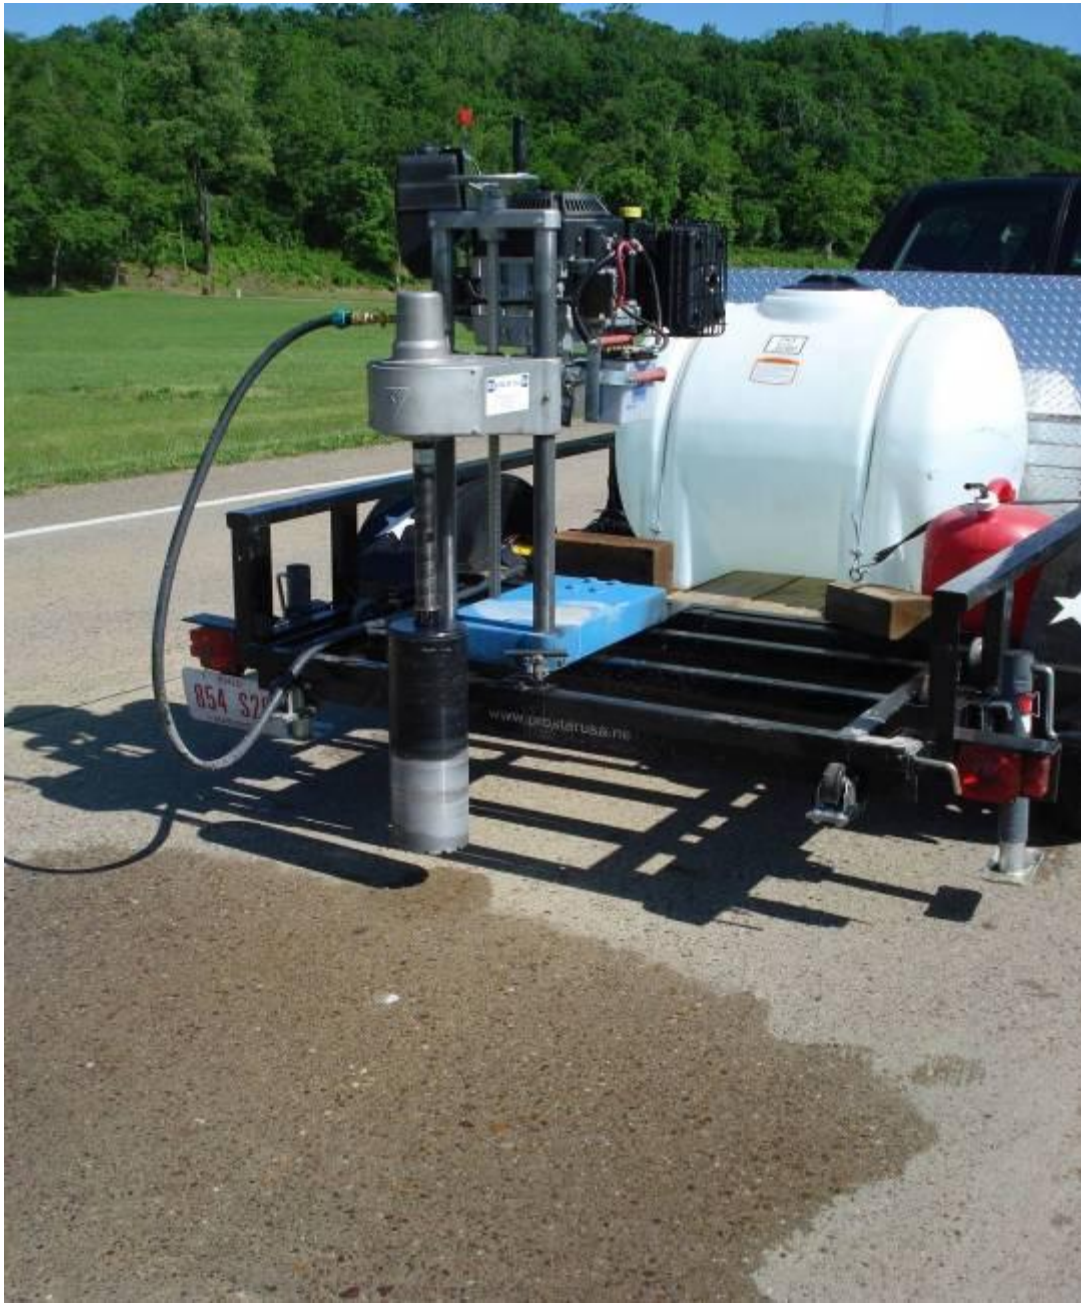
**Figure 3.2 – Core Rig Fabricated by ORITE**

Figure 3.2 shows the core rig fabricated by ORITE for ODOT. After cutting, the cores were dried, labeled by county, route, nearest mile marker, direction of travel and core number, and wrapped in bubble wrap to minimize damage during transit to the laboratory. Pictures were taken of any unusual features at the site and on the cores. After coring was completed at each site, samples of base and subgrade material were removed from two or three core holes along the section length with a hand trowel and auger. A Dynamic Cone Penetrometer (DCP) was used to determine the stiffness of the base and subgrade in three to five other holes down to a depth of about 2-3 feet (0.6-0.9 m). Hard base material or large rocks in the subgrade sometimes limited the depth of DCP testing. The Ground Penetrating Radar (GPR) device at ORITE was not functional for scanning the sampling and testing area, and a 6 foot (1.8 m) long straightedge with a graduated wedge was used to measure rut depths on flexible pavements.

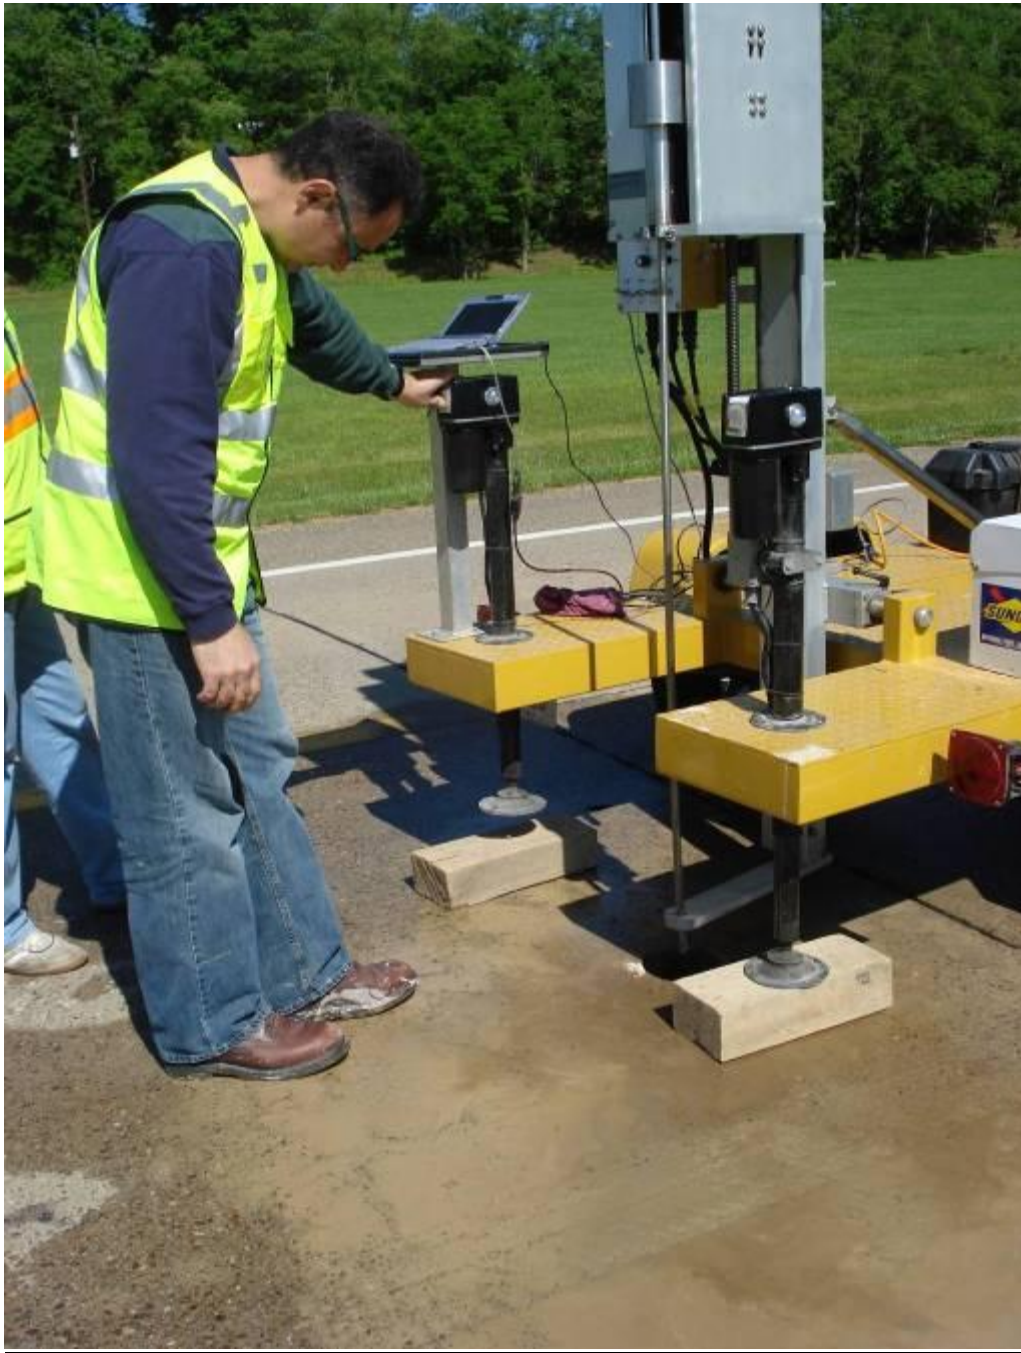
**Figure 3.3 – DCP Owned and Operated by ORITE**

The DCP unit used on this research project is shown in Figure 3.3. The steel cylindrical weight near the top of the picture, weighing 17.6 lbs. (8 kg), is raised and repeatedly dropped 22.6 inches (574 mm) onto a smaller cylindrical piece of steel affixed to the long penetration rod until the rod reaches its full depth of penetration or until something hard is encountered which stops the rod. The penetration rate (PR) is determined as the vertical depth attained per blow of the weight. Data were collected in up to five core holes at each site to determine the vertical resilient modulus profile of unbound aggregate and subgrade supporting the pavement to a depth of up to ~36 in. (91.4 cm) below the pavement. Because these materials are non-homogeneous, penetration rates varied with depth. Before in-situ soil stiffness can be determined, there must be a reduction of noise in the trace, usually caused by the rod hitting stones, and a definition of “uniform” layers. Noise reduction is accomplished by removing any single blow penetration of 1 mm (.04 in.) or less, and any reading less than one-fourth of the adjacent two readings. PR is then recalculated for the adjusted number of blows with large spikes in modulus being removed.

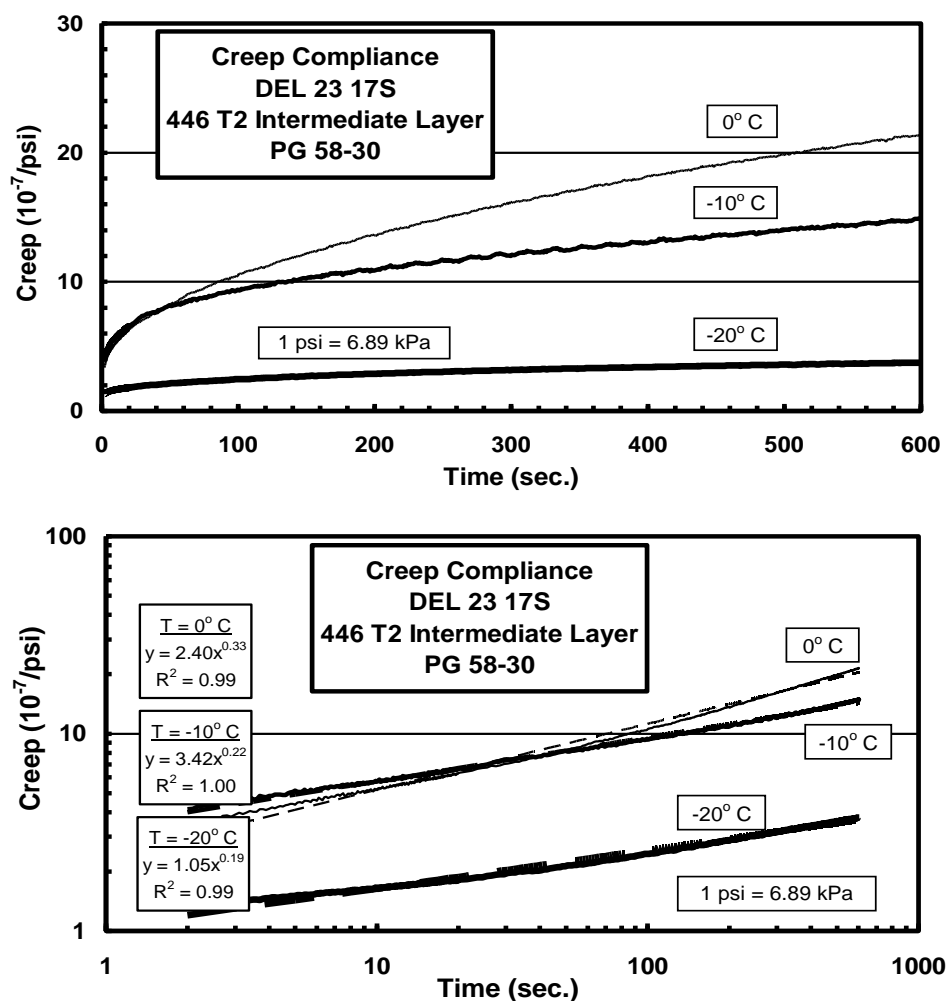
Figure 4.4 – Creep Compliance on DEL 23 17S

Figure 4.4 shows linear and log-log plots of creep compliance on the DEL 23 17S intermediate layer where, as expected, creep compliance increased with time and temperature. Power trendlines of the form  $y = Ax^B$ , where  $A$  is the creep at one second and  $B$  is the slope of the curves on log-log plots, describe short and long term creep, respectively. Constants  $A$  and  $B$  should both increase with rising temperature. Because creep compliance measured in the first second was consistently low, and because  $R^2$  on all creep compliance trendlines calculated between two and 600 seconds ranged between 0.97 and 1.00, the trendlines were extrapolated back to calculate creep at one second. The DEL 23 17S data were most consistent of the intermediate layer materials tested for order and spacing of the temperature curves. All intermediate and base creep compliance plots are shown in Appendix G.

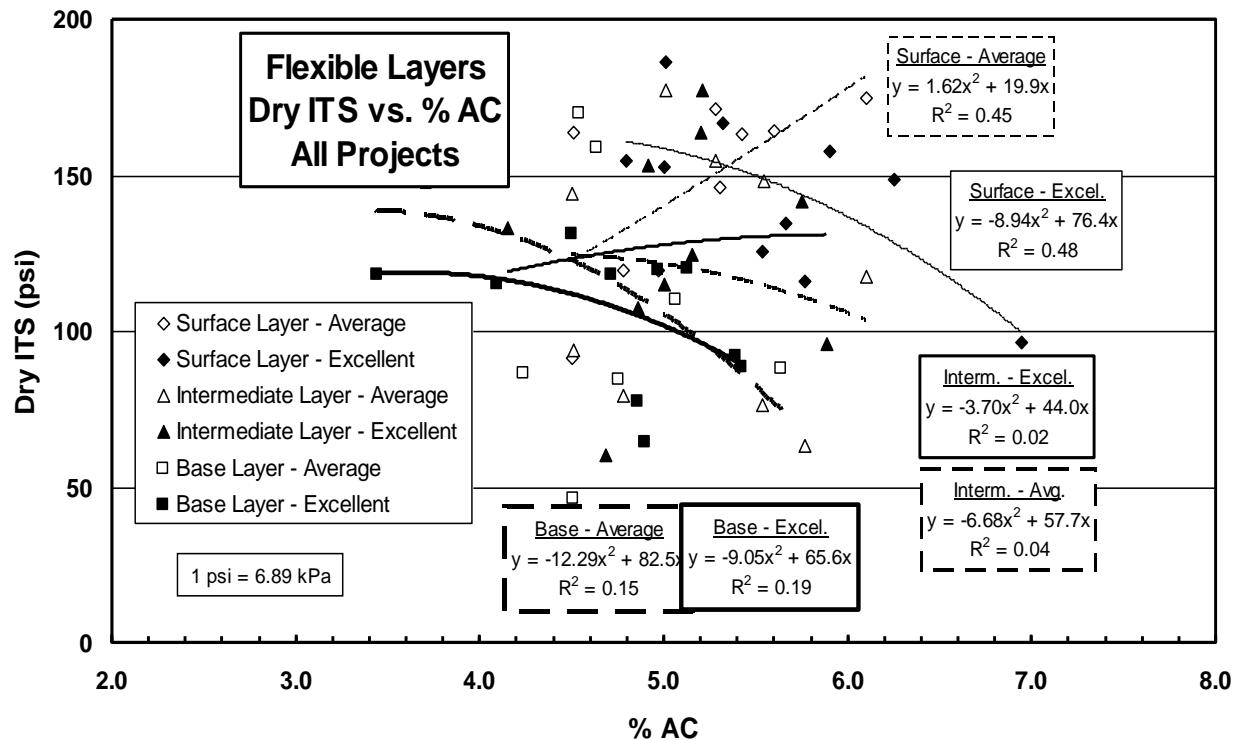
**Figure 4.23 - % Asphalt Cement vs. Indirect Tensile Strength by Layer and Performance**

Figure 4.23 shows the same data in Figure 4.22, but broken down by level of performance. With fewer points available for each group of data, the trends become more uncertain, although  $R^2$  for the average and excellent performing surface courses are much better than the combined data in Figure 4.22. The trendline for average performance on the surface layer, while having an improved  $R^2$ , has an entirely different shape than the other trendlines.

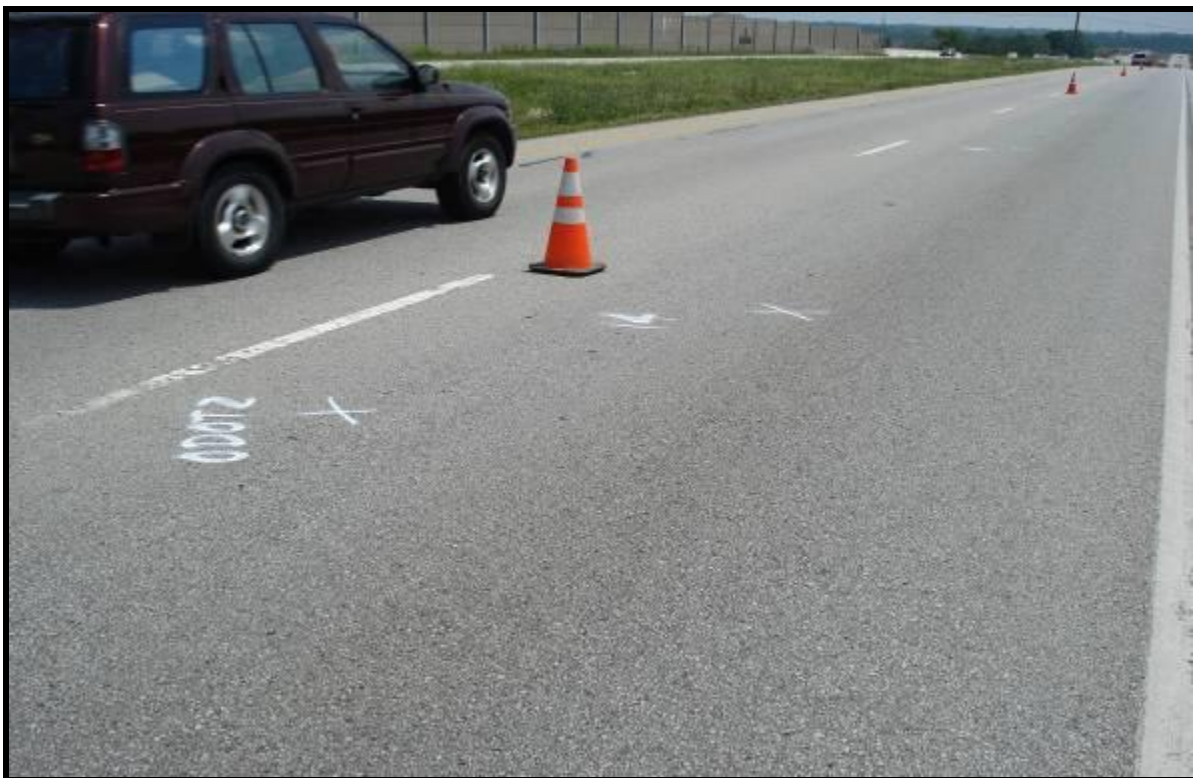
**Figure E1. – BUT 129 22 E Surface**

BUT 129 22E and BUT 129 22W were selected as paired sections because of their differing performance under similar location and design conditions. The sites was located over an 800 feet (244 m) length of pavement west of MP 22. As determined with the PCR rankings, this eastbound pavement was in excellent condition, as shown in Figure E1. No measurable distress was visible and rutting in the right wheelpath was less than 1/16 inch (2 mm). On one core, the 446 layers delaminated from the 302 layer.

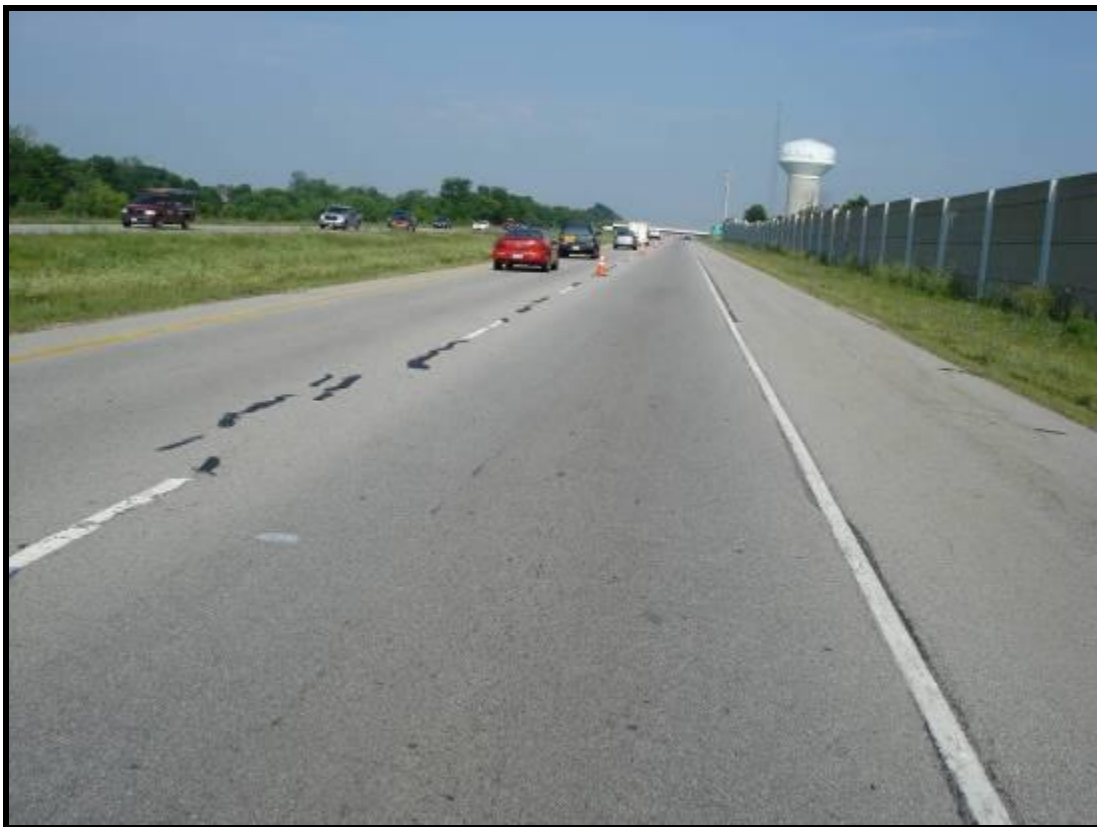
**Figure E2. – Longitudinal Centerline Cracking on BUT 129 22 W**

These westbound lanes had some longitudinal cracking along the centerline of the pavement. Some of this cracking had been sealed, as shown in Figure E2, and some unsealed cracks had evidently developed since the sealing. Rutting in the right wheelpath was slightly more in the westbound lanes than in the eastbound lanes, at 1-2/16 inch (2-3 mm). One core delaminated between the 302 lifts, as shown in Figure E3. This figure also shows the ATFD base at the bottom of the core.

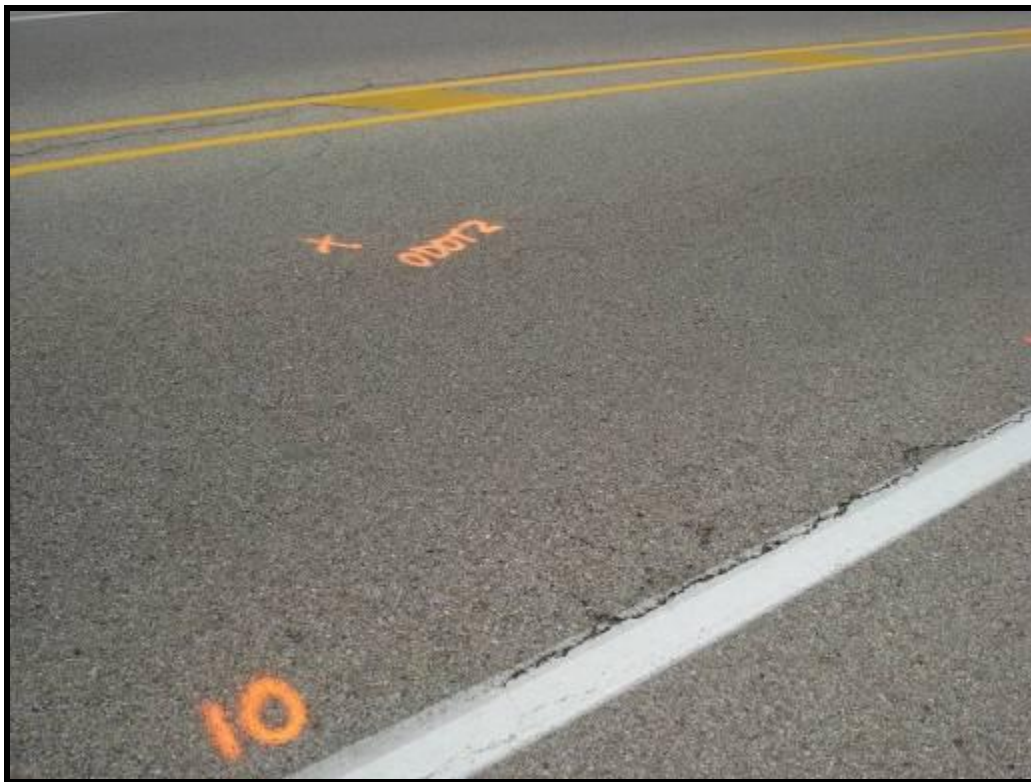
**Figure E4. – Minor edge cracking on CHP 2 N**

This rural pavement was in excellent condition, as determined from the performance ratings. The site selected for sampling and testing was in an area where a four lane pavement was transitioning to a two lane pavement. Section CHP 68 2.5N served as a paired complement of this section providing average performance. Figure E4 shows some minor longitudinal cracking along the pavement edge, which likely was the joint separating the pavement and shoulder. There was also some slight random cracking. Rutting in the right wheelpath ranged from 1-2/16 inches (2-3 mm).

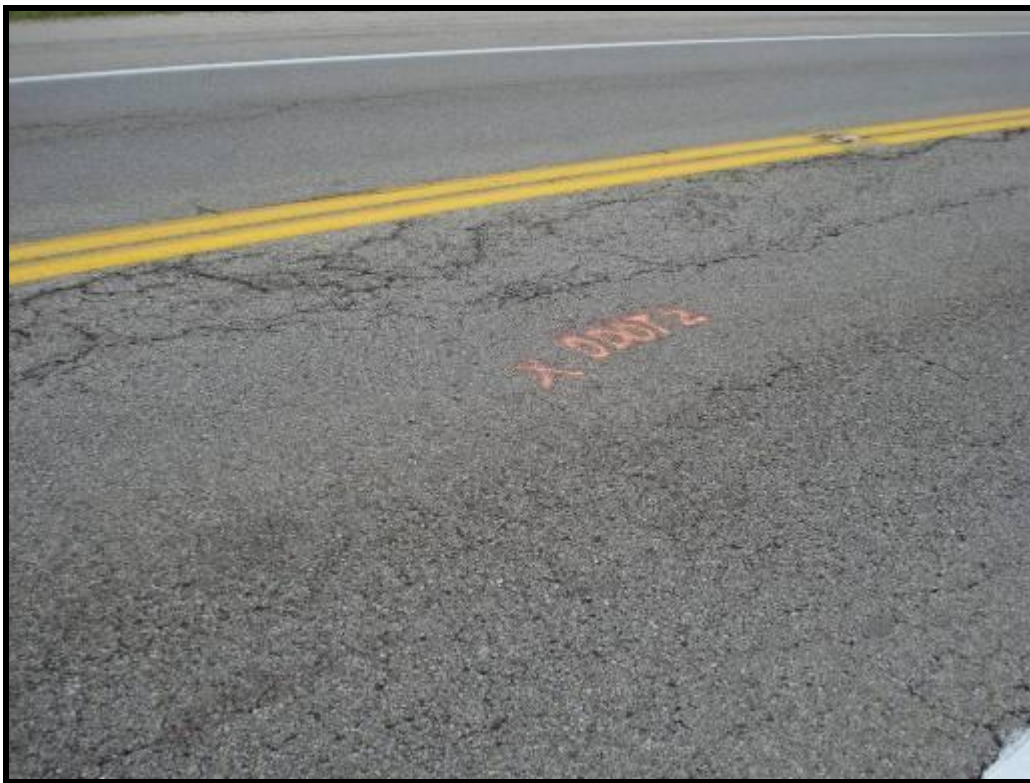
**Figure E5. – Surface Cracking on CHP 68 2.5N**

This section was a two lane complement immediately north of Section CHP 68 2N, which showed excellent performance. Distresses included moderate cracking along the pavement centerline, as shown in Figure E5, and other cracking along the center and edge of the lane. Rutting in the right wheelpath was approximately 2/16 inches (3 mm) deep. As cores were cut, it became apparent that the left wheelpath was more severely rutted than the right wheelpath. Figure E6 shows the differences in rutting between the right and left wheelpaths, and how water ponded in the left wheelpath, but not the right wheelpath. The cores suggested some possible problems with consolidation in the 301 base. Figure E7 shows large voids at the joint between two lifts of 301 and some of the 301 at the bottom of other cores crumbled as the cores were being cut. The worst zone of crumbling was over a 50 foot (15.2 m) length of pavement nearest MP 2.

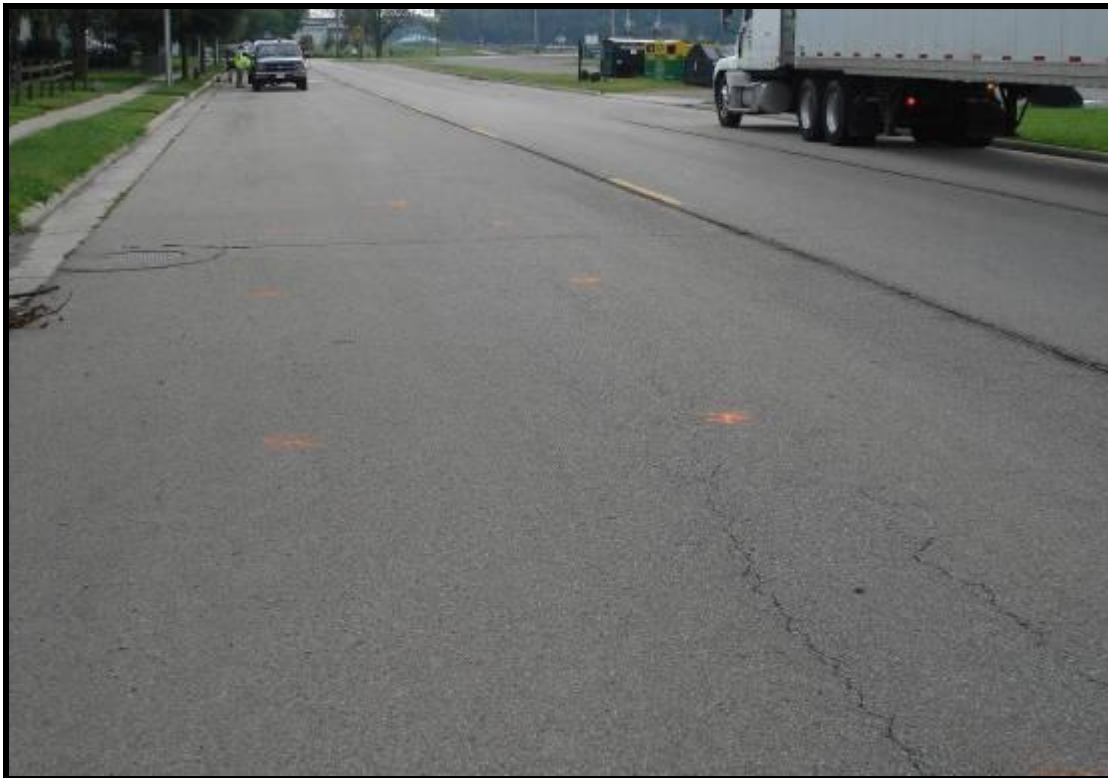
**Figure E8. – Surface Cracking on CLA 41 3N**

The CLA 41 3 N site was located on a residential portion of northbound SR 41 near the south edge of South Charleston which lead to a grain storage facility and the center of town. Loaded trucks use this route in the fall to deliver grain from fields in the area. Figure E8 shows some minor longitudinal cracking in the left wheelpath and a transverse crack at a manhole along the right edge of the pavement, which was bounded by a concrete curb and gutter. This 20 foot (6.1 m) wide pavement lane was able to provide parallel parking along the curb. Rutting in the right wheelpath was minimal at 1-3/32 inches (0.8-2.4 mm). Core thicknesses varied from 9 ¾ - 12 ½ inches (24.8-31.8 cm).

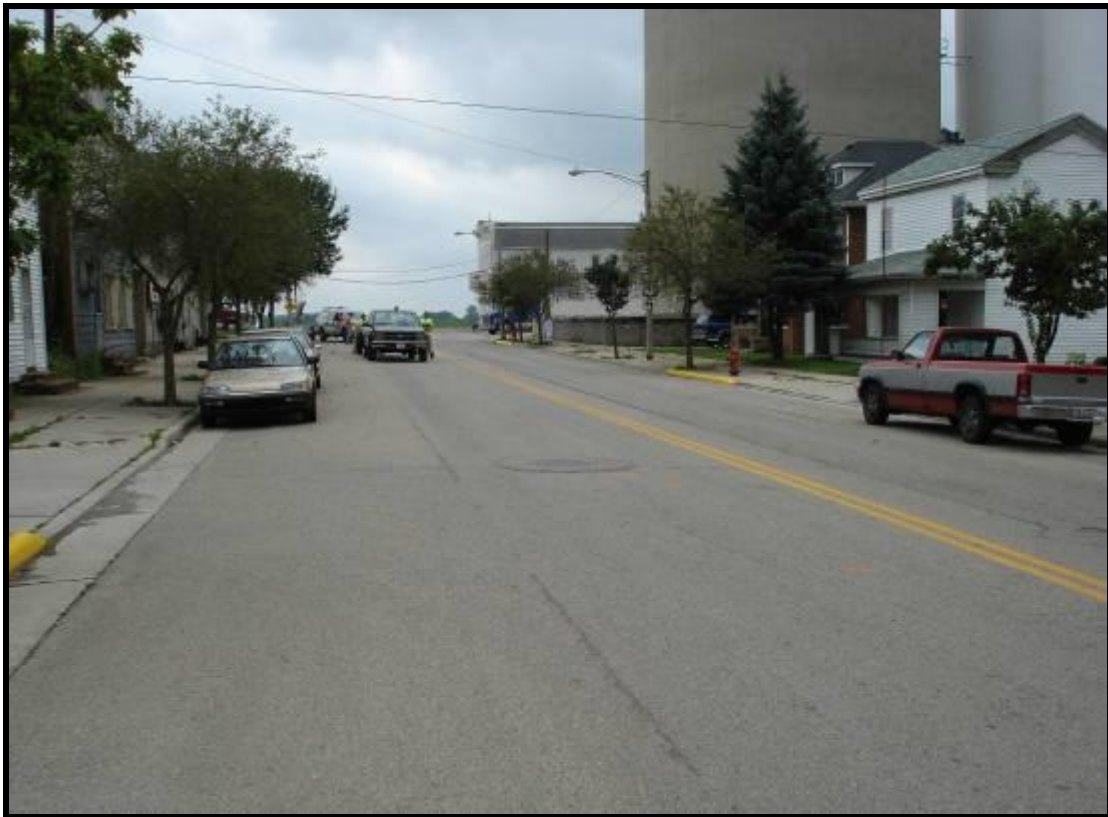
**Figure E9. – Layout of CLA 41 4N**

This pavement section is a complement of CLA 41 3N, which is around the corner in Figure E9 where the core and DCP vehicles are coming into view. The grain storage facility in the background was mentioned in the discussion for CLA 41 3N. A long longitudinal crack, which appeared to be a construction joint, was present over the length of the section. Rut depths ranged from 1-5/32 inches (1-4 mm) along the project.

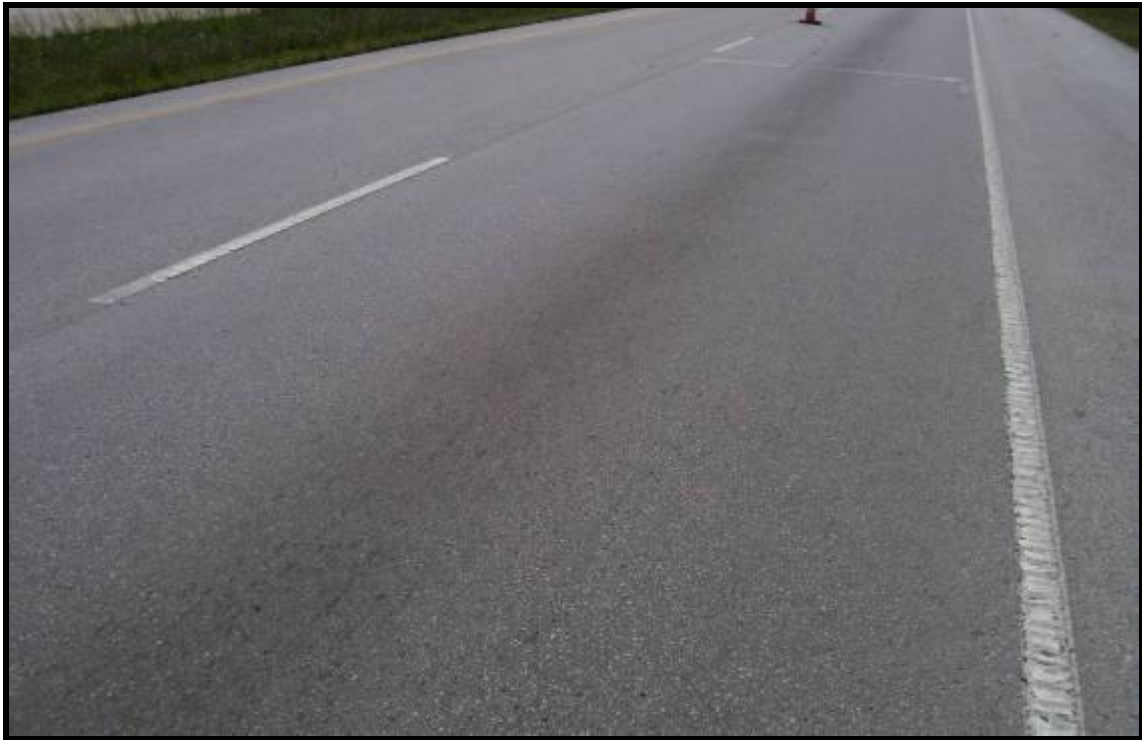
**Figure E10. – Surface of Section 902 on DEL 23**

This original section in the SPS-9 experiment on the DEL 23 SHRP Test Road has remained in excellent condition since construction in 1984, as shown in Figure E10. Asphalt cement in this section was PG 58-28. Maximum rutting measured in the right wheelpath of this 500 ft. (152 m) long section was 1/8 " (3 mm). All cores were taken outside the SHRP section to retain its research value.

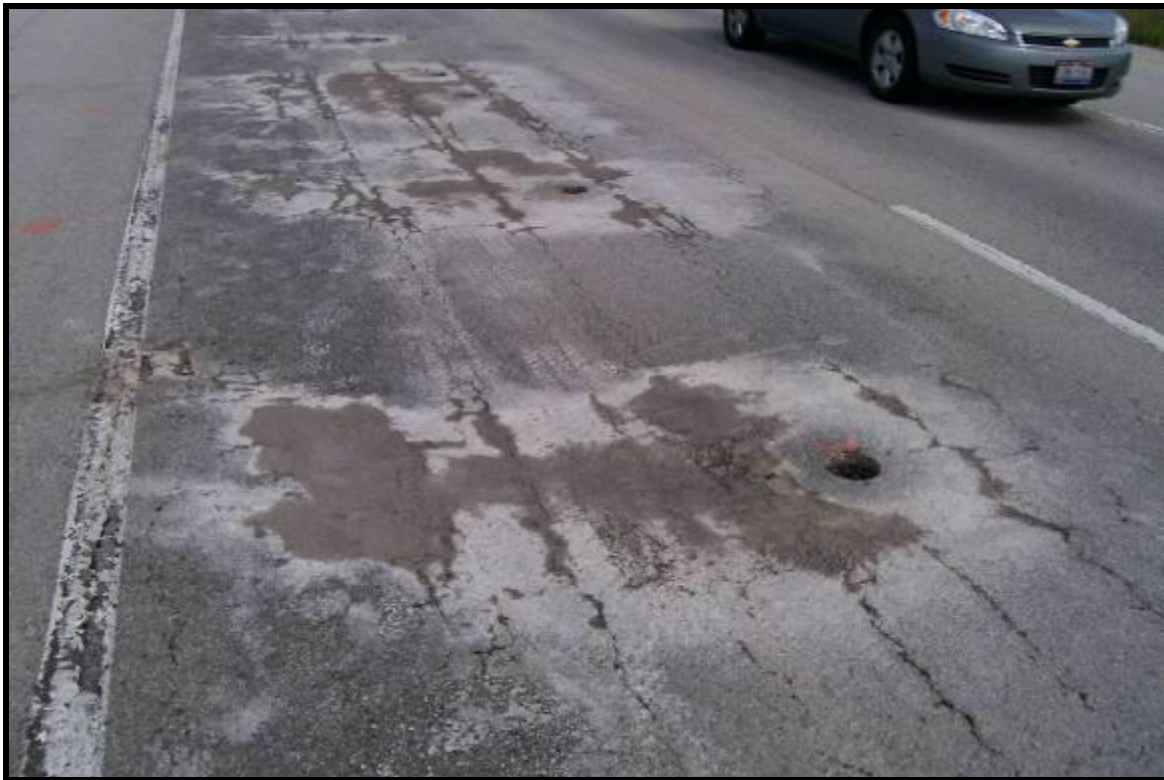
**Figure E11. – Surface of Section 112 on DEL 23**

This section was part of the SPS-1 experiment on the DEL 23 SHRP Test Road. The build up on this section is very similar to Section 902 discussed above, except that the asphalt cement was standard AC 20 rather than PG 58-28 in Section 902, and there was no 304 aggregate layer on the bottom. Cores were removed outside the 500 ft. (152 m) long SHRP section and rutting was limited to 1/16" (2 mm). Figure E11 shows patterns of longitudinal cracking made more evident by moisture from the coring operation. Cores removed from Section 112 showed various degrees of distress from delamination at a 301 lift line to deterioration of the 446 T1 near a longitudinal crack shown in Figure E11. Figure E12 shows delamination of a 301 lift and Figure E13 shows how the surface course had deteriorated in the cracked areas. These distresses were not present in Section 902 on DEL 23, as shown in Figure E10.

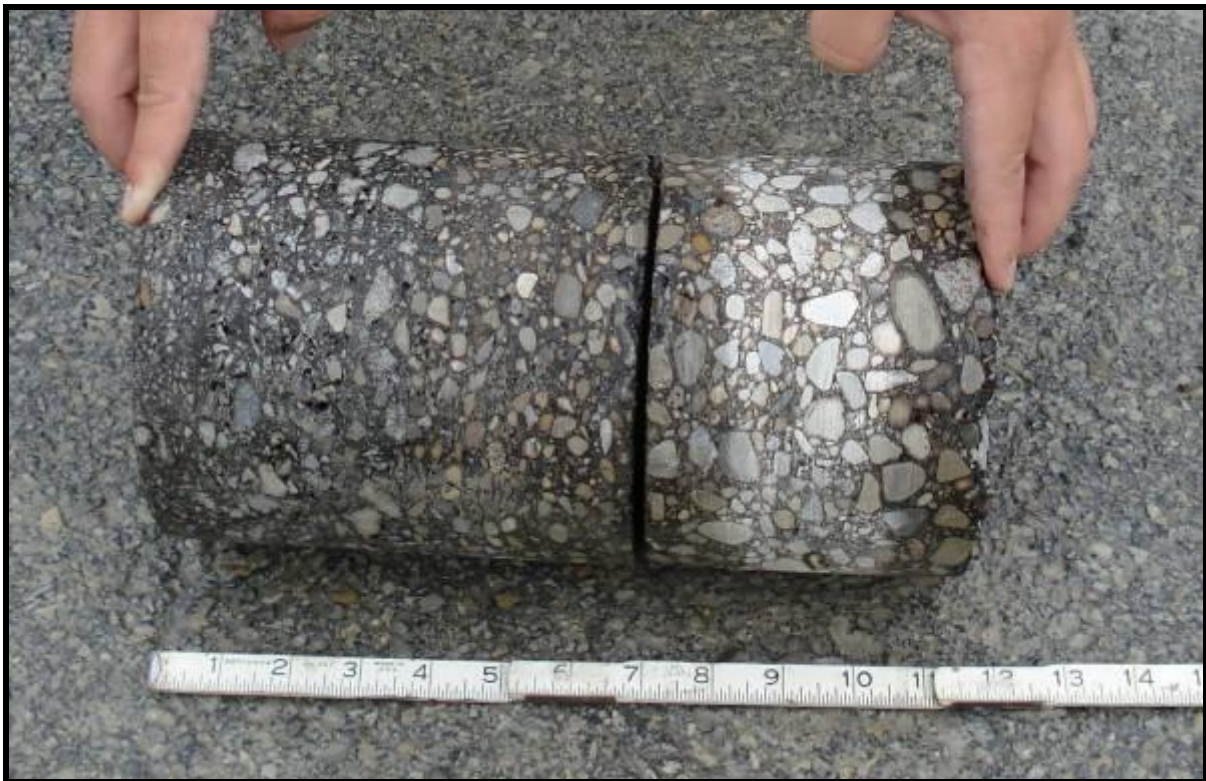
**Figure E14. – Delamination of 301 on GRE 35 21E**

This pavement received a 1 inch (2.5 cm) thick overlay of asphalt concrete in 2008 but, since all performance data were prior to 2004, it was retained in the study. The one inch (2.5 cm) AC overlay was removed before testing. A couple of cores delaminated between the two lifts of 301, as shown in Figure E14.

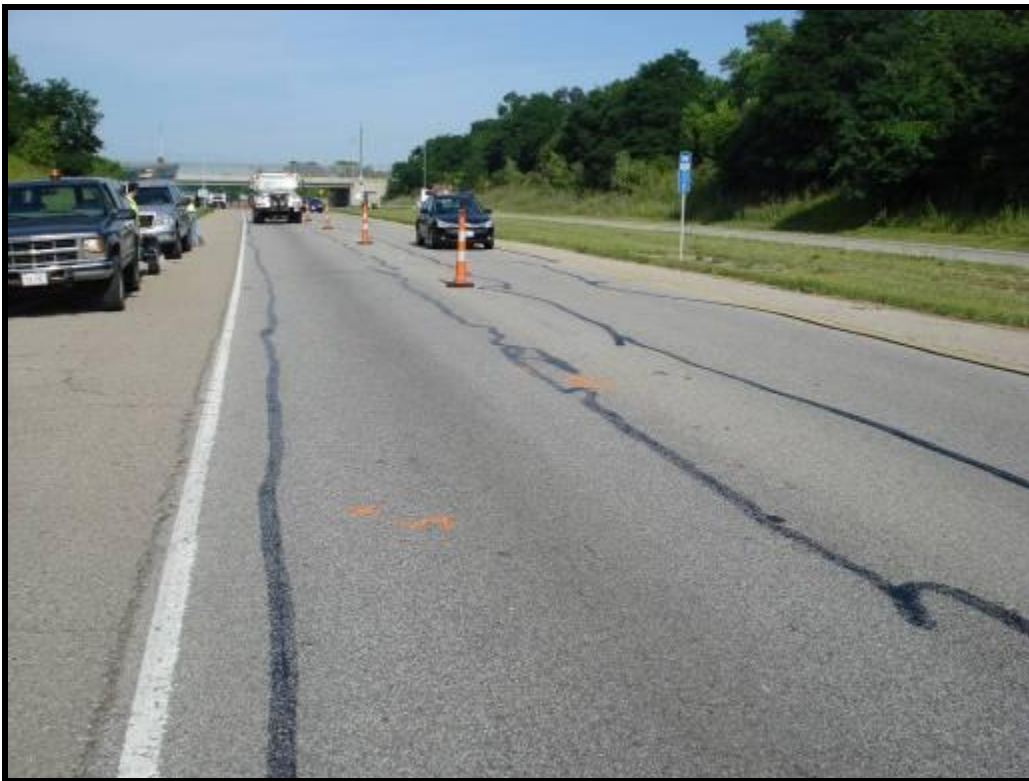
**Figure E15. – Surface on HAM 126 11E**

This pavement was located on a lightly traveled section of HAM 126 approximately three miles (4.83 km) west of I-75. The pavement had sealed longitudinal cracks shown in Figure E15 but, otherwise, was in good condition. Ruts were approximately 1/8" (3 mm) deep.

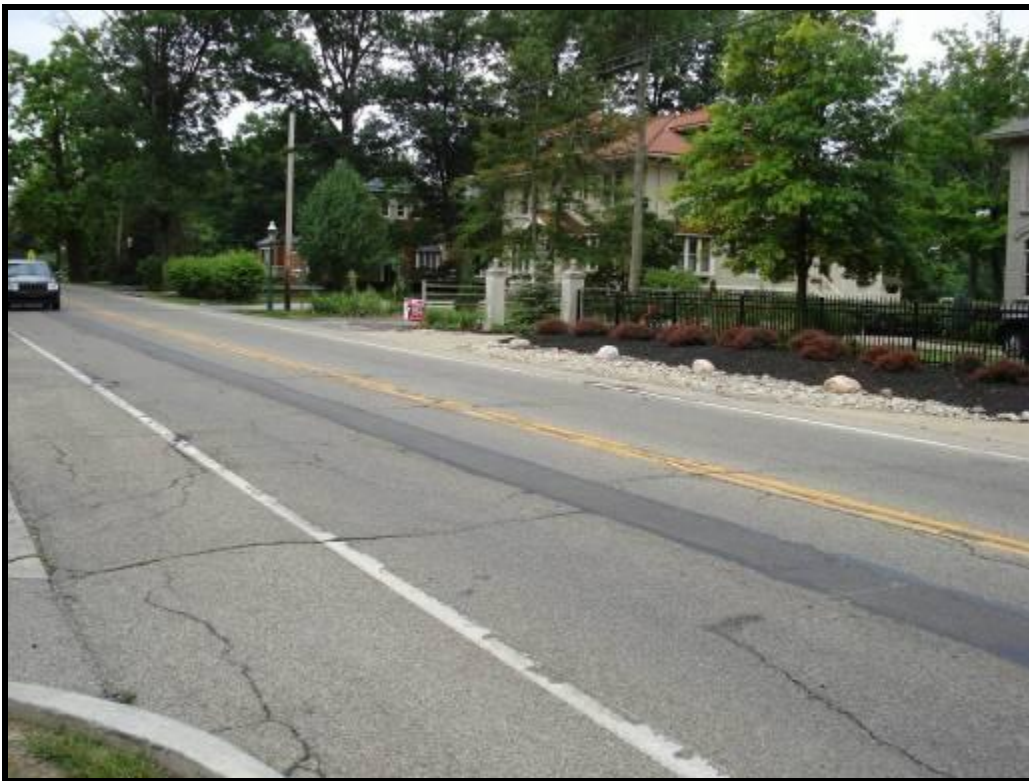
**Figure E16. – HAM 747 1S Coring Site**

Project 347(85) was located on SR 747 south of I-275 in a residential section of Glendale, a suburb of Cincinnati, as shown in Figure E16. This older pavement had numerous patches, including the extended longitudinal patch in the northbound lane, and random cracking.

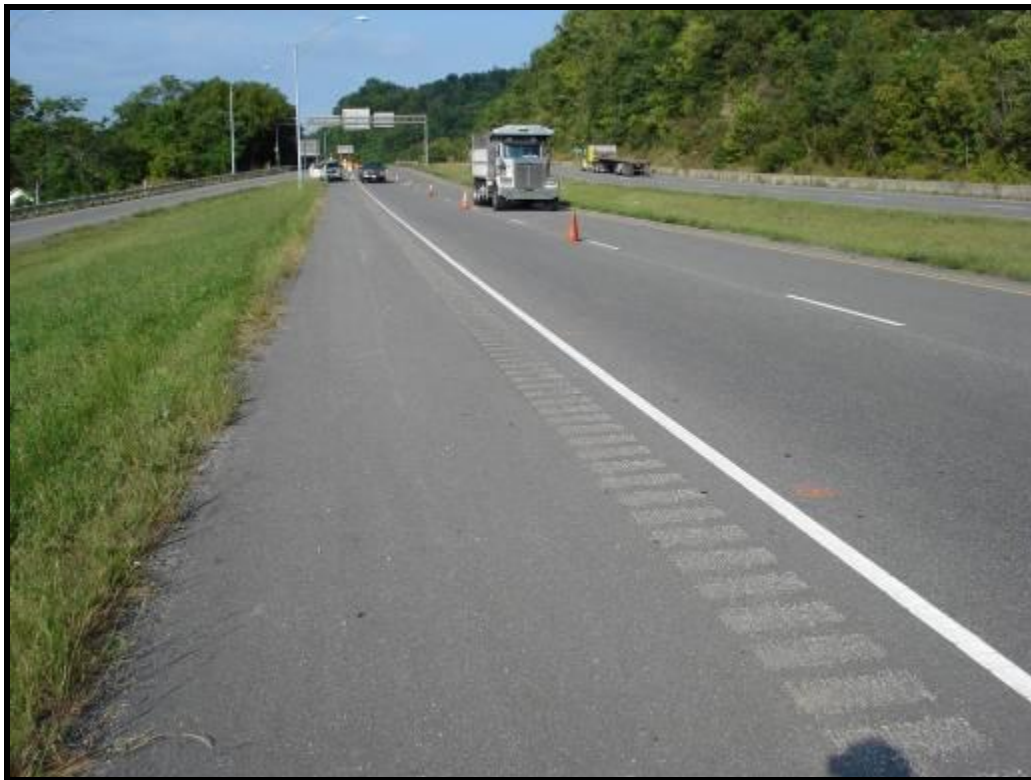
**Figure E17. – LAW 527 2N Coring Site**

Project 17(85) included sections of SR7 and SR 527. The original section of pavement selected for Project 17(85) was on SR 7 between SLMs 1.4 and 2.28. When visiting the site for sampling and testing in 2009, the entire project had recently been overlaid with about 3" (7.6 cm) of AC. Since all performance data were collected prior to the overlay, the cores were cut and the new overlay was removed before testing in the laboratory. Figure E17 is looking south in the northbound lanes and the exit ramp in the background is where SR 527 ends at SR 7. SR 7 exits on the ramp into Chesapeake. Because of traffic considerations and because these sections of SR 7 and SR 527 were constructed under the same project, the cores were cut on SR 527 north of where SR 7 exits into Chesapeake. Figure E18 shows a typical core with the new overlay intact.
