# Forensic Investigation of AC and PCC Pavements with Extended Service Life

## Volume 1

Report FHWA/OH-2010/004A

for the  
Ohio Department of Transportation  
Office of Research and Development

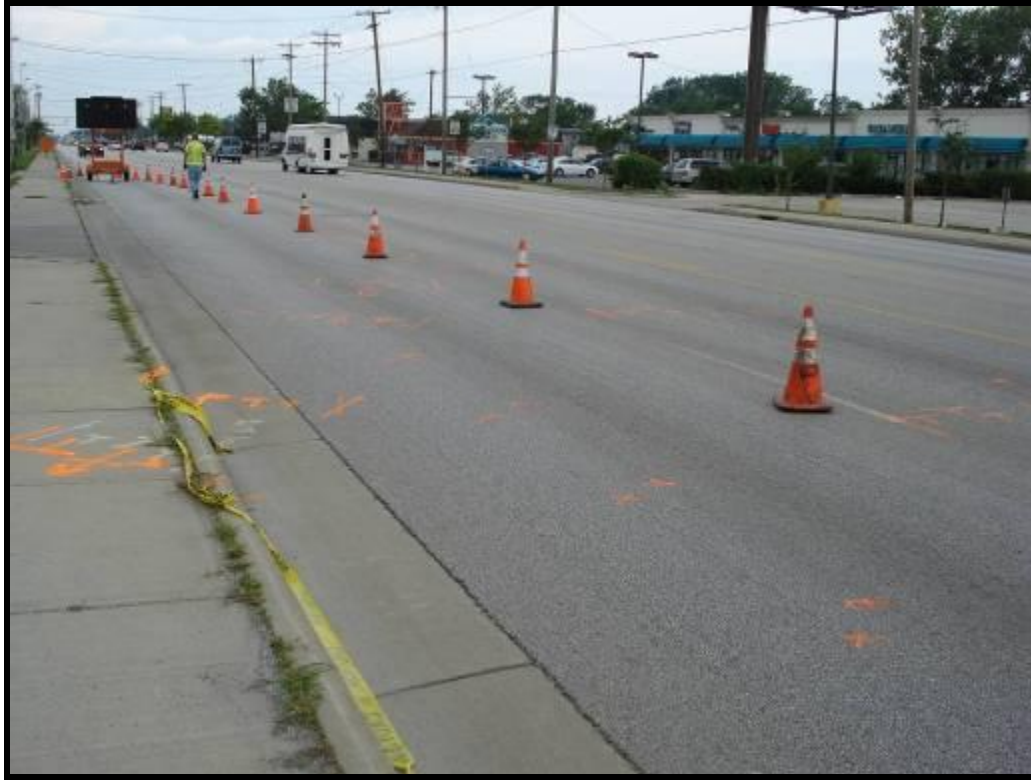
**Figure E19. – LUC 2 22E Coring Site**

This project was located in a business area with considerable utilities buried under the pavement, an AT&T routing station just west of the coring site and a high pressure gas line just east of the site. OOPS was called to locate the utilities and cores were cut at a safe distance from the OOPS marks, as shown in Figure E19. Manholes and catch basins indicated storm sewers were also present. To avoid any unpleasant surprises with buried fixtures, DCP tests were not conducted at this site. FWD measurements were available for determining base and subgrade stiffness. Rut depths were about  $\frac{1}{4}$ " (6 mm) in the right wheelpath and cores ranged from 11  $\frac{1}{2}$  - 13  $\frac{1}{2}$ " (29.2–34.3 cm ).

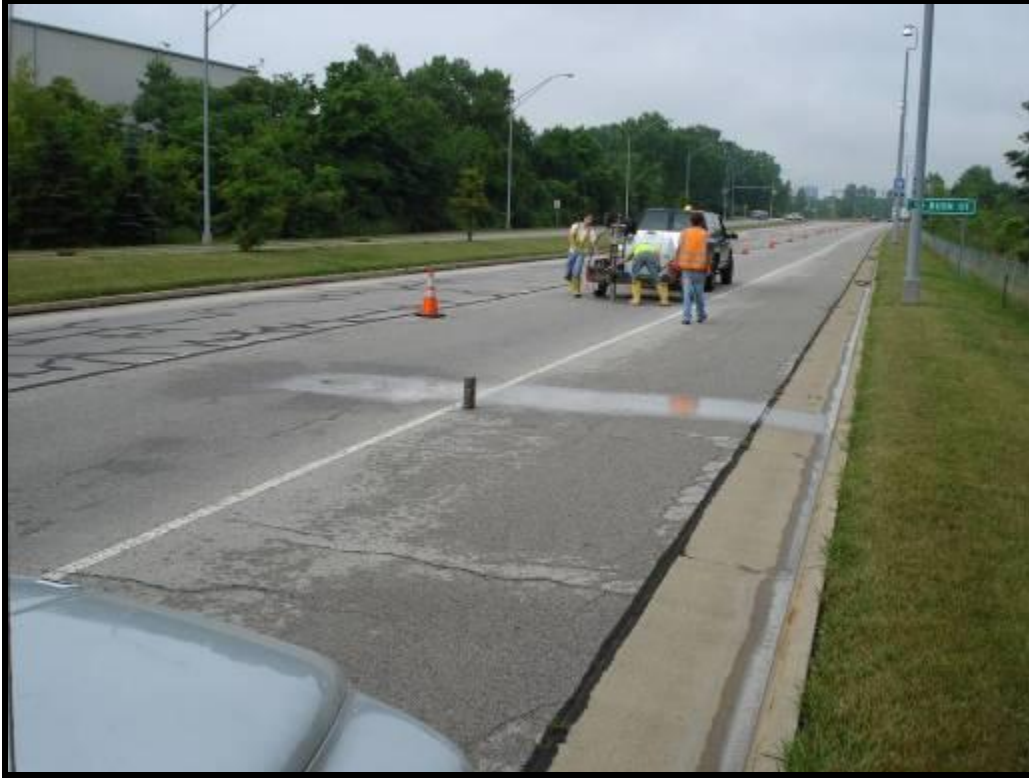
**Figure E20. – LUC 25 10S Site**

This pavement project was rated as providing excellent performance in 2004. It was a two-lane flexible pavement with an 8' (2.4 m) shoulder, and concrete curb and gutter, as shown in Figure E20. Cracks in the northbound lanes had recently been sealed and the southbound lanes were to be sealed soon. Figure E21 shows typical cracking in the southbound lanes and ruts in the right wheelpath were only about 1/16" (2 mm). The 304 base was compacted very well and was too hard for the DCP to penetrate.

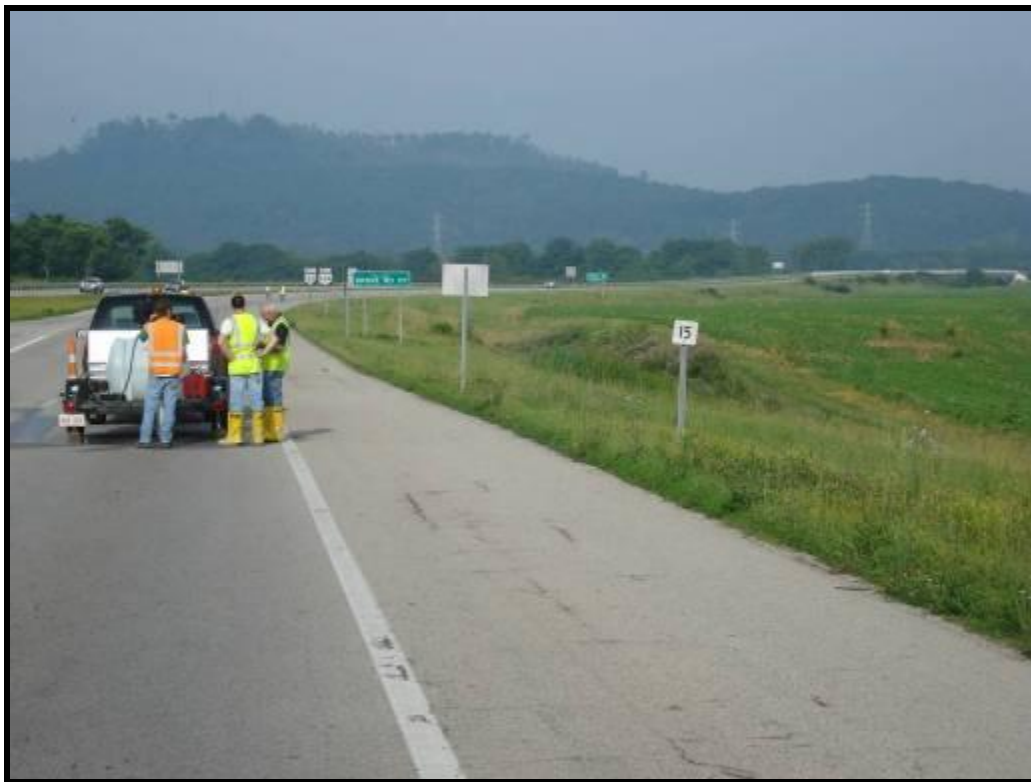
**Figure E22. – PIK 32 15W Coring Site**

This project, just west of US 23, was in very good condition with only minimal longitudinal cracks appearing in the centerline and wheelpaths. Rutting was limited to 1/16" (2 mm). The PMIS showed the build up to be as indicated above without the PATB, but PATB was in the cores.

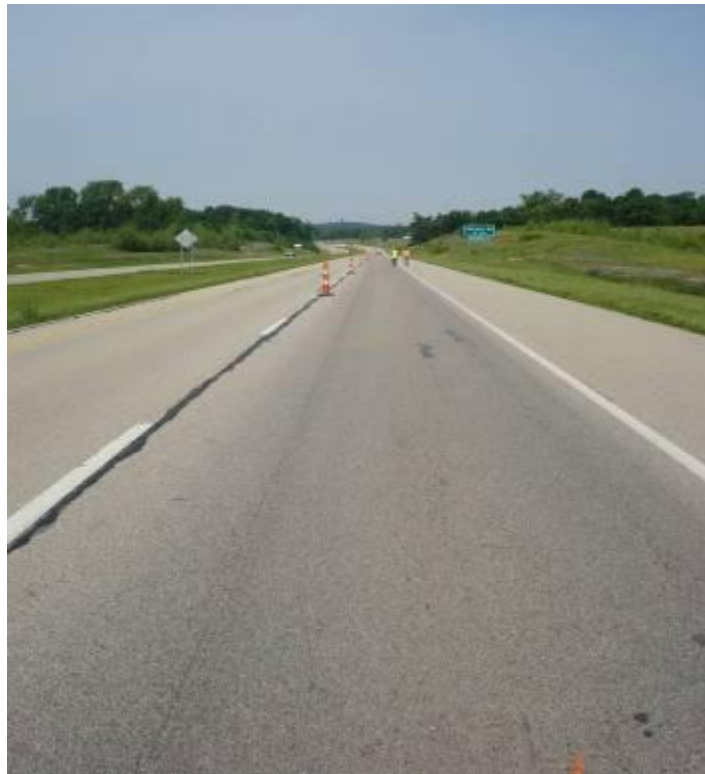
**Figure E23. – PIK 32 19W Site**

With the exception of longitudinal cracking in the right wheelpath, the westbound lanes of this project was in generally good condition. Figure E23 shows the coring site starting approximately ¼ mile (400 m) west of Tipton Lane, and Figure E24 shows the longitudinal cracking. Rutting varied from 1-5/16" (2-8 mm) in the right wheelpath. The PMIS showed the build up to be 3" (7.6 cm) of 446 over a total thickness of 12" (22.9 cm) of 301 and ATFDDB over 4" (10.2 cm) of 304. Cores indicated there was 11" (27.9 cm) of 301 and 4" (10.2 cm) of ATFDDB instead of a combined thickness of 12" (22.9 cm) of 301 and ATFDDB, as shown in Figure E25. Four cores delaminated at the interface between the two 301 lifts, suggesting poor bonding at this level, and the upper 301 lift in the ODOT2 core came out of the core bit as rubble.

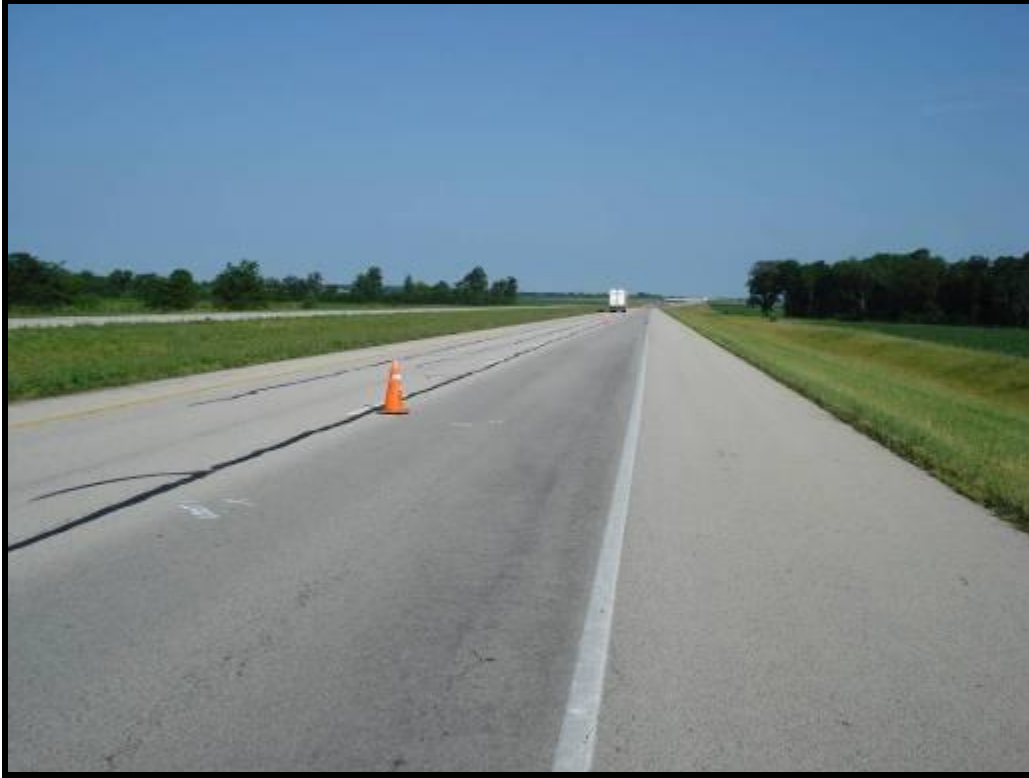
**Figure E26. – ROS 35 1W Site**

This rural pavement was in very good condition with only minor longitudinal cracking along the centerline of the lane. Figure E26 shows the ROS 35 1W site and Figure E27 shows the cracking. Rutting was minimal at less than 2/16" (3 mm). The 306 cement treated base layer indicated in the PMIS was not present in the cores. The core bit jumped around when coring started, as though the aggregate was unusually hard, and considerable delamination occurred at all material boundaries and midway through the 301 during the coring operation, suggesting insufficient tack was applied. On Core 13, the 446/301 boundary and the lift between the 301 lifts all delaminated, and aggregate in the 301 was stripped in Core 12.

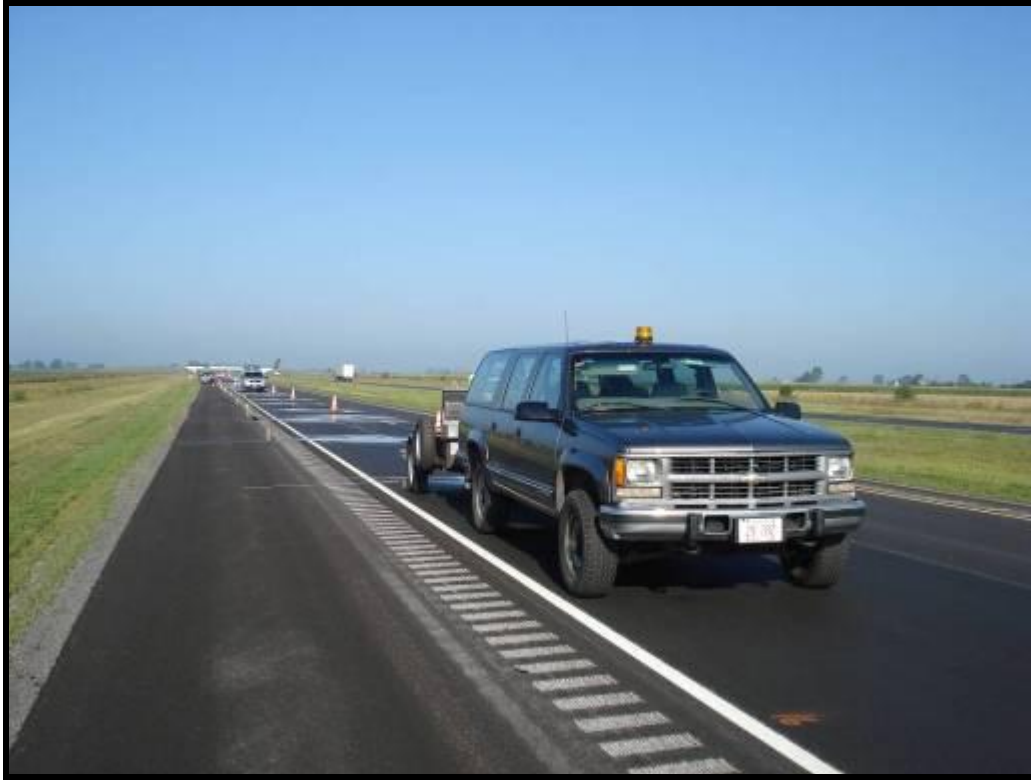
**Figure E28. – VAN 30 18E Coring Site**

Cores removed in 2009 largely support the history of this project assembled from ODOT files, although there would not be joints on plain concrete covered with AC. The PMIS identifies the activity code for Project 219(97) as being 100 (flexible) and the structural base as being 301.

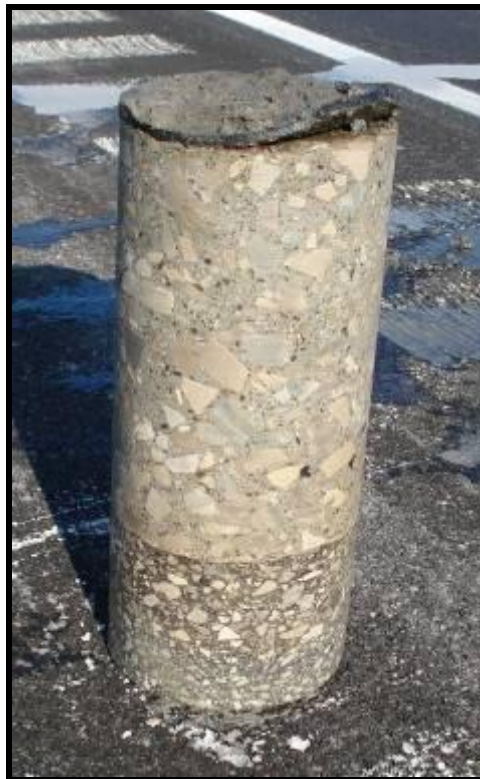
**Figure E29. – Core from VAN 30 18E**

2009 Cores – 1.5" (3.8 cm) new AC, 2.5" (6.4 cm) old AC, 9" (22.9 cm) PC concrete, and asphalt underseal.

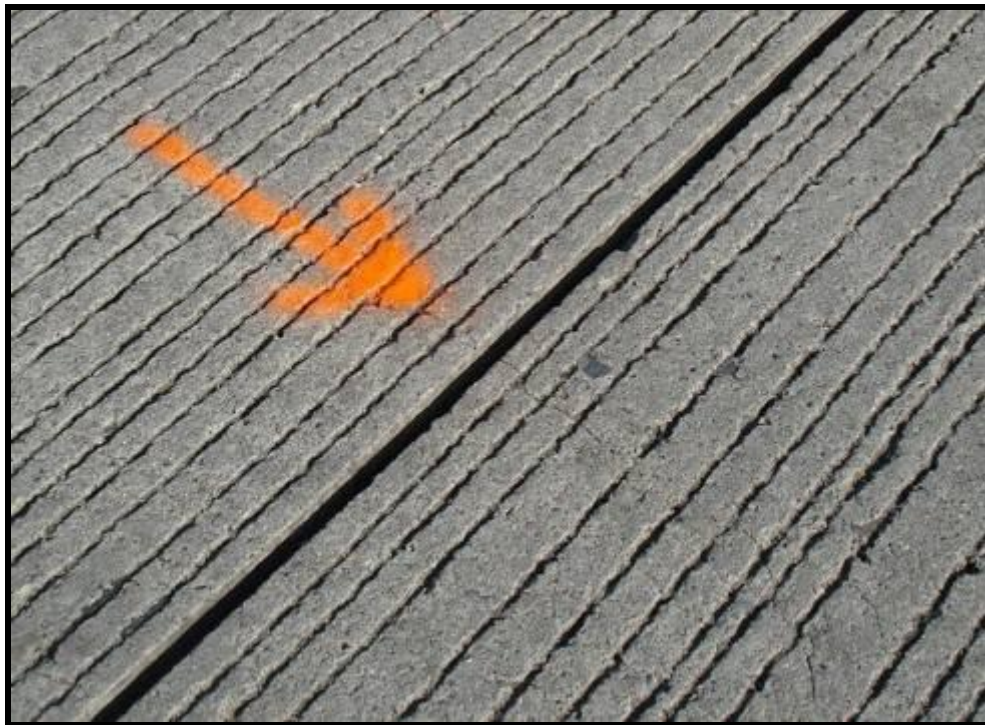
**Figure F1. – Longitudinal Crack over Dowel Bar on ALL 30**

The pavement appeared to be in excellent condition throughout. The sampling and testing site was located in the eastbound direction at the 22 mile marker (~Sta. 1162). Upon closer examination of this site, a few minor longitudinal cracks were observed over dowel bars and longitudinal reinforcement strands approximately 24 inches (61 cm) in from the outer edge of the pavement, especially between Stations 1163+90 and 1166+42. Figures F1 and F2 show these cracks. A severely distressed slab beginning at Station 1166+42 appeared to be the beginning of a new days pour in which no longitudinal cracks were found. Figure F3 shows this slab with a transverse crack caused by severe distress at the construction joint, and Figure F4 shows considerable concrete being removed around the dowel bar in the core taken at the arrow in Figure F3. Figure F5 shows horizontal cracking observed at dowel bars on the leave side of a core removed during the same day for another project near joints at Stations 1163+40 and 1164+00.

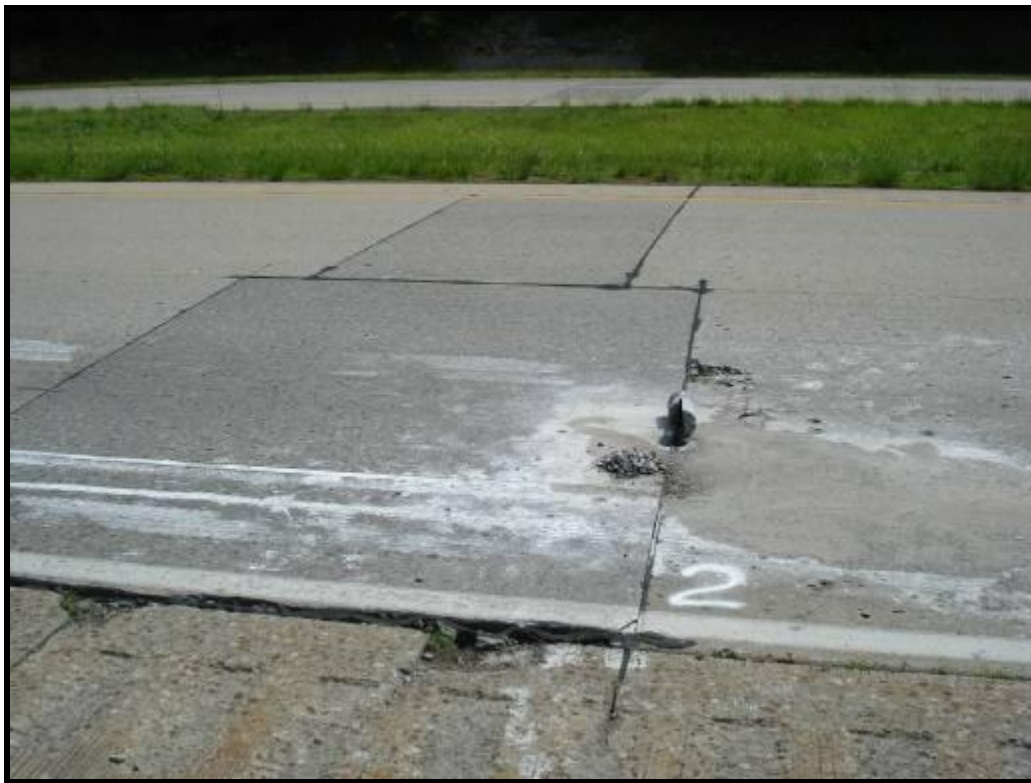
**Figure F6. – Joint Replacements on ATH 33**

This project was selected for study because of the time it has carried moderate truck traffic on a primary route in southeastern Ohio. Essentially all of the joints were replaced and the surface was ground in 1999 due to deterioration and faulting of the joints. The site selected for sampling and testing was near on the eastbound side near MP 12. The length of the joint replacements at the site varied from 4-5 feet (1.2-1.5 m) to 10-12 feet (2.5-3.7 m). The original concrete between the replaced joints remains in excellent condition with tight transverse cracks appearing in about every other slab. Some spalling is present along the longitudinal and transverse joints, and some areas over high reinforcing mesh have popped out. Figure F6 shows a joint replacement and Figure F7 shows how the replacement concrete has deteriorated while the original concrete remains intact.

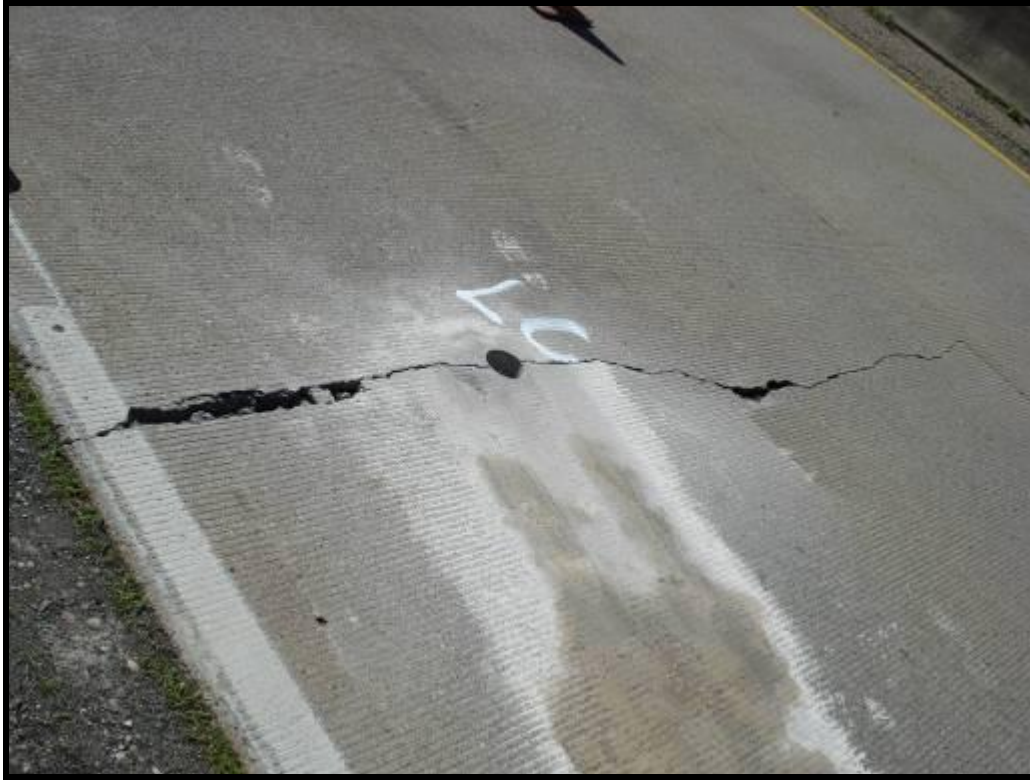
**Figure F8. – Transverse Crack on ATH 682**

This short section of SR 682 connects US 33 with Richmond Avenue which is the main south entrance to the Ohio University campus. The entire section contained moderate to severe transverse cracking in every slab and spalling along many joints. With average performance being determined in 2004, the pavement has deteriorated rapidly since then. Only a few trucks were observed using this route during the sampling and testing, but the traffic control crew indicated that loaded trucks transported coal to the OU campus in the northbound lanes and left empty in the southbound lanes. Figure F8 shows a transverse crack with a core removed for Lankard Material Laboratories, Figure F9 shows deteriorated concrete on the bottom of the slabs, and Figure F10 shows # 8 gravel aggregate in a midslab core.

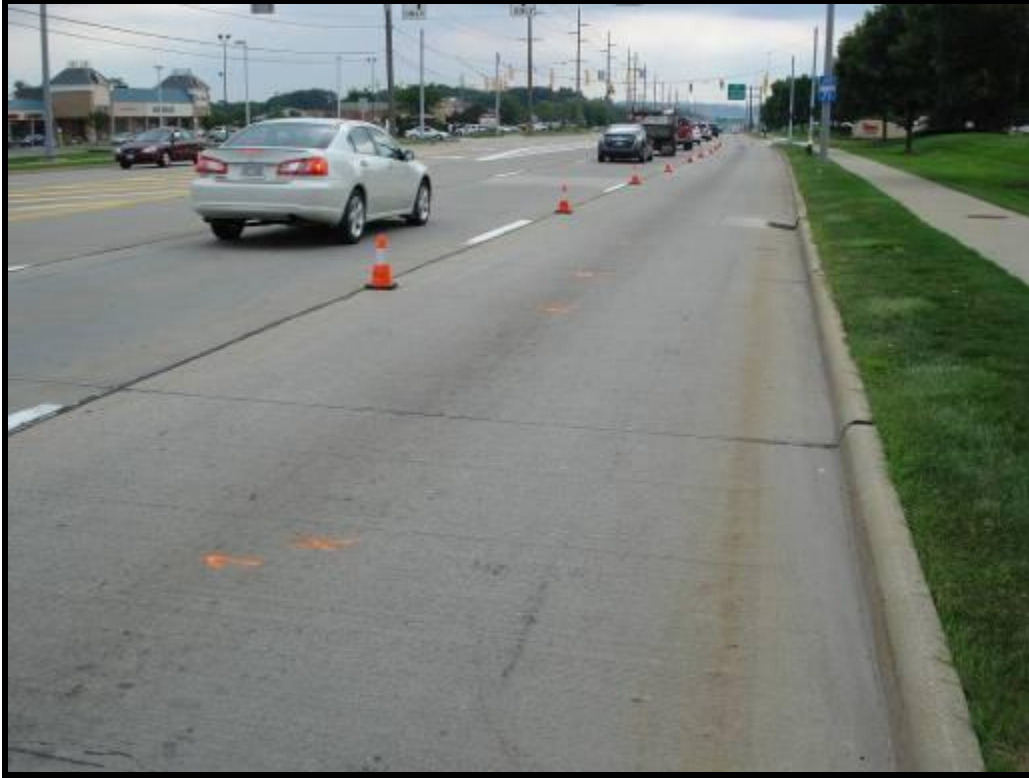
**Figure F11. – Layout of CUY 82 3E**

This pavement section was located in a business area just west of I 71. The pavement was in excellent condition with very tight transverse cracks in most slabs. There was no faulting at the joints. Figures F11 and F12 show the pavement surface with integrated curb and gutter, and a close-up of a transverse crack. Figure F13 shows the green slurry caused by the slag aggregate base as the core bit cut through the pavement. #8 aggregate was used in this pavement.

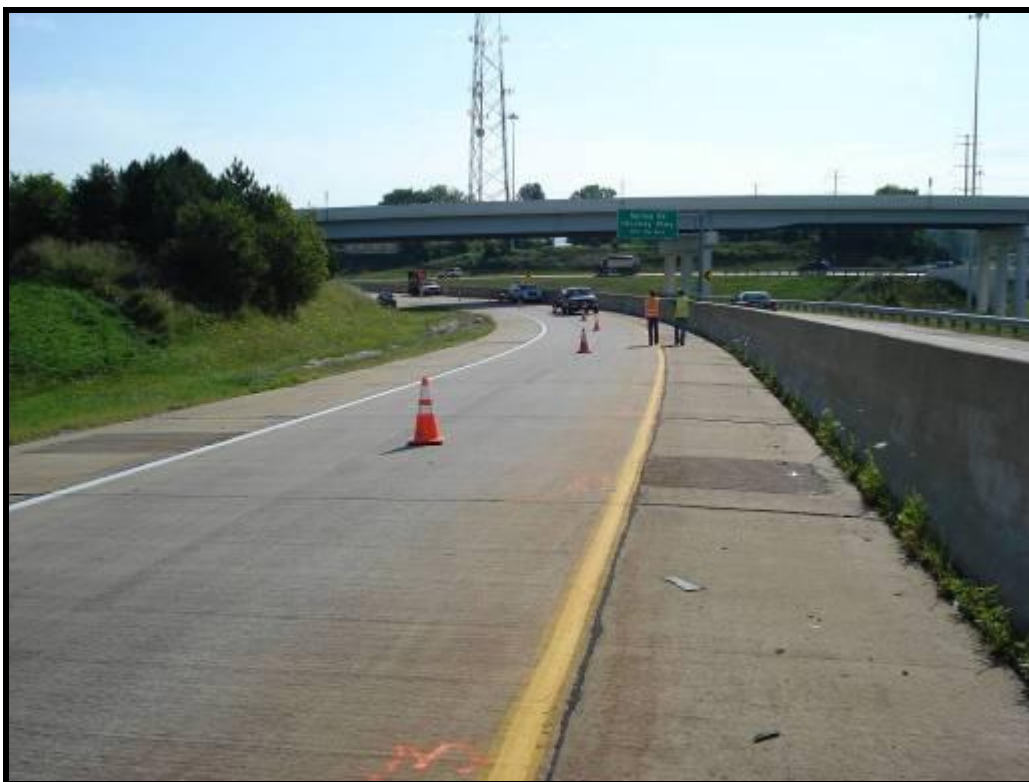
**Figure F14. – Sampling and Testing Site on CUY 176 10S**

The section of Project 683(94) selected for sampling and testing was the southbound ramp to SR 17 shown in Figure F14. Cores ranged from 11 ½ to 12 ½ inches (29.2-31.8 cm) in length, and there was no faulting at the joints. There were a couple of moderate transverse midslab cracks. One unusual feature was the presence of multiple, randomly spaced longitudinal hairline cracks distributed throughout the slabs. Cores indicated these cracks did not appear to be associated with reinforcing mesh in the pavement and may have been caused by insufficient moisture during curing. These cracks stand out in Figures F15 and F16 as moisture from the coring operation remained in the cracks. These figures were taken side by side at the same location. Cores taken at joints for another project showed horizontal cracking at dowel bars on the approach side of the joints.

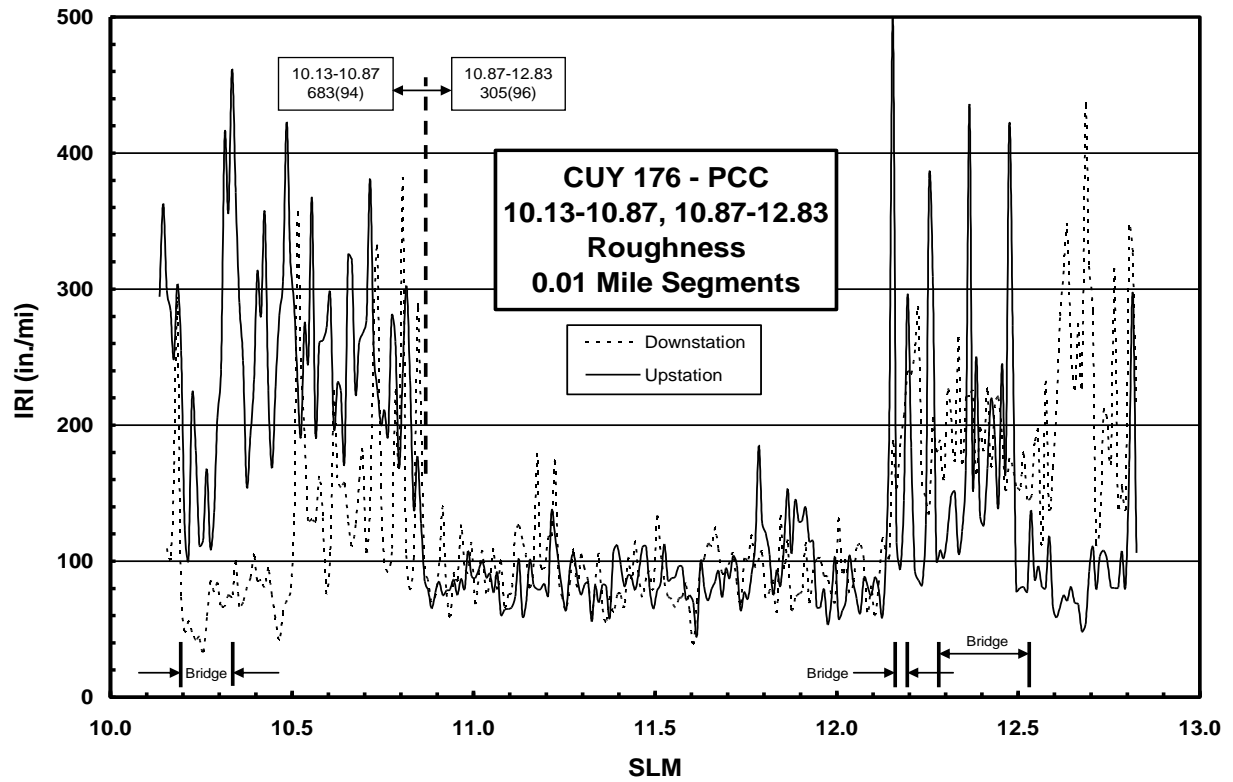
**Figure F17. – Roughness Profiles Measured on CUY 176**

Figure F17 shows ride quality profiles measured on Projects 683(94) and 305(96) on CUY 176. Upstation is northbound and downstation is southbound on the profiles. Of particular interest is the clear difference in ride quality before and after SLM 12.15 on Project 305(96). Because the cause of this difference in ride quality may be a factor in improving pavement performance, sampling and testing sections were selected from areas near SLM 11 (CUY 176 11S) and SLM 12.7 (CUY 176 12S). There was no faulting and no transverse cracking at these locations. Hydrated slag aggregate in the 310 base was attached to the cores when they were removed from the pavement and the DCP could not penetrate this material. The smoother section of Project 305(96) had three lanes of traffic in both directions while the rougher section to the north had two lanes in both directions. Figure F18 shows horizontal cracking at dowel bars on the approach side of joints near Station 192 in the CUY 176 11S section.

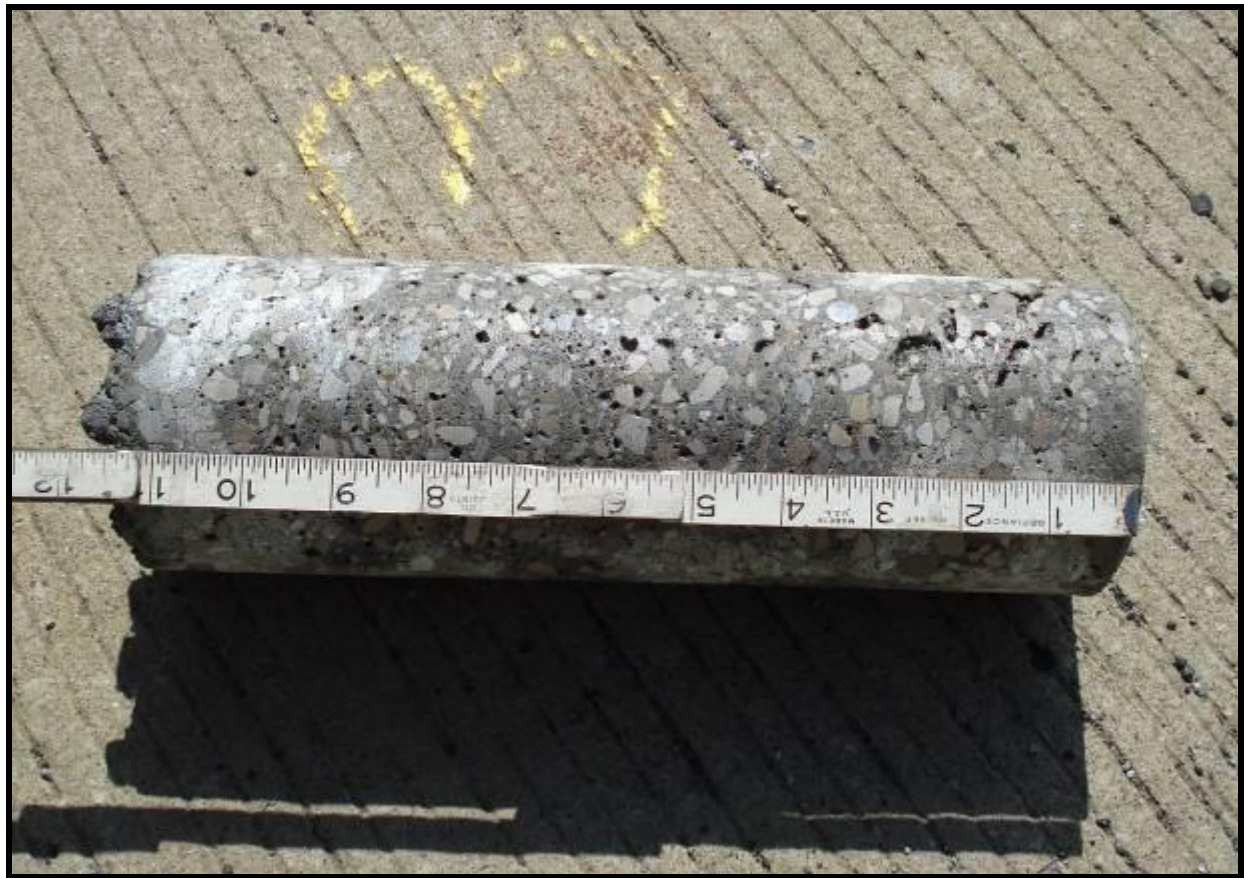
**Figure F19. – Air Voids in CUY 176 12 S Core**

This site was the complement of Section CUY 176 11S and represented the rougher portion of Project 305(96). Neither of these sections had any particular distress on the surface. Figure F19 shows numerous air voids in the cores which was common at this site. Some of the hydrated 310 base can also be seen on the bottom of the core.

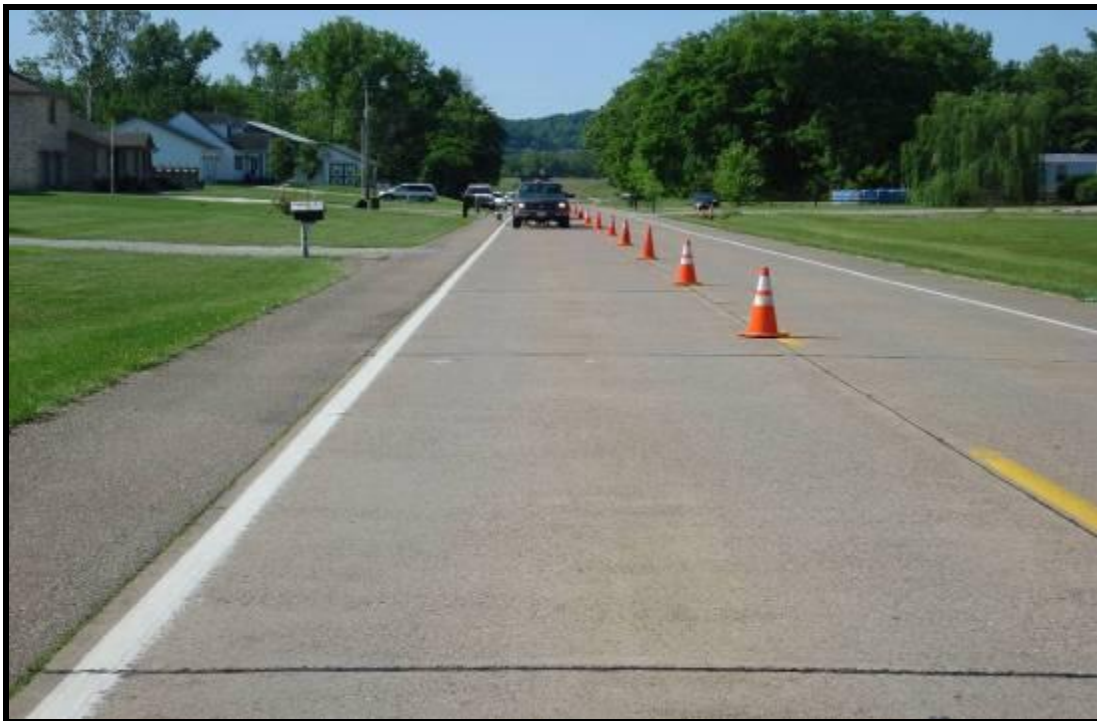
**Figure F20. – Surface of GAL 7 8N**

This pavement, constructed in 1946, was the oldest rigid pavement included in the study. It was located in a rural area along the Ohio River in Gallia County. Although this pavement carries little heavy truck traffic, it is only 8 inches (20.3 cm) thick and has endured more than 60 years of freeze-thaw cycling while carrying local traffic. Some areas along the pavement had replaced joints and transverse cracking, but many other areas, like the one selected for sampling and testing in Figure F20, were in excellent condition. There was no faulting and only occasional minor transverse cracking and spalling at the location in Figure F20. The extremely hard river gravel in this mix made coring difficult. Figure F21 and F22 show how transverse cracks went around the large aggregate particles. One core cut at a joint showed the dowel bar to be rusted through. The joint core in Figure F23 shows: 1) the formed joint with sealant containing fine aggregate, 2) the depth to which the sealant flowed into the crack, and 3) coning on the bottom of the pavement at the joint which has been observed on other much newer rigid pavements.

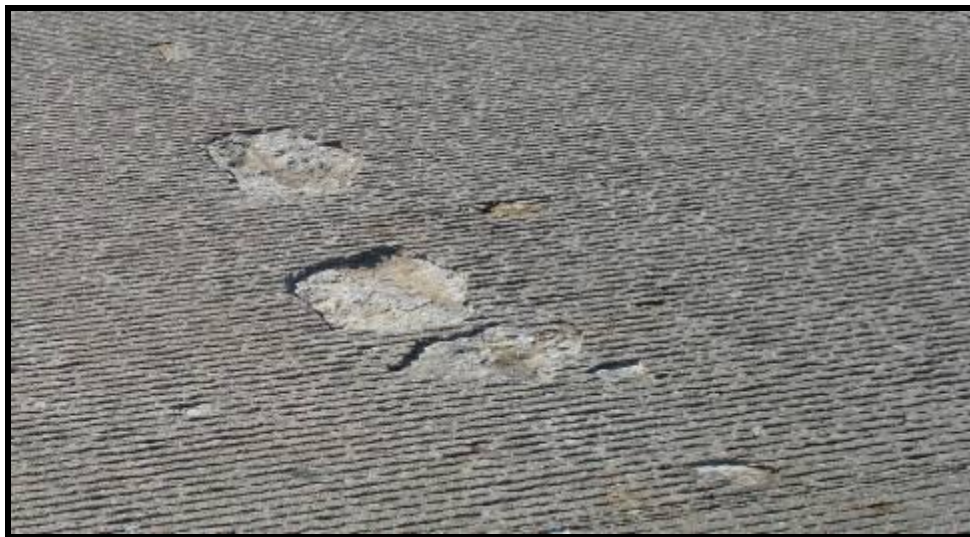
**Figure F24. – Popouts from High Steel on GRE 35 19W**

This pavement was in excellent condition with good surface texture, no faulting, and only a couple of minor transverse cracks, one of which was a partial crack initiated at the centerline joint. Occasional popouts from high reinforcing mesh were also visible, as shown in Figure F24.

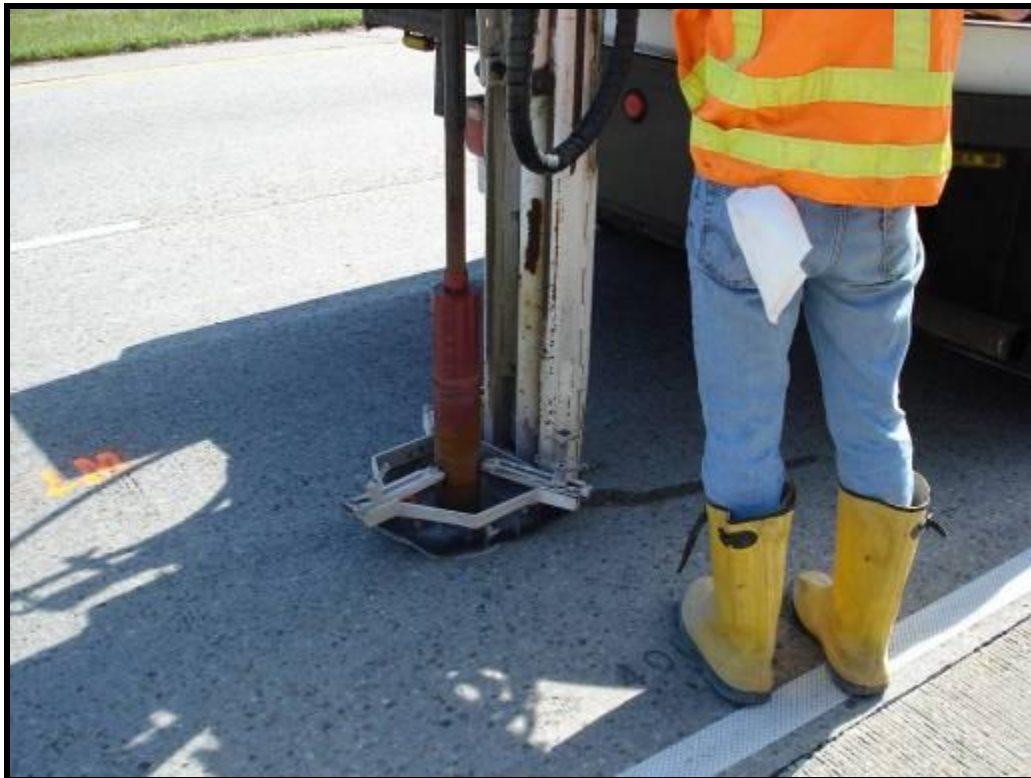
**Figure F25. – ODOT Core Rig on HAM 126 12E**

This pavement was in excellent condition. ODOT assisted with the coring on days when one traffic control zone was used to protect two sampling and testing sections. The core bit on their truck mounted unit is shown in Figure F25. The pavement appeared to have been ground at some point which was probably associated with dowel bar replacements scattered along the project. No dowels had been replaced in the sampling and testing section which was located on a high fill. There was no faulting in the sampling and testing zone and only one transverse crack shown in Figure F26. Core lengths ranged from 11 – 11 ½ inches (27.9 - 29.2 cm) which was well above the 10 inch (25.4 cm) design thickness.

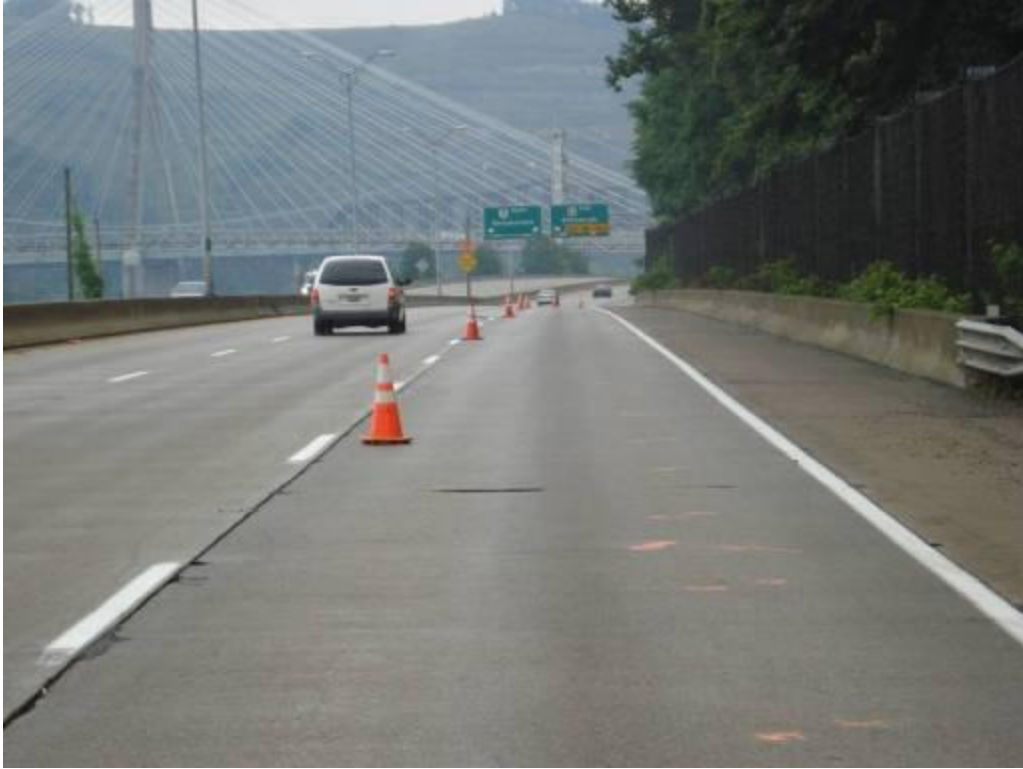
**Figure F27. – JEF 7 19S Site**

Based on PMIS data prior to 2004, this pavement was rated as providing excellent performance. By 2009 when the cores were removed, however, moderate to severe transverse cracks, faulting and spalling were widespread on the project. The project, shown in Figure F27, is in a heavily industrial area where coal is shipped in on barges for power plants and other facilities along the Ohio River. Many heavy trucks use this route to haul coal and other products. One of the more severe transverse cracks in the sampling and testing section is shown in Figure F28. The 310 base material was quite loose under this pavement.

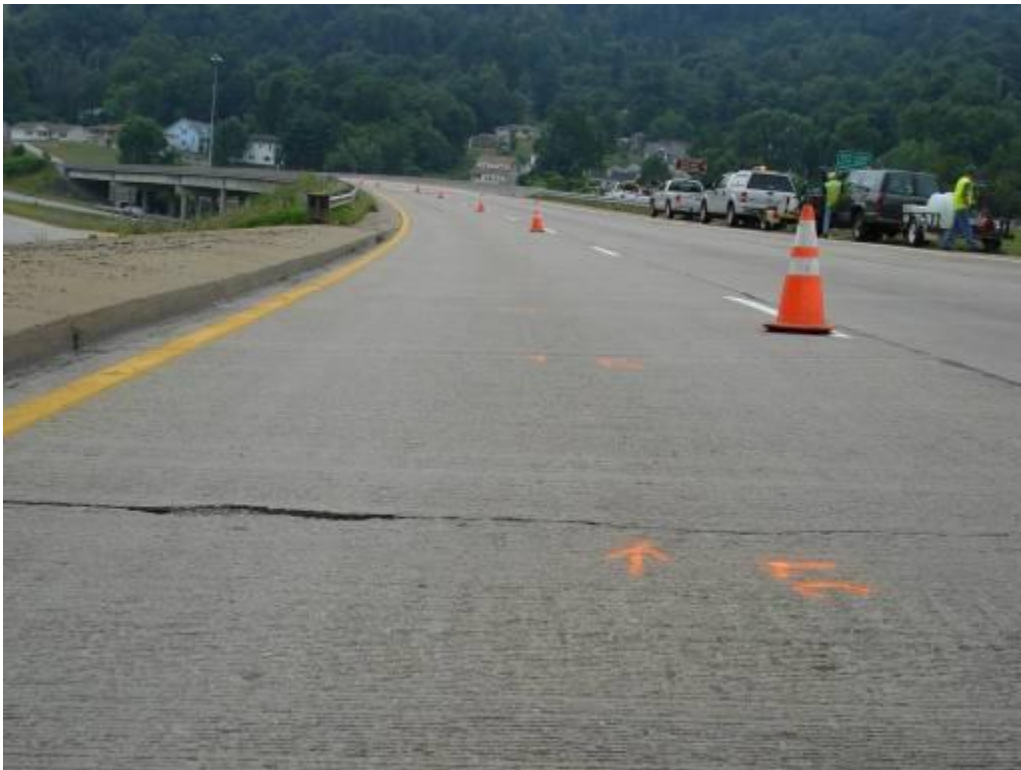
**Figure F29. – JEF 22 15E Site**

This section of US 22 was constructed under the same project as the preceding section on JEF 7. It was rated as providing average performance, although transverse cracking and spalling were quite common, but not as severe as on the SR 7 section. See Figure F29. There was no faulting at construction joints but the left lane, where cores were cut, had dropped about ¼ inch (6 mm) below the adjacent lane in one area. The 310 base was compacted very well and DCP measurements indicated the base and subgrade had similar stiffnesses.

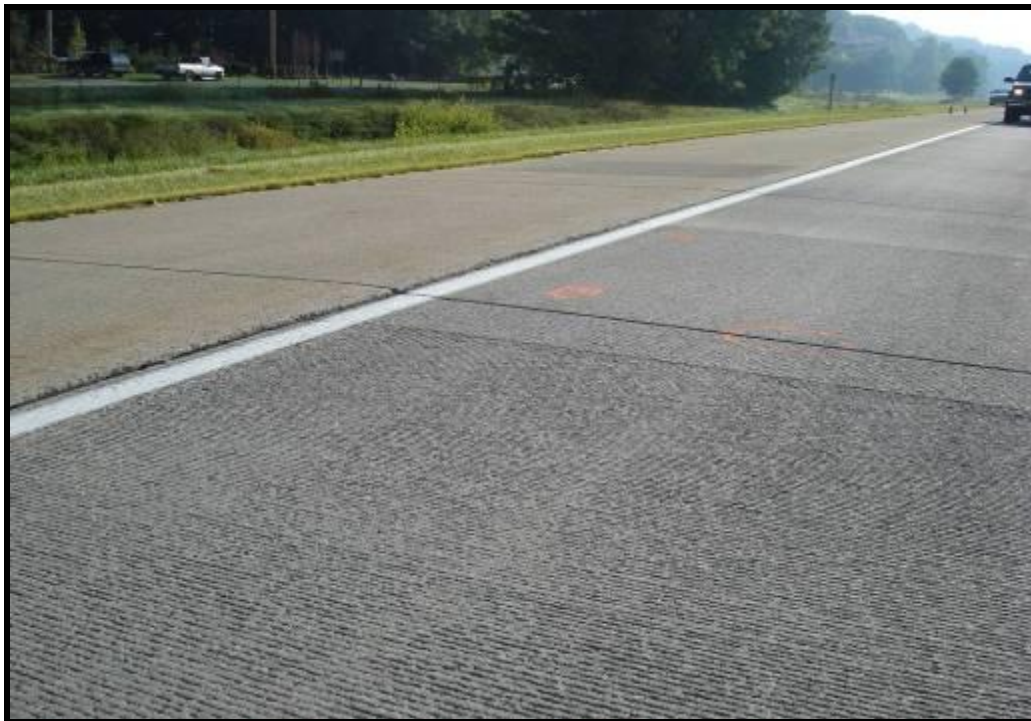
**Figure F30. – Pavement Surface on LOG 33 24W**

While this project appeared to be in very good condition, there were some dowel bar repairs and longitudinal joint patches scattered along the project. More of these distresses were observed in the westbound lanes than in the eastbound lanes. The section selected for sampling and testing on Project 845(94) started at MP 24 WB. Figure F30 shows the 24 MP in the background and shows how the right edge of this driving lane was depressed below the concrete shoulder over a distance of about five slabs and to a maximum depth of about 1 inch (2.5 cm). The pavement surface had excellent texture and there was no cracking or joint faulting. Cores removed from this section contained numerous voids, as shown in Figure F31. Figure F32 shows distress and a patch along the longitudinal joint at a transverse joint approximately ½ mile (0.8 km) west of the sampling site. This core hole retained water from the coring, while core holes in the sampling section drained quite well, suggesting some type of drainage problem around the distress. The traffic control crew indicated that natural springs were in the area.

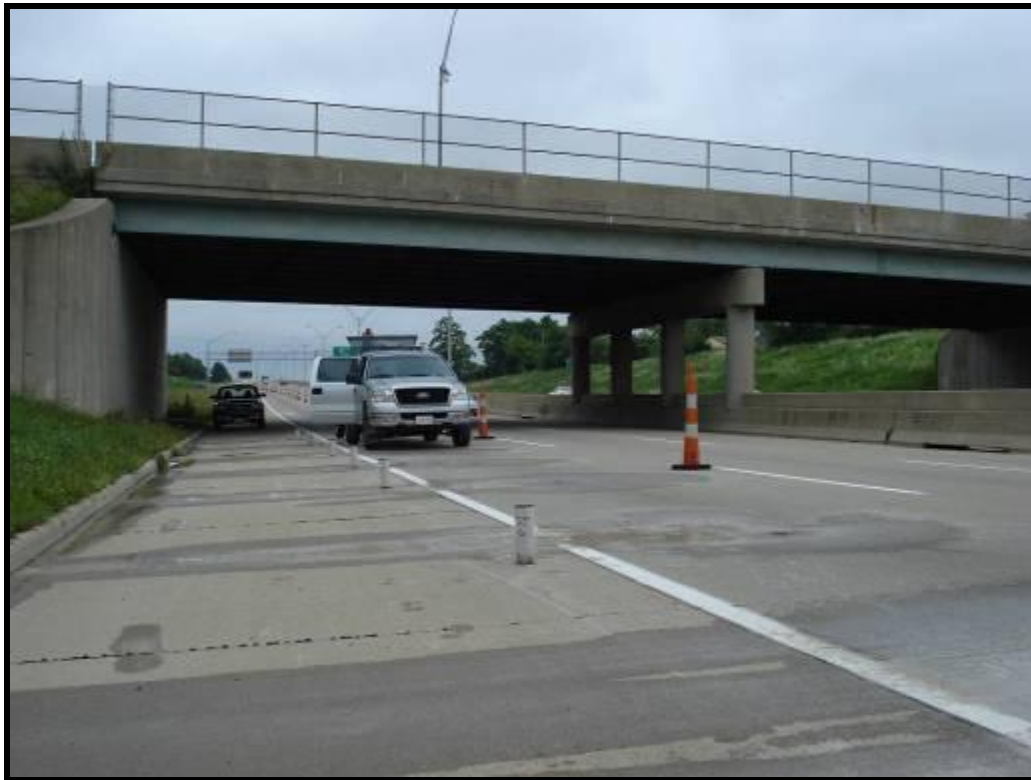
**Figure F33. – Coring Site at MOT 35 14W**

This sampling and testing site for Project 343(88) started just east of the McGee Blvd. bridge over US 35 in the westbound direction, as shown in Figure F33. Two cores were cut before the bridge and the remaining cores were cut after the bridge to avoid abnormal environmental conditions and distresses that sometimes occur under bridge decks. No distresses were evident on the cored slabs, but thickness of the PC concrete progressively increased from 10 inches (25.4 cm) on the east side of the bridge to 13 ¼ inches (33.7 cm) at the last core on the west side of the bridge. All cores were in excellent shape when removed from the holes.

The 300 foot (91 m) long sampling and testing section near MP 14 WB on MOT 35 was located in a cut under a bridge, but the area directly under the bridge was avoided. While no cracking was noted in the 2004 PMIS condition ratings, two tight transverse cracks were observed in the sampling and testing section in 2009. Overall, the 10 inches (25 cm) of 452 / 4 inches (10 cm) of 301 / 4 inches (10 cm) 304 design appears to be performing quite well. Project 678(91) on MOT 202 was located on a three-lane residential street. While only minor longitudinal cracking was noted in the 2004 PMIS, tight transverse cracks were observed in most slabs in 2009. This 9 inch (23 cm) thick 452 pavement was constructed on 6 inches (15 cm) of 310 T2 aggregate base and is performing reasonably well.

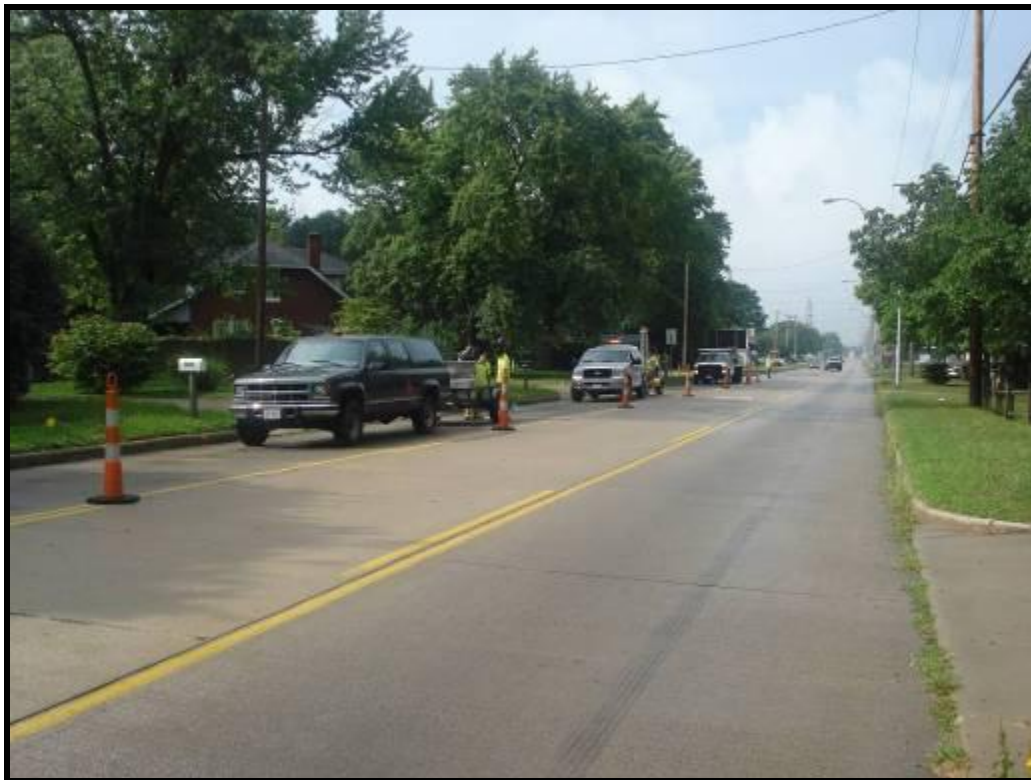
**Figure F34. – MOT 202 3N Site**

Project 678(91) was a three-lane pavement with an integral curb and gutter just north of SR 4 in Dayton. It was in excellent condition at the time of coring with most slabs having one tight transverse crack. Two joints were cored; one had a tight crack extending from the bottom of the saw kerf to the bottom of the concrete slab and the other had only some small micro-cracks which would probably have developed into a crack.

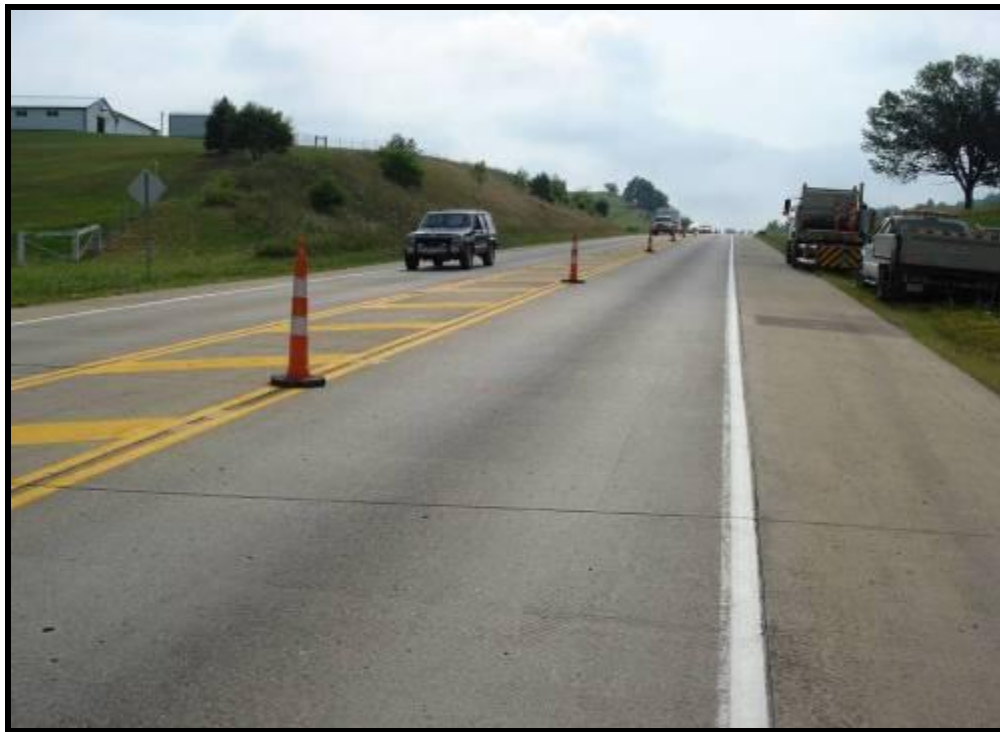
**Figure F35. – First Site on TUS 39 4E**

This project was located on SR 39 just east of Sugarcreek and the sampling and testing site started about 200 feet (61 m) east of CR 139, as shown in Figure F35. A few minor to moderate transverse cracks were observed in the slabs and coring was difficult, possibly because of hard aggregate. After seven cores were cut, the core bit got stuck and had to be removed manually. One more core was then cut with some difficulty. By this time, the sampling and testing section was on a vertical grade which had caused coring problems in the past. The crew moved to a flatter section of pavement about ¼ mile down the road to complete the coring. The condition of the pavement at this new location was similar to the original location with minor to moderate transverse cracking. After cutting three 6" (15.2 cm) diameter cores, diamonds worn from the bit and, since another 6" (15.2 cm) bit was not available, the remaining cores were cut with a 4" (10.2 cm) diameter bit.
