# Application of High Performance Concrete in the Pavement System

## Structural Response of High Performance Concrete Pavements

Final Report  
March 2002

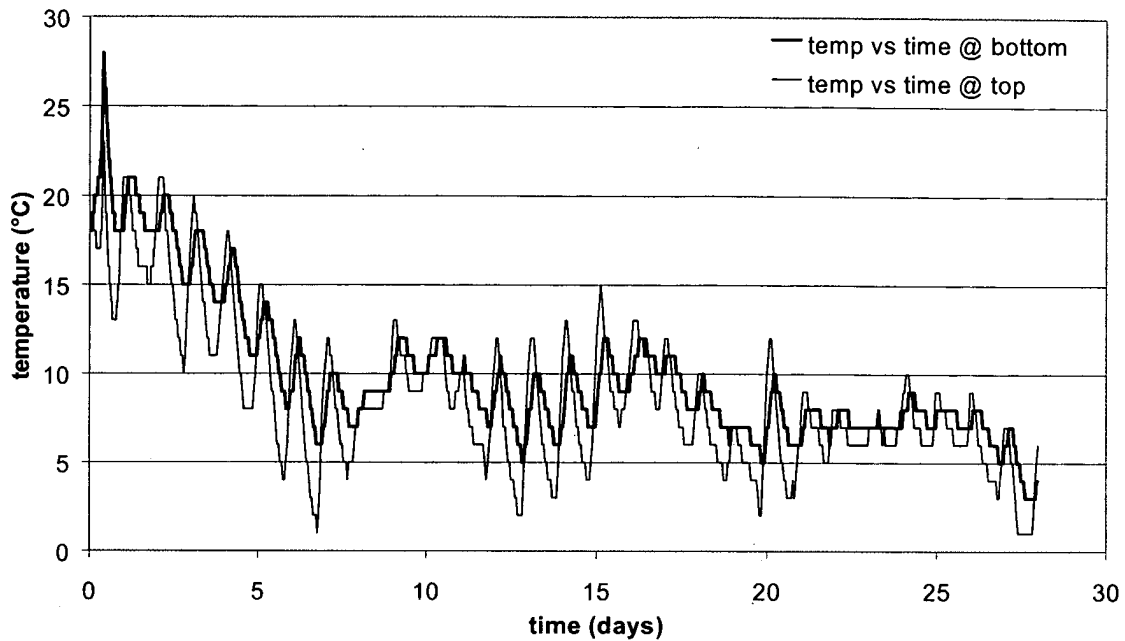
**Figure 3.4** Temperature History of the HP Concrete Slab

Since the temperatures between the bottom and top of the slab were different, the concrete had different maturities. This raises a question as to what temperature history, i.e. equivalent age, to which the strength data should be set in a relationship. The most reasonable approach was to take the temperature history of the concrete from the bottom of the slab given the 6-inch diameter of the cylinders and the insulating impacts of the molds. The curing conditions of the specimen appeared to vary significantly from the curing conditions 1.5 inches below the pavement surface.

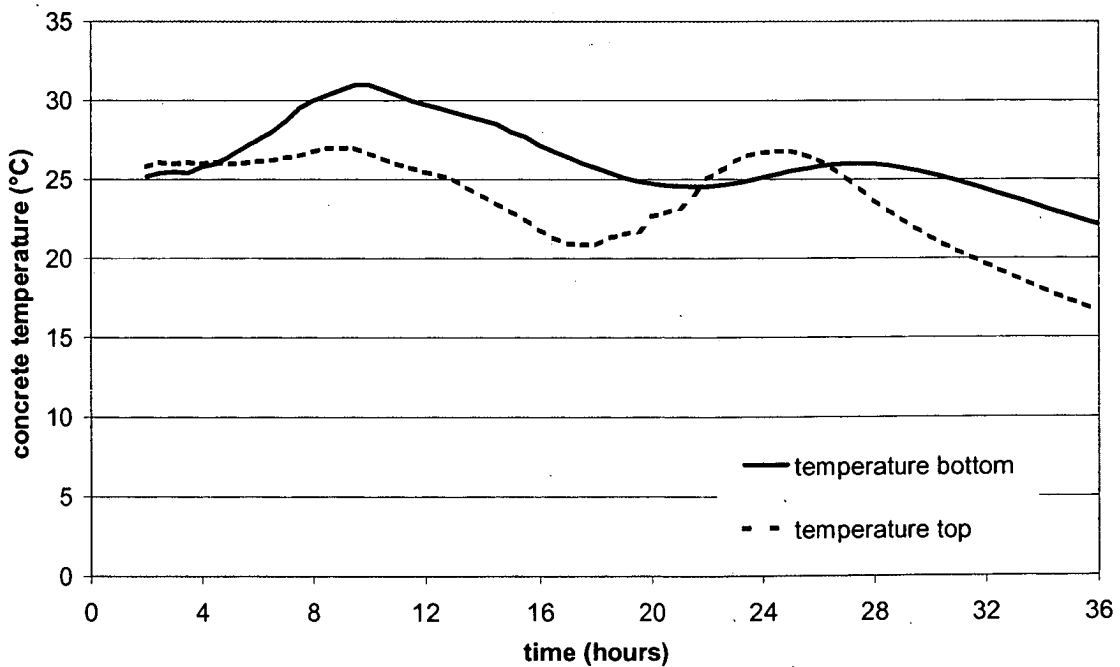
**Figure 3.10** Concrete Temperatures at Different Depths of the Slab at the HP3 Section

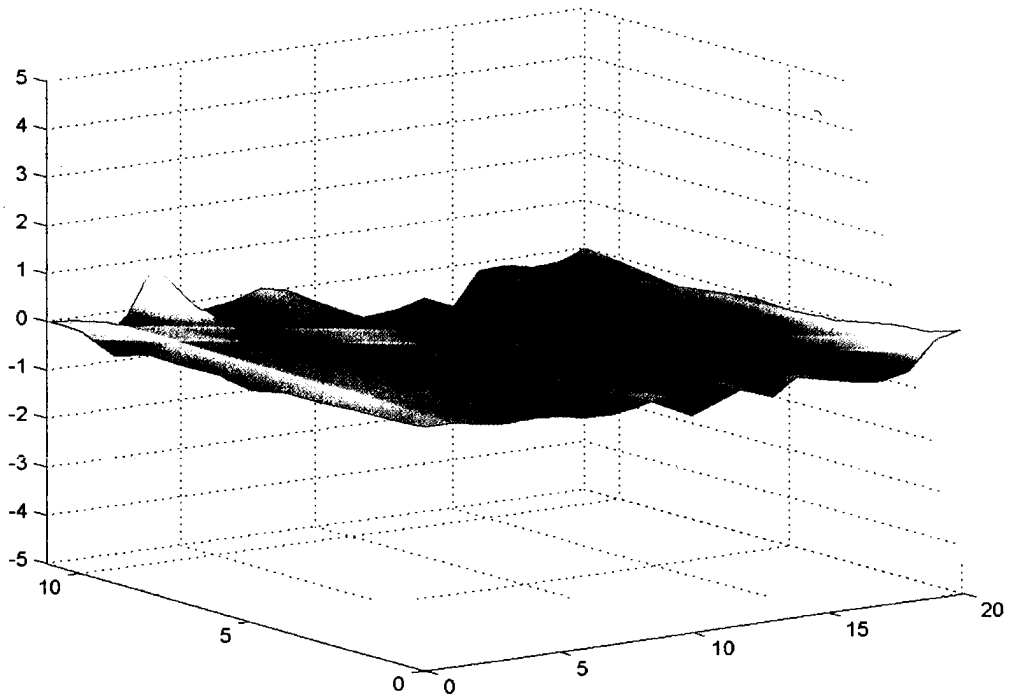
**Figure 4.6** Change of the Shape of Slab # 3 in the HP Section after 4 Weeks

slab ID: 33-1104-10, max def = -0.88 mm @ dist from corner: 2.83 ft

When the SP and HP sections are compared, it is apparent that the edges of the slabs in the SP section turned up more than in HP section. The difference in height between the deepest point measured on the slab relative to the corners was on average 0.097 inches for the SP section, and 0.047 inches for the HP section.
