FINAL REPORT

LONG TERM MONITORING OF BROKEN AND SEATED PAVEMENTS

**Arudi Rajagopal
and
Issam Minkarah**

**May 2002
University of Cincinnati
Cincinnati, Ohio**

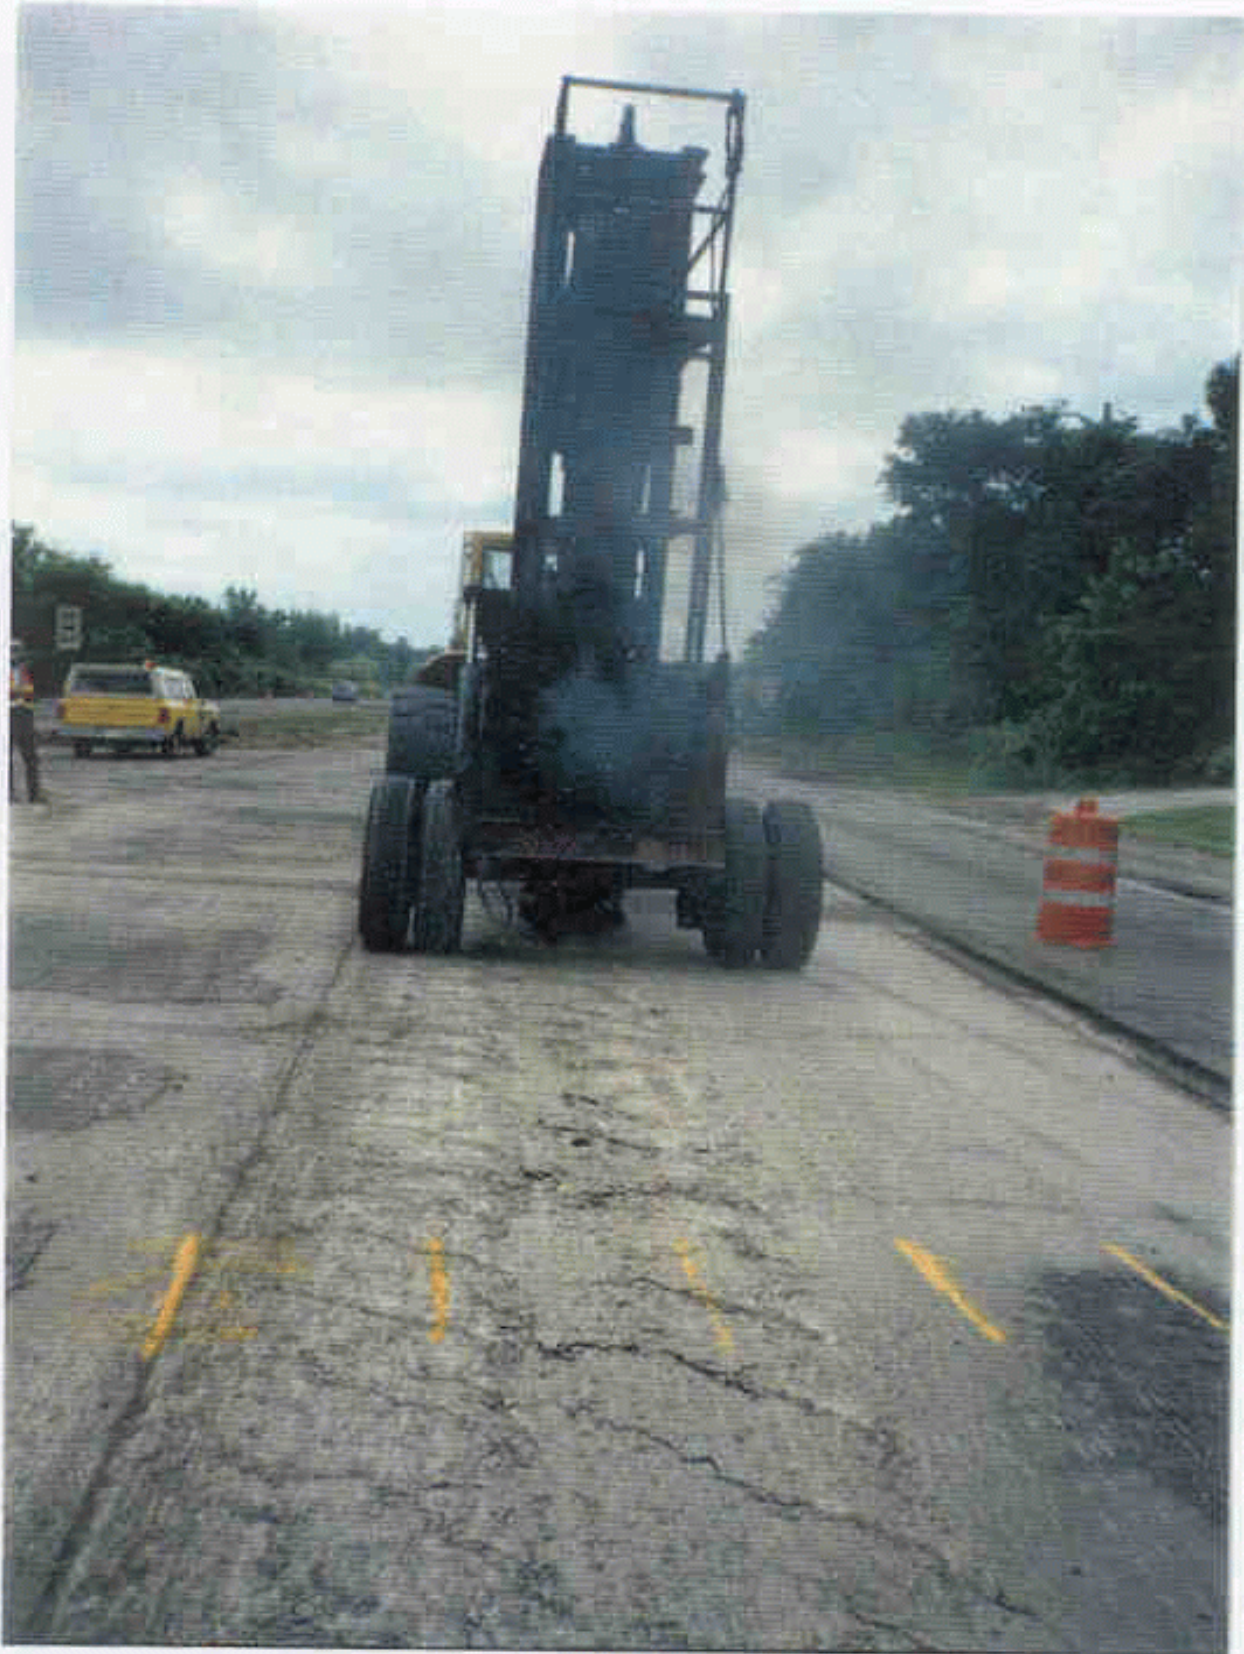
Figure 2. Pile Hammer in Operation on SR-4 Sections

The sections on SR-4 were broken with a pile hammer on a 0.46 m (18") by 0.46 m (18") grid. Figures 2 and 3 show the pavement breakers in operation.

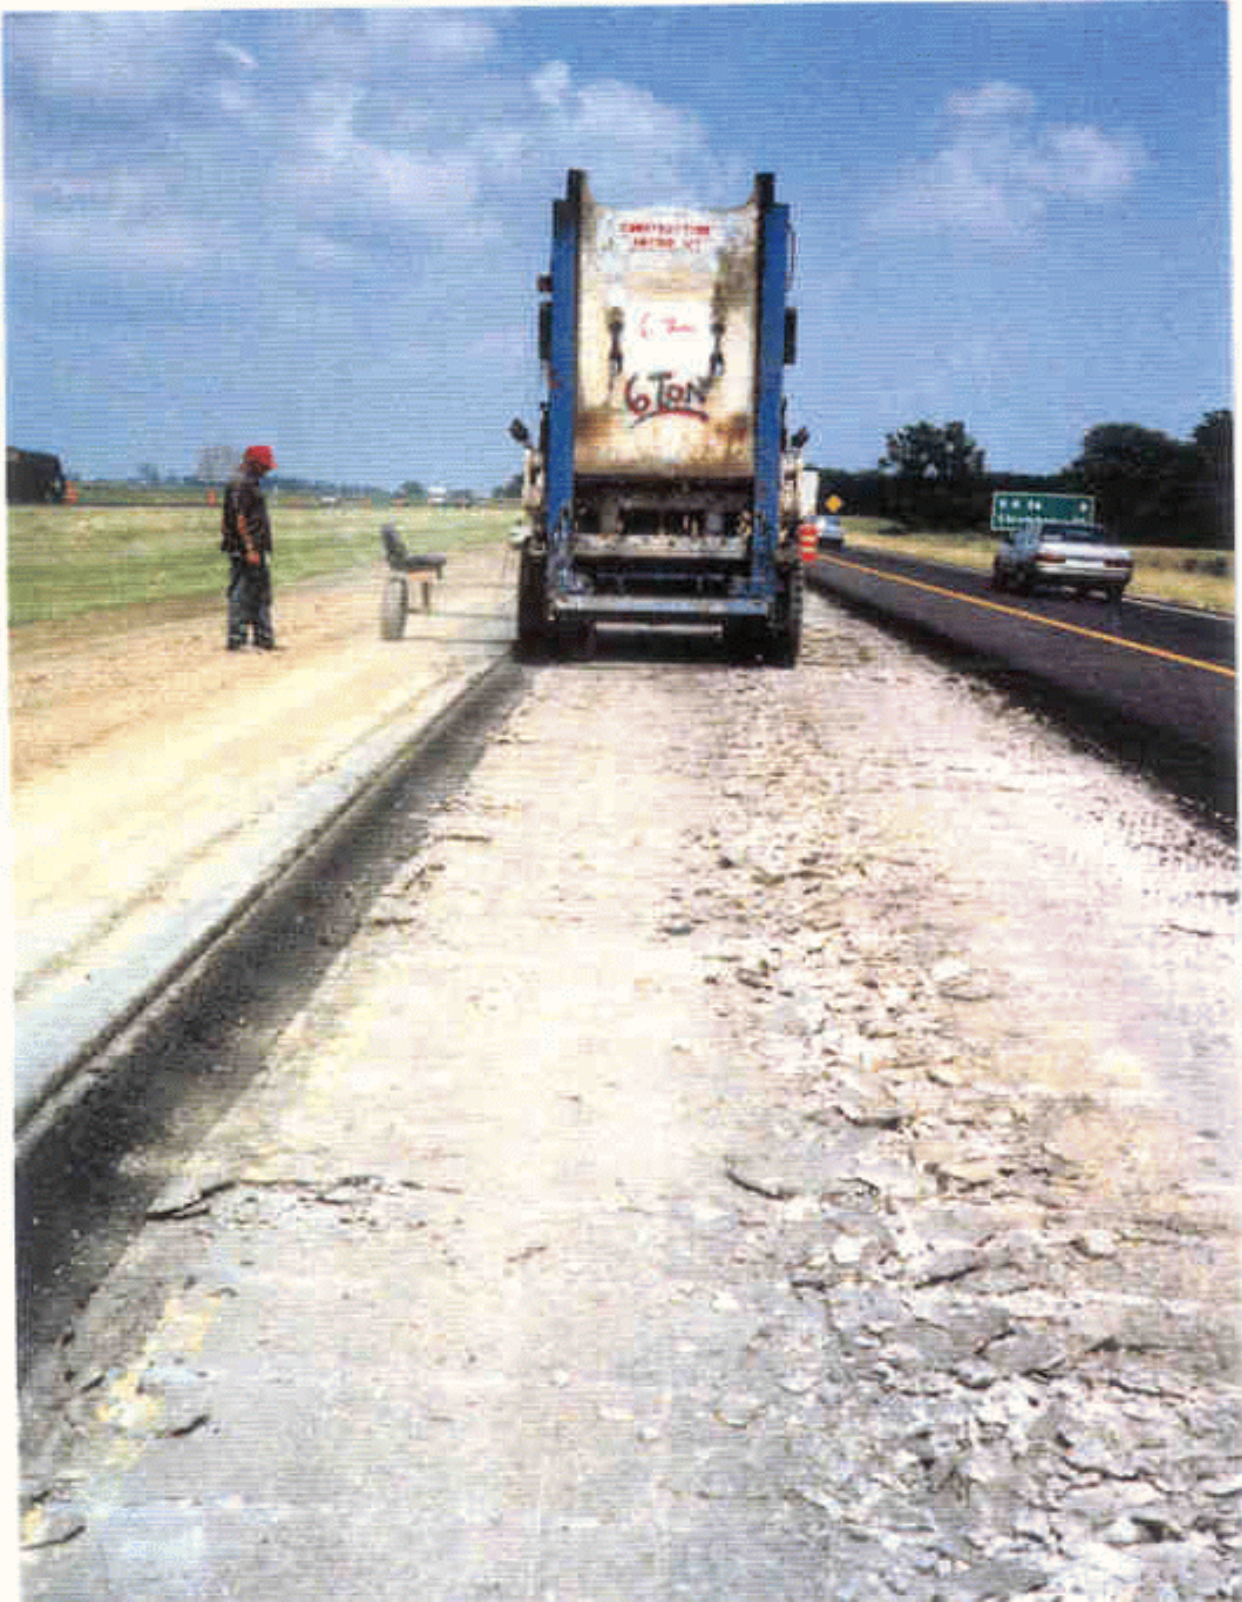
Figure 3. Breaking Pattern with Guillotine Hammer

An attempt was made to get uniform breakage in each section; however, most of the pavements broken with the guillotine hammer had a problem where drops overlapped, usually in the middle of the lane. This area was cracked much more than other parts (see Figure 2). Breaking with

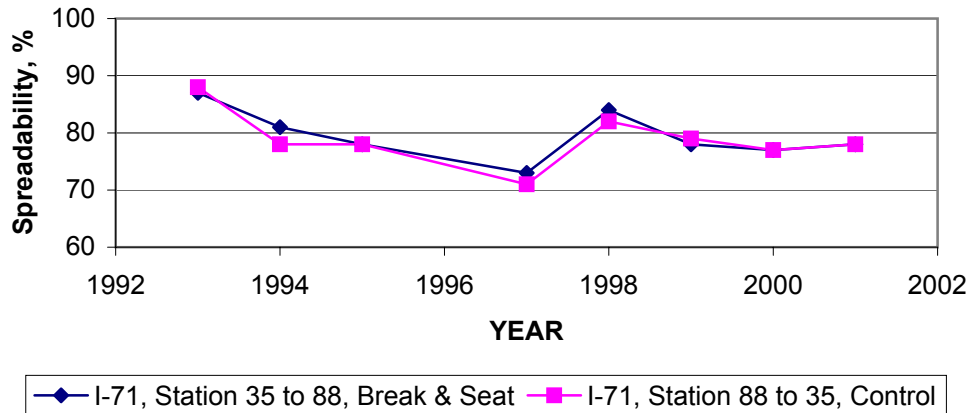
Figure 11. Variation in Spreadability on AC Overlay

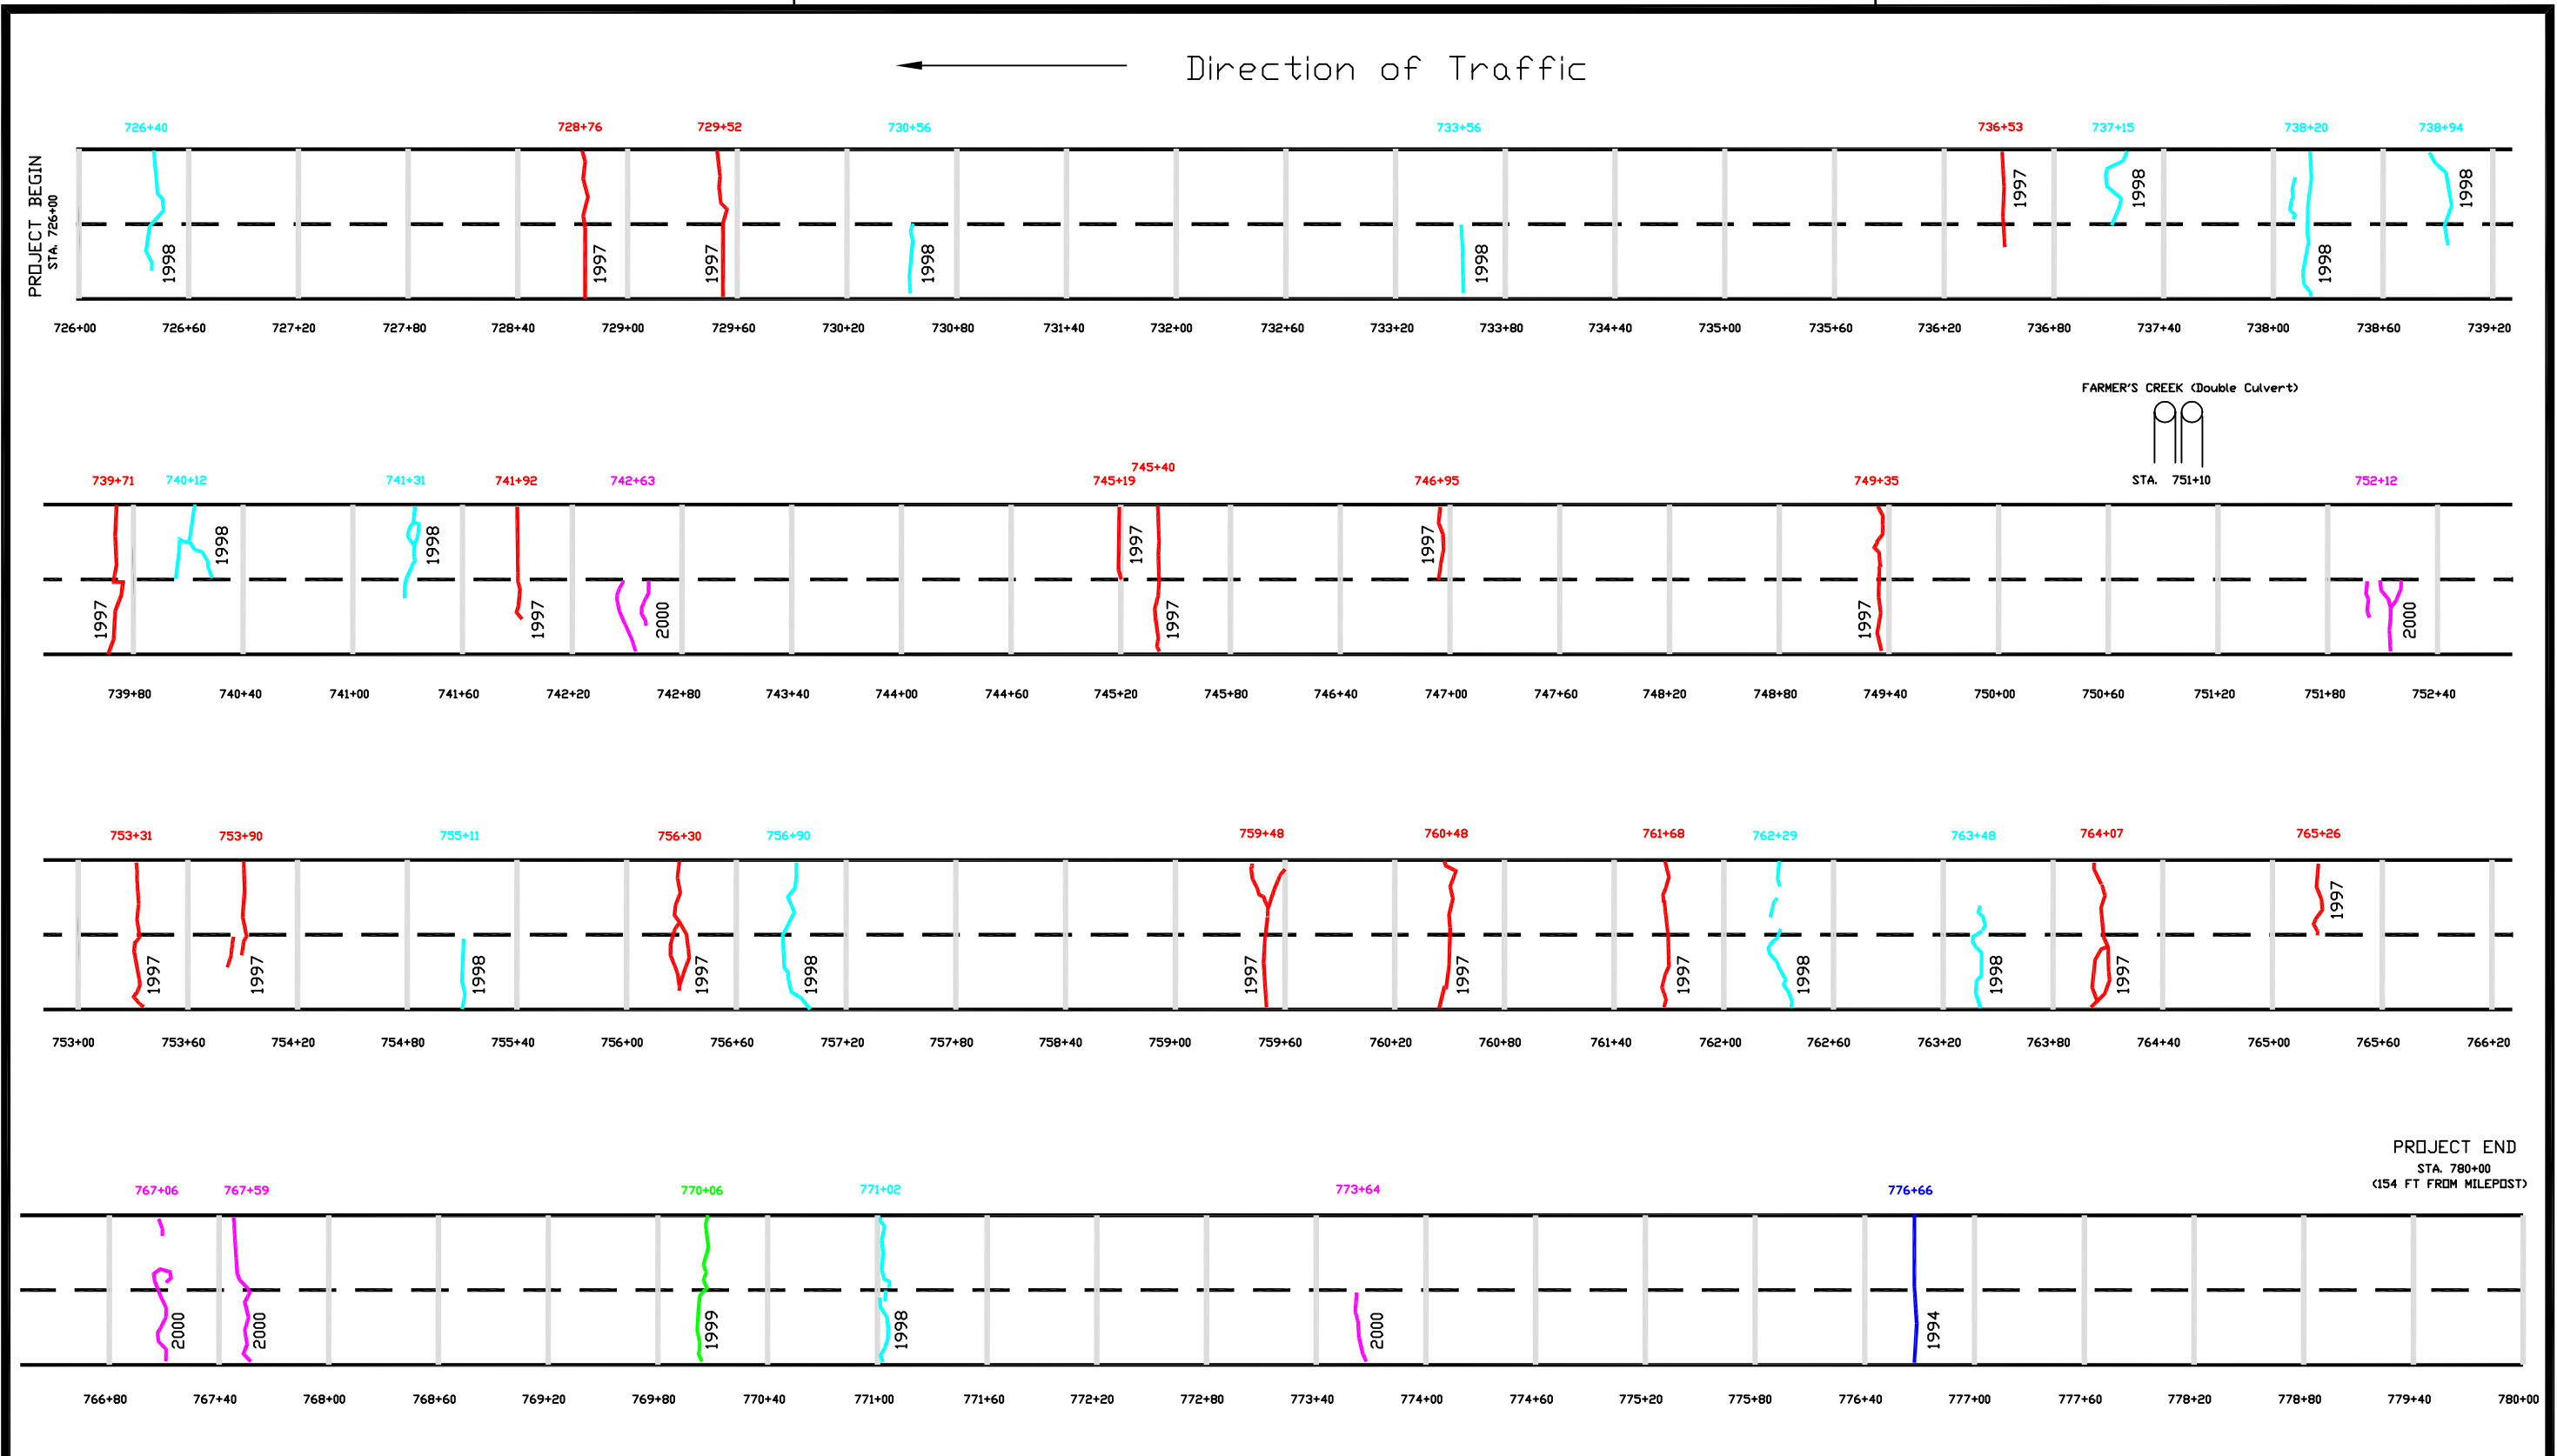
Figure 27. Reflection Cracking on I-71, Station 780 to 726 (Break and Seat section)

Location of Transverse Cracking
 SECTION ID: I-71 (FAY) Station: 726+00 to 780+00
 TOTAL LENGTH: 1.65 km (1.02 miles)
 BREAK AND SEAT SECTION

Overlay Construction: 1992
 ADT (1992): 22,880
 ADT (2010): 34,330
 % Truck: 23

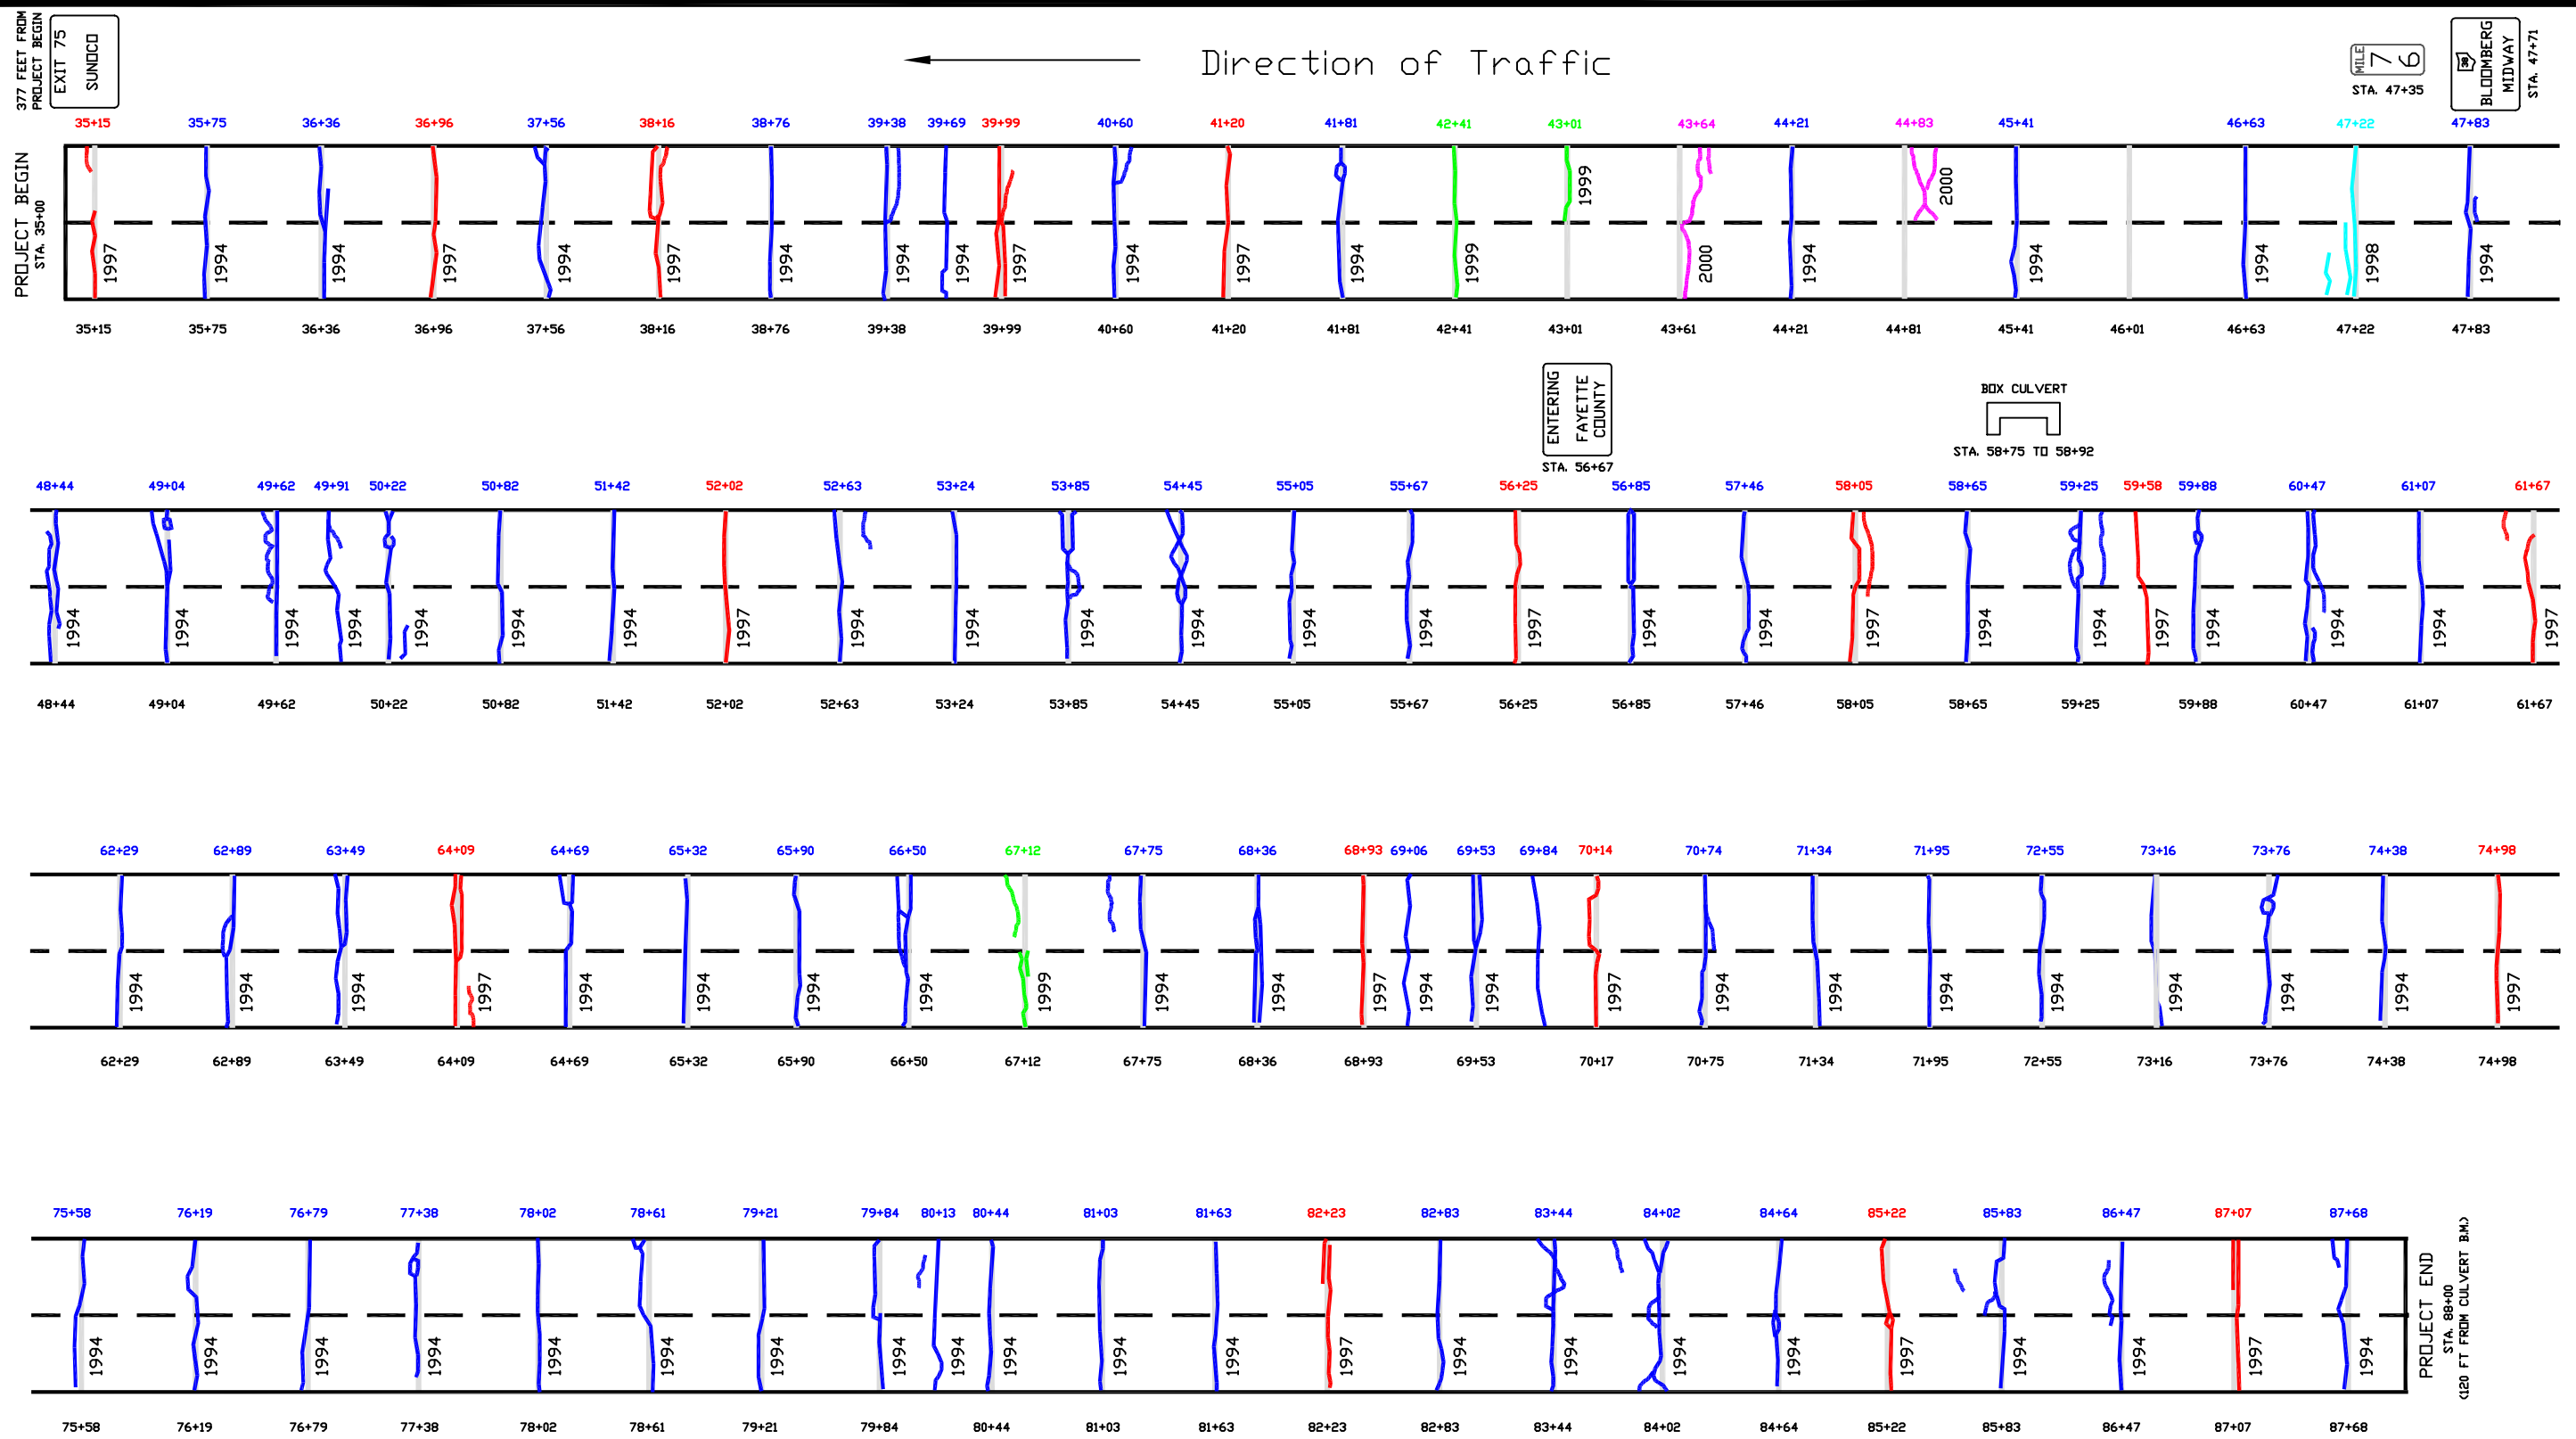
Figure 28. Reflection Crackin on I-71, Station 35 to 88 (control section)

Location of Transverse Cracking
 SECTION ID: I-71 (FAY) Station: 35+00 to 88+00
 TOTAL LENGTH: 1.6 km (1.0 mile)
 CONTROL SECTION

Overlay Construction: 1992
 ADT (1992): 22,880
 ADT (2010): 34,330
 % Truck: 23
