**Durability of Precast Prestressed Concrete Piles
in Marine Environment:
Reinforcement Corrosion and Mitigation – Part 1**

Final Report

**Office of Materials and Research
Georgia Department of Transportation**

**GDOT Research Project No. 07-30
Task Order No. 02-55**

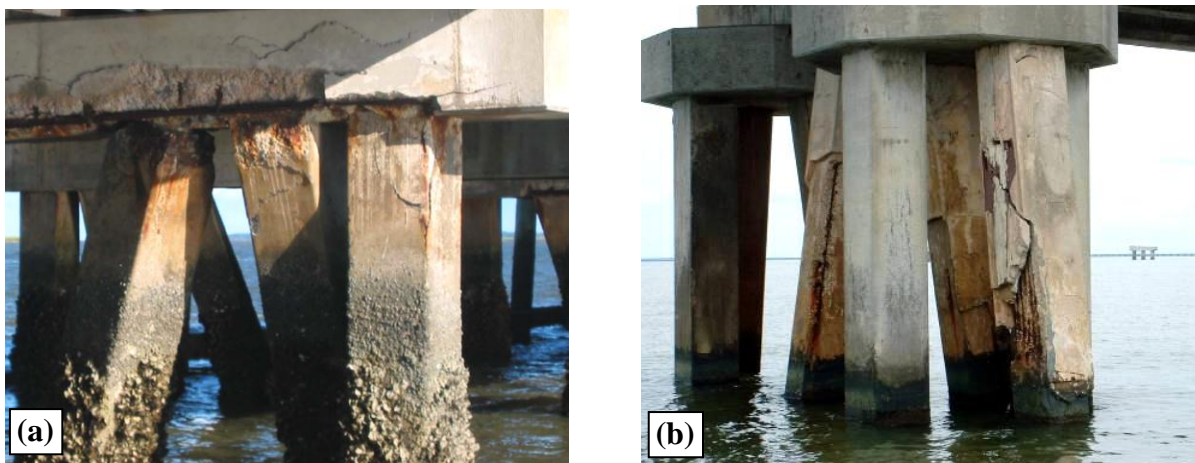
Figure 1-1: Corrosion of (a) concrete pile cap and (b) precast prestressed concrete piles (from Hamilton, 2007)

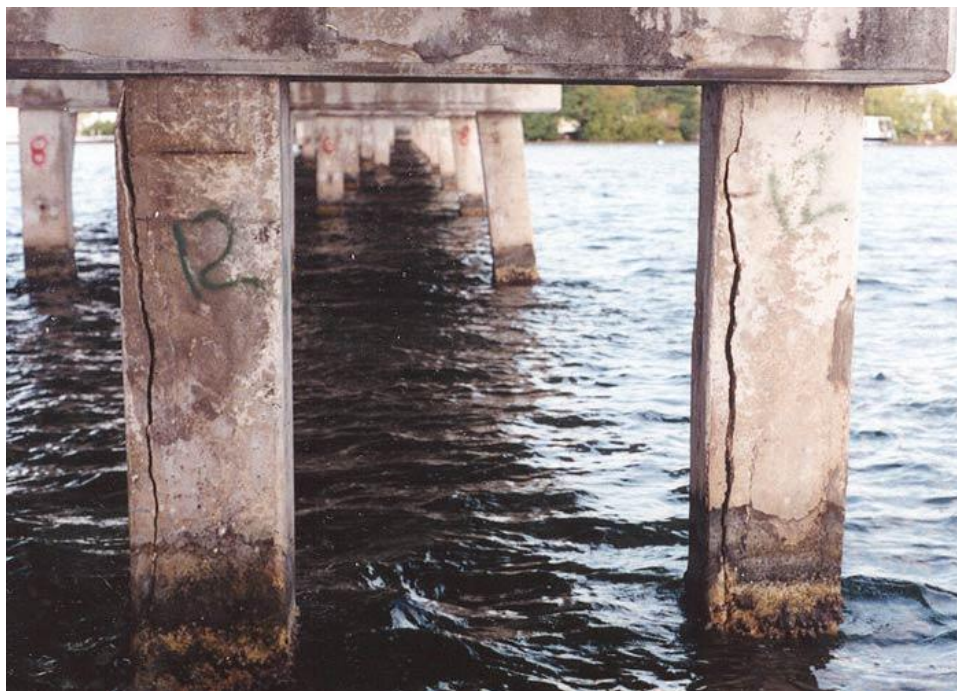
Figure 2-1: Typical Corrosion of Precast Prestressed Concrete Piles (NACE, 2007)

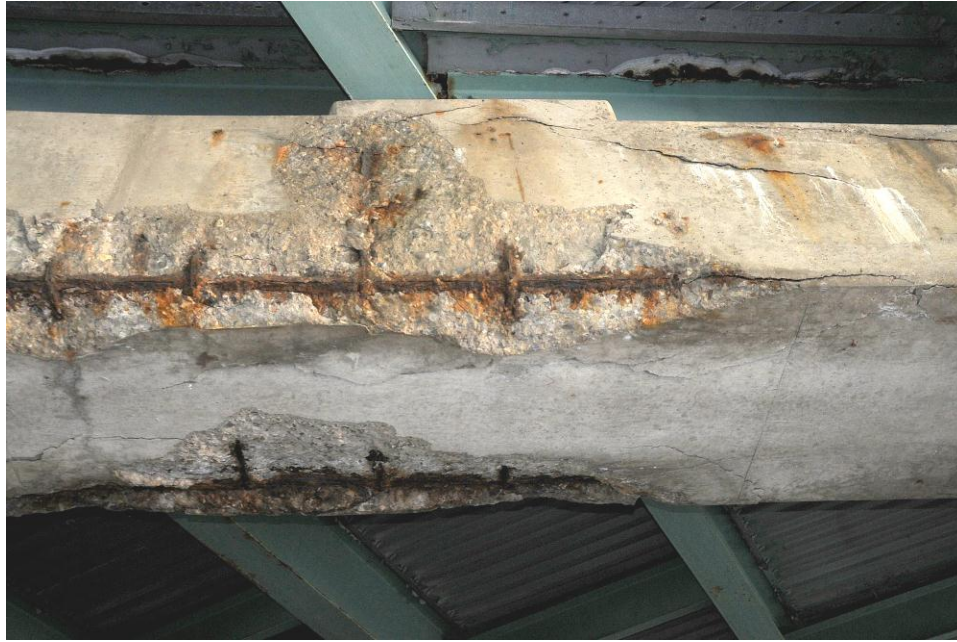
Figure 2-2: Corrosion of Pier Cap on Steel Girder Bridge (Inc., 2008)

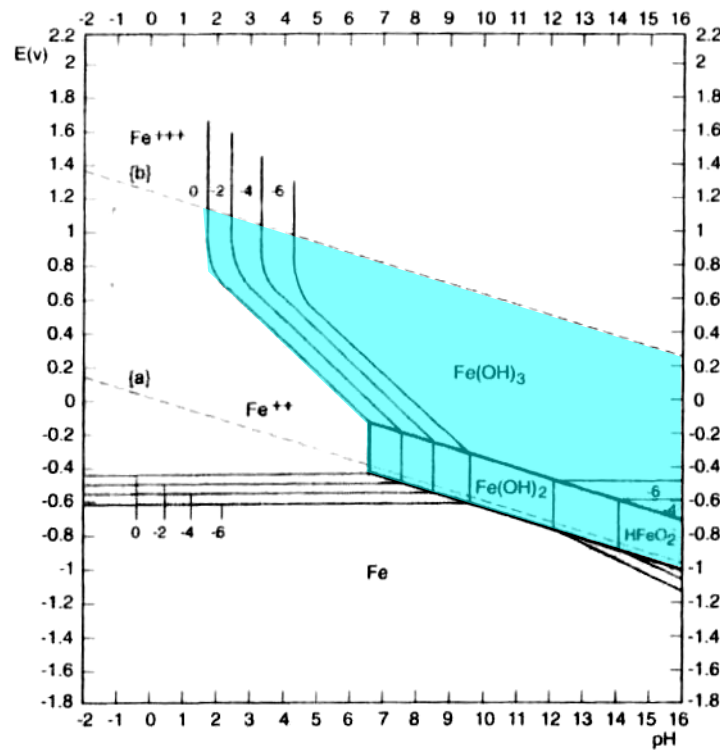
Figure 2-13: Iron E vs. pH Pourbaix Diagram (Pourbaix, 1974)

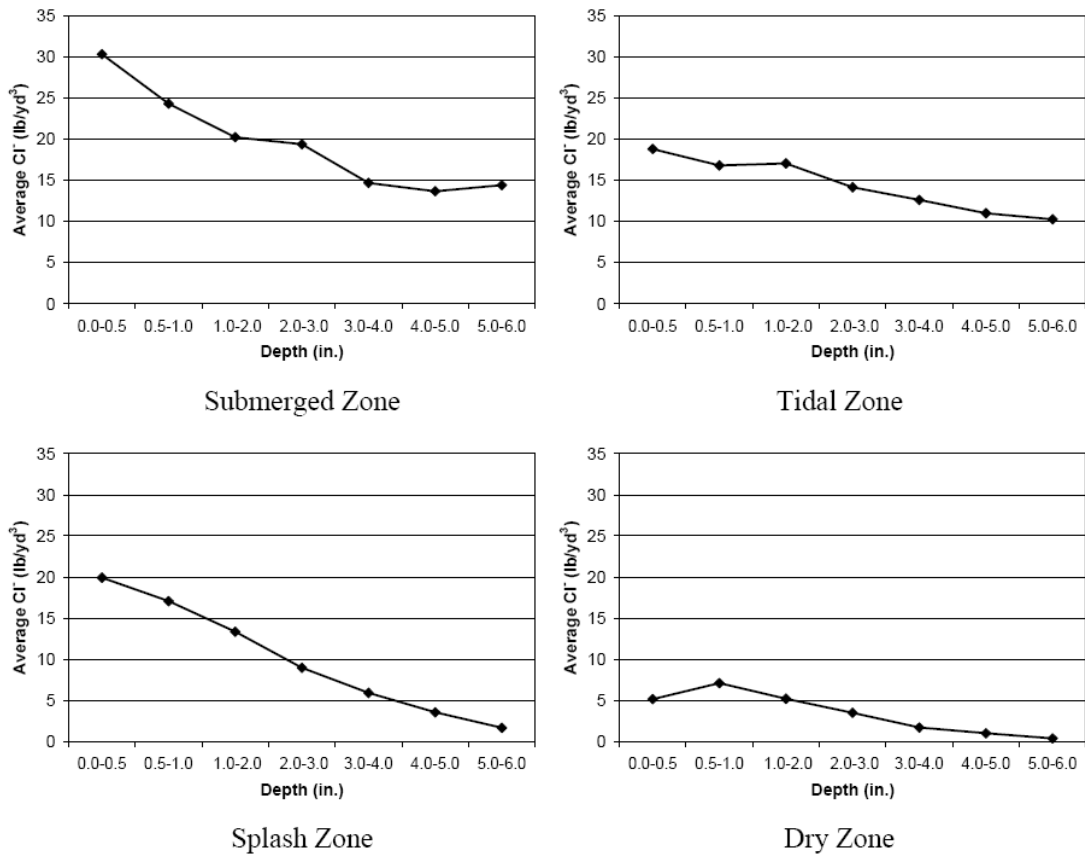
Figure 2-24: Cl^- Concentration vs. Depth for Coastal Piles (Hamilton III, 2007)

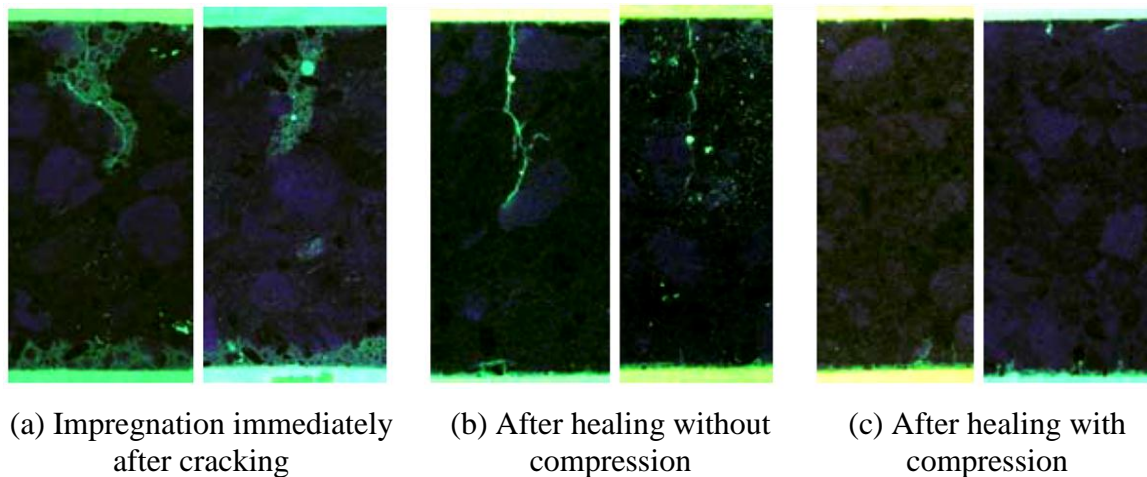
investigation. It has been shown that the self healing of cracks to restore original permeability properties is greatly accelerated at early ages by the presence of compressive stress to close the crack. In addition, it was found that only enough compressive stress to close the faces of the crack was needed to initiate self healing (Heide, 2005). Figure 2-30 shows the results of crack self healing in the presence of compressive stress imaged using fluorescent epoxy impregnation. Self healing experiments conducted in compression are typically performed at early ages when hydration is still occurring. Further research is warranted which investigates the effect of cracks in compression in fully hydrated concrete exposed to realistic non-laboratory environments.

Figure 2-30: Self Healing of Cracks With and Without Compressive Stress (Heide, 2005)

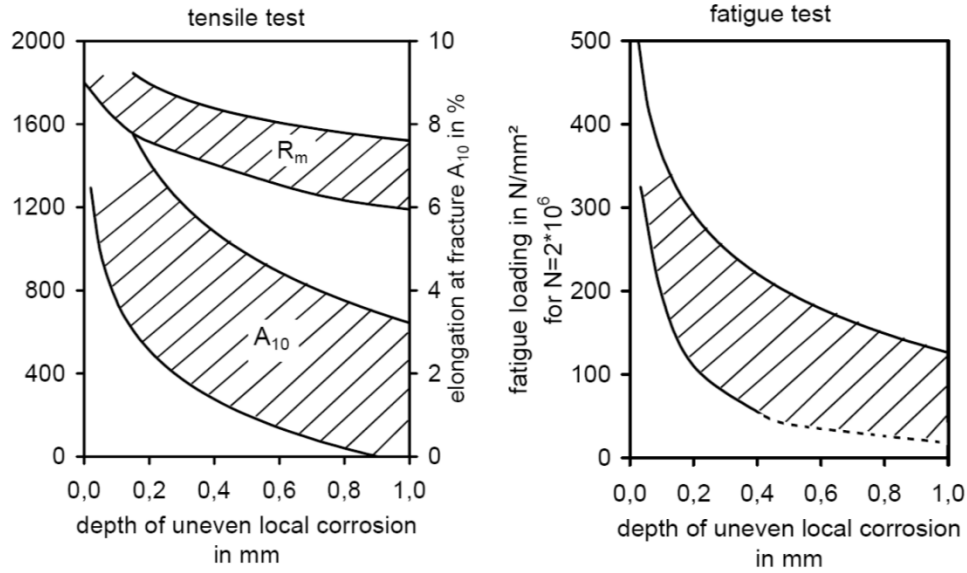
Figure 2-51: Deterioration of Mechanical Performance by Corrosion (Nuernberger, 2002)

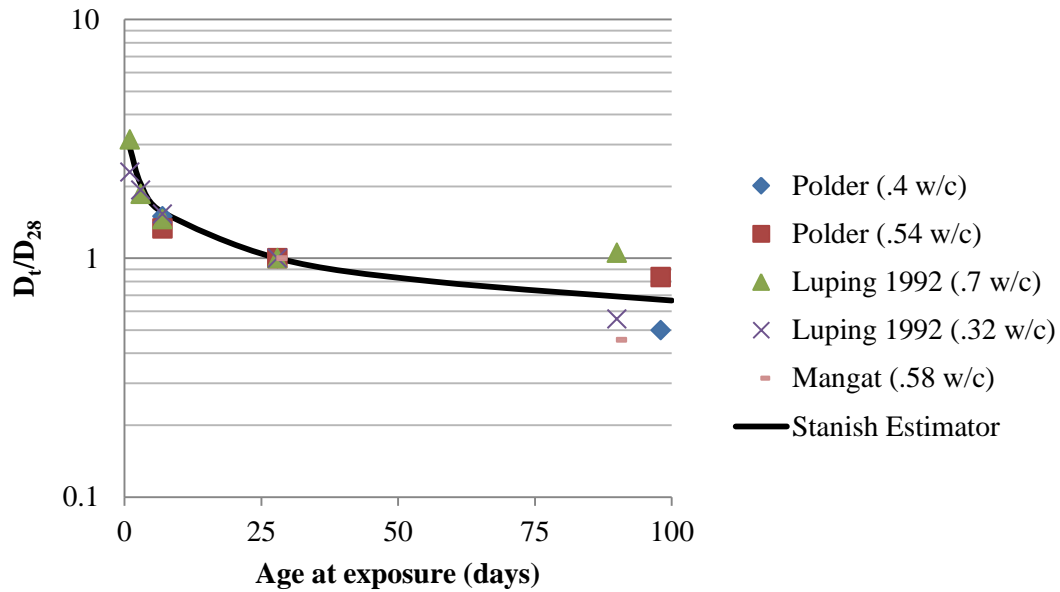
Figure 3.4 shows Stanish's estimator equation plotted with the experimental results for diffusion coefficients of OPC concrete mixes. The data suggests the estimator equation provides an accurate estimate of how the diffusion coefficient varies with time. The decreased diffusion coefficient with time suggests that longer curing periods would lead to decreased rates of chloride ingress.

Figure 3.4: Comparison of time dependent diffusion coefficients with estimator equation

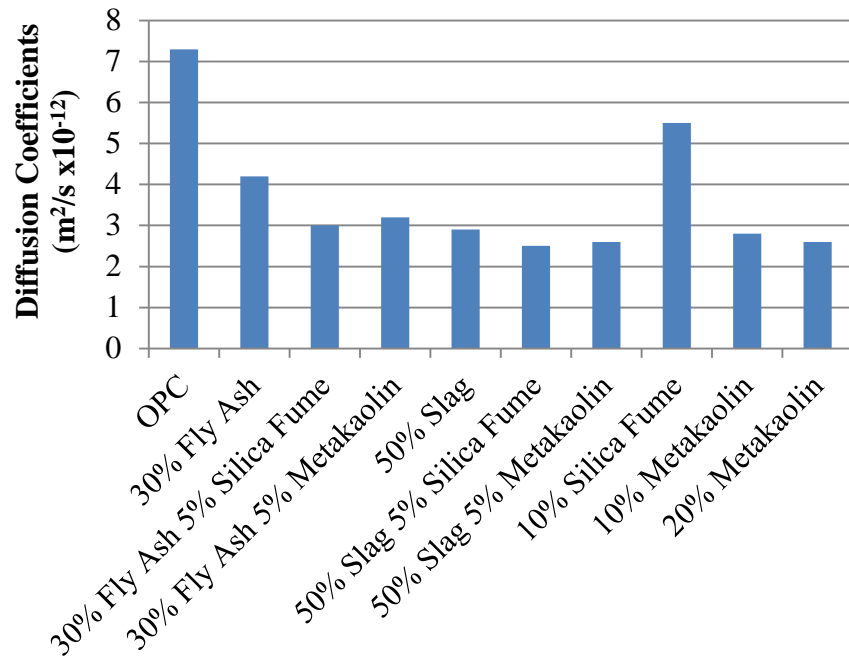
The effect of using supplementary cementitious materials (SCMs) on the diffusion coefficient has been investigated by Bentz (2000), Basheer (2001), and Thomas (1999). The results of the Basheer study are shown in Figure 3.5. The results show that the use of SCMs decreases the diffusion coefficient, with fly ash, slag, and metakaolin having larger effects than silica fume. This result is in contradiction to the research performed by Bentz. Bentz's research, which is shown in Figure 3.6, showed that the diffusion coefficient with 10% silica fume replacement was an order of magnitude smaller than the OPC mix with the same parameters.

Figure 3.5: Effect of SCM's on diffusion coefficient

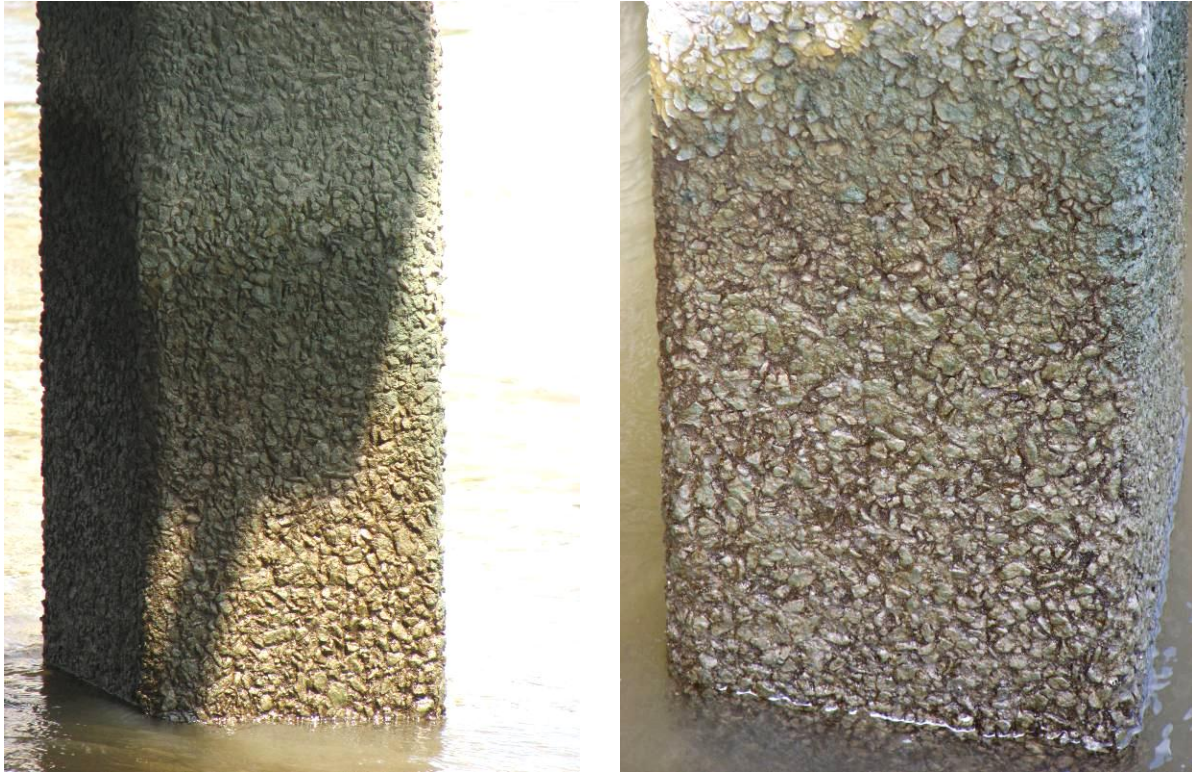
Figure 5-6. Surface Abrasion Observed in Concrete Substructure of Houlihan Bridge (Bridge No. 051-0054)

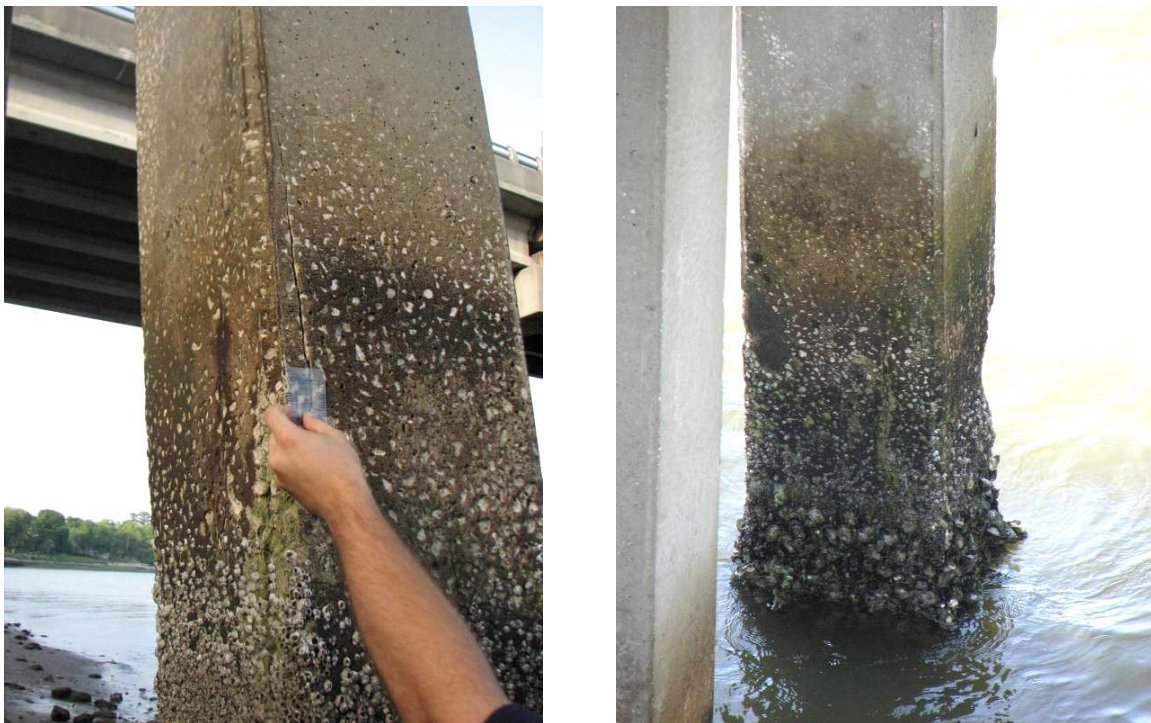
Figure 5-15. Severe Damage to Concrete Piling on Island Expressway at Wilmington River Bridge (Bridge No. 051-0132)

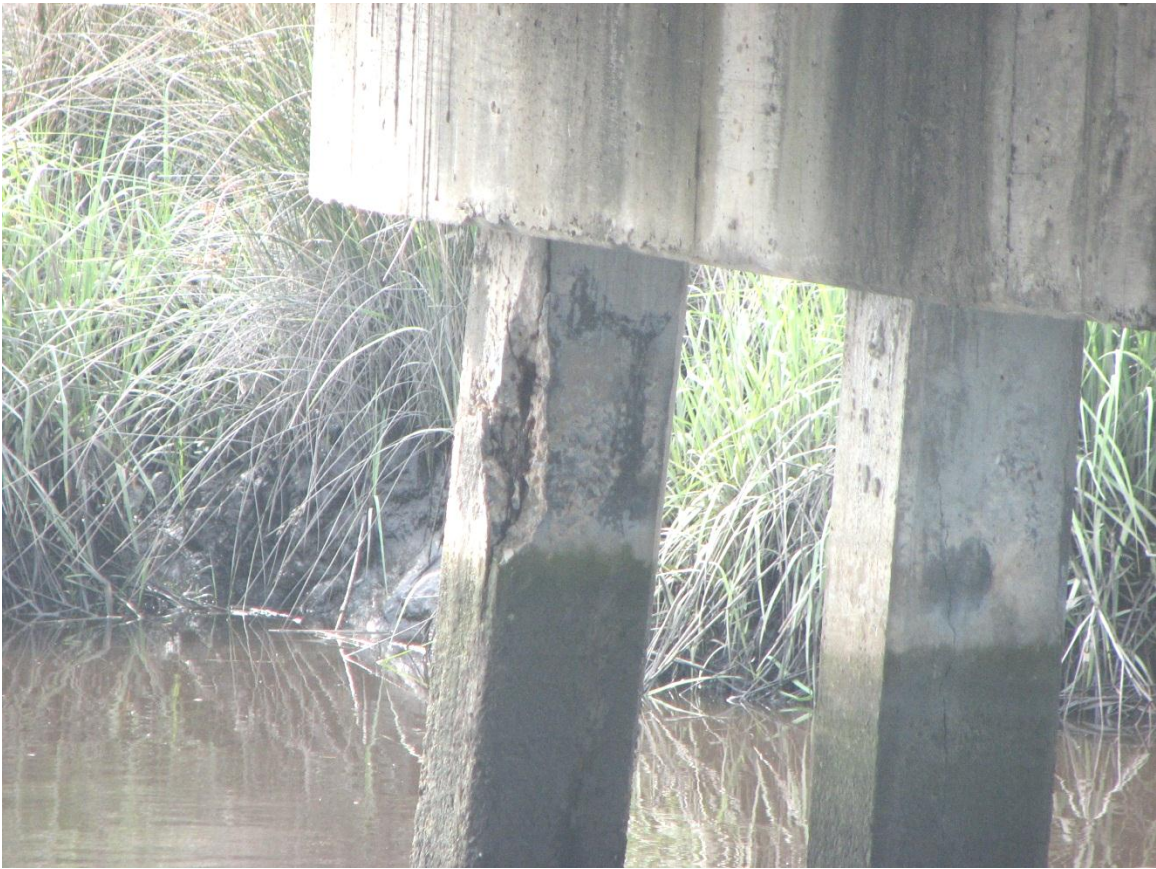
Located 20 miles inland over Riceboro Creek in Liberty County, bridge 179-005 was constructed with a reinforced concrete superstructure and precast concrete pile-bent substructure in 1957. An overall view of the bridge is shown in Figure 5-26. All piles showed significant deterioration with surface abrasion of the paste fraction below the high-water mark, longitudinal cracks at the corners, and rust staining from corrosion present on most piles (see Figure 5-27).

Figure 5-27. Deterioration of Precast Concrete Piles in Substructure of Ocean Highway at Riceboro Creek Bridge (Bridge No. 179-0005)

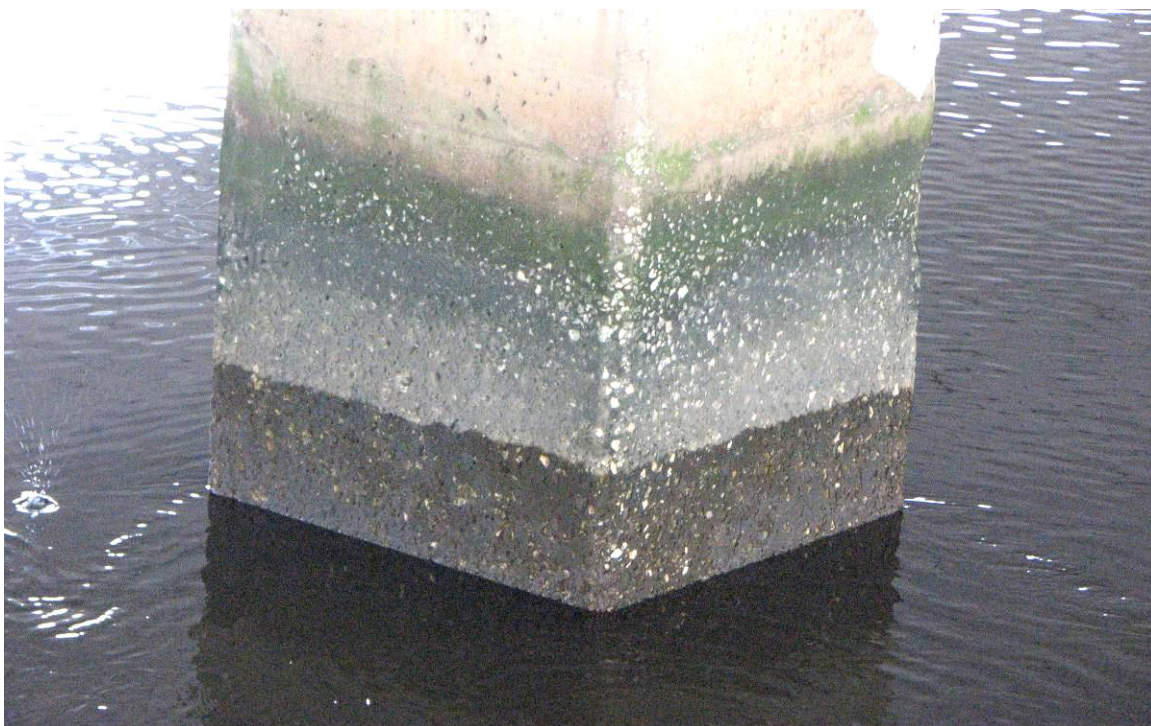
A fishing pier attached to the side of the bridge was used to take photos of the substructure. The bridge was inspected at high tide and photos of regions of the piles well below the high water mark could not be taken. Surface abrasion, particularly at the site of limestone aggregates, was present on all of the piles. No significant cracking or rust staining was observed on any of the piles. The typical condition of the piles is illustrated in Figure 5-30.

Figure 5-30. Typical Surface Abrasion of Concrete on Ocean Highway at Champney's River Bridge (Bridge No. 191-0005)

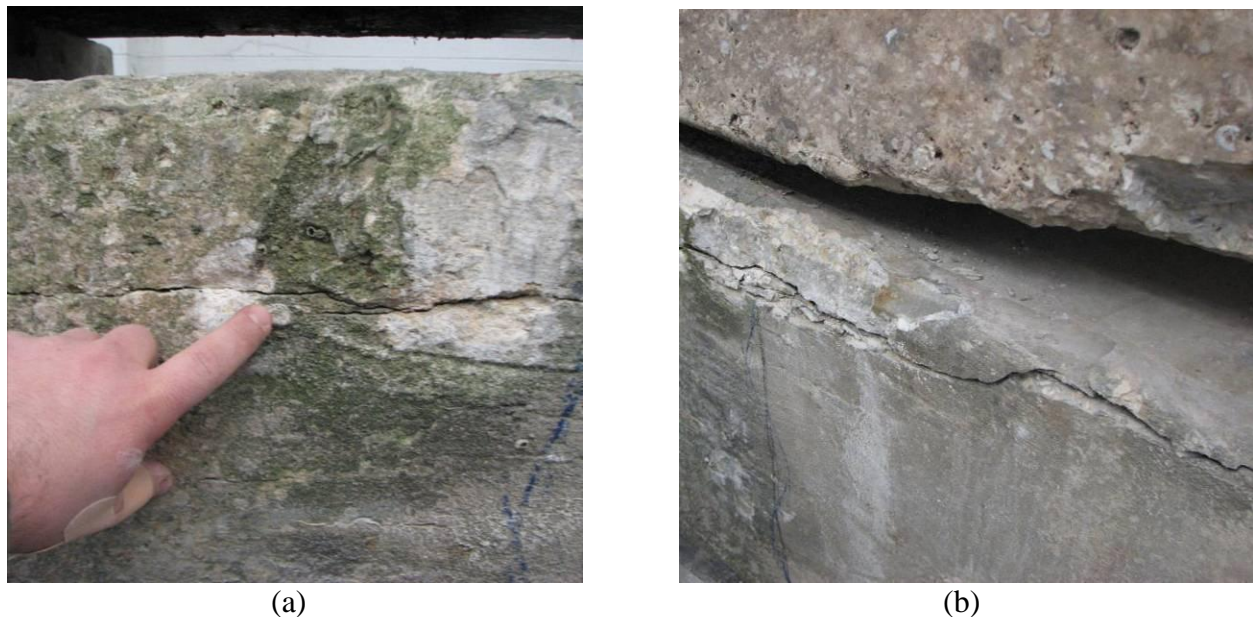
Figure 6-7: (a,b) Corrosion induced longitudinal cracking of piles

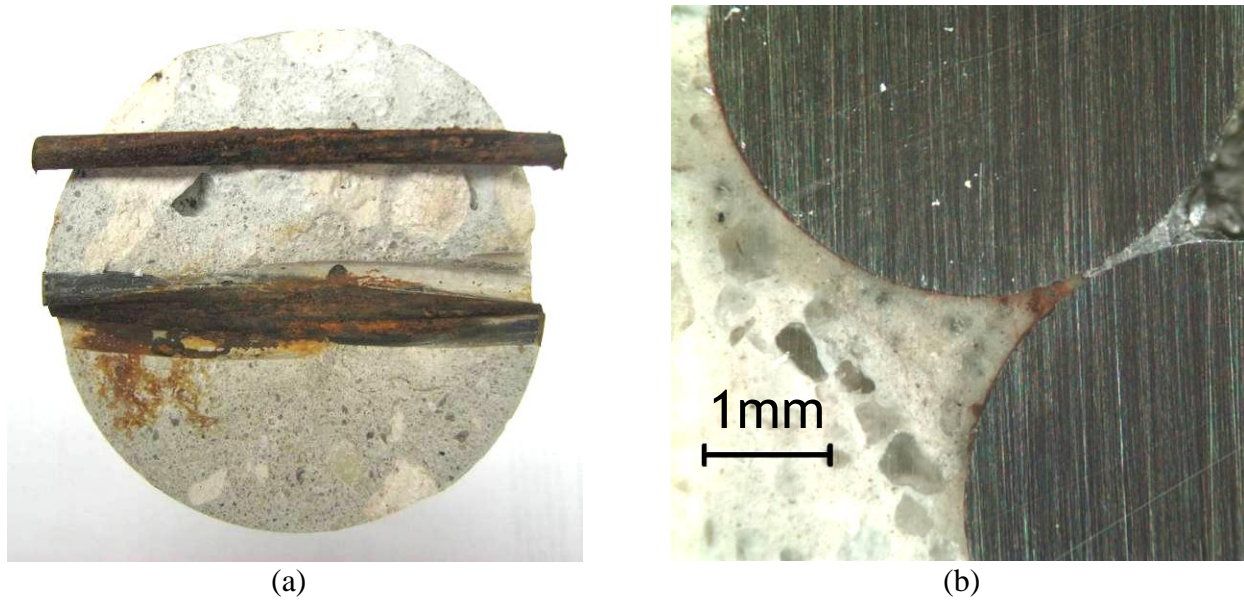
Figure 6-10: Corrosion of prestressing steel in extracted core

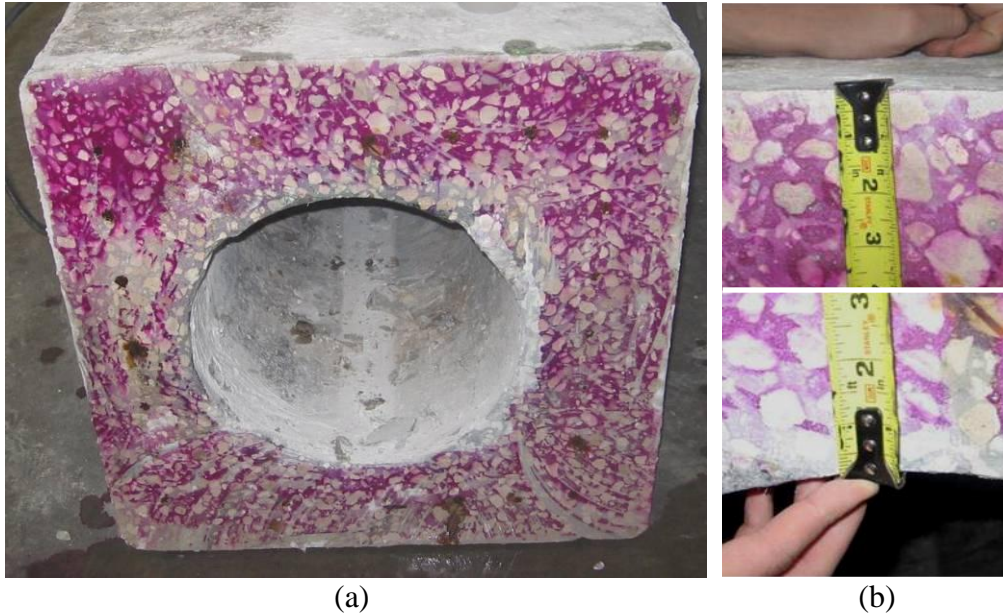
Figure 6-11: (a) Phenolphthalein indicator solution on sawn surface of pile, and (b) measurement of carbonation front

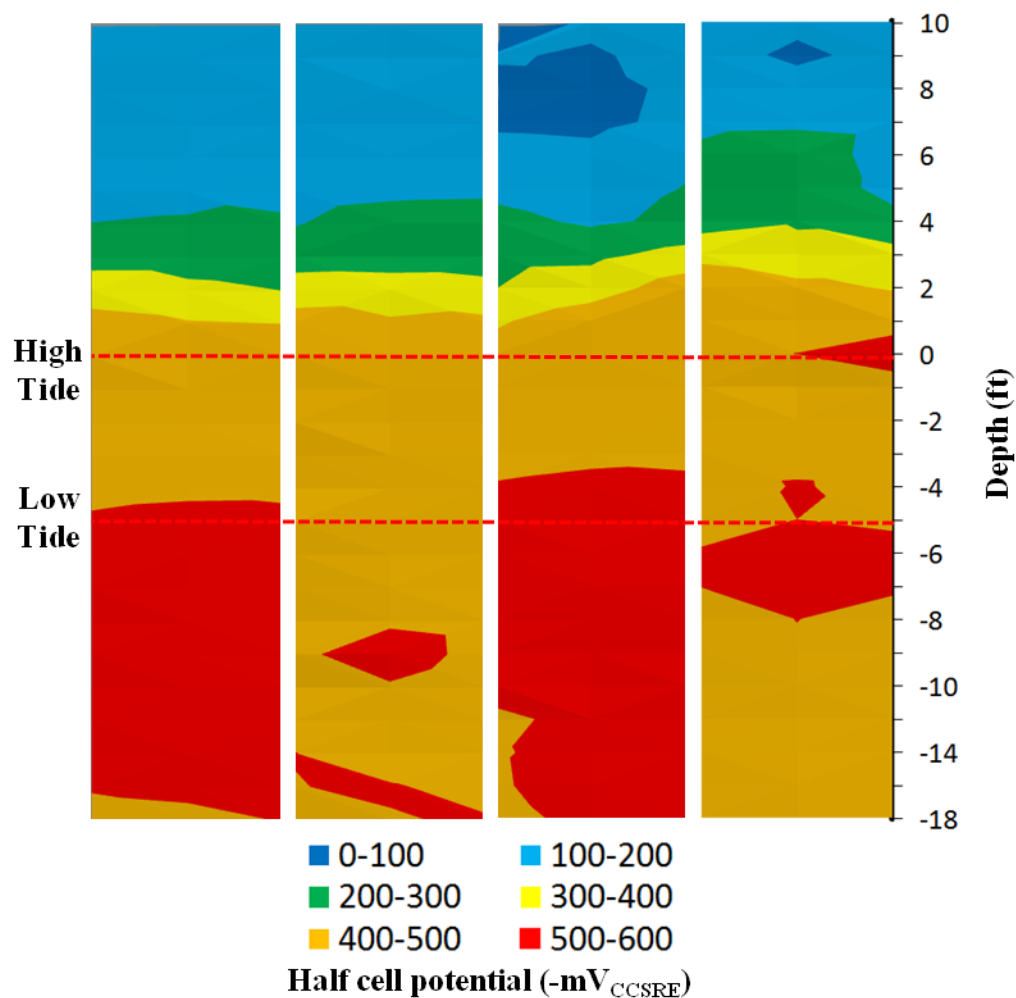
Figure 6-13: Half-cell potential map of the four faces of a Turtle River Bridge pile

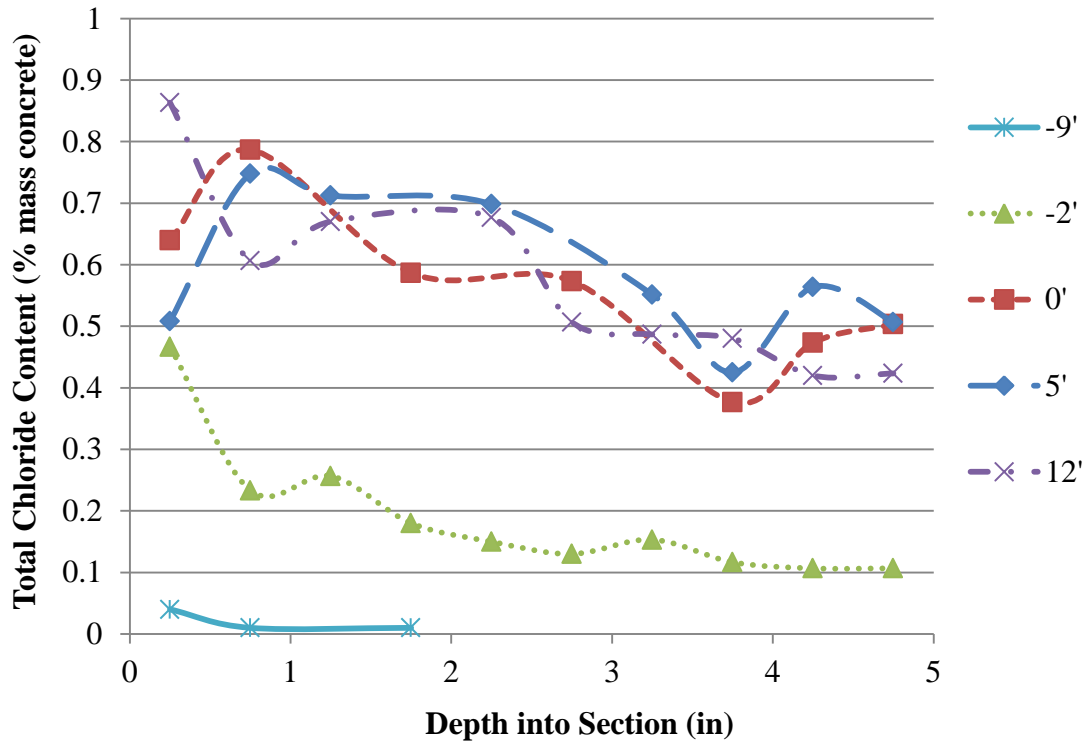
Figure 6-16: Total chloride content of concrete columns at various depths

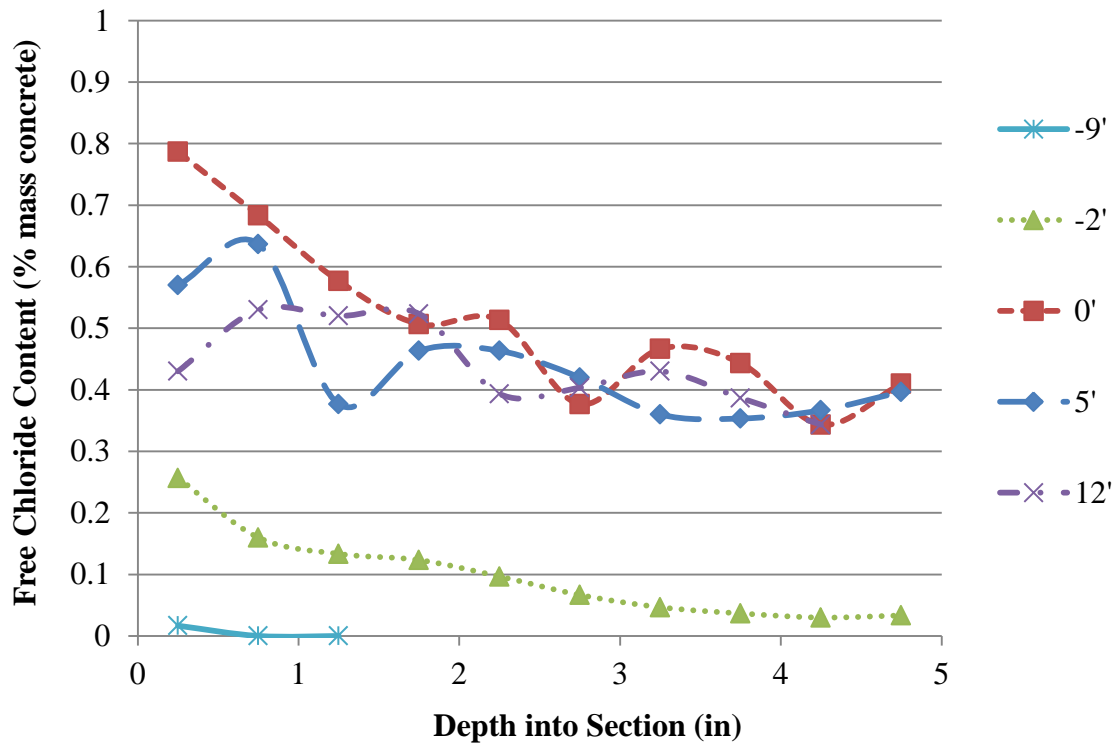
Figure 6-17: Free chloride content of concrete columns at various depths

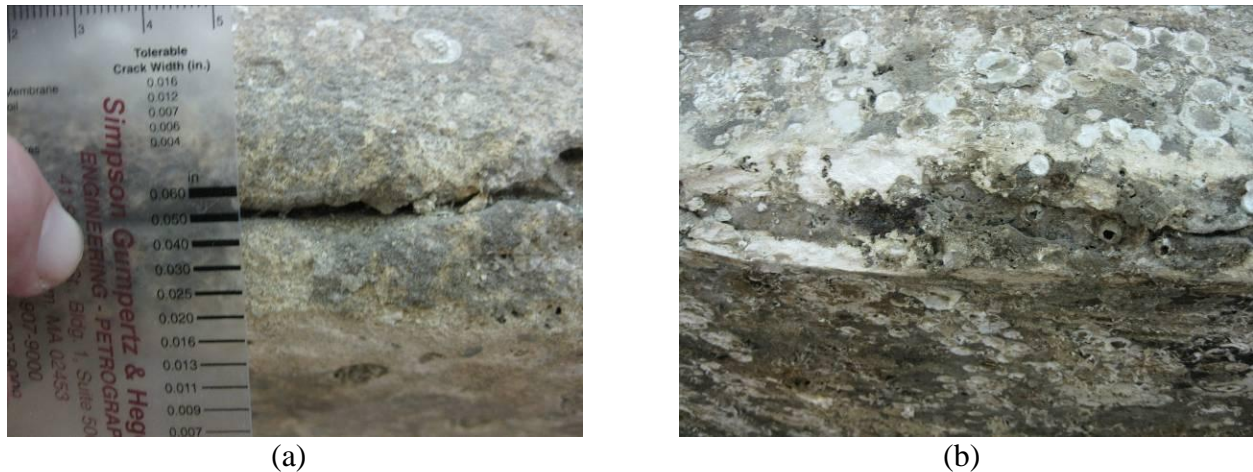
Figure 6-20: (a) Cracking along corner of pile, and (b) marine growth in crack

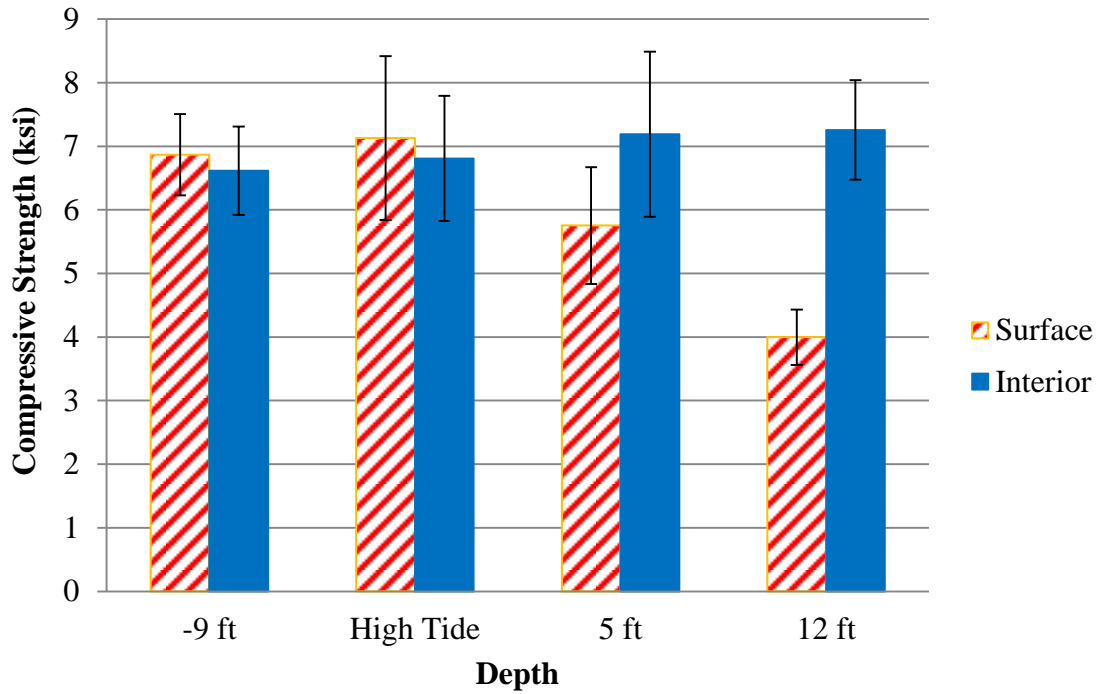
Figure 6-31: Compressive strength of surface versus interior concrete

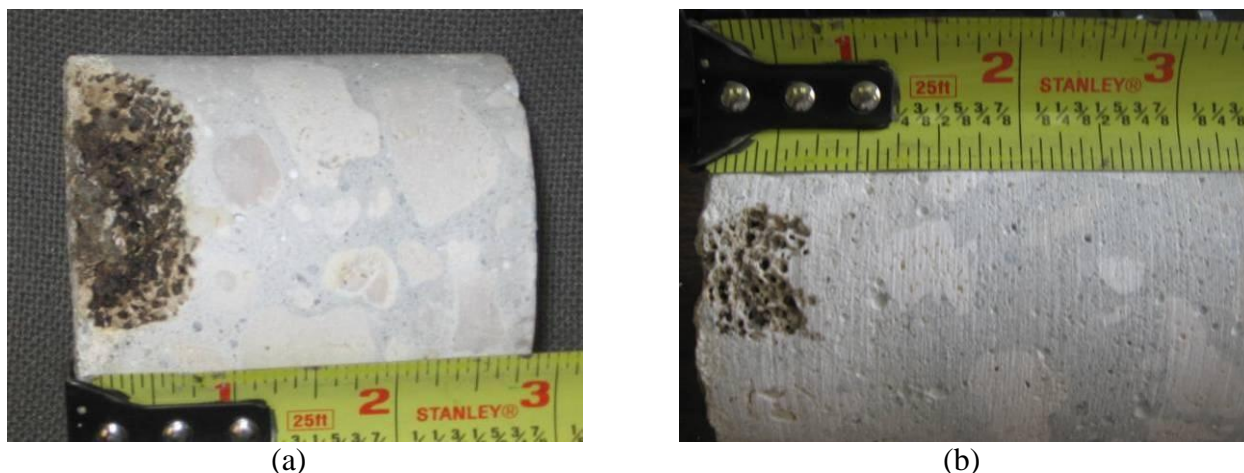
(a) (b)
Figure 6-61: Boreholes in limestone aggregate of cores

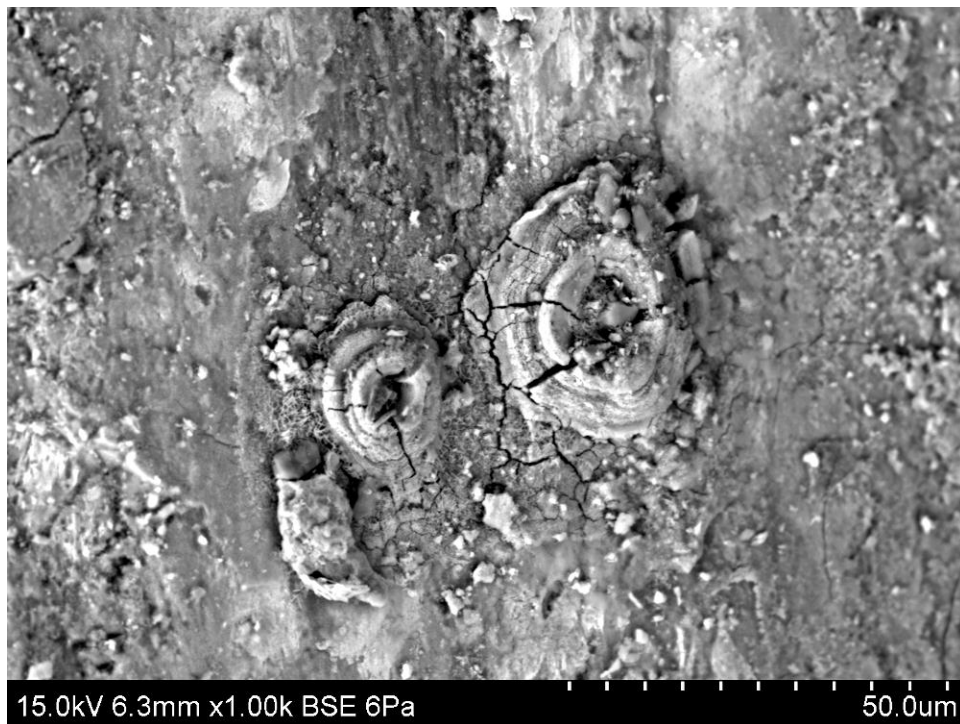
Figure 6-69. Pitting / crevice corrosion sites present at wire impingement sites

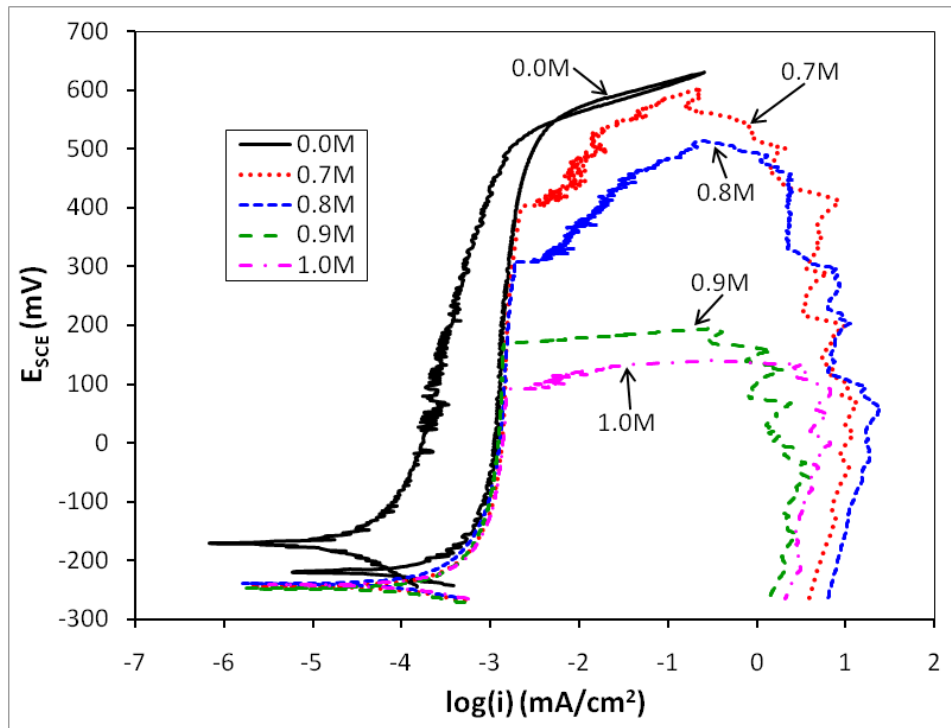
Figure 7- 10. Polarization curves for prestressing wire specimens at various Cl^- concentrations

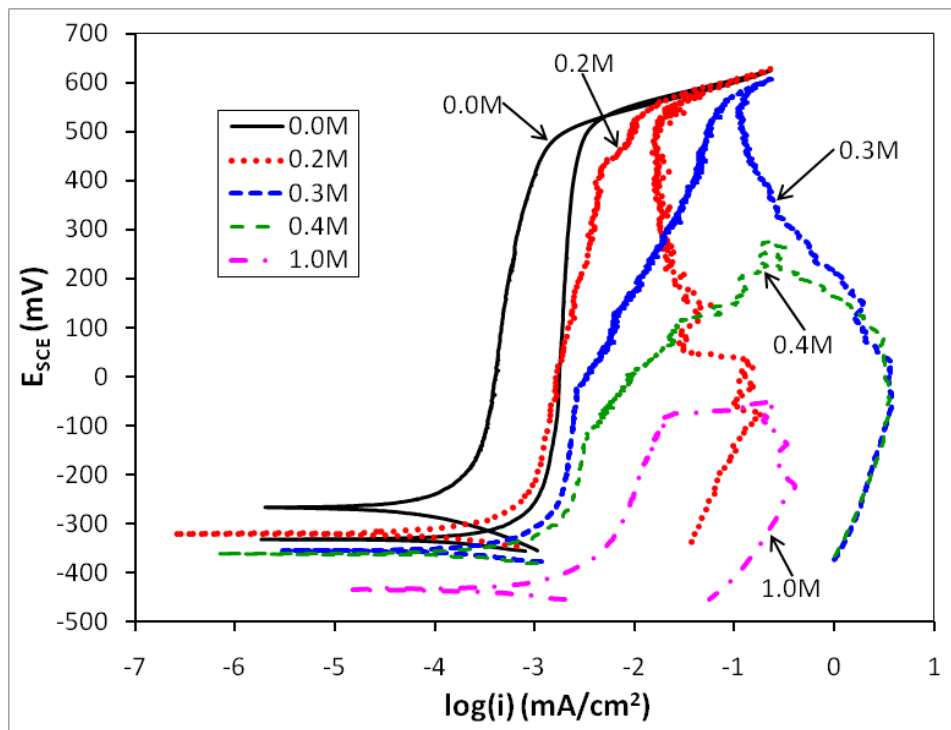
Figure 7- 12. Polarization curves for prestressing strand specimens at various Cl^- concentrations

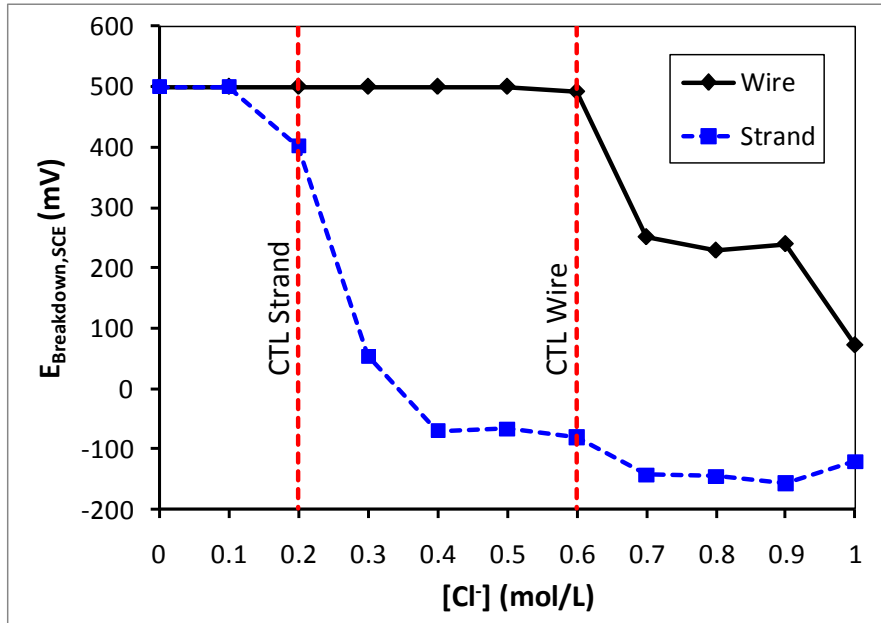
Figure 7-14. Breakdown potential vs. Cl^- concentration for prestressing wire and strand specimens

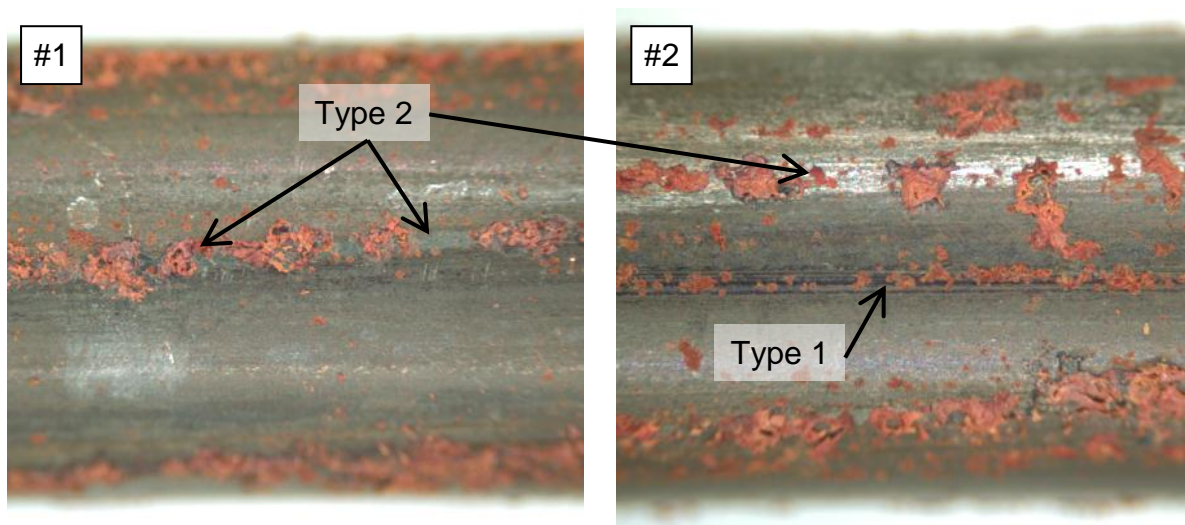
Figure 7- 20. Attack of surface imperfections during CPP corrosion initiation experiments

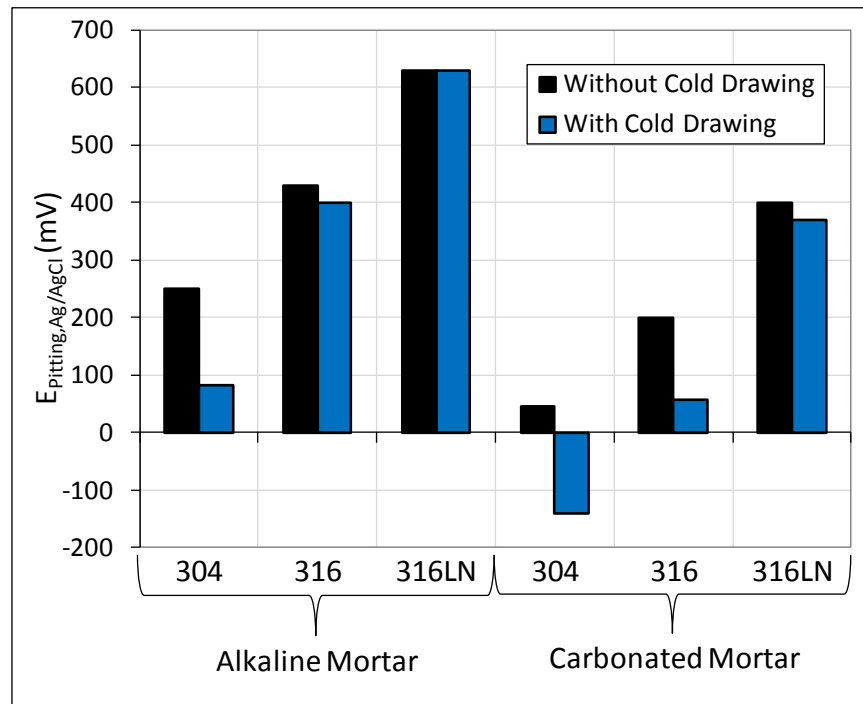
Figure 8-4: Pitting potential of HSSS embedded in alkaline and carbonated Cl^- -containing mortars (adapted from (Wu, et al., 2009))
