**Nighttime Visibility of In-Service  
Pavement Markings, Pavement  
Markers, and Guardrail Delineation in  
Alaska (with and without Continuous  
Lighting)**

Prepared by: Paul Carlson, Ph.D., P.E.  
Operations and Roadway Safety Division Head  
Texas Transportation Institute

**March 2011**

FHWA-AK-RD-11-04

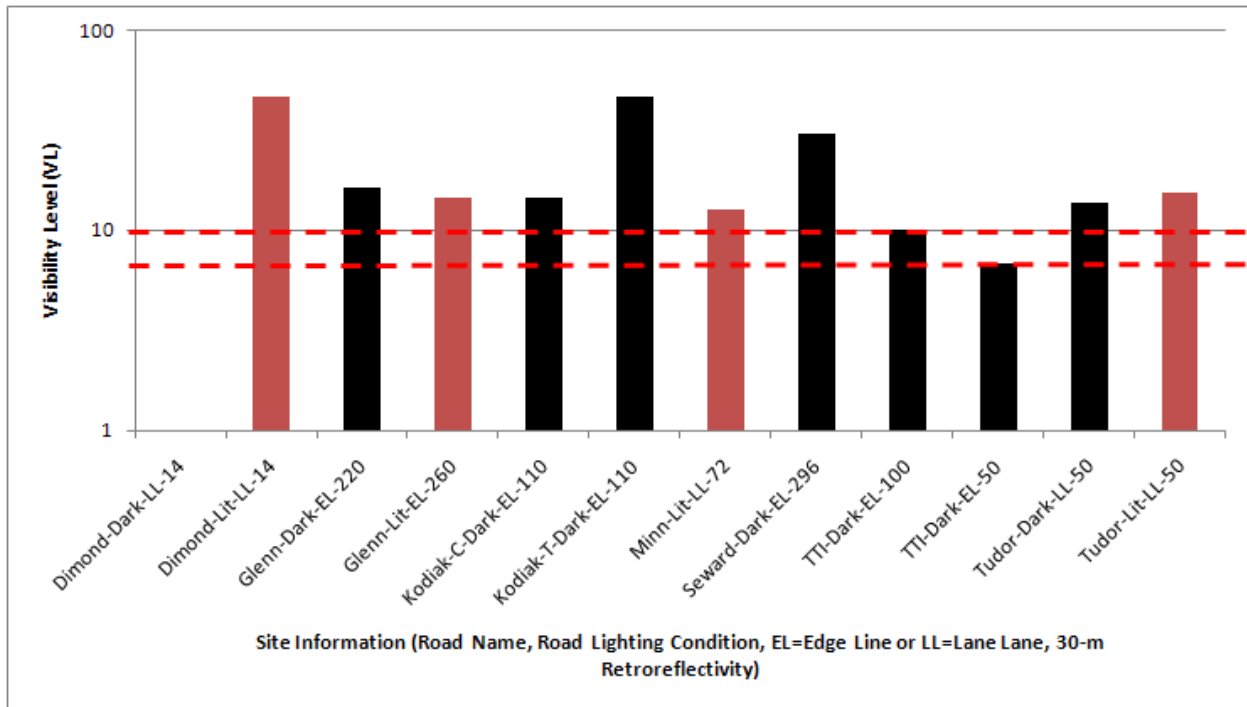
**Figure 4. Pavement Marking Visibility Levels at 44 Meters.**

In Figure 4, the VL is shown in the y-axis and the study sites are shown on the x-axis. The VL of sites without roadway lighting is shown with black bars. The dashed lines represent the implied visibility of the FHWA proposed minimum retroreflectivity levels at a distance of 44 m (see the bars labeled TTI-Dark-EL-100 and TTI-Dark-EL-50). Again, all of the pavement markings at the study sites provide as much visibility as implied by the FHWA proposed minimum retroreflectivity levels at a distance of 44 m.

The differences in pavement marking visibility between the lit and unlit sections of the Glenn Highway were quite small. The same goes for Tudor Road. At this distance, the study sites with lighting provided as much visibility without the lighting as they did with the lighting (AKDOT&PF illumination specifications call for 400 Watt High-Pressure Sodium lighting with medium cutoff fixtures. Spacing ranged from 300 to 400 ft). It should be noted, however, that the VL values can vary significantly depending on where the measurements are made with respect to the roadway lighting luminaires. A data collection protocol was established and implemented using readings from three equidistance locations spanning two consecutive luminaires. Figure 5 is similar to Figure 4 except it represents the visibility of the pavement markings at 54 m instead of 44 m. The 54 m was derived from a speed of 55 mph with 2.2 seconds.

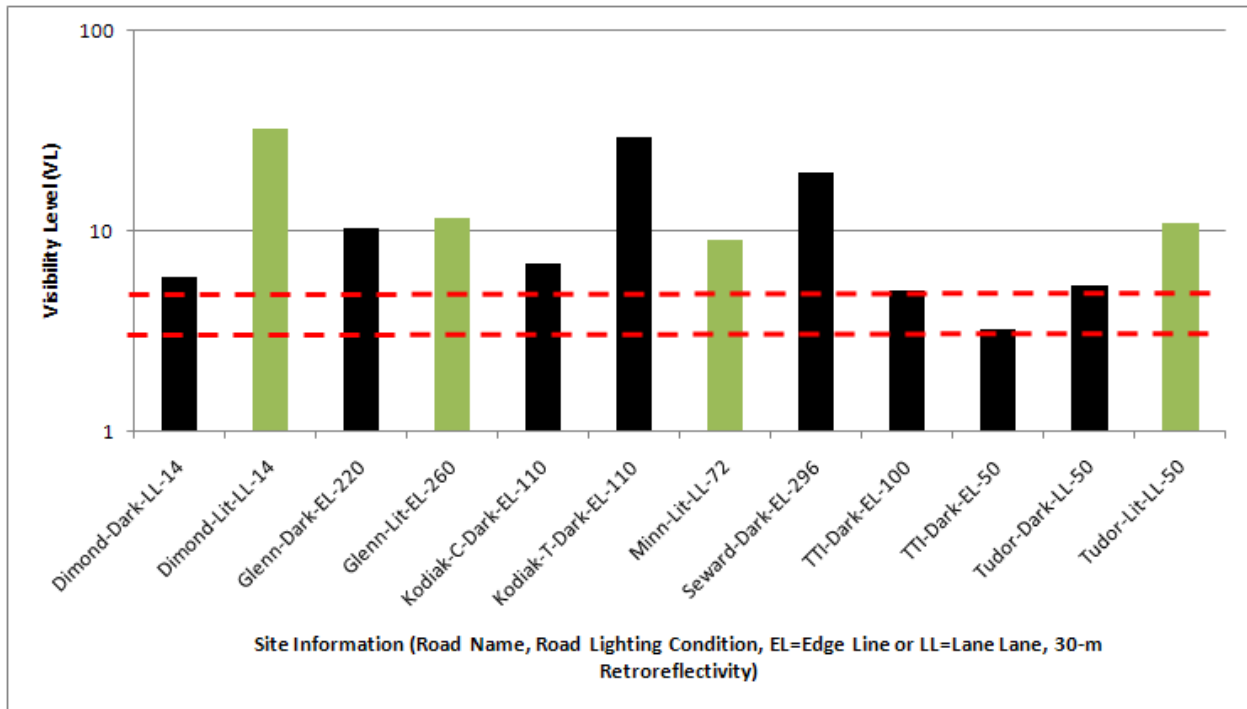
**Figure 5. Pavement Marking Visibility Levels at 54 Meters.**

As before, Figure 5 also shows that all of the pavement markings at the study sites provide as much visibility as implied by the FHWA proposed minimum retroreflectivity levels, but this time at a distance of 54 m. The differences in pavement marking visibility between the lit and unlit sections of Dimond and Tudor are more prominent at this distance and demonstrate the value of roadway lighting. For the Glenn Highway, the differences are smaller but these measurements were not made at the same location as the Dimond and Tudor measurements so there could be other influences.

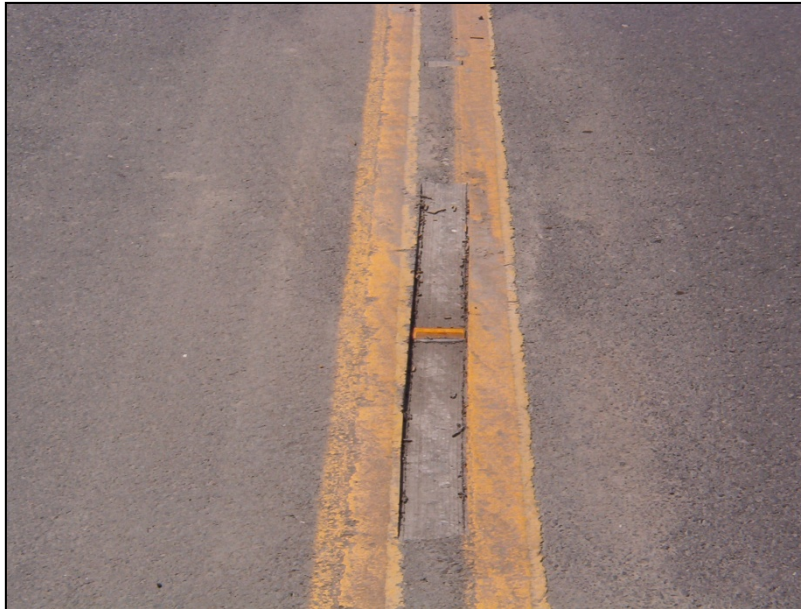
**Figure 8. Original RRPM Placement on Rezanof Dr. (circa 2005).**
