EMERGENCY EVACUATION TESTS OF A CRASHED  
L-1649

August 1966

FEDERAL AVIATION AGENCY  
Office of Aviation Medicine

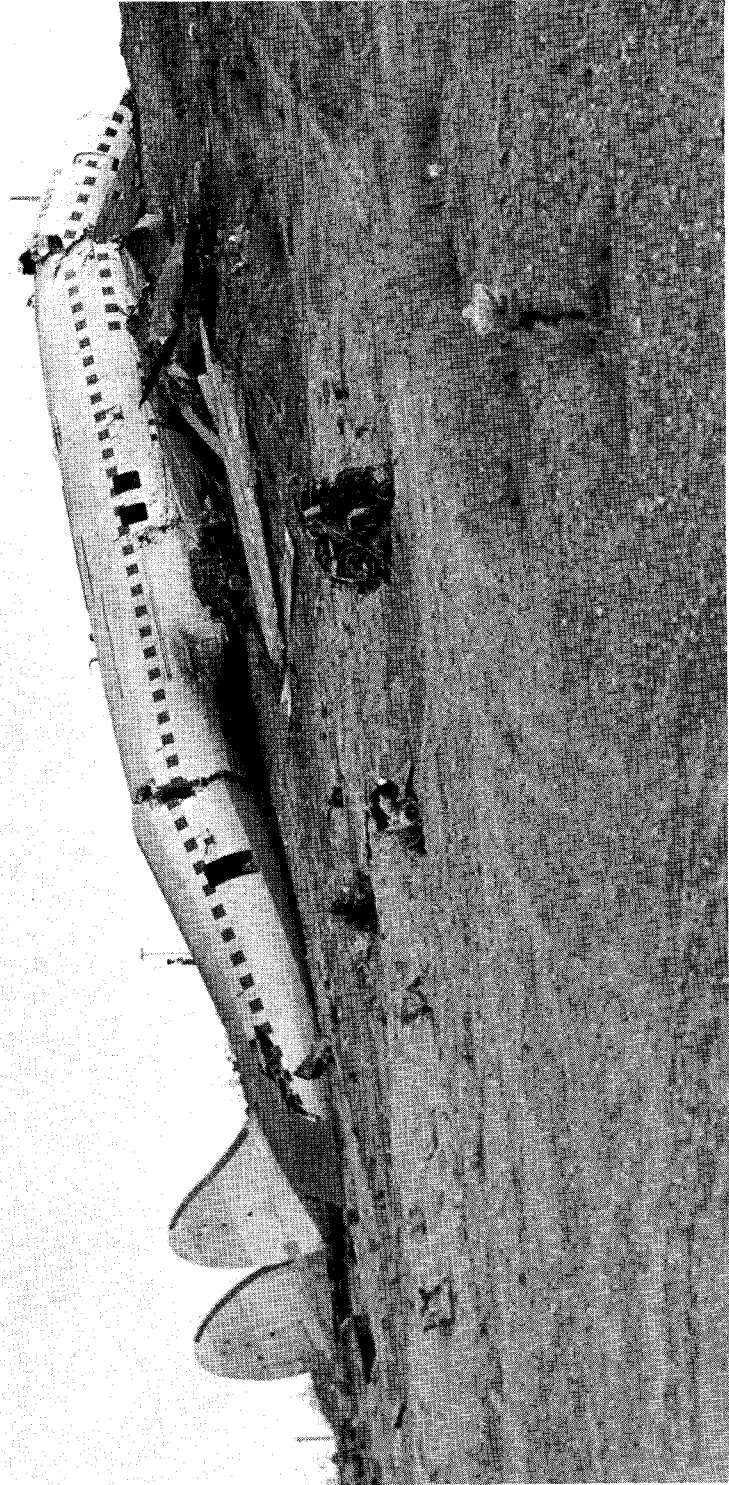
FIGURE 1.—A general view of the wreckage on the 17° to 20° slope.

All exits in the test area of the cabin were operable after the crash. These exits were the two right and two left overwing window exits, the left galley door and the aft right exit. The window exits on the left side of the fuselage were made inoperable because of the ragged, torn and shredder metal outside each exit. The left forward main door and right crew door near the flight deck were damaged in the crash and excluded from the test.

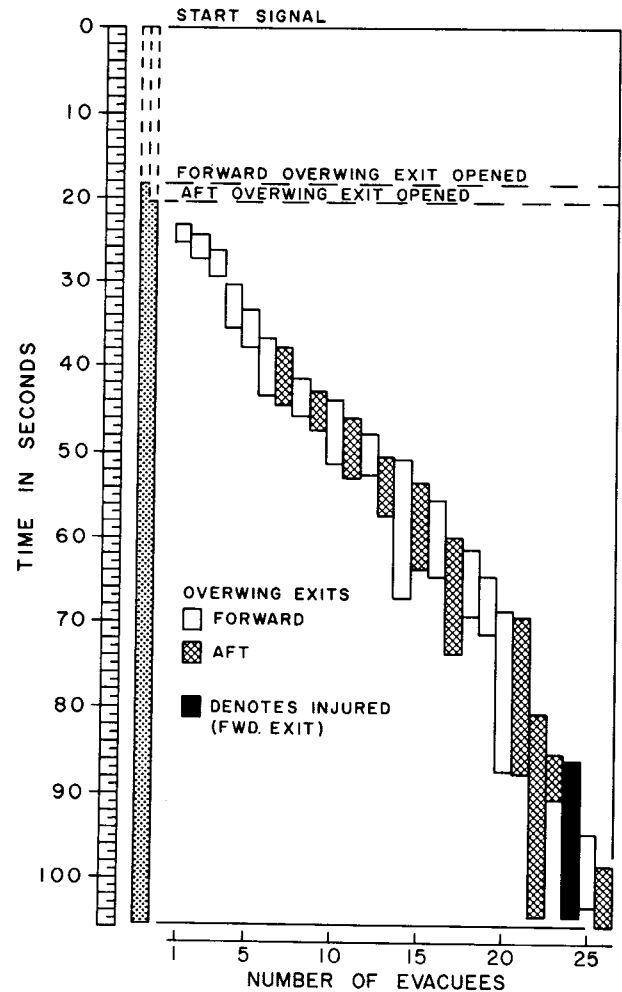
FIGURE 8.—Individual evacuation flow from the right forward and aft overwing exits in Test III. Rectangles represent each person and the time the exit was in use by them.

Following removal of the exit, at first there was a vying for approach to the exit opening from both the second and third rows. Two men were first out from the second row, followed by a women and two children (seven and nine years old) from the third row. Another female passenger and three males continued steadily from the third row followed by the forward stewardess who was last out of this exit. Individual escape times from both overwing exits are shown in Figure 8.
