CRASHWORTHINESS: AN ILLUSTRATED COMMENTARY ON OCCUPANT SURVIVAL IN GENERAL AVIATION ACCIDENTS

William R. Kirkham  
S. Marlene Wicks  
Donald Lee Lowrey

Civil Aeromedical Institute  
Federal Aviation Administration  
Oklahoma City, Oklahoma

APRIL 1983

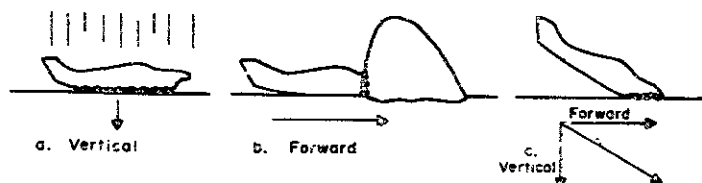
Figure 1

An aircraft with little or no forward movement, such as in a flat spin, will fall almost vertically (Figure 1a). As the aircraft comes to a halt the structure and occupants will be subjected to decelerations over a short distance in the opposite (upward) direction. Typically, the engine and wings will tend to break down, the gear and lower portion of the hull will crumple, and the fuselage will billow out laterally. The motion of the occupants' bodies will be stopped in a seated buttocks-to-head (vertical) direction.

When an aircraft with forward motion crashes into an object, the velocity will be horizontal (Figure 1b), and the occupants will experience front to back decelerations. In most accidents, occupants are subjected to one major deceleration. The deceleration of the occupant can be divided into vertical and horizontal components just as can be the velocity of the aircraft (Figure 1c).

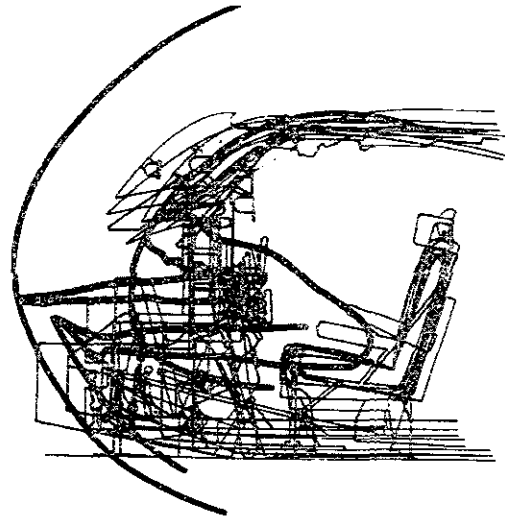
Figure 2

When a seatbelt is worn, the belt will hold the pelvis and keep the lower torso from traveling forward (Figure 2). The upper torso, head, arms, and legs will continue their forward motion. These flailing body parts may strike the windscreen, instrument panel, fuselage structural parts, control wheels, rudder pedals, and other components. This subjects the occupants to impact force of high magnitude and can cause severe or fatal injuries. The head is frequently stopped by the instrument panel, causing fractures of the skull and facial bones, and lacerations of the brain. If the head is stopped by impact with the interior, but the torso continues movement, fracture or dislocation of the neck can occur, perhaps with spinal cord involvement. The chest may impinge upon the control wheel or yoke, causing crushing or penetrating injuries. The forward flexion of the upper torso can be reduced to a large degree by the use of an upper torso restraint--a shoulder harness. The legs and feet flail forward into the rudder pedals or underneath the instrument panel. The vertical component of the deceleration causes downloading on the seat which may fail the seat/floor attachments, the seat legs or the seat pan. The floor may deform and cause seat attachments to fail. In crash injury studies, it is important that the direction of the impact and the magnitude and directions of decelerations experienced by the occupants be investigated, reported, and analyzed to assess the degree of protection provided by an aircraft and its restraint systems.

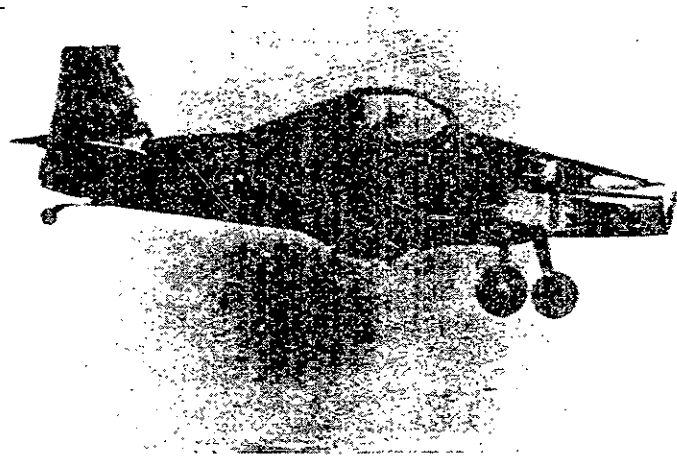
Figure 10

Crashworthiness principles, as advocated by De Haven and Hasbrook, were incorporated in the AG-1 prototype agricultural aircraft designed and built in 1950 at Texas A&M University by Weick (Figure 10). In this aircraft the pilot sat high above and behind the wing. There was a hopper between the pilot and the engine. The structural members of the cockpit were strong--a sturdy outer package. The pilot was restrained by a lapbelt and a double strap shoulder harness. He wore a helmet and there was a large roll of aluminum above the low positioned instrument panel--to distribute the force of any impact should the pilot's head move forward and contact it during a crash.

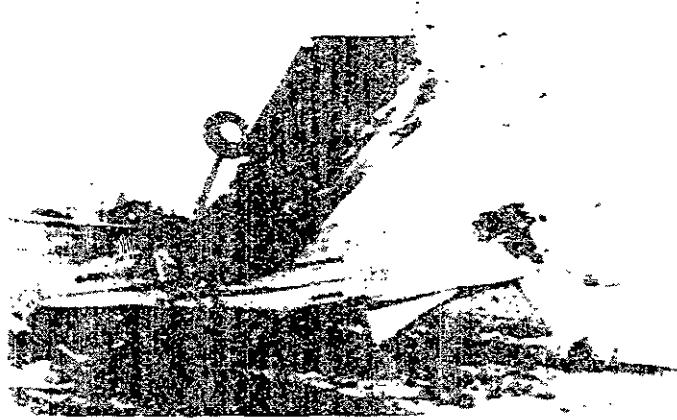
Figure 11

John Paul Jones, an FAA test pilot, flew this aircraft on many occasions to demonstrate its features. One day he got too close to a pole, struck it, and the aircraft crashed inverted (Figure 11). He was able to get out of the cockpit and wave to onlookers to assure them he was uninjured. The crashworthiness features built into the aircraft spared him serious injuries. The dedication note on this picture says, "To my very good friends at crash injury research who designed the cockpit."

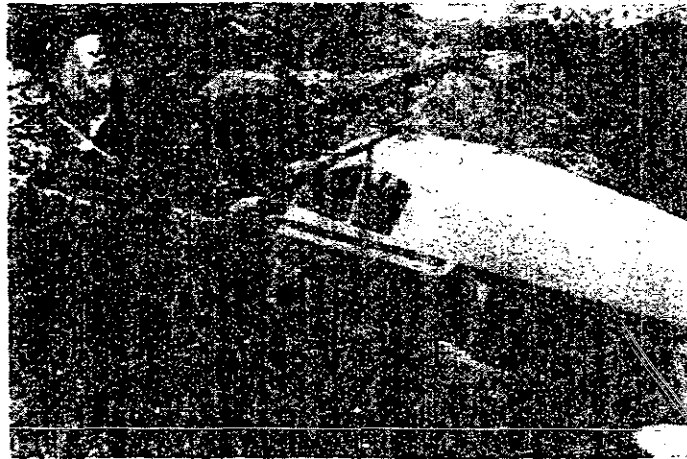
Figure 16

This aircraft (Figure 16) struck relatively level ground and some willow trees. The pilot got out, walked several miles and was then taken to a hospital emergency room. His only injury was a bruised chest.

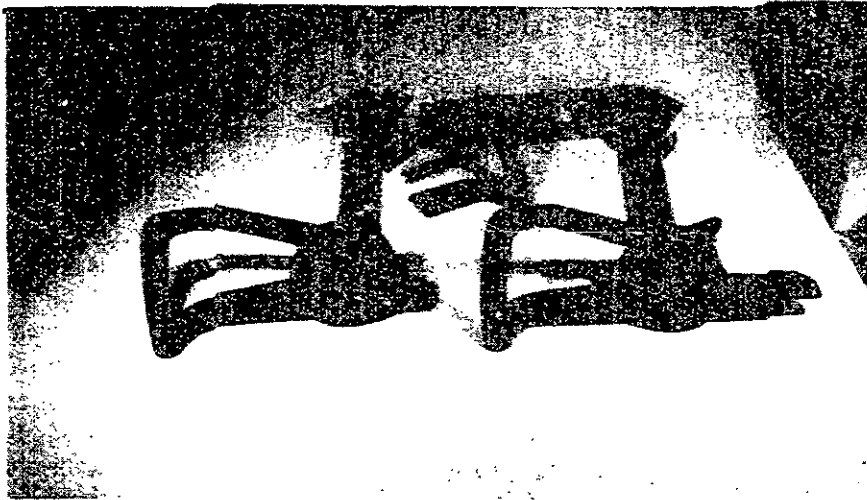
When the control wheels in Figure 18 were examined, two different breaking patterns were noted. The one on the left (pilot's) broke close to the hub as the pilot jackknifed forward and hit the wheel. This resulted in blunt trauma to his chest. The right seat occupant, also jackknifed forward, striking the yoke with his chest and the yoke broke in such a way that a sharp spike remained protruding from the hub. Microscopic examination of a brown film on this spike showed it contained red blood cells, fragments of skin, and pieces of muscle. This "spike" portion of the control wheel

These two accidents demonstrate the importance of upper torso restraint. Pilots should heed such findings concerning the value of shoulder harnesses in crashes. The FAA requirement that crewmembers wear shoulder harnesses (if available) on takeoffs and landings is a rule designed to provide these crews with crash safety protection during critical phases of aircraft operations. Accident investigators should carefully document if shoulder restraints were used and the postcrash condition of each. They, also, should document the injuries and determine their correlation (if any) with the performance of the restraint systems. Such observations can lead to improved crashworthy design of occupant protection devices.

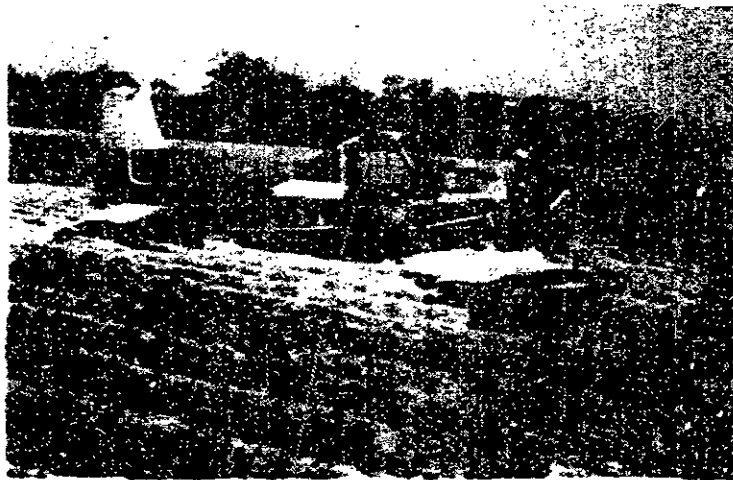
The agricultural aircraft in Figure 19 ran out of fuel, stalled, and struck the ground in a 45° nosedown attitude. The plowed ground tended to attenuate the impact forces. The pilot was provided additional stopping distance by structural crushing, which ended with the engine displaced aft and somewhat above the hopper. Although the pilot had conspicuous shoulder harness and lapbelt contusions and abrasions, he sustained minor injuries.

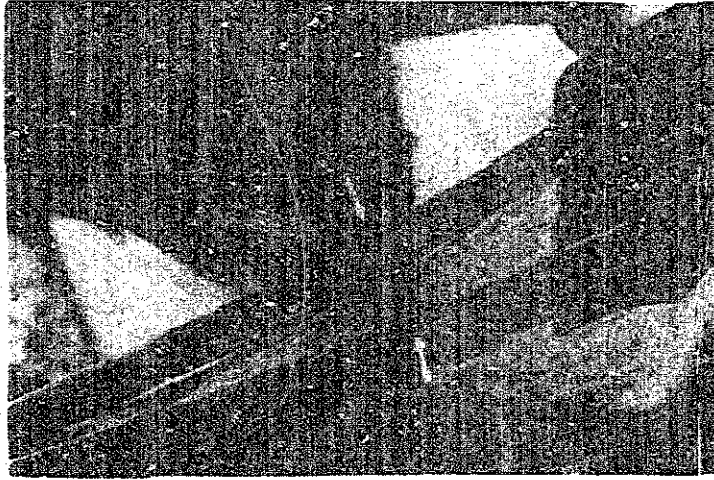
Figure 22

One possible reason is illustrated by Figure 22. Notice that the two fuselage tubes aft of the cockpit were bent slightly at the site where the shoulder harness anchorage was located; the shoulder harness attachment brace broke free at the welds, thereby denying the pilot the full protection of his upper torso restraint. In packaging terms, the article in the package (the pilot) was not held sufficiently immobile to prevent its movement against the inside of the package. An observation of this type of failure might be enough to lead to improvements in the restraint system.

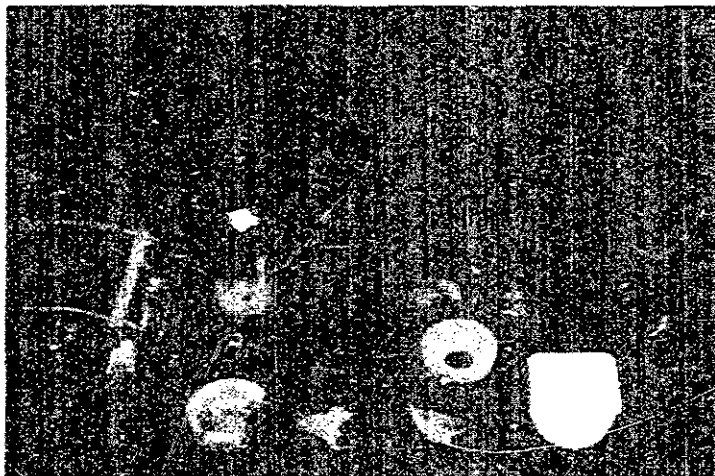
It is desirable to have an inertia reel in restraint systems for one to reach forward without restriction. In an accident the impact activates the inertia locking mechanism and the reel keeps the shoulder harness straps from playing out, thus holding the upper torso away from the yoke and instrument panel. Unfortunately, in some crashes the inertia reel has proved to be the weakest part of the restraint system.

For example, Figure 24 shows an inertia reel that failed in a survivable accident. The pilot was severely injured but survived.

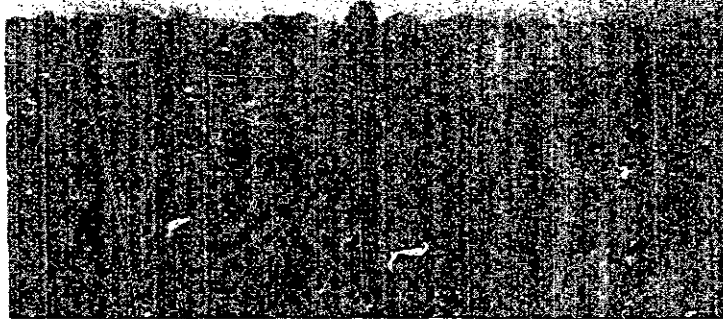
An accident like the one shown in Figure 28 attests to the value of the single strap diagonal upper torso restraint. This was judged to be a non-survivable accident because the cabin structures collapsed and partially disintegrated; the pilot was killed. The occupant of the right seat, who was wearing a shoulder harness, survived with numerous broken bones. Apparently the shoulder harness provided protection for his head and chest, saving him from lethal injuries.

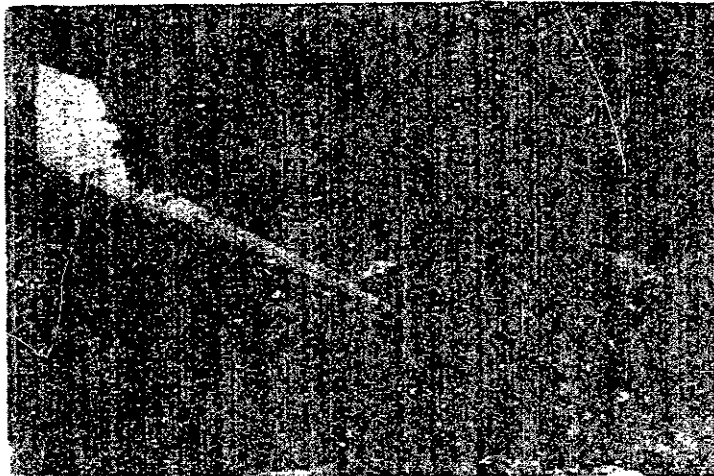
The aircraft shown in Figure 29 had power failure on takeoff and crashed into a dirt bank at relatively low velocity. One of the two 17-year-olds in the rear seat was uninjured. The other had unexpected internal injuries. Unrestrained objects in the baggage area struck the back of the seat, driving it forward and causing the lapbelt to compress the occupant's abdomen. The right front seat occupant, who was not using a shoulder harness, received a fracture of the mandible.

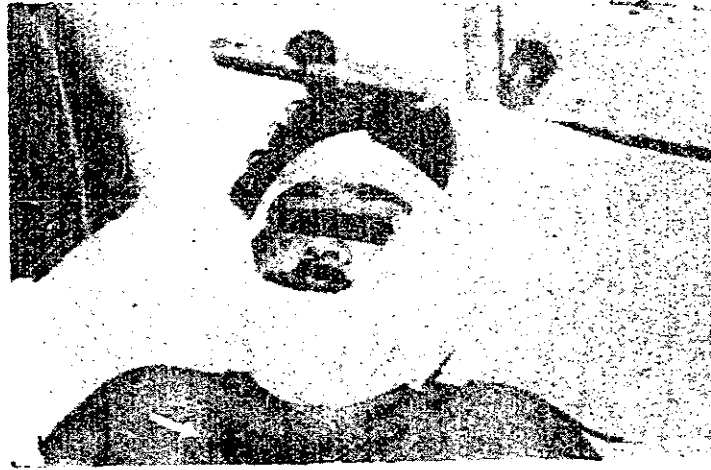
Figure 30

This pilot's injuries illustrate the value of the shoulder harness (Figure 30). The bandage on the head covers a large laceration. Notice marks on his upper chest made when he struck the control wheel. He was wearing the shoulder harness and lapbelt.

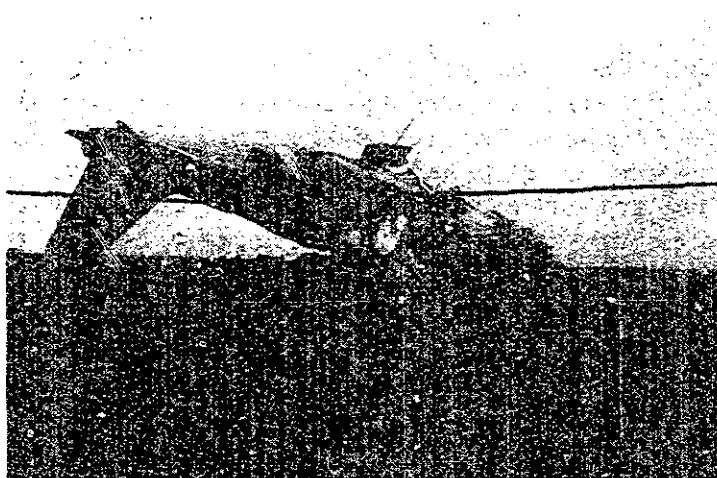
This accident in Figure 33 illustrates the value of the lapbelt in keeping occupants in place. The aircraft with three persons aboard made a downwind takeoff, failed to gain altitude and crashed on top of a building near the airport. The occupant in a rear seat had only a broken finger.

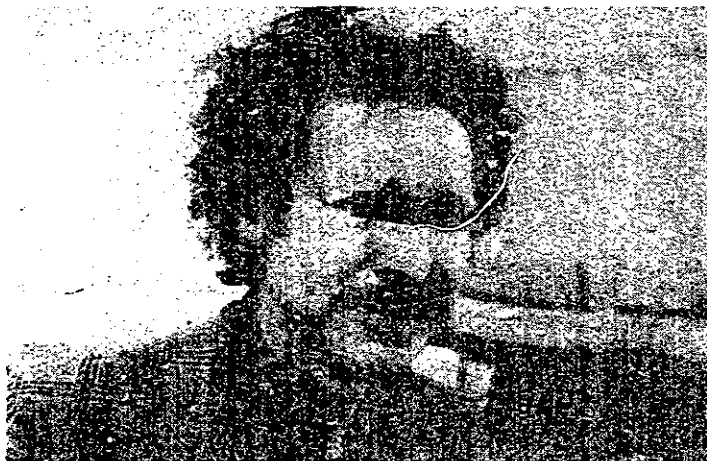
Figure 34

The right seat passenger (shown in Figure 34) had a small cut above his eye. However, the pilot was found on top of the roof, dead from a crushed skull. Why was there this discrepancy in injuries to the occupants? Investigators of accidents in which there are similar disparities in injuries should satisfy themselves as to the sources of these differences.

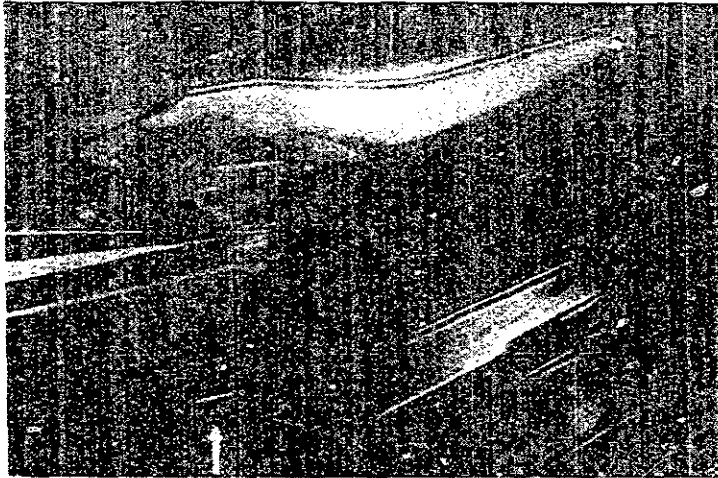
Figure 35

In this accident an investigator would ask "Was the pilot wearing his lap-belt?" Inspection of the floor of the aircraft revealed a slot (as shown in Figure 35) where the right-hand lapbelt attachment had extended through the carpet and was fastened to the underlying metal structures.

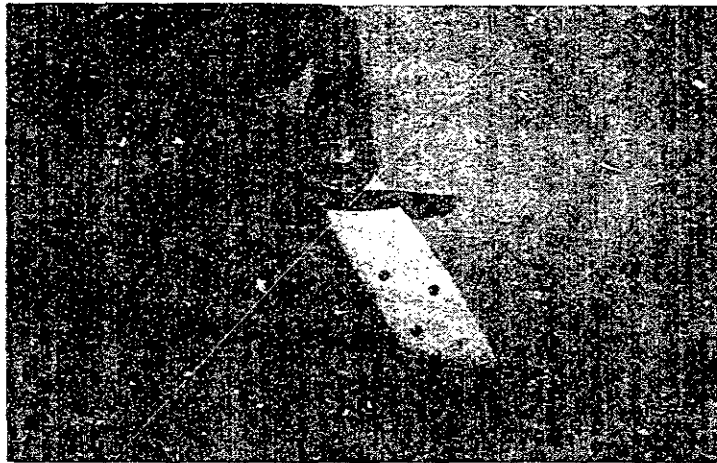
Figure 36

Investigation showed (as in Figure 36) that the lapbelt attachment had pulled free from its anchorage. During impact, sufficient force was applied to the lapbelt (there were no shoulder harnesses) to break its attachment and the pilot was thrown from the aircraft onto the roof of the building. The resulting fatal head injuries were caused by the secondary impact.

Investigators should examine such a lapbelt attachment closely, perhaps even under magnification, to estimate the degree of deformity of each hole to determine whether or not all the rivets or bolts had been in place. Did the restraint fail due to poor manufacture? Was there intrinsic weakness in the materials or attachment configuration?

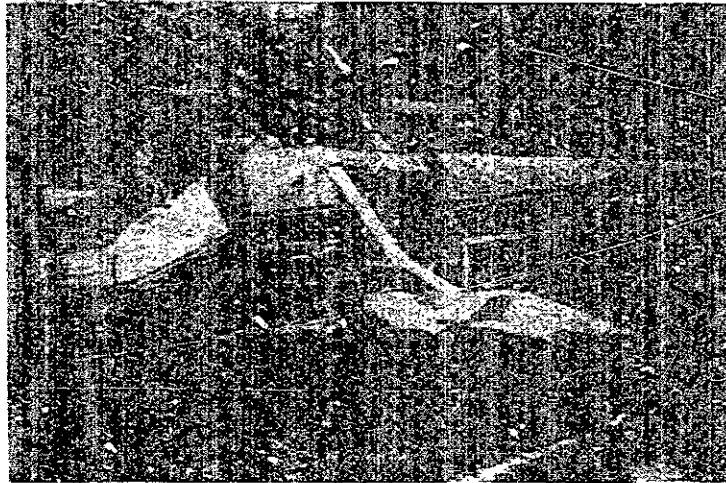
Figure 37

Similar questions should be asked in an accident such as that shown in Figure 37. The aircraft hit electric wires during an attempted emergency landing. Most of the aircraft's forward velocity was dissipated by a large cable; the aircraft then fell upside-down to the ground. Would one expect the pilot to survive this fall? The cabin was intact. Would the lapbelt hold the pilot against the seat and prevent his impact against the inverted top of the aircraft cabin?

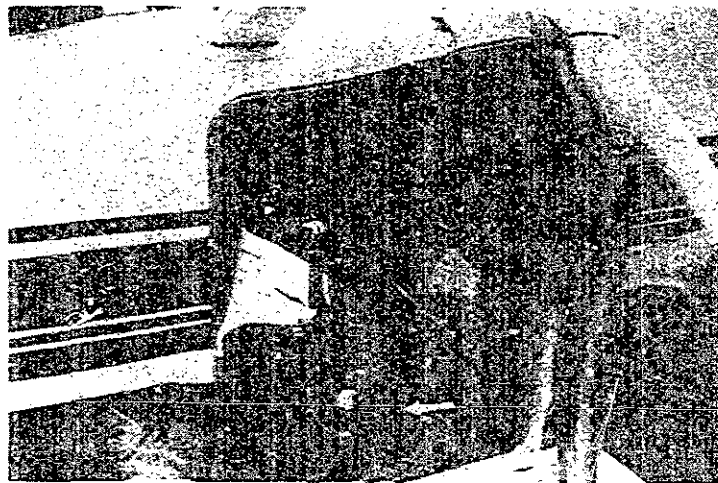
Figure 38

Investigation showed that the lapbelt was hanging with one end free from its attachment as shown in Figure 38.

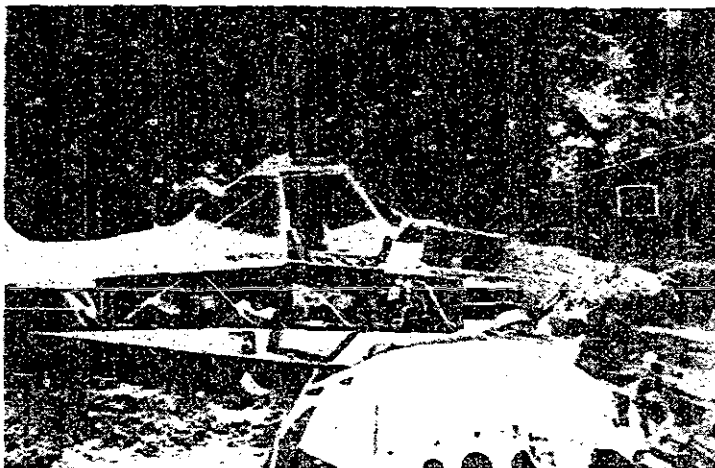
Figure 40

A problem with restraint attachments is illustrated by the accident in Figure 40. The engine was torn off but the cabin structure remained intact.

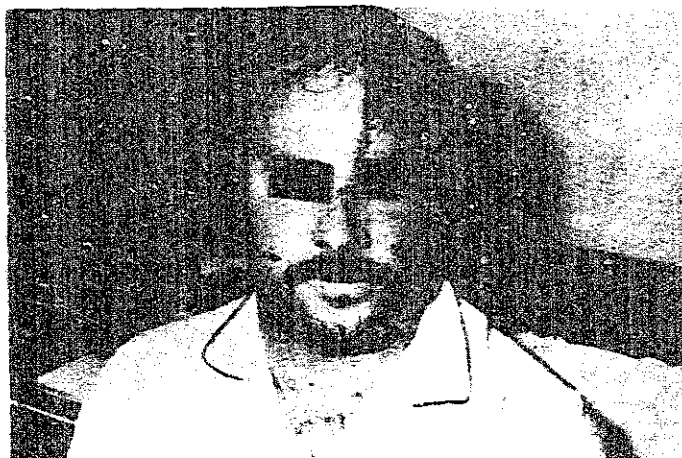
Figure 41

The pilot (Figure 41) sustained a long vertical laceration on his forehead. Accident investigators found a corresponding vertical cleavage in his helmet. By absorbing most of the energy of the head impact, the helmet probably saved this pilot's life. One experienced in crash injury correlation would seek to explain the unusual injury pattern.

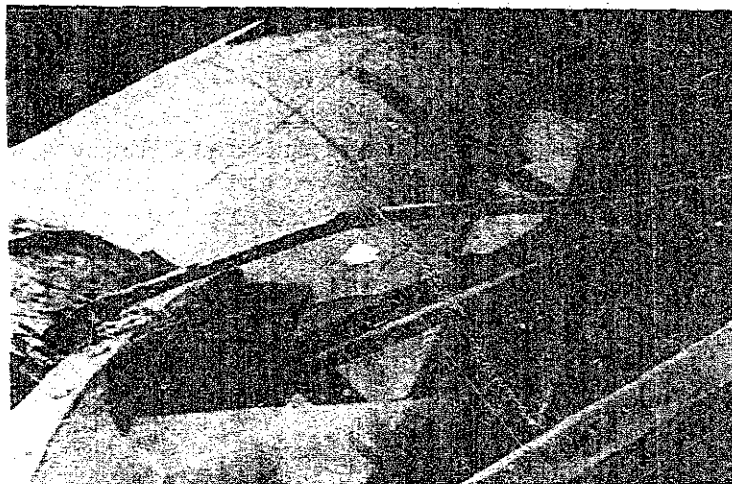
Figure 42

Examination of the aircraft revealed that the windshield was broken and that the vertical wire cutter bar in front of the windshield was bent forward (Figure 42). Here, then, was the most probable explanation for the vertical cleavage in the helmet and corresponding laceration of the pilot's scalp--the pilot had been thrown forward, striking the wire cutter bar with his head. There was also a broad concavity in the instrument panel showing that it had been struck by the pilot's chest. Analysis provided the crash injury correlation but the question remained, "Since the pilot wore a double shoulder harness and lapbelt, why did he travel far enough forward during the crash to strike forward structures in such a 'mild' crash?"

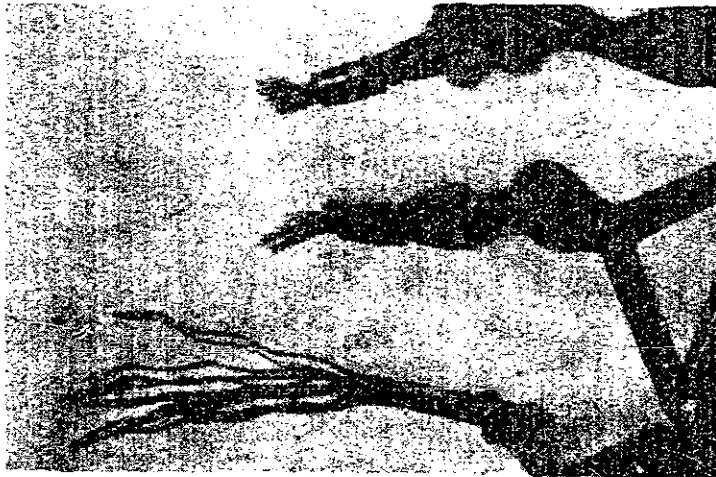
Figure 43

The answer appeared from inspection of the restraint system (Figure 43). The lapbelt ends were attached to wire cables. The cables extended through a bulkhead behind the pilot and were attached to the rigid aircraft frame. The shoulder harness cable led over a pulley behind the pilot's seat and was attached to an inertia reel. The photograph shows all three cables broken. The lapbelt cables had wires which had broken by repeated bending during normal use. The shoulder harness cable wires had broken in a similar manner. Other aircraft of the same model were found to have cables with broken wires. The manufacturer, subsequently, changed the cables and the configuration of the attachments to prevent weakening of the restraint system.

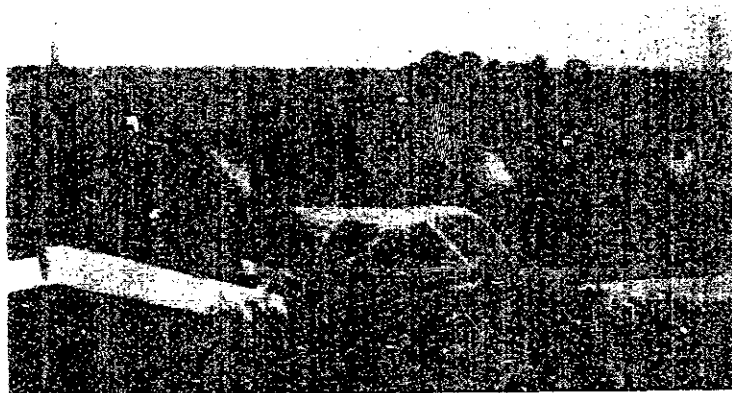
Figure 44

This was an accident (Figure 44) in which there was heavy vertical loading. The aircraft ran out of fuel and hit an overhead power line wire, stalled, and pancaked into a wheat field. The aircraft dropped straight down in a level attitude. None of the six occupants survived. They all sustained severe spinal and internal injuries. Could impact attenuating seats have prevented their deaths?

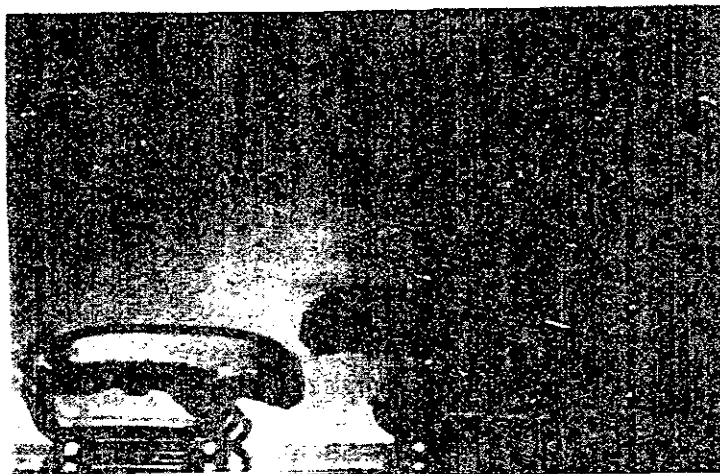
The seats shown in Figure 45 were designed for increased impact attenuation. The seat supports are of a tubular, ductile metal. They are designed with an "S" (preformed bent configuration) so they will bend without suddenly fracturing. This has proved to be an effective impact attenuating design for aircraft seats.

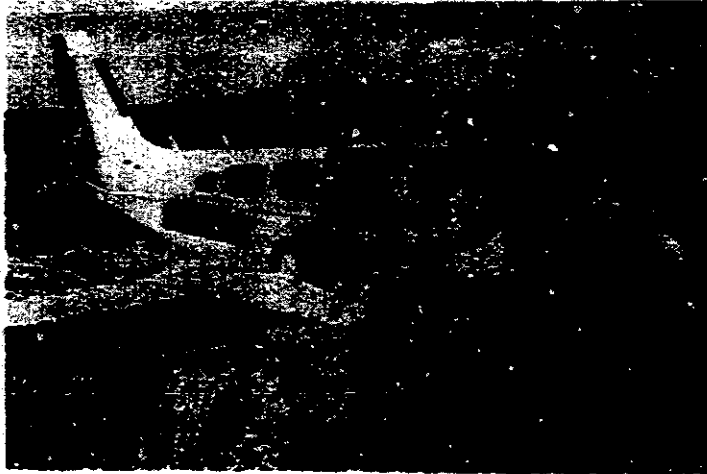
The aircraft in Figure 46 failed to become airborne and during takeoff struck a levee. The deceleration primarily was in a forward direction and one would expect the front seat occupants to receive the most severe injuries. On the contrary, the two occupants in the rear seats sustained fatal injuries and the front seat occupants, who were not using shoulder straps, had severe head injuries but survived.

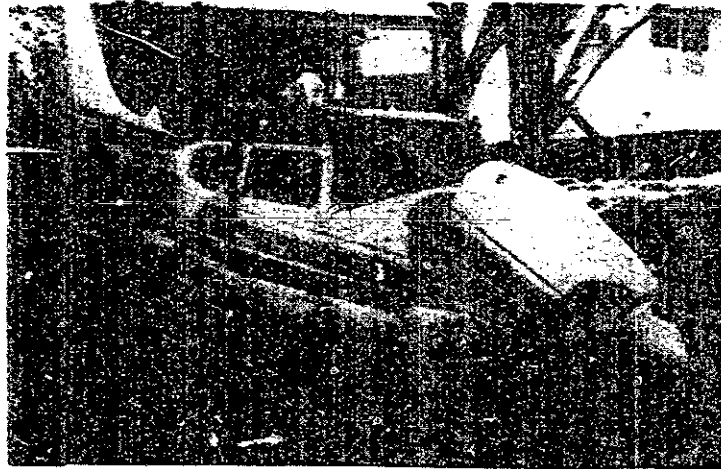
Investigators noted that the six occupants of the aircraft shown in Figure 48 received injuries out of proportion to the impact and severity of damage to the fuselage. They also found that the cast alloy supports of each seat had fractured (Figure 49).

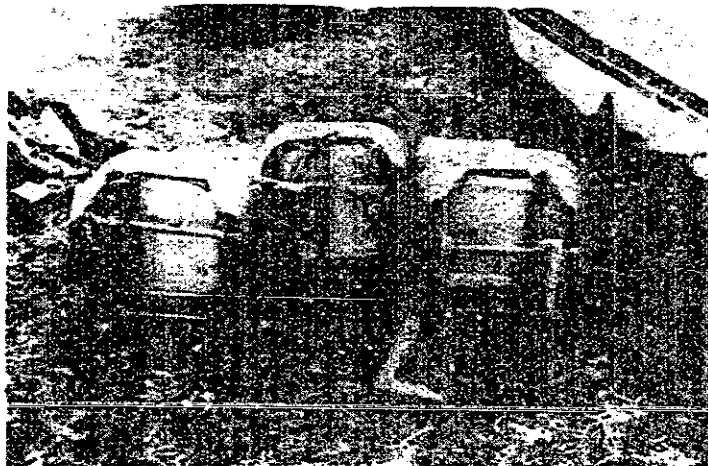
Figure 49

This type of failure occurs suddenly and the occupant is subjected to greater peak loading during secondary impact with the cabin floor or other structures.

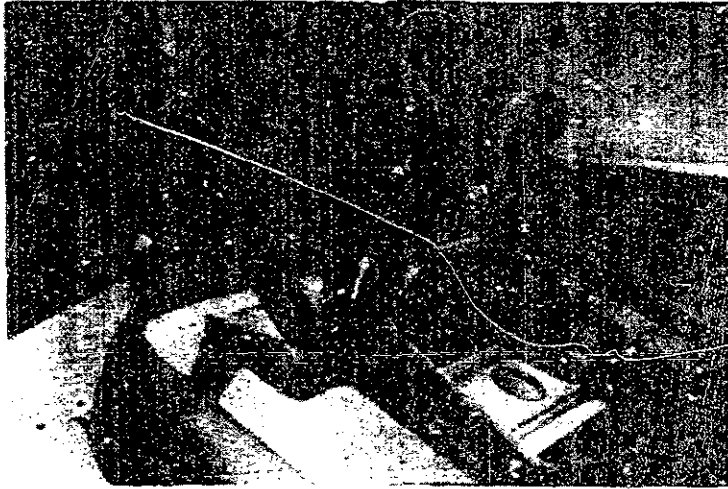
Figure 50

A typical failure in a cast alloy seat support is shown in Figure 50. Although the metal is strong, it does not bend or yield progressively. When it fails, it fails suddenly, and potential energy absorption is lost.

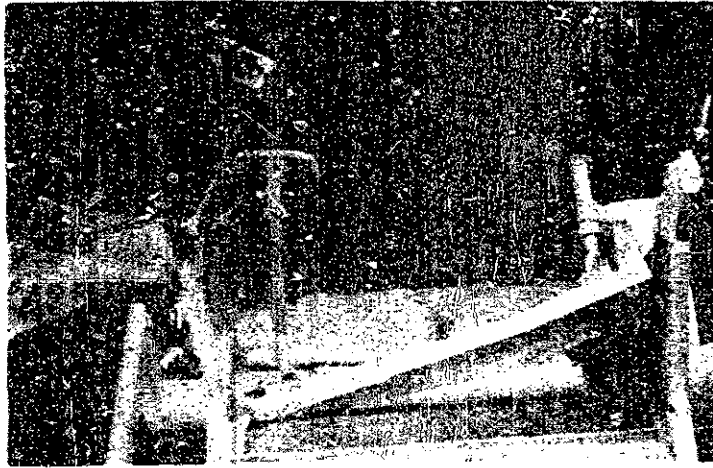
Figure 51

Similarly, loading and twisting of the attachment of the seat to the track can cause the brittle metal to fail (Figure 51) so that the seat and its occupant are free to flail about in the cabin.

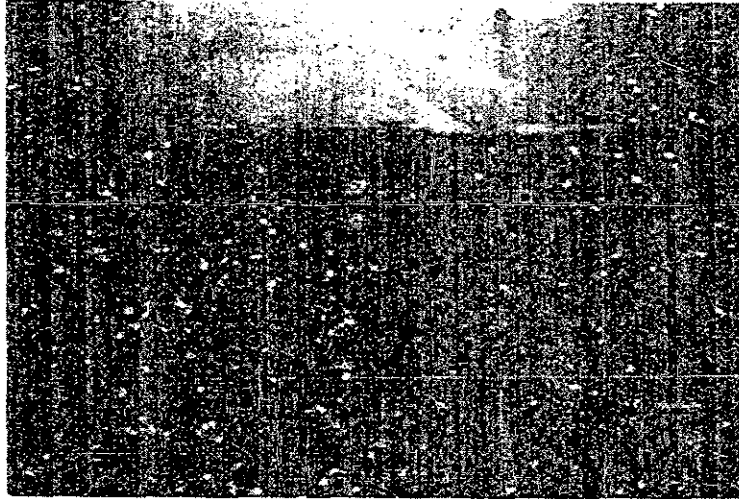
Figure 54

Such a seat attachment failure is shown in Figure 54, by the bent and broken seat supports (arrows). As mentioned before, failure of the seats leads to increased occupant injuries from secondary impact and is a departure from desirable occupant packaging principles.

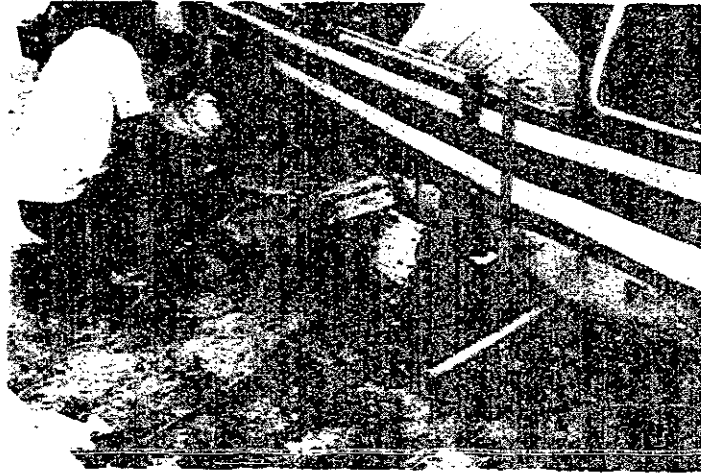
As discussed before, a seat that is rigid may offer little crash energy attenuation of occupant impact. Figure 55 shows an aircraft with an intact fuselage, yet the two occupants had severe spinal injuries--out of proportion to the apparent severity of the accident. What caused the

spinal injuries? A clue is the fact that the wing spar is a large rigid metal tube extending through the cockpit between the floor and the seat bottom.

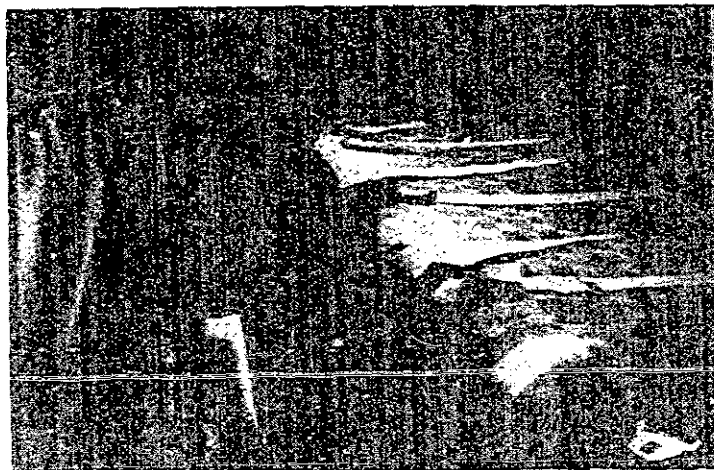
Figure 59

However, the single occupant of the side facing bench seat (Figure 59) was seriously injured, suffering internal bleeding from a rupture of the liver. During the deceleration, the occupant's body traveled sideways toward the

front of the aircraft. He slid along the seat and was restrained only by a lapbelt, which rode up over the pelvis into the abdomen, compressing and rupturing the liver. For best effect a lapbelt should be pulled down tightly on the pelvis and thighs; a loose belt can move easily over the pelvis and injure organs in the abdomen.

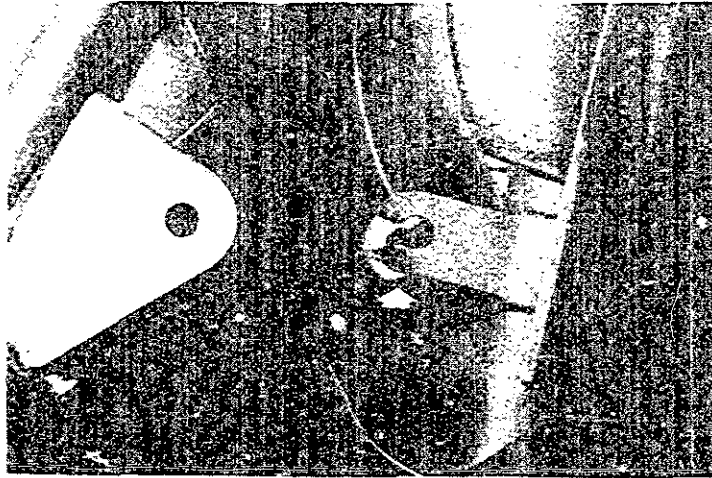
Figure 61

During the deceleration, the upright seat backs were apparently overloaded by the weight of the occupants and failed where the seat back attached to the seat pan (Figure 61). Note the torn hinge metal where the back was attached. Because of this failure, the two occupants slid forward (toward the front of the aircraft) from under their belts and sustained fatal neck injuries in secondary impacts. The lapbelts at the other seats (forward facing) kept the occupants in place. This accident illustrates the differences in occupant dynamics and the need for careful engineering design when aft facing seats are used.
