# Kentucky Transportation Center

# Development of a Statewide Landslide Inventory Program

February 2003

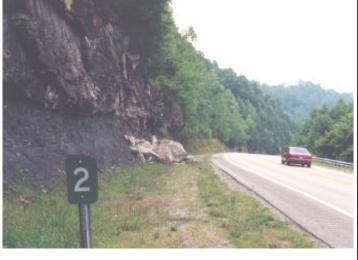
Figure 12. After reconstruction, US 23 in Johnson and Floyd Counties was renumbered KY 321 in the midnineties.

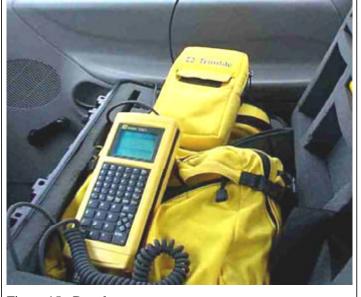
Figure 15. Data logger

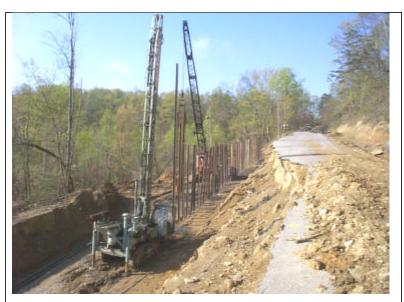
Figure 64. Installation in 1998 of railroad rails to form a wall to restrain a side hill landslide. Concrete panels were installed behind the anchored rails. The wall was backfilled with lightweight material, which consisted of cinders and shredded rubber tires.

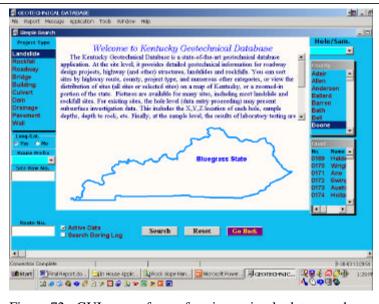
Figure 72. GUI screen for performing a simple data search.

or a "Comprehensive Search." When the simple search is executed, the GUI screen in Figure 72 appears. Different types of sites, such as landslides, or rock slopes, and their attributes may be retrieved for sites located in a selected county or geologic quadrangle, as shown in Figure 73.
