**INSPECTION AND EVALUATION OF A BRIDGE DECK REINFORCED
WITH CARBON FIBER REINFORCED POLYMER (CFRP) BARS**

INSPECTION AND EVALUATION OF A BRIDGE DECK REINFORCED WITH CARBON FIBER REINFORCED POLYMER (CFRP) BARS

March 2006

| 7. Author(s): Choo Ching Chiaw and Issam Harik | | 8. Performing Organization Report No. KTC-06-06/FRT102-00-1F | |

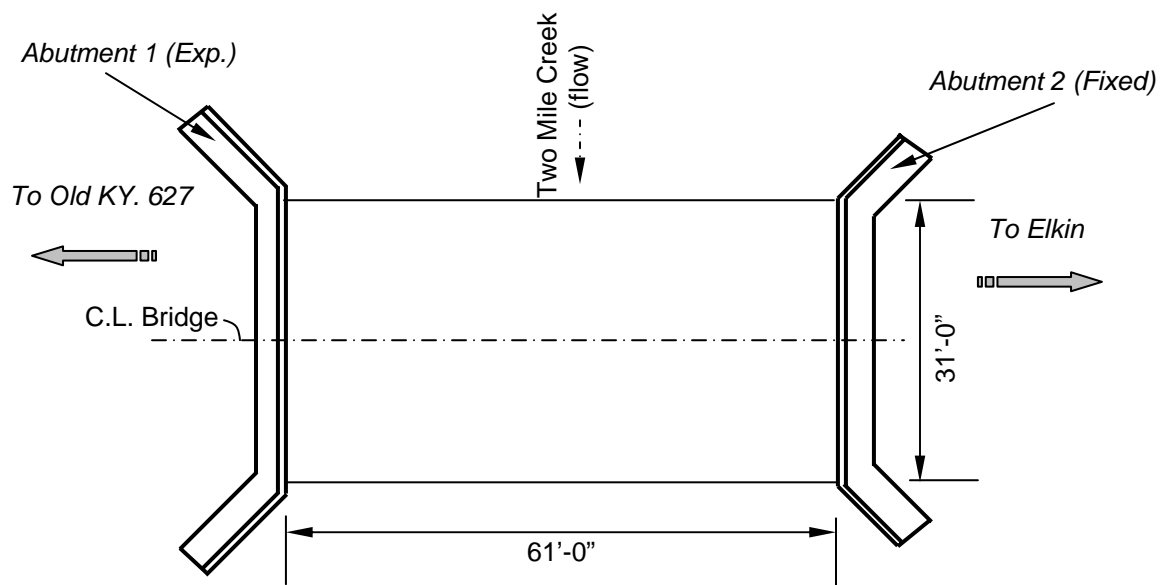
The subject of this study is located on Elkin Station Road on route CR1210 over the Two Mile creek in Clark County, KY. The two-traffic lane concrete bridge is 31 ft (9.5 m) wide and 61 ft (18.6 m) long as depicted in Fig. 2.1. The bridge is designed for HS25 truck loads.

Fig. 2.1 – Plan view of the Elkin Station Road Bridge on route CR1210 over the Two Mile creek, Clark County, KY.

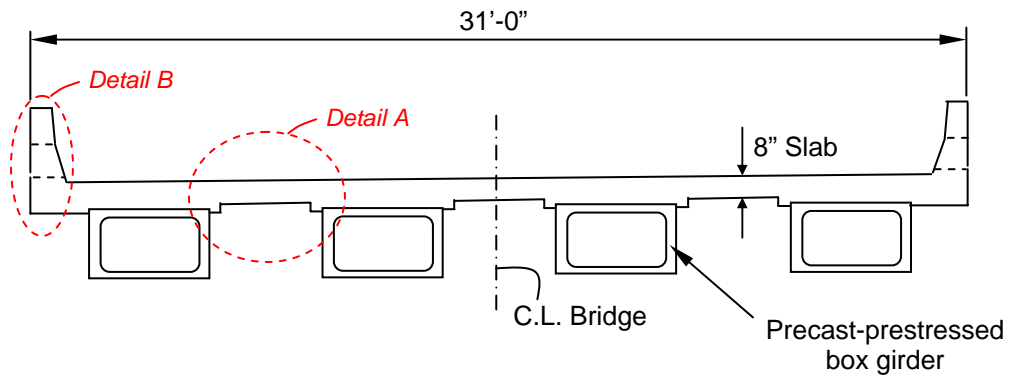
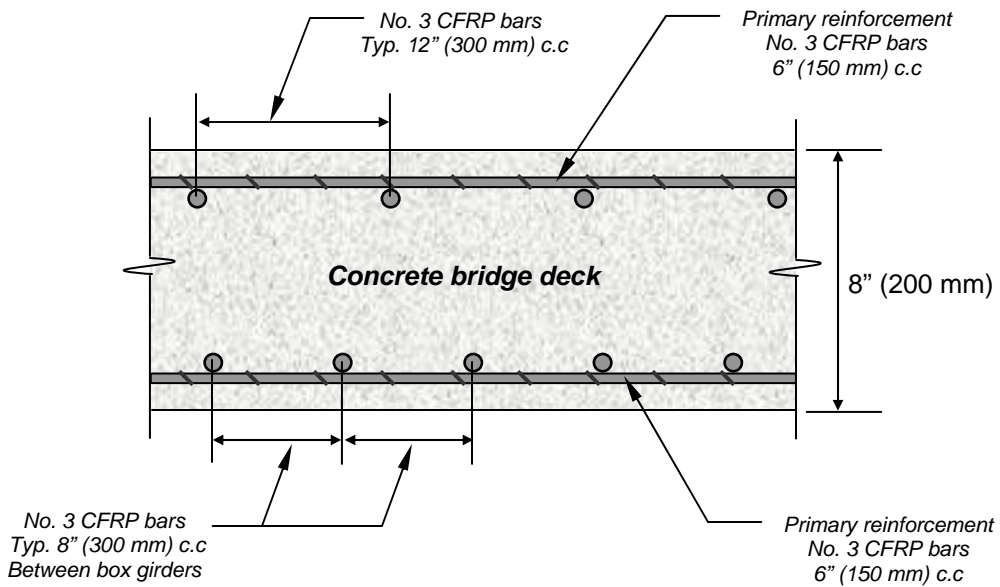
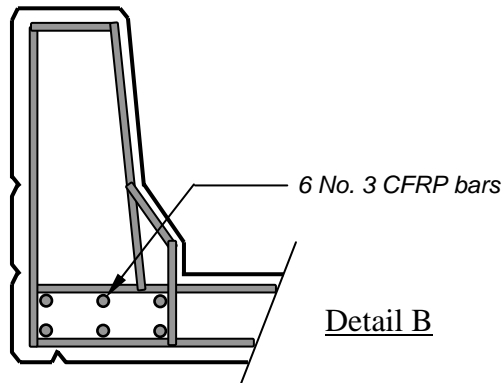
The bridge deck is cast-in-place concrete supported by four precast-prestressed concrete box girders (Fig. 2.2). The main (primary) reinforcements are of No. 3 carbon fiber reinforced polymer (CFRP) bars spaced 6 inches (150 mm) center-to-center at the top and bottom of the concrete deck. The No. 3 CFRP temperature and shrinkage (in the bridge direction) bars at the top of the concrete deck are spaced 12 inches (300 mm) center-to-center, and No. 3 CFRP temperature and shrinkage bars at the bottom of the concrete deck are placed between the box girders and are spaced 8 inches (200 mm) center-to-center.

Typical section

Detail A

Fig. 2.2 – Details of the concrete bridge deck reinforced with CFRP bars.

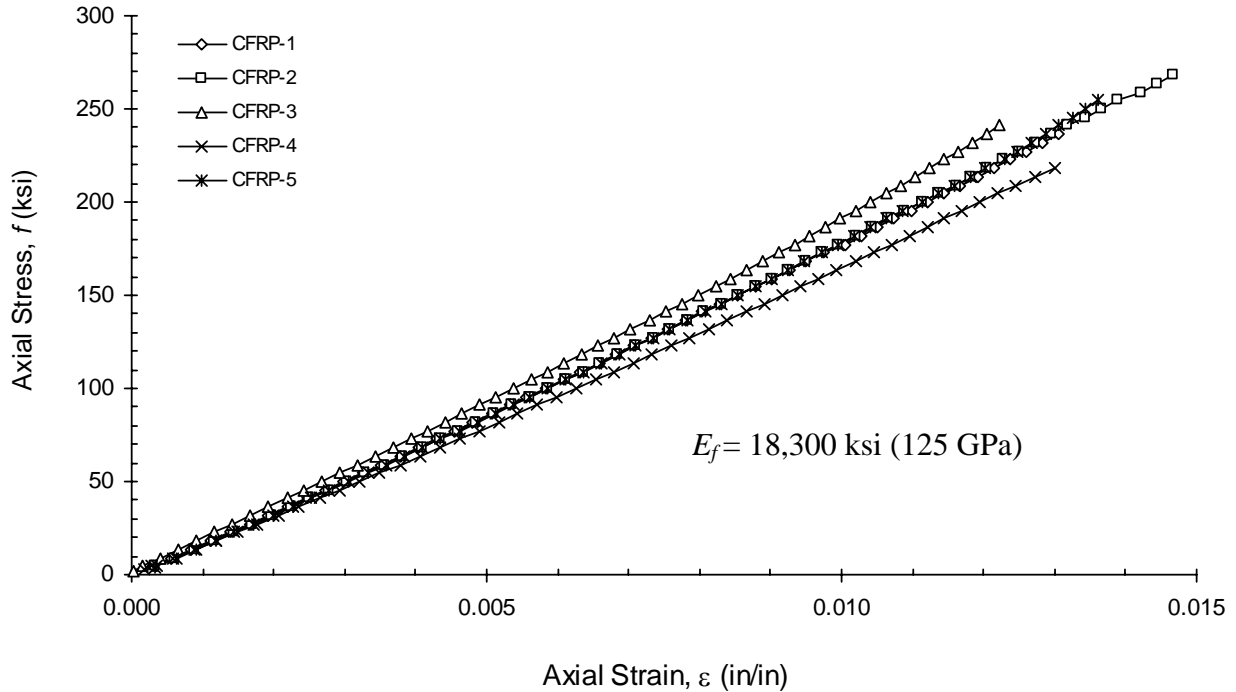
Before deploying the CFRP bars, the tests to determine mechanical properties such as tensile strength and stiffness of the bars were conducted. Details of the experiments can be found in Hill et al. (2003). Fig. 2.3 summaries the tensile stress/strain relation of the CFRP bars.

Fig. 2.3 – Tensile stress/strain relation of CFRP bars (Hill et al. 2003).

The ultimate tensile strength of the CFRP bars [$f_u = 270 \text{ ksi (1,875 MPa)}$] is many times greater than the conventional grade-60 steel [$f_u = 80 \text{ ksi (550 MPa)}$]. The tensile modulus of elasticity of this particular type of CFRP bar [$E_f = 18,300 \text{ ksi (125 GPa)}$] is approximately 65% that of steel [$E_s = 29,000 \text{ ksi (200 GPa)}$].

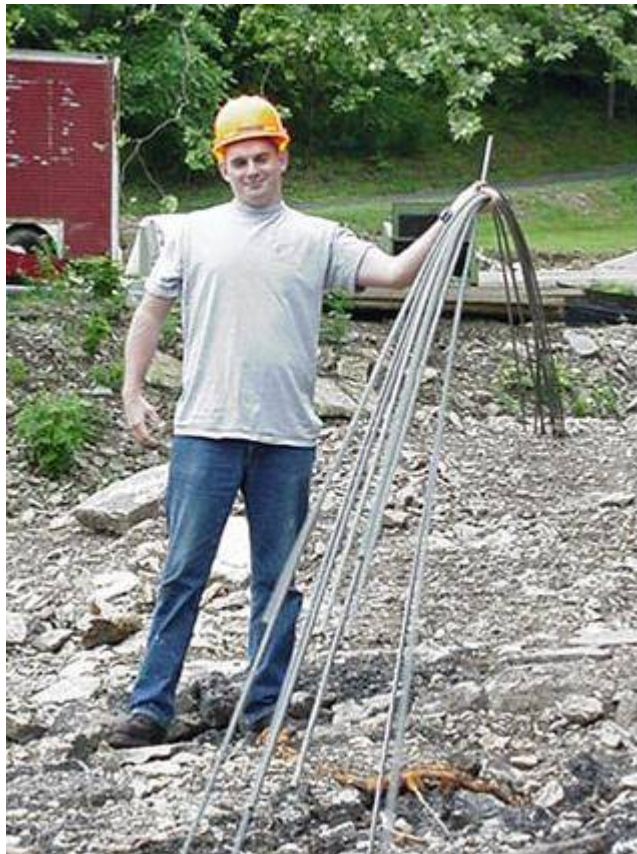
The construction of concrete bridge decks reinforced with CFRP bars follows the same procedure used in concrete bridge decks reinforced with conventional steel. However, the handling of CFRP bars in the field required fewer workers because of the light-weight nature of the material (Fig. 3.1). Fig. 3.2 shows the CFRP bars for the bridge deck before the placement of concrete. It should be noted that since CFRP bars are more flexible than steel bars when construction workers are stepping on them to pour the concrete for the deck, the regular spacing of chairs used for steel bars was reduced in half for CFRP bars. Additional recommendations when dealing with FRP bars can be found in Deitz et al. 1999.

Fig. 3.1 – Light-weight CFRP bars.

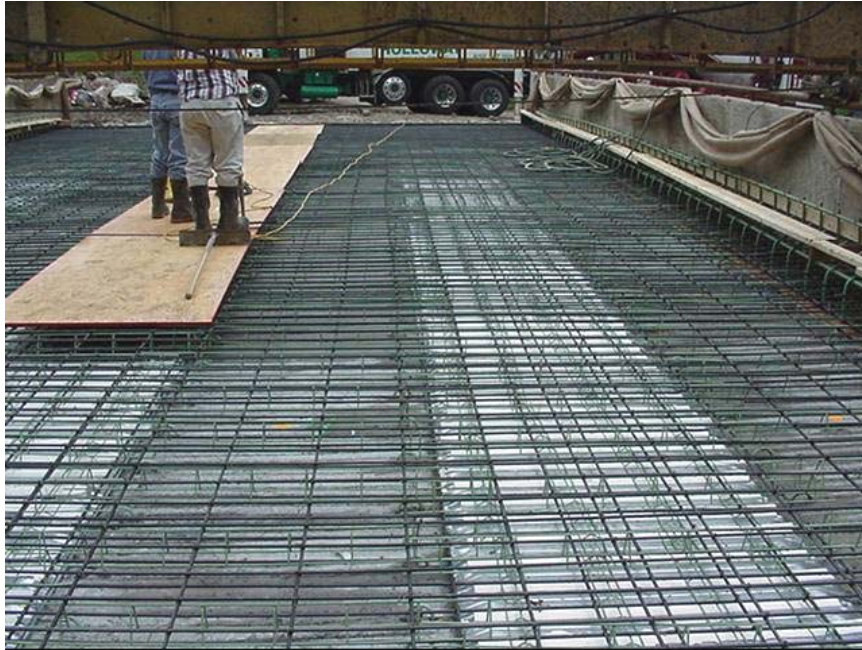
(a) Placement of CFRP bars

Fig. 3.2 – Construction of concrete bridge deck reinforced with CFRP bars.

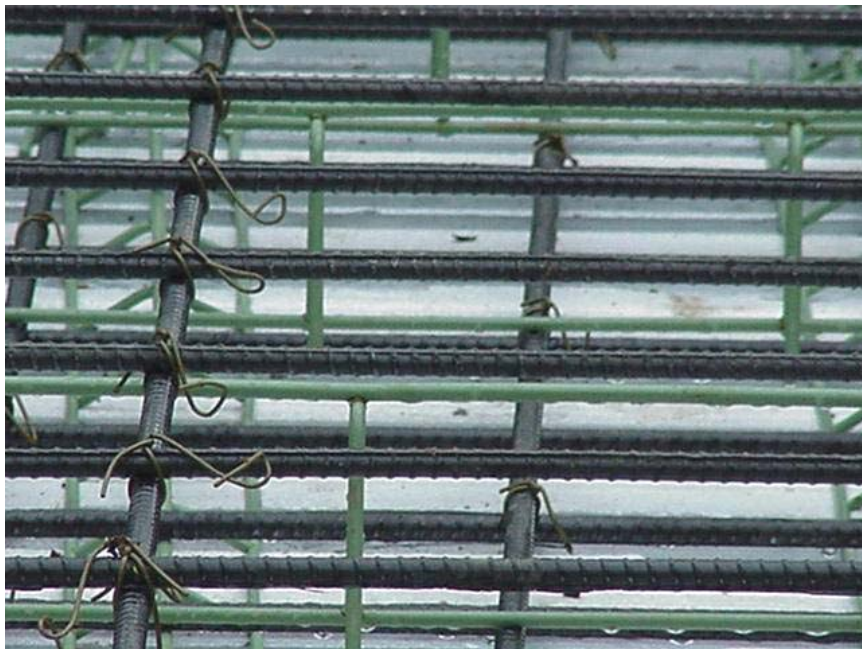
(b) Close-up view of CFRP bars
