### **HIGHWAY-RAILWAY AT-GRADE CROSSING STRUCTURES: OPTIMUM DESIGN/INSTALLATION PRACTICES AND MANAGEMENT PROGRAM - AN OVERVIEW**

**KTC-09-04/FR 136-04-1F**

## **Highway-Railway At-Grade Crossing Structures: Optimum Design/Installation Practices and Management Program – An Overview**

**Jerry G. Rose  
Professor of Civil Engineering**

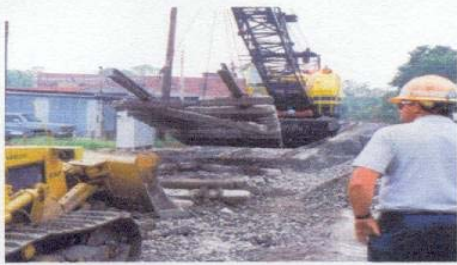
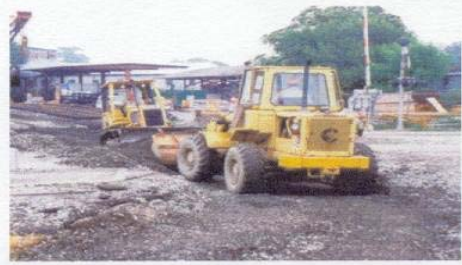
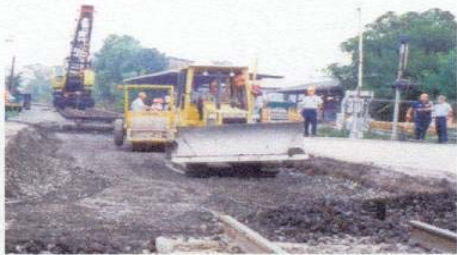
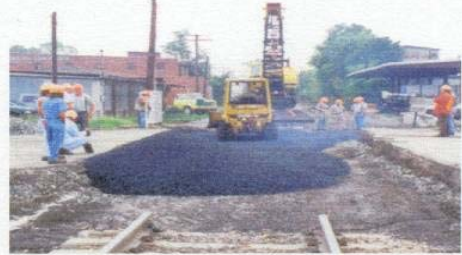
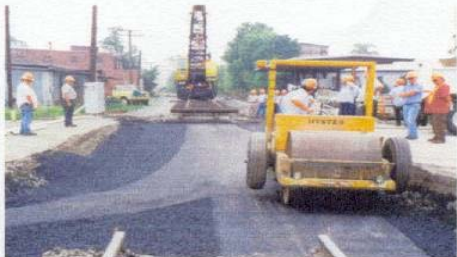
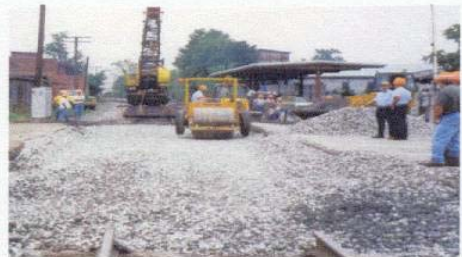
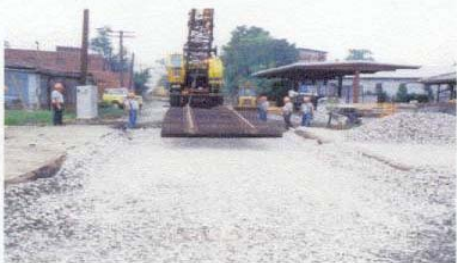
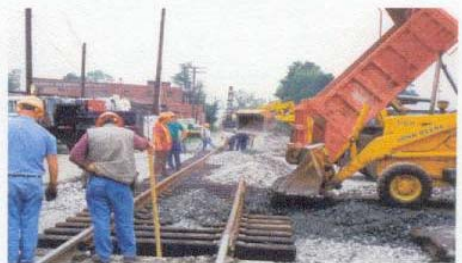
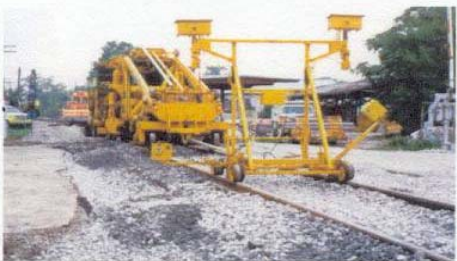
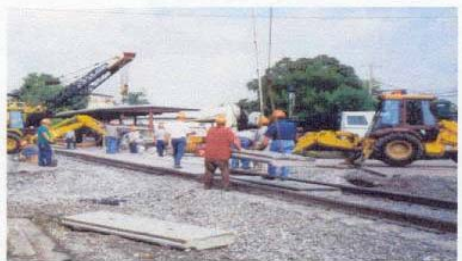
Figure 3.2a Typical Fast-Track Renewal Operations

Lifting out old Panel

Excavation

Compacting roadbed

Compacting placement of asphalt

Compacting asphalt

Compacting ballast

Positioning wood tie panel

Dumping cribbing rock

Surfacing track

Placing concrete surface

As noted in Table 3.2, the basic processes involve removing the existing crossing surface and track panel, excavating the contaminated trackbed material for a selected distance below top-of-rail, and replacing with a compacted layer of hot mix asphalt, a compacted layer of ballast, a new track panel, adding cribbing ballast, surfacing, and raising (if desired) the track, placing the crossing surface and paving the trenches and highway approaches. Figures 3.2a and 3.2b depict the various operations.

The equipment utilized will vary depending on the length of the crossing, availability, and site conditions. A hydraulic excavator (trackhoe) is extremely versatile and can assist with practically all phases of project activities. An additional trackhoe or crane is desirable for longer crossings. A backhoe or two is necessary to assist the trackhoe and provide loading capability. Removal of the old crossing and trackbed spoils can be accomplished simultaneously provided that a loader and trucks are available. A steel wheel roller is necessary to compact the subgrade, asphalt, and ballast. After the asphalt underlayment is compacted, the ballast can be dumped immediately on the hot compacted mat.

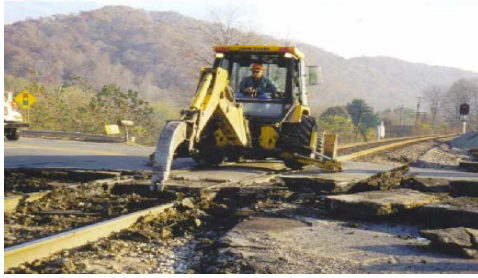
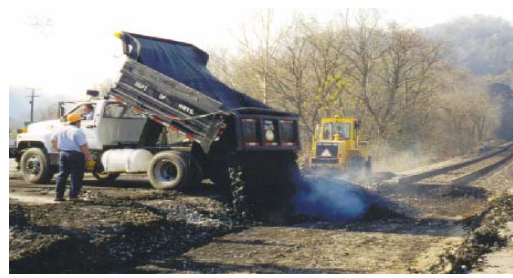
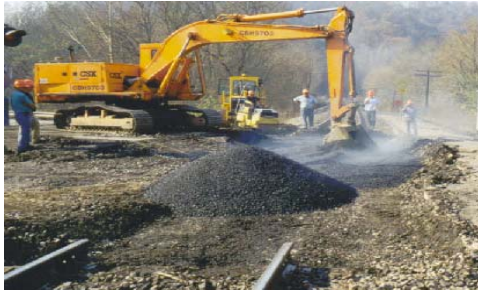
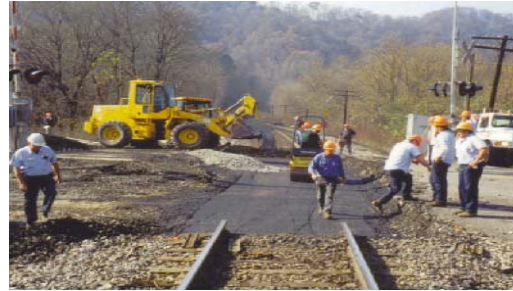
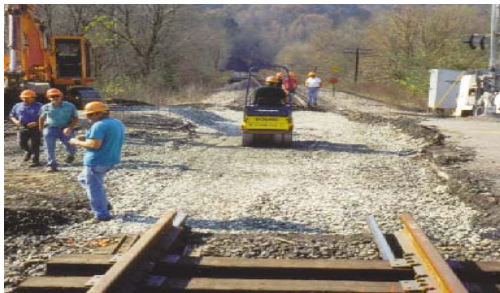
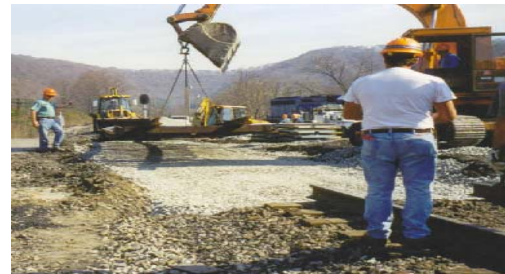
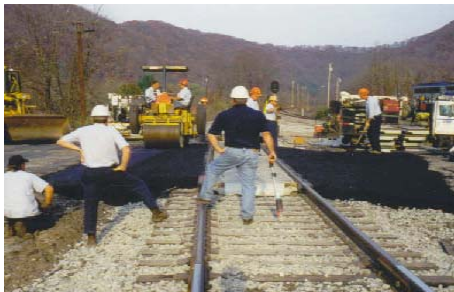
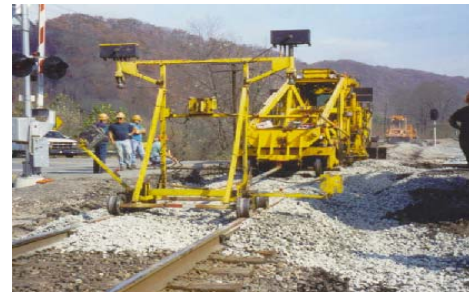
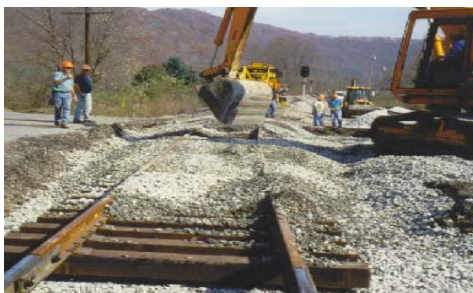
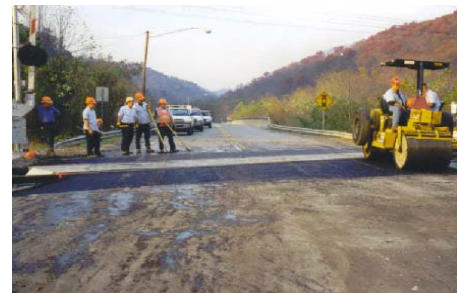
**Figure 3.2b Typical Fast-Track Renewal Operations**

**KY 3 Condition prior to rebuild**

**Dumping asphalt 10:15**

**Spreading asphalt**

**Compacting asphalt and dumping ballast**

**Compacting ballast 11:20**

**Positioning new panel**

**Spreading cribbing rock 11:30**

**Tamping ballast**

**Compacting hand-spread approaches**

**Finished compacting asphalt approaches 16:50**

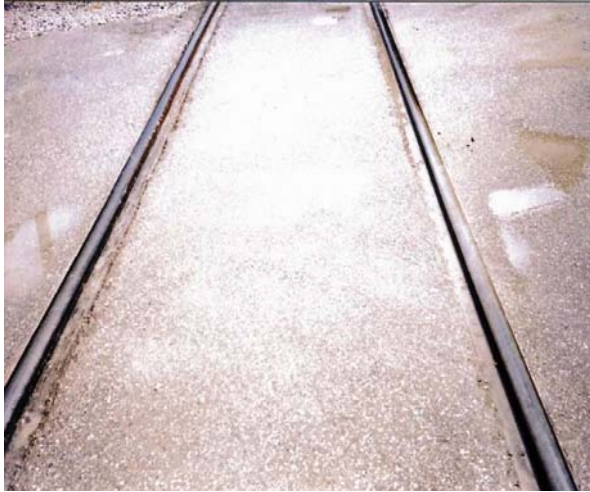
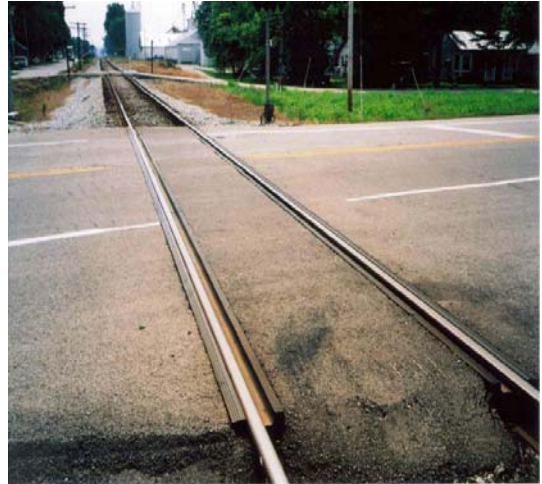
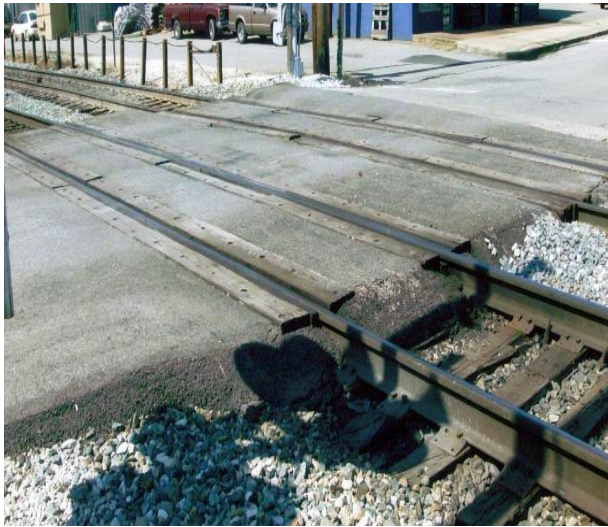
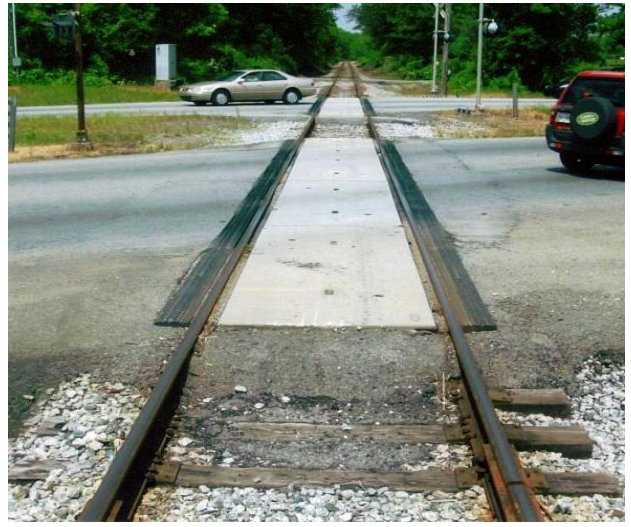
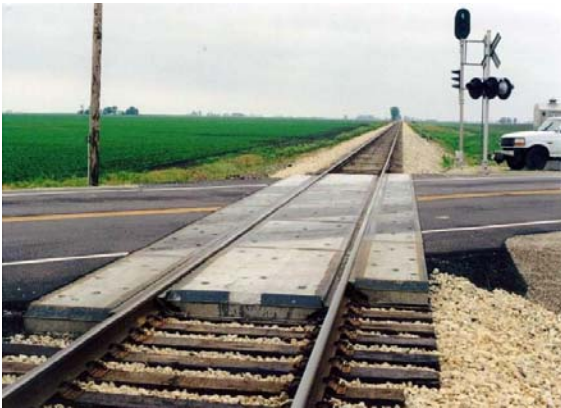
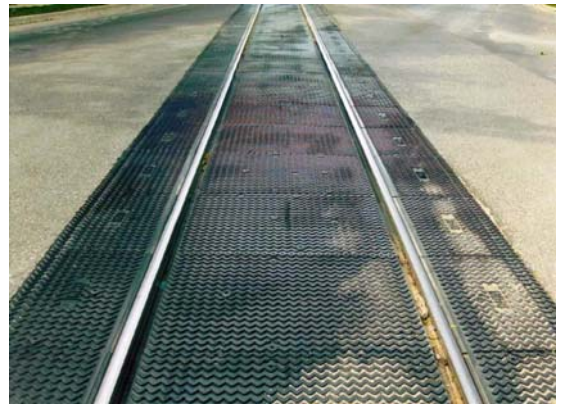
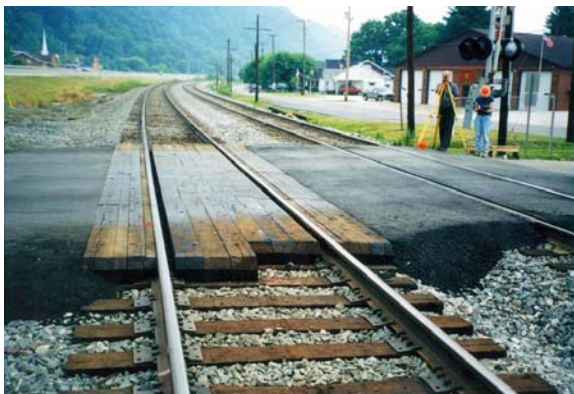
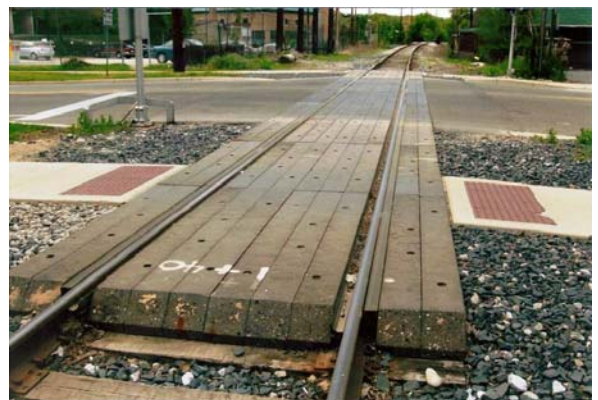
Figure A.3.4 Typical Compositions of Highway-Railway Crossing Surfaces

**All Asphalt**

**Asphalt/Rubber Seal**

## Asphalt/Timber

## Concrete/Rubber/Asphalt

## Full-Width Concrete

## Full-Depth Rubber

**All-Timber**

**Composite**
