**CRACK SEALER FILL
CHARACTERISTICS**

Final Report

SR 500-230

1. Report No. OR-RD-10-23		2. Government Accession No.		3. Recipient's Catalog No.	
4. Title and Subtitle Crack Sealer Fill Characteristics				5. Report Date June 2010

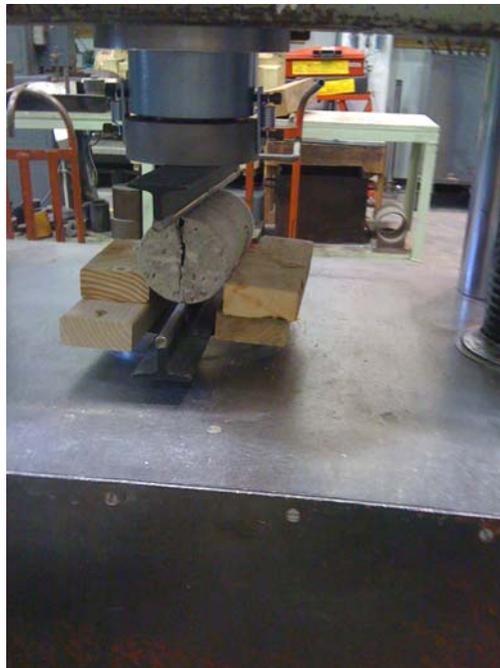
Figure 2.1: Set up to crack cylinders.

The investigation used 4 in x 8 in concrete cylinders for the test specimens. The cylinders were split lengthwise using the setup shown in Figure 2.1. The crack faces were cleaned of debris and loose concrete, and the two halves were fitted together. Steel hose clamps were placed around the cylinders, and the clamp tension was adjusted to achieve a nominal 0.01 in crack width measured on the two ends of the cylinders. Silicone caulk was used to seal the crack along the sides of the cylinders but not the ends. The cylinders were then placed in a moist room until needed to allow moisture to fully penetrate the cracks. One week before applying the crack sealer, the cylinders were removed from the moist room and allowed to dry at ambient laboratory conditions. The exposure to water followed by one week of drying was done to simulate expected Oregon field conditions in which sealers are likely to be applied a week after full saturation from rain. During the week of drying, a ring of tape and silicone caulk was placed around the circumference of one end of the cylinders to contain the sealers during application. Two cylinders for each crack sealer were prepared in this manner. Figure 2.2 shows cylinders ready for sealer application.

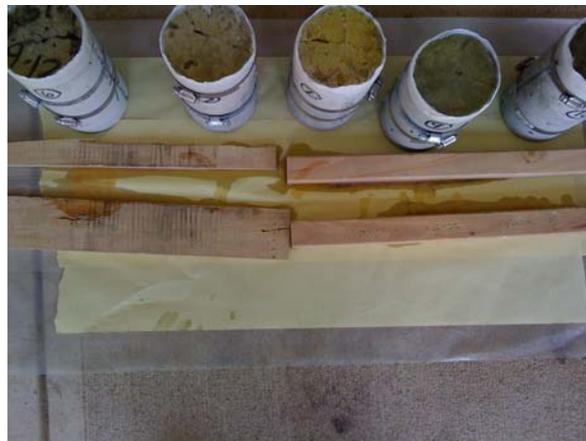
Figure 2.3: Cylinders with cured resin in the reservoirs and evidence of leakage on the ground cover.

Small quantities of the crack sealer resins were mixed according to the manufacturers' instructions and poured into the prepared reservoirs. If possible, a surplus of resin was maintained in the reservoir before the resin set. However, some resins leaked through the length of the cylinder so quickly, that trying to maintain a pool of resin in the reservoir was futile. Figure 2.3 show cylinders with cured resin in the reservoir and resin on the ground cover from leakage.

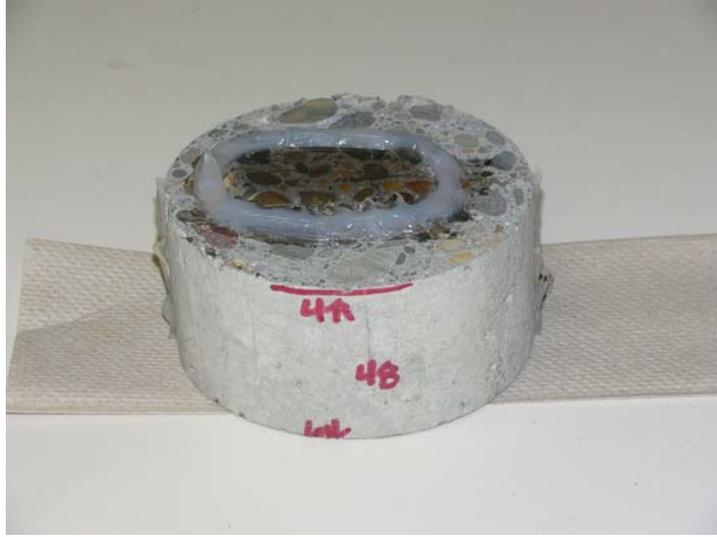
Figure 2.4: Leak test.

Leak testing on select slices covering a range of filled crack lengths was conducted. The test was performed by creating a reservoir on one side of the slice with caulk, filling the reservoir with water, and waiting up to two hours to see if water leaked through to the opposite side. A test in progress is shown in Figure 2.4.

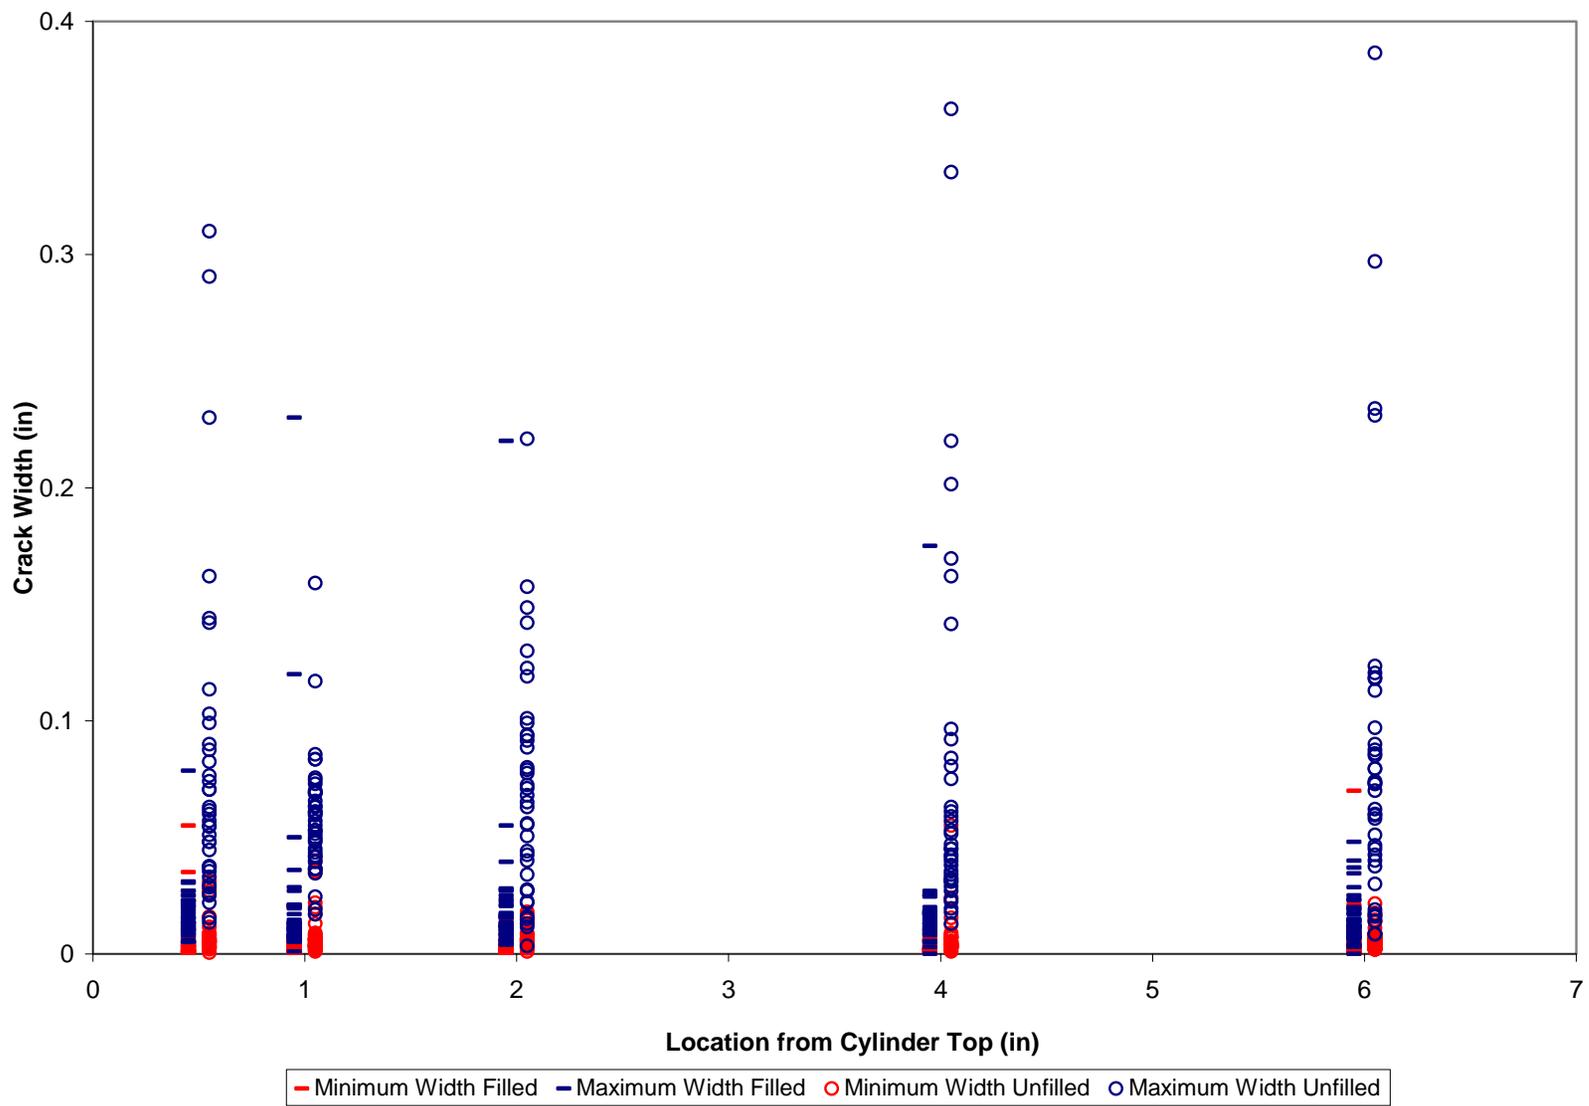
Figure 3.1: Compiled crack width filled results.

Initially, the intent of slicing the cylinders was to determine the depth of penetration. However, it was observed after the first few slices that a simple measure of penetration was not possible or even applicable. The crack width varies across a cut surface. Generally for specimens in this investigation, smaller crack widths were more likely to be filled than larger crack widths. The effect is illustrated in the graphs for the various sealer resins shown in Appendix C using the measurements tabulated in Appendix B. In these graphs, the saw-cut location is given along the x-axis relative to the top of the cylinder. If the cylinder is thought of as a core through a bridge deck, the cut locations would be the depth below the riding surface. At each location, closed symbols are plotted for the minimum and maximum crack widths that were filled (4 points: 1 minimum and 1 maximum read for each of the two cut surfaces at that location); open symbols are used for the minimum and maximum crack widths that were not filled. The closed and open symbols in essence define a range of filled and unfilled crack widths. Figure 3.1 illustrates the effect by showing the results for all the cylinders combined. The graphs show that the effect was independent of the depth below the surface.

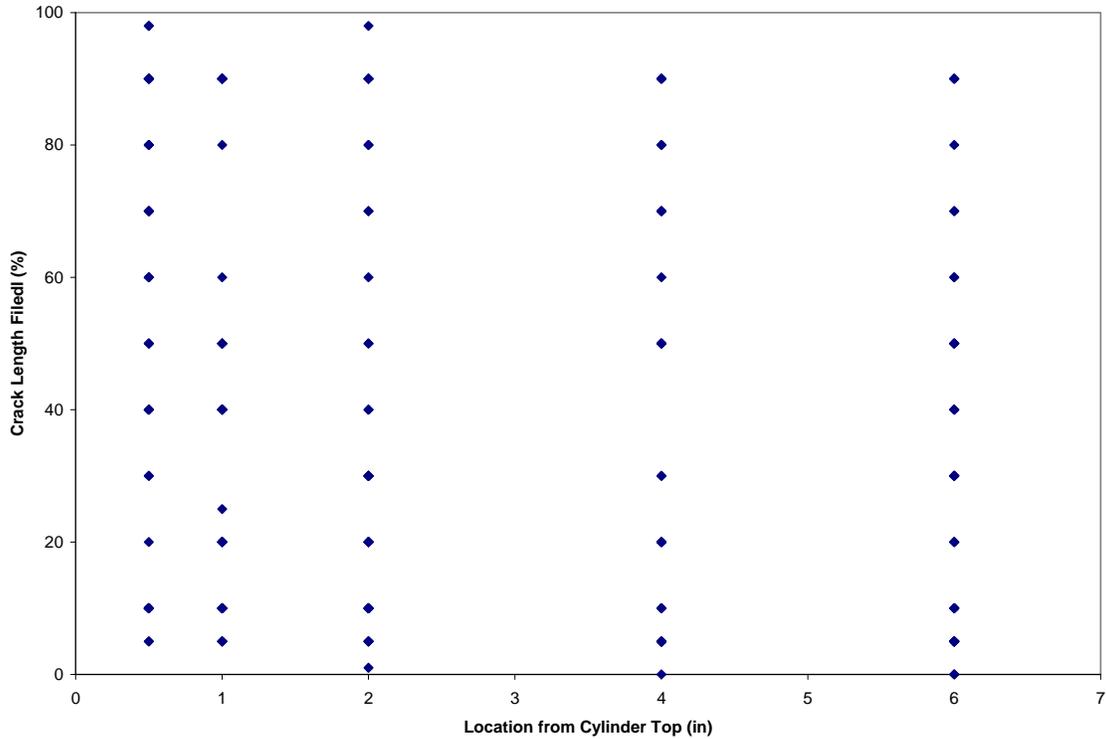
Figure 3.2: Crack length filled vs. location compiled for all resins.

The depth below the surface also had little influence on the fraction of the crack that was filled as shown in Figure 3.2 for the combined results from all cylinders. Except for the Dural LM 50, all the products showed low levels of crack filling as shown in Table 3.1. Material type had no discernible effect on the extent of crack fill. The epoxies, with their relatively high viscosities, filled cracks as well as (or as poorly as) the lower viscosity materials.

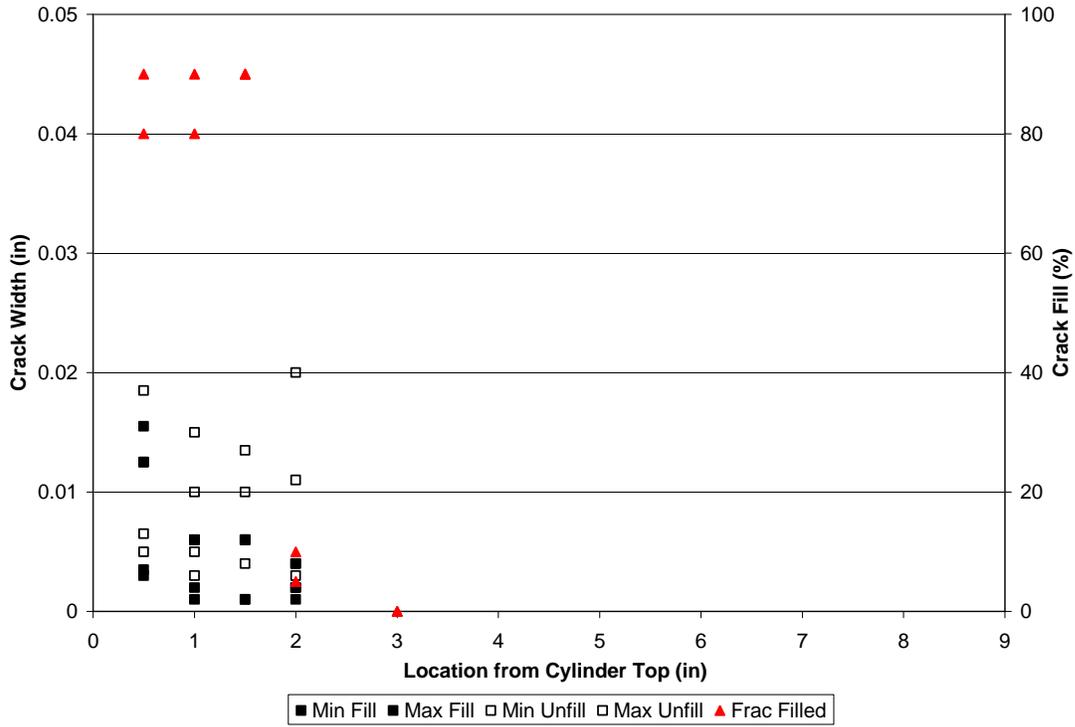
Figure 3.3: Crack fill data for SikaPronto 19 from a bridge core.

Analysis was conducted on two cores removed from bridge decks that had undergone crack sealing. One deck was sealed with SikaPronto 19, a HMWM, and the other was sealed with Dural 335, an epoxy. The crack sealed with Dural 335 was caulked on the bottom of the bridge deck before the sealer was applied. Figure 3.3 shows the SikaPronto 19 was present to a depth of 2 in. with at least 80% crack fill for the first 1.5 in. Based on the laboratory results, this level of penetration and fill should be sufficient to seal the crack from water intrusion. The trend found in the laboratory tests of narrower crack sections more likely to fill than wider sections was also observed in the SikaPronto core. It is unknown whether the SikaPronto resin beyond 2

in. had leaked out of the bottom of the deck or had not penetrated deeper than 2 in. The Dural core had 90% and greater crack fill for the entire depth of the core where a crack was visible as shown in Figure 3.4. Also, the trend of larger crack widths having a lower probability of fill was not observed in this core. The extensive crack fill may have been due to the fact that the sealer could not leak out the bottom of the crack during application because of the caulk.

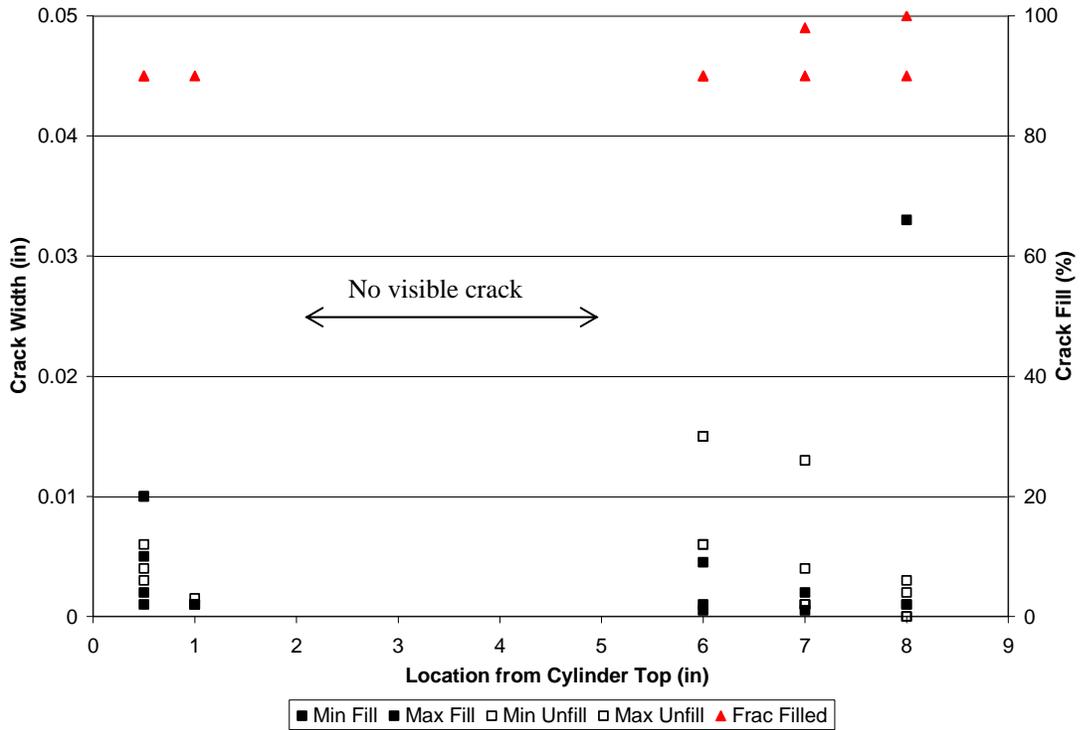
Figure 3.4: Crack fill data for Dural 335 from a bridge deck core.

For Figure 3.4, four data points for Max Fill were greater than 0.05 in. and are not shown on graph. Crack was caulked at the bottom of the deck prior to crack sealing.

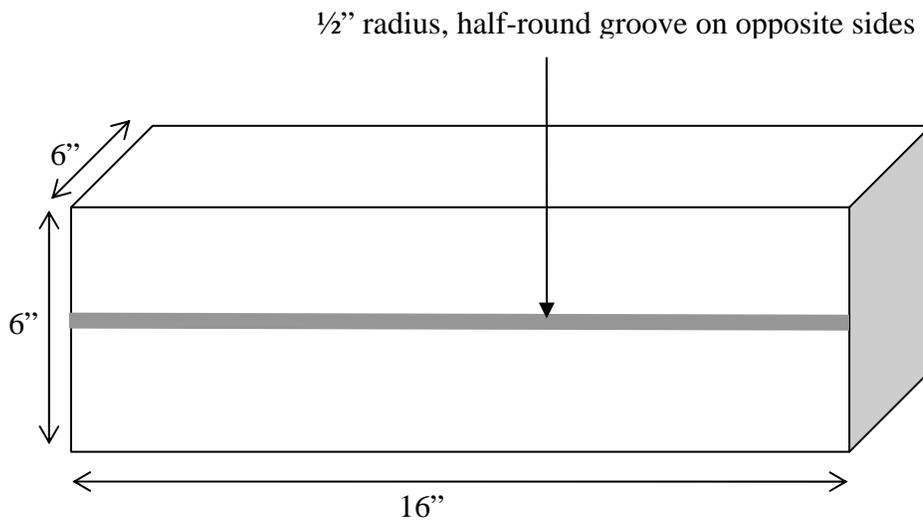
Figure A-1: Concrete block schematic.

A concrete block design that allowed for controlled cracking was developed based on experiments conducted by WISDOT (REF). A schematic of the block is shown in Figure A-1. All blocks were made from Sakrete 5000 Plus Concrete mixed according to the manufacturer's instructions and cured in a moist room for at least 28 days. The blocks were cut in half to create 6"x6"x8" specimens. Each specimen was cracked by applying compressive force through round bars positioned in the grooves.

Cracks were formed by placing small aluminum foil spacers along the edge of one half and clamping the two halves together. Crack width was determined by averaging the measured crack width at 1" intervals on both ends of the specimens and averaging the values. The width was then adjusted by tightening or loosening the clamping pressure. The ends and bottom were sealed with silicone caulk.

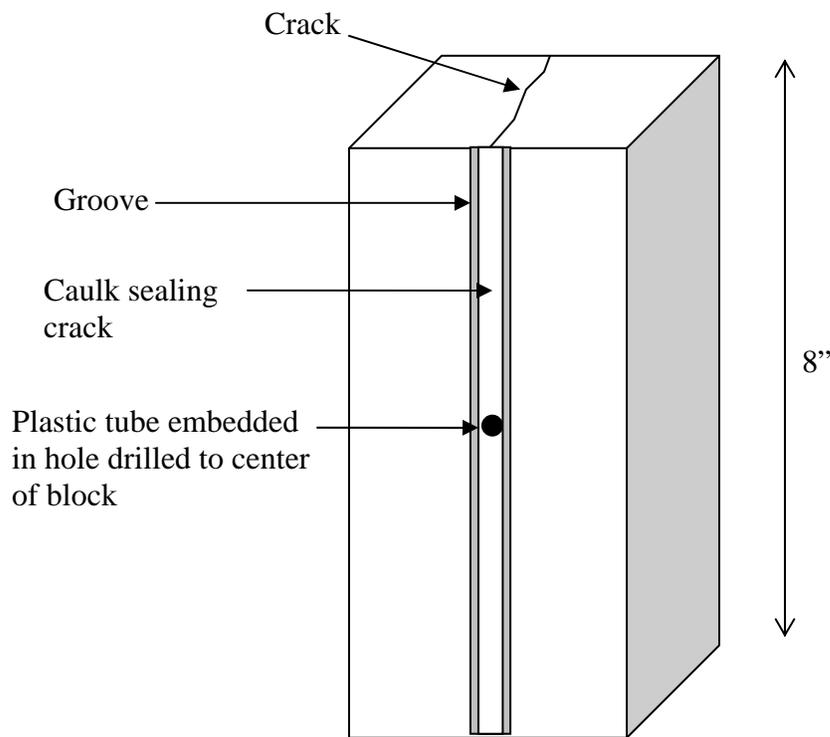
Figure A-2: Crack drying specimen.

One specimen was used to measure the rate at which cracks dry. The specimen configuration is shown in Figure A-2. The intent of the arrangement was to allow moisture to escape through the crack only along the long dimension of the specimen, which would mimic crack drying in a through-crack in an 8"-thick bridge deck. The specimen was kept in the moist room since

casting and after each preparatory step. The crack surfaces were wet just prior to installing the plastic tube and sealing the crack with caulk. The hole for the tube was dried with compressed air and heat and a bead of caulk applied to the edge of the tube embedded in the hole. The two halves were placed together, clamped to an average crack width of 0.019", and the crack caulked along the 8"-dimension of the specimen. After the caulk seal had cured, the plastic tube was capped, and the specimen was placed in the moist room for five days. The specimen was moved from the moist room to the ambient laboratory environment. An Ingius moisture sensor connected to an IntelliRock datalogger was used to measure the moisture level by removing the cap from the tube, inserting the probe, and allowing the readout to stabilize. The sensor was left in place for six weeks.

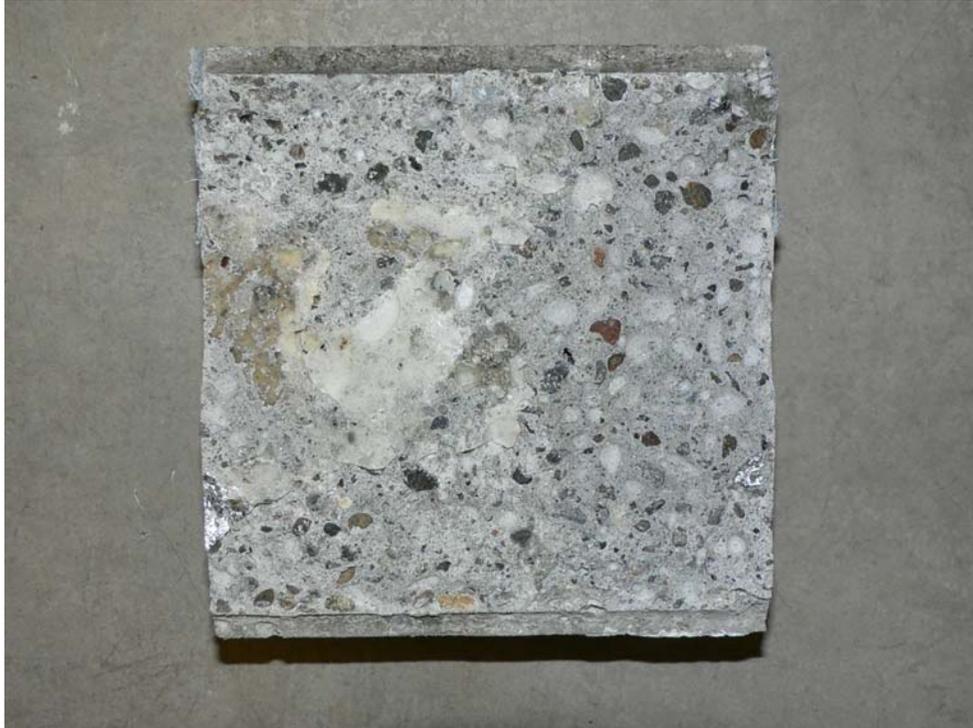
Figure A-3: Fracture surface showing a combination of debonding and concrete fracture.

The results of recracking the specimens after crack sealing are shown in Table A-4. The fracture surfaces verified that all the cracks that had shown complete fill at the ends of the specimens were in fact filled. The fracture surfaces exhibited various combinations of debonding and fractured concrete as shown in Figure A-3. Fractured concrete indicates that the resin and resin-to-concrete bond were stronger than the concrete. A comparison of the wet and dry crack conditions shows that moisture may reduce bond strength. Unfortunately, all the MBT Degadeck wet crack conditions leaked sealer, so a thorough comparison for this sealer is not possible.
