TEXTURING OF CONCRETE PAVEMENTS

Final Report

Research Report No. 134

LOUISIANA DEPARTMENT OF TRANSPORTATION
AND DEVELOPMENT
Research and Development Section
In Cooperation with
U.S. Department of Transportation
FEDERAL HIGHWAY ADMINISTRATION

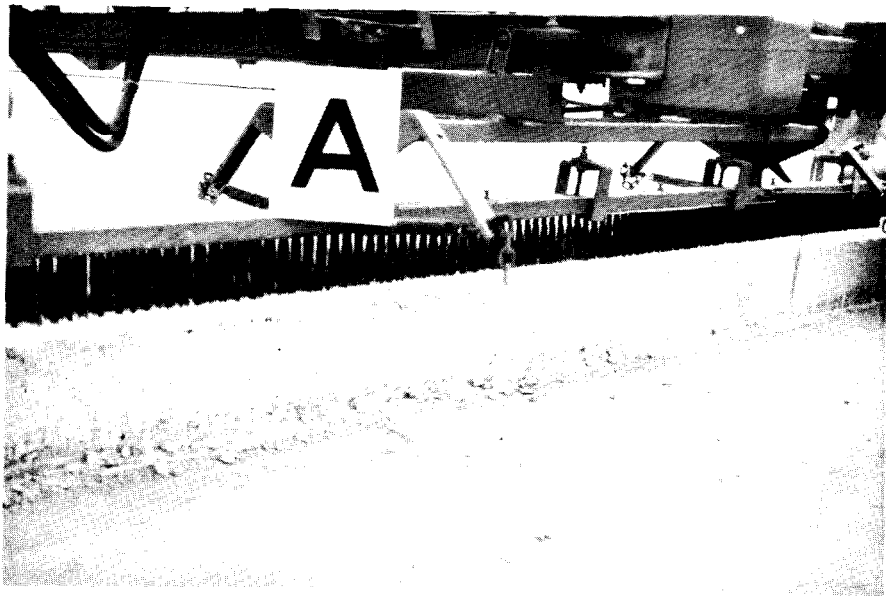
FIGURE 10
Heavy Polyplastic Broom on
Transverse Texturing
