RAPID SETTING CONCRETE PATCHING STUDY

FINAL REPORT

Research Report No. 84

Research Project No. 71-1C(B)
Louisiana HPR 1 (12)

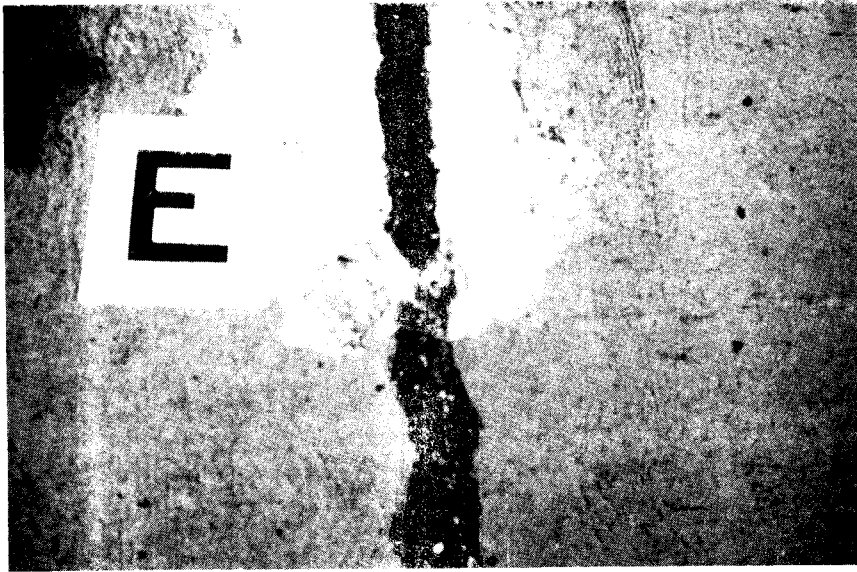
FIGURE 1
CONCRETE SURFACE AT STATION E-1

FIGURE 2
CONCRETE SURFACE AT STATION E-1

After one year of service the patch was beginning to deteriorate rapidly. The bond area was beginning to spall and open and aggregates were being exposed due to traffic wear.

System E: This patch used the same material as System D, except the cement factor was seven, whereas System D had a cement factor of six. The six-hour compressive and flexural strengths were considered low. A split beam durability test was performed for this system, and the results indicated that the bond to hardened concrete was not successful. The material itself had a very low durability factor.
