INSTRUMENTATION OF THE RED RIVER BRIDGE
AT BOYCE, LOUISIANA

FINAL REPORT

K. NAM SHIU
Construction Technology Laboratories, Inc.
5420 Old Orchard Road
Skokie, Illinois 60077

August 1988

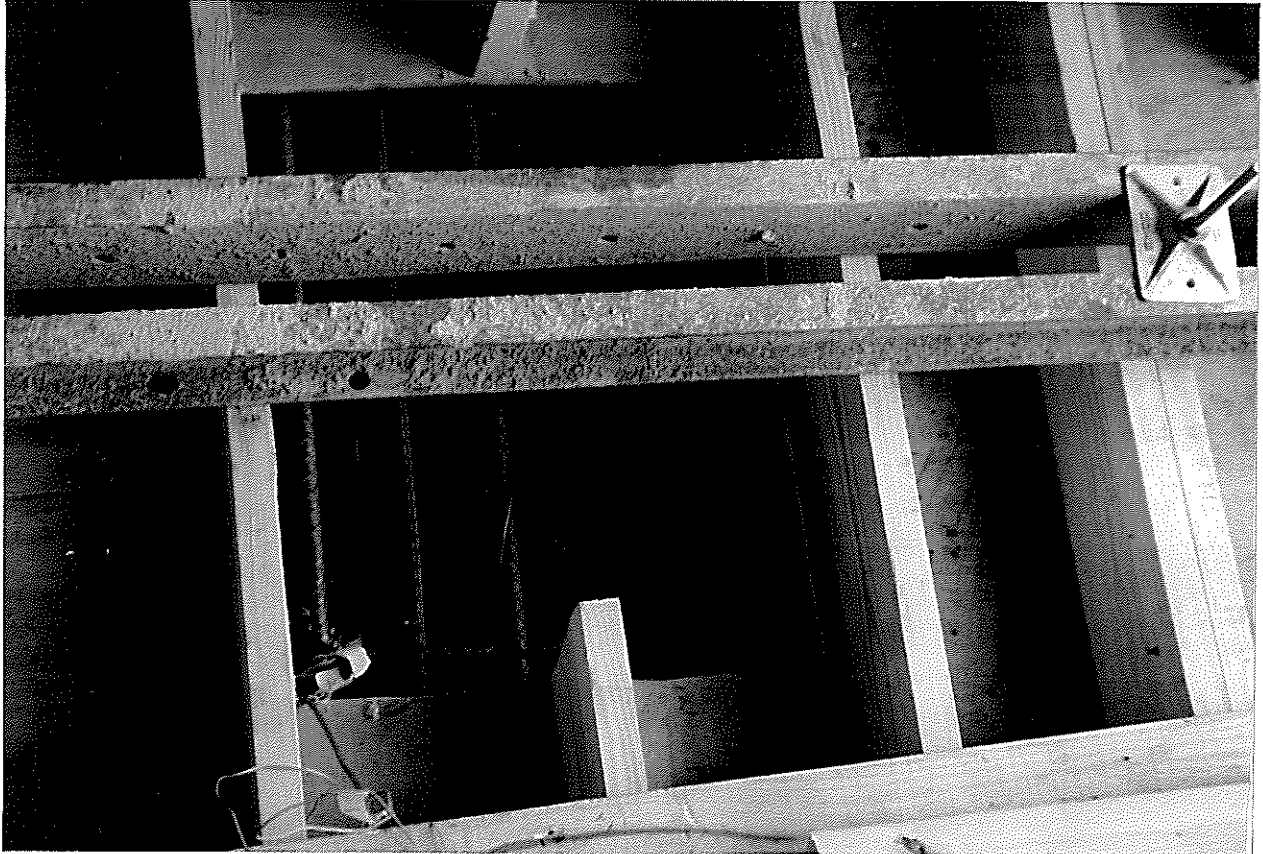
FIG. 4-4 OPENING FOR INSTALLATION OF CARLSON STRAIN METERS IN THE WEB OF THE BOX GIRDER

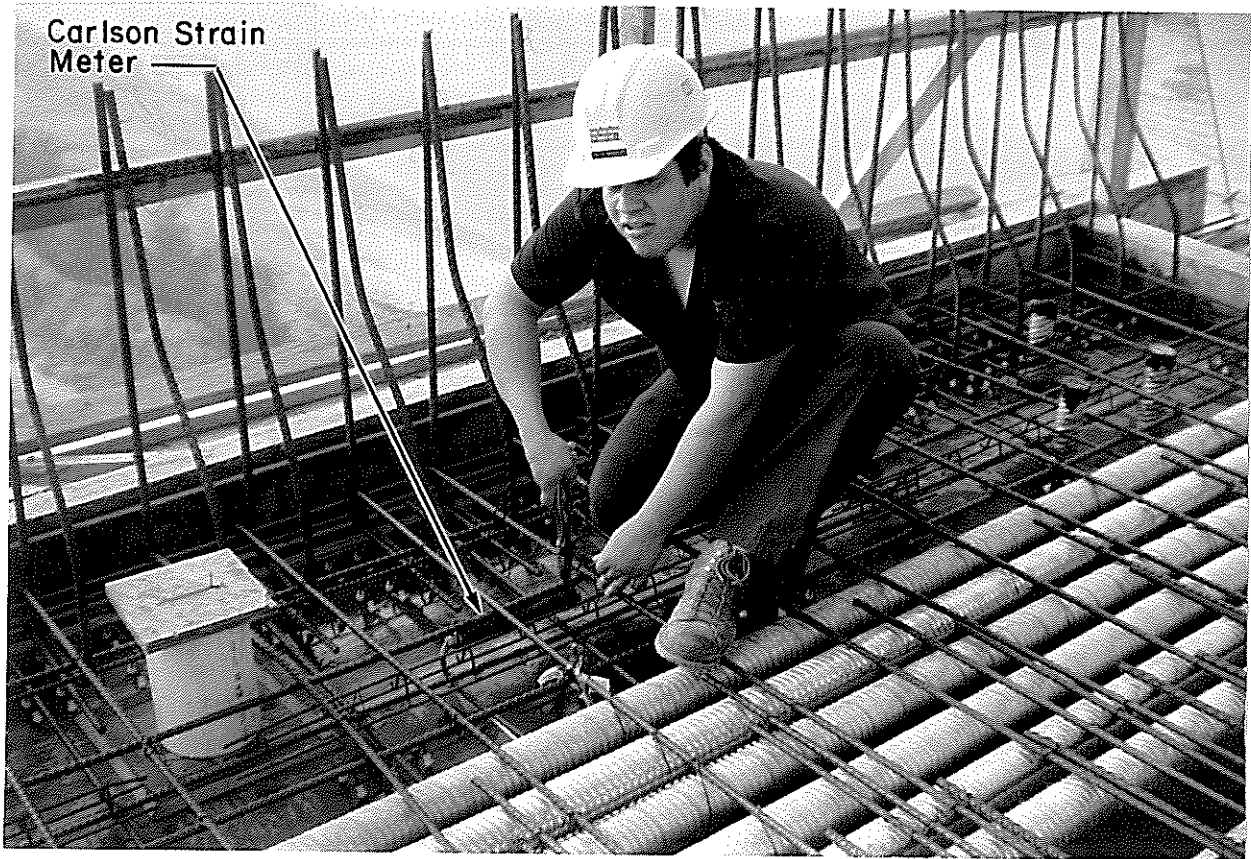
Figure 11. Installation of Carlson strain meter.

FIG. 4-5 INSTALLATION OF CARLSON STRAIN METER

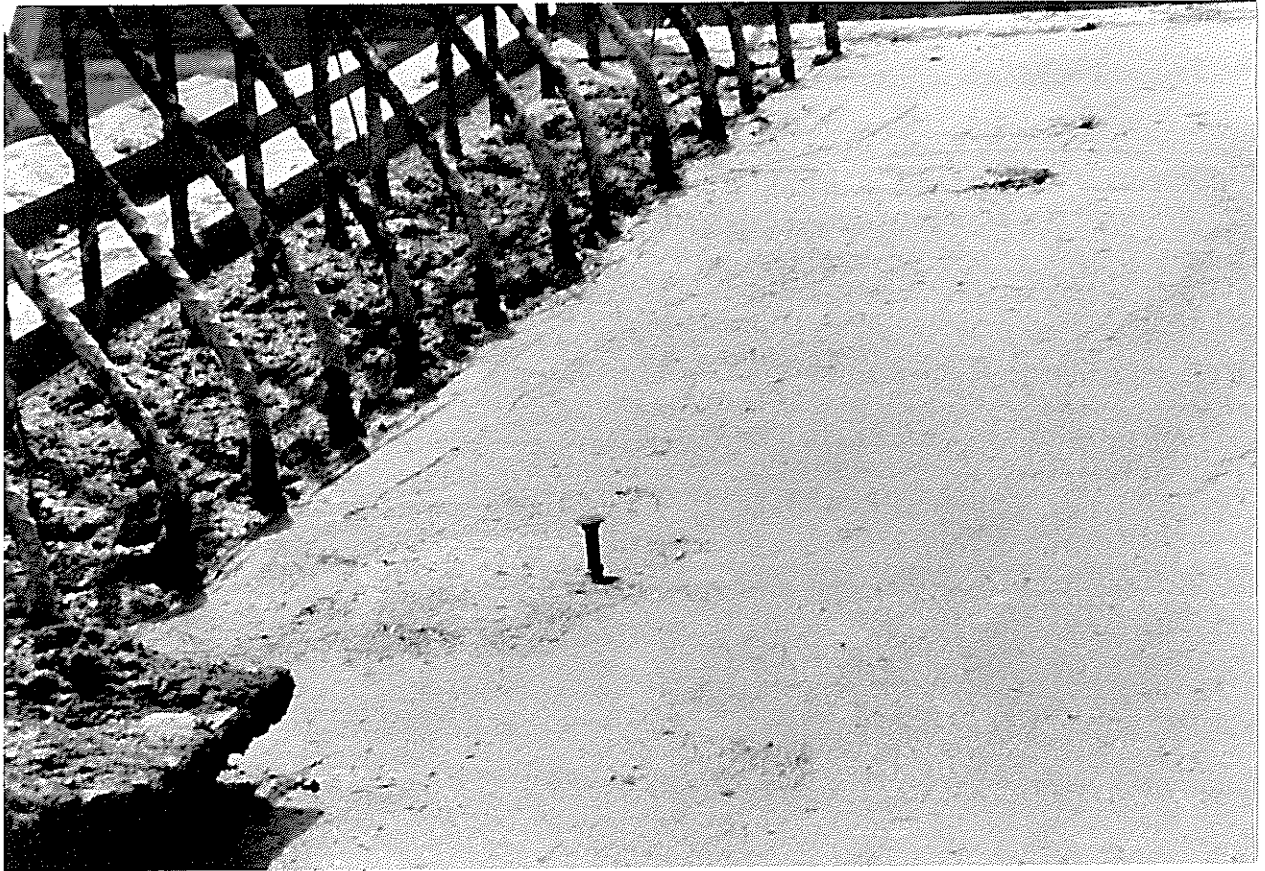
Figure 19. Installed deflection measurement point.

FIG. 4-13 INSTALLED DEFLECTION MEASUREMENT POINT
