EVALUATION OF JOINT SEALANT MATERIALS

(INTERIM REPORT NO. 1)

Research Report No. 62

Research Project No. 69-2G
Louisiana HPR 1 (9)

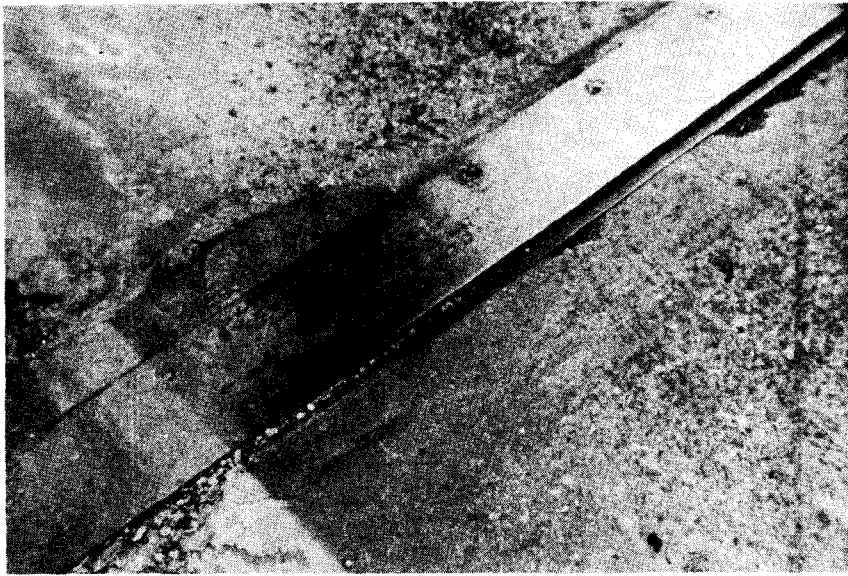
Incompressible materials that find their way onto a bridge eventually invade unprotected joints. Sliding plate joints and finger joints are not effective (Figures 12 and 13). The buildup of material over several years can be substantial; Figure 14 depicts an unexpected roof garden complete with willow trees growing in debris on the bridge. Figure 15 shows a runoff outlet completely clogged with debris on a bridge which spans a lake; the outlet is located over two miles from land. The destructive effects of this incompressible buildup can be seen in Figures 16 and 17, the 1 3/4 inch joint has been rendered rigid, and the triangular extensions on the cap in Figure 17 are "saddles" built to prevent the girders from falling off the cap. When a bridge with skewed joints is subjected to unexpected compressive forces, a diagonal movement exists (Figure 18). If the bearing pads allow too much friction, the whole pier may lean as shown in Figure 19.

FIGURE 12
Typical Sliding Plate Joint

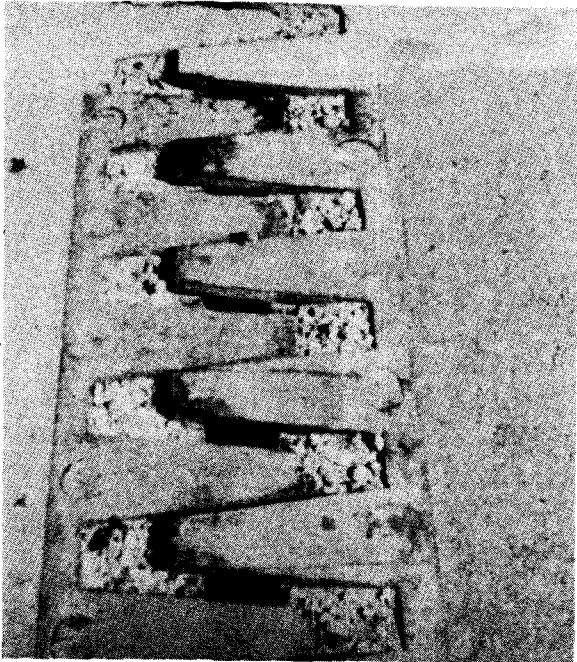
FIGURE 13
Typical Finger Joint

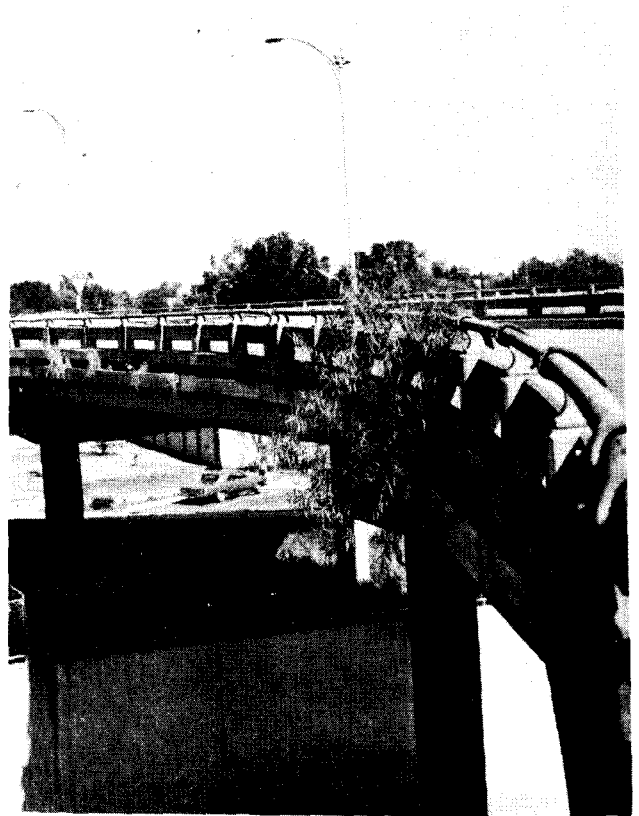
FIGURE 14
Bridge Debris

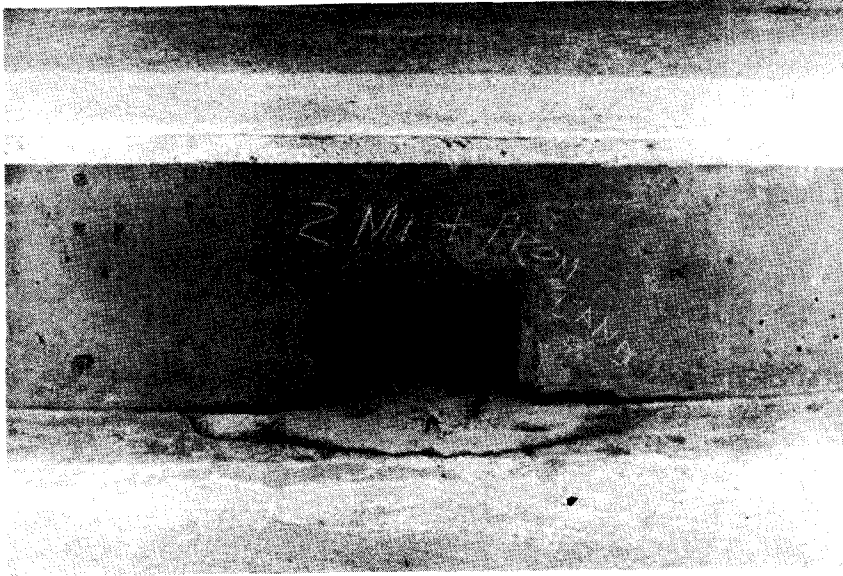
FIGURE 15
Bridge Debris

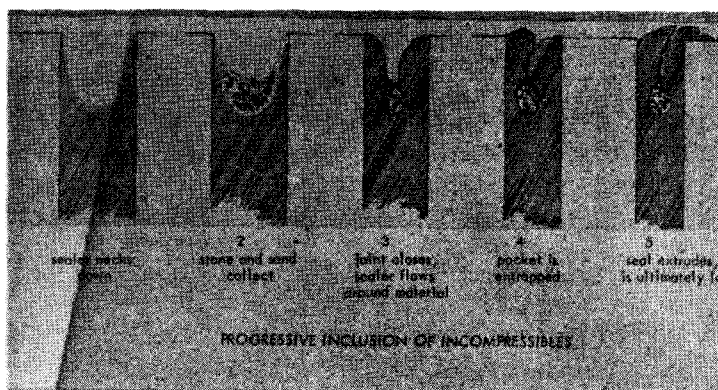
FIGURE 20

Figure 20 illustrates the progressive inclusion of incompressible material into a typical hot poured sealant such as the one in Figure 21. Adhesion failures of a two component catalyzed material (Figure 22) or compression set of a neoprene sealer (Figure 23) allows incompressibles to infiltrate. Once the incompressibles do infiltrate, trouble begins. Figure 24 is a typical pavement joint, the width being dependent upon the slab length. If incompressible material fills the joint reservoir, when the pavement expands the incompressibles cause concentrated compressive stresses in a small area, and the result is a spall (Figures 25 and 26). When the incompressibles infiltrate beyond the joint reservoir into the lower joint where concrete butts against concrete, the joint cannot close during pavement expansion, and tremendous compressive stresses build up and either cause blowups (Figure 27) or, if a structure is adjacent, create tremendous pavement thrust upon the structures. This thrust has been previously reported by Henry (4), Gordinier and Chamberlin (5). Pavement thrust has twice closed the four inch wide joint in Figure 28. When the pavement thrust is not relieved, considerable damage to the bridge members may occur; such as crushing, shoving and radial thrust (see Figures 29, 30 and 31).

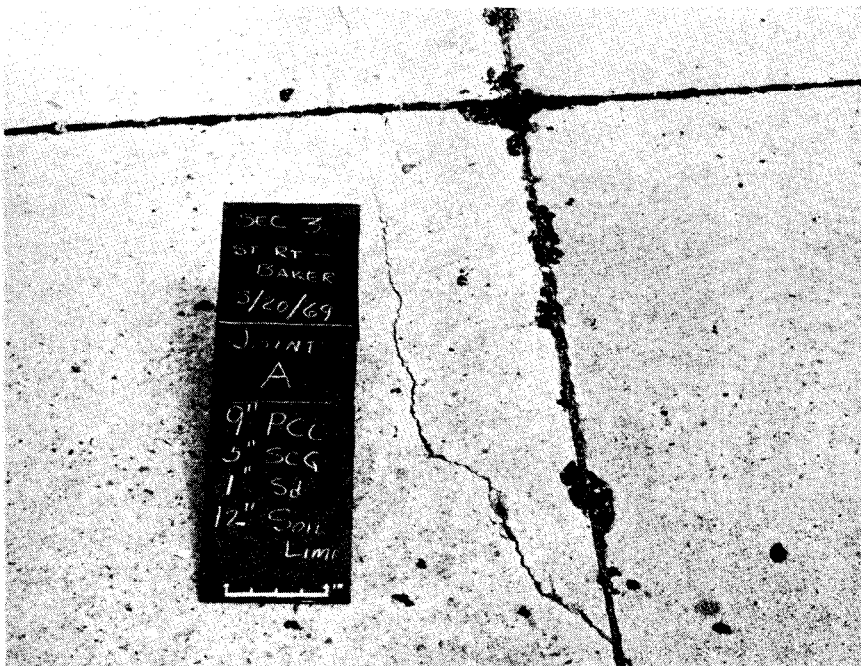
FIGURE 25
Pavement Spall

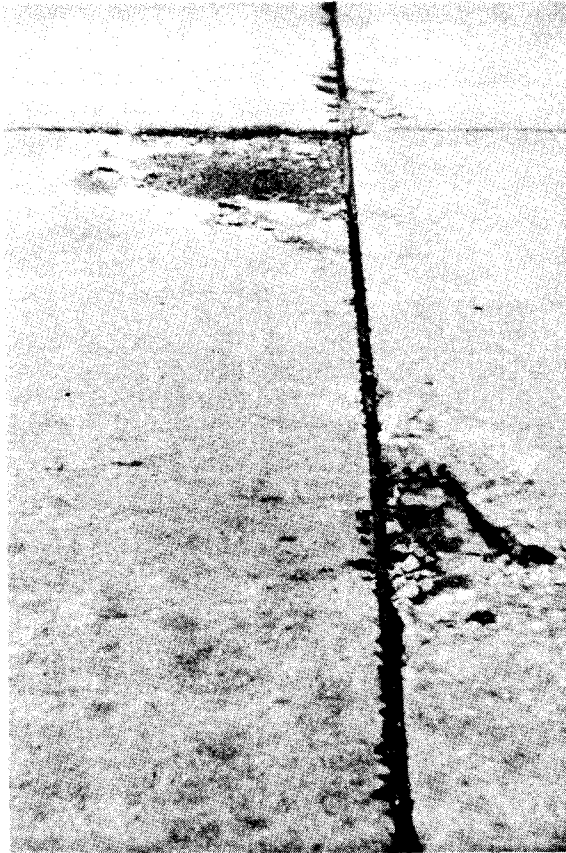
FIGURE 26
Pavement Spall

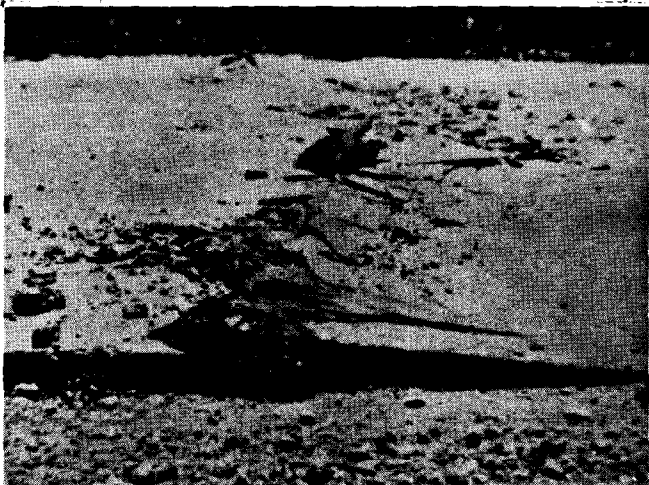
FIGURE 27
Pavement Blow-up

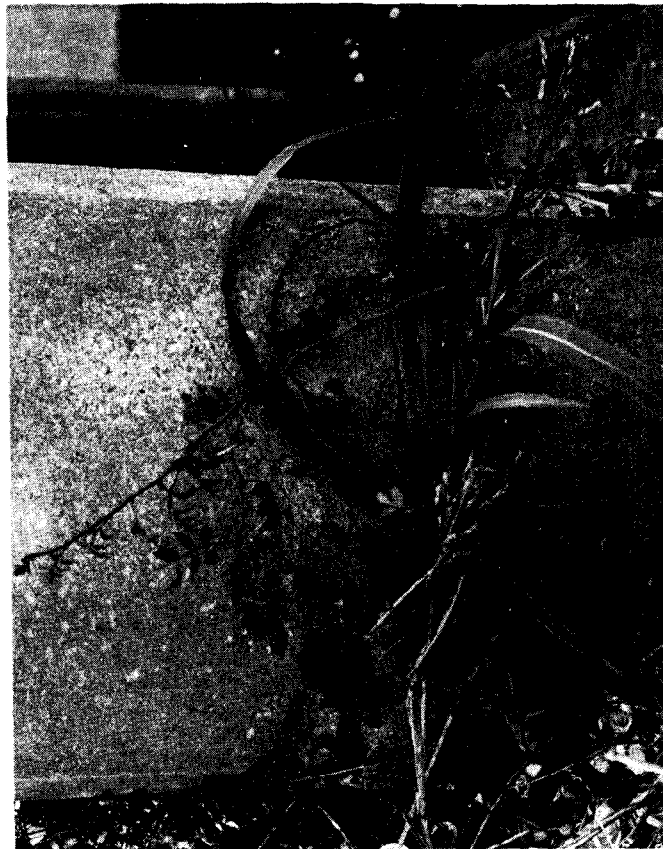
FIGURE 31
Radial Movement

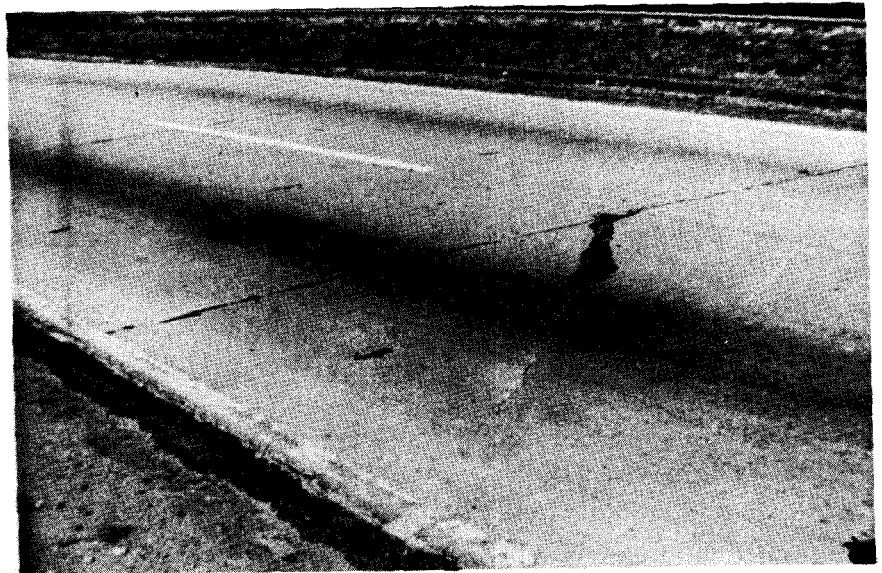
the joint, the weight is suddenly relieved, the slab rebounds upward, the void beneath the slab is increased, and the water rushes back to fill the opening. When the joint is open due to sealant failure, additional substantial suction is created, compounding the destructive effects. This constant swirling of water continually erodes the subbase thus intensifying the problem. As reported by Spellman (6), this destructive action can also cause faulting as well as slab breakage (see Figures 33 and 34).

FIGURE 34
Slab Breakage

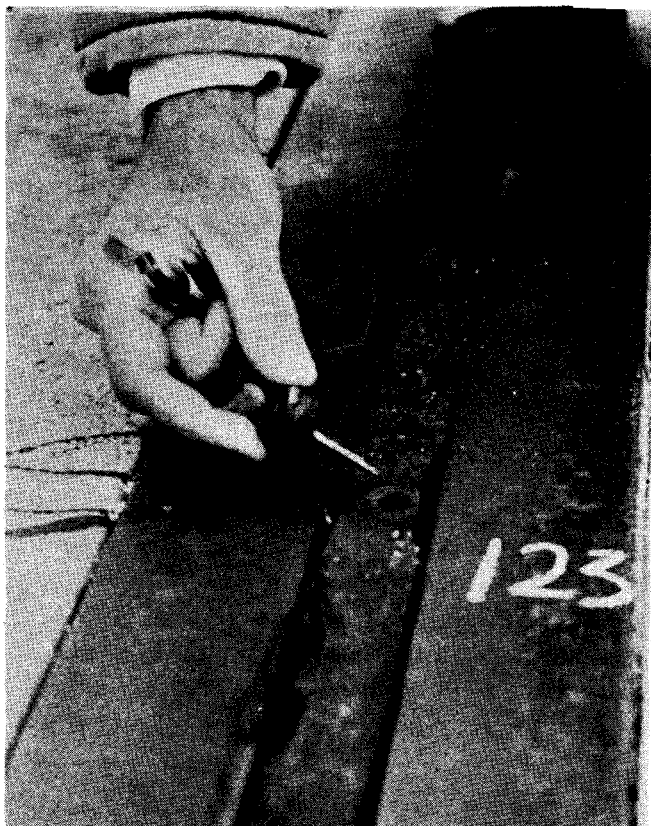
The sealant system should be long lasting. A sealant should be effective for five years (when the expense is great, longer life is expected). Small failures (Figure 35 and 36) eventually will occur and are to be expected, but should not propagate.

FIGURE 35
Failure Due to Truck Flare

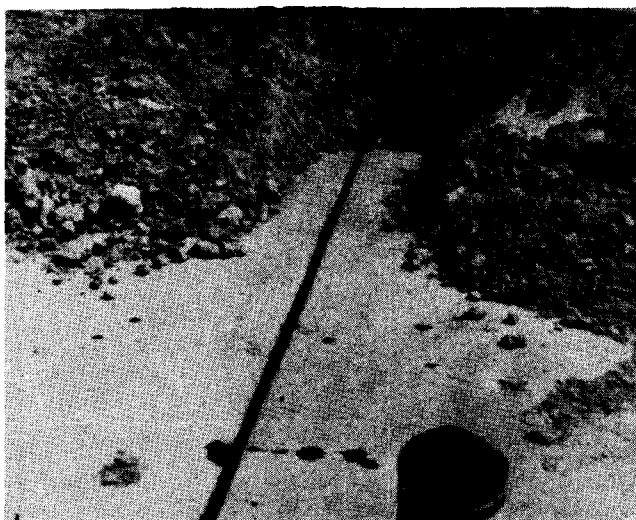
FIGURE 49

Most concrete pavement projects take two years to construct. Some of the most damaging infiltration can occur during this period (Figure 49). The specification language and actual inspection must scrupulously prevent this damage. Ideally, the joint sealants should be placed just prior to job acceptance provided the joints could be adequately protected from incompressible infiltration (water leakage could be tolerated). This would permit the concrete edge to sufficiently strengthen and the flaws to expose themselves and be easily repaired. In addition, the sealant would not be subjected to the ravages of the atmosphere. One solution may be to create the joint and protect it with a temporary sealant such as the backup rod of polyethylene until just prior to job acceptance. The backup rod could then be removed and discarded and the joint thoroughly cleaned and sealed. Some of the backup rod could possibly be reused if a liquid-poured sealant was used. This process would increase the joint sealing costs by approximately seven cents per foot, but may prove worthwhile on the basis of successful service life.
