LATEX MODIFIED ASPHALT AND EXPERIMENTAL JOINT TREATMENTS
ON
ASPHALTIC CONCRETE OVERLAYS

FINAL REPORT

EXPERIMENTAL PROJECT NO. 3
ASPHALT ADDITIVES

Research Report No. 237

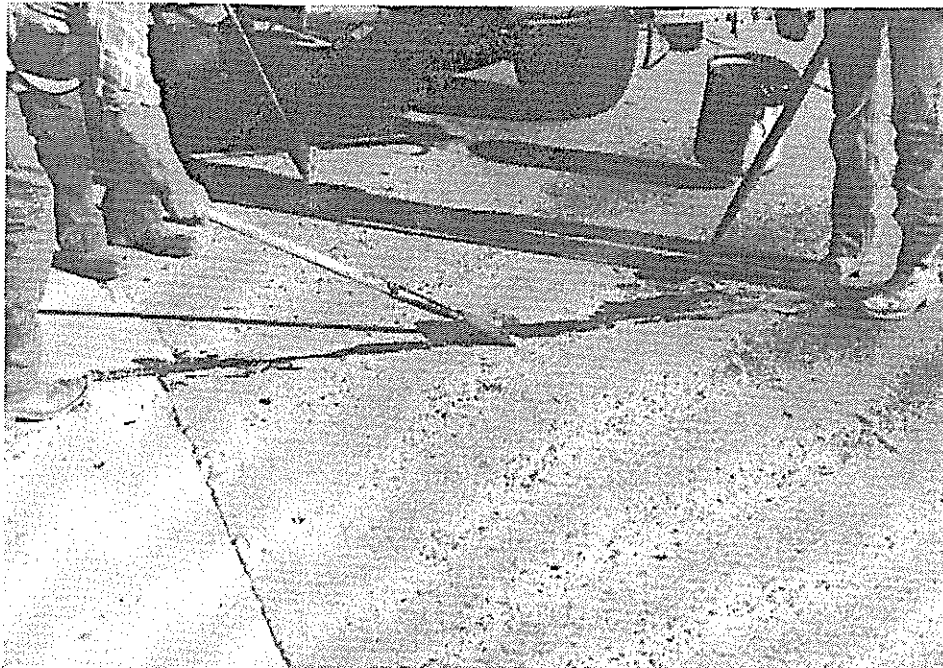
Removing excess joint seal material.

where the membrane had not been placed in the westbound lanes and throughout the entire project in the eastbound direction. Removal was generally accomplished by heating the rubberized asphalt material with a torch and manually scraping off the excess with a blade. This method of removal generally left a thin smear of sealant on the concrete surface near the transverse joints. Due to the fact that the humps occurred in the membrane sections and not in the uncorrected control section (4), it is believed that the excess joint sealant contributed little if any to the humping.

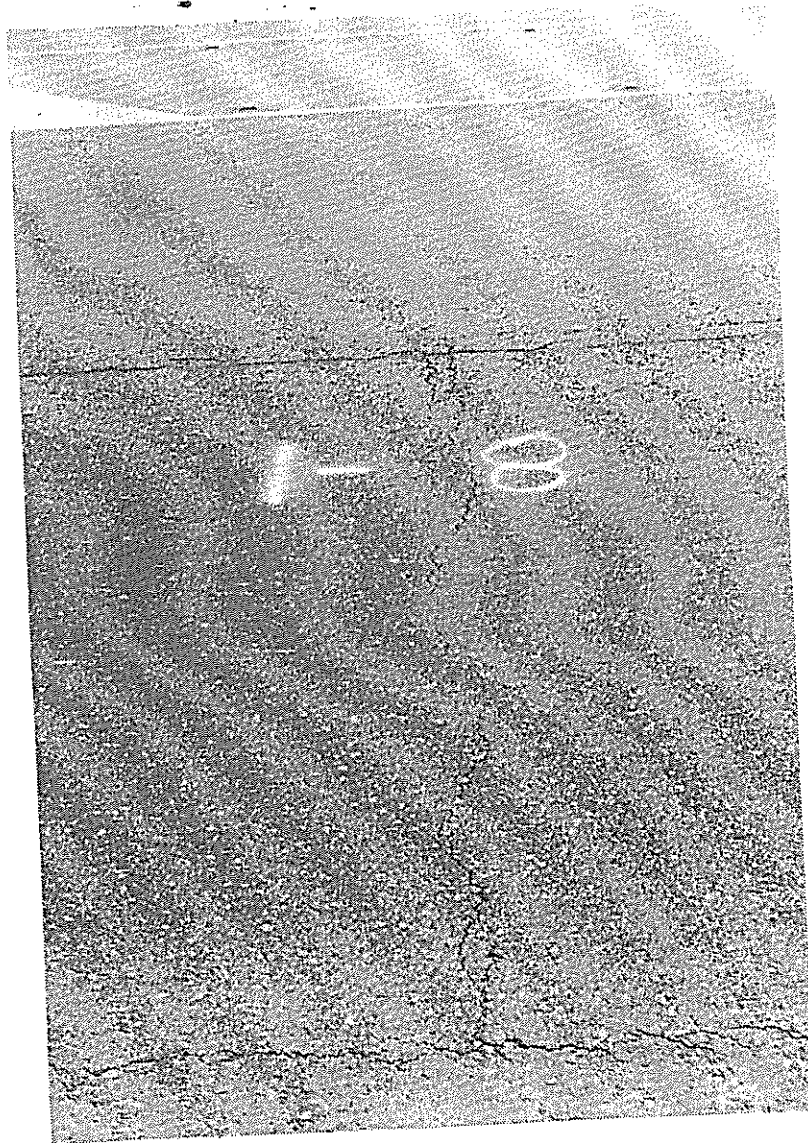
Test section 1. Less distressed taped-joint (with conventional asphalt cement).

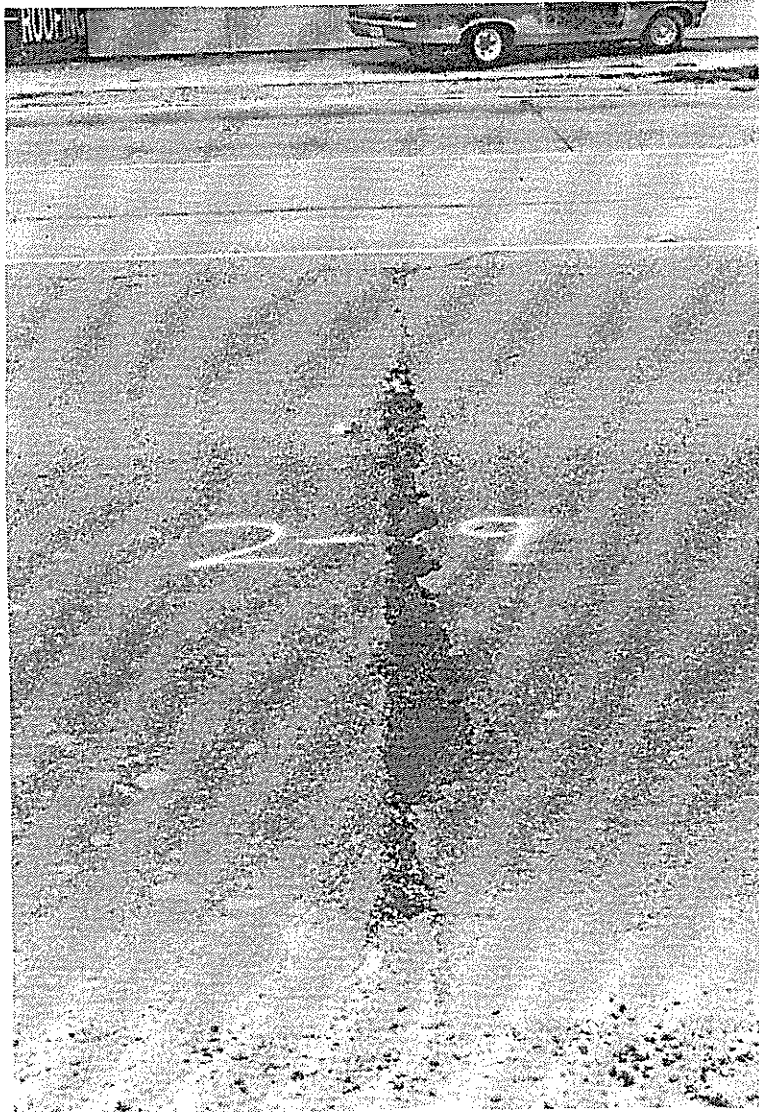
Test section 2. Taped-joint failure with maintenance patches (and conventional asphalt cement).

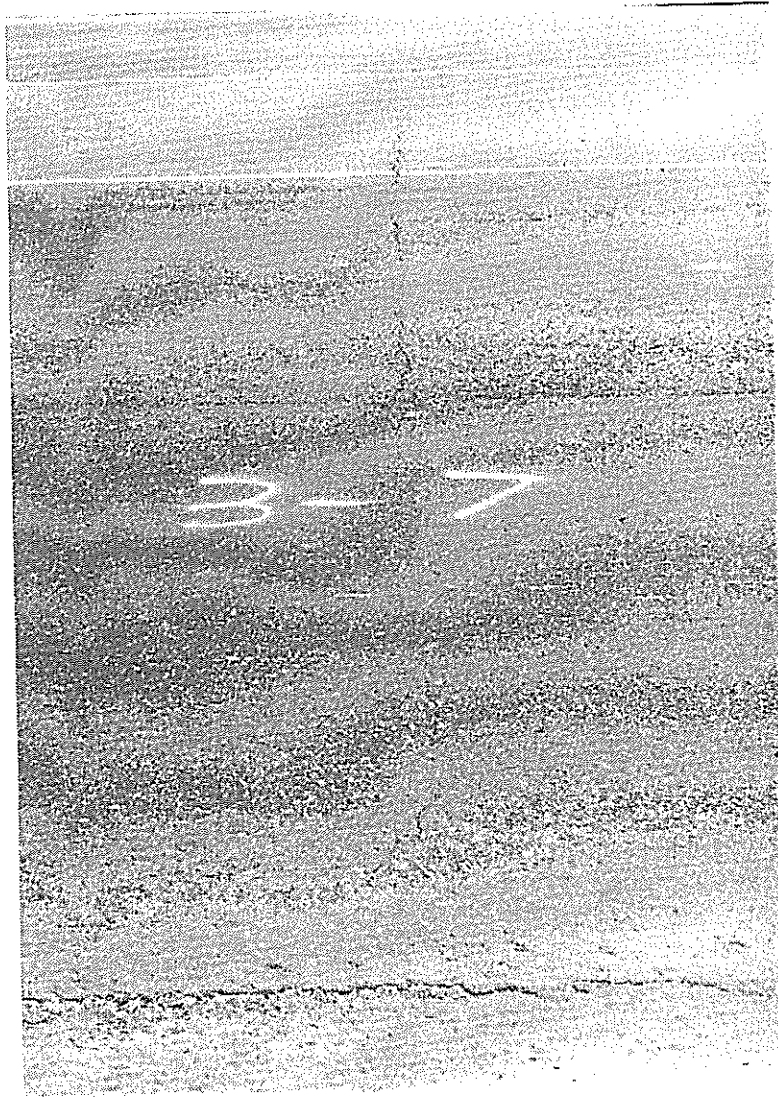
Test section 3. Taped-joint failure with maintenance patches (and conventional asphalt cement).

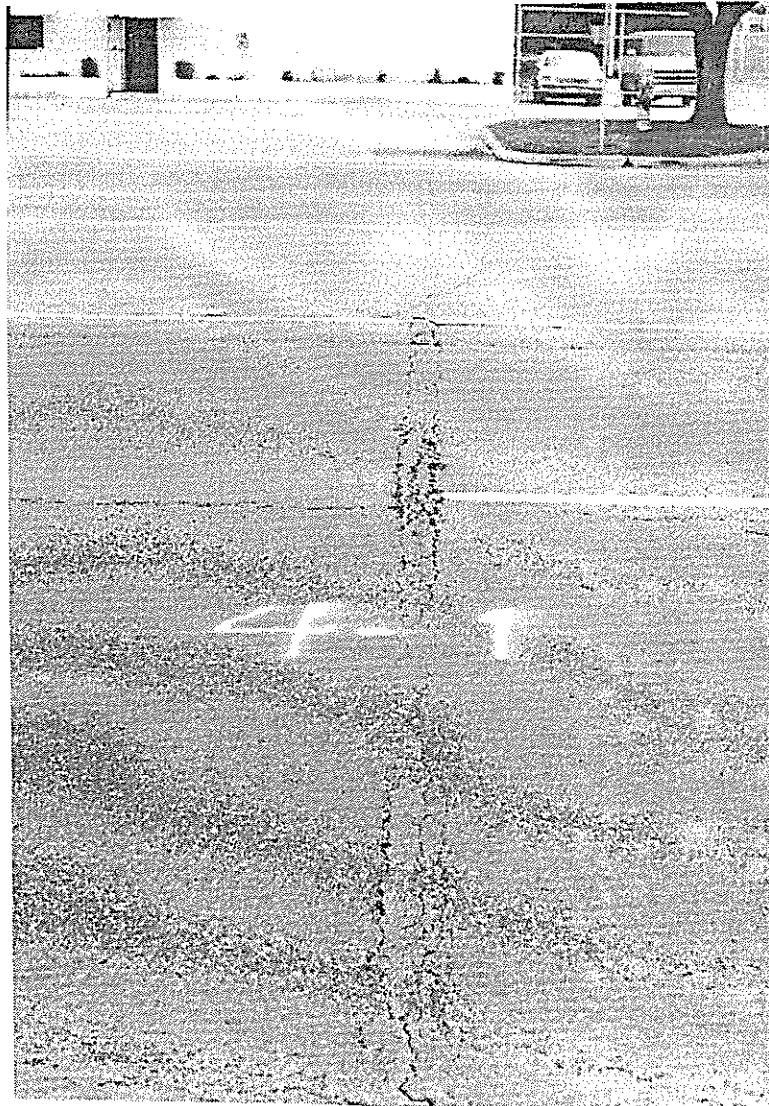
Test section 4. Conventional joint failure (with conventional asphalt cement).

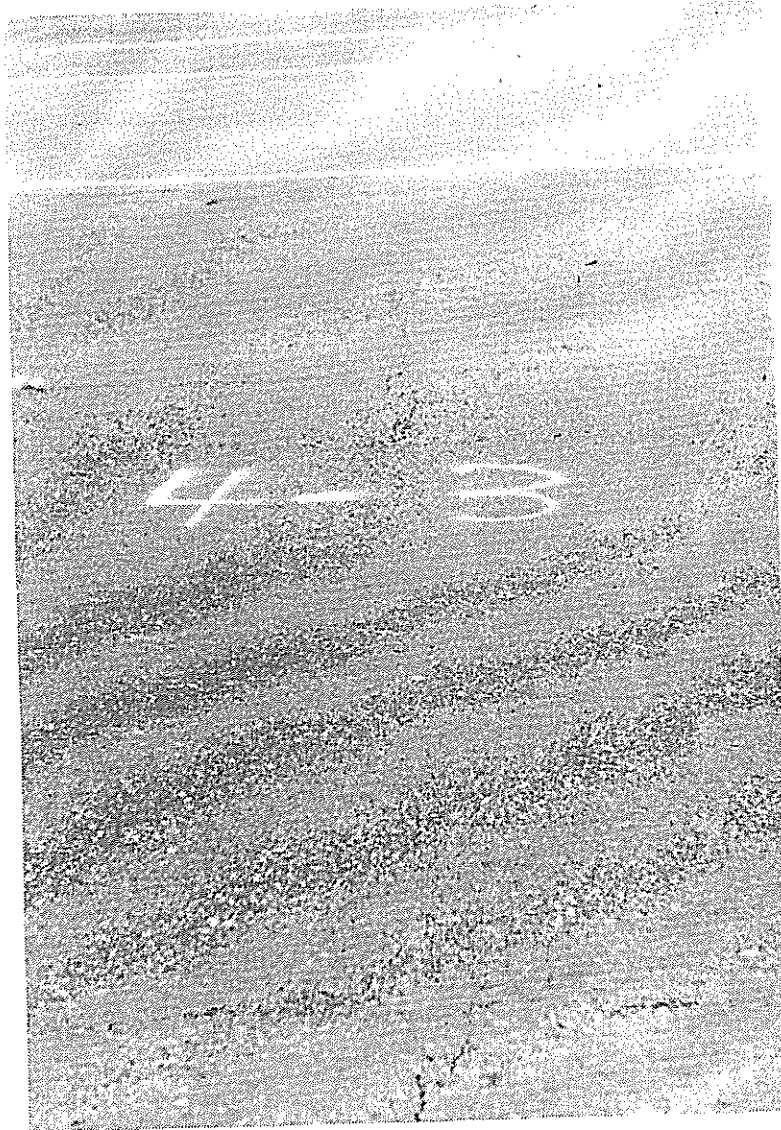
Test section 4. Less distressed conventional joint
(with conventional asphalt cement).

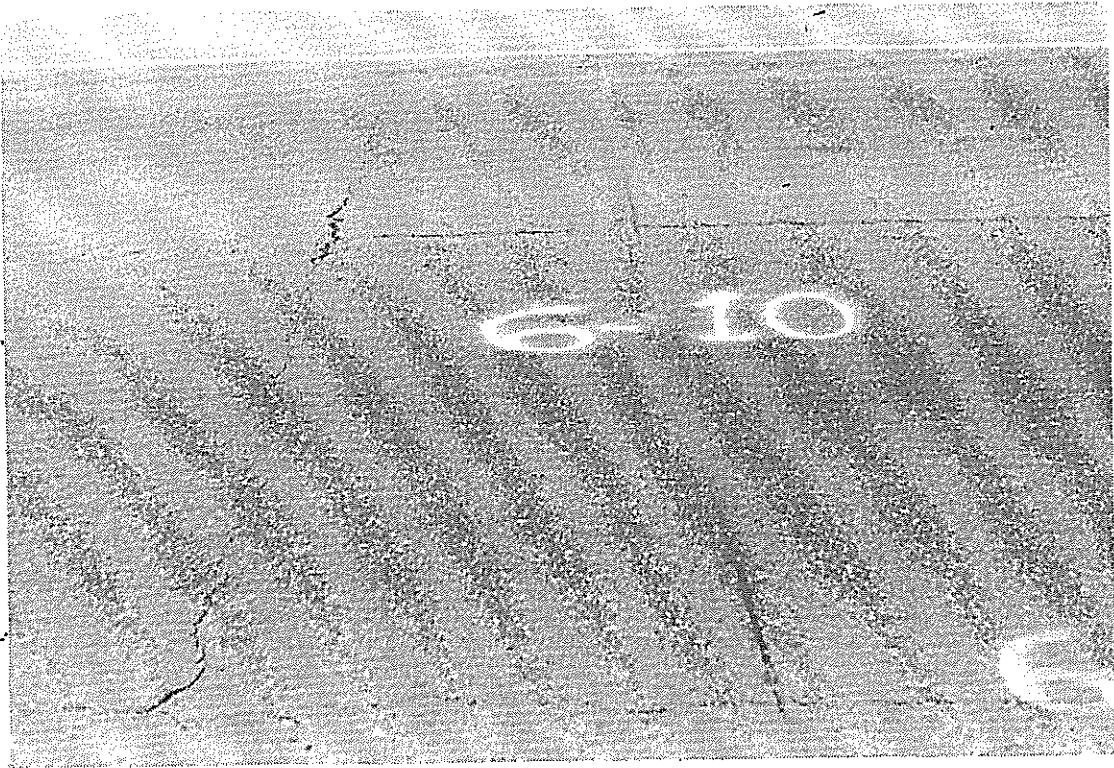
Test section 6. No-distress sawed and sealed joint
(with latex-modified asphalt).

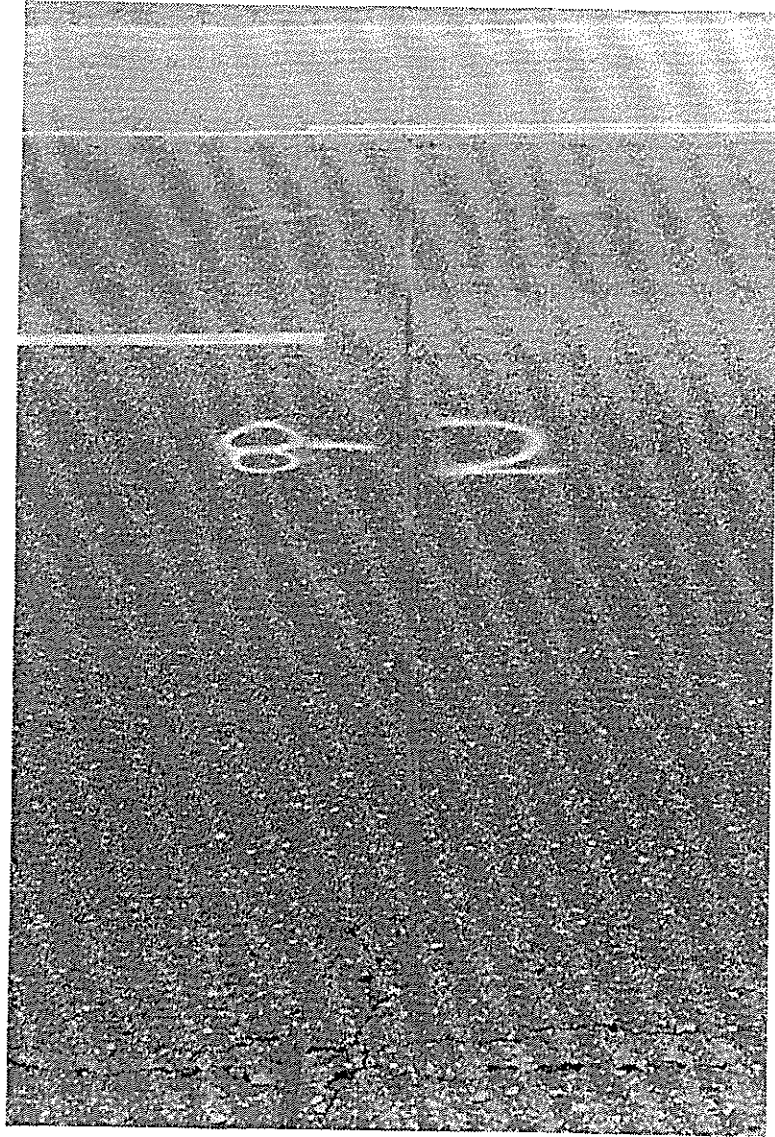
Test section 8. Distressed sawed and sealed joint
(with conventional asphalt cement).
