FEASIBILITY OF APPLYING CATHODIC PROTECTION TO UNDERGROUND CULVERTS

FINAL REPORT

LTRC REPORT NO. 289
LTRC RESEARCH PROJECT NO. 88-4P(B)

January 1995

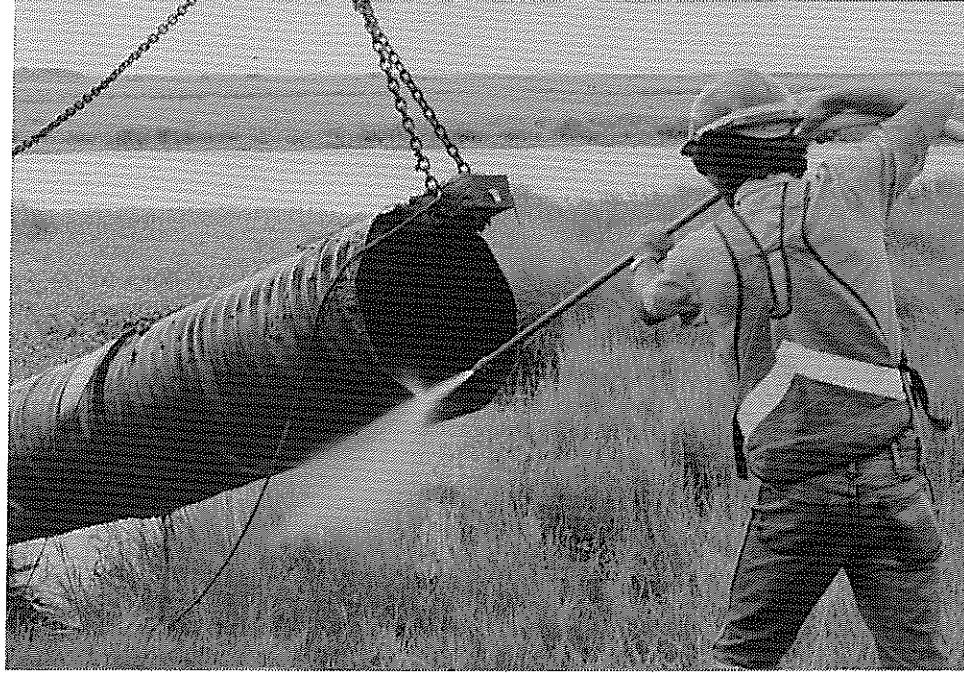
Figure 4. Each culvert is sprayed inside and outside with water.

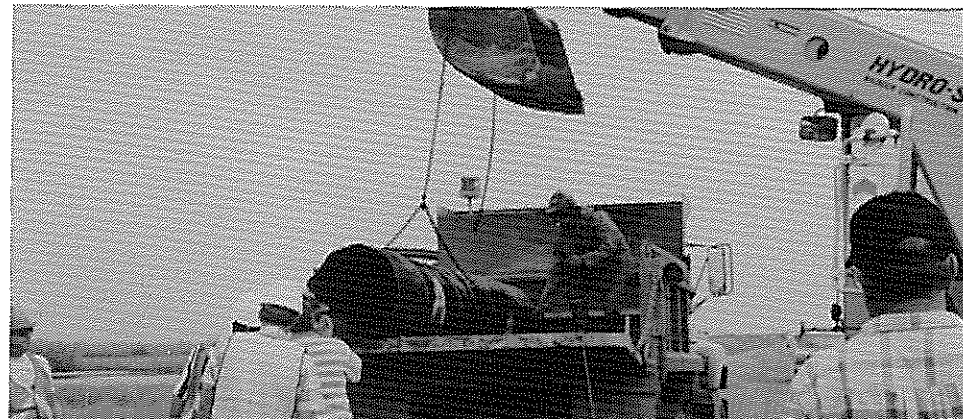
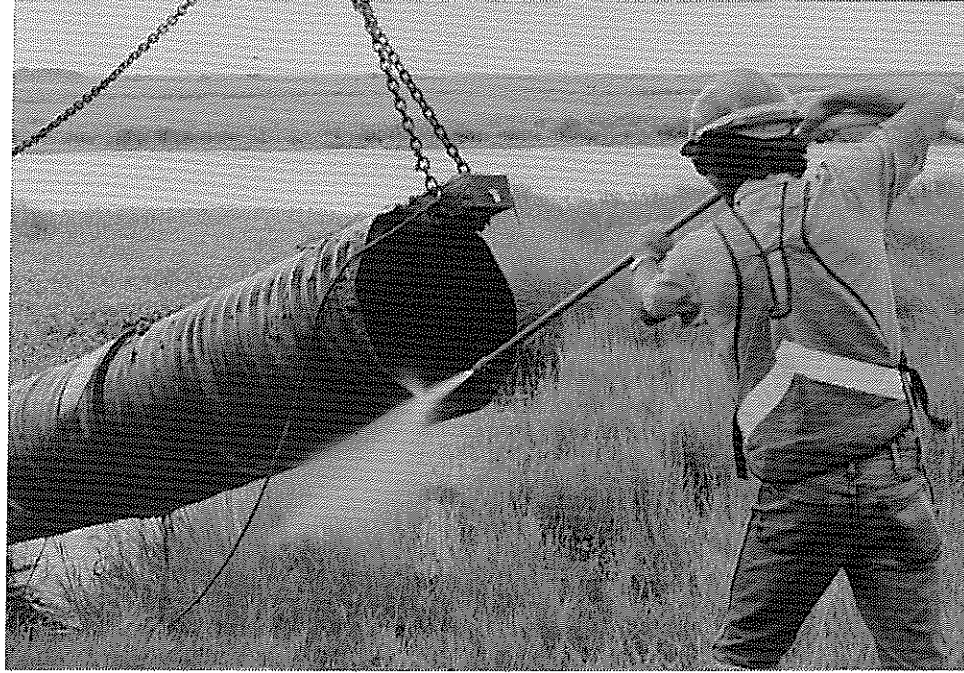
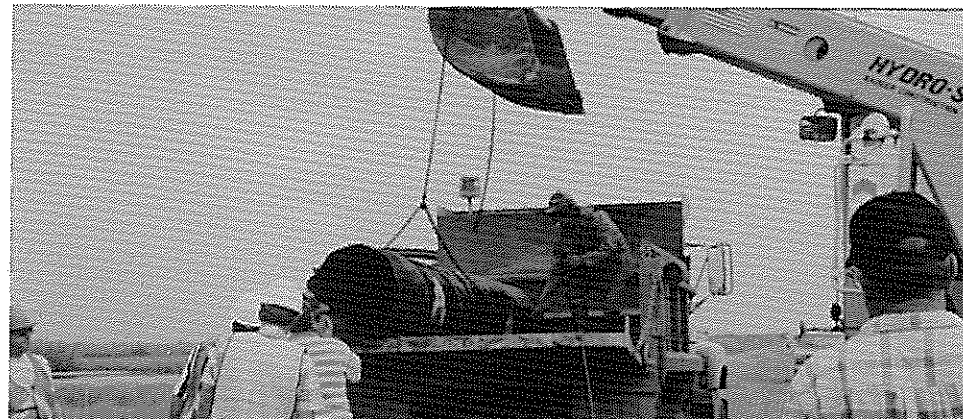
Figure 4. Each culvert is sprayed inside and outside with water.

The removal of the sixteen (16) culverts was accomplished in one day by using equipment and men from Louisiana DOTD. Figure 1 shows the soil being removed from the top of a test culvert. Once the soil on top of the buried culvert was removed a twelve-foot 4" x 6" beam was passed through the culvert. Figure 2 shows the chains attached to both ends of the beam and the culvert being lifted by the excavator (Grade-All). Figure 3 shows the culvert being removed from the ground and that there was a considerable amount of sediment inside this culvert. This sediment was removed by dumping and spraying the inside and outside with water, Figure 4. After wash up was completed, each culvert was visually observed, tagged and then placed on a DOTD truck for transport to the District 03 Headquarters in Lafayette, Figure 5.

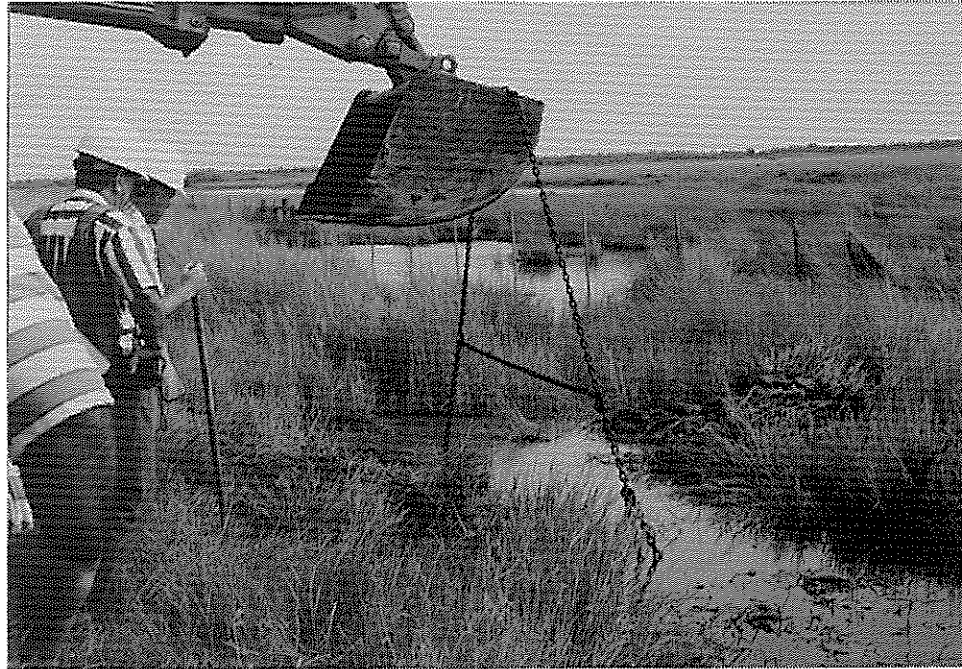
Figure 2. The excavator is seen lifting a culvert.

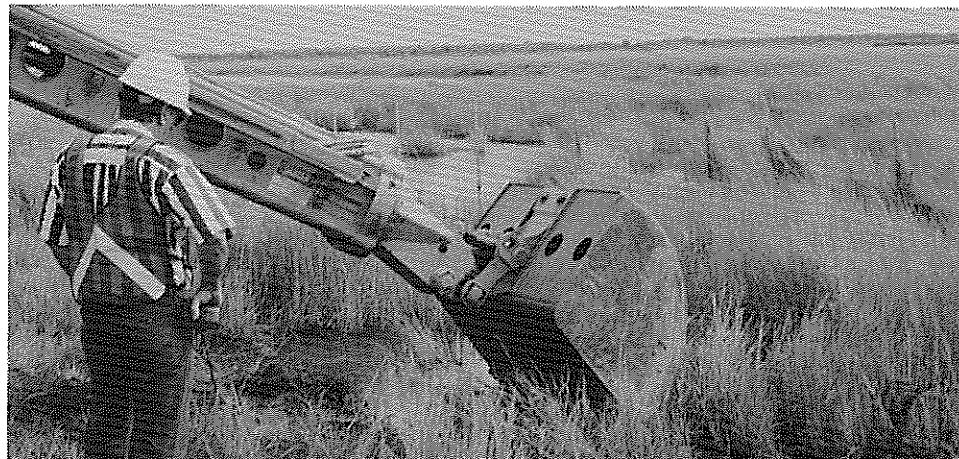
Figure 11. Visual rating of overall culvert condition after completion of field study.

TABLE 11
OVERALL VISUAL RATING

Type Culvert	Unprotected	Protected	Difference
Polymeric Coated Cold-Rolled Steel	2.4	2.4	0
Polymeric Coated Aluminized Type II Steel	3.8	2.0	1.8
Polymeric Coated Aluminized Type I Steel	3.4	2.0	1.4
Polymeric Coated Galvanized Steel (Supplier 2)	2.1	1.8	0.3
Polymeric Coated Galvanized Steel (Supplier 1)	2.1	1.9	0.2
Bituminous Coated Galvanized Steel	3.2	2.8	0.4
Galvanized Steel	3.6	2.8	0.8
Fiber-Bonded Bituminous Coated Galvanized Steel	2.7	2.2	0.5
Average	2.9	2.2	0.7
