# **Assessment of the Urettek Process on Continuously Reinforced Concrete Pavement, Jointed Concrete Pavement, and Bridge Approach Slabs**

Technical Assistance Report Number 03-2TA

LTRC Project No. 05-1TA  
State Project No. 736-99-1282

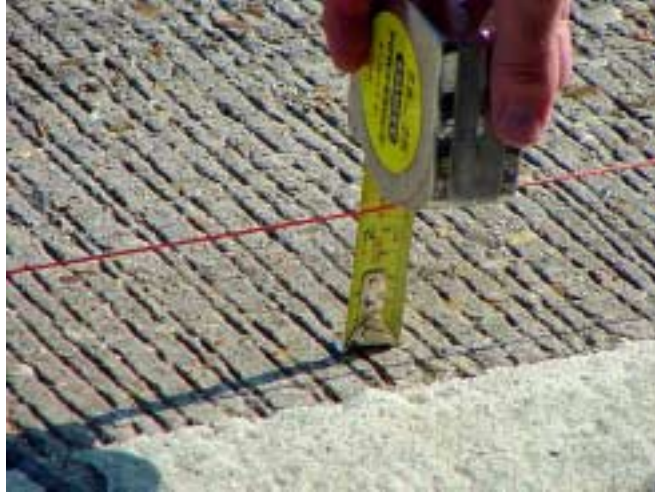
**Figure 1**  
**CRCP Depression**

The CRCP evaluated was located at mile post 193.4, I-10, West bound in St. James parish. The embankment for this section of I-10 was constructed over an area with poor subgrade conditions using hydraulic sand fill. The pavement is approximately 35 years old, and its structure consists of 8 inches of CRCP, 5 inches of asphaltic concrete base course, and 12 inches of sand-shell base course. Pavement depressions have been observed over the years on this section of I-10, many of which are located at cross drain pipes. Embankment settlement and poor compaction around the cross drain pipes are believed to cause these depressions.

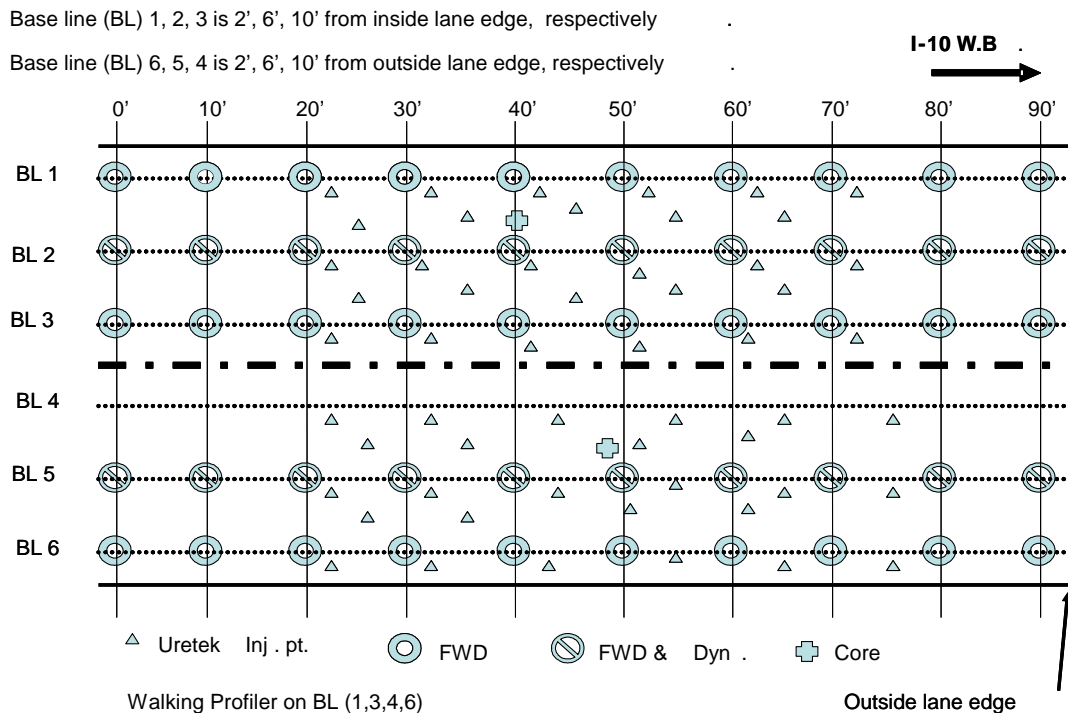
**Figure 2**  
**CRCP testing layout**

The location selected for this study had a measured pavement depression of 2.3 inches at the pavement edge and did not show signs of failure. Polyurethane injection area boundaries were located by holding a string line along the edge of the pavement. The locations where the pavement was visibly vertically departing from the string line were marked, as shown figure 1. Testing began approximately 10 feet before and after the depression. For details of all baselines, equipment testing, concrete coring, and Uretek injection locations, see figure 2.

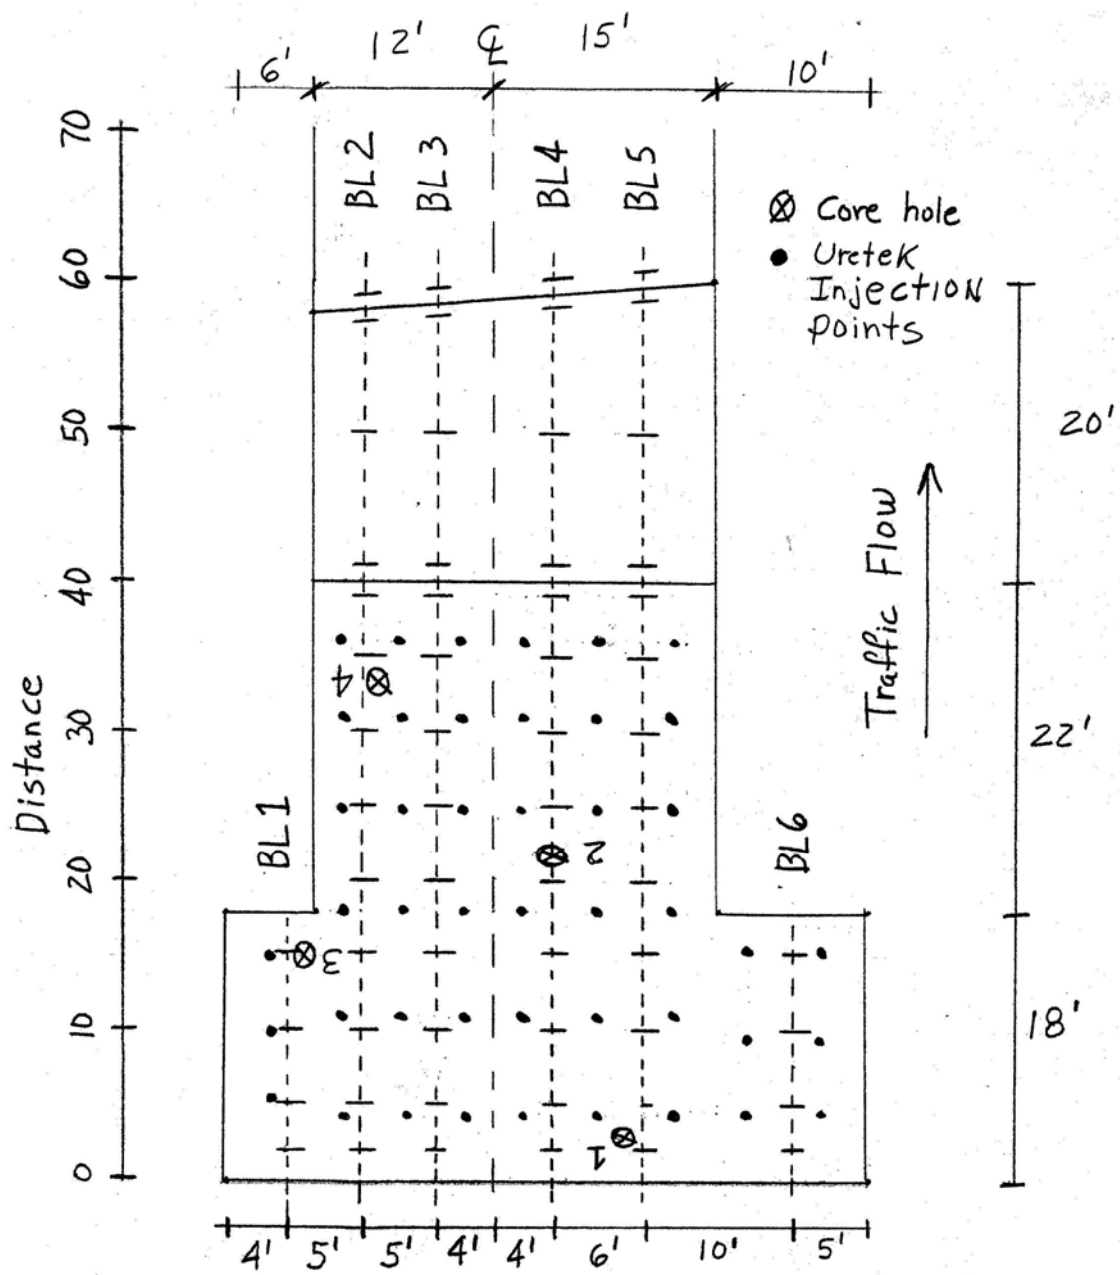
Figure 3  
Testing layout for US 167 NB approach slab

These approach slabs have experienced settlement that caused pavement depressions. Depressions in concrete approach slabs are common in Louisiana. They have been mitigated by overlaying with asphaltic concrete, mud jacking, reconstruction, and polyurethane injection. District 03 asked LTRC to evaluate the polyurethane injection process and determine its effectiveness. The approach slabs and adjacent pavement are approximately 21 years old. The existing roadway typical section is 10-inch thick concrete pavement, 2-inch thick asphaltic concrete base course, and 6-inch thick treated soil. The existing bridge approach slabs had typical sections that consisted of 10-inch thick concrete pavement, 12-inch thick stone, and 6-inch thick treated soil. Figures 3 and 4 present the testing layout.

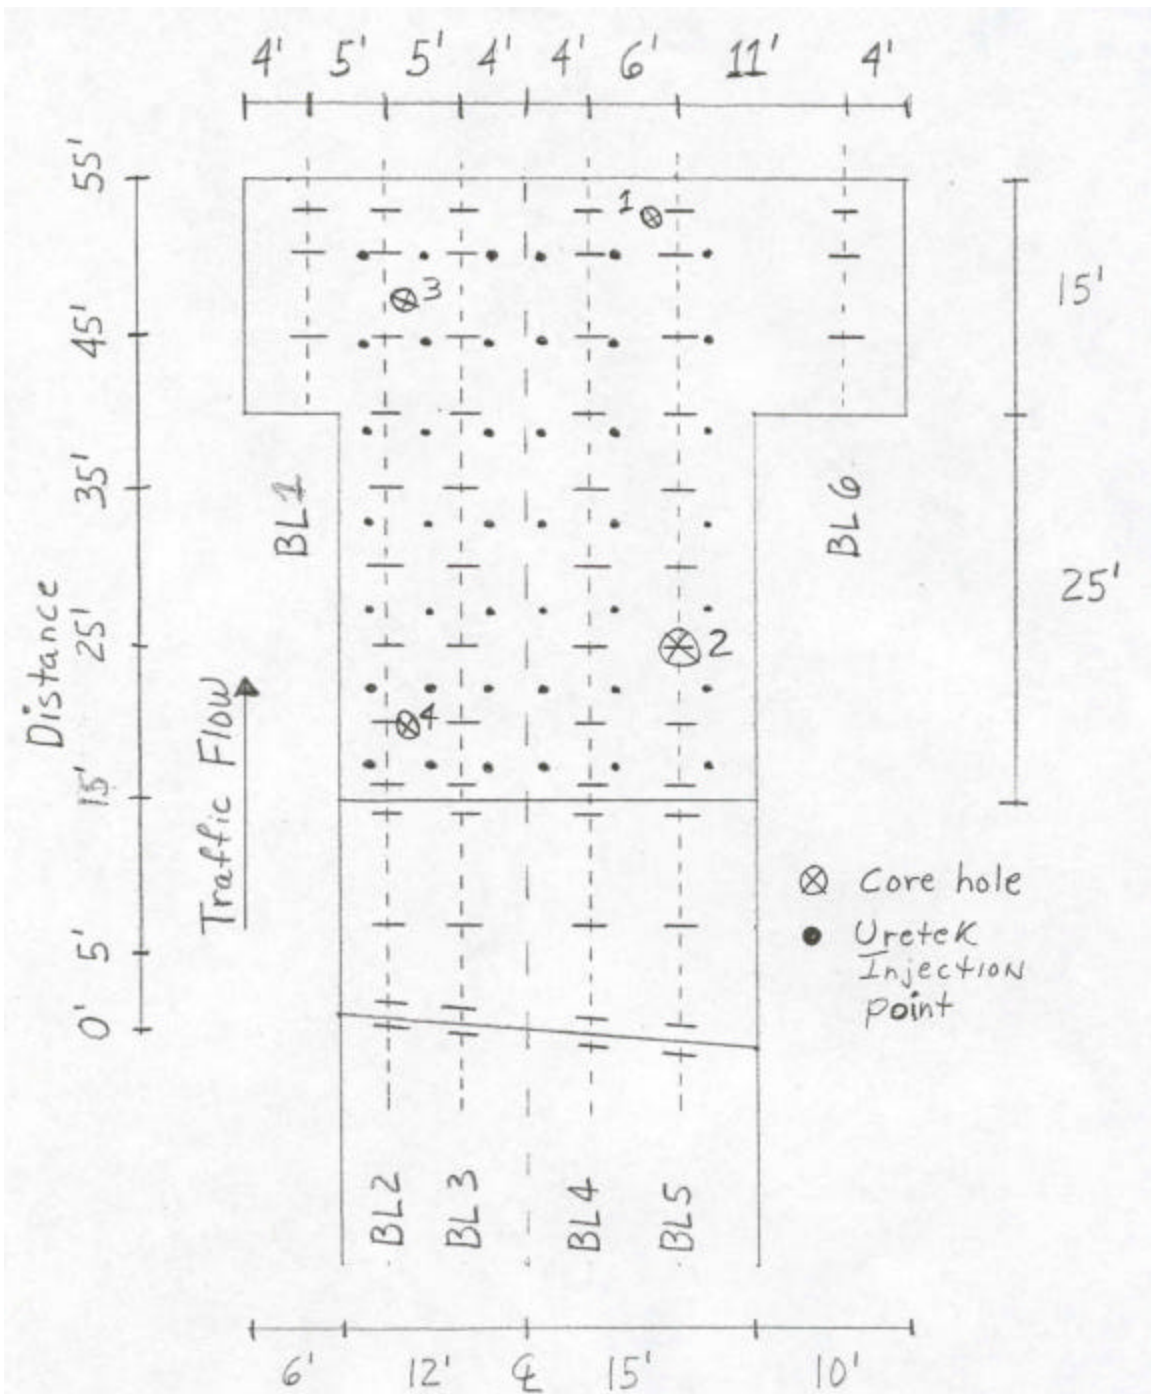
**Figure 4**  
**Testing layout for Bayou Duplente approach slab**

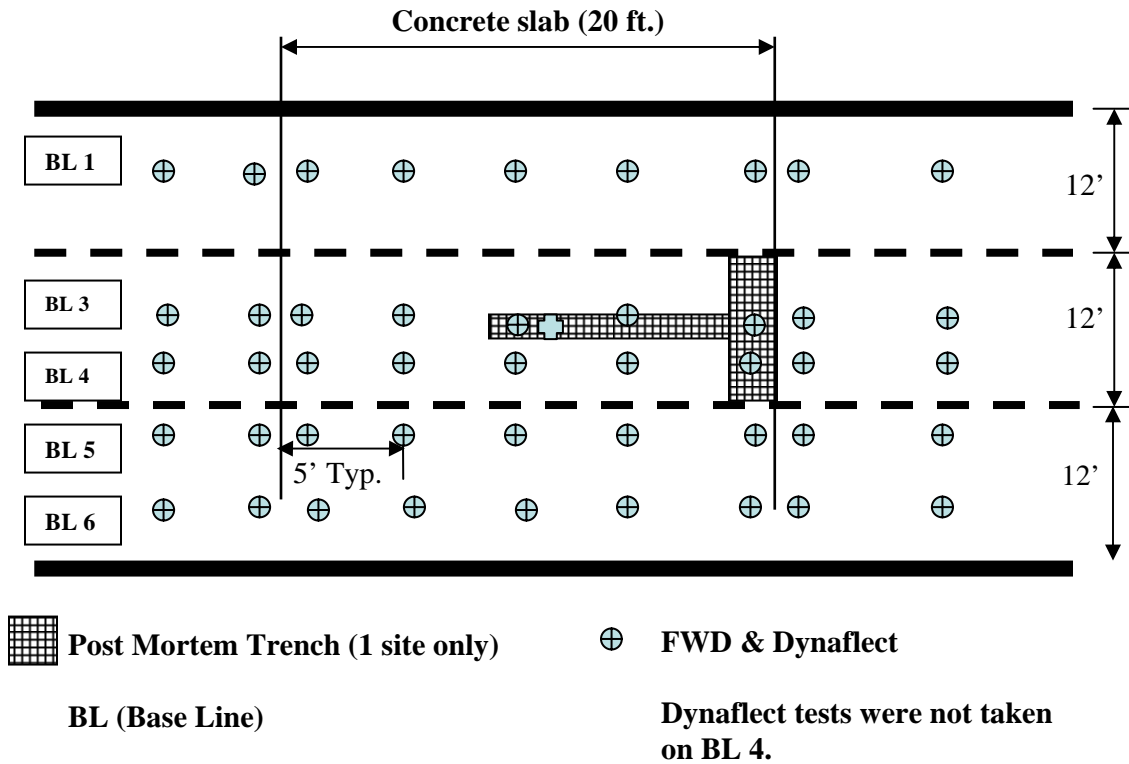
**Figure 5**

**Typical diagram for trenching and testing**

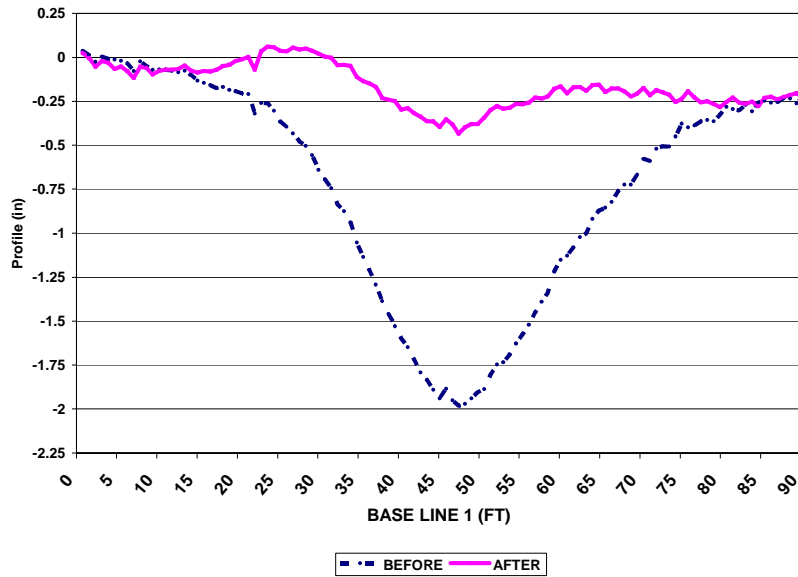
**Figure 6**  
Walking Profiler base line 1

Figure 6 illustrates the profile and table 2 illustrates the IRI values before and after the polyurethane injection. The remaining walking profiler figures can be found in Appendix 3. Based on the point of maximum depression, the pavement was raised 2.019 inches on average. IRI was significantly reduced from 57 to 68 percent.

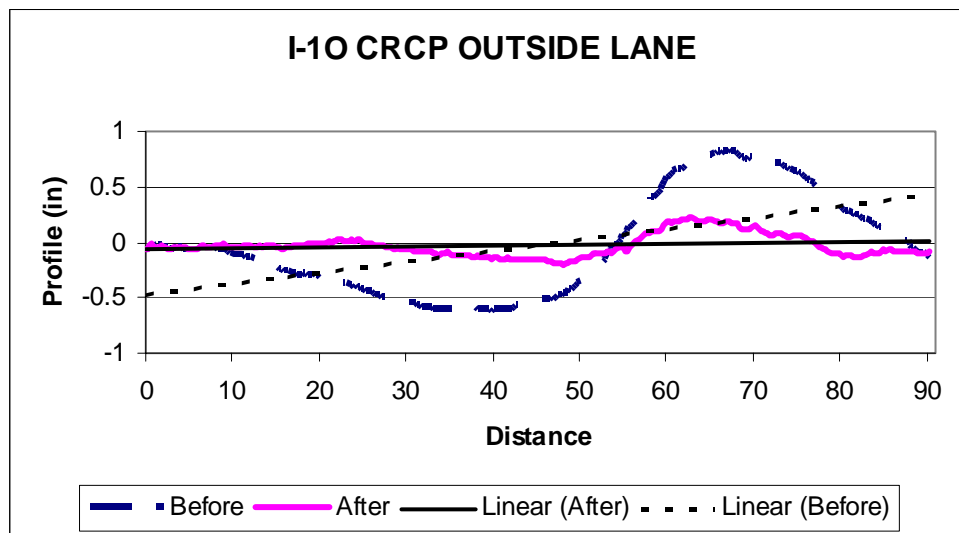
**Figure 7**  
**I-10 CRCP profile (outside lane)**

Table 2 illustrates the IRI values before and after the polyurethane injection. IRI values were significantly reduced from 37 to 57 percent. Figures 7 and 8 illustrate the profiles before and after polyurethane injection. Linear regressions were taken through both profiles. Lesser slopes on the linear regression line indicate a smoother profile. It should be noted that the polyurethane injection process significantly lessened the slope, indicating an improvement.

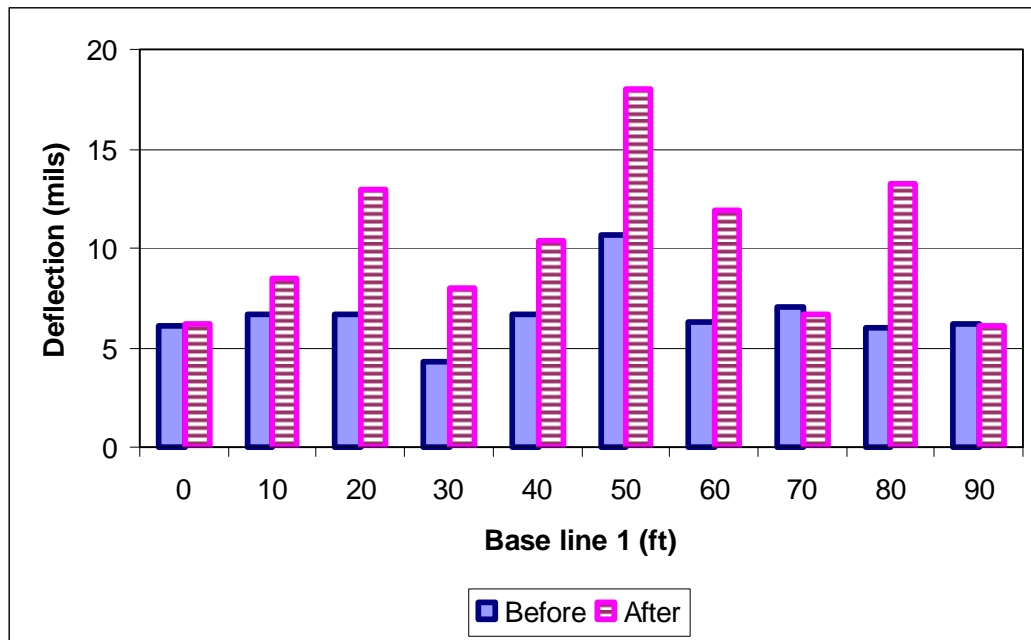
**Figure 10**

**FWD first sensor deflections (14,500 lb load)**

Figure 10 illustrates the deflections at the load plate (first sensor). The remaining figures can be found in Appendix 3. These deflections are based on a load of approximately 14,500 pounds. There is a trend towards higher deflections after the slabs were injected with polyurethane.

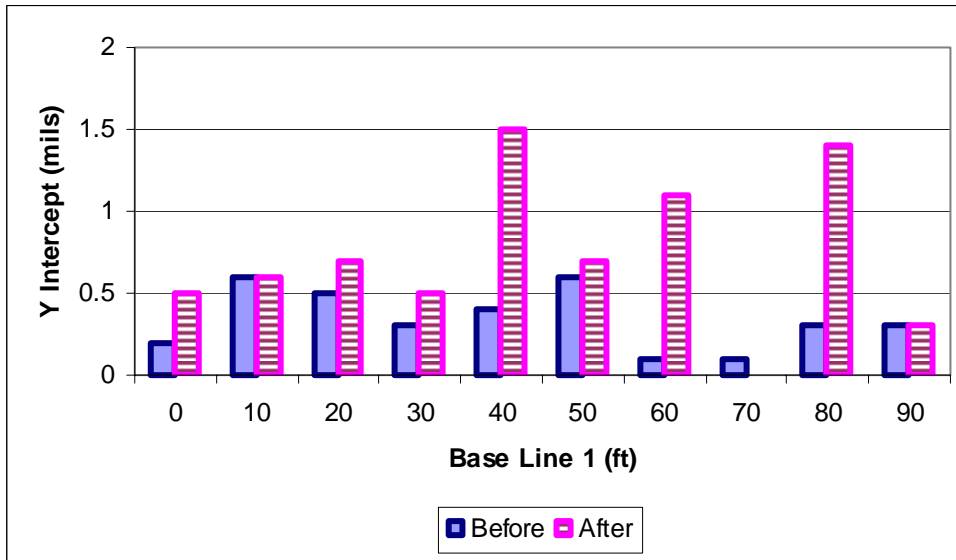
**Figure 11**  
**FWD void potential for base line 1**

Figure 11 illustrates the Y intercepts. The remaining figures can be found in Appendix 3. There was a trend towards higher Y intercepts after the slab was injected with polyurethane.

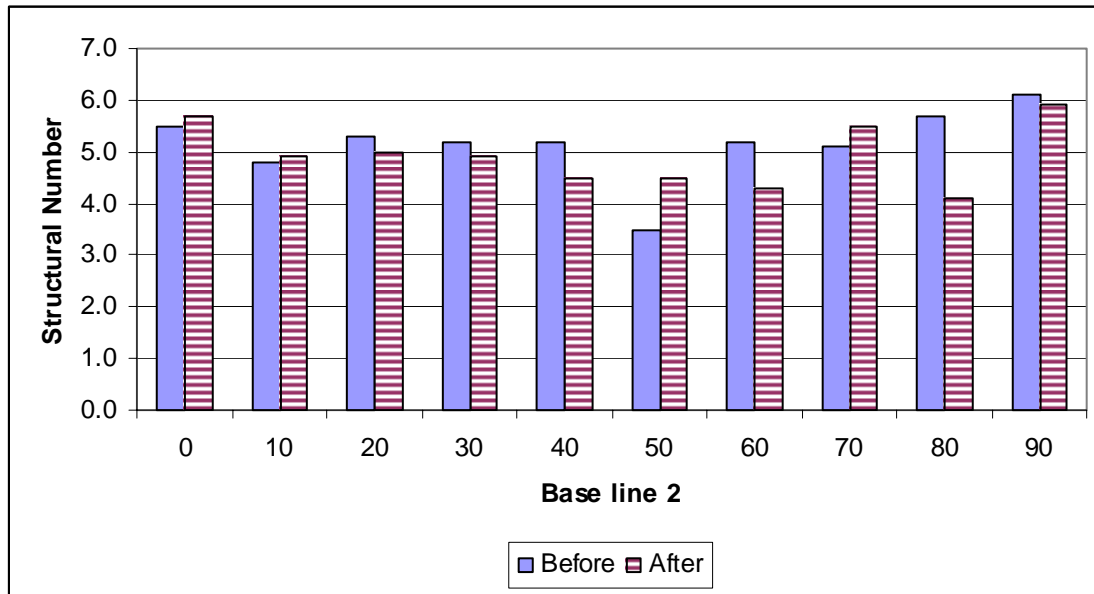
**Figure 12**

**Dynaflect readings base line 2**

The results indicated that the polyurethane injection did not adversely impact the structural number of the pavement.

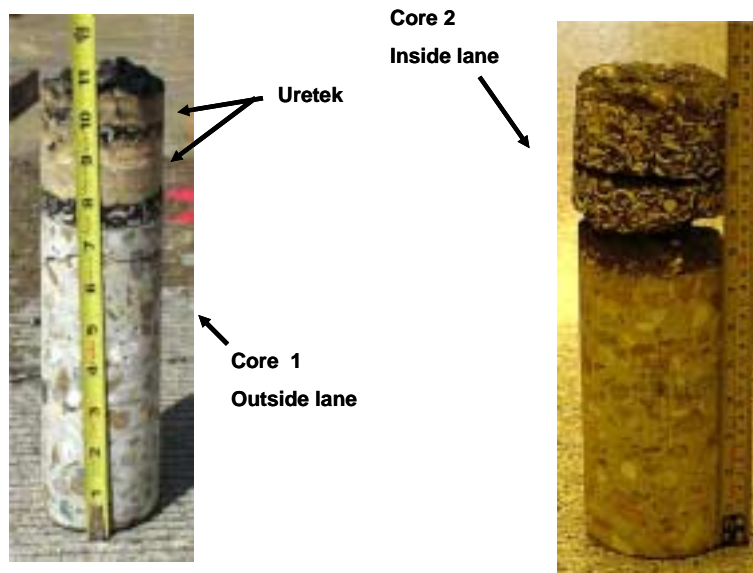
**Figure 14**  
**Concrete cores**

Concrete cores were taken at the locations listed in table 3. The concrete pavement in core number 1 taken from the outside lane broke as it was being removed from the hole. The asphaltic concrete base course was permeated with polyurethane, as shown in figure 14. It is speculated that the asphaltic concrete in this area was stripped and weak which allowed the polyurethane to infiltrate it. The polyurethane specimens were so dense that a ball point pen could not be pushed into the specimen. Since the core hole was filled with water, the sand-shell base course could not be observed. The concrete pavement in core number 2, which was taken from the inside lane, was intact, but the asphaltic concrete base course in the core broke when it was removed from the core hole. The asphaltic concrete base course did not show any signs of being infiltrated as did core number 1. The sand shell base course was clearly visible and no signs of polyurethane foam could be seen, as shown in figure 15. Based upon visual inspection, it is unknown if a void was created by the polyurethane injection process. However, data from FWD tests did indicate a slightly higher intercept (0.5) after injection. Y intercepts less than 2.0 indicated that no voids were present.

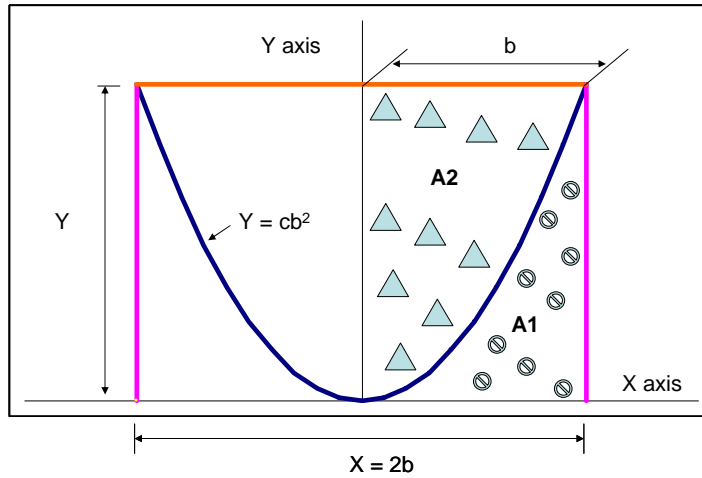
**Figure 16**

**Parabolic equation diagram**

As previously mentioned, the volume can be determined by several methods. In order to simplify the process as much as possible, the profile was simulated with a parabolic curve ( $y = ax^2$ ) and straight lines. Since the area of the sections previously mentioned were known and represented true field conditions, they were used as a bench mark to evaluate the equations.

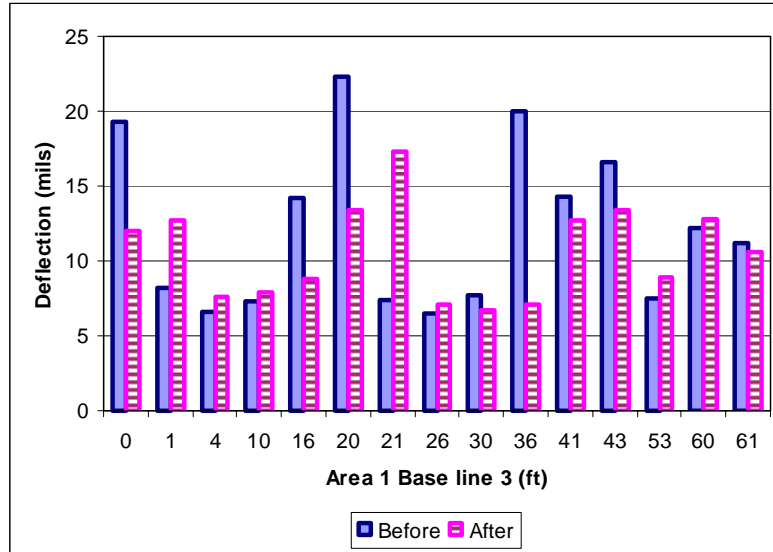
**Figure 19**

**FWD first sensor deflections Area 1 Base line 3**

Figure 19 illustrates the first sensor deflections. The remaining figures and tables can be found in Appendix 1. The deflection analysis that follows is based upon a review of all data points (joints, intermediate, and center) for the areas and base lines listed.

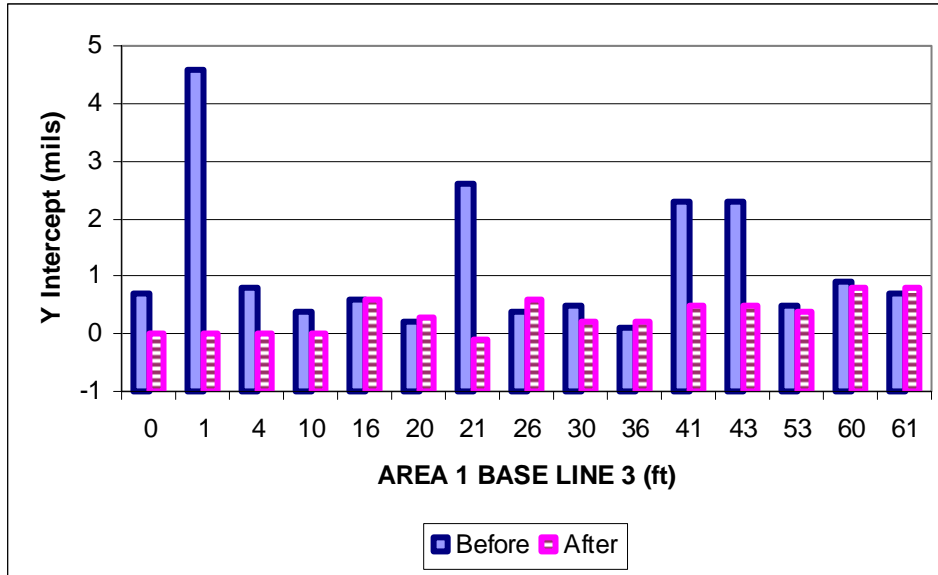
**Figure 21**  
**FWD void potential Area 1 Base line 3**

Figure 21 illustrates the Y intercepts. The remaining figures and tables can be found in Appendix 1. The void analysis that follows is based upon a review of all data points (joints, intermediate, and center) for the areas and base lines listed.

**Area 1 (Center and intermediate points):** The average Y intercepts before and after polyurethane injection were 0.5 and 0.4, respectively.

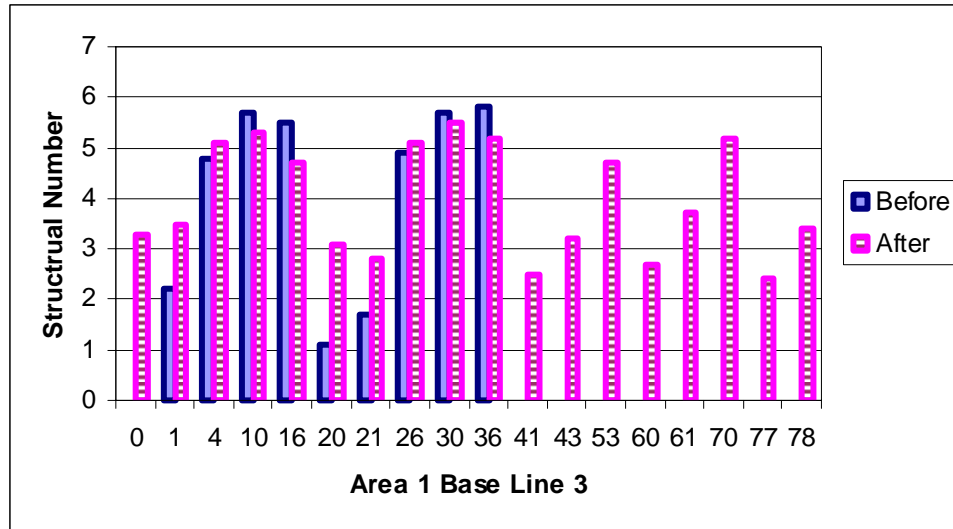
**Figure 25**  
**Dynalect Area 1 Base line 3**

Figure 25 illustrates the first sensor deflections. The remaining figures and tables can be found in Appendix 1.

**Area 1 (Base lines 3 & 5):** The average SN values before and after polyurethane injection were both 3.6.

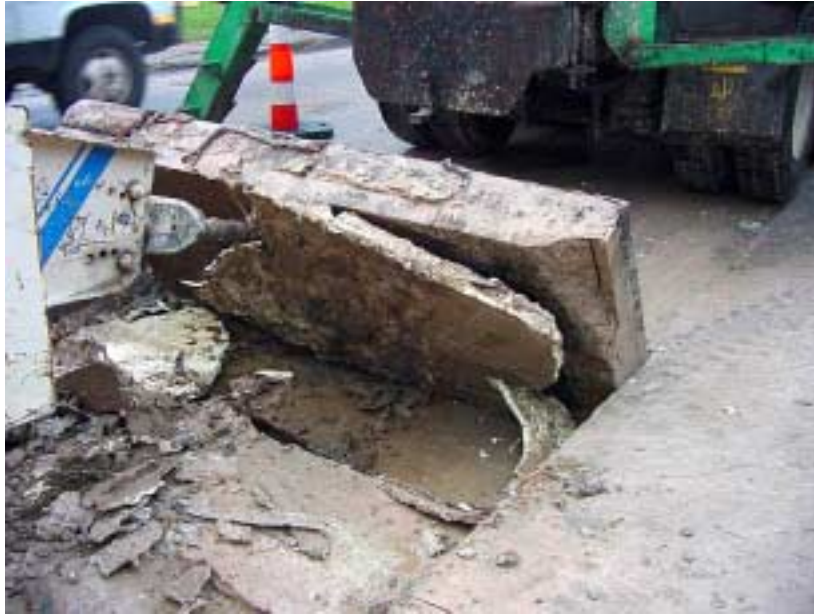
**Figure 26**  
**Polyurethane in trenched area (Area 3 Slab 74)**

- Layers of varying stiffness were observed in the polyurethane sample acquired near the joint. The density of the polyurethane appears to be depend upon the confining pressure. The contractor's normal procedure is to inject a small quantity, wait for it to set up, and then inject again. This procedure is followed until the desired outcome is obtained. These layers could be observed in the sample. Having different densities in the polyurethane can be problematic, as shown in Figure 27. It should be noted that the injection process took place when the voids were filled with water present. Because the effect that this has on density is unknown, it should be researched further.

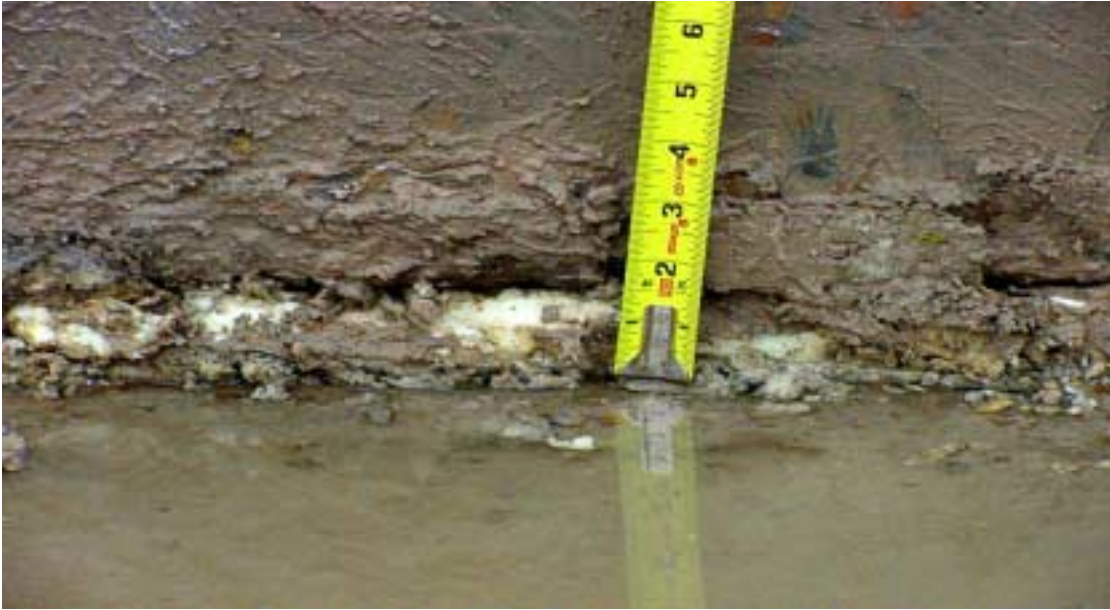
Figure 28  
Polyurethane between slab and base course

- When the adjacent left lane slab, 73, which had been injected with Uretek the previous year, was observed, the polyurethane between the base course and slab was clearly visible, as shown in figure 28. Even though polyurethane was present, water could be seen trickling out from the layer between the polyurethane and soil cement base course, as shown in figure 29. The joint at panel 73 could be seen deflecting under traffic loads. Whether the source of the pavement deflections was from the polyurethane, base course, subgrade, or a combination of the layers is unknown and warrants further investigation. The rainfall data for that month is shown in table 5, and 2.34 inches of rain fell the day previous to these observations.

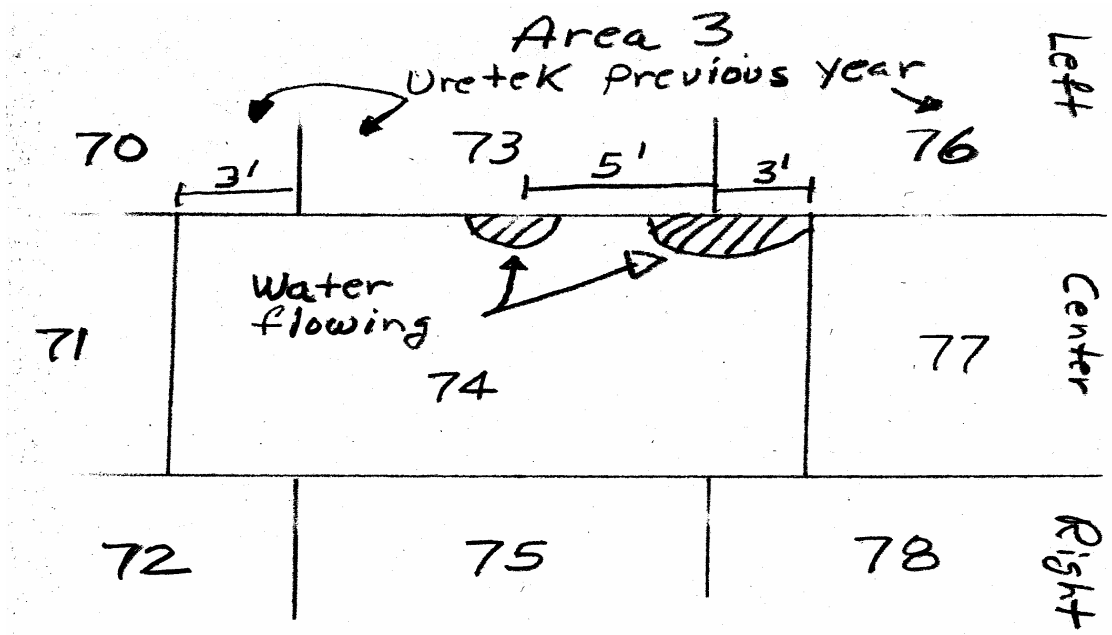
Figure 29  
Area 3 pumping locations

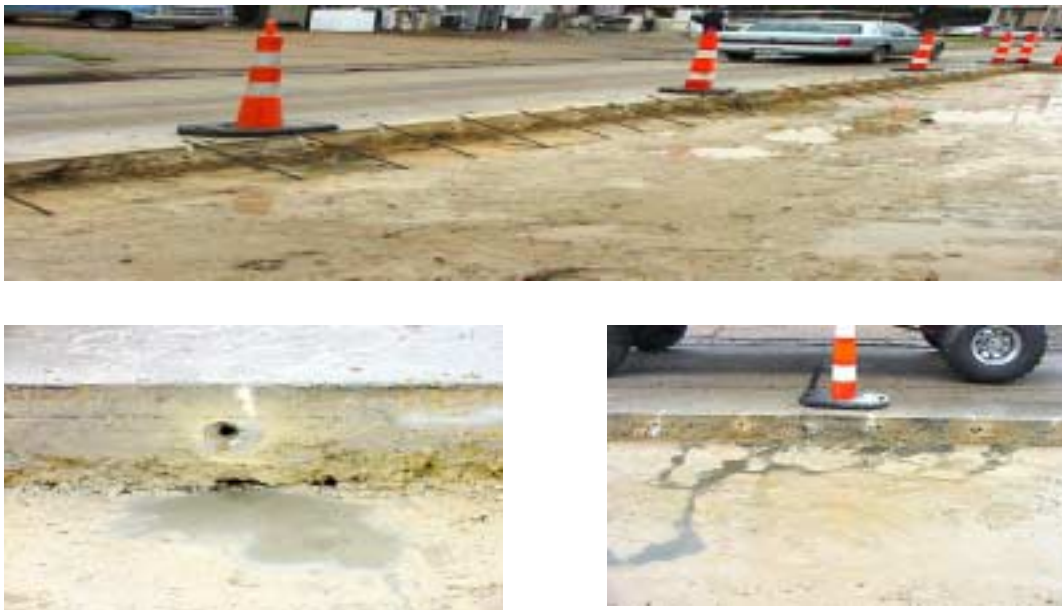
**Figure 30**  
**Pumping locations (Area 2)**

**Area 2:** Because of patching in the center lane, left lane slabs 61, 64, and 67, which were injected the previous year could be observed and are shown in figures 30 and 31. As traffic moved across the slabs, the joints were observed deflecting, which indicates poor load transfer. As time progressed, water was observed pumping through the joints and flowing onto the subgrade. Similar to slab 73 (Area 3), previously injected polyurethane was observed at these locations. Whether the source(s) of the pavement deflections was from the polyurethane, base course, subgrade, or a combination of the layers is unknown and warrants further investigation.

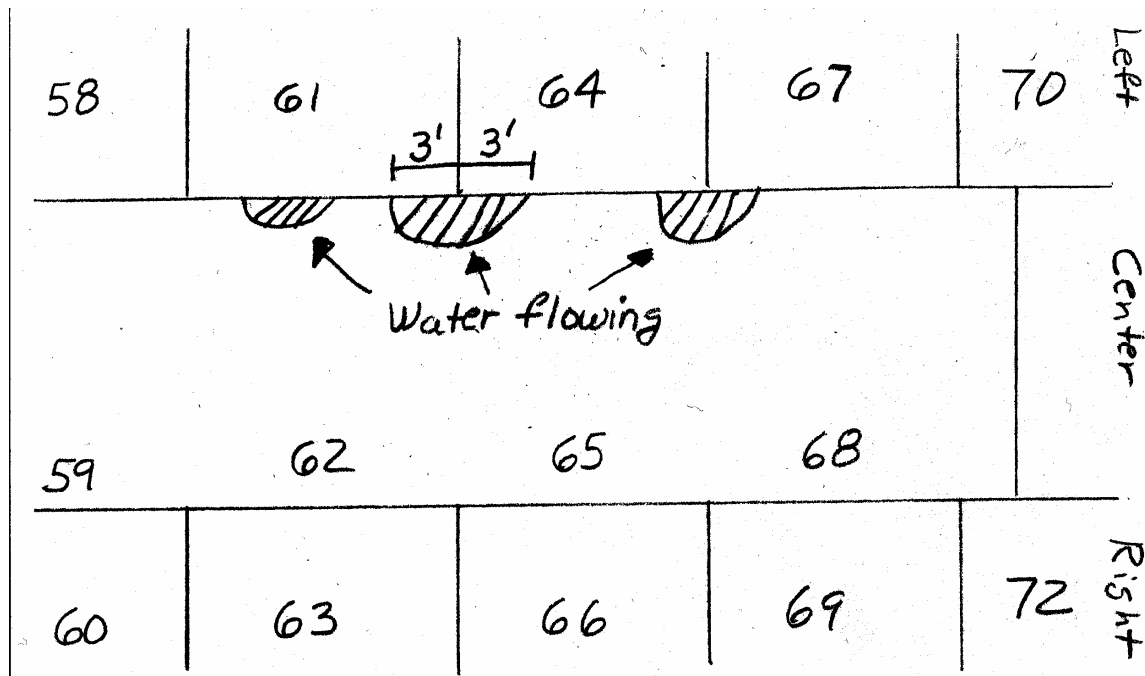
Figure 31

Sketch of area 2 pumping locations

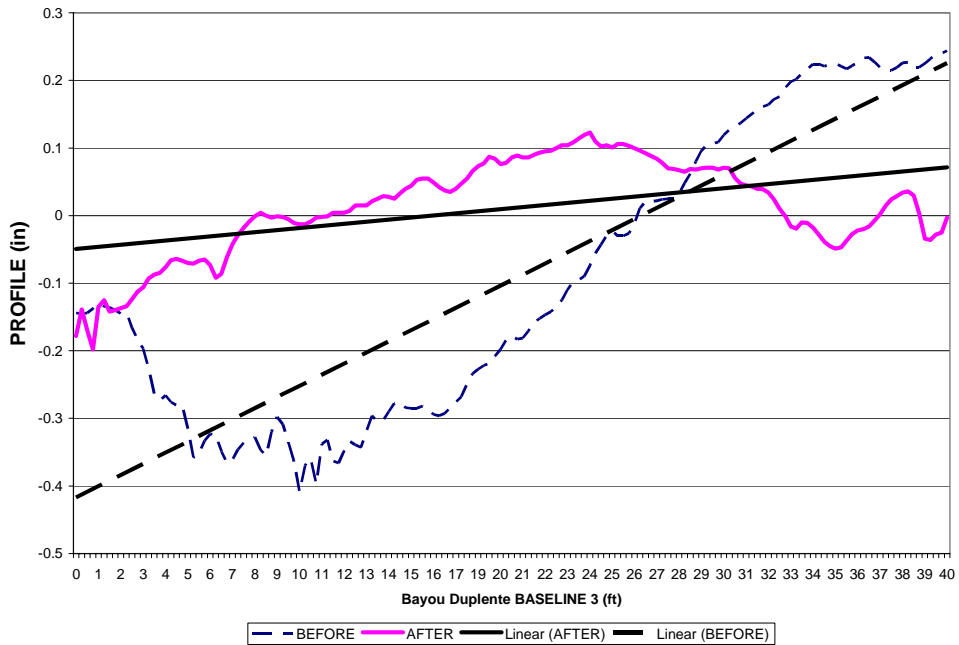
**Figure 35**  
**High speed profile for Bayou Duplente SB base line 3**

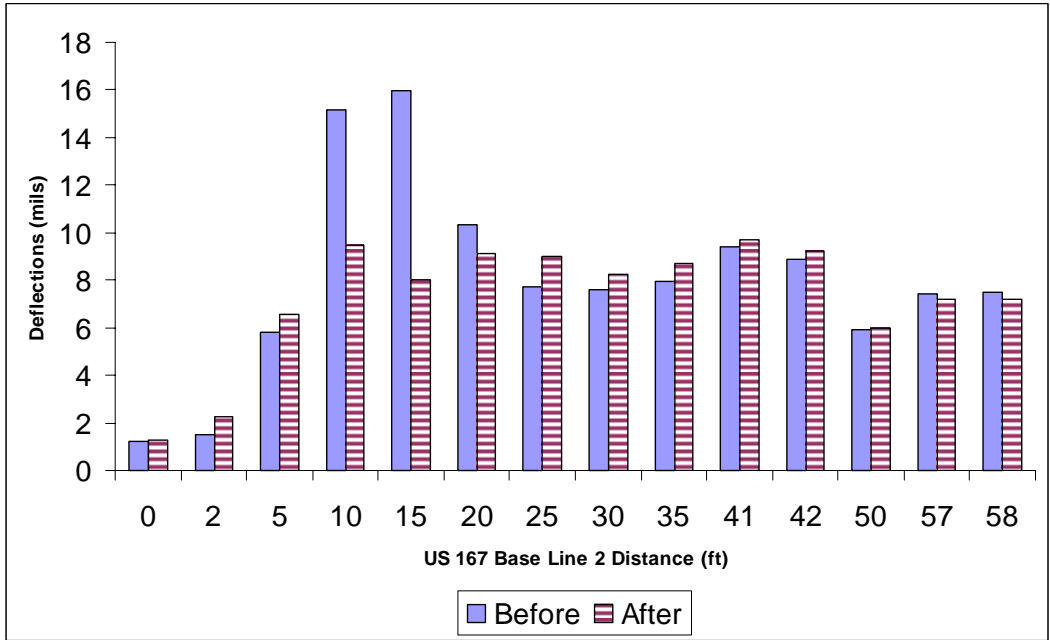
**Figure 36**

**FWD first sensor deflections US 167 NB base line 2**

Figure 36 illustrates the deflections at the load plate (first sensor). The remaining figures can be found in Appendix 4. These deflections are based on a load of approximately 16,000 pounds. The deflections were generally maintained or lowered as a result of injecting with polyurethane.

The deflections from the tests taken within the first five feet from the bridge end may be not be useful for this study. The deflections at these locations are less than 50 percent of the readings taken at 10 feet from the bridge end. The deflections are believed to be less since the steel-reinforced approach slab is anchored to a pile-supported abutment.

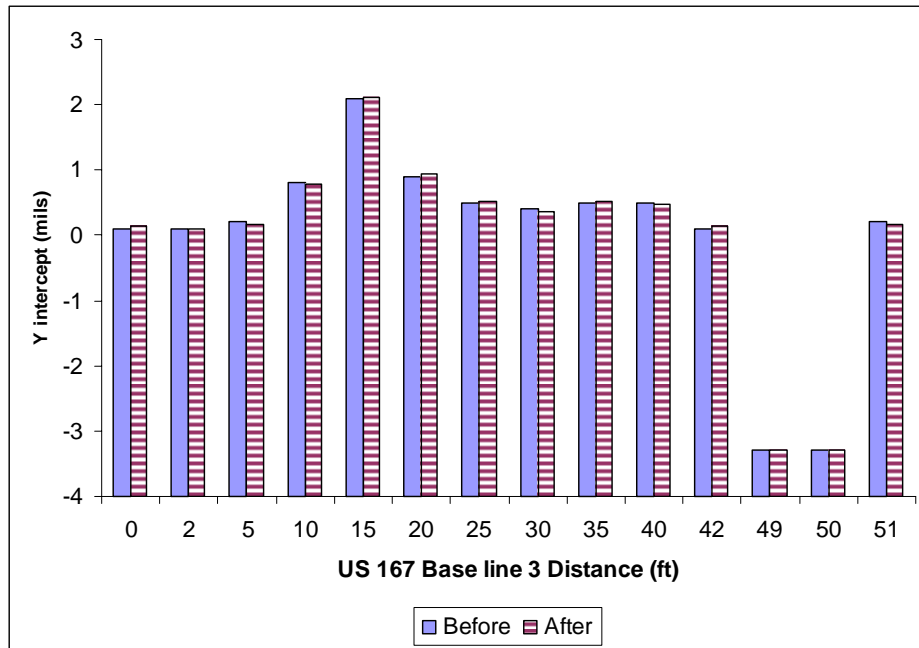
**Figure 37**

**FWD void potential for US 167 NB base line 3**

Figure 37 illustrates the Y intercepts. For further details about the cores, refer to section on core samples. It should be noted that polyurethane found in the core samples was dense throughout the specimen. The Y intercepts were generally maintained after injection with polyurethane. Out of 50 test points, 8 had Y intercept values near or exceeding 2.0 prior to injection. After injection, 4 out of the 50 test points had Y intercept values exceeding 2.0.

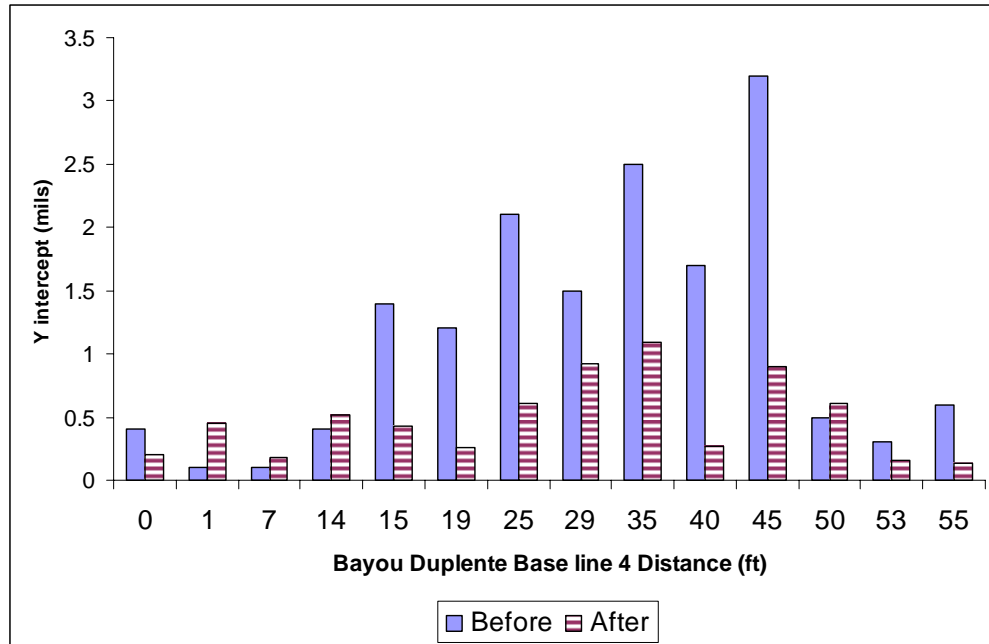
**Figure 38**

**FWD void potential for Bayou Duplente base line 4**

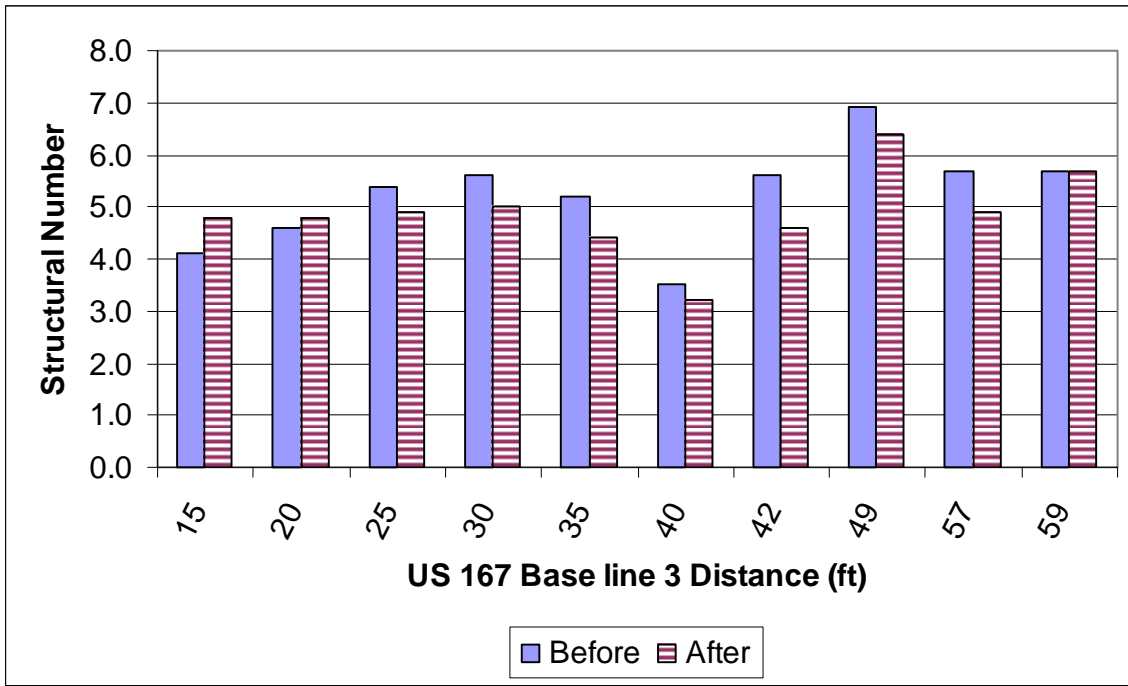
**Figure 39**

**Dynalect results for US 167 Base line 3**

The Dynalect readings showed that there was basically no change in the Structural number of the pavement before and after injection with polyurethane. The values could not be computed on some base lines because the Dynalect was not able to induce enough load to adequately deflect the pavement. Figure 39 illustrates the results. The remaining figures may be found in Appendix 4.

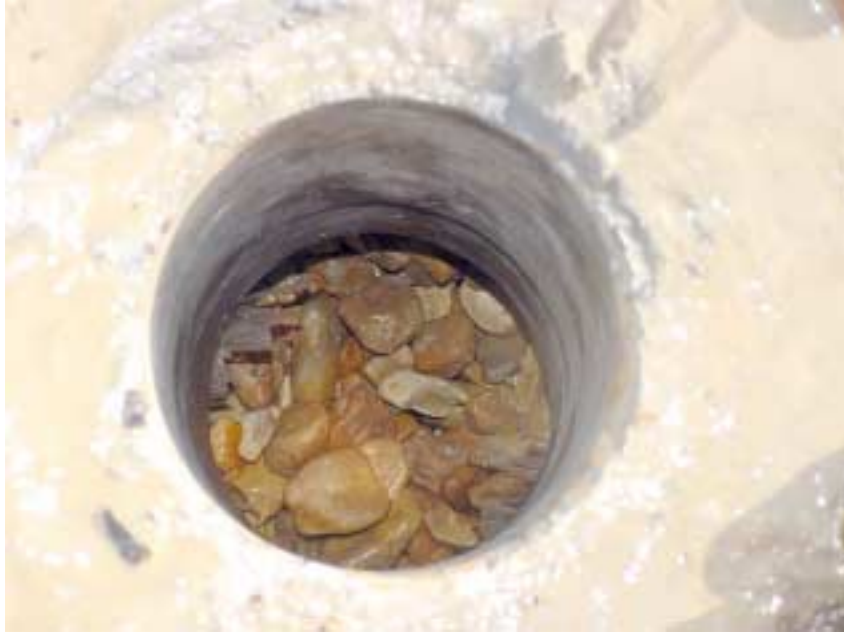
**Figure 40**  
**Concrete core hole (US 167 NB, Core N1)**

Concrete cores were taken. Table 7 presents the results, and figures 40 to 42 illustrate the cores in which polyurethane specimens were found.

Polyurethane was found at three out of the eight core locations. The polyurethane specimens were so dense that a ball point pen could not be pushed into the specimen. Though polyurethane was injected into the base course and subgrade on an approximately 4 x 4 feet grid pattern, it was found at only three locations. Perhaps the polyurethane is deeper than the core depths or it did not spread out to the locations cored. At core N1 (US 167 NB), a 5-inch void was found. Core N1 is located about 2.5 feet from the bridge end and about 2 feet from

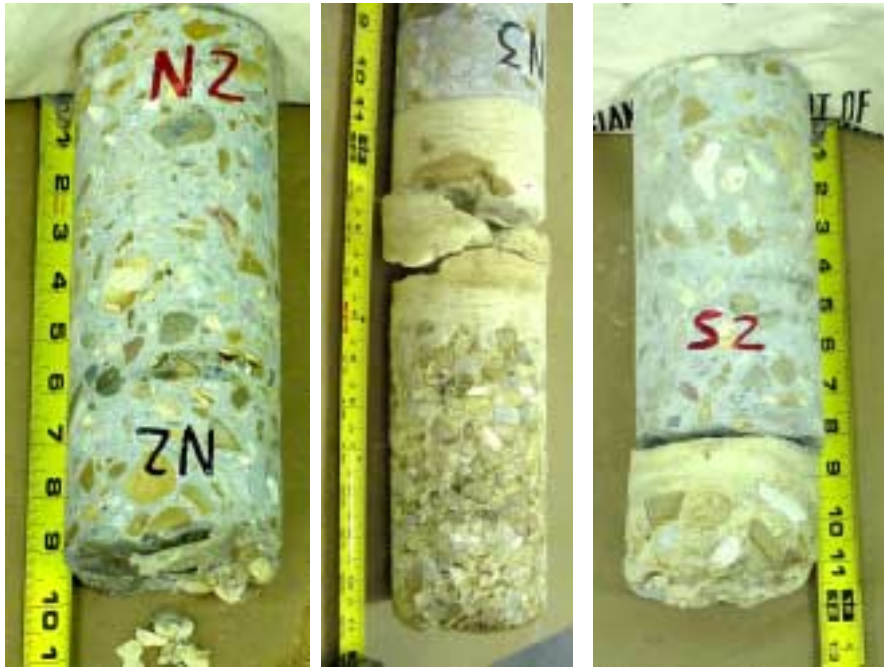
**Figure 41**  
**Concrete cores with polyurethane (N2, N3, and S2)**

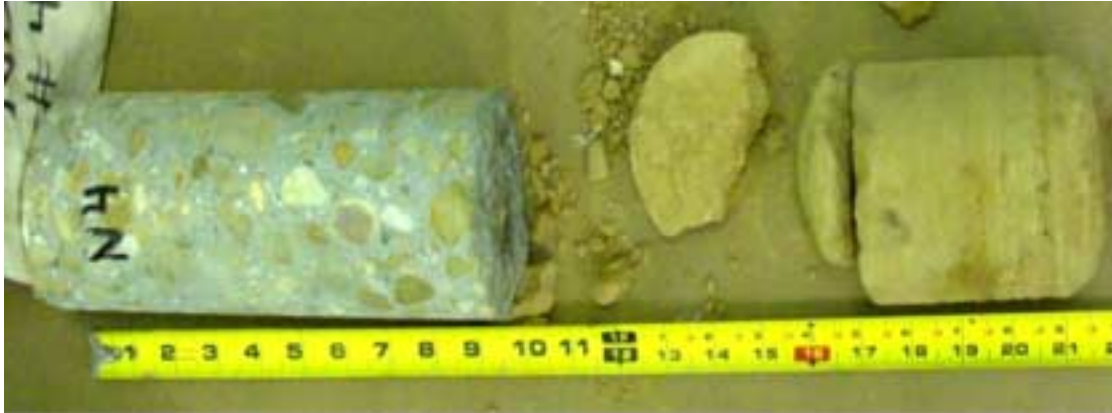
**Figure 42**  
**Concrete core with soil cement specimen**

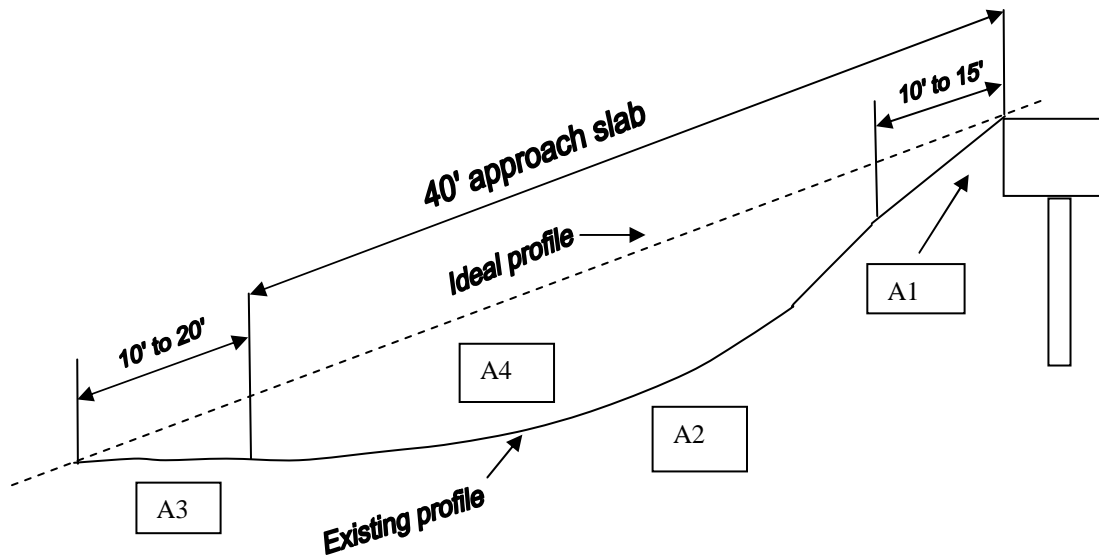
**Figure 43**  
**Typical approach slab profile**

In order to accurately develop an equation to estimate quantities, the volume of the treatment area and the amount of polyurethane required to fill must be known. Unlike the CRCP, the approach slab pavement will not settle completely with the embankment. Bridge approach slabs are steel-reinforced concrete pavement that rests on pile-supported abutments. Even though the embankment settles at the bridge end, the approach slab at that location will rotate, but will not settle unless the approach slab fails. Because of this, developing an accurate equation to predict the void totally based on the string line and maximum vertical deflection method used on the CRCP may be difficult and will be subject to inaccuracies. It is impossible to determine the depth of the void near the bridge end without coring through the pavement or using some other method, such as ground penetrating radar. Figure 43 shows the typical profile seen at the approach slabs on the US 167 NB and Bayou Duplente SB locations.
