# **Assessment of the Urettek Process on Continuously Reinforced Concrete Pavement, Jointed Concrete Pavement, and Bridge Approach Slabs**

Technical Assistance Report Number 03-2TA

LTRC Project No. 05-1TA  
State Project No. 736-99-1282

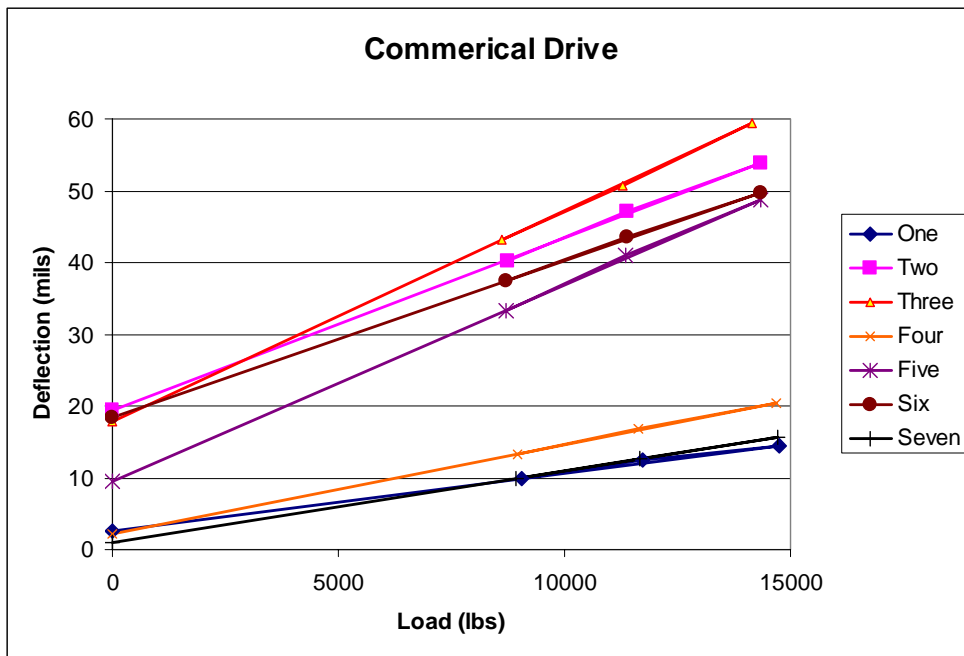
**Figure 99**  
**Y intercept diagram**

The Y intercept refers to the linear regression of a line through three points. The point at which the line crosses the Y axis is the intercept value. For this study, the Y intercept is based upon deflection versus load. The loads used on this project were 9000, 12,000, and 14,500 pounds. The load and its corresponding deflection at the load plate were plotted and a linear regression was performed. The figures below illustrate this process. According to the AASHTO design guide, a Y intercept value greater than 0.002 inches means that there is either a void or loss of support.
