# Portland Cement Concrete Pavement Best Practices Summary Report

WA-RD 744.1

**Portland Cement Concrete Pavement Best Practices Summary Report**

By  
Stephen T. Muench  
Assistant Professor

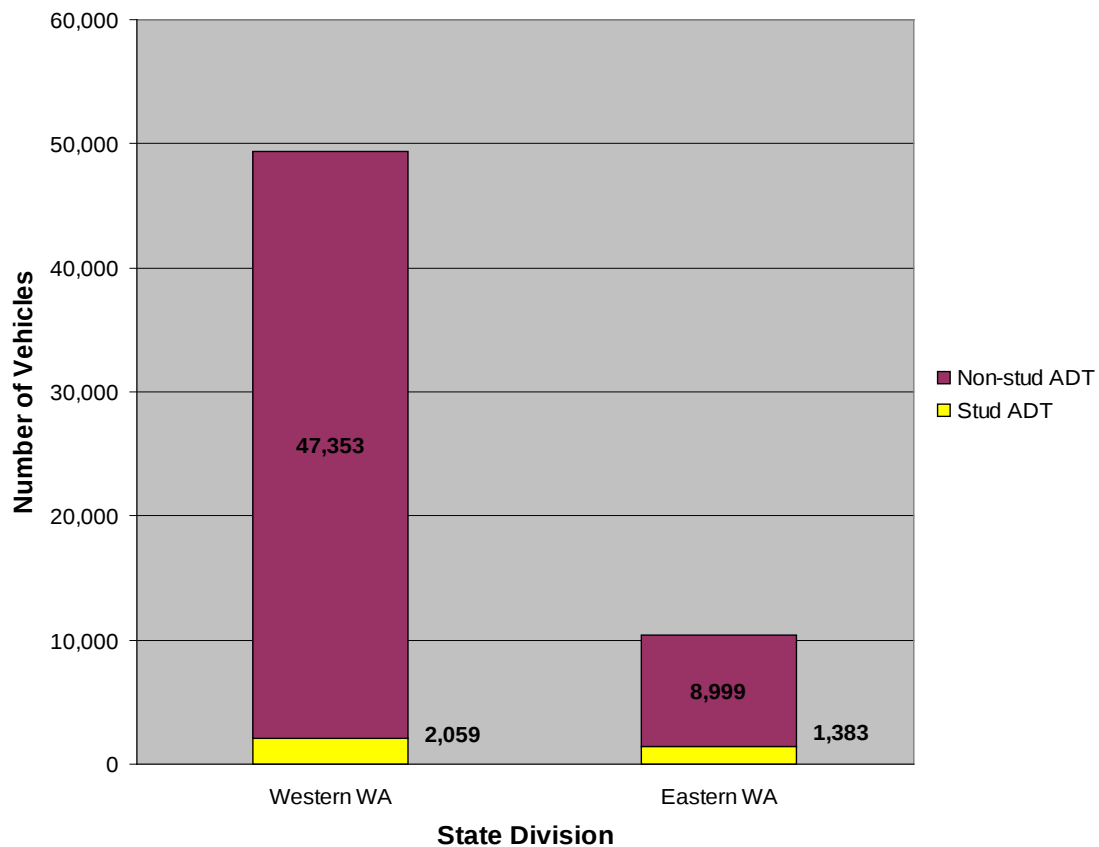
**Figure 1: Average traffic levels in western Washington and eastern Washington showing non-stud ADT (top) and stud ADT (bottom).**

- **Stud volumes across Washington State are comparable.** In general, western Washington has higher AADTs and lower stud use, while eastern Washington has lower AADTs and higher stud use (Figure 1). Given the existing data, there does not seem to be much merit to the argument that stud traffic is significantly higher in eastern Washington with the possible exception of I-90 through Spokane.

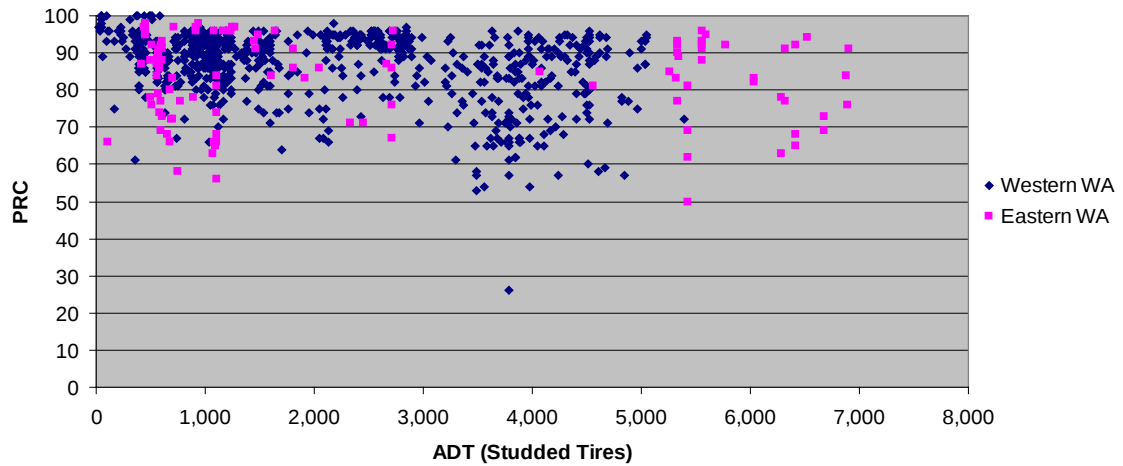
**Figure 2: PRC vs. stud ADT.**

- **Higher stud volumes generally correlate with lower wear depth ratings** (Figures 2 and 3). This is a weak conclusion because most PCC pavement in

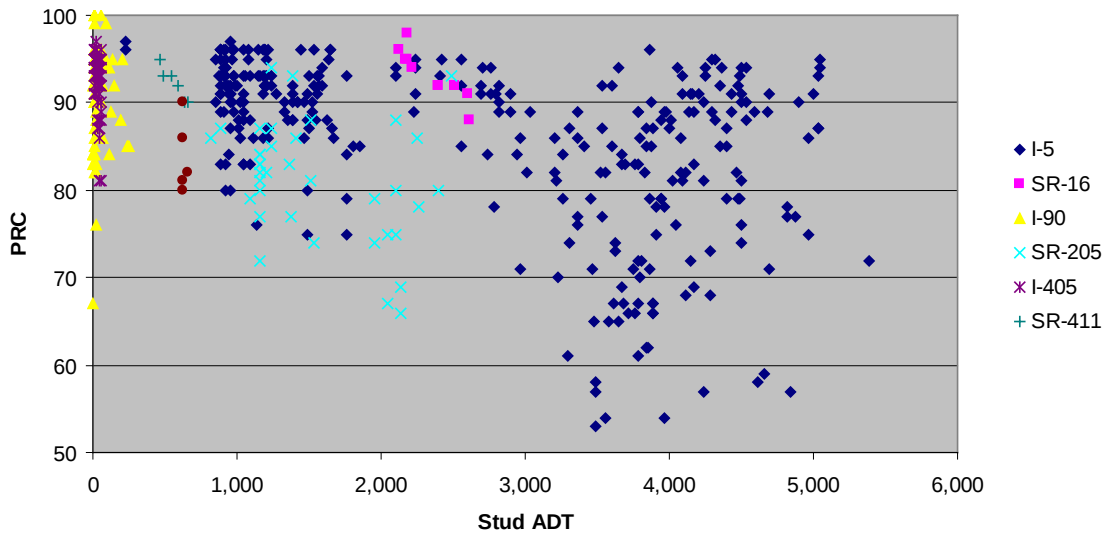
**Figure 3: Distribution of PRC vs. stud ADT by western highway.**

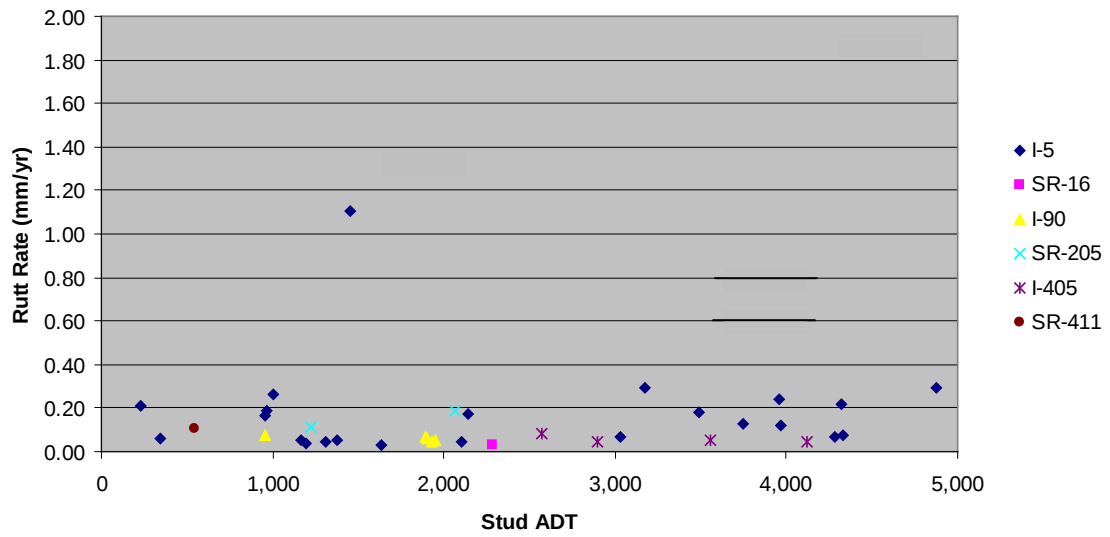
**Figure 4: Western stud ADT vs. wear rate.**

- The average PCC pavement wear rate across Washington State is about 0.01 inches per 1 million studded vehicle passes (Figures 4 and 5). This holds true for both western and eastern Washington with few exceptions.

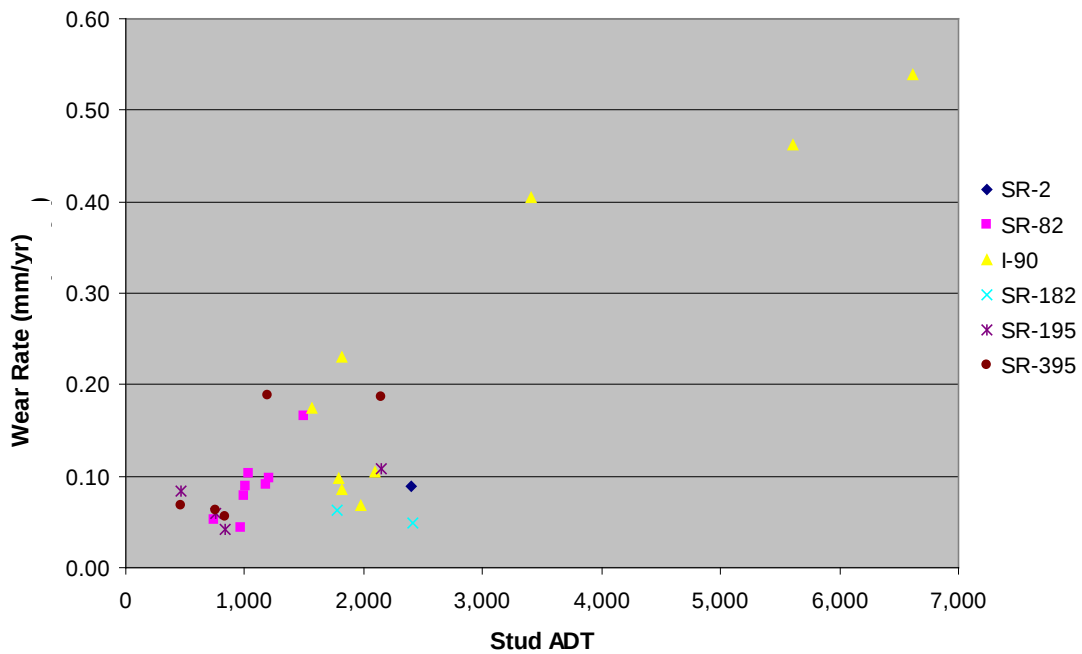
**Figure 5: Eastern stud ADT vs. rut rate.**

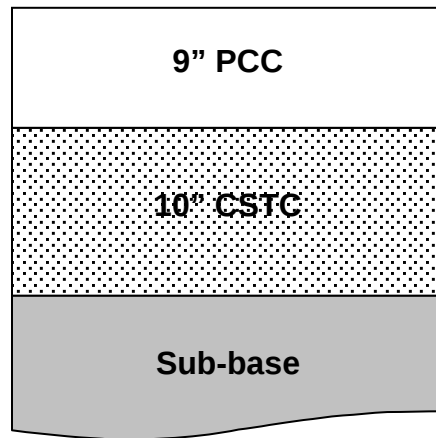
**Figure 6. Cross-section of Existing PCC Highway.**

WA-RD 744.4 compares the environmental impact of three different options for replacing an existing PCC pavement (Figure 6) over an analysis period of 50 years. This existing pavement section was chosen to represent typical conditions on I-5 in the greater Seattle area. Replacement options are:

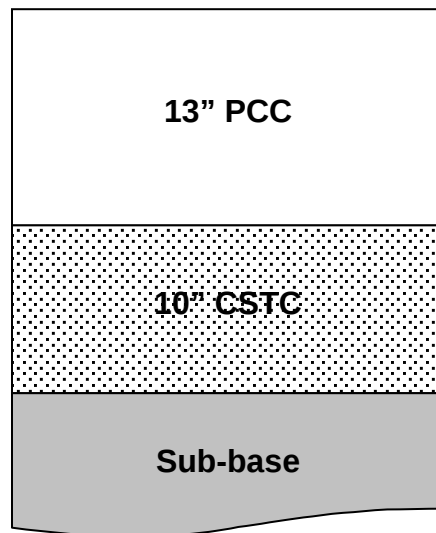
**Figure 7. Cross-section of PCC replacement option.**

- **Remove and replace with new PCC pavement.** Remove the existing 9 inches of PCC and replace with 13 inches of doweled PCC (Figure 7).
- **Remove and replace with new HMA pavement.** Remove the existing 9 inches of PCC and replace with 13 inches of HMA placed in five lifts (Figure 8).
- **Crack, seat and overlay (CSOL).** Crack seat and overlay the existing pavement with 5 inches of HMA placed in two lifts (Figure 9).

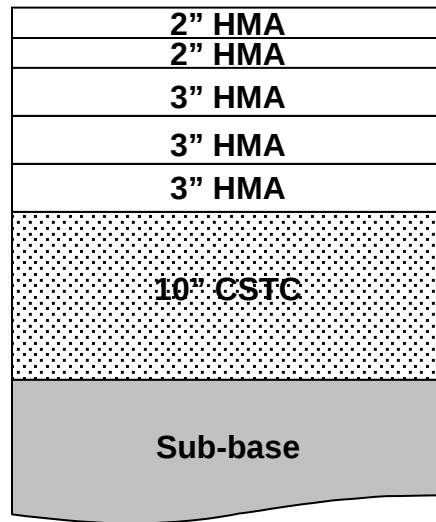
**Figure 8. Cross-section of HMA replacement option.**

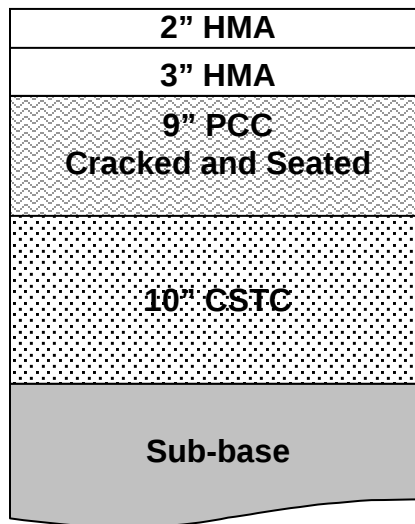
**Figure 9. Cross-section of CSOL option.**

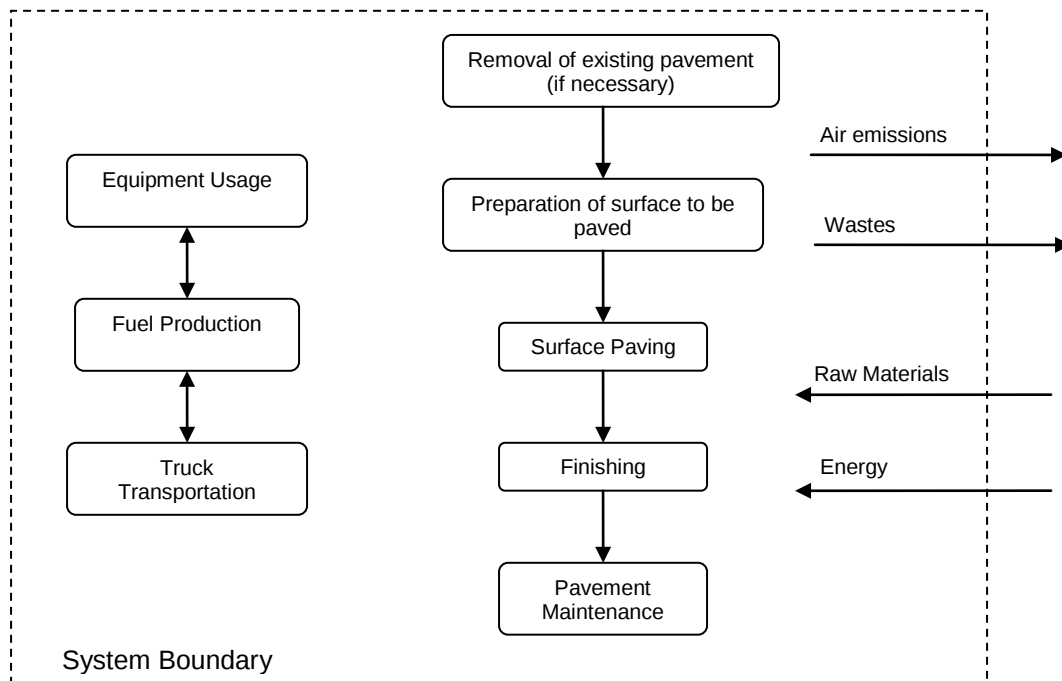
**Figure 10. Sequence of main activities and scope included in LCA.**

These options are not meant to comprehensively evaluate current WSDOT design standards with LCA. Rather, they were chosen as representative of potential pavement designs for a new pavement on I-5. Even if the ultimate pavement replacement options do not exactly match those analyzed in WA-RD 744.4, the relative relationship between the options is unlikely to change. In general, the LCA considered the processes associated with paving as shown in Figure 10.

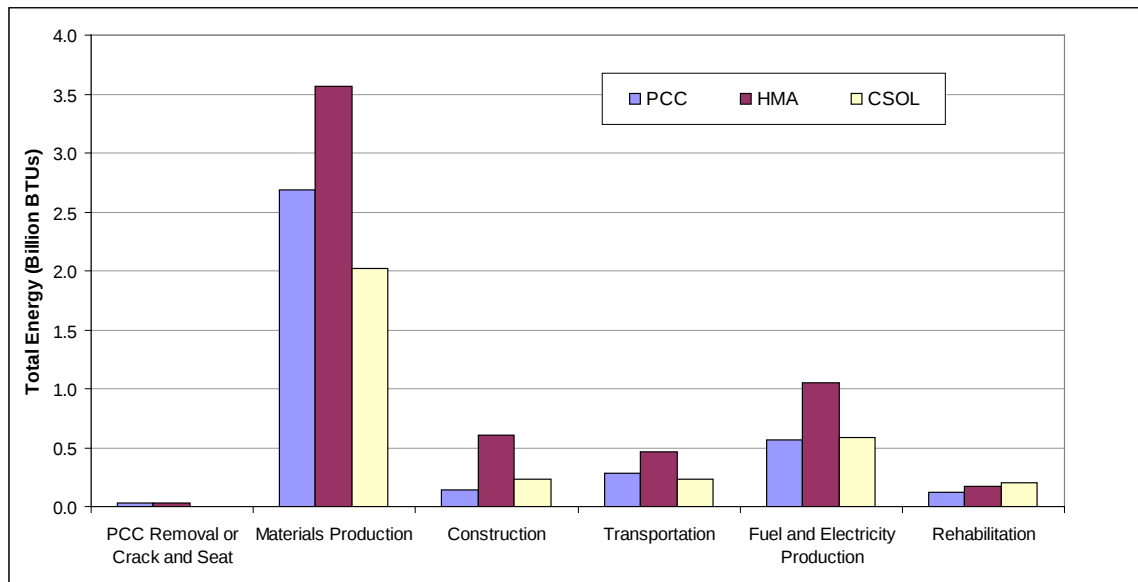
**Figure 11. Total energy contribution analysis.**

**Interpretation.** An effort was made to determine the relative contribution of each process within an option to the overall inventory and impact of that option. Figures 11 and 12 show that the overwhelming contributor to all three rehabilitation options is materials production (i.e., production of asphalt, cement, HMA and PCC). This suggests that efforts to reduce environmental impact could be focused on the materials production or higher use of recycled products in order to have the biggest impact.

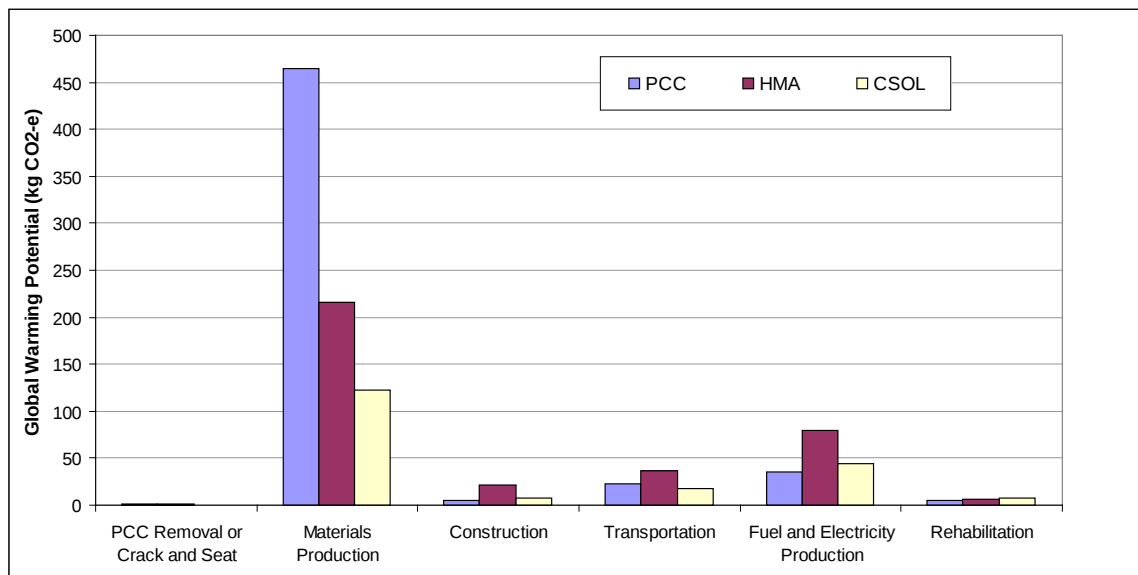
**Figure 12. Global warming potential contribution analysis.**
