# Studded Tire Wear on Portland Cement Concrete Pavement in the Washington State Department of Transportation Route Network

WA-RD 744.3

WSDOT Research Report

Research Report  
Agreement T2695, Task 88  
PCCP Best Practices

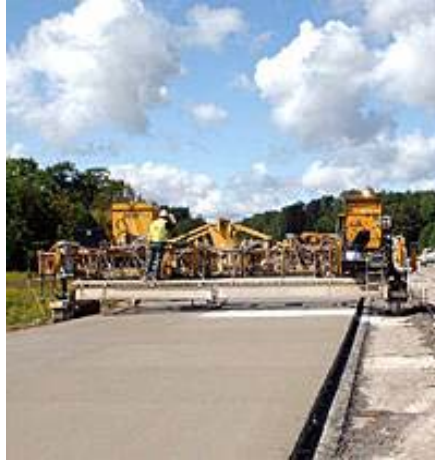
**Process.** There are two main types of PCC overlays applied to existing PCC pavements: bonded and unbonded (FHWA 2007b). A bonded overlay is a thin (typically 4 inches or less) PCC overlay over an existing PCC pavement with a prepared surface. As with a typical HMA overlay, a bonded PCC overlay relies on creating a good bond between the existing pavement and the overlay such that the result behaves as one unified structure (rather than two independent ones). An unbonded overlay is a thicker PCC overlay (usually 6 inches or more) placed over an existing PCC pavement (Figure 16). The overlay is intended to act as a separate pavement and thus steps are taken to ensure bonding to the existing pavement does not occur (ACPA 1998).

**Figure 16: Thin unbonded PCC overlay (Kuennen, 2006)**

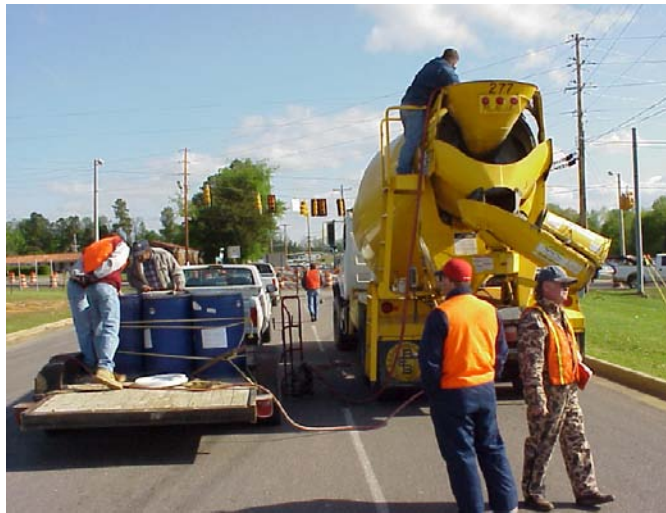
For the past two decades resin has been used in conjunction with HMA to resist rutting and abrasive traffic primarily on military bases. In recent years test sections have been researched on highways as well. RMP is a surface overlay of an open graded HMA mixture where 25-35% of air voids are filled with a latex-rubber modified portland cement grout (Figure 17). In the overlay procedure the open-graded mixture and grout are produced and placed separately to result in a 1.8 to 2.5 inch thick composite material. The benefit to this option is that it provides many of the performance characteristics of PCC but can be constructed easier and less expensively. Also, the additive is believed to increase the flexural and compressive strength of the hardened material, thus increasing abrasion resistance, and potentially studded tire wear as well (Battey & Whittington 2007).

**Figure 17: Latex additive going into the grout (Battey & Whittington, 2007)**

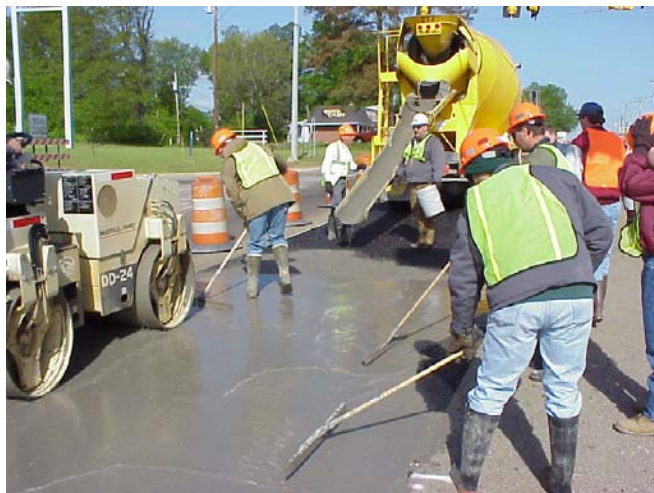
A Mississippi study placed RMP test sections on two HMA pavement intersections on US 72 with histories of traditional rutting (from pavement deformation) (FHWA 2006b). Ultimately, after 5 years of observation between 2001 and 2006, the Mississippi Department of Transportation (MDOT) published a final report in 2007 which featured both positive and negative reviews of their experience with RMP. From the construction end, the project was reported to be very challenging overall. Despite attention to detail, as shown in Figure 18 below, there was one area of failure where the removal of a 75-ft section of the pavement due was required due to a lack of grout penetration of the mat.

**Figure 18: Excess grout worked into areas needing more (Battey and Whittington 2007).**

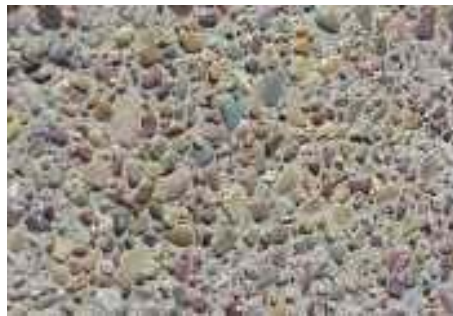
It is possible to construct a new PCC pavement in two separate lifts, which allows different materials to be used in each lift. This technique has been Germany, Austria and Belgium to place a high-quality, carefully engineered top lift over a more basic bottom lift. Often the top lift is constructed with an exposed aggregate finish to lessen tire-pavement noise (Figure 19).

**Figure 19: An exposed aggregate surface (Silent Roads, 2003)**

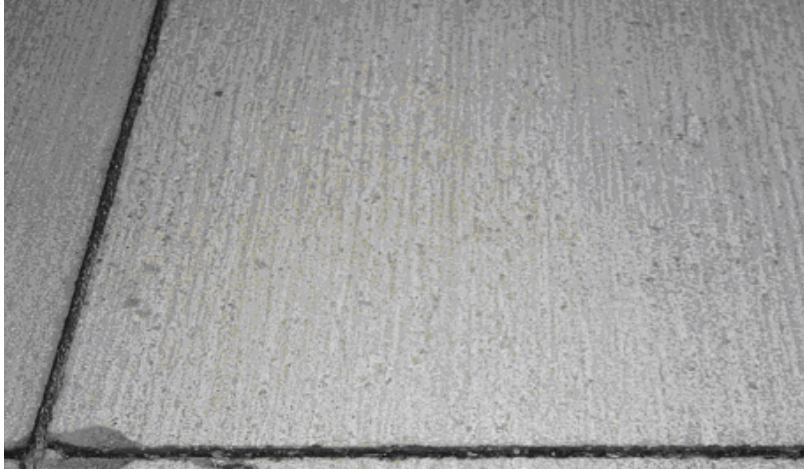
Surface texture is thought to have some correlation to studded tire wear. As the two primary textures used in Washington, the results of transverse tining and artificial turf carpet drag were explored in a WSDOT experiment on the performance of different surface textures (Figure 20). The amount of exposed aggregate relating to surface wear was also examined and it was recognized that pavements initially wore at a higher rate when first exposed to studded tires but then stabilized with time (Anderson et al. 2007). One idea suggested that the difference could be attributed to the paste on the surface of the new concrete. For example the paste wears quickly but then when the aggregate underneath is exposed the pavement wears at a much slower rate. One final conclusion noted was that all of the tined sections in this experiment had faster wear rates than other sections with equivalent mixes. Due to this it was suggested that tining may weaken the surface of the pavement by exposing more surface area to rapid drying, which is an idea that the Texas DOT has also proposed. The additional paste on the tined surface was also noted as a possible contributor (Anderson et al. 2007).

**Figure 20: Surface texture from a carpet drag (Anderson et al. 2007).**

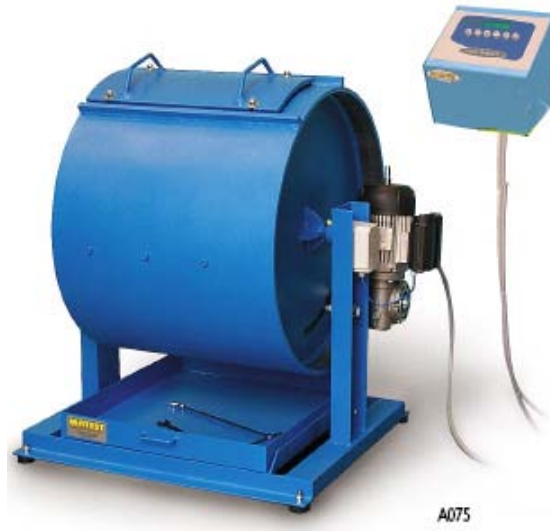
standard Los Angeles abrasion test is AASHTO T 96 or ASTM C 131. Figure 24 is an example of the LA Abrasion machine.

**Figure 24: LA Abrasion machine (Qualitest International, Inc. 2009).**

Studies of the LA Abrasion tend to conclude that it has little relationship with field performance (Rangaraju et al. 2005; Mokwa, et al. 2007; Folliard, et al. 2003).

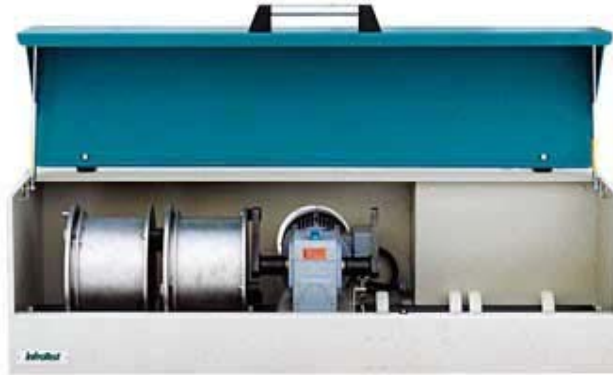
The Micro-Deval test (Figure 25) is another test used to evaluate the performed of an aggregates resistance to wear, and is similar to the LA Abrasion test. There are two versions of the test available. The test is described as placing the sample in a steel jar with steel balls (9.5 mm in diameter) and water, then rotating the jar at 100 rpm for 2 h for coarse aggregates, as previously described, or 15 min for fine aggregates (Land et al. 2006). Then the aggregate damage is assessed by mass loss using a 1.25-mm sieve for coarse aggregates and a 75- $\mu$ m sieve for fine aggregates (Lang et al. 2006).

**Figure 25: A Micro-Deval test machine (Inopave 2003).**

Unlike the LA Abrasion test, this test method is unique in that the aggregates are tested in saturated conditions rather than dry-conditions. According to the South Carolina DOT, analysis indicated that Micro-Deval test method is a better test in characterizing aggregate's field performance. The SCDOT found that for any given source of aggregate, finer gradation consistently yielded higher losses compared to coarser gradations (Rangaraju et al. 2005). Further, a Micro-Deval loss limit of 17% identified nearly all of the aggregates that were rated as being “fair” or “poor” in field performance.
