# Effects of Loop Detector Installation on the Portland Cement Concrete Pavement Lifespan: Case Study on I-5

WA-RD 744.5

Gudmundur A. Bodvarsson  
Stephen T. Muench

Research Report  
Agreement T2695, Task 88  
PCCP Best Practices

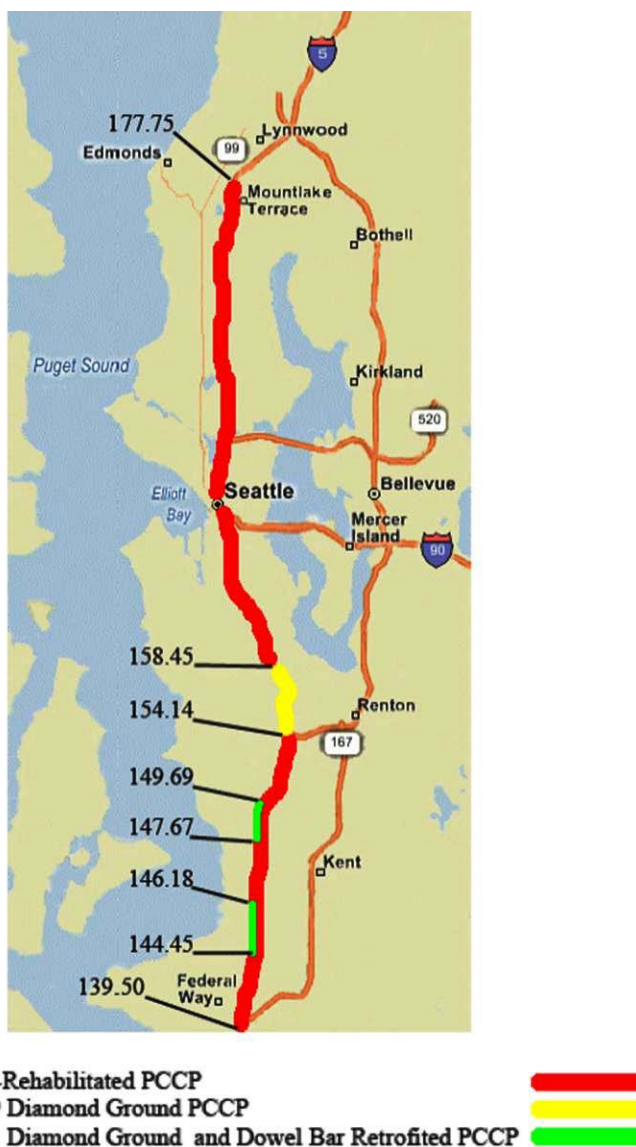
**Figure 5. Rehabilitation of PCC pavement on I-5 in King County as of 2004 (from Hansen et al. 2007).**

Two sections of the study corridor were reconstructed with dowel bar retrofit (DBR) and diamond ground PCCP in 2001. Southbound I-5 from milepost 144.45 to 146.18 and from milepost 147.67 to 149.69, total of 6.04 lane miles or about 3% of total lane miles in I-5 in King County. Figure 3.1 shows the study corridor and which sections have been reconstructed and which have not (Hansen et al. 2007).

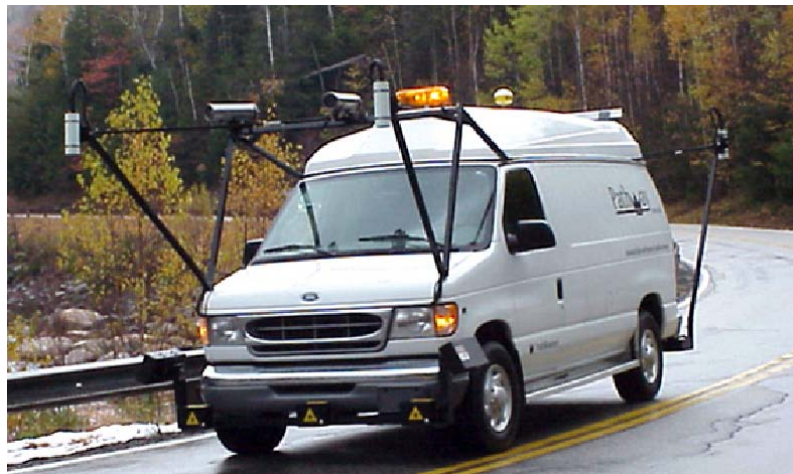
**Figure 7. Pavement distress data collection van (Pathway 2008).**

The PCCP distress data used for this study was collected between July 8, 2004, and July 22, 2004 with the WSDOT distress collection van (Figure 7). Lanes 1 through 4, both north- and southbound directions, were driven between South- and North boundary of King County (milepost 139.5 to 177.75) and data collected. Data were filtered to remove pavement sections consisting of hot mix asphalt (HMA) surfacing and bridge decks. Data regarding slab cracking, transverse joint faulting and wheel path wear was gathered but only slab cracking data was used for this study since the main concern with loop detectors is their effect on slab cracking.

Images used for this study were collected from four cameras mounted on the WSDOT distress collection van (Figure 7). Two of the cameras face down and take continuous images of the pavement. These two images overlap to provide a complete image of the

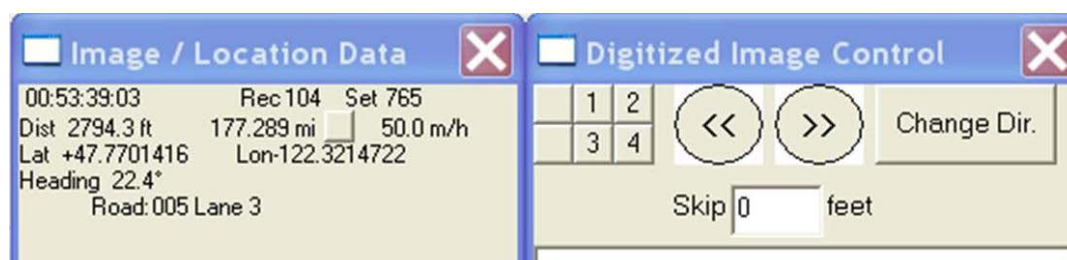
**Figure 10. Enlarged image of bottom left corner of Figure 8.**

Image numbers are displayed in the Image/location window (at the bottom left corner of Figure 8, enlarged in Figure 10). The file names are connected to numbers shown in the window: Set 765 means that the file is in folder 765 inside the database and the time which the data was collected, 00:53:39:03. The last digit can be 1, 2, 3, or 4 depending on from which camera the image is from. The total file name is a combination of these numbers: 765005339033.jpg.

Other information used for the study were the milepost (177.289 in Figure 10), highway designation (“Road 005” in Figure 10) and lane (“Lane 3” in Figure 10). While WSDOT refers to the right-most lane as lane 1 and then increases lane numbers towards the center of the road, Pathview II does the opposite; referring to the left-most lane as lane 1 and increasing lane numbers towards the outside of the road. This can be confusing at times, however it is consistent. The Digitized Image Control window (Figure 10) is used to go to the next image, or a user-defined distance (in feet) can be entered in to skip images.

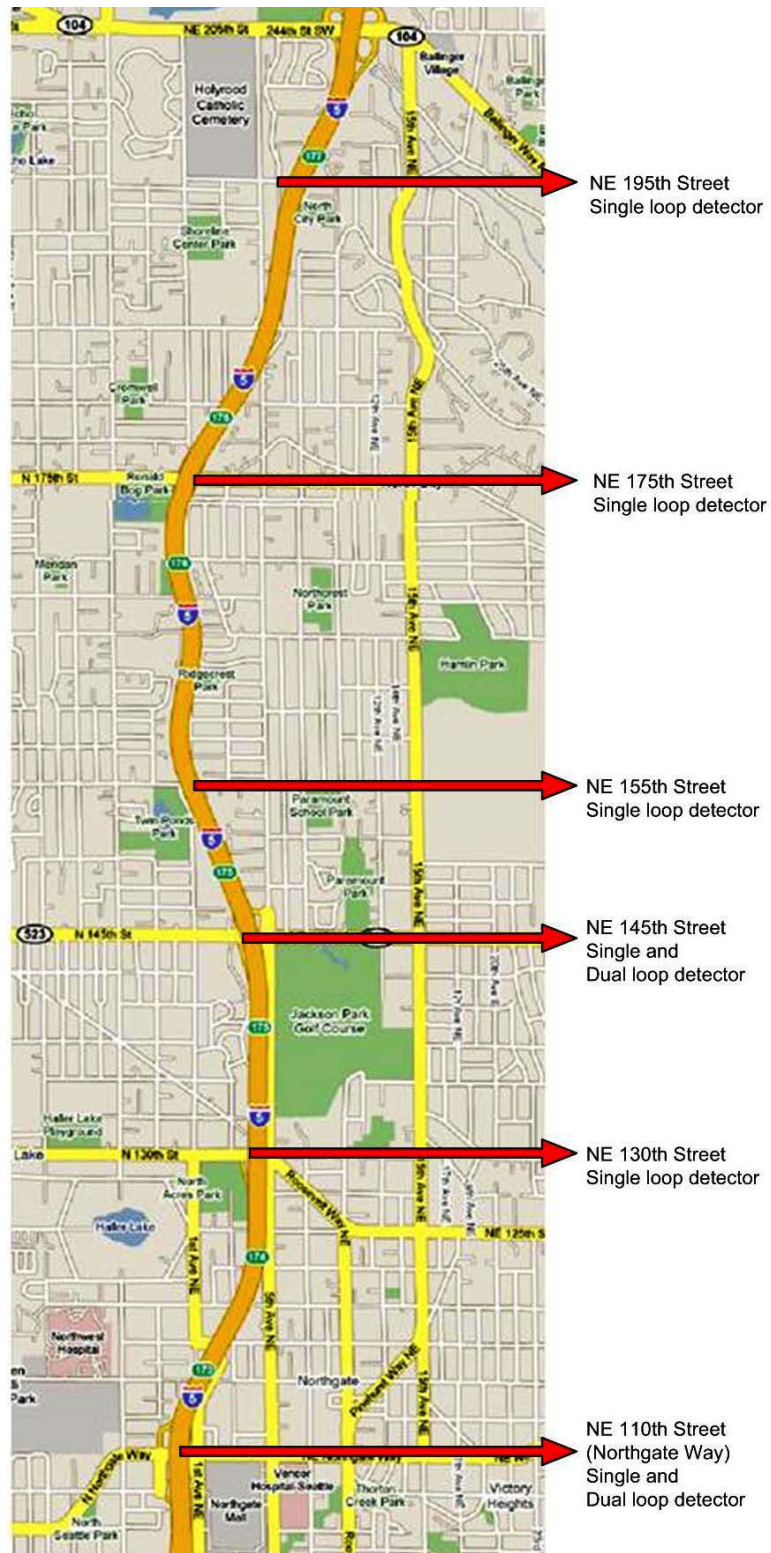
Figure 11. Loop detectors used in the simulation corridor.

square (6-ft by 6-ft), circle loops and combo loops. There were 11 mainline loop detection stations in the simulation corridor. Six of these were chosen to get lane-by-lane volume data. These six were chosen because they were generally equidistant from one another with about 20 city blocks between them and they also contained most of the on/off-ramp locations (Figure 11). Speed data and vehicle classification were attained by using dual loop detectors. There are four dual loop stations in the simulation corridor but only two were used: one in the middle of the simulation corridor (NE 145<sup>th</sup> street) and one in the end (NE 110<sup>th</sup> street). Dual-loop detectors are two consecutive single-loop detectors, placed about 16 feet apart. Time is measured from the time the first loop detects a vehicle until it is detected on the second one. The distance between the loops is known and therefore the vehicle speed can be calculated. To determine the length of the detected vehicle, the calculated speed and occupancy is used.

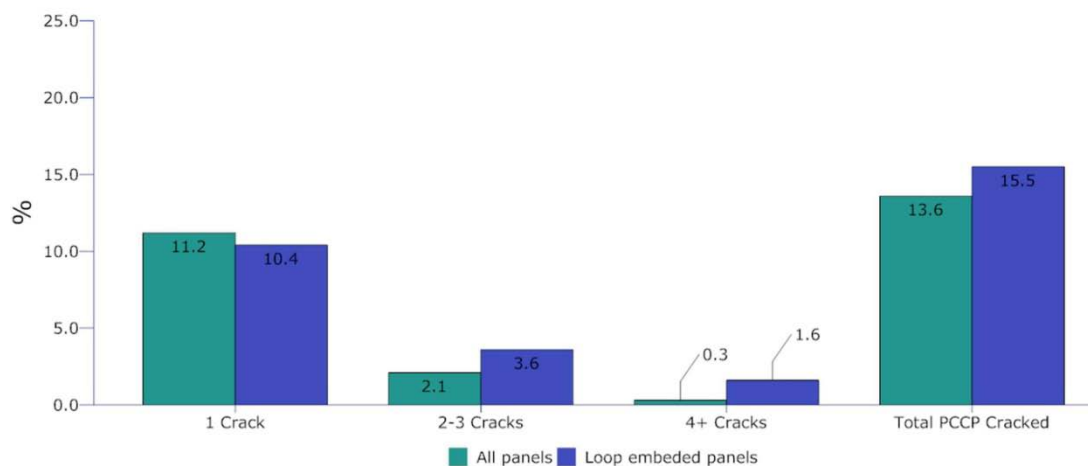
**Figure 16. Average cracking for non-rehabilitated PCC pavement.**

On average there is higher percentage of LEPs cracked than the LFPs. Results by number of cracks are:

Item	Non-Rehabilitated PCCP			
	All panels in the corridor (LFP)	# of samples	Loop embedded panels (LEP)	# of samples
NB Mile Posts	139.5 - 177.75 103.75 In-mi	-	139.5 - 177.75 103.75 In-mi	-
SB Mile Posts	139.75 - 177.75 59.05 In-mi	-	139.75 - 177.75 59.05 In-mi	-
No Cracks [%]	86.4	N/A	84.5	538
1 Crack [%]	11.2	N/A	10.4	66
2 - 3 Cracks [%]	2.1	N/A	3.6	23
4+ Cracks [%]	0.3	N/A	1.6	10
% PCCP Cracked	<b>13.6</b>	N/A	<b>15.5</b>	637

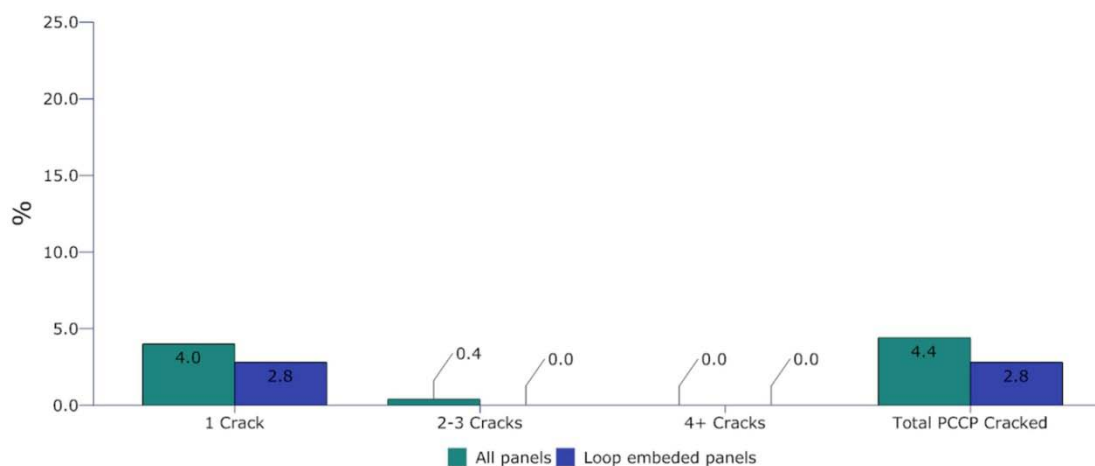
**Figure 18. Average cracking for DBR PCC pavement.**

On average there is lower percentage of LEPs cracked than the LFPs. Results by number of cracks are:

Item	Dowel Bar Retrofit and Diamond Grinded PCCP			
	All panels in the corridor (LFP)	# of samples	Loop embedded panels (LEP)	# of samples
NB Mile Posts	N/A	-	N/A	-
SB Mile Posts	144.45 - 149.69 6.04 ln-mi	-	144.45 - 149.69 6.04 ln-mi	-
No Cracks [%]	95.6	N/A	97.2	69
1 Crack [%]	4.0	N/A	2.8	2
2 - 3 Cracks [%]	0.4	N/A	0.0	0
4+ Cracks [%]	0.0	N/A	0.0	0
% PCCP Cracked	<b>4.4</b>	N/A	<b>2.8</b>	71
Average age of PCCP as of 2004	39.7	-	39.7	-

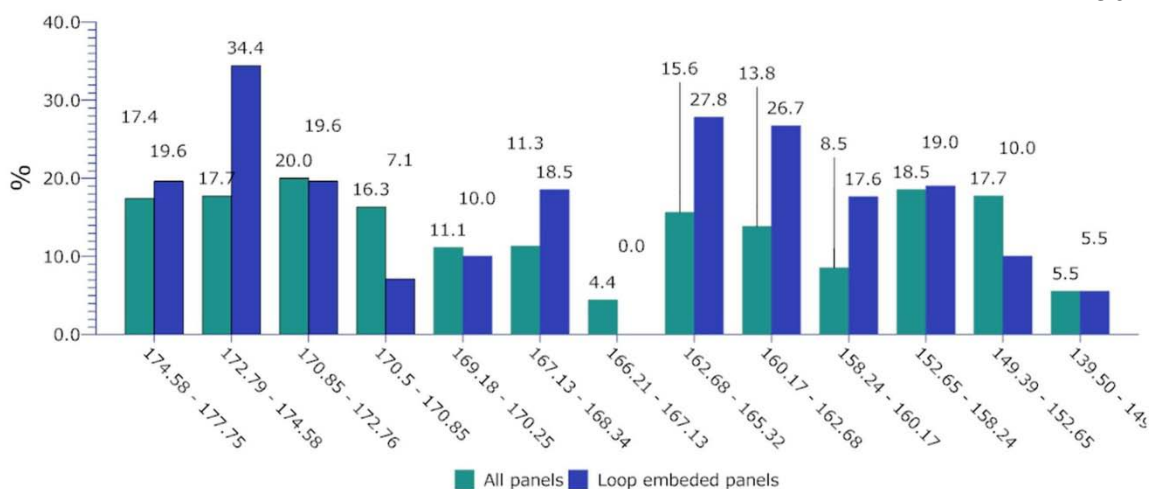
**Figure 19. Comparing LEPs and LFPs by section.**

The sections vary in length, the longest section is about 10 miles and the shortest less than a mile, so the number of panels (sample sizes) in each section are different. The LEPs have higher percentage of cracking in 7 of the 13 sections. In three sections the LFPs have higher percentage of cracking. It seems that LEPs perform worse compared to LFPs from mileposts 158 – 165; the section around and north of King County Airport (Boeing Field). No apparent correlations exist between cracking and any data contained in Table 3 (construction year, number of lanes, base type, base thickness).

← N S →													
MILE POST NB	174.58-177.75	172.79-174.58	170.85-172.76	170.5 – 170.85	169.18-170.25	167.13-168.34	166.21-167.13	162.68-165.32	N/A	158.24-162.68	152.65-158.24	149.39-152.65	139.50-149.39
Mile Post SB	N/A	N/A	170.85-177.75	170.5 – 170.85	169.18-170.25	167.72-168.34	N/A	162.68-166.36	160.17-162.68	157.47-160.07	153.15-158.45	149.40-153.15	139.50-149.40
% of Cracked panels (all panels)	17.4	17.7	20.0	16.3	11.1	11.3	4.4	15.6	13.8	8.5	18.5	17.7	5.5
% of Cracked LEP	19.6	34.4	19.6	7.1	10.0	18.5	0.0	27.8	26.7	17.6	19.0	10.0	5.5
Sample size of LEP	56	32	92	14	30	27	14	36	30	108	126	40	200

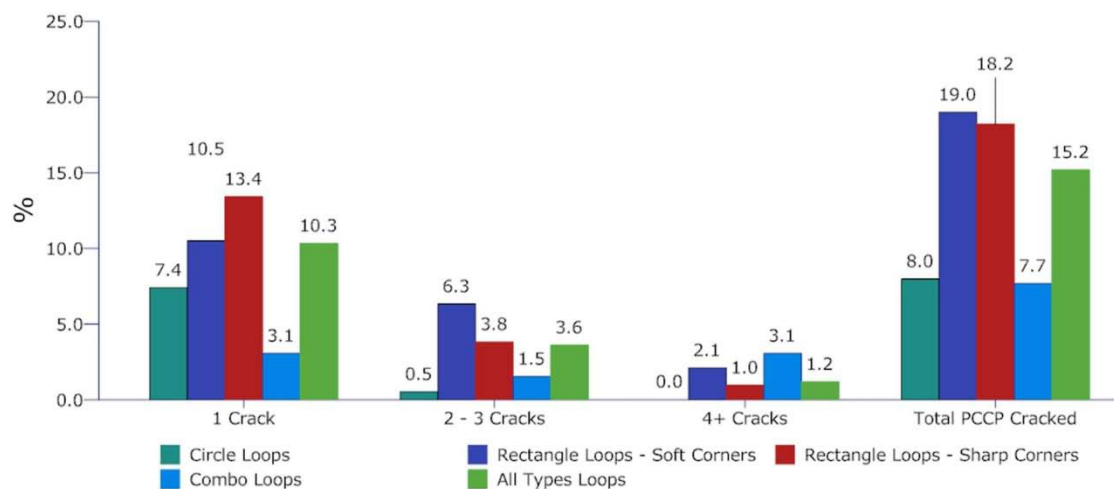
**Figure 20. Number of cracks in LEPs by type of loop detector.**

There is a significant confounding effect that makes direct comparison by loop type difficult: loop type is highly correlated with the age of a loop (e.g., circle loops were installed most recently so are younger than rectangle loops, etc.). Thus, of the three types of loops the circle loop performs best as would be expected since they were installed

Item	Circle loops	Rectangle loops Soft corners	Rectangle loops sharp corners	Loop Combo	All types of loops
No Cracks	92.0	81.0	81.8	92.3	84.8
1 Crack	7.4	10.5	13.4	3.1	10.3
2 - 3 Cracks	0.5	6.3	3.8	1.5	3.6
4+ Cracks	0.0	2.1	1.0	3.1	1.2
% PCCP Cracked	8.0	19.0	18.2	7.7	15.2
First installed	1997 - 2000	Mid 80's	Mid 60's	N/A	N/A
# of samples	188	237	313	65	803

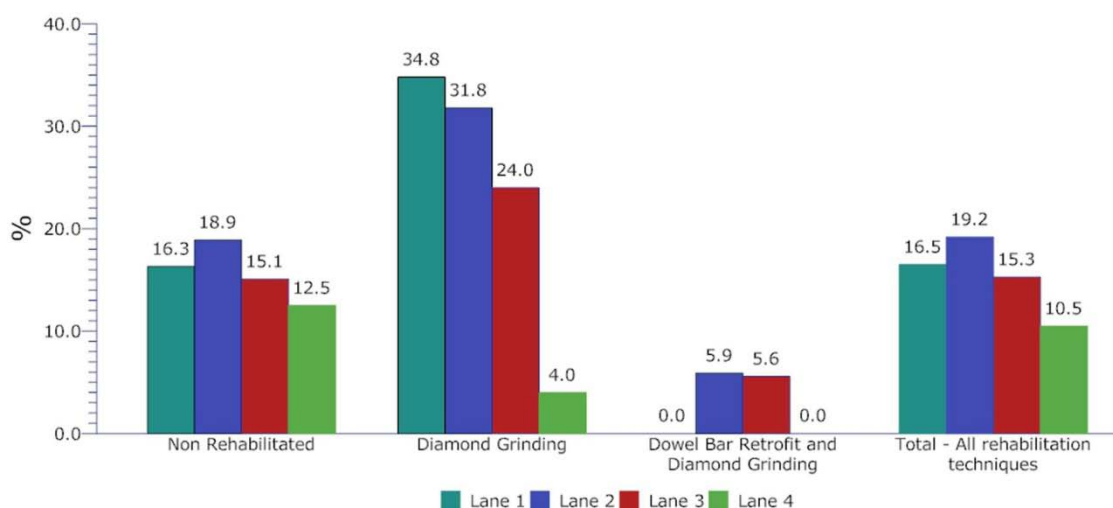
**Figure 21. Percentage of cracked LEPs by lane and rehabilitation type.**

Non-Rehabilitated PCCP		Diamond Ground PCCP		Dowel Bar Retrofit and Diamond Grinded PCCP		Total – With and without Rehabilitation	
	% Cracked LEP	Samples	% Cracked LEP	Samples	% Cracked LEP	Samples	% Cracked LEP	Samples
Lane 1	16.3	123	34.8	23	0.0	18	16.5	164
Lane 2	18.9	159	31.8	22	5.9	17	19.2	198
Lane 3	15.1	179	24.0	25	5.6	18	15.3	222
Lane 4	12.5	176	4.0	25	0.0	18	10.5	219

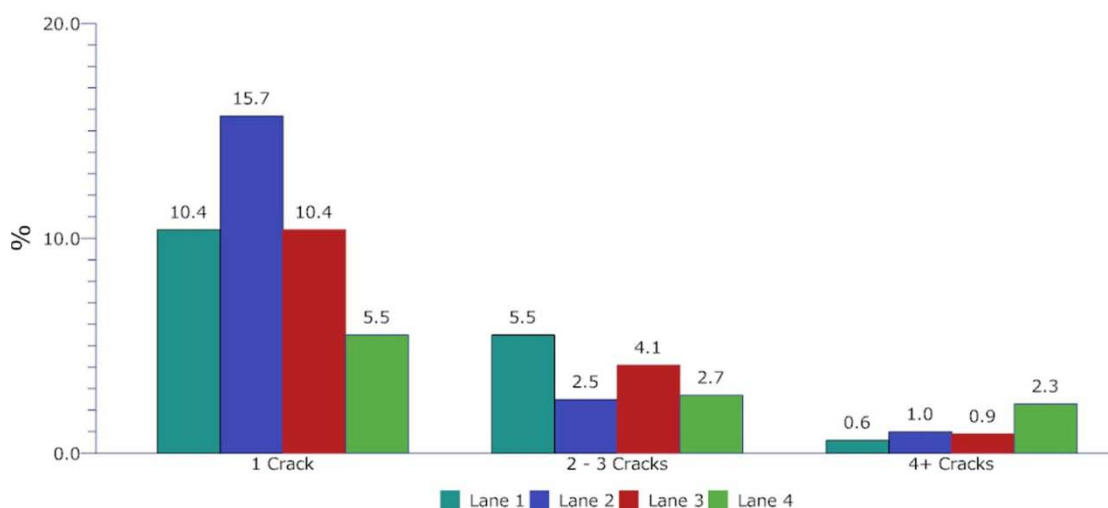
**Figure 22. Number of cracks by lane.**

The results for 1 crack per panel is very similar to the overall percentage of cracked panels but for 2-3 cracks there is a spike in lane 3 which might not be expected. The most unexpected result is in 4+ cracks, lane 4 has the highest percentage of 4 or more cracks per panel. If sample size were increased (here the sample size is low) it is unknown if this trend would still be prevalent.

<b>1 Crack</b>		<b>2 - 3 Cracks</b>		<b>4+ Cracks</b>	
	%	samples	%	samples	%	samples
Lane 1	10.4	17	5.5	9	0.6	1
Lane 2	15.7	31	2.5	5	1.0	2
Lane 3	10.4	23	4.1	9	0.9	2
Lane 4	5.5	12	2.7	6	2.3	5

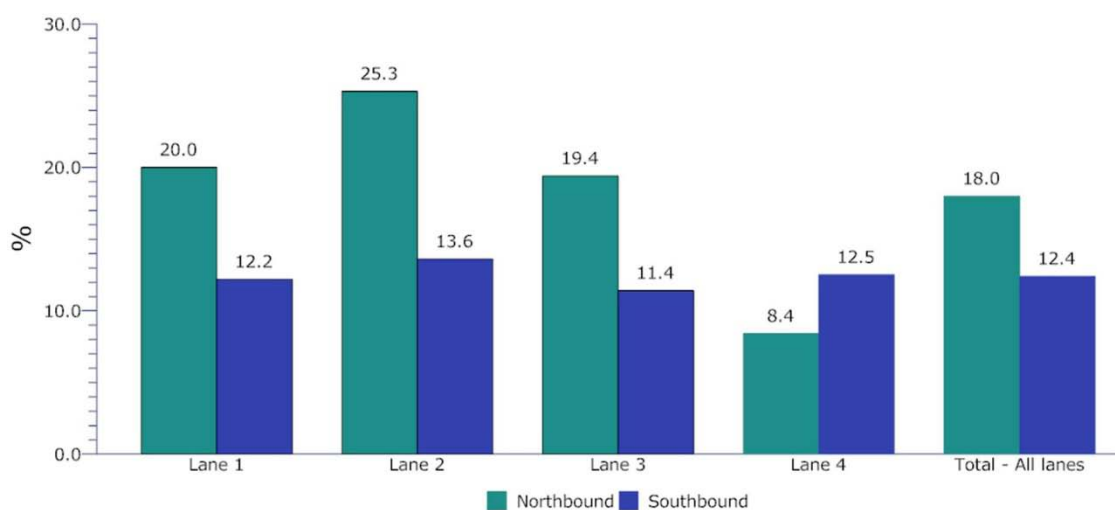
**Figure 23. Cracked LEPs by lane and direction.**

With the exception of lane 4, the northbound direction is in significantly worse shape than the southbound. One hypothesis to explain these results is that truck traffic in the northbound direction is higher. To test this hypothesis, a small sample of truck traffic by direction was taken on northbound and southbound I-5 at NE 145<sup>th</sup> Street. There are five lanes on this location in the northbound direction compared to four in the southbound direction. As with the previous truck sample, the sample was taken in August 2006 and contained 4 hours of average evening (8:00 pm – 12:00 am), 4 hours of average weekday

With and without rehabilitation			
	NB % of cracked LEP	NB # of LEP	SB % of cracked LEP	SB # of LEP
Lane 1	20.0	90	12.2	74
Lane 2	25.3	95	13.6	103
Lane 3	19.4	108	11.4	114
Lane 4	8.4	107	12.5	112
All lanes	18.0	400	12.4	403
