ENERGY ABSORPTION OF GRAVEL MOUNDS
FOR TRUCK ESCAPE RAMPS

HP&R Study: 5149-15

Gordon Beecroft
Research Engineer

March, 1978

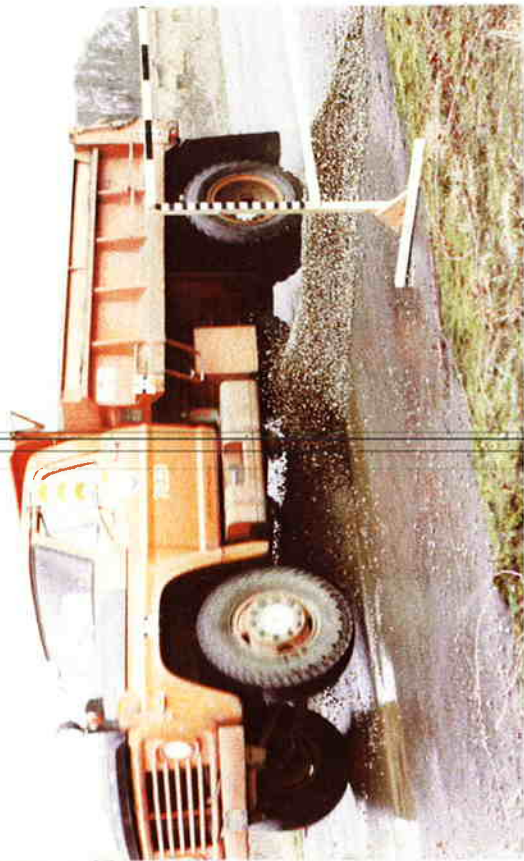
Test No.2 - Single 1 ft mound. Left front wheel airborne.

The first tests were conducted with mounds made from 3/4-inch to 1/2-inch gravel. The first three tests were with a single one foot high mound having slopes of 1.5 to 1 coming to a peak at the top. With this mound, test speeds of 25, 34, and 43 mph were used. The truck reaction to this mound was not exceptionally harsh, however the front wheels did leave the ground at the 34 and 43 mph speeds. Prior to testing, it was hoped the truck would pass through the mounds with only minimum vertical reaction. The vertical reaction during testing was greater than anticipated. Although the trucks displaced a large amount of gravel in the wheel paths, the tires ramped over a portion of the gravel in the mound. Most of the vertical reaction was absorbed by the springs, with a much smaller movement of the truck bed. At each test speed, this one foot high mound reduced the velocity by one mile per hour as the truck passed through the mound. A summary of all of the test runs is presented in Table 1, following this section.

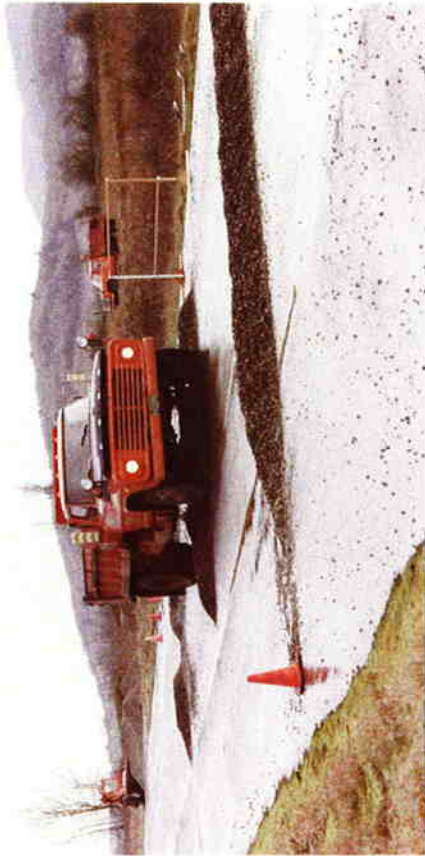
Test No.6 - Three 1 ft mounds at 30 ft.

The next two runs, test numbers 6 and 7, were conducted with a series of three 1 foot high mounds spaced at 30 feet center to center. Each mound had approach and back slopes of 1.5 to 1. As with the single mound having 1.5 to 1 slopes, much of the vertical reaction at the front of the truck was taken by the springs. At an entry speed of 26 mph, the three mounds reduced the speed by 2 mph. The radar trace indicates each mound reduced the speed by about 0.5 mph. At a test speed of 35.5 mph, the exit speed was 33 mph after passing the three mounds. Although the reaction to striking the mounds was not particularly severe, neither were they very effective in slowing the vehicles.

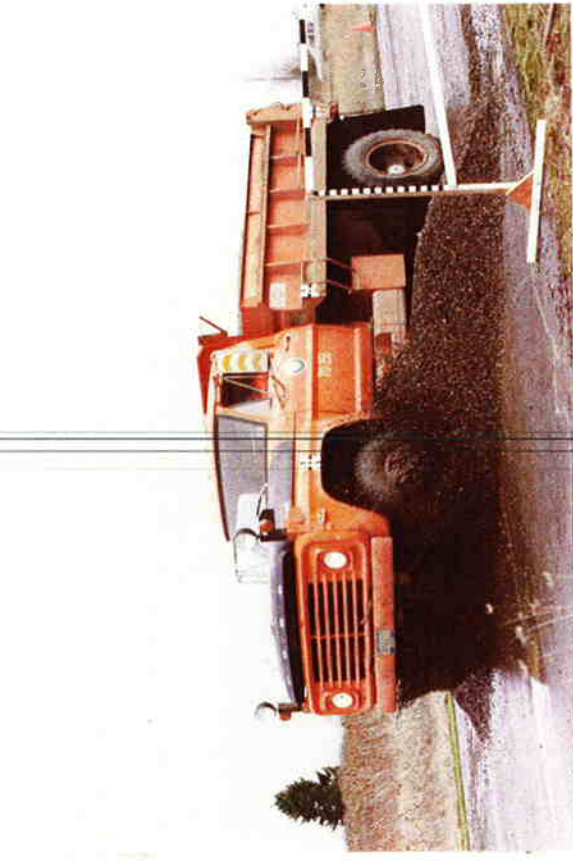
Test No.8 - Single 2 ft mound. Flying gravel obscures front wheels.

The next group of tests was conducted with 2 foot high mounds. Test number 8 used a single mound with 1.5 to 1 approach and back slopes coming to a peak at the top. It was constructed with the same 3/4-inch to 1/2-inch gravel used in the previous tests. At a test speed of 25.5 mph both the front hub and the target on the front fender were displaced vertically over 0.5 feet. The mound slowed the vehicle by 3 mph but significant damaged was caused. The reaction broke both front shock absorber mountings, caused a radiator leak, and the steering wheel was bent by the driver.

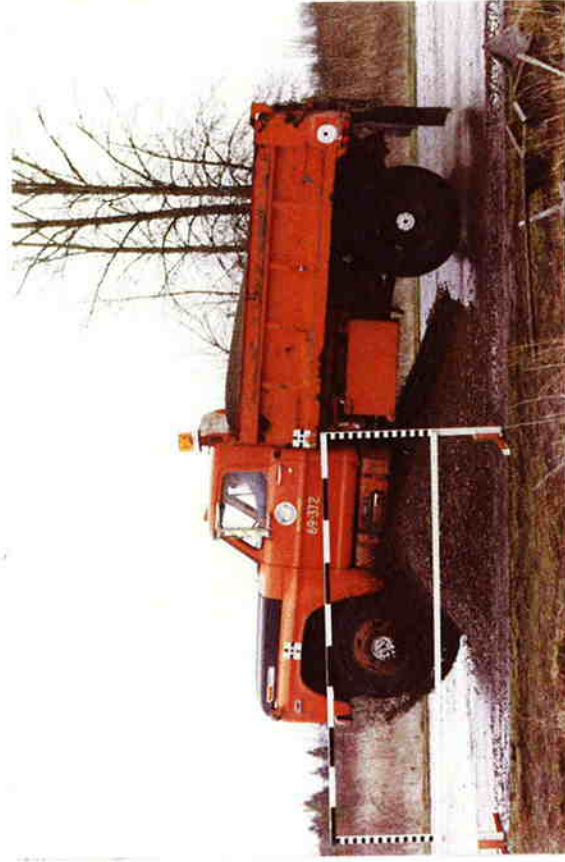
Test No.10 - 2 ft mound with 3:1 front slope. Front wheels airborne.

Test number 9 used a 2 foot high mound with a 3 to 1 approach slope and a 1.5 to 1 back slope. The entry speed was 36.5 mph and the truck slowed 4 mph in passing through the mound. The reaction was violent and the driver commented he nearly lost control of the truck. The front axle was damaged to the extent the truck was out of action. Test number 10 used the same 2 foot high mound with 3 to 1 front and 1.5 to 1 back slopes. The entry speed was 26 mph and the exit speed 22.5 mph. The test was conducted without truck damage although the measured vertical reactions were more severe than the previous tests.

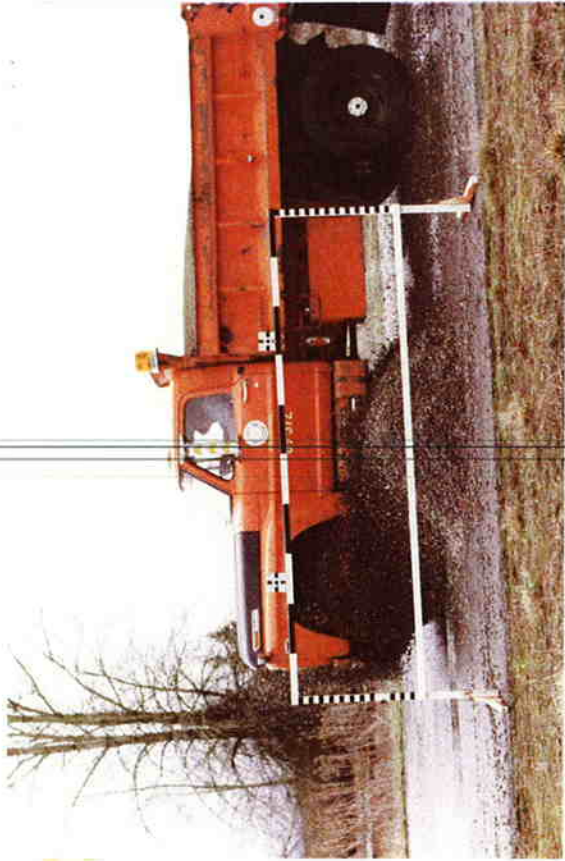
Test No.11 - Three 2 ft mounds. Tie rod bent.

Test number 11 employed three 2 foot high mounds spaced at 30 feet center to center having 1.5 to 1 front and back slopes coming to a peak. The test was conducted at a nominal speed of 25 mph, however, the recording radar was inoperative.

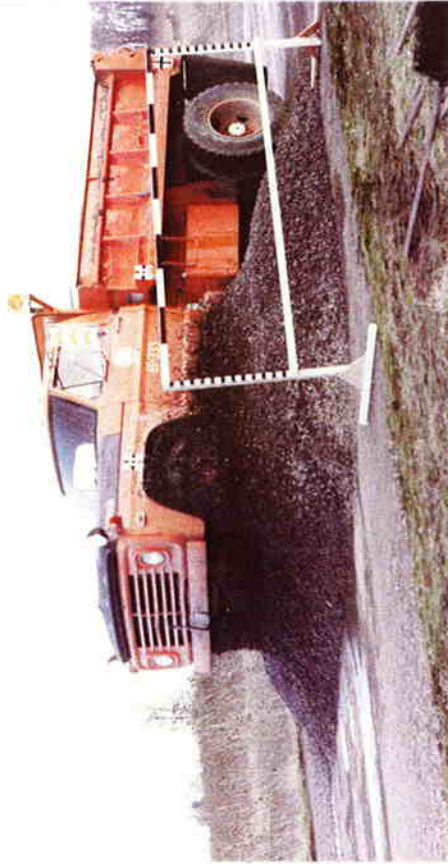
Test No.17 - 2 ft mound with 6 ft flat top.
Truck climbs through mound.

Test number 17 utilized a 2 foot high mound constructed of the 3/4 to 1/2 inch gravel having a 6 foot flat top in the direction of travel and 1.5 to 1 slopes front and rear. With the flat top, the truck climbed as it passed through the berm and was essentially airborne as it passed through the back of the mound. Again, the tie-rod of the truck failed and the wheels turned outward so a skidding action assisted in decelerating the truck. The entry speed was 22.5 mph and the exit speed 16 mph. If the truck had passed through the mound, rather than climbing up as it went into the mound, the extra mass provided by having a 6 foot flat top would have provided additional stopping resistance not available with a pointed mound. However, since the truck did climb as it went into the mound, the reaction was severe.

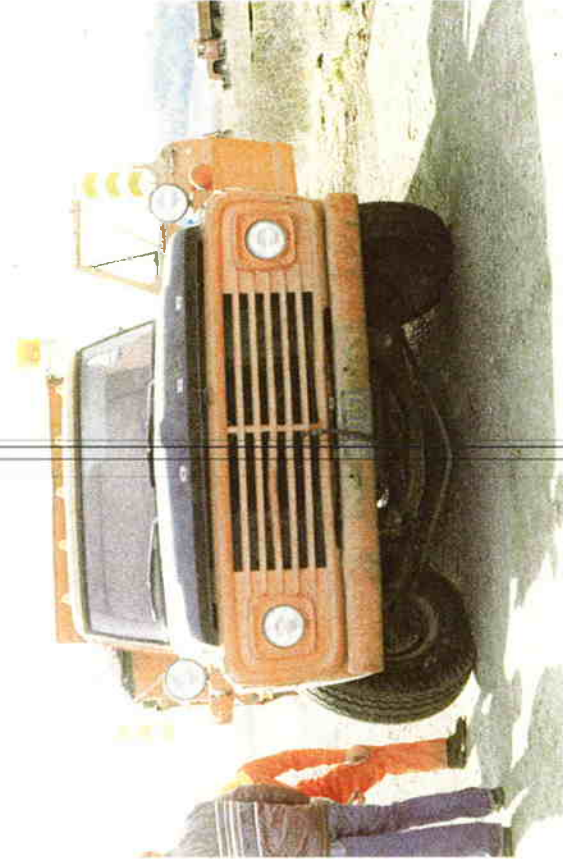
Test No.18 - Typical truck damage.

axle reached the second mound and a similar situation existed as the front axle reached the third mound. Tie-rod damage was initiated at the first mound and worsened with each succeeding impact. The truck barely cleared the third berm before stopping, and while much of the deceleration can be attributed to the skidding action of the wheels after the tie-rod buckled, placing a berm at the point of maximum spring compression did increase the effectiveness of the berms. The entry speed was 24 mph and the exit speed 10 mph.

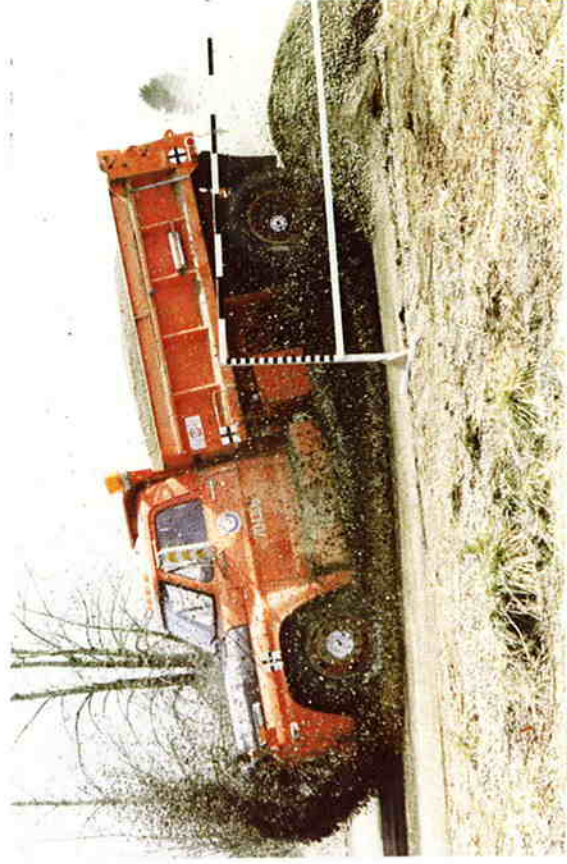
Test No.19 - Single 2.5 ft mound.

Test number 19 utilized a single mound 2.5 feet in height with 1.5 to 1 slopes coming to a peak. The mound was constructed with 3/4-inch to 1/2-inch gravel. The vertical displacement of the front target as the truck passed through the mound was 1.0 foot and for the rear target the value was 1.1 feet. Again, the tie-rod buckled making the truck inoperable. The mound slowed the vehicles by 6 mph, from 25 to 19 mph.

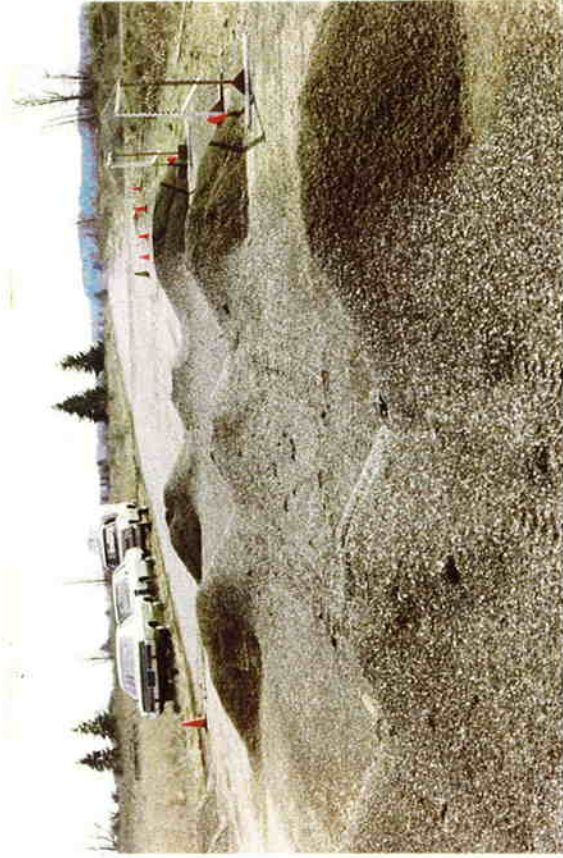
Test No.20 - Mounds after truck passed.

Starting with test number 20, a 3/8-inch to #10 pea gravel was used to construct the mounds. Tests 20 and 21 utilized three 2 foot high mounds spaced at 30 feet center to center with 1.5 to 1 slopes coming to a peak. Trucks passed through the finer gravel with less vertical movement and a greater displacement of the aggregate. In number 20, the speed was reduced from 20.5 to 8.5 mph in passing through the three mounds. The reaction was less violent than with ~~the coarser aggregate and no vehicle damage resulted.~~ ~~The only variable~~ between test 20 and 21 was the vehicle speed. Test 21 had an entry speed of 32 mph and an exit speed of 20 mph. The front axle of the truck was bent during the test, probably when the wheels came down hard on the bituminous pavement of the street. The tie-rod was not buckled in this case.

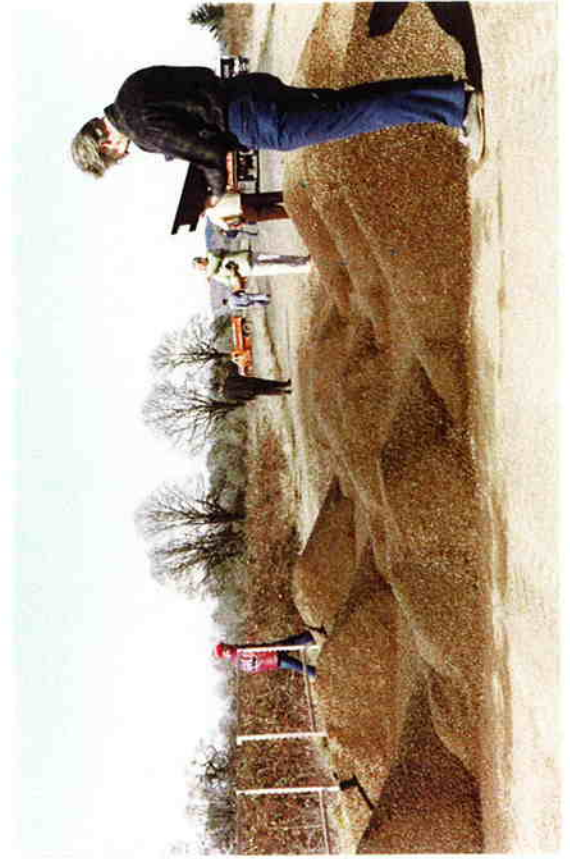
Test No.22 - Mounds after truck passed.

Test No.22 - Three 2 ft mounds at 14 ft.

Test number 22 utilized a series of three mounds spaced at 14 feet center to center. Each mound was 2 feet high and came to a peak with 1.5 to 1 front and back slopes. The entry speed was 26 mph and the exit speed 14.5 mph. Observers thought the three closely spaced mounds stopped the truck more quickly than those spaced at 30 feet center to center; however, the in and out radar measurements indicate very little difference. Truck damage in the form of a bent tie-rod and bent front axle resulted from the test.
