**WOODBURN HOT  
IN-PLANT ASPHALT PAVEMENT  
RECYCLING PROJECT**

**Final Report**

Demonstration Project No. 39  
and  
Experimental Features Project No. 76-01

**Oregon Department of Transportation  
Materials and Research Section  
Research Unit**

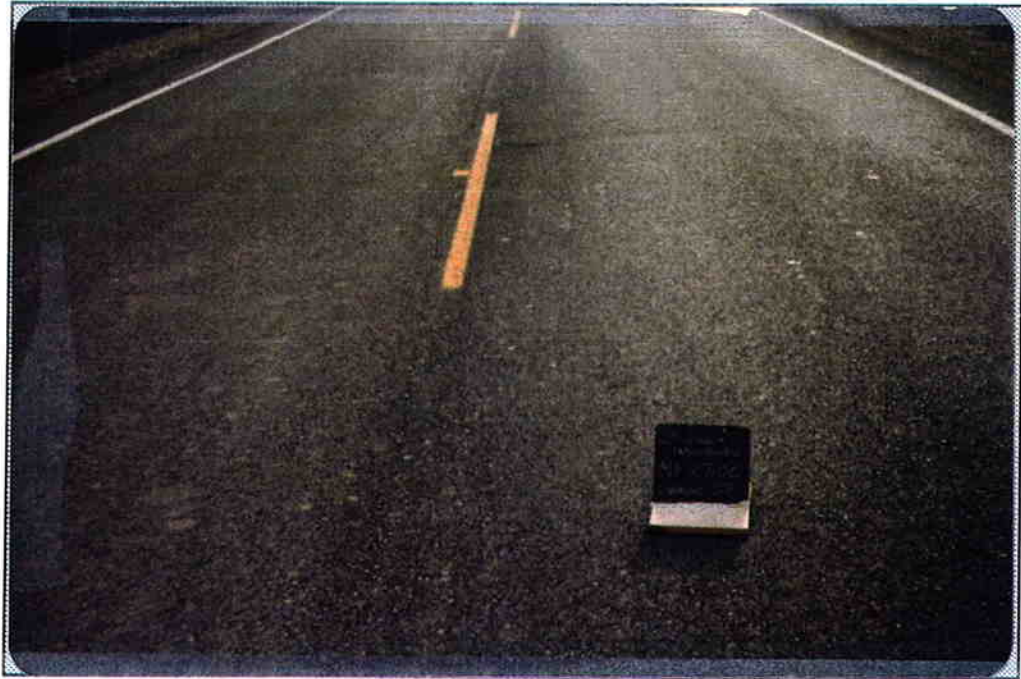
**Figure 4.1: Typical Pavement Condition Immediately after the Construction in 1977  
(At MP 27.00 EB)**

The pavement was inspected immediately after the construction in 1977, two years after the construction in 1979, and eight years later in 1985. Typical pavement conditions are shown in Figures 4.1 to 4.3.

As can be seen in Figures 4.1 and 4.2, the pavement surface immediately and two years after the construction was in very good condition. By 1981, the pavement had carried its design EAL's and the pavement was still in good condition. In 1985, after eight years of service, another inspection was performed and the typical pavement condition is shown in Figure 4.3. The inspection results showed that the pavement surface started light raveling and cracking. There were localized areas where pavement showed a substantial amount of moderate to high severity alligator cracking. Most of these areas were within the section where pavement received 2.5-inch recycled AC overlay.

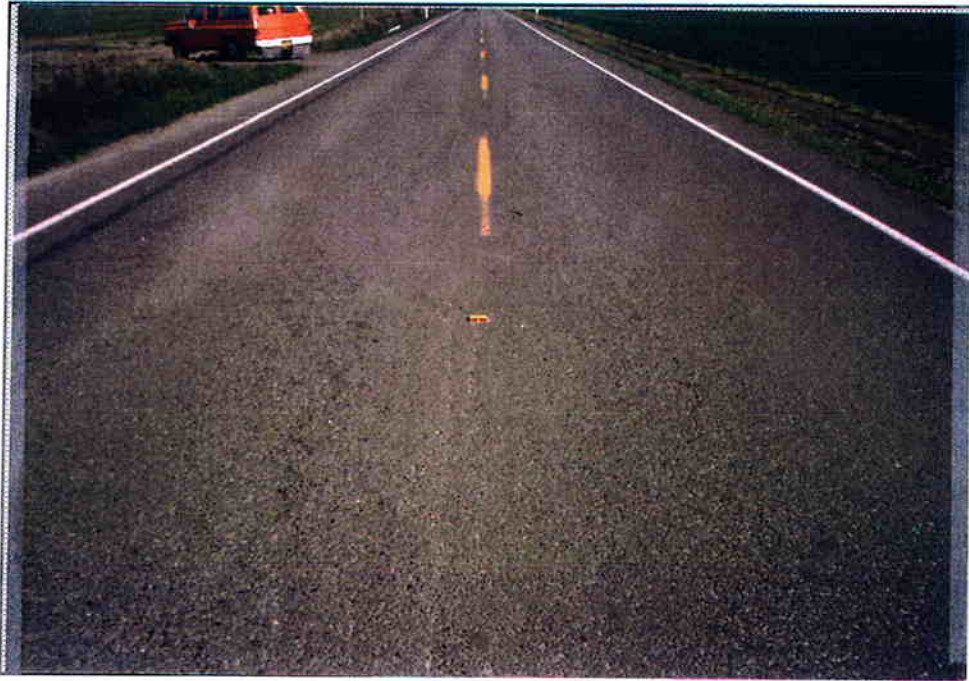
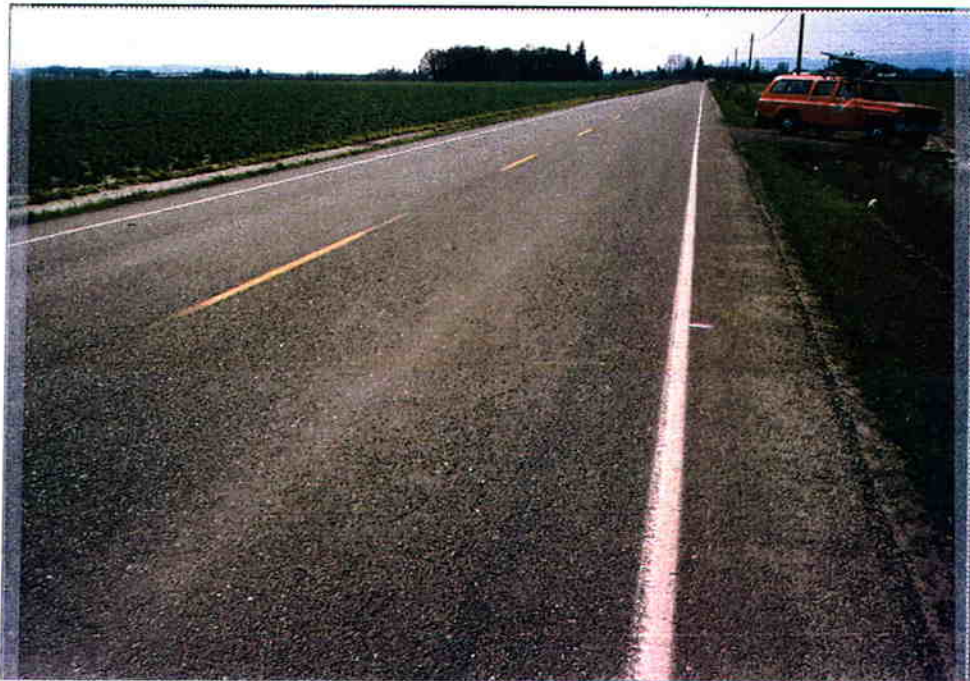
**Figure 4.3: Typical Pavement Condition After Eight Years of Service in 1985**

It should be noted that by 1985, the pavement had carried approximately 270,000 EAL's, which is almost twice the design EAL's. By 1987, the pavement had received about 340,000 EAL's and was still in fair and serviceable condition. In 1989, after twelve years of service, a chip seal was applied to the pavement surface.
