# **A FITNESS-FOR-PURPOSE EVALUATION OF ELECTRO-SLAG FLANGE BUTT WELDS**

## **FINAL REPORT**

**April 2002**

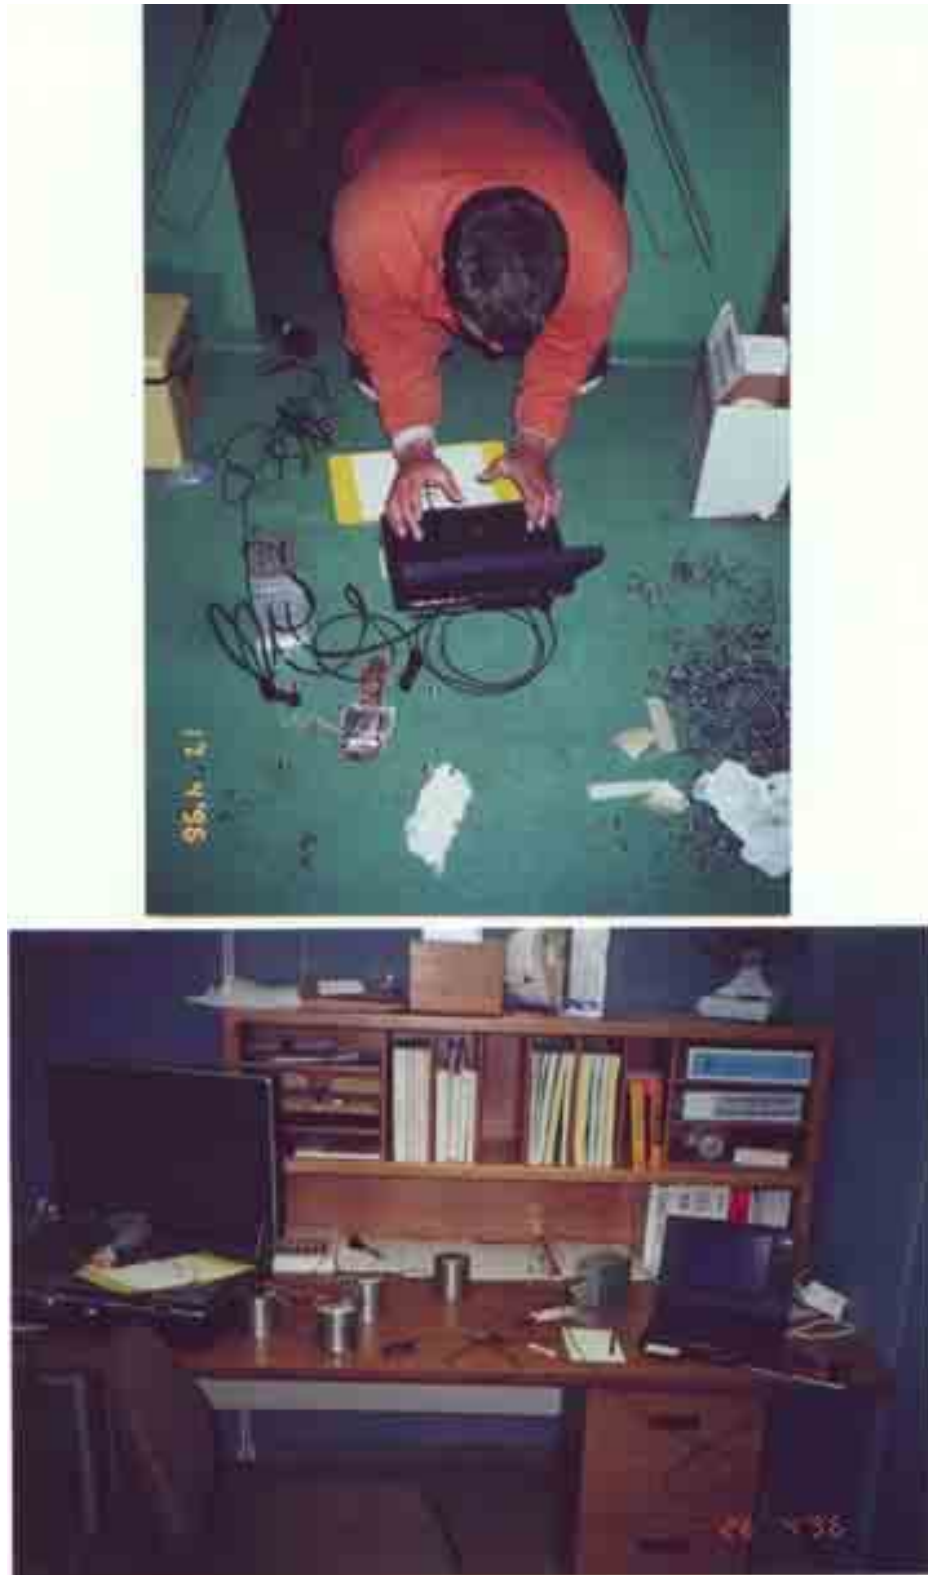
Figure 2.17 shows core strain measurements before and after removal from the compression flanges. Figure 2.18 shows one of the strain rosettes being read during the hole-drilling method (E837) of residual stress measurement.

Figure 2.17: Weld metal core strain measurements. Top photo shows gauge reading prior to core removal and bottom photo shows strain measurements after cores were removed from flange ESW.

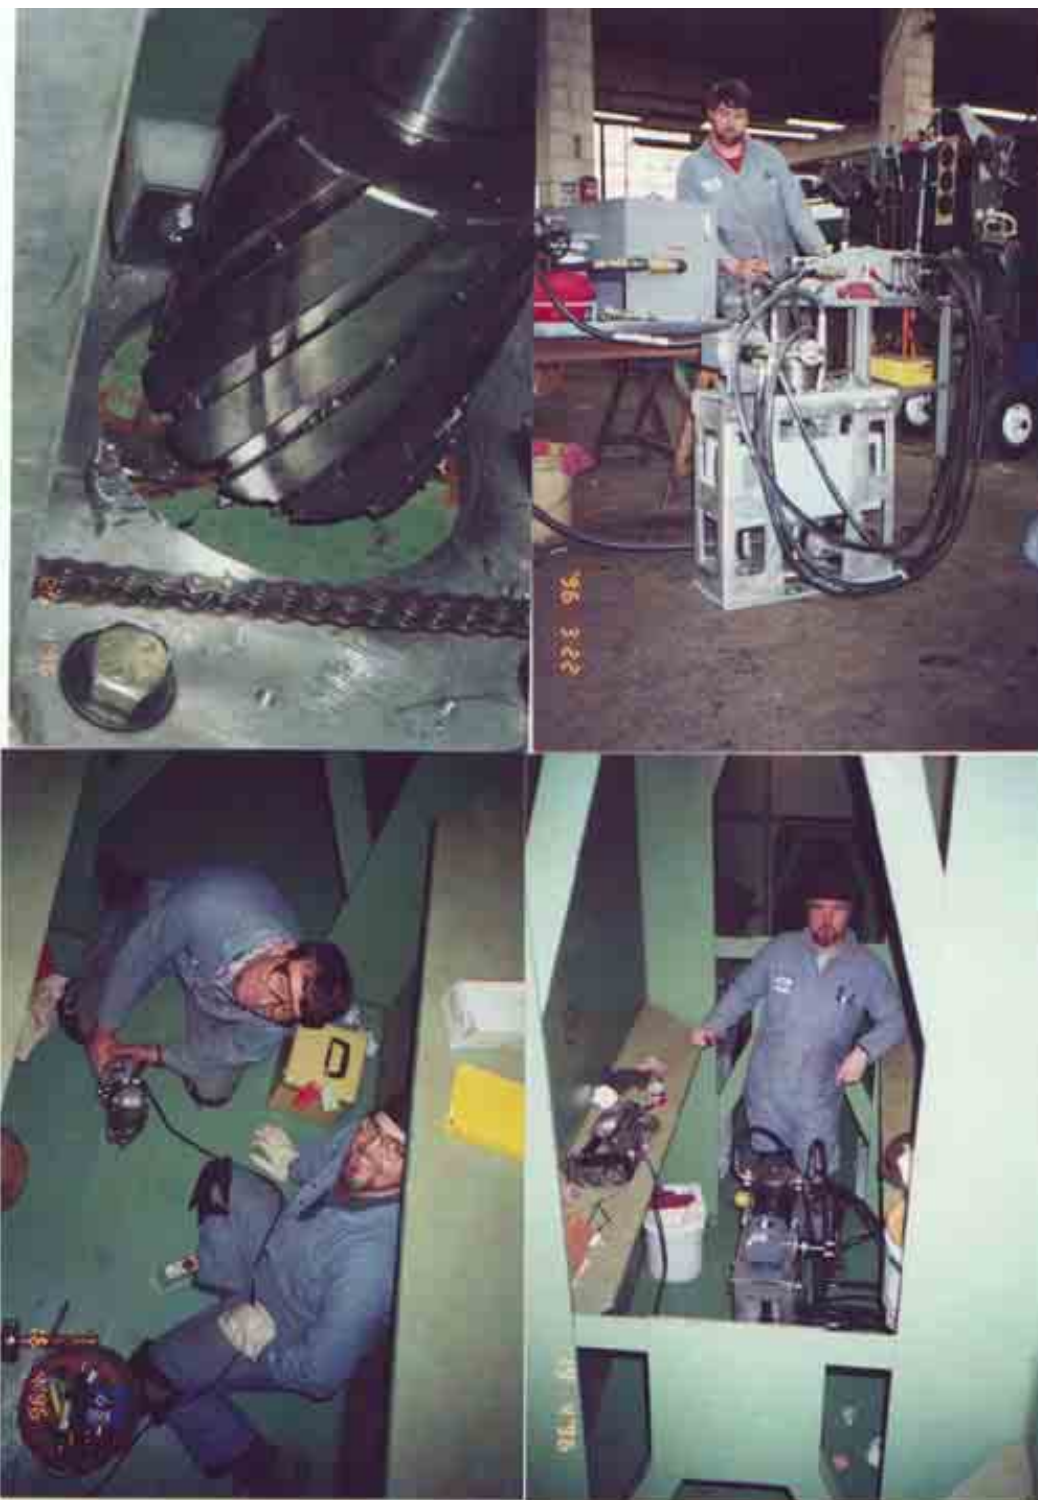
Figure 3.1: Coring ESW for material testing: 1) top left: close-up view of 4-inch diameter cutter; 2) top right: custom built drill; 3) bottom left: drilling and tapping mounting holes; 4) drill in place ready to core

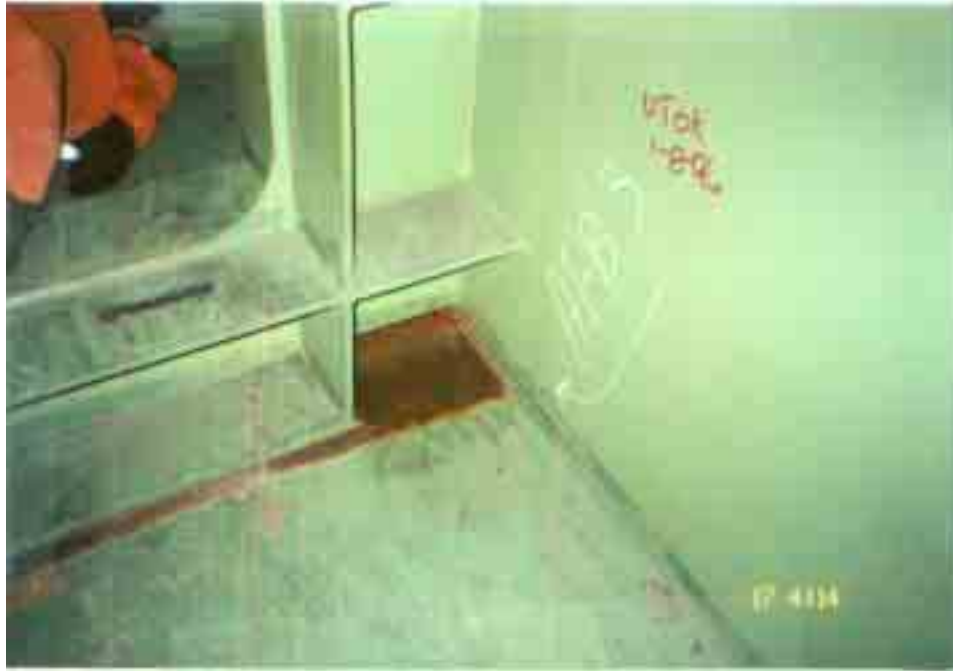
It should be noted that there is a fatigue Category E' detail fabricated into the box girders. At the access hole in each diaphragm, a 3/4 inch thick plate has been welded to the bottom flange. Figure 5.4 shows a picture of one of these details. The CAFL for Category E' is 1.3 ksi, which, using the above procedures, is predicted to have a finite fatigue life because the maximum stress range measured exceeds the CAFL. Using an effective stress range of 1000 psi and an ADTT per direction of traffic of 3500, the estimated remaining fatigue life of these details is 280 years. None of these details is attached to an ESW in this structure and thus does not effect the fatigue lives of the welds in question.

Figure 5.4: Fatigue Category E' detail found in box girders at diaphragm connection to flange. The detail does not effect the butt welds.
